Inspection Report

Property Address:
2064 Brookmont Dr
Conroe TX 77303

PROPERTY INSPECTION REPORT

By: Derrick McMullen 7117 / AK Inspection Services/AK Termite and Pest Control
1/13/2021
(Name and License Number of Inspector) (Date)

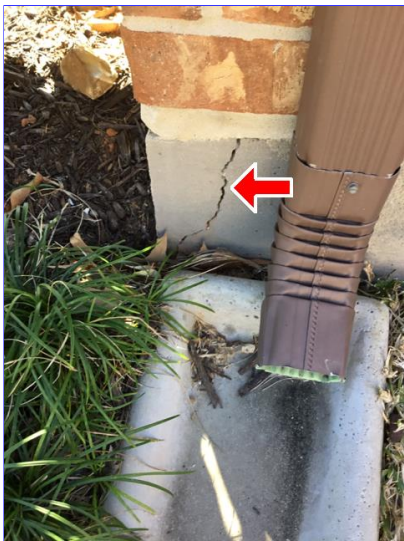
A. Item 1(Picture)

(2) Maintenance: Spalling found within 12" of the foundation's corners may occur because of bonds between the brick and brick ledge and differential thermal movement. Spalling was noted at self-evident corners. This damage did not appear structurally significant and was not in need of repair at the time of this inspection. (other than possibly sealing the cracks) Item 1(Picture)

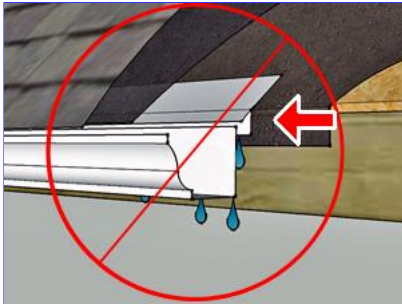
C. Item 1(Picture)

(1) The gutters have been improperly installed in respect to the edge flashing. The edge flashing material should overlap the edge of the gutter to prevent water from draining behind the gutter. (per shingle manufacturers) Item 1(Picture) Item 2(Picture)

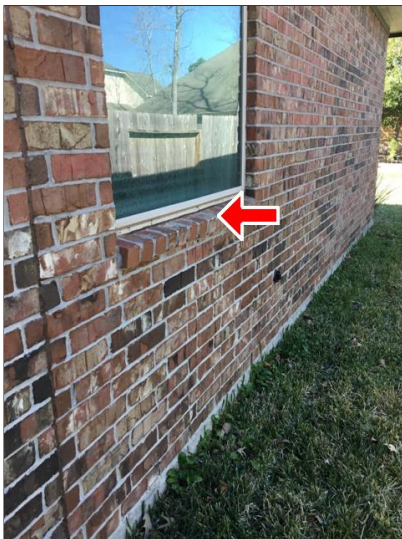
H. Item 1(Picture)

The brick ledges at the windows were improperly sloped. Per the brick institute of America, the bricks should be installed at a minimum slope of 15 degrees, however, the majority of the ledges are sloped approximately 5 degrees. Item 1(Picture)

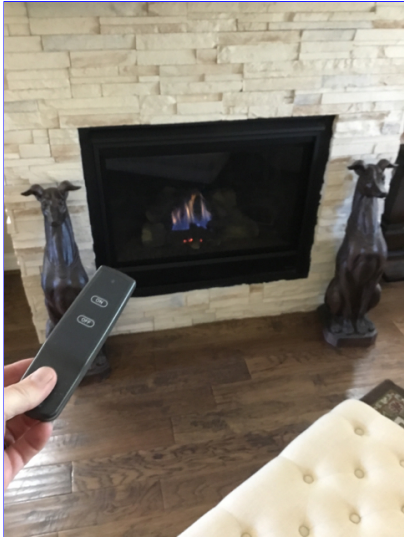
J. Item 1(Picture)

Photo of fireplace: Item 1(Picture)

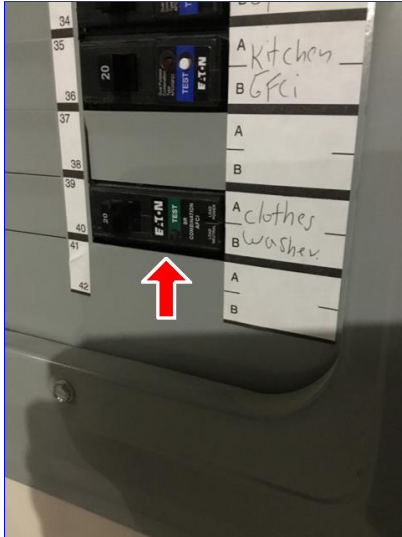
B. Item 1(Picture)

(1) The receptacles in the laundry room were not GFCI protected. Receptacles in a laundry room should be GFCI protected. (an AFCI breaker was provided. The receptacles should be provided a dual function AFCI/GFCI breaker). Item 1(Picture)

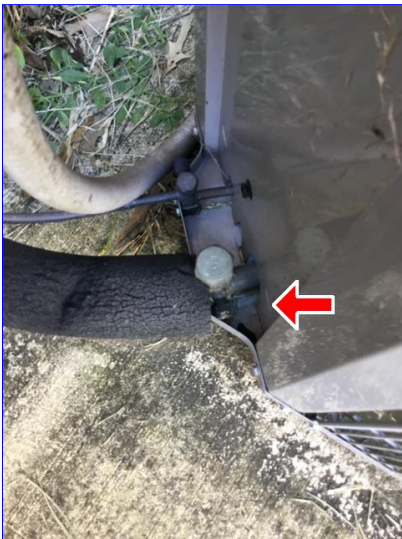
B. Item 1(Picture)

(1) The caps provided on the service valves on the condenser unit(s) were not locking type. The caps should be replaced. M1411.8 Locking access port caps. Refrigerant circuit access ports located outdoors shall be fitted with locking-type tamper-resistant caps or shall be otherwise secured to prevent unauthorized access. Item 1(Picture)

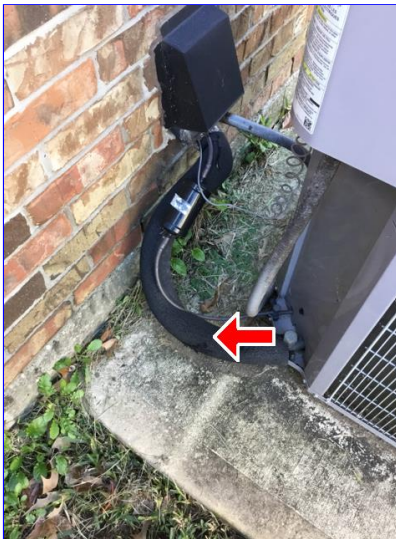
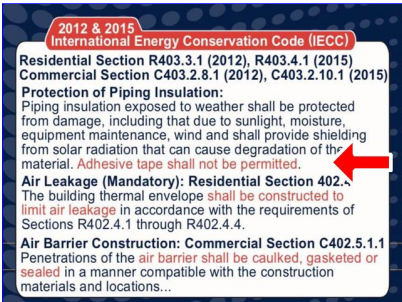
The insulation was found to be damaged on the refrigerant lines between the condenser units and the house. The insulation should be repaired/replaced. Item 2(Picture) Item 3(Picture)

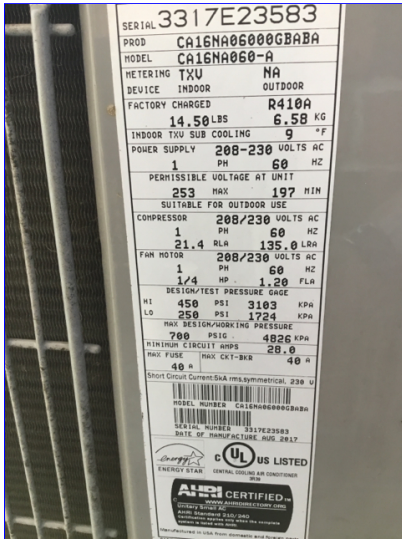
B. Item 4(Picture)

The condenser unit appeared to be manufactured in: 2017. Item 4(Picture)

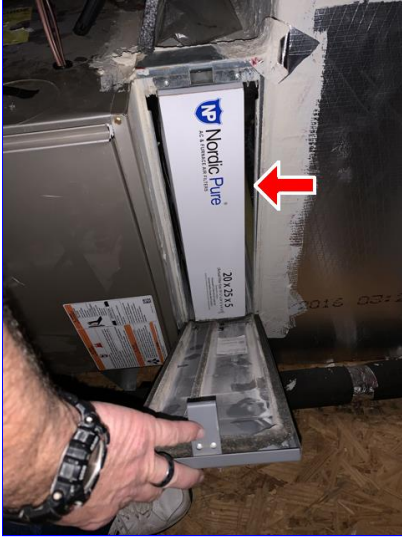
C. Item 1(Picture)

The filter was provided in the air handler, in the attic. Item 1(Picture)

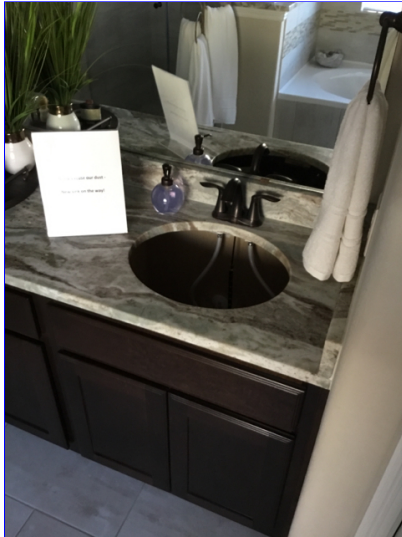
A. Item 1(Picture)

(1) A sink was not provided at the back of the counter in the master bathroom. The faucet and drains were not tested as a result. Item 1(Picture)

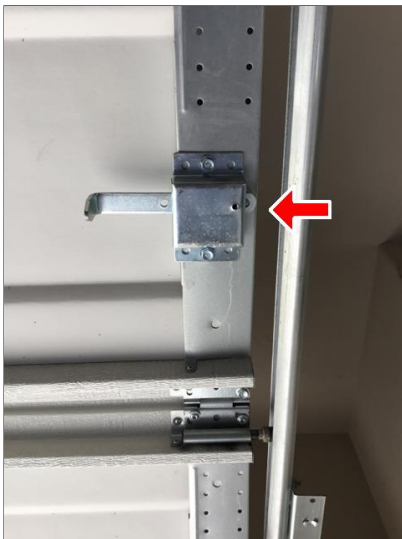
G. Item 1(Picture)

The latching mechanism(s) on the garage door(s) should be disabled to prevent damage to the doors or openers. Item 1(Picture)
