Inspection Report

LOCATED AT:
29222 Waltham St
Spring, TX 77386

INSPECTED ON:
Tuesday, May 10, 2022

Inspector, Justin Vincent, TREC # 24206;
A Plus Inspections Of Texas

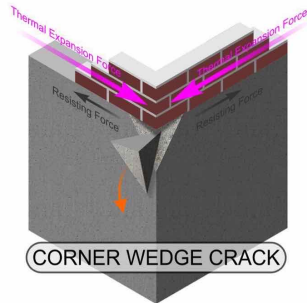
IMPR Corner pops were present, which are fairly common and seen at a majority of homes with slab foundations. Normally these are not structural, but may allow for concealed subterranean termite infestation. It is recommended that the soil at these locations be treated periodically by a qualified pest control contractor to help prevent infestation.

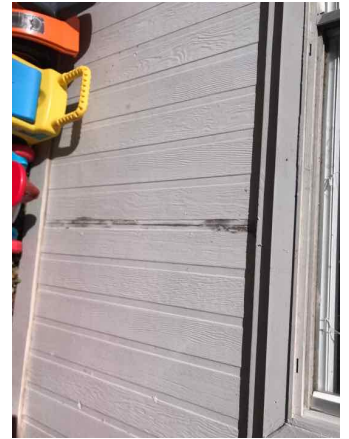
REP The exterior siding and trim had limited gaps, deterioration, and irregularities, that could be repaired.
