# PROPERTY INSPECTION REPORT

Concerning: 15123 Green Whisper Dr, Cypress TX 77433

By: Dan Richter - TREC#21351

01/07/2020 9:00 am

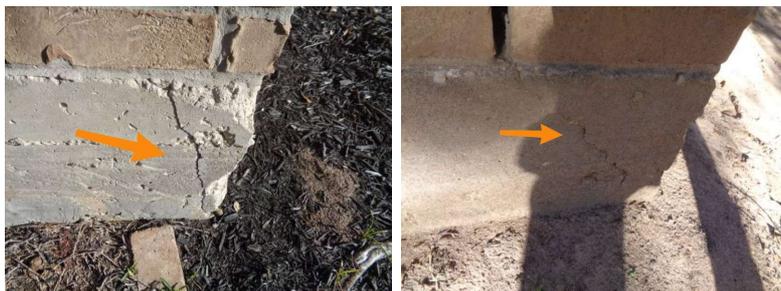
### 1: Corner Cracks

Some corner cracks were present on some corners. These should be properly sealed and monitored.

Recommendation: Contact a qualified professional.

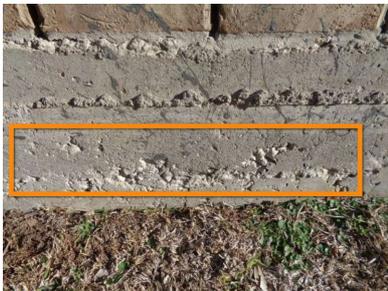
**3: Honeycombing**

There were some areas around the foundation that showed signs of honeycombing. It did not appear to be affecting the structural integrity of the foundation and no exposed steel was observed. These areas should be properly repaired.

Recommendation: Contact a qualified professional.

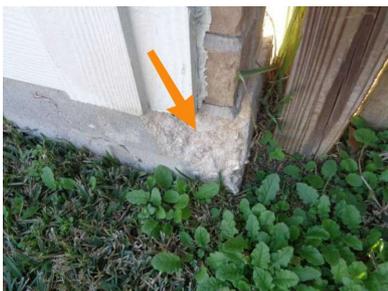
**4: Concrete Missing**

A small chunk of concrete was missing from the perimeter of the foundation at the left rear corner. Recommend this area be properly repaired.

Recommendation: Contact a qualified professional.

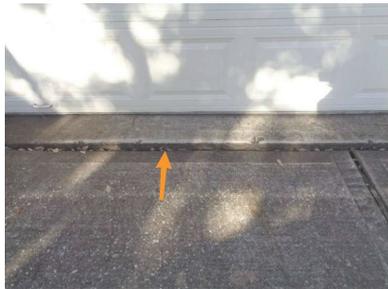
Flatwork around the home appeared to be uneven. This presents a possible trip hazard.

Recommendation: Contact a qualified professional.

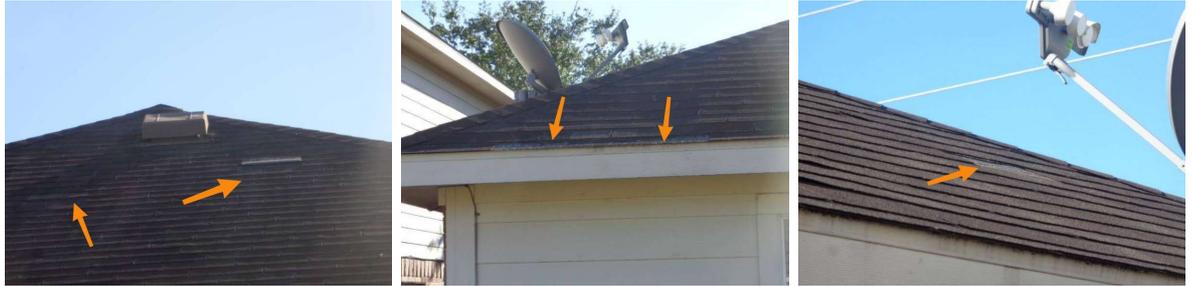
**2: Damaged Shingles**

Damage to shingles were observed around the roof surface.

Recommendation: Contact a qualified roofing professional.

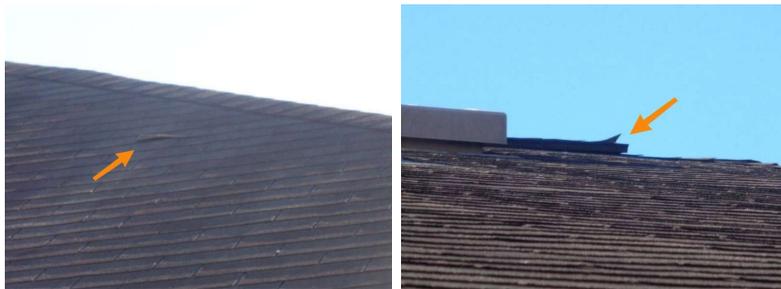
Shingles were slightly lifted on the roof surface.

Recommendation: Contact a qualified roofing professional.

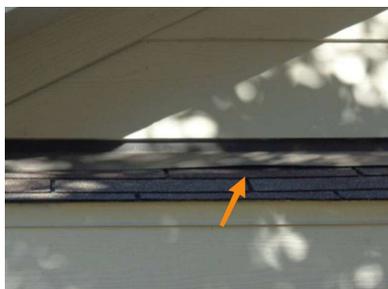
**5: Flashing not Flush**

Flashing was not flush with the roof surface.

Recommendation: Contact a qualified roofing professional.

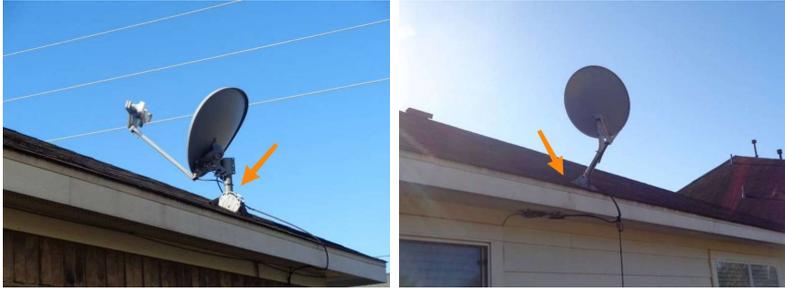
Satellite dish brackets were installed directly through the shingles. We do not recommend fastening the brackets through the shingles. This should be corrected and/or monitored for leaks.

Recommendation: Contact a qualified roofing professional.

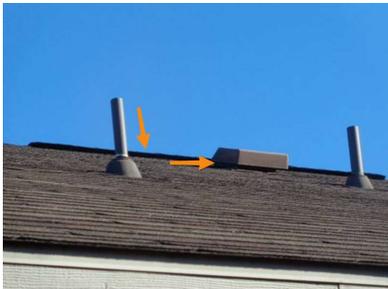
**2: Unlike Exhaust Vents**

Static exhaust vents were observed on the upper roof lines that appeared to be installed lower than and/or in conjunction with the ridge exhaust vents. Though air flow patterns were not measured or observed, most roof ventilation manufacturers recommend that all exhaust vents be installed at the same level and be of the same type as this could cause a short circuit of proper air flow in the attic. See article from Lomanco Vents [HERE](#).

Recommendation: Contact a qualified professional.

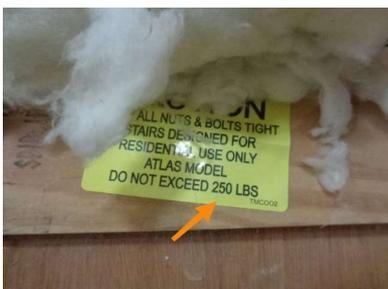
**3: Attic Access Ladder**

Attic access ladder was not rated for 350 lbs.

Recommendation: Contact a qualified professional.

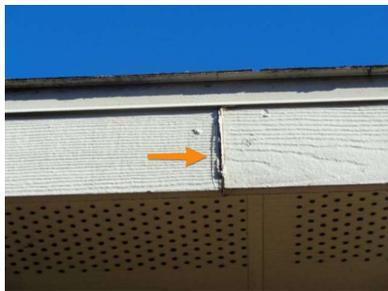
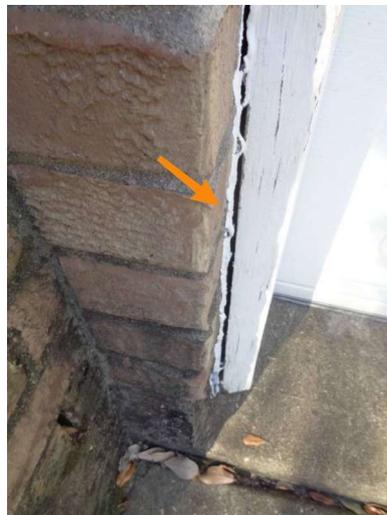
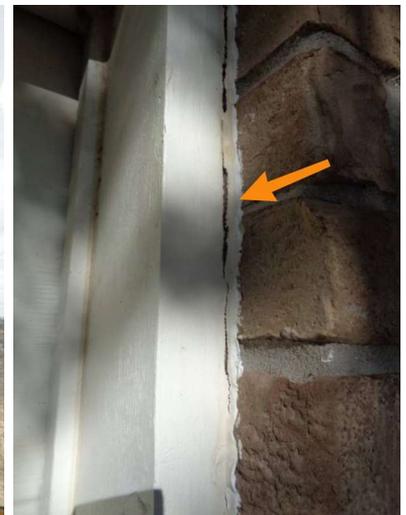
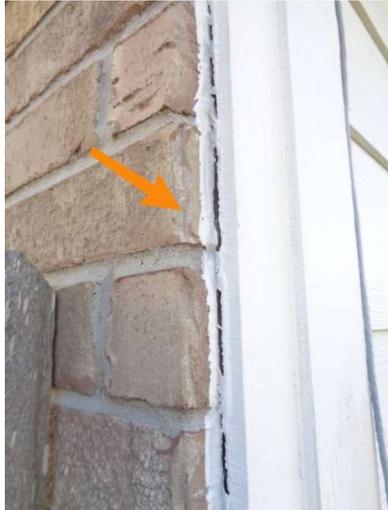
Exterior wall gaps were observed. All exterior wall penetrations, changes of materials and direction should be properly sealed to prevent water and pest intrusion.

Recommendation: Contact a qualified professional.

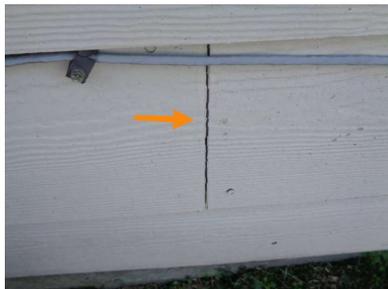
**2: Siding Not Sealed**

Exterior wall gaps were observed. Most notably at siding seams and/or nail heads. Fiber cement siding manufacturers recommend all gaps be sealed. All exterior wall penetrations, changes of materials and direction should be properly sealed to prevent water and pest intrusion.

Recommendation: Contact a qualified professional.

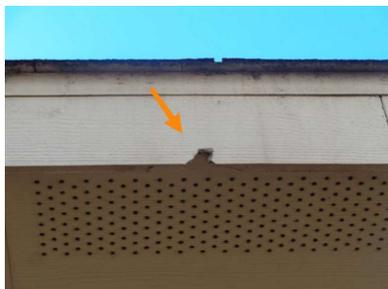
**3: Damaged Siding**

Damaged siding was observed around the home.

Recommendation: Contact a qualified professional.

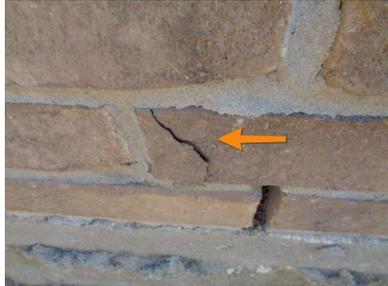
**4: Mortar/Brick Cracks**

Some mortar/brick cracks were noted around house. In our opinion, there did not appear to be excessive amounts deflection or settlement in these areas. These should be properly sealed and monitored.

Recommendation: Contact a qualified professional.

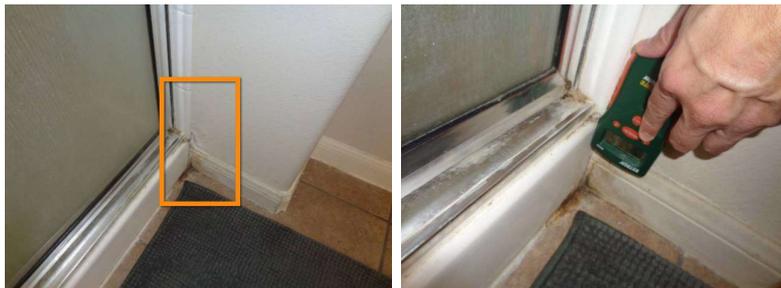
**6: Active Elevated Moisture**

Evidence of active elevated moisture was detected in the home. Most notably at the left front bathroom wall at the bottom of/next to the shower door. It appeared that the shower door leaks slightly at the bottom an excessive moisture was getting on wall. Excessive moisture was detected visually and with moisture meter.

Recommendation: Contact a qualified professional.

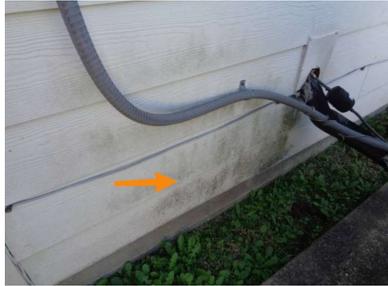
**7: Wall Stains - Exterior**

Evidence of possible wall stains were noted around the exterior walls of the home.

Recommendation: Contact a qualified professional.

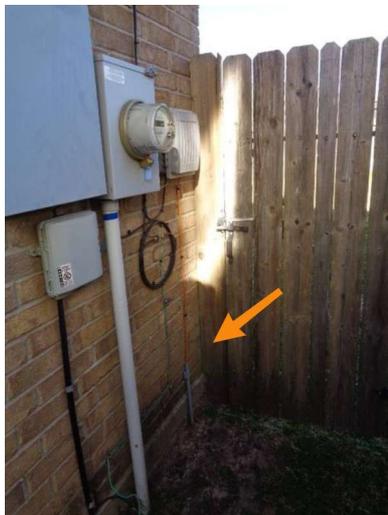
**8: Fence on Walls**

Wood fence was contacting the exterior walls. This could be conducive condition for wood destroying insects.

Recommendation: Contact a qualified professional.

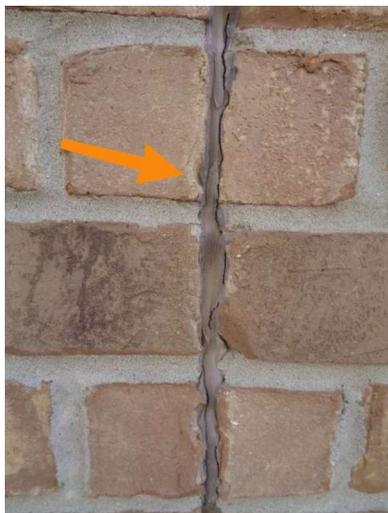
**9: Expansion Joint Filler**

Expansion joint filler showed signs of deterioration. Expansion joints should be properly sealed around the home.

Recommendation: Contact a qualified professional.

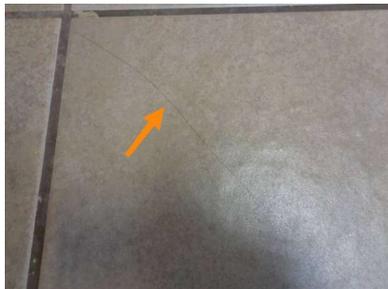
Some tile floor cracks were observed around the home. In our opinion, there did not appear to be excessive deflection or settlement in these areas. These should be properly sealed and monitored.

Recommendation: Contact a qualified professional.

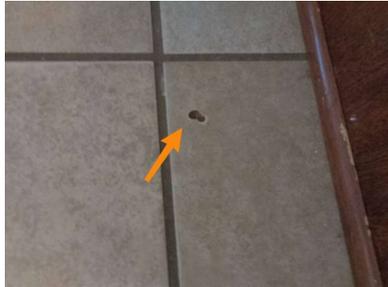
**4: Damaged Floor Tile**

Damaged/chipped floor tile was observed.

Recommendation: Contact a qualified professional.

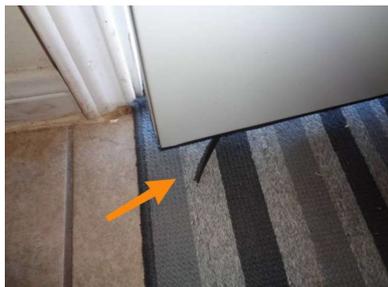
Weatherstripping was worn at the bottom of the rear exterior door.

Recommendation: Contact a qualified professional.

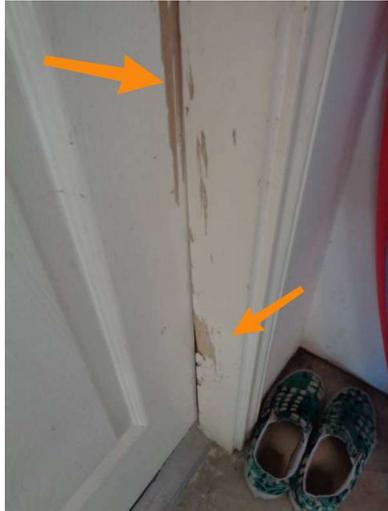
Garage entry door and door frame were slightly damaged..

Recommendation: Contact a qualified professional.

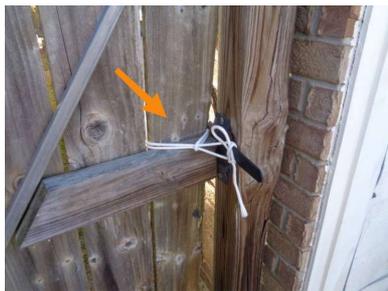
**5: Right Yard Gate**

Right yard wood gate was not latching properly.

Recommendation: Contact a qualified professional.

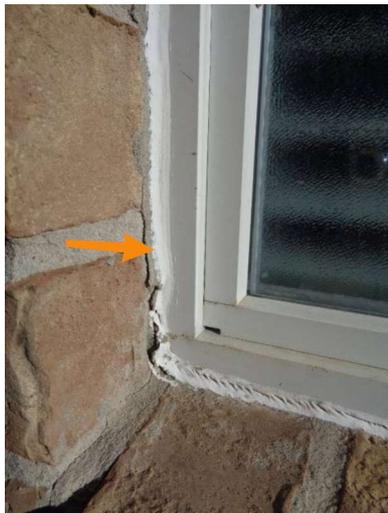
Some windows were not completely sealed around the exterior framing.

Recommendation: Contact a qualified professional.

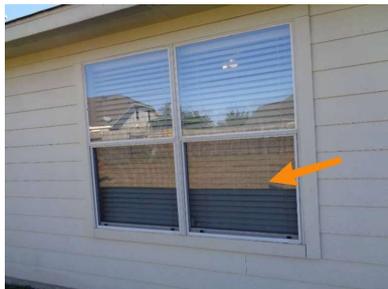
**3: Window Seal Compromised**

Window(s) appeared to be stained on the interior of the window between the panes. This may indicate that the window seal has been compromised. Recommend further evaluation by a window professional.

Recommendation: Contact a qualified professional.

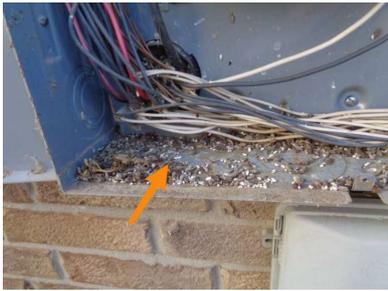
There was debris on the interior of the distribution panel.

Recommendation: Contact a qualified professional.

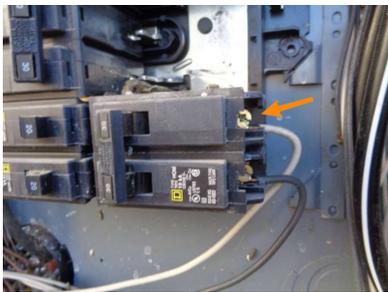
**4: White Hot Wires**

There were white wires connected to breakers that appeared to be used as hot wires in the panel. Typically white wires should be designated as neutral only.

Recommendation: Contact a qualified electrical contractor.

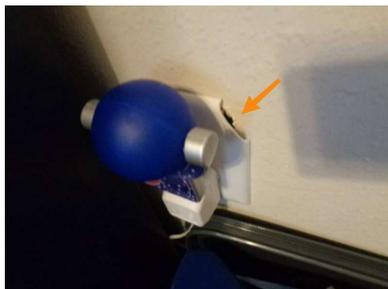
Outlet cover was cracked/damaged in the right rear bedroom.

Recommendation: Contact a qualified professional.

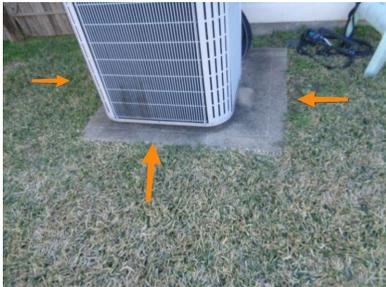
Condensing unit was not elevated enough. Common building code requires condensers to be elevated at least 3" from the ground.

Recommendation: Contact a qualified professional.

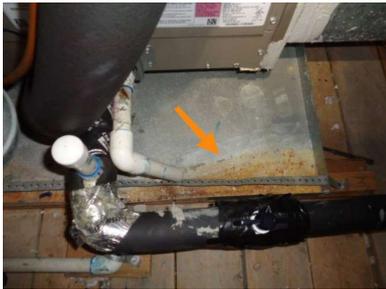
**3: Water/Rust Stains**

Evidence of possible water/rust stains were observed in the secondary evaporator drain pan. We suspect this is the old drain pan, however this could be a sign of improper drainage of the main drain line. Recommend that unit(s) be evaluated and serviced by a qualified, licensed HVAC professional.

Recommendation: Contact a qualified heating and cooling contractor

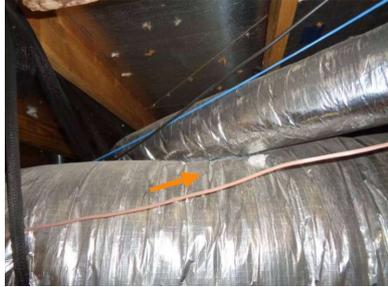
Some air ducts did not appear to be properly supported and were laying on insulation and/or contacting other ducts.

Recommendation: Contact a qualified professional.

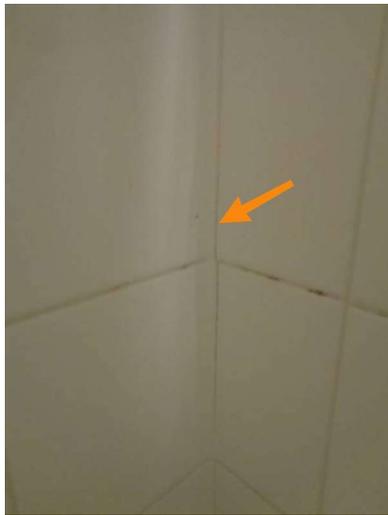
Shower enclosure(s) were not properly sealed in the home.

Recommendation: Contact a qualified professional.
