Discovery Home Inspection Services

Property Inspection Report

6333 MADISON, GROVES, TX 77619
Inspection prepared for: MICHAEL ROBERTS
Real Estate Agent: John Arcana - Re/Max ~ One Beaumont

Date of Inspection: 4/21/2020 Time: 10:30am
Age of Home: 50+ yrs Size: 2400+/- sf
Weather: clear, 70's

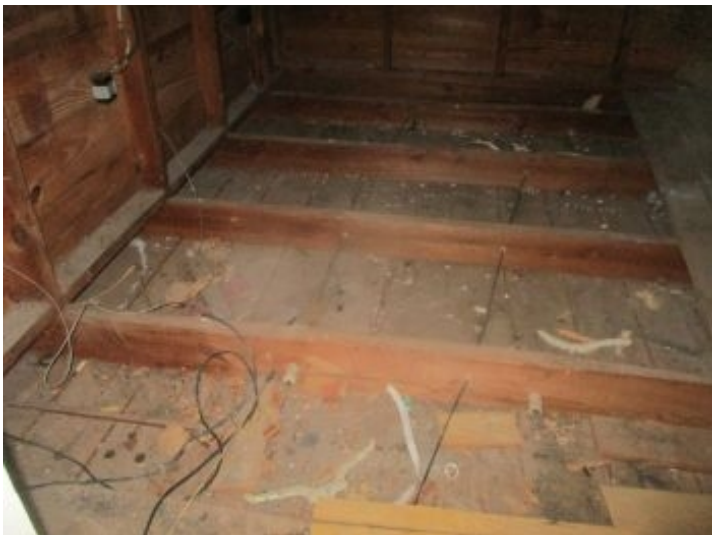
No attic floor and wall insulation observed in upper wall scuttle area.

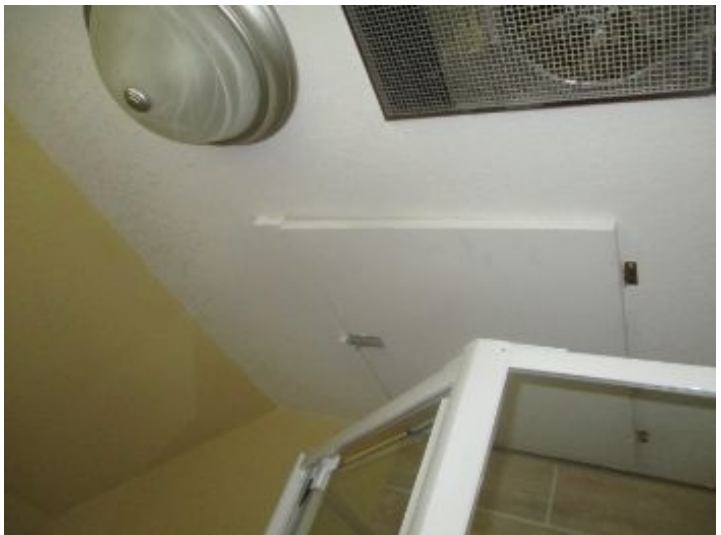
FYI: The upper attic is not accessible, shower structure prevents ceiling scuttle from opening. Upper attic is not inspected.

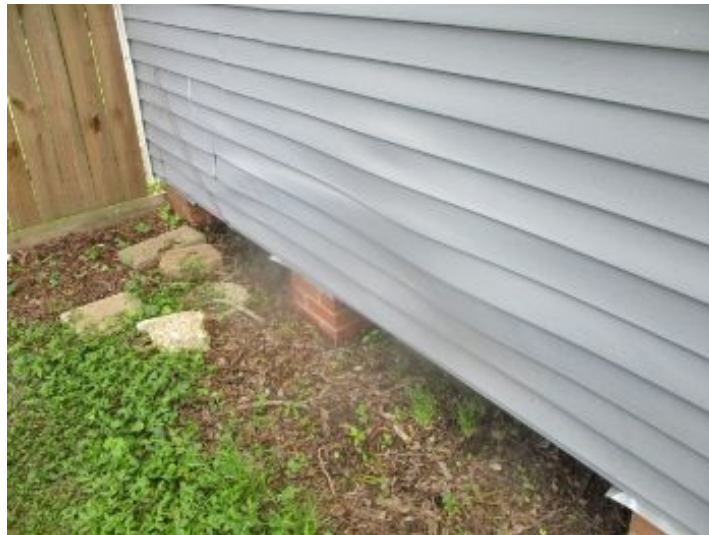
Warped exterior vinyl siding at left wall of home.

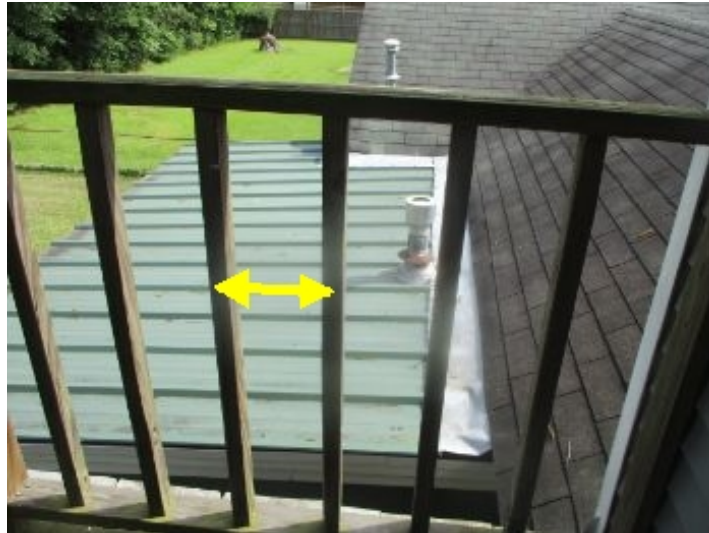
Opening between banisters at the upper hand railing is greater than 4 inches at exterior stairs, does not meet industry standards.

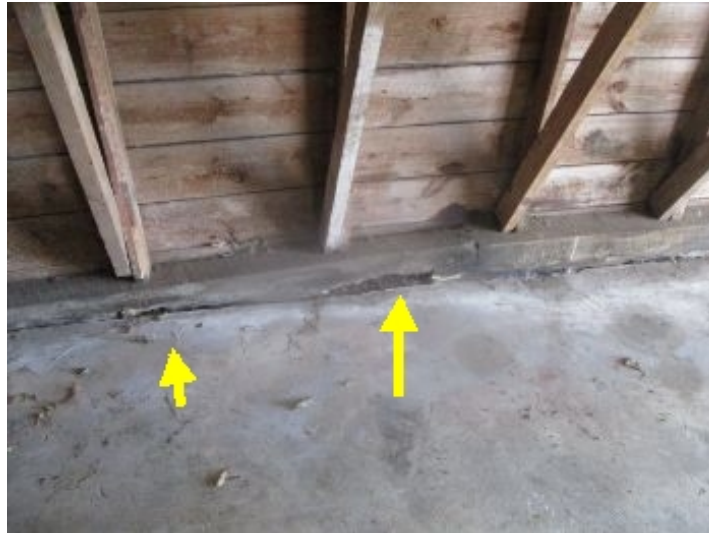
Rot to lower seal plates at garage.

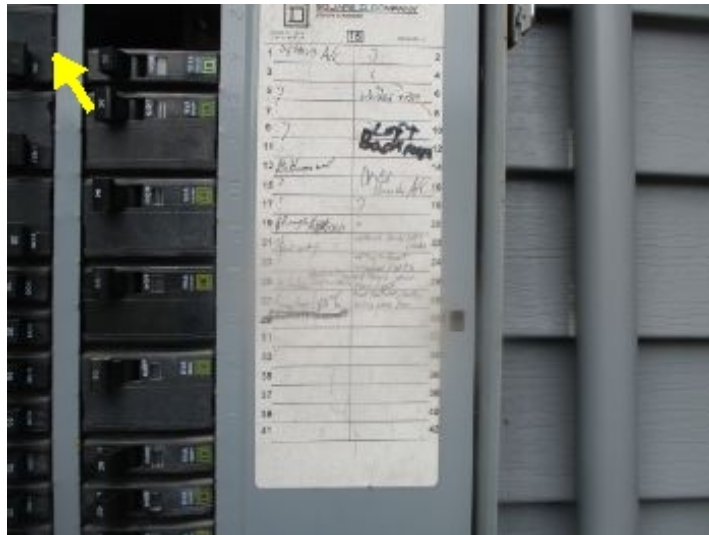
Knockout missing in dead plate panel, provide cover / cap to prevent insects or "other" items from ending into interior of panel.

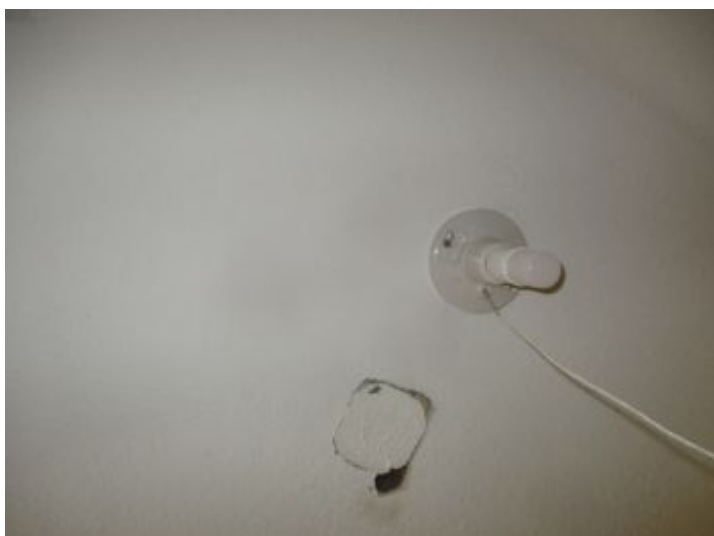
Kitchen pantry light did not function.

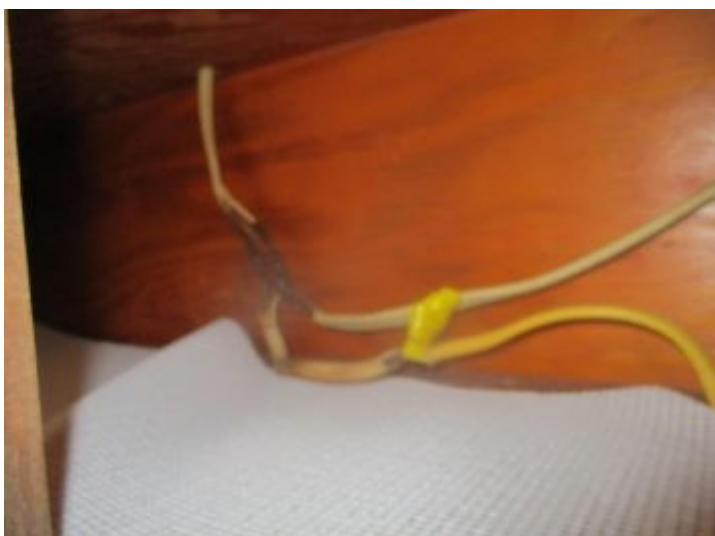
Exposed wire splices in kitchen cabinet above vent hood are required be in protected junction box for safety reasons.

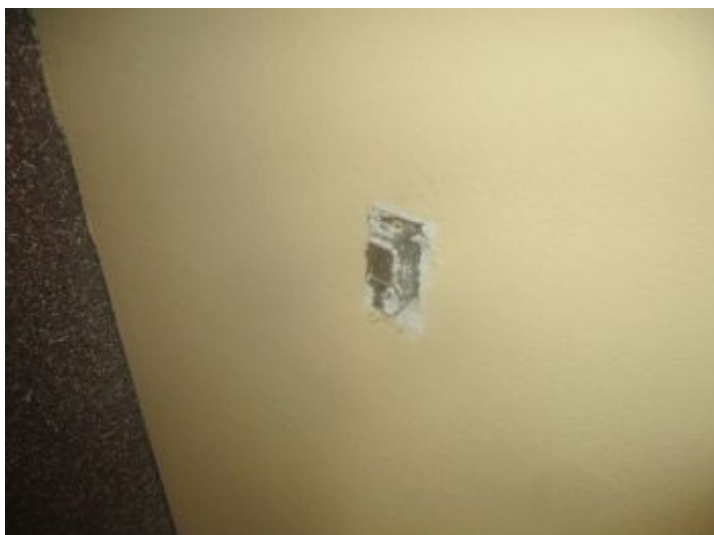
Loose wall receptacle at refrigerator.

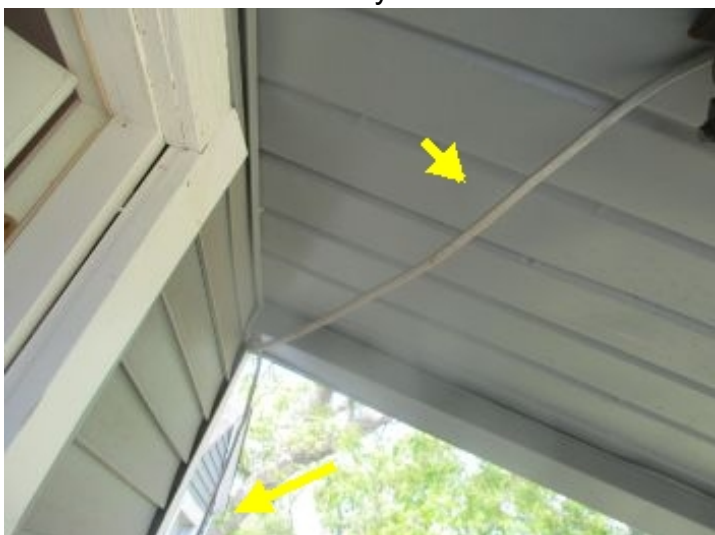
The exposed romex (electrical wire) at rear upper porch is required to be in protective conduit for safety reasons.

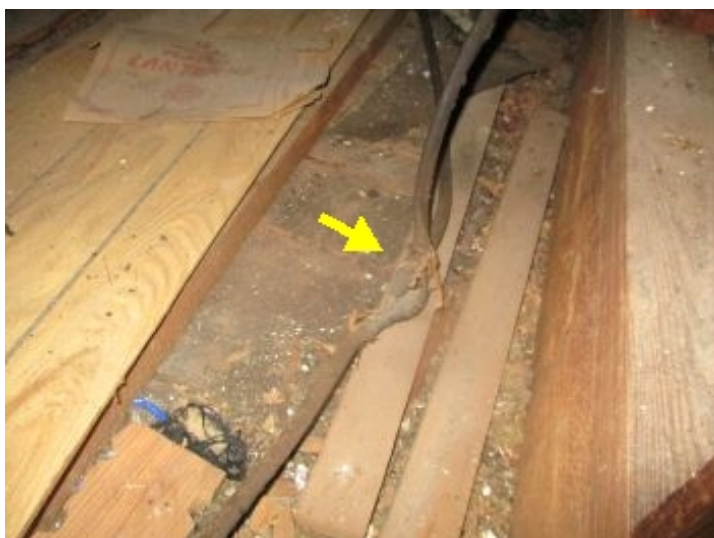
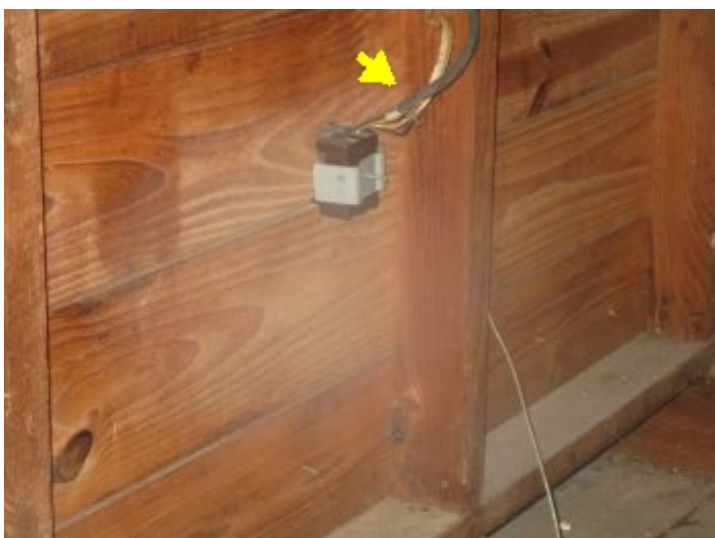
Exposed wire splices in attic areas are required be in protected junction box for safety reasons.

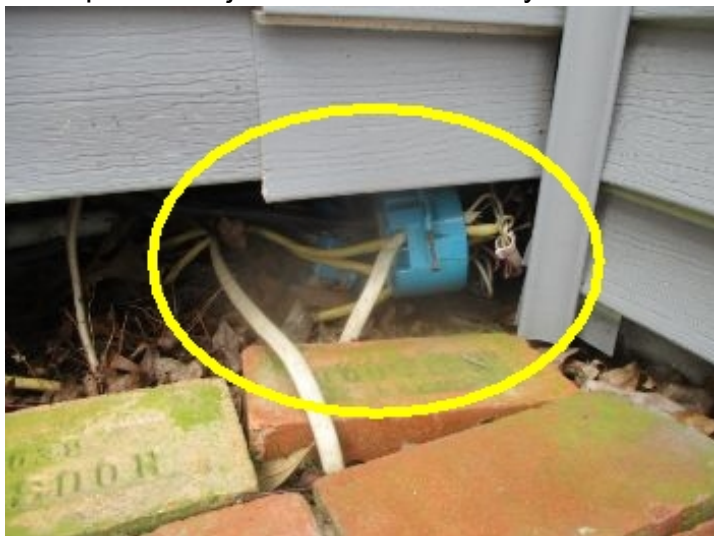
Open junction box with many exposed splices and exposed romex wire under home near breaker panel on right wall of home.

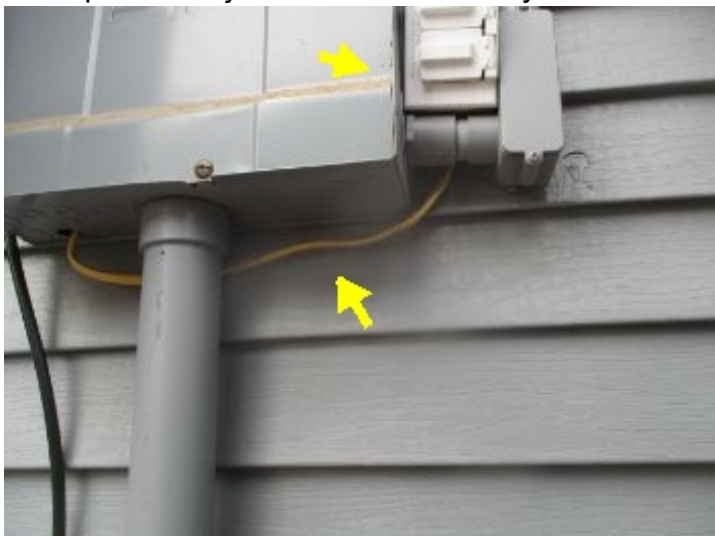
Loose exterior receptacle and exposed romex at exterior panel.

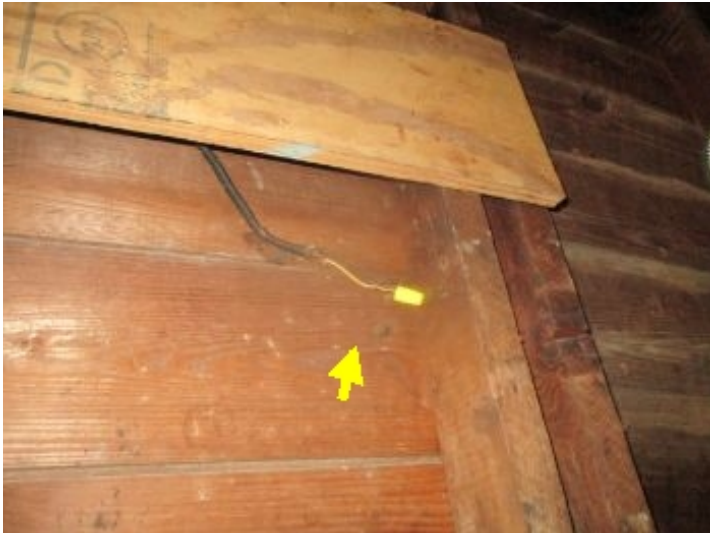
Non standard termination of romex (electrical wire) in garage.

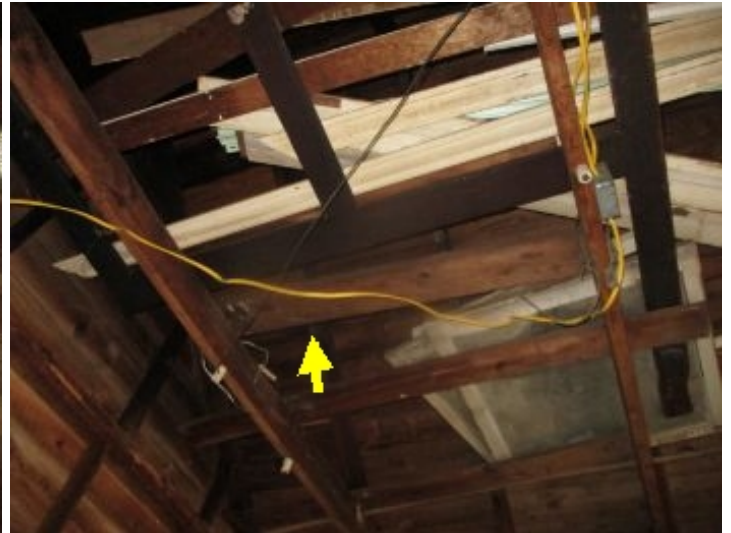
The exposed romex (electrical wire) in the garage area is required to be in protective conduit for safety reasons.

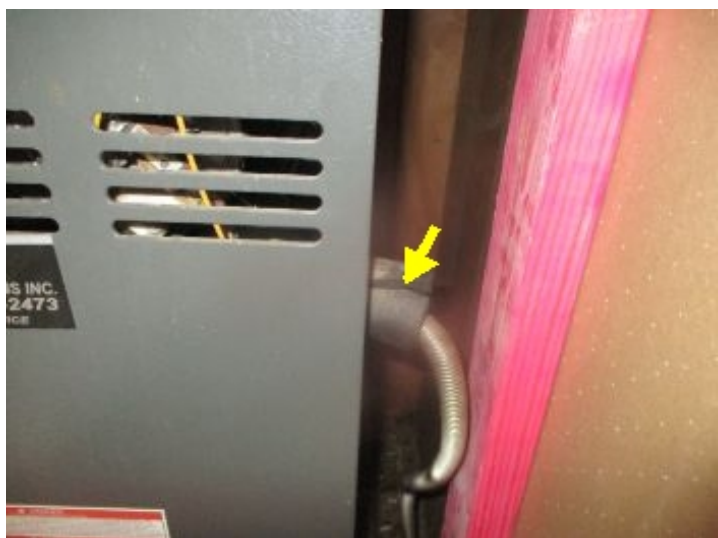
Lower: Use of flex gas line to the interior of housing, standards require hard pipe to be used inside of housing, does not meet industry standards.

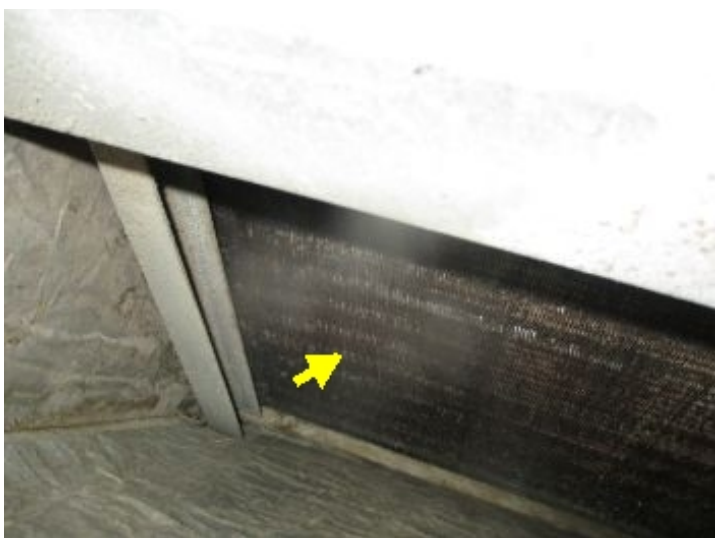
Coils are very dirty.

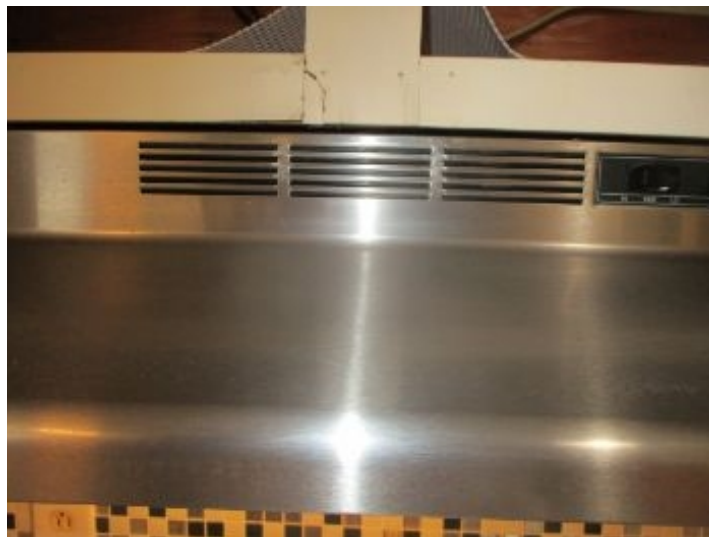
Blower has not been rotated to recirculate, blows to under side of cabinet above.

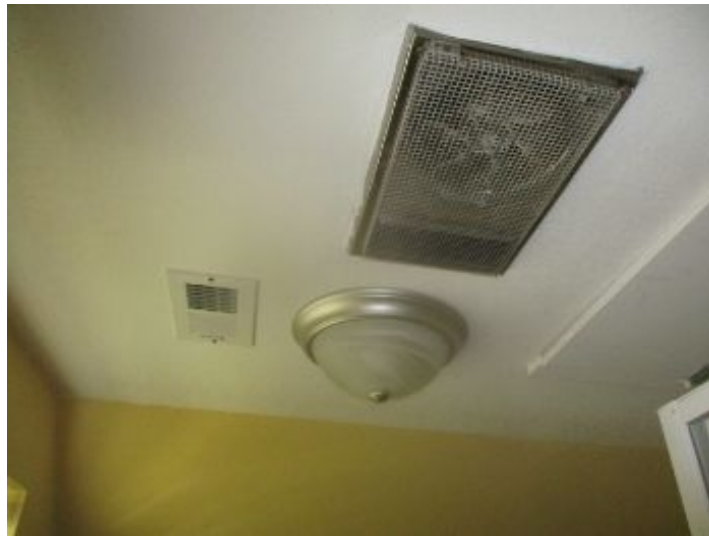
Heater / fan in upper bathroom did not function.
