DualCheck Inspections LLC
Effective.Efficient.Everytime

07/21/2022

PROPERTY INSPECTION REPORT FORM

Address of Inspected Property: 1023 Barkston Dr. Katy, TX

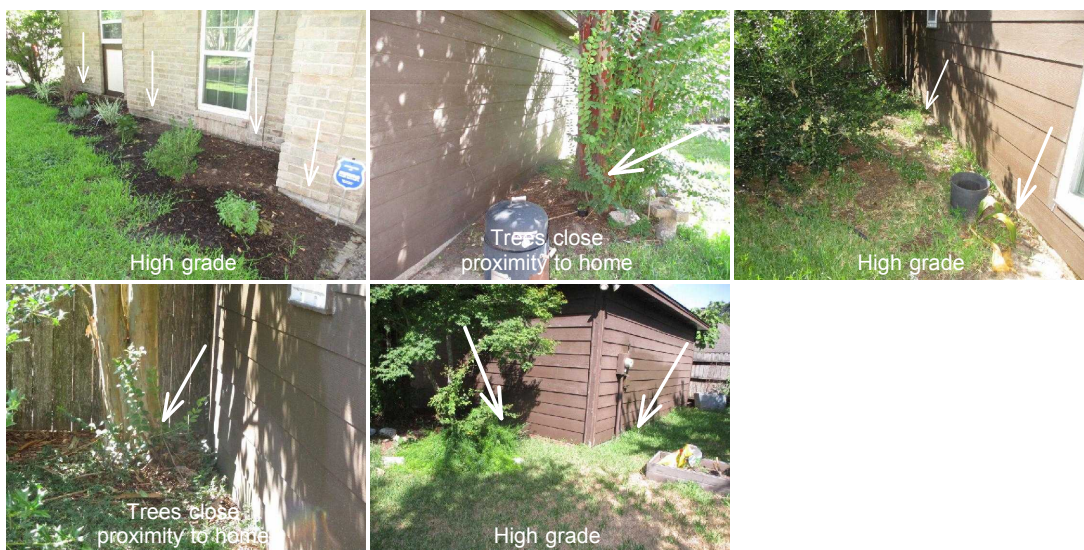
- The foundation walls should be exposed at a minimum 4" for masonry siding (Brick, Stone, Stucco), and a minimum of 6" for non-masonry siding material. Recommend removing excess grade for proper exposure and to assure proper drainage away from the foundation walls and to deter wood destroying insects.
- There were trees and exposed roots in close proximity to the foundation wall. Tree roots can cause uneven settling and movement, resulting in Foundation issues. Recommend removing trees that are within 10-15ft of the structure, to prevent future foundation problems.
- The foundation walls were not exposed at all locations and could not be visibly inspected.
- The foundation appears to be performing as intended at the time of the inspection, common settling was noticed.

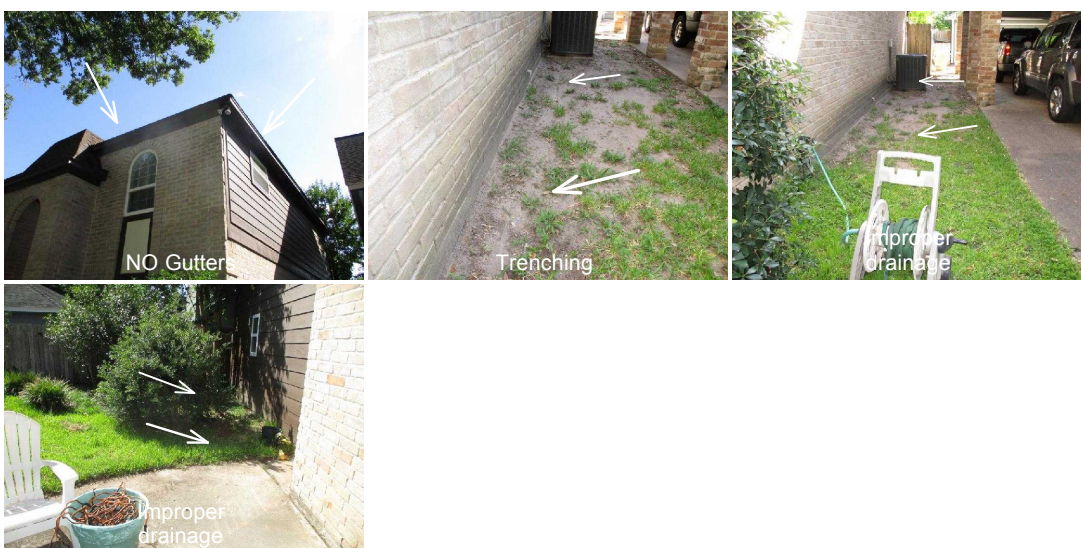
- There were no gutters installed on the home. Gutters are not required, however, they are highly encouraged to prevent erosion of the soil around the foundation. Install as needed.
- The lack of gutters on the home has resulted in erosion around the exposed foundation walls. Recommend installing gutters to prevent further trenching around the structure.
- There appears to be improper grading and drainage of the property at the right and rear side of the structure. The property should be graded so that surface water will drain away from foundation walls at a minimum slope of 6" within 10'. Lot drainage should divert to the street as to not create a hazard on the property.

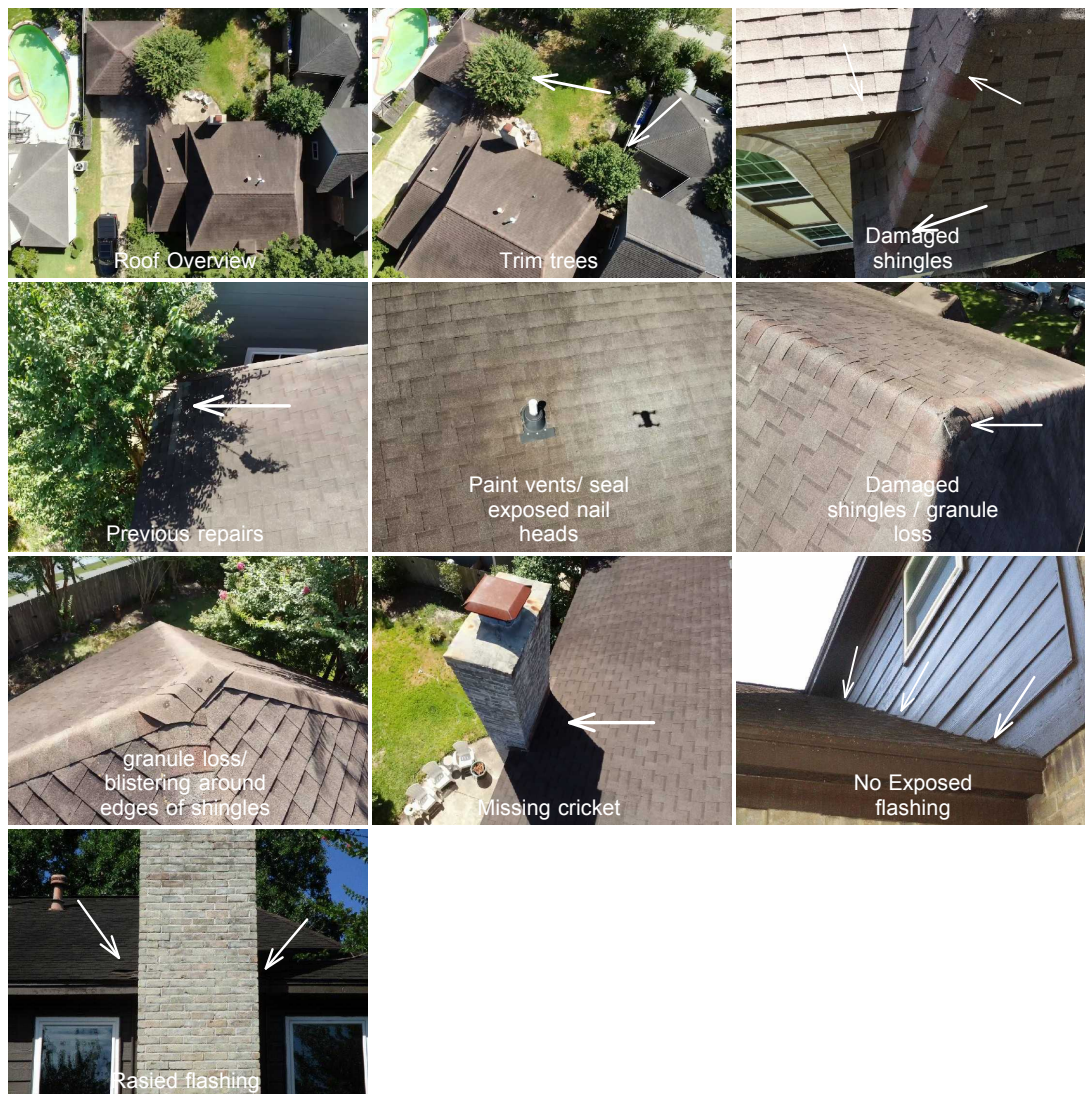
- Trees were observed to be in contact with the roof surface. Recommend trimming trees to give 36" clearance to prevent rapid deterioration of the roof covering material. Correct as needed.
- Several areas at the roof were noticed to have damaged, loose or missing shingles. Repair/Replace as needed.
- Previous repairs were observed at the roof surface. Possibly from previous leaks or damage due to trees.
- All vents, plumbing stacks, and flashing are required to be painted to prevent rapid deterioration from UV and weather exposure. Paint as needed.
- Exposed nail heads were observed at the roof surface and vents. Recommend sealing all exposed nail heads to prevent moisture penetration into the attic space. Correct as needed.

- There should be a 2" space of exposed underlying flashing where the exterior siding meets the roof surface. The spacing allows for visual inspection of the flashing and to prevent rapid deterioration of the siding and roof covering. Repair/Replace as needed.

- Raised flashing was observed at several locations on the roof. flashing helps prevent moisture penetration and should be sealed periodically as a part of regular homeowner maintenance. Repair and seal as needed.

- The shingles were observed to be showing signs of deterioration consistent with the age of the roof covering. The shingles were noticed to have granule loss and blistering around the edges. Recommend a licensed and insured roofer evaluate the roof to provide an accurate life expectancy of the roof covering material.

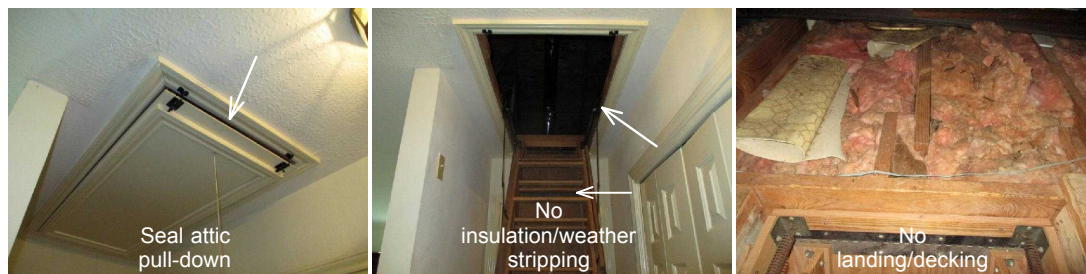
- The attic access door would not seal properly. Recommend adjustment/repair to prevent AC/heat loss.
- The pull down attic access door was not insulated. Recommend installing insulation or a properly rated cover to prevent AC/heat loss.
- There was no decking/landing at the top of the attic access ladder, making it hard to access the attic space. Correct as needed.

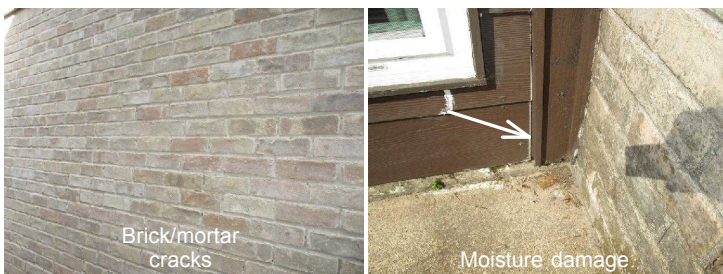
- Several brick cracks were observed at the exterior masonry siding. These appear to be from settling/movement, No structural issues were observed at the time of the inspection.
- There were areas of moisture damage at the exterior wood siding. Repair/replace as needed to prevent further deterioration.

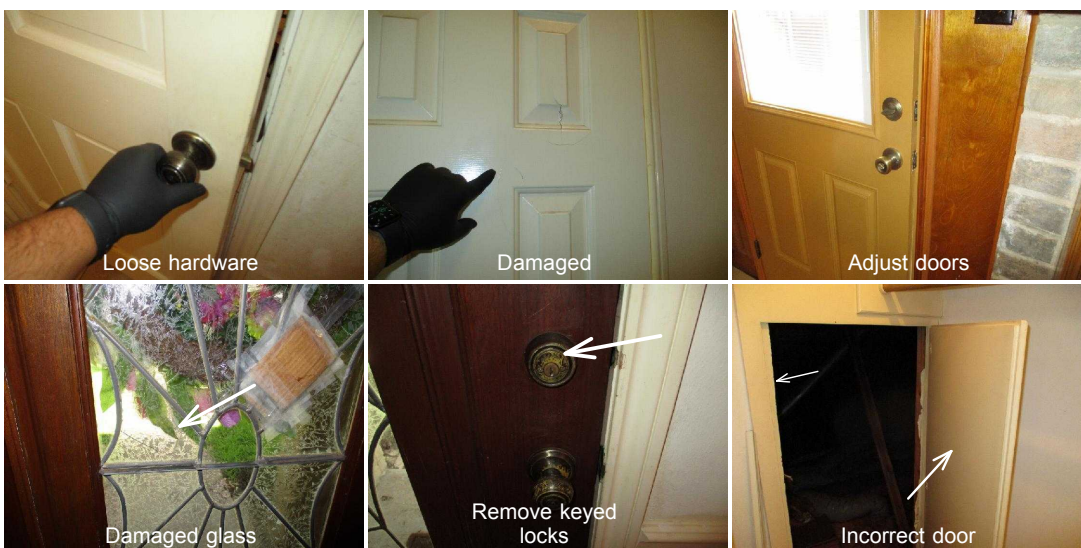
- Several doors are in need of minor adjustments due to loose or worn hardware. Repair/Replace as needed.
- The front entry door was observed to have damaged glass. Repair/Replace as needed.
- Any keyed locks for exterior doors should be changed to manual locks that do not require a key to operate from the inside. These doors are main paths of egress and pose a potential safety hazard if the home needs to be evacuated. Correct as needed.
- The attic access door located in the upstairs bedroom closet did not appear to be insulated or a fire-rated attic door. this door should be replaced with a permitted door with the appropriate insulation, fire-rating and should be self latching. Correct as needed.

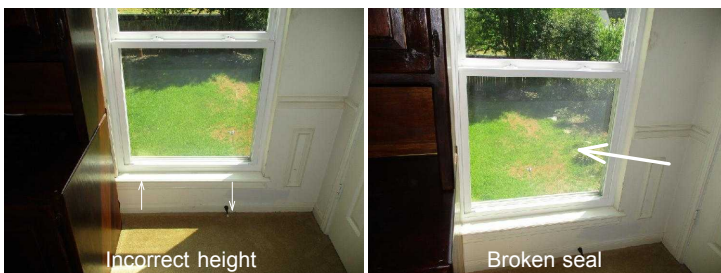
- The windows at the upstairs, were noticed to be the improper height above the finished floor. Operable windows are required to be a minimum height of 24 inches above the interior floor when they are more than 72 inches above the exterior final grade. This is a safety concern and should be corrected with locks that limit the opening of the window until the sill is the correct height.
- A window in the upstairs gameroom, was starting to fog on the interior sides of the panes. This is the result of a broken seal. A broken seal does not diminish the integrity of the windows. However, it does lose the majority of its energy efficiency features once the seal is broken. Repair/Replace as needed.

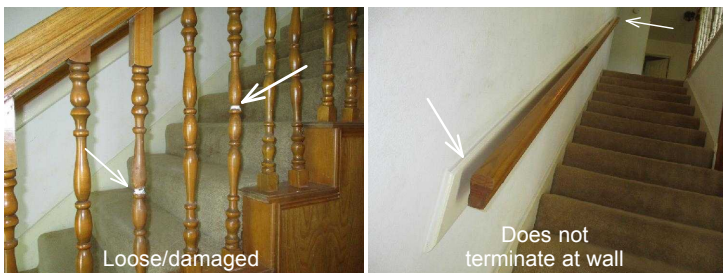
- The wood balusters at the staircase were observed to be loose/damaged. Repair/Replace as needed to prevent further deterioration and risking safety.
- The railing at the wall for the staircase should start and terminate at the wall and should be continuous to prevent clothing from being snagged on railing. Correct as needed.

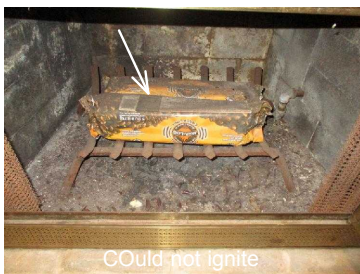
- The fireplace appears to be performing as intended at the time of the inspection. The gas fireplace was not ignited due to starter logs being in place at the time of the inspection. The gas was run and the valve appeared to be working at the time of the inspection.

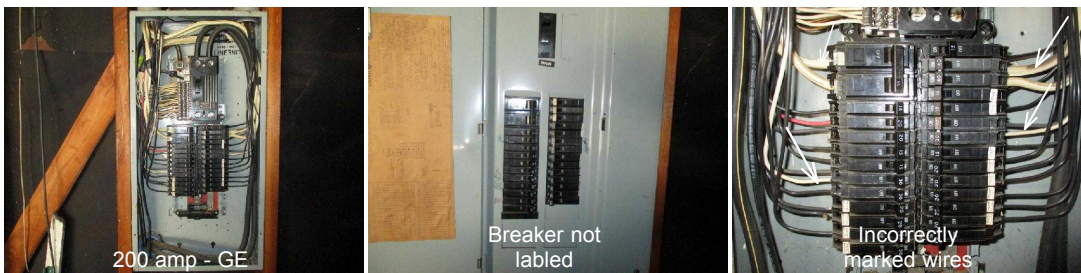
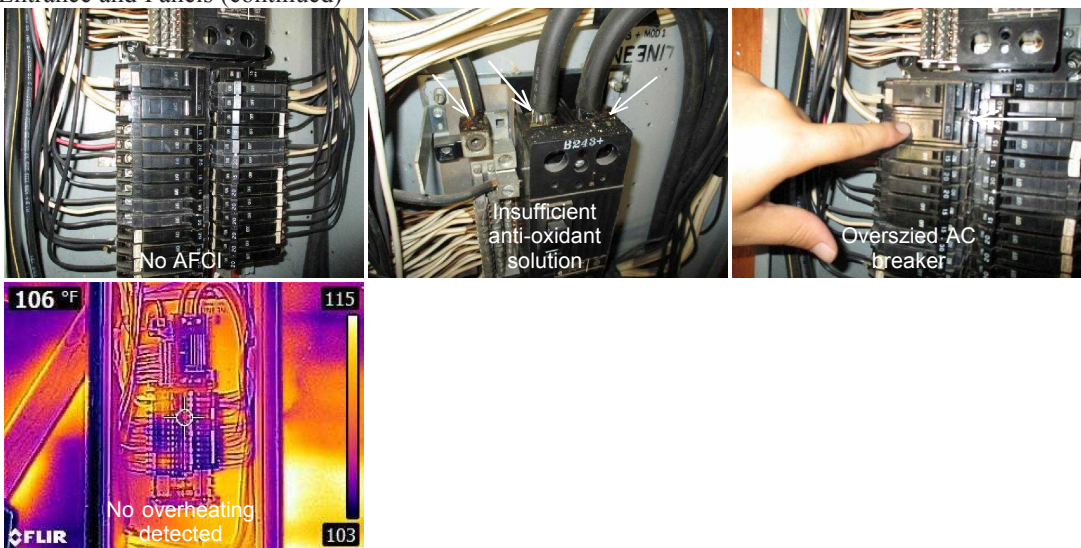
- White wires used for power distribution, connected to breakers with no colored tab for identification. This is a safety hazard. Recommend proper labeling of the wire(s).

- There were no AFCI breakers installed at the time of the inspection. AFCI breakers were not required in older residential construction. However, they are required in all living areas of the home, such as bedrooms, living rooms, study, game-room, hallways, etc. Recommend a licensed Electrician come out and make all necessary repairs.

- Main service wires were missing the required anti-oxidant solution. Aluminum wiring can become very hot and also corrode over time. It is crucial to apply an anti oxidant solution where the wires meet the lugs inside the panel. correct as needed.

- The breaker for the AC was observed to be a 60 amp when the current AC unit calls for a maximum 50 amp breaker. Recommend a licensed and insured electrician install the correct size breaker for the unit to prevent overheating of the system and wiring. This could cause damage to a system or home if the breaker does not trip when needed.

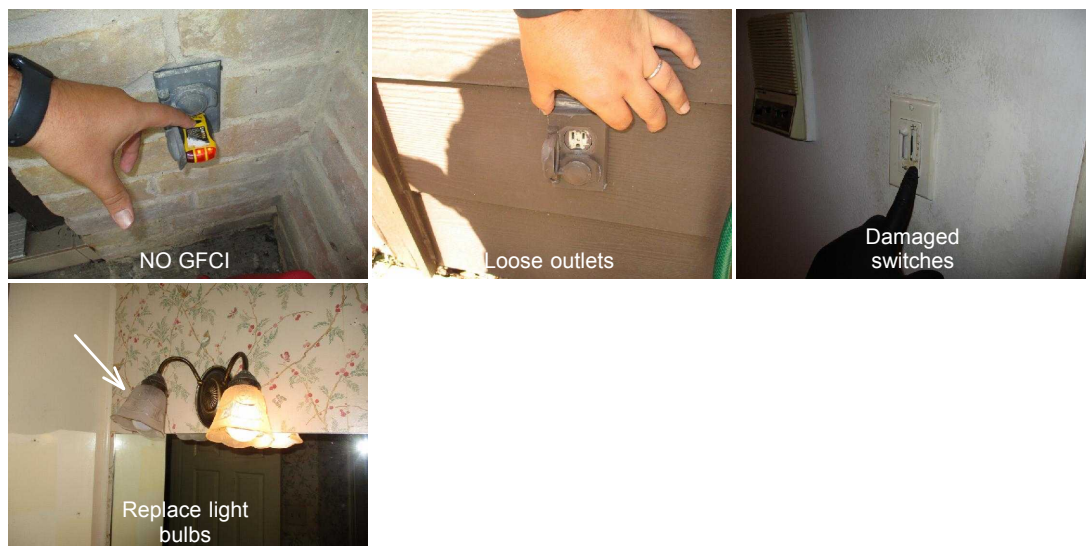
- A few switches throughout the home were observed to be damaged. Repair/Replace as needed.
- Several light fixtures throughout the home were not functioning at the time of the inspection. Possibly bulb related. Repair/replace as needed.

- There were no GFCI protected outlets installed at the home. GFCI protected outlets are required to prevent electrical shock. GFCI protected outlets should be installed at all exterior, garage, kitchen, bathroom, laundry room, and wet bar outlets. Recommend a licensed and insured electrician further evaluate the electrical system and make any necessary changes/repairs.
- Several outlets were observed to be loose throughout the home. Repair/Replace as needed.
- All accessible outlets were checked for open grounds, open neutrals, open hot, hot/ground reverse, hot/neutral reverse, and proper GFCI requirements.

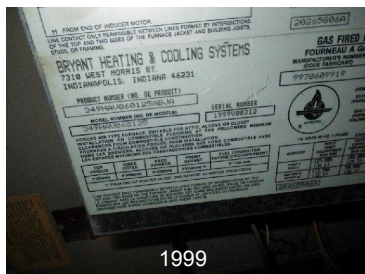
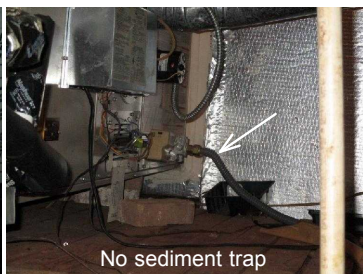
- The gas line for the furnace was noticed to be missing its drip leg. The drip leg helps prevent blockage and should be installed to prevent build-up of sediment inside the gas line. Install for proper functionality.

- The heating equipment is an older unit and is past its manufacturer warranty and usual life expectancy. Recommend getting the equipment serviced by a licensed HVAC technician if not done so in the past year.

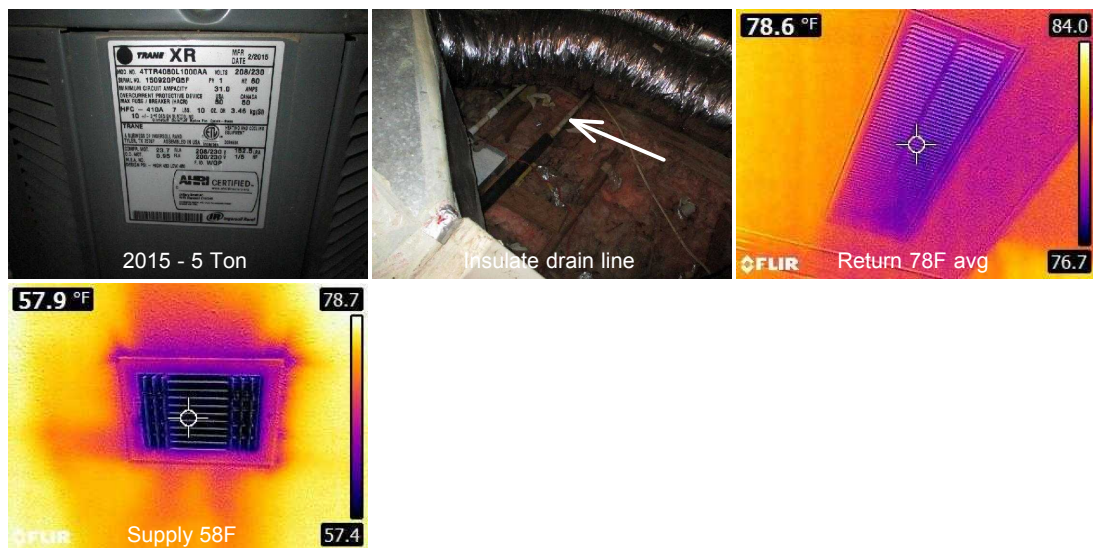
- The primary drain line was not fully insulated at the attic space. The drain line can create condensation and drip moisture onto the drywall/insulation. Correct as needed.

- Although the system has met the requirements for the Delta T test, the conditioned air supplied to several different rooms, was not uniform and balanced. There was differentials of more than 10 degrees between some of the rooms. Recommend a licensed and insured HVAC technician balance the system for proper cooling of all areas of the home.

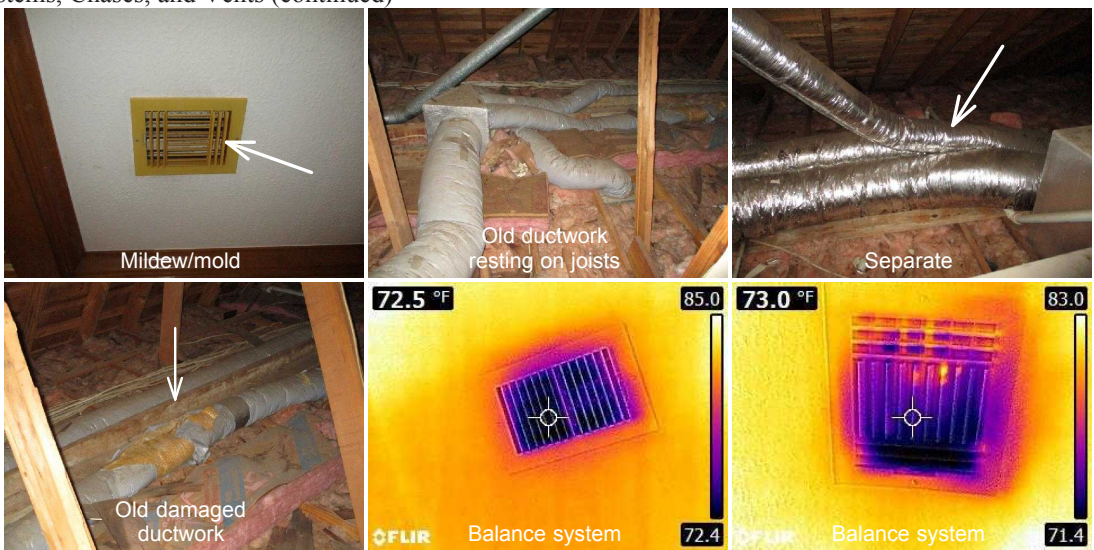
- Several supply and return vents were observed to be dirty and have build up on them. Recommend cleaning vents and ducts for better efficiency of the system and to prevent health problems.

- The duct work was noticed to be older and damaged at several locations. Repair/Replaces as needed for optimum efficiency of the system and to prevent leaks of conditioned air at the attic space.

- Recommend balancing the ductwork for the HVAC system. The thermal revealed minimal airflow and increased temperatures at the supply vents at several rooms. Recommend a licensed and insured HVAC technician further evaluate the ductwork and make any adjustments/repairs.

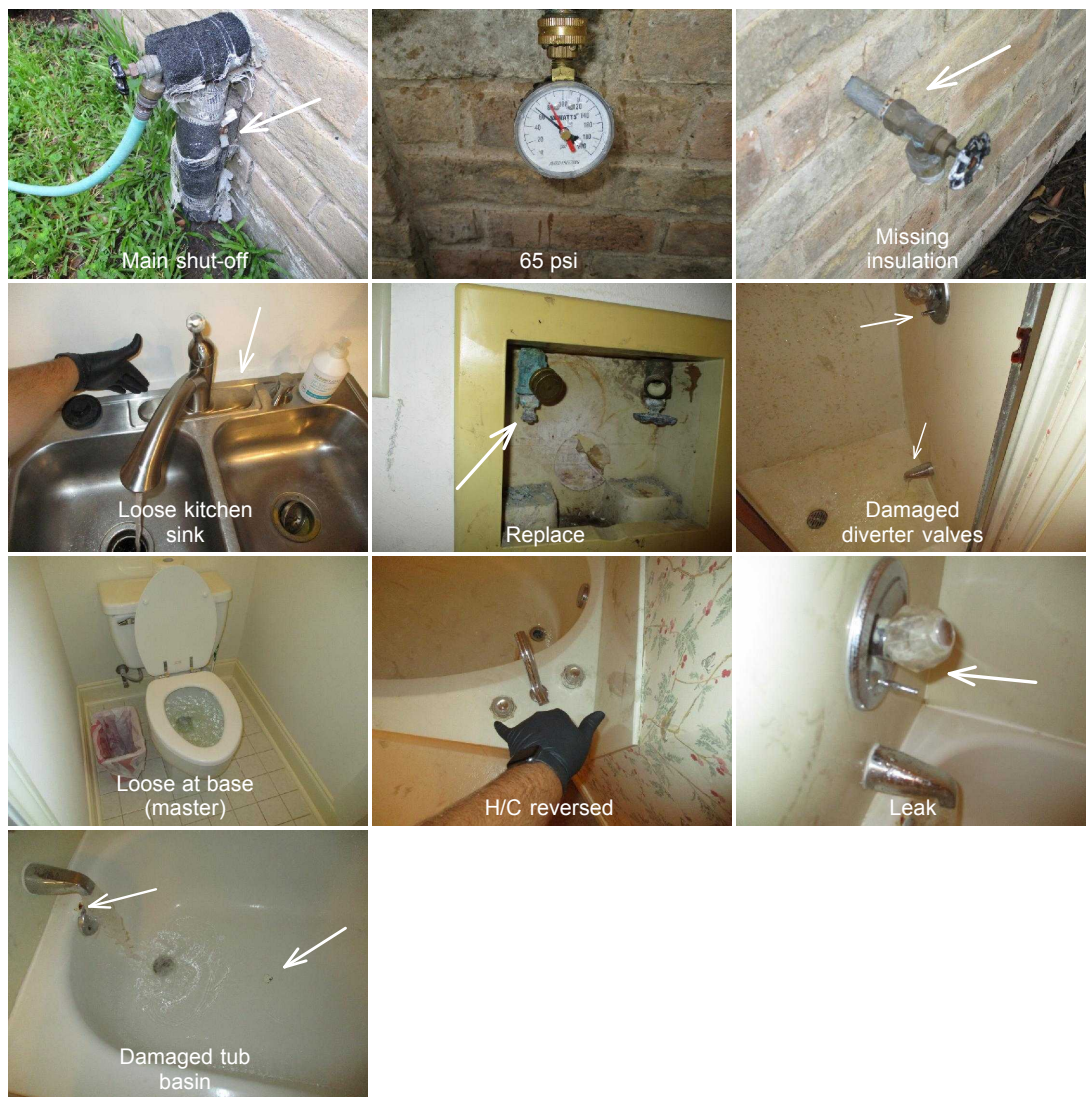
- The kitchen sink was observed to be loose where it should be sealed to the counter top. This allows water to leak into the cabinet space below. Repair/Replace as needed.
- The diverter valve for the showers were not operating correctly. The valve would not close completely in order to divert all the water to the above shower fixture. Repair as needed.
- The Hot/Cold supply lines for the master bathroom tub were observed to be reversed. Recommend properly installing supply lines to prevent possible burns from hot water. Repair as needed.
- The water supply valve for the upstairs bathroom was observed to leak when the fixture was turned on. Repair/Replace as needed to prevent further deterioration.
- The tub at the upstairs bathroom was observed to be damaged and have worn patches from previous repairs. Correct as needed.

- The master bathroom commode, was observed to be loose at its base. Loose commodes can damage the wax flange seal, and create a leak. Repair/Replace as needed.

- The washing machine connections were observed to be damaged/deteriorated. Repair/Replace as needed.

- The exterior plumbing for the home was noticed to be missing the proper insulation material around the exposed pipe. Recommend installing insulation, to prevent freezing during lower temperatures.

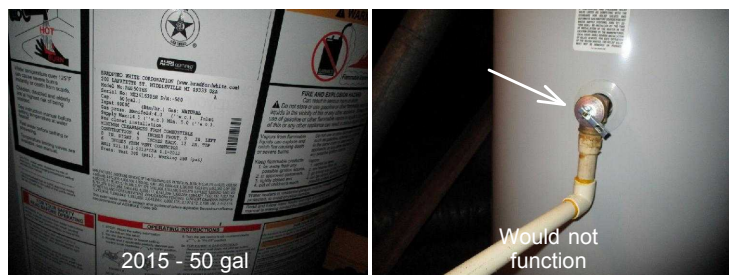
- The temperature and pressure relief valve (T&P) for the water heater would not function properly at the time of the inspection. T&P valves protect the water heater equipment from excess pressure. Repair/Replace as needed.

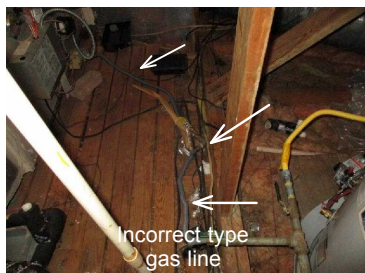
- The gas piping for the water heater and furnace at the attic space, was observed to be flex line. The gas piping should be made of cast iron and properly secured to the decking to prevent damage. Correct as needed.

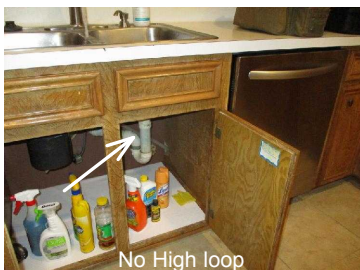
- There was no high loop or air gap for the dishwasher drain line. These methods prevent dirty water from backing up into the dishwasher. Correct as needed.

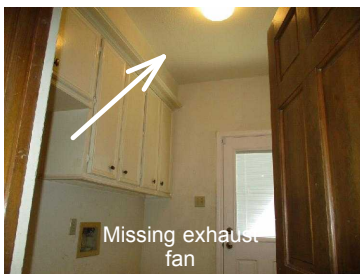
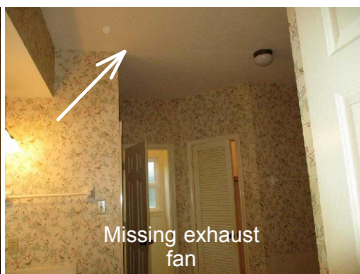
- The laundry room did not have an exhaust fan installed. Exhaust fans are required in laundry rooms where there is no operable window. This helps to prevent moisture and humidity build up. Install as needed.
- The master bathroom did not have an exhaust fan installed in the main area. Exhaust fans are required in bathrooms where there is no operable window. This helps to prevent moisture and humidity build up. Install as needed.

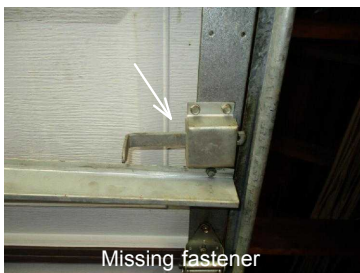
- There should be a fastener installed to disable the locking mechanisms for the overhead garage door, when there is a operator installed. This prevents the door from being locked and damaged. Correct as needed.

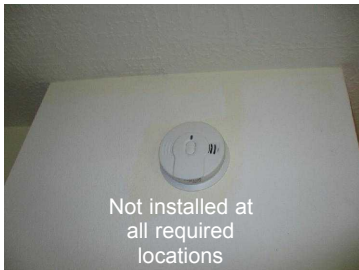
- Several smoke detectors were not installed at all required areas. Smoke detectors are required in all bedrooms outside all bedrooms and at least one on each floor of the structure. This is a safety issue and should be corrected as soon as possible.
