RESIDENTIAL INSPECTION REPORT

5021 Doolittle Blvd
Houston TX 77033

Jennelle Shaw
SEPTEMBER 2, 2020

PROPERTY INSPECTION REPORT

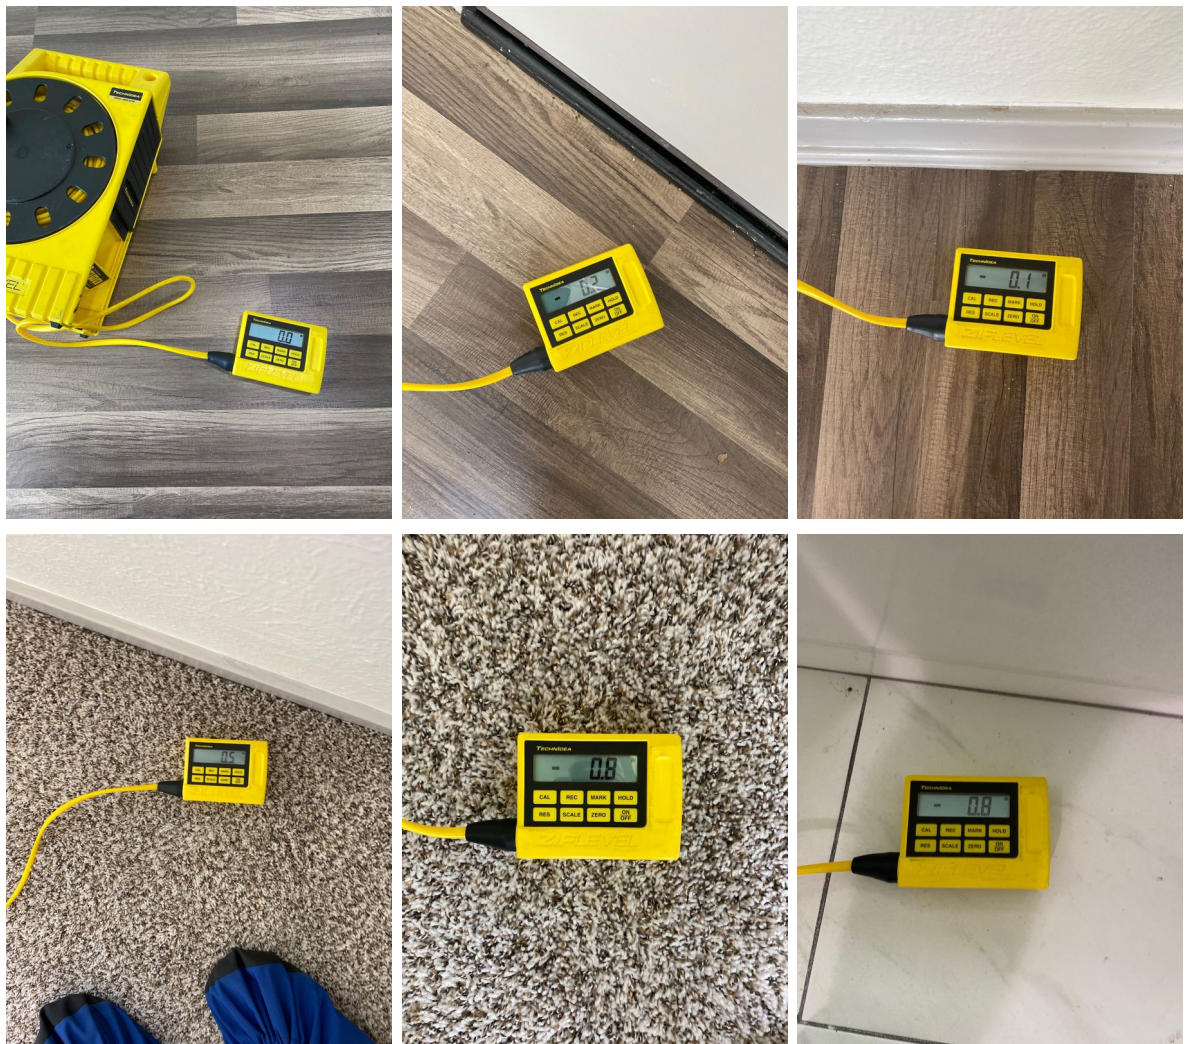
This foundation was measured with the use of an electronic digital measurement tool. Multiple elevation points were registered on the foundation throughout the property to determine if there were elevation variations that indicated excessive movement of the foundation. At the time of this inspection the measured areas did not indicate any variations that, in this inspector's OPINION, indicated any need for invasive repairs to the foundation.

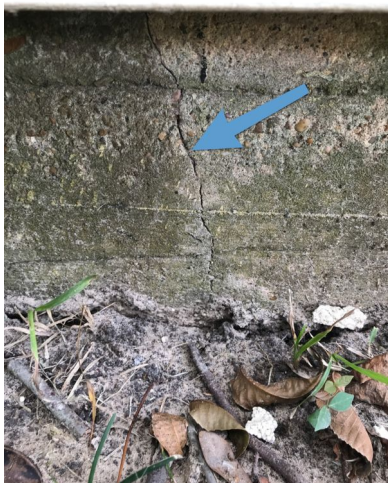
Rear

Minor cracking was noted at the foundation. This is common as concrete ages. Shrinkage surface cracks are normal with no typical structural implications. Monitoring for more serious shifting or displacement is recommended.

Recommendation: Recommend monitoring.

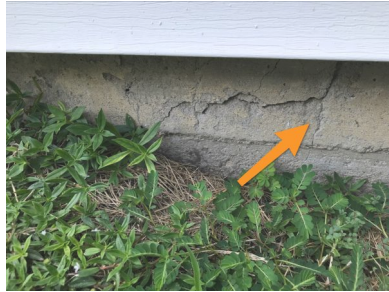
Left Side

Cracking was noted at the foundation. This is typically consistent with soil movement and could lead to serious damage to structural components, foundation and/or slabs. Evaluation and recommendation of a course of action/remedy by a licensed structural engineer is recommended.

Recommendation: Contact a qualified structural engineer.

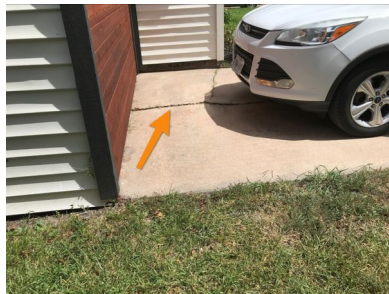
Uneven or Cracked driveways can be a trip hazard.

Recommendation: Contact a qualified professional.

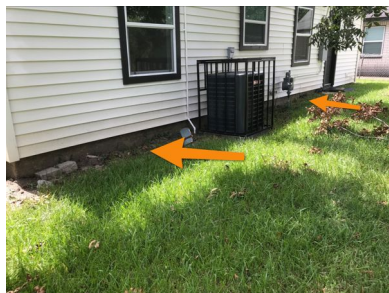
Grading was sloping towards the home in some areas. This can lead to water intrusion and foundation issues. Regrading by a qualified landscaping contractor or foundation contractor so that water flows away from the home is recommended.

Recommendation: Contact a qualified landscaping contractor

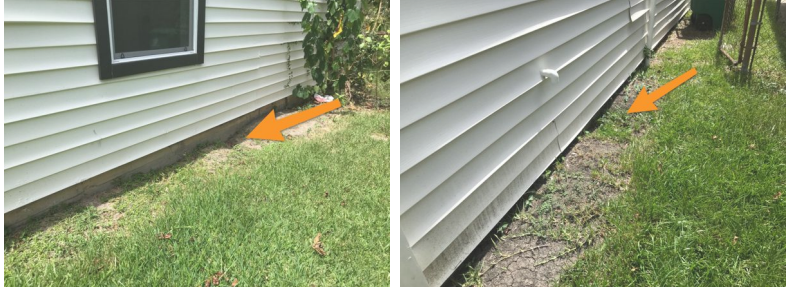
Left Side

Soil erosion was observed which can lead to grading issues. Evaluation and remedy by a landscaping contractor as needed to prevent further erosion is recommended.

Recommendation: Contact a qualified landscaping contractor

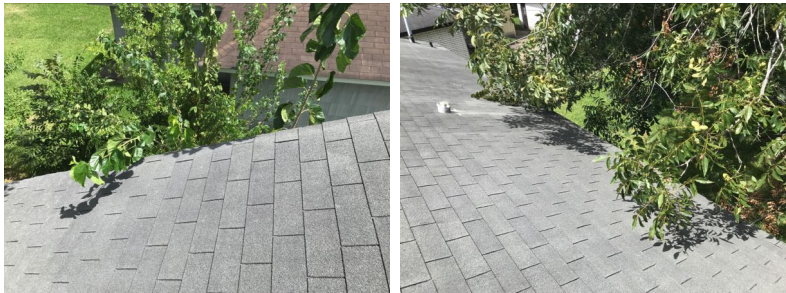
Tree limbs that are in contact with roof or hanging near roof should be trimmed to prevent damage to the roofing materials.

Recommendation: Contact a qualified tree service company.

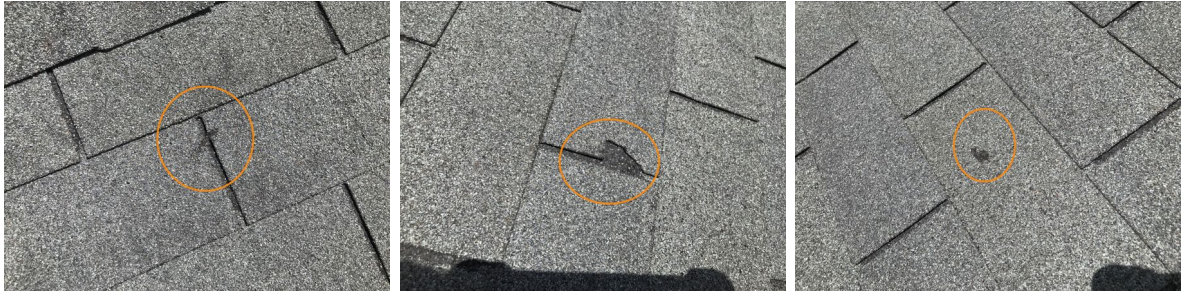
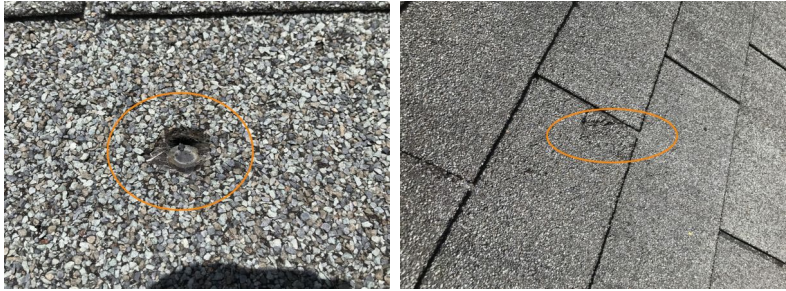
Roof shingle material was missing, damaged, or torn in areas. Evaluation and/or repair by a qualified roofing professional is recommended.

Recommendation: Contact a qualified roofing professional.

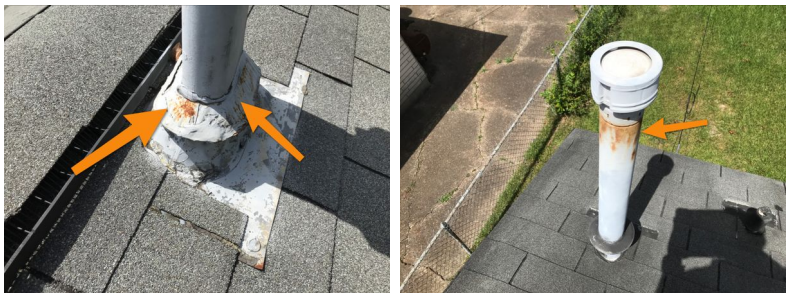
The cover for an attic vent (or fan) is rusting. Remedy as needed.
Recommendation: Contact a qualified roofing professional.

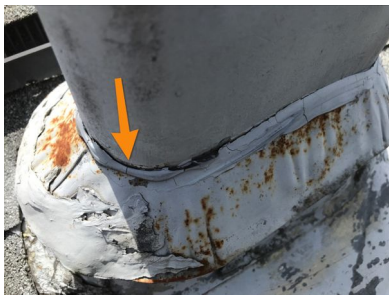
The neoprene vent pipe flashing was cracked or damaged. Remedy as needed.
Recommendation: Contact a qualified roofing professional.

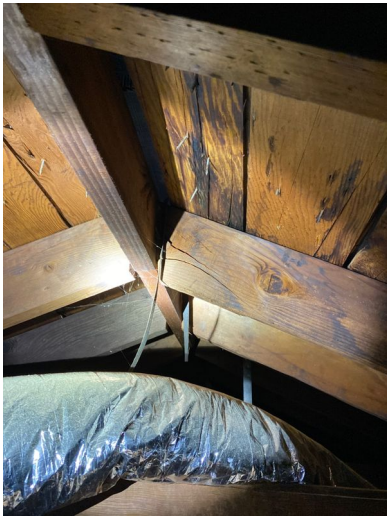
For Example: Attic

A cracked or damaged rafter was observed. Evaluation by a qualified contractor is recommended.

Recommendation: Contact a qualified professional.

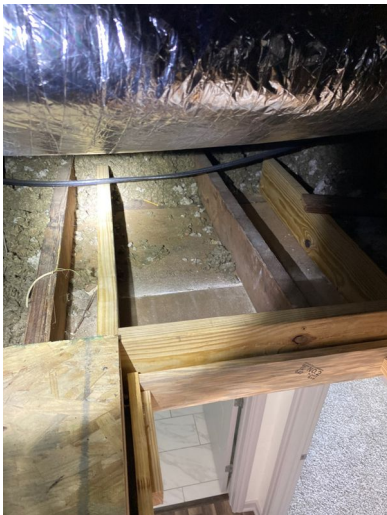
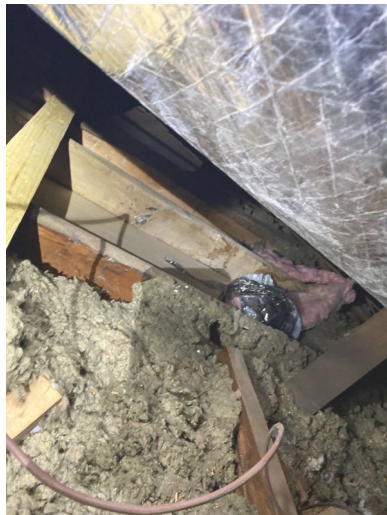
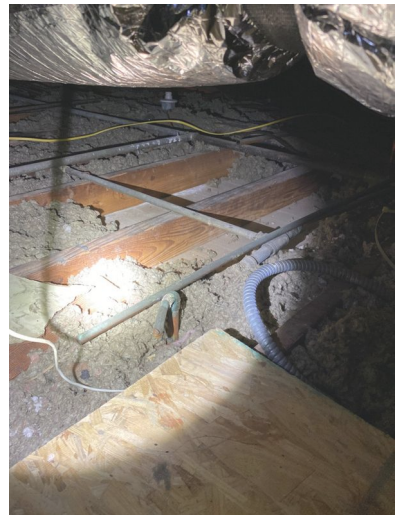
Gaps or areas of poor insulation coverage were observed in one or more locations of the attic. This may reduce the R value of the insulation system.

Recommendation: Contact a qualified insulation contractor.

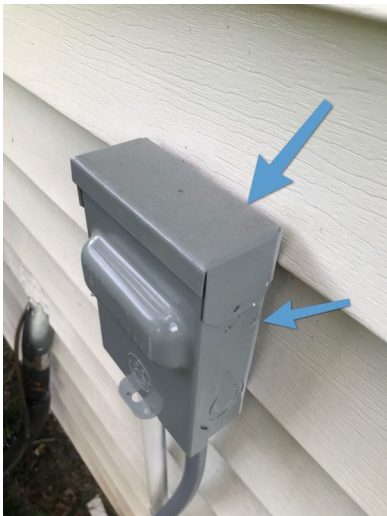
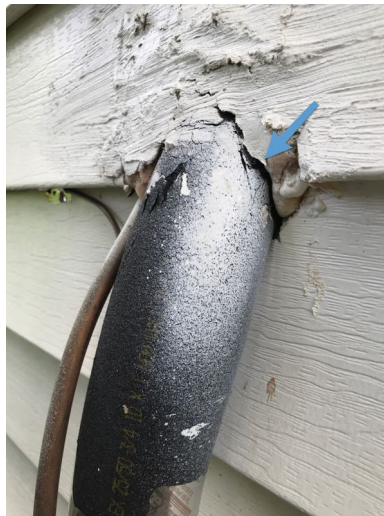
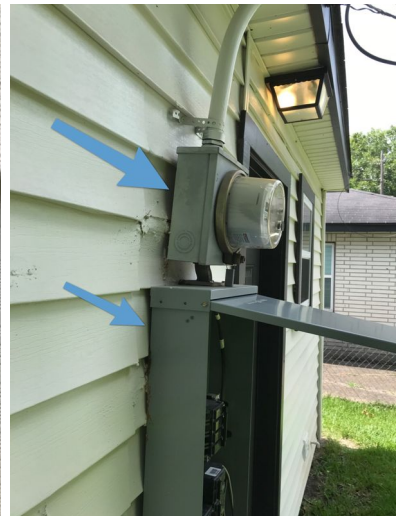
All Exterior Wall Penetrations, A/C Disconnect Box(es), A/C return lines, Service Panel(s) - Fixtures/Electrical boxes were not properly sealed. Remedy as needed.

Note: Modern building practices recommend sealing around components that are mounted on or pass through the exterior wall to limit moisture intrusion.

Recommendation: Recommended DIY Project

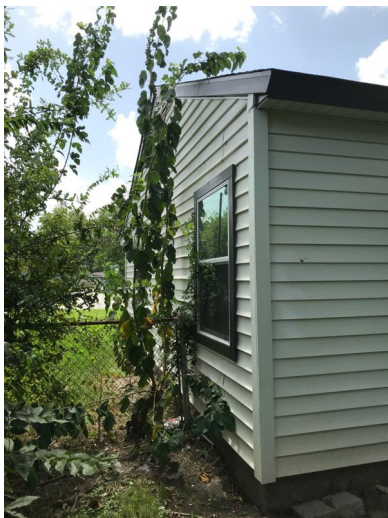
Right Side

Foliage that is too close to siding materials can cause moisture buildup and deterioration.

Recommendation: Contact a qualified professional.

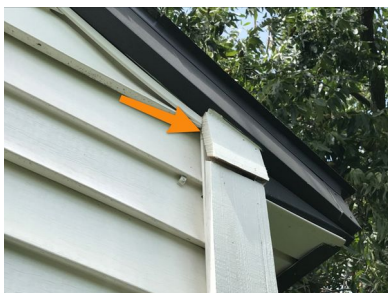
Right Side

Caulking around siding or trim was deteriorated or missing.

Recommendation: Contact a qualified professional.

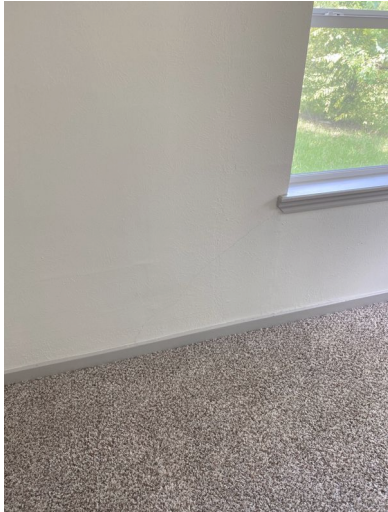
For Example: Rear Bedroom

Stress cracks are observed in the interior drywall. This is consistent with structural movement of the home.

Recommendation: Contact a qualified professional.

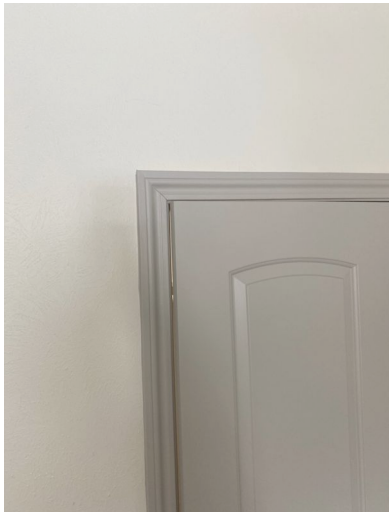
For Example: Left Side Garage

Door sticks and is tough to open. Remedy as needed.

Recommendation: Contact a handyman or DIY project

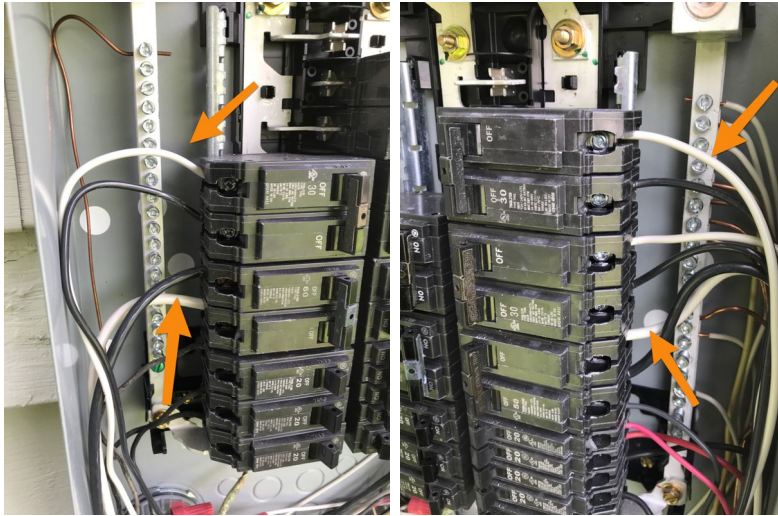
White wires connected to breakers are not marked with black or red electrical tape to indicate that they are "hot". Remedy as needed.

Recommendation: Contact a qualified electrical contractor.

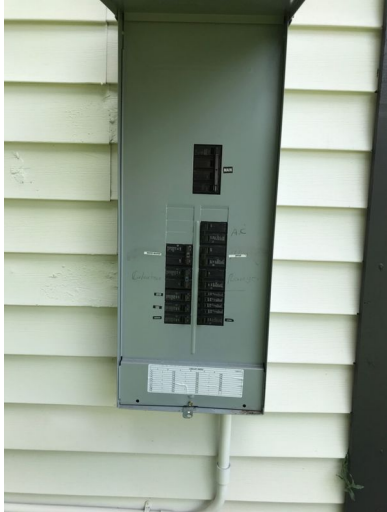
Circuits in the distribution panel were not properly labeled. Remedy as needed.

Recommendation: Contact a qualified electrical contractor.

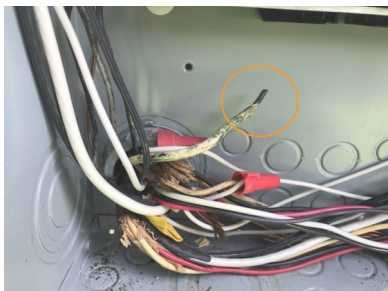
4: Abandoned Wire in Panel

Evaluation and remediation by a licensed electrician is recommended.

Recommendation: Contact a qualified professional.

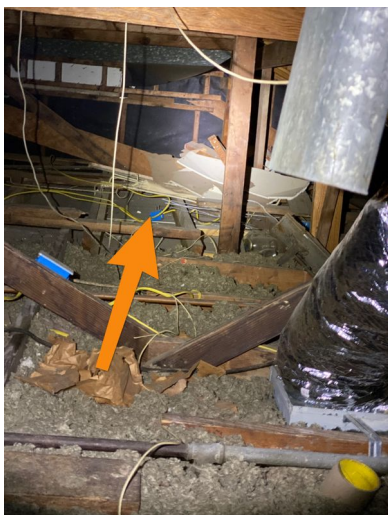
For Example: Attic

One or more receptacles were loose at the time of inspection. Evaluate and remedy as needed.

Recommendation: Contact a qualified professional.

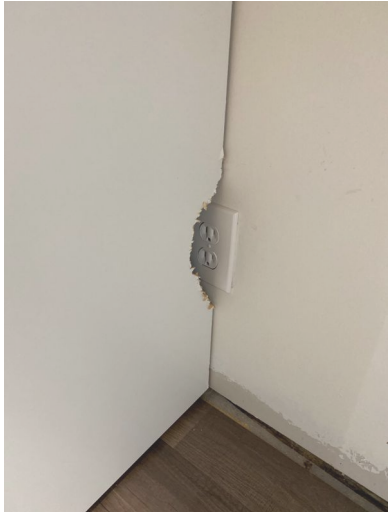
The outlet in the kitchen is blocked by the installed cabinet. This makes use of this outlet difficult. Repair as desired

Recommendation: Contact a qualified professional.

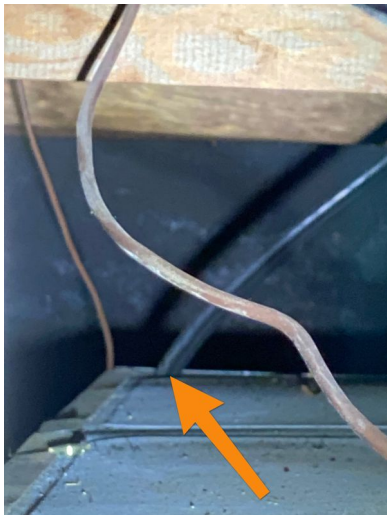
For Example:

No bushing was present to protect wiring entering the unit. Remedy as needed.

Recommendation: Contact a qualified professional.

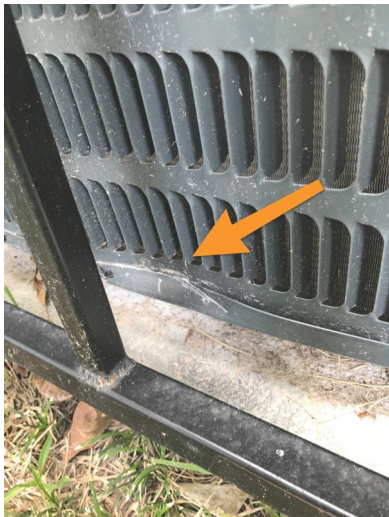
External fins on the condensing unit were damaged. Evaluation and remediation by a licensed HVAC contractor is recommended.

Recommendation: Contact a qualified HVAC professional.

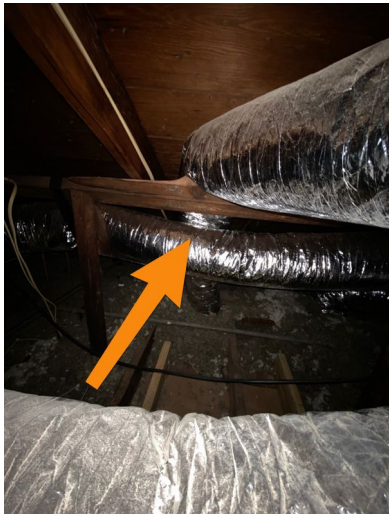
For Example: Attic

Ducts were resting on each other. This can result in condensation forming between the two sections of ductwork. Remedy as needed.

Recommendation: Contact a qualified professional.

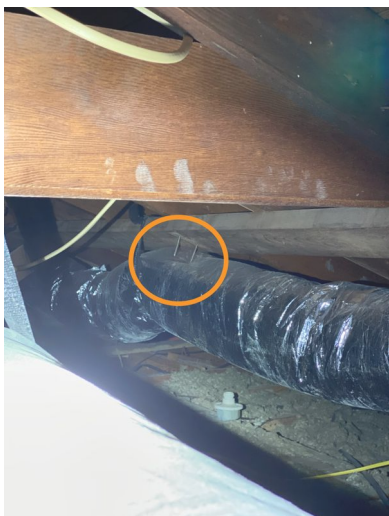
For Example:

The air supply duct was damaged. Evaluation and remediation by a licensed HVAC contractor is recommended.

Recommendation: Contact a qualified HVAC professional.

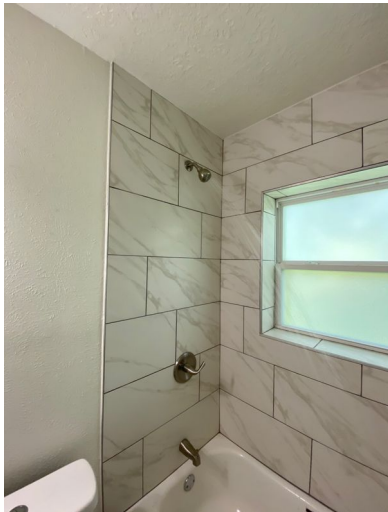
For Example: Bathroom

The bathtub faucet was not sealed at the wall. Remedy as needed.

Recommendation: Contact a handyman or DIY project

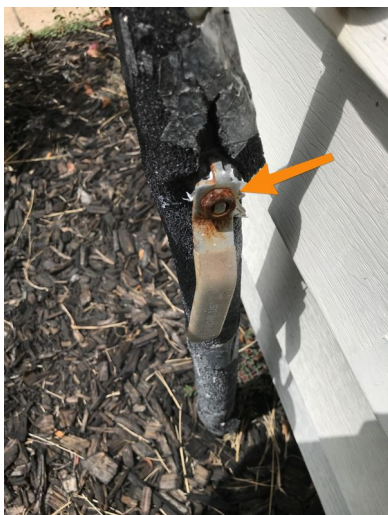
For Example: Front

One or more supply valves were corroded. Remedy as needed.

Recommendation: Contact a qualified plumbing contractor.
