Your Inspection Report

404 South Beauregard Street
Alvin, TX 77511

INSPECTION DATE:
Thursday, March 16, 2023

PROPERTY INSPECTION REPORT FORM

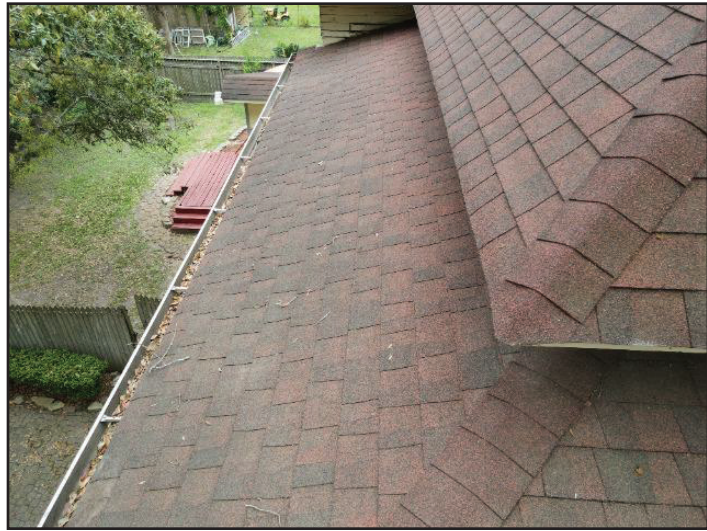
2. Granule loss

- Sloped roofing\Asphalt shingles: **Granule loss** Location(s): **Various Roof**
- Sloped roofing\Asphalt shingles: **Missing, loose or torn** Location(s): **Various Roof**

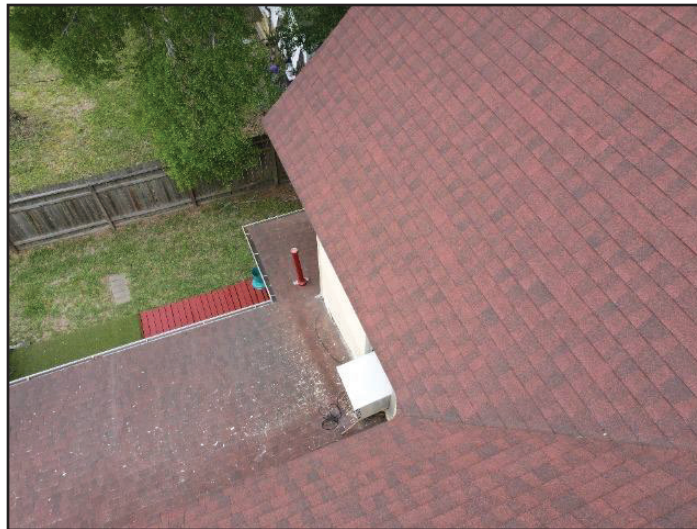
4. Slope too low

4. Condition: • [Slope too low](#)

Implication(s): Chance of water damage to structure, finishes and contents

Location: Rear Exterior Kitchen Roof

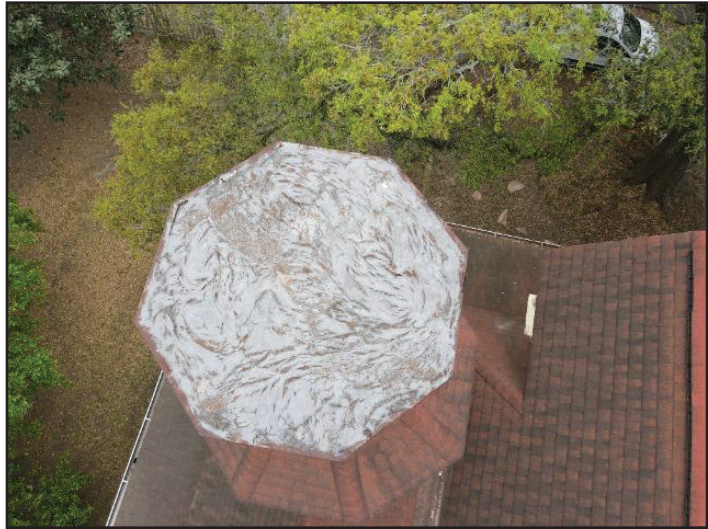
8. Patched

- Flat roofing\Roll roofing: **Patched** Location(s): **Middle Turret Roof**
- Recommendations\Overview: **Key Note: Some indicators of small roof leaks were noted at the time of the inspection. Water staining and interior walls demonstrate some loose plaster and water staining. The upper roof set appears to have 2 large rises pooling into one valley that drains next to the turret. It does appear that these areas are having a little increased water penetration and may be causing rot around the turret.**

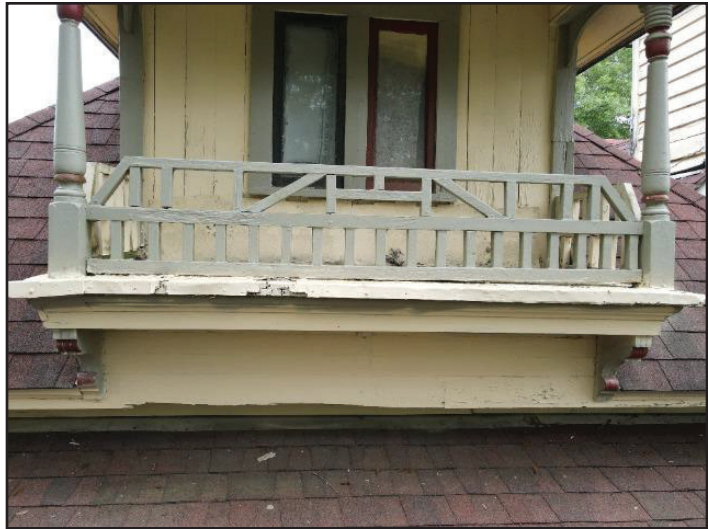
14. Paint or stain - deteriorated / missing

12. Condition: • [Paint or stain - deteriorated / missing](#)

Location: Various Throughout

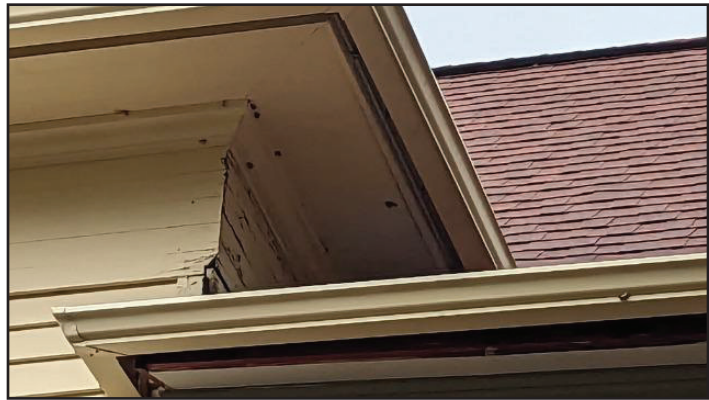
15. Vents - ineffective / missing

- Walls\Soffits (underside of eaves) and fascia (front edge of eaves): **Vents - ineffective / missing**

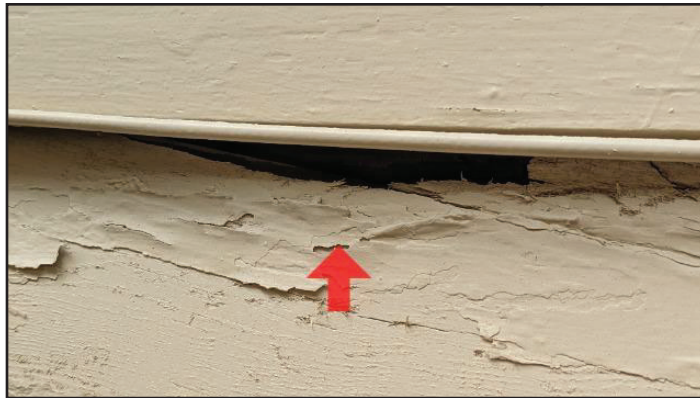
17. Rot or insect damage

Implication(s): Chance of water damage to structure, finishes and contents | Material deterioration

Location: Rear Right Exterior Wall

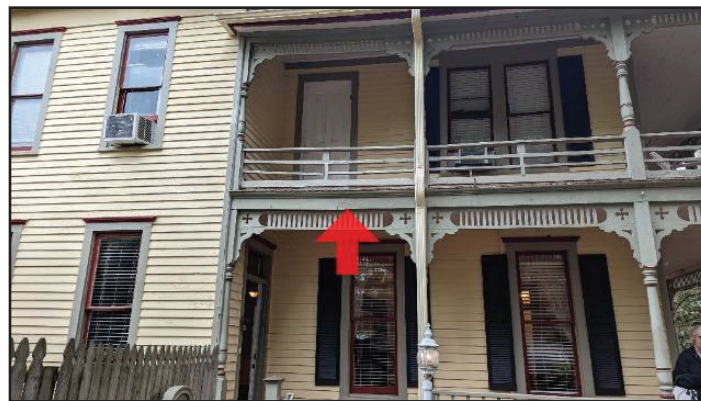
24. Sag

Implication(s): Weakened structure | Chance of movement

Location: Left Side Second Floor Porch

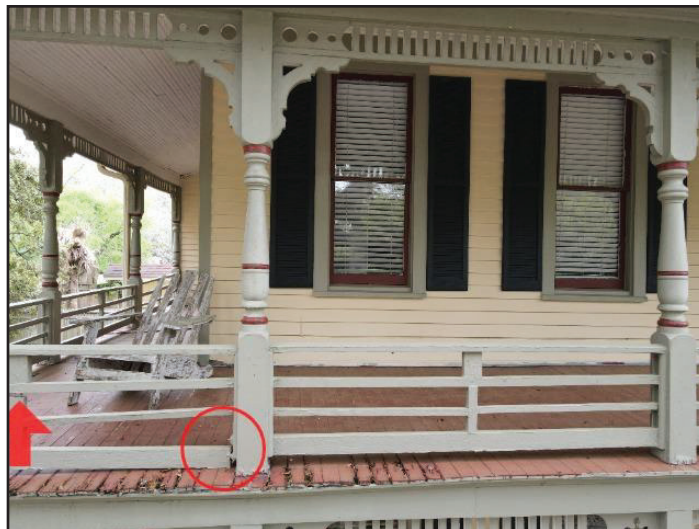
32. Damage at bottom

Implication(s): Fall hazard

Location: Various Second Floor Porch

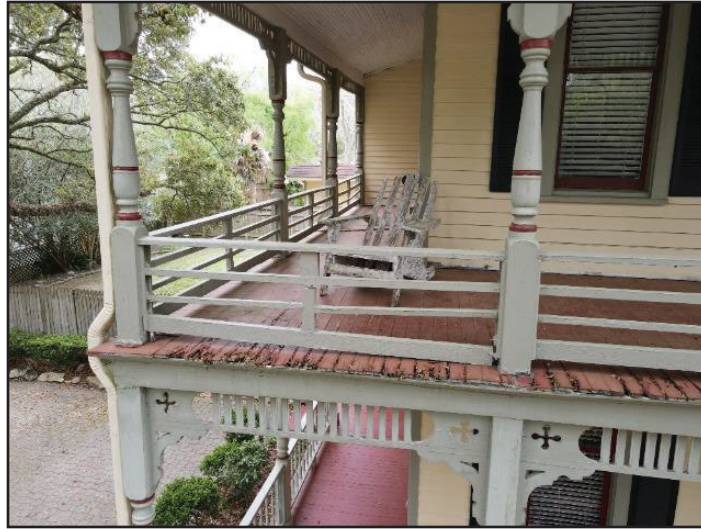
33. Loose

- *Porches, decks, stairs, patios and balconies\Handrails and guards:* **Loose** *Location(s):*

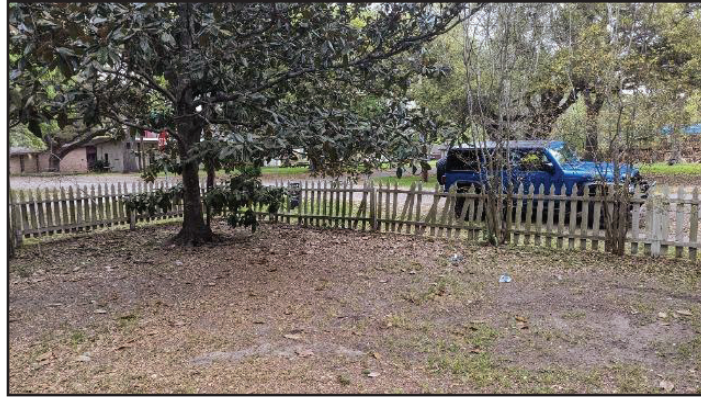
36. *Boards damaged*

Implication(s): Material deterioration | Poor security

Location: Various Right Side Yard

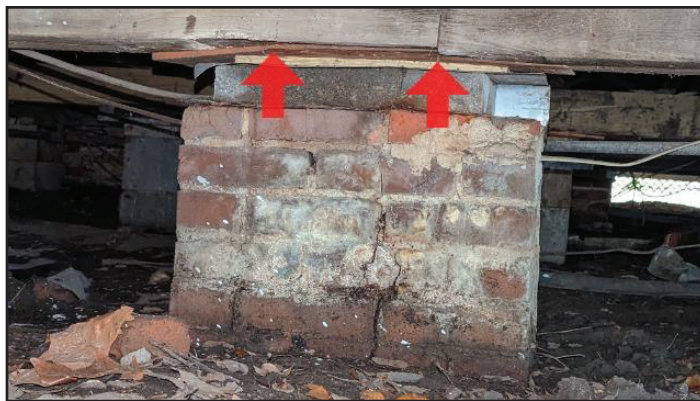
43. Prior repairs

- *Landscaping\Fence:* **Boards damaged** *Location(s):* **Various Right Side Yard**
- *Recommendations\Overview:* **Foundation appears to have been repaired previously with new masonry columns, flashing, and shims to level out the major beams. This appears to have caused major fireplace footings to be damaged and caused some racking in the windows and doorways. Monitor the foundation for possible future movement. No cross bridging or joist bracing was noted at the time of the inspection and can cause springy flooring.**

Implication(s): Weakened structure

Location: Various Throughout Crawl Space

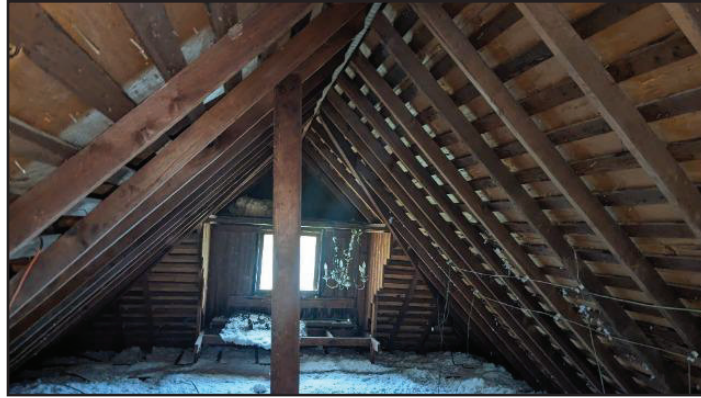
47. Missing

Implication(s): Weakened structure | Chance of structural movement

Location: Throughout Attic

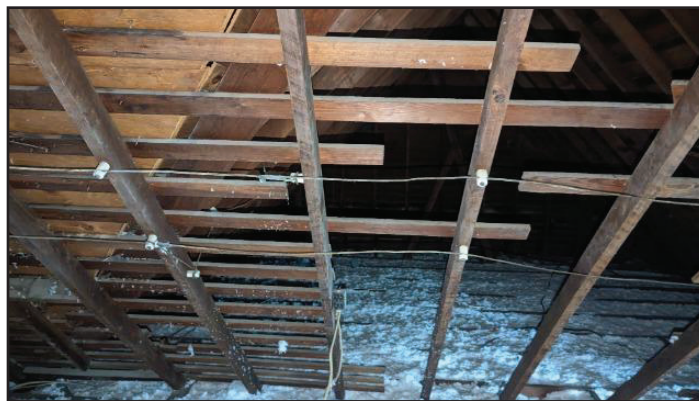
DISTRIBUTION SYSTEM \ Knob-and-tube wiring (wires)**49. Condition:** • [Outdated](#)**Implication(s):** Nuisance | Potential problem when obtaining home insurance**Location:** Rear Attic

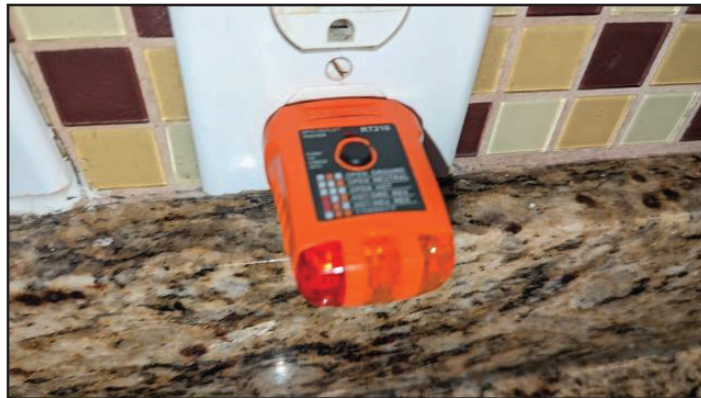
69. Open hot

Implication(s): Electric shock

Location: Various Kitchen

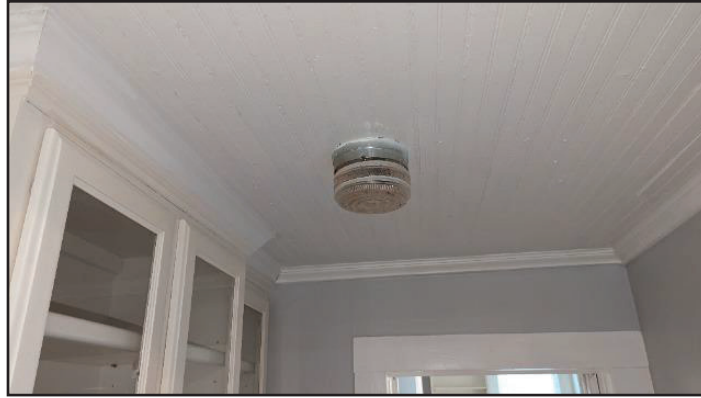
73. Inoperative

Implication(s): Inadequate lighting

Location: Kitchen

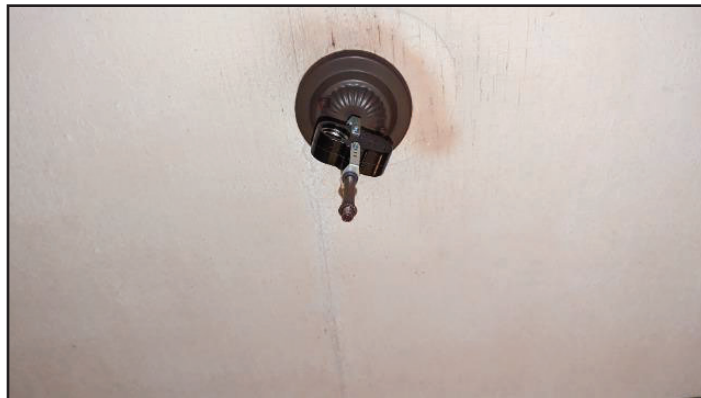
74. Exposed to mechanical damage (No cage or...

64. Condition: • Exposed to mechanical damage (No cage or protective lens)

Implication(s): Glass breaking | Physical injury

Location: Various

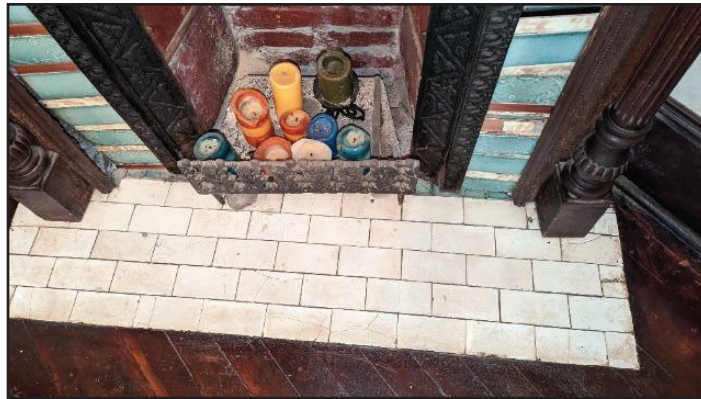
78. Deteriorated, missing or loose masonry or...

Implication(s): Hazardous combustion products entering home | Fire hazard

Location: Middle Living Room

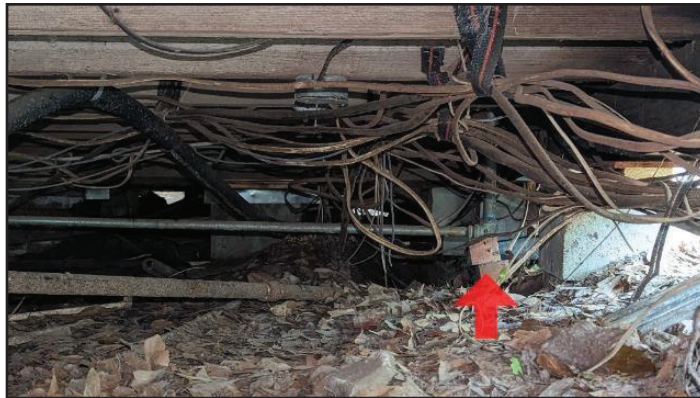
96. Poor support

Implication(s): Chance of water damage to structure, finishes and contents | Leakage

Location: Rear Middle Crawl Space

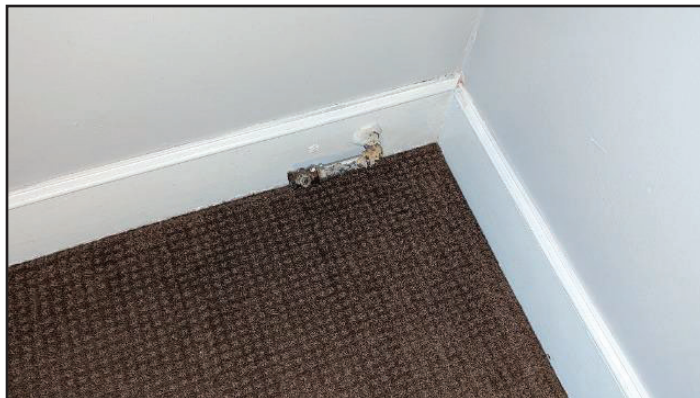
97. Poor access to shut off valve

Valves Not Capped and Some are Broken

Location: Various

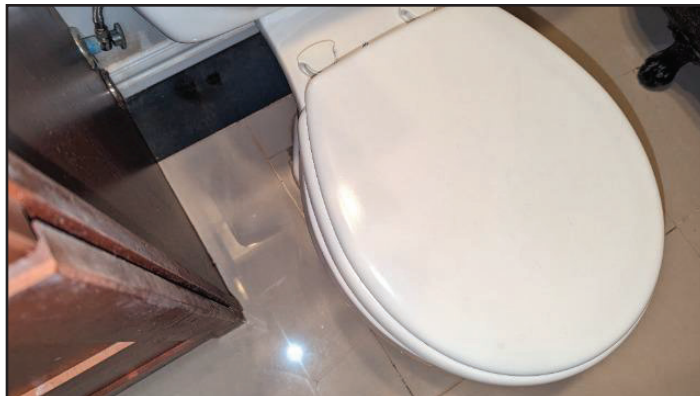
104. *Floor damage suspected*

Implication(s): Chance of water damage to structure, finishes and contents

Location: Second Floor Hallway Bathroom

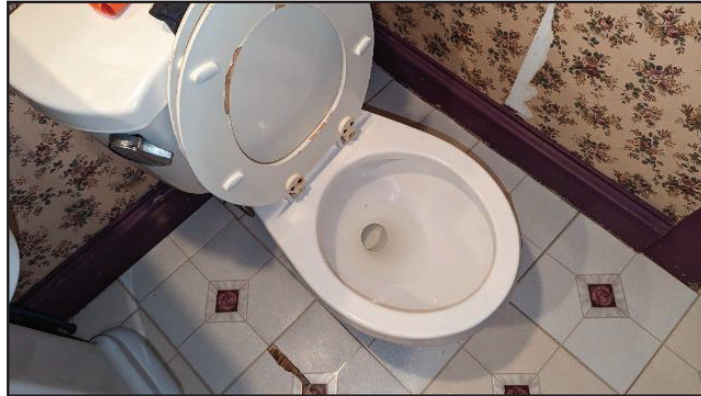
105. Leak

Implication(s): Chance of water damage to structure, finishes and contents

Location: First Floor Hallway Bathroom

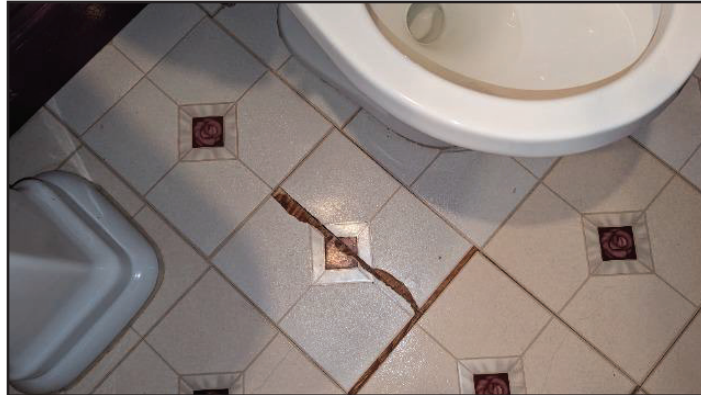
106. Loose

87. Condition: • [Loose](#)

Implication(s): Chance of water damage to structure, finishes and contents | Sewage entering the building | Possible hidden damage

Location: First Floor Hallway Bathroom

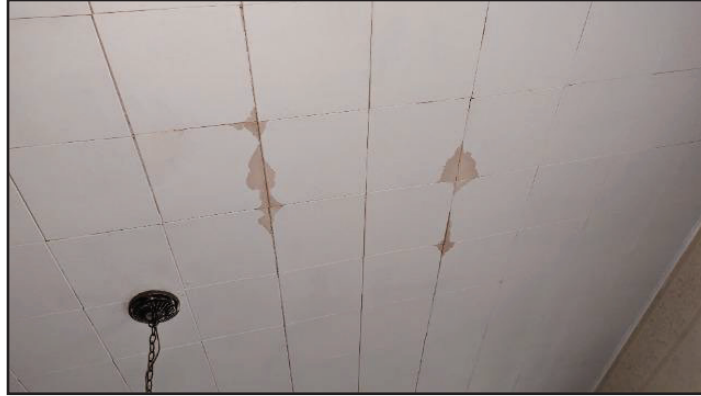
111. Water stains

Implication(s): Chance of water damage to structure, finishes and contents

Location: Front Living Room

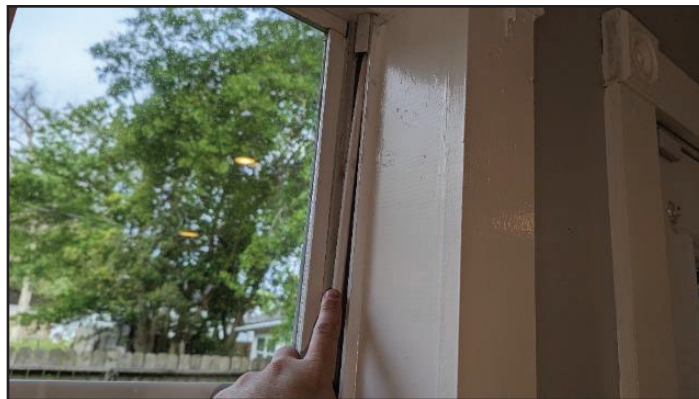
117. Difficult to operate

Implication(s): System inoperative or difficult to operate

Location: Various Throughout

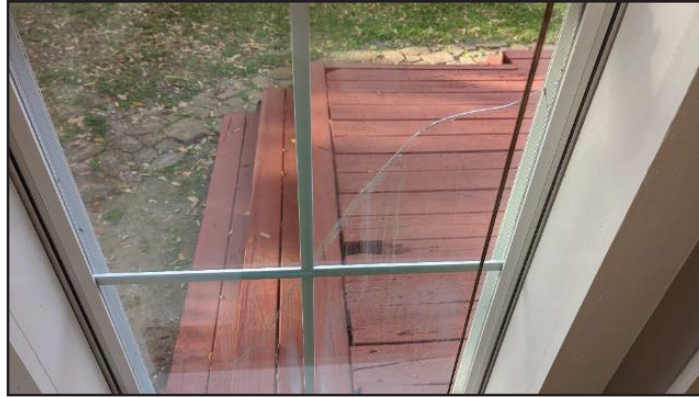
120. Cracked

99. Condition: • [Cracked](#)**Implication(s):** Physical injury**Location:** Various Rear Dining Room Kitchen

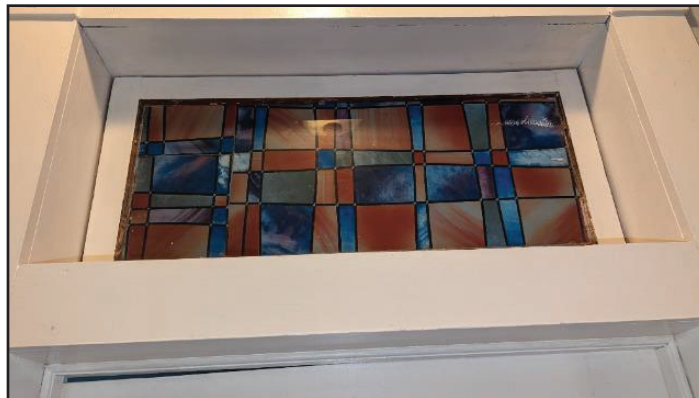
121. Missing

100. Condition: • [Missing](#)**Implication(s):** Chance of water entering building | Increased heating and cooling costs | Reduced comfort**Location:** Various Middle Living Room & Dining Room Hall

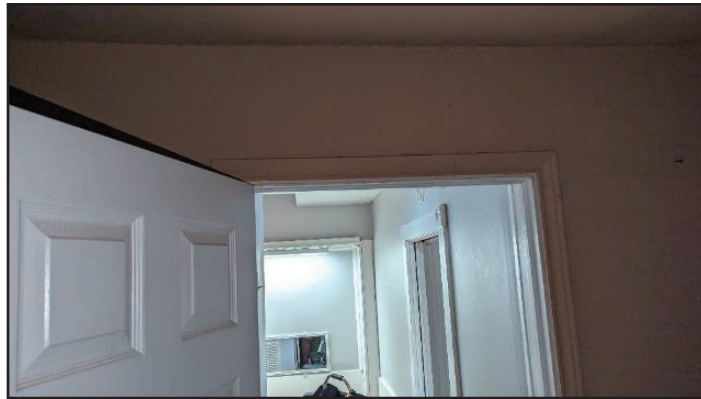
127. Racked/out-of-square

106. Condition: • [Racked/out-of-square](#)

Location: Laundry Area

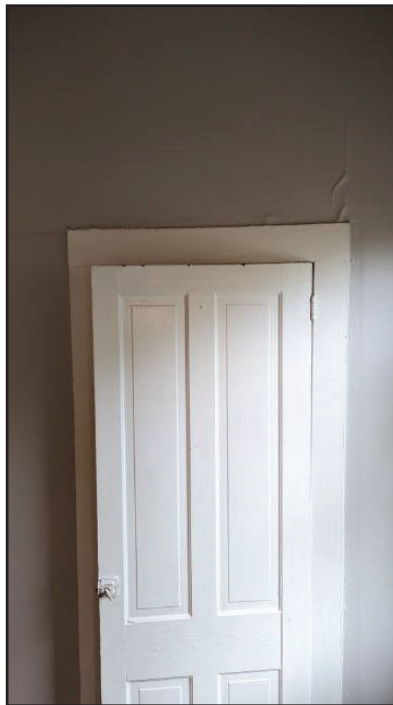
128. Loose or poor fit

107. Condition: • [Loose or poor fit](#)

Implication(s): Chance of damage to finishes and structure

Location: Various

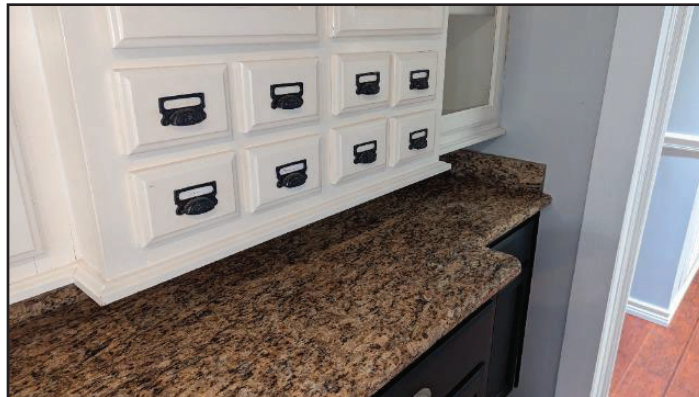
136. Pieces missing or loose

Implication(s): Damage or physical injury due to falling materials

Location: Rear Right Kitchen

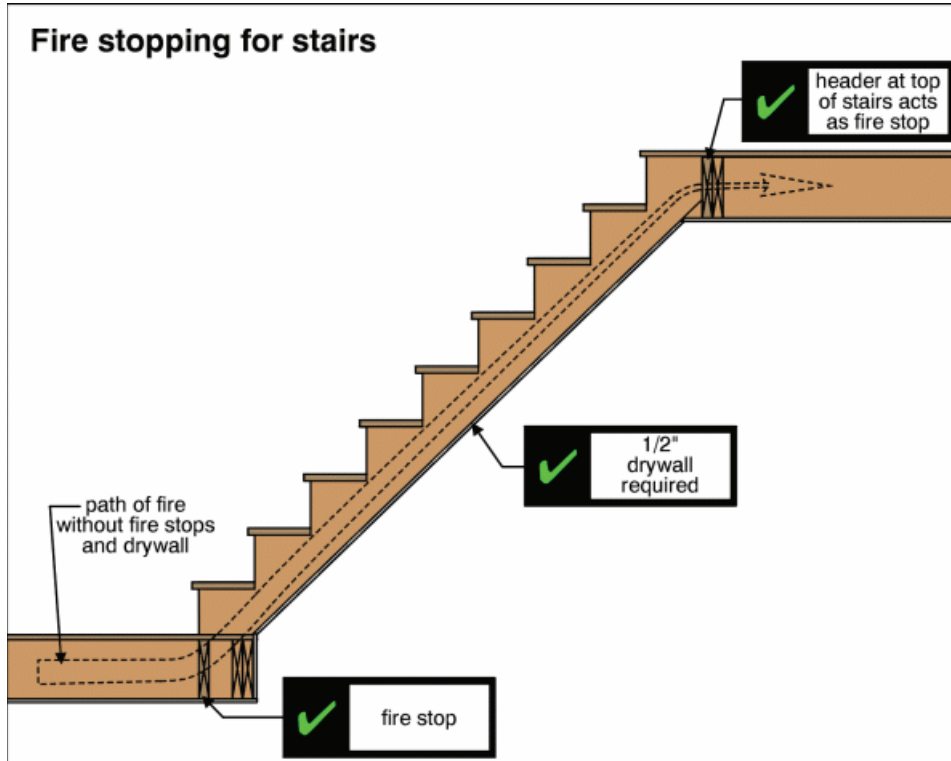
139. Drywall missing or incomplete on underside...

Location: Right Side Older Dining Room
