# REDSTAR PROFESSIONAL HOME INSPECTION, INC

## REDSTAR RESIDENTIAL INSPECTION REI 7-6

404 S Beauregard St  
Alvin, TX 77511

# PROPERTY INSPECTION REPORT FORM

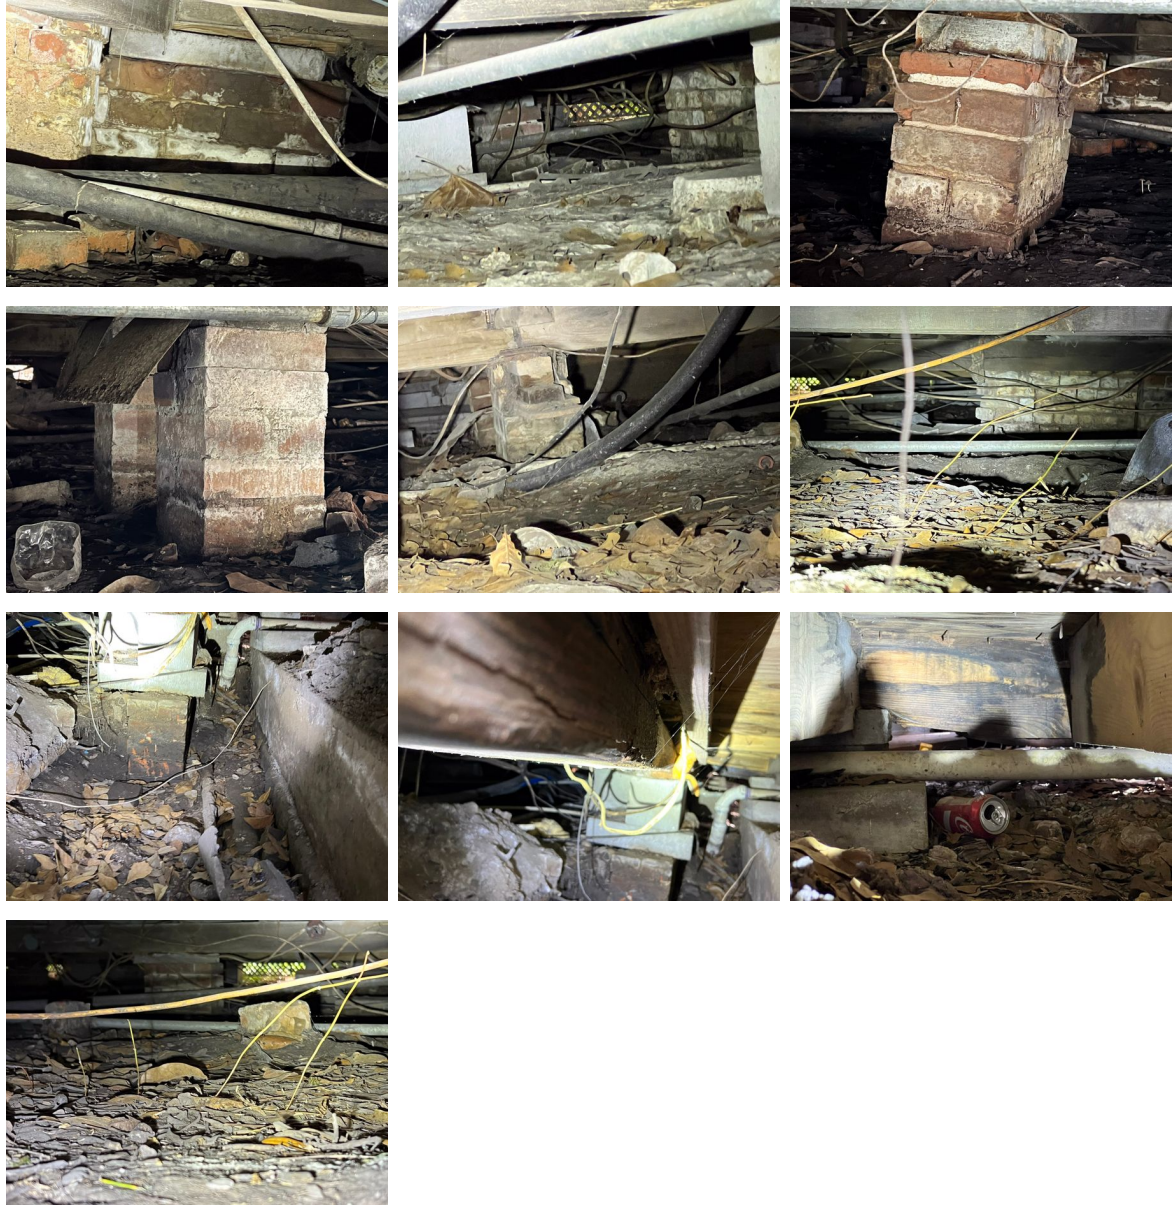
Signs of excessive structural movement and issues observed in relation to the condition of the pier and beam foundation as observed at time of inspection. These issues include:

- Inadequate support of the structural beams at some locations with some of the wood beams being loose or inadequately shimmed and supported.
- Piers are shifted/leaning or show signs of deterioration. The piers in place are aged brick piers with some newer concrete blocks and most of the aged piers showed excessive deterioration and will likely require replacement. Consult with a qualified contractor to evaluate the condition of the piers and extent of repairs/replacement/additions needed.
- Deflections in the subfloor and signs of the foundation being excessively out of level.
- Wood rot and previous wood destroying insect damage observed to sections of the wood beams and areas that will likely require supplementing or replacement.

The pier and beam foundation and related components require further evaluation by qualified contractor to determine the extent of necessary repairs. Recommend a foundation repair company (who is familiar with pier and beam structures) or a structural engineer be consulted to perform a foundation performance evaluation and determine what corrective action is needed.

Recommendation: Contact a qualified structural engineer.

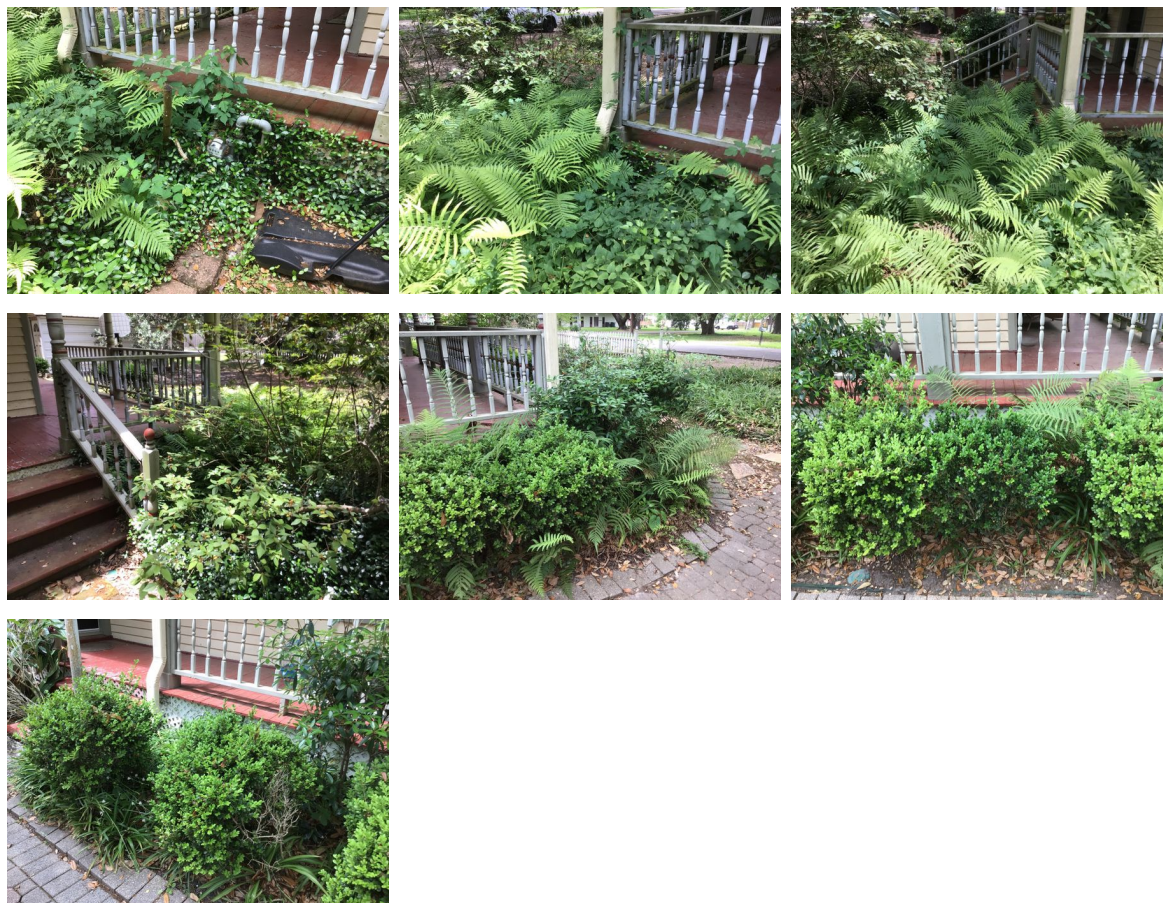
Recommend trimming foliage in contact with the structure to prevent damage to the veneer and moisture penetration over time. Recommend all tree limbs be cleared back a minimum of 3' from the roof covering and foliage 18" from the exterior walls.

Recommendation: Contact a qualified landscaping contractor

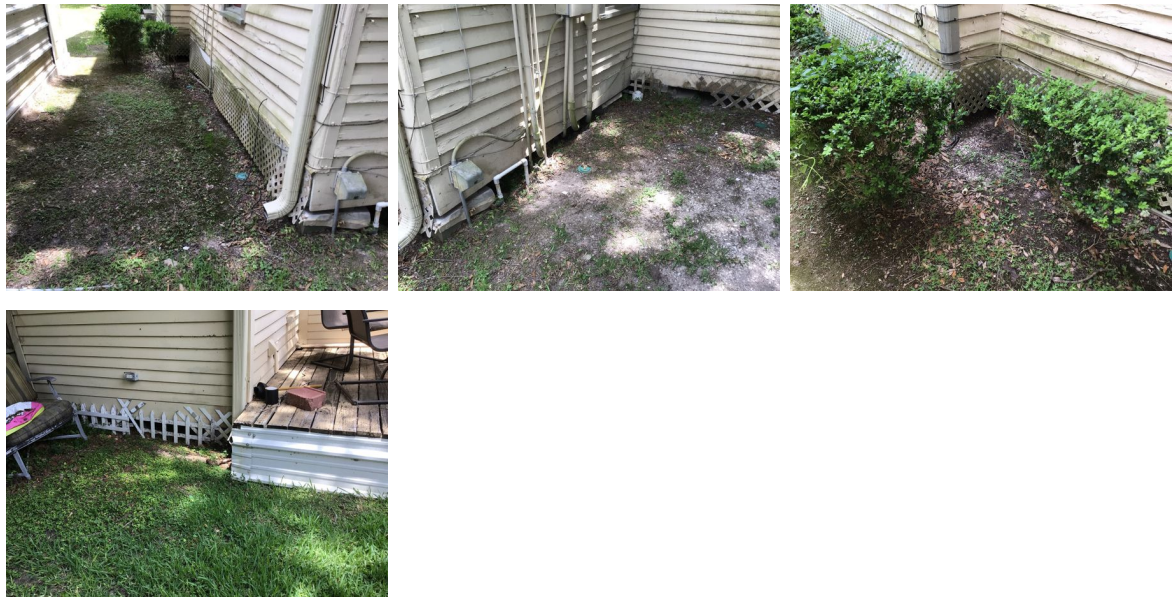
**2: Grading & Drainage: Multiple issues**

There appears to be improper grading and drainage of the property at multiple locations around the home. Issues observed include negative slope towards foundation, soil erosion around perimeter of the home, and inadequate slope of the grade around property to ensure proper drainage. Recommend consulting with a qualified contractor to determine the best method of repair.

Recommendation: Contact a qualified landscaping contractor

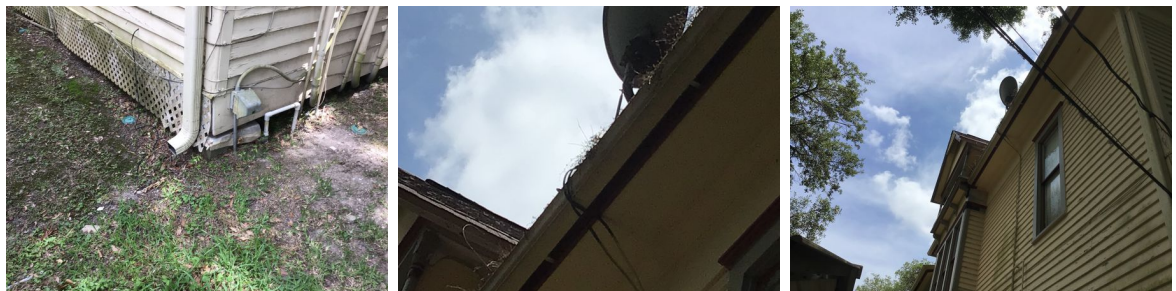
**3: Gutters: Multiple issues**

Multiple issues observed with the condition of the gutters around the property at time of inspection. These issues may include: damaged or loose sections, signs of leaking, and inadequately sloped or clogged sections. Due to the extent of observed issues, I recommend further evaluation by qualified contractor to determine the extent of needed repairs.

Recommendation: Contact a qualified gutter contractor

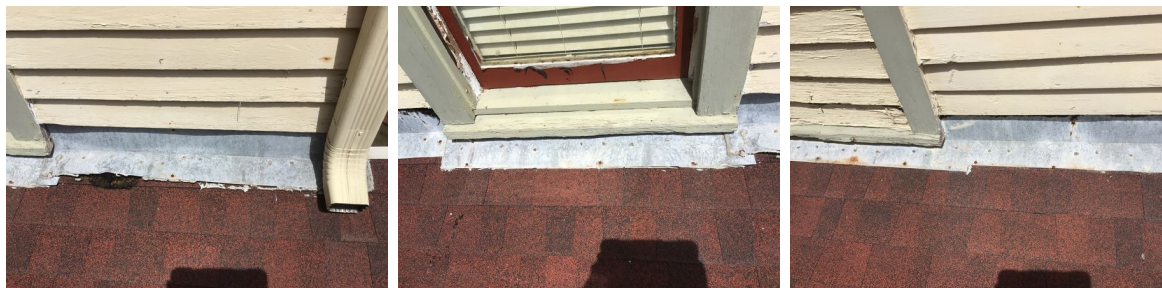
**1: Unpainted Materials**

Several locations including exposed flashing, vent assemblies, and/or plumbing vents were observed to have not been painted. All areas exposed above the roof line are required to be properly painted to avoid deterioration. Recommend correction.

Recommendation: Contact a qualified roofing professional.

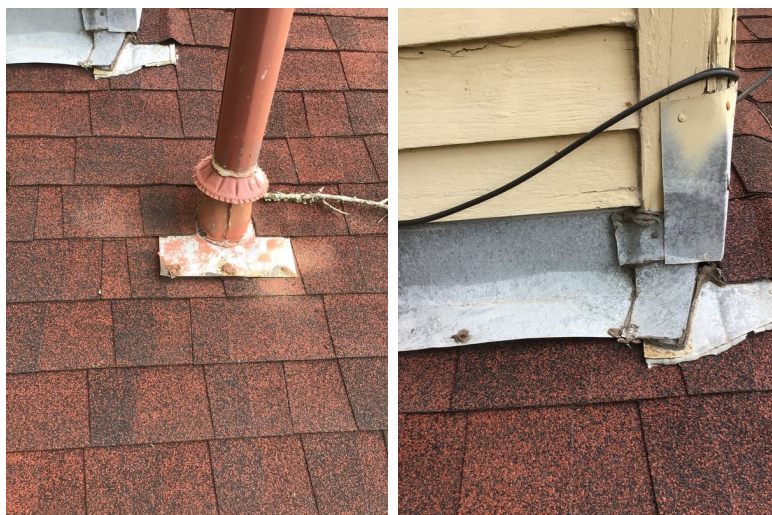
**2: Flashing: Deteriorated Sealant**

Deteriorated sealant was observed around plumbing and other flashing components. It is vital to maintain these locations to ensure performance of the covering. Recommend correction to avoid further deterioration or potential moisture intrusion issues.

Recommendation: Contact a qualified roofing professional.

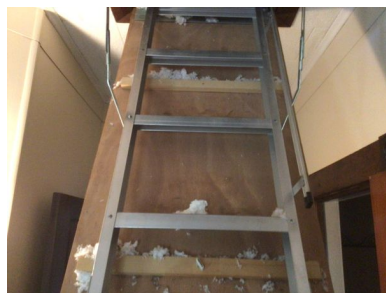
**1: Attic Door: Issues Observed**

The above stated issues were observed in relation to the attic access door at the time of inspection. Attic access doors are required to be properly insulated, weatherstripped, and seal firmly for energy efficiency reasons. Pull down attic ladders are required to be properly secured to the ceiling framing with appropriate fasteners, the hardware on the doors should be kept in good condition and be regularly serviced for safety reasons. Recommend correction of any above referenced issues to ensure performance and proper installation.

Recommendation: Contact a qualified handyman.

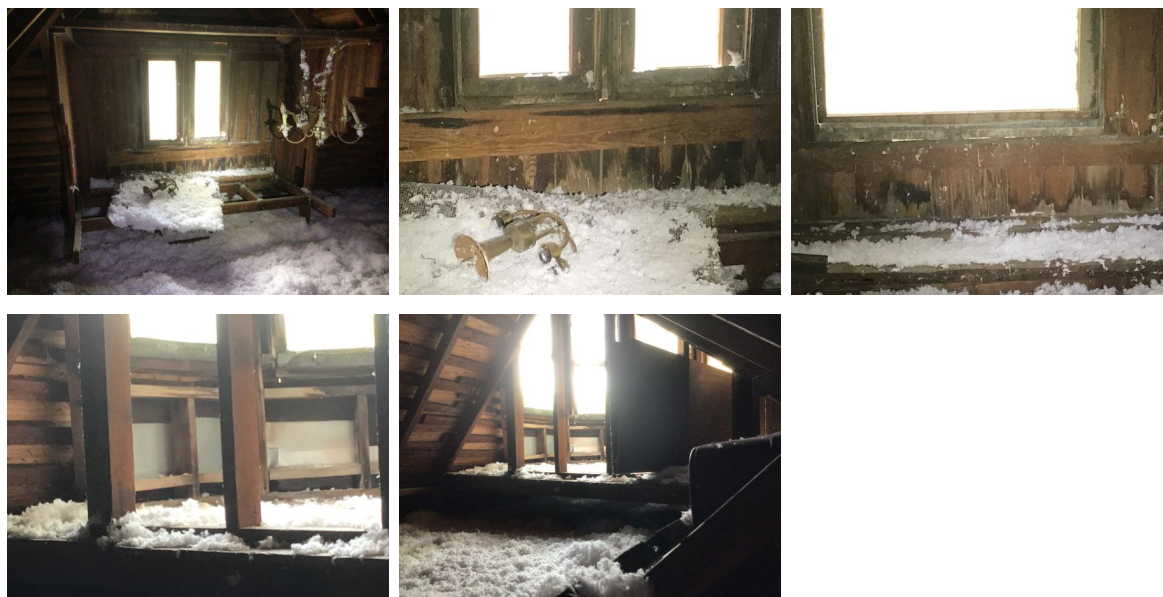
**2: Moisture intrusion**

Inspector observed multiple issues inside the attic space where it appeared moisture had penetrated the exterior at the time of inspection. Recommend evaluation and correction to avoid future moisture intrusion.

Recommendation: Contact a qualified professional.

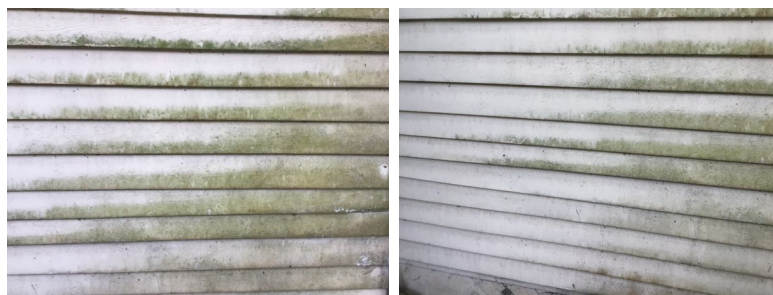
Mildew buildup, Paint touch up needed -

The above stated issues were observed at the home at time of inspection. These items are related to cosmetic issues or maintenance due to expected wear and tear. Recommend you budget for repair of these issues for cosmetic reasons, or to avoid further deterioration.

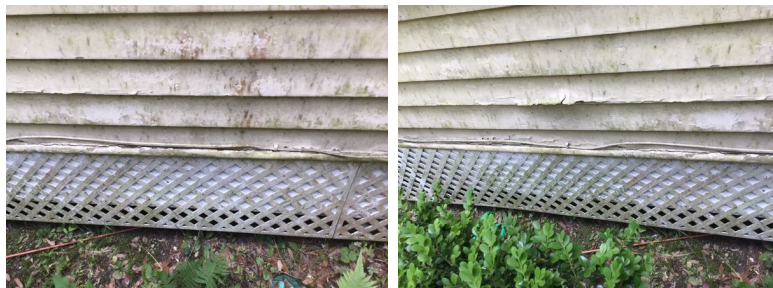
**2: Caulking and Sealing Needed**

The above stated locations were identified as areas in need of proper caulking and sealing, or maintenance to the existing sealant. Examples of locations needing sealing are pictured for your reference. Recommend further evaluation of these areas and all others to determine the extent of needed repairs.

Recommendation: Contact a qualified handyman.

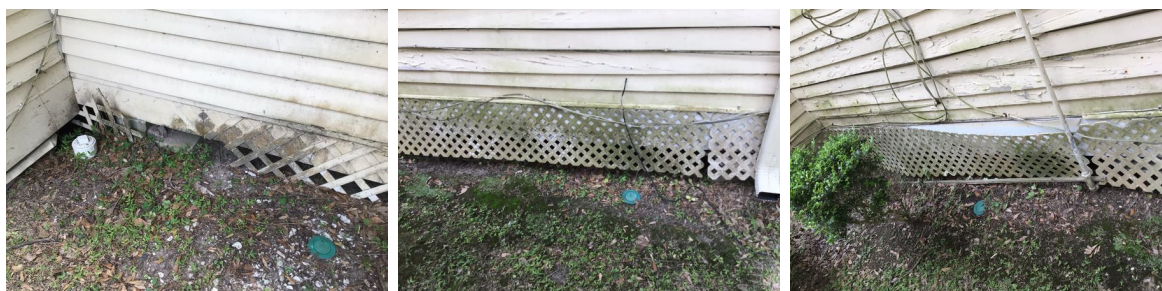
### 3: Siding: Moderate Damage/Repairs Needed

The siding displayed sections with moderate damage that requires further evaluation and corrective action to avoid potential moisture intrusion or other issues. Recommend further evaluation of these locations by a qualified contractor and budget for necessary repairs.

Recommendation: Contact a qualified siding specialist.

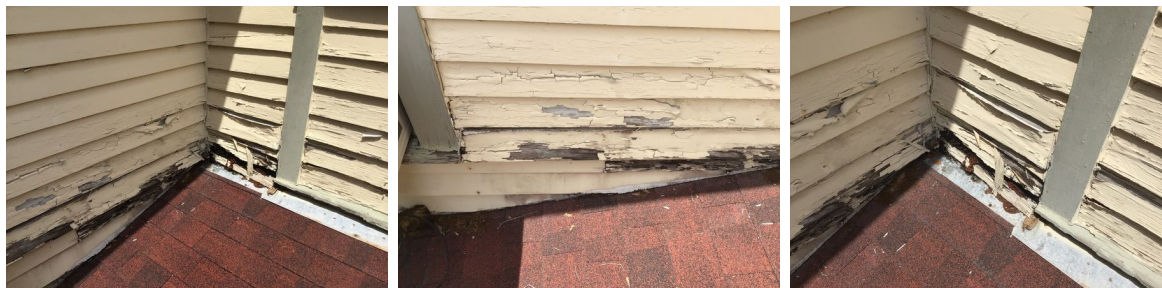
### 4: Siding: Wood Rot/Moisture Issues

Moisture penetration was observed to the wooden trim, fascia boards and siding at multiple locations around the home. Repair as needed to prevent further deterioration.

Recommendation: Contact a qualified professional.

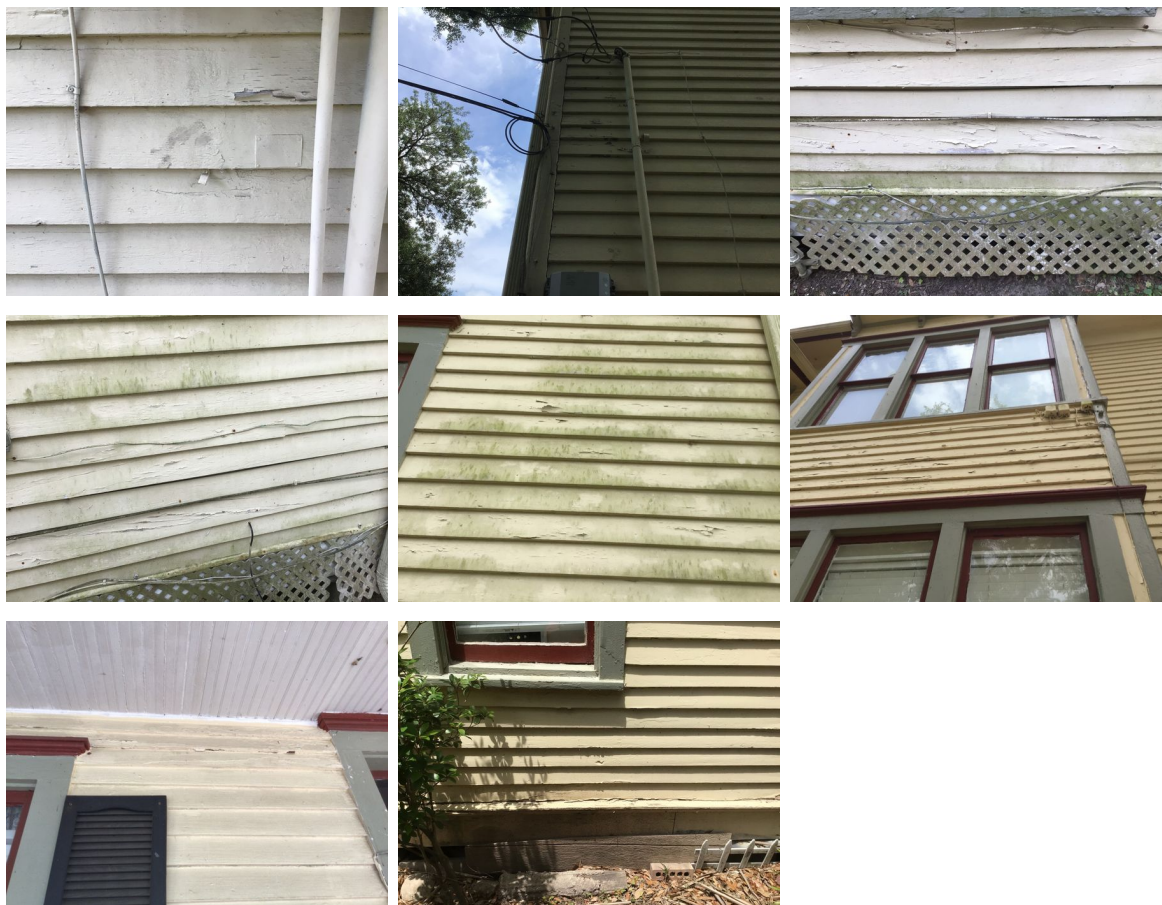
**5: Siding: Paint/Finish Issues**

There were some areas of the exterior siding or trim that needs painting or staining to prevent premature weathering of building materials. Remedy as needed.

Recommendation: Contact a qualified professional.

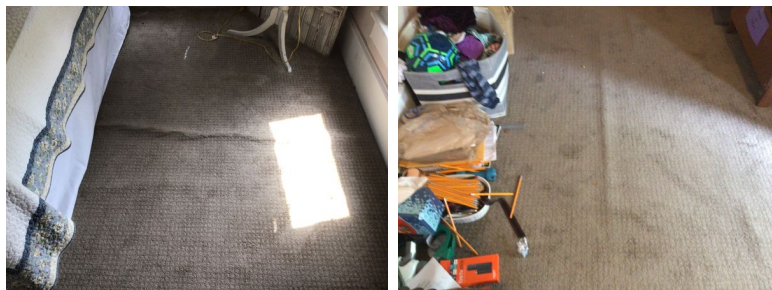
**4: Flooring: Buckled/Rippled Carpet**

Buckled or rippled carpet can be a trip hazard. Re-stretching by a qualified flooring contractor is recommended.

Recommendation: Contact a qualified professional.
