Web Presentation

Property Address: 3006 Pecan Way Court, Richmond, TX 77406

ABET Home Services

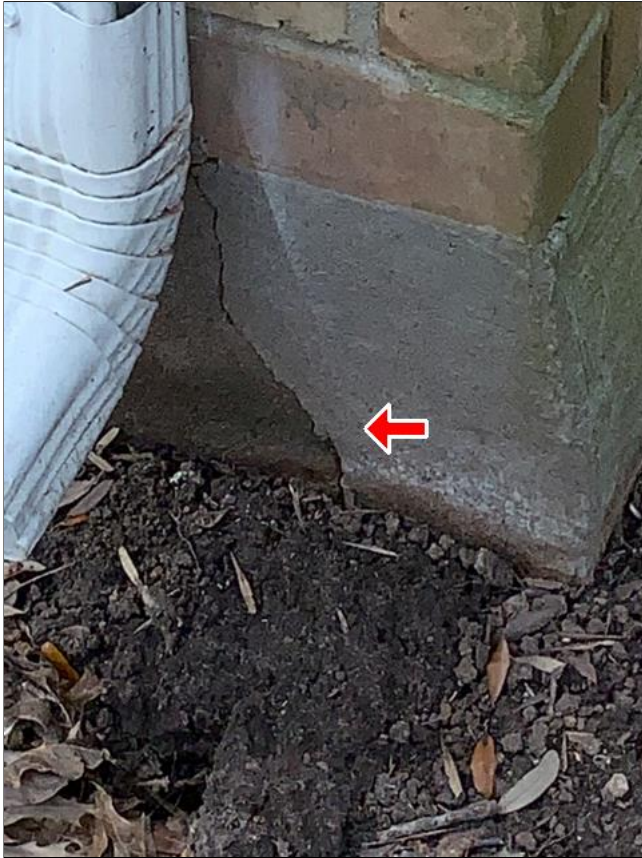
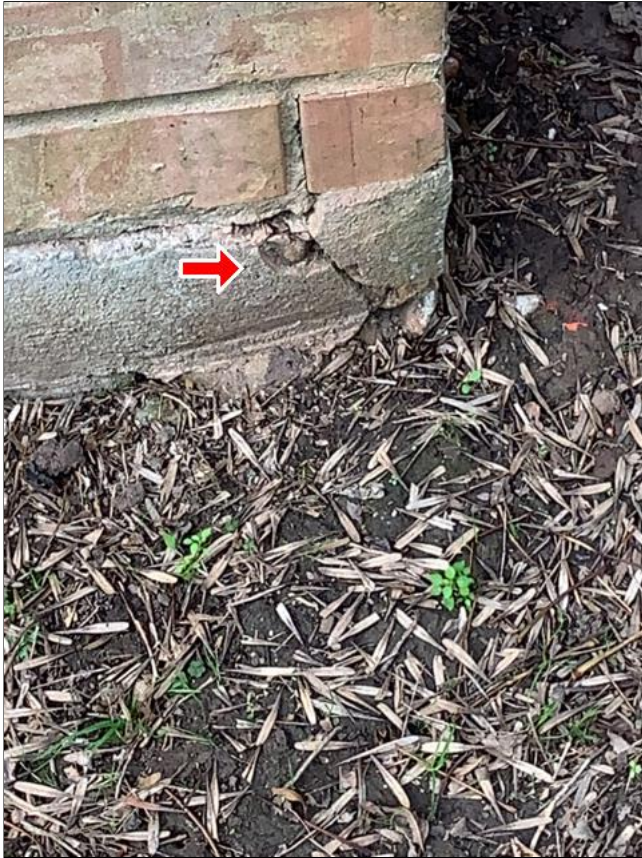
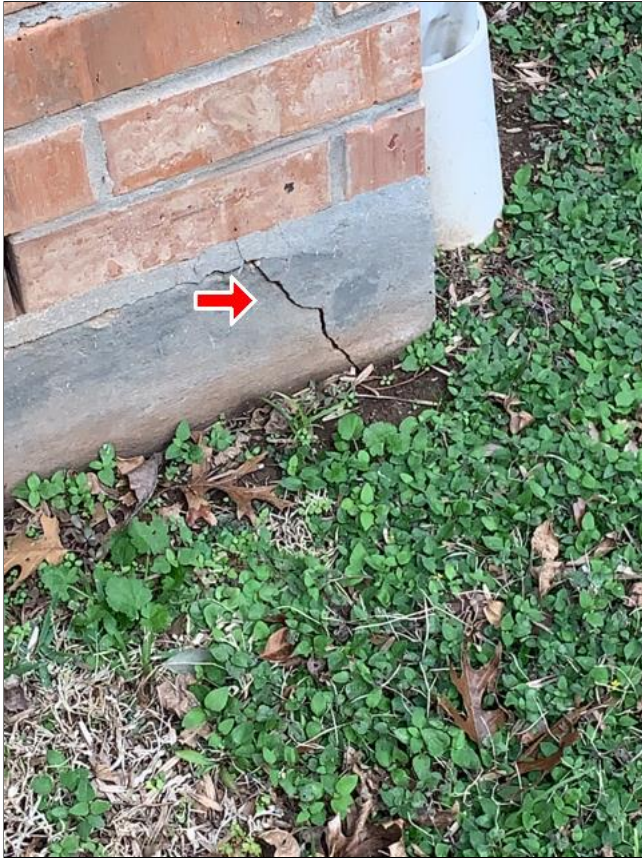
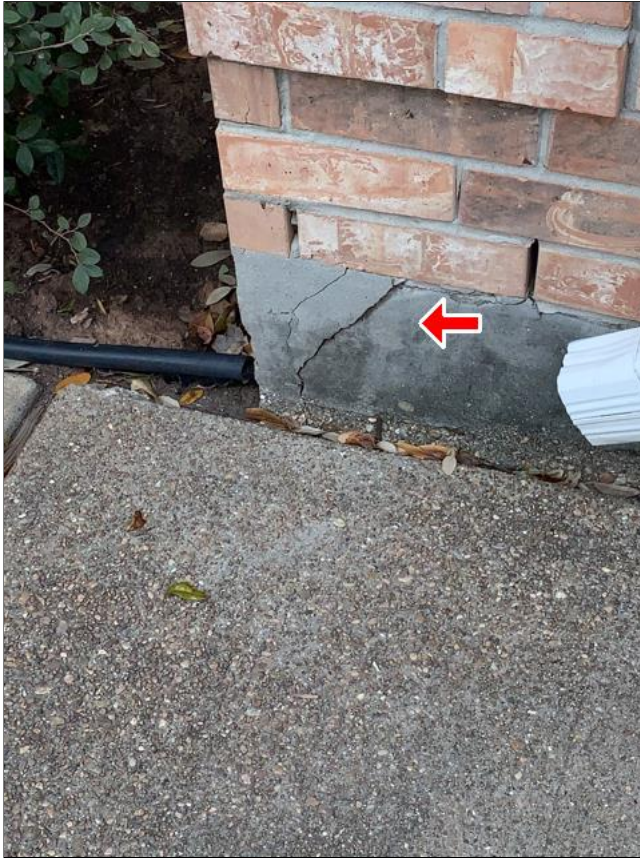
(2) Slab corner spalls require cleaning and/or resealing at the rear corners and at the front corner

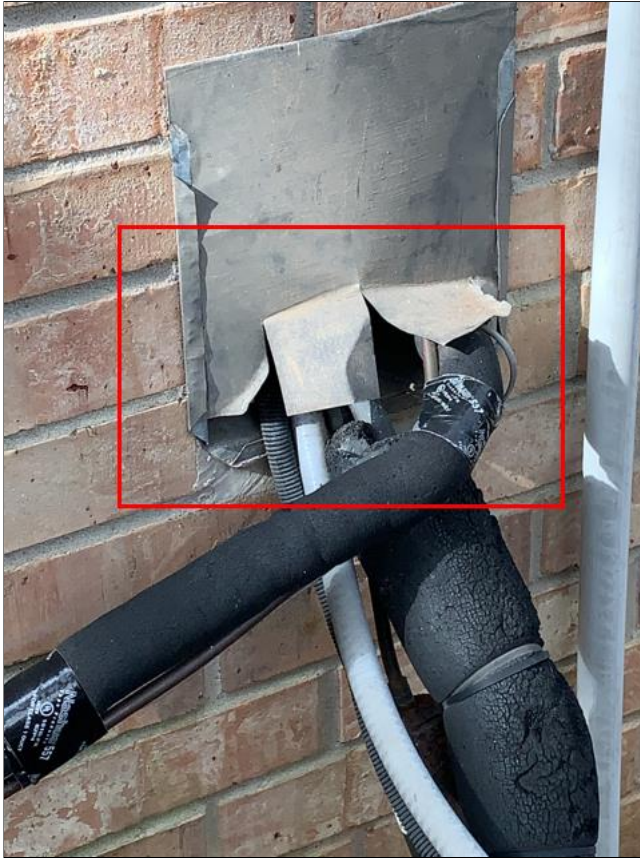
E. Item 1(Picture)

(2) Freon line is not sealed at exterior wall penetration point.

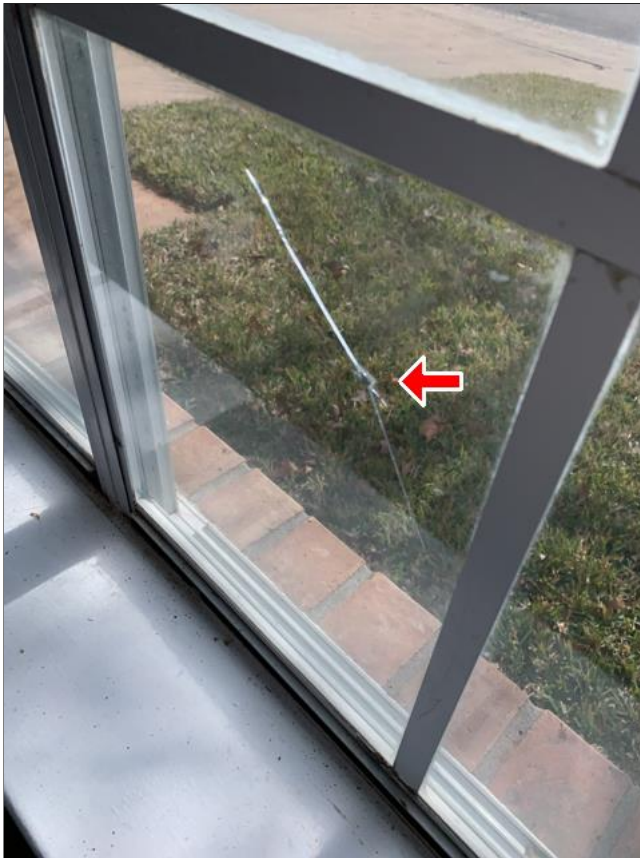
H. Item 1(Picture)

(3) Glass panes are broken and/or cracked at the garage at one location

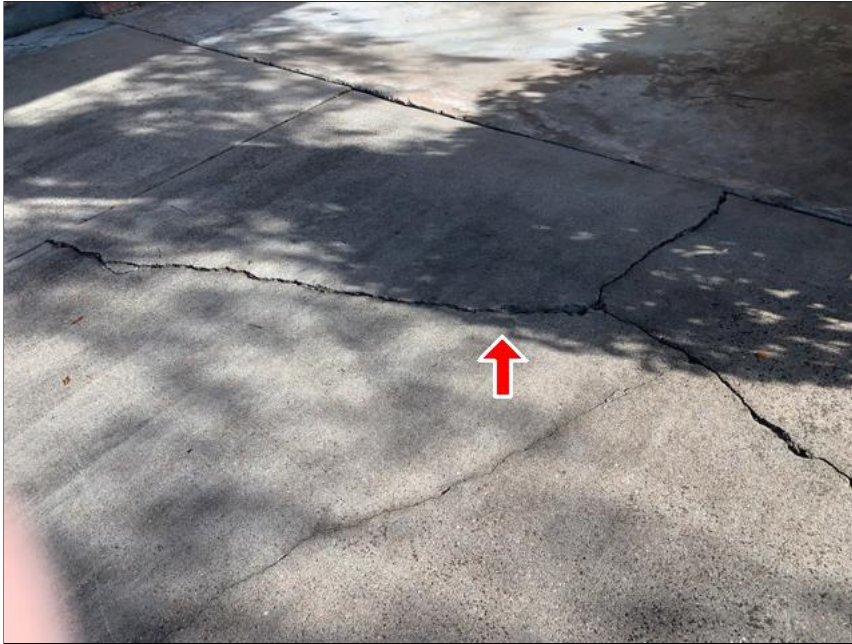
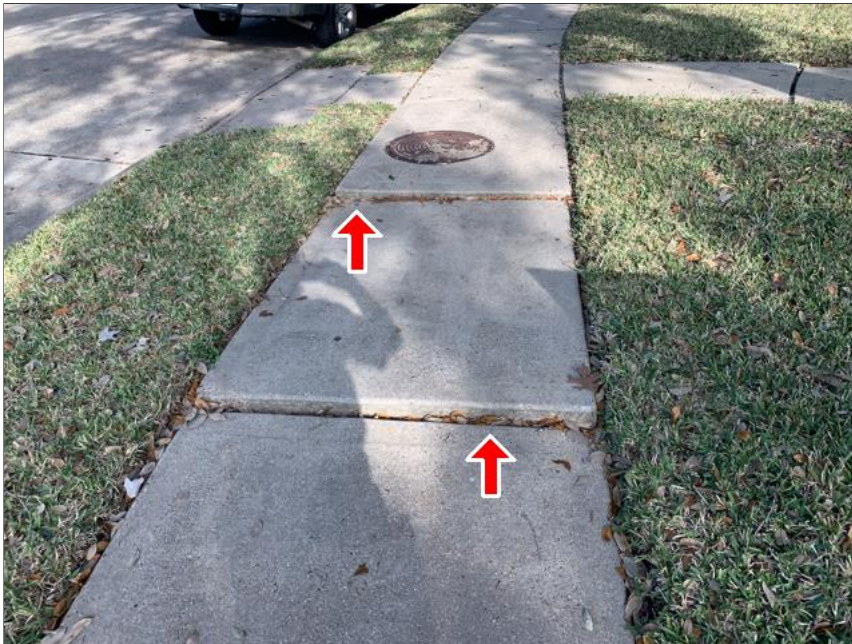
Driveway or sidewalk is cracked at multiple locations

Expansion joint material is deteriorated

Cracks or separations in driveway or sidewalk exceed 1" in height or separations - This is considered a trip hazard

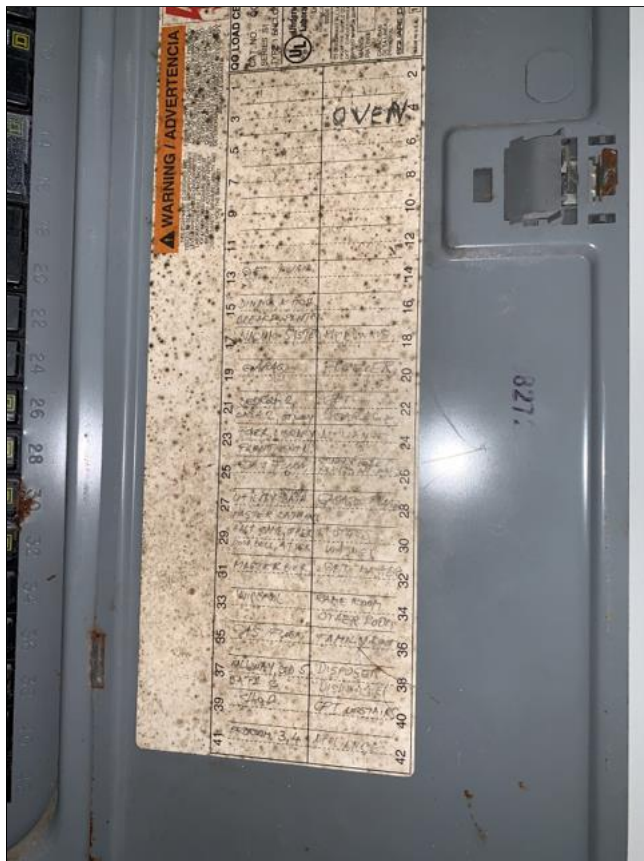
A. Item 2(Picture)

(2) The breaker panel labels are not legible

Panel is not labeled at all locations

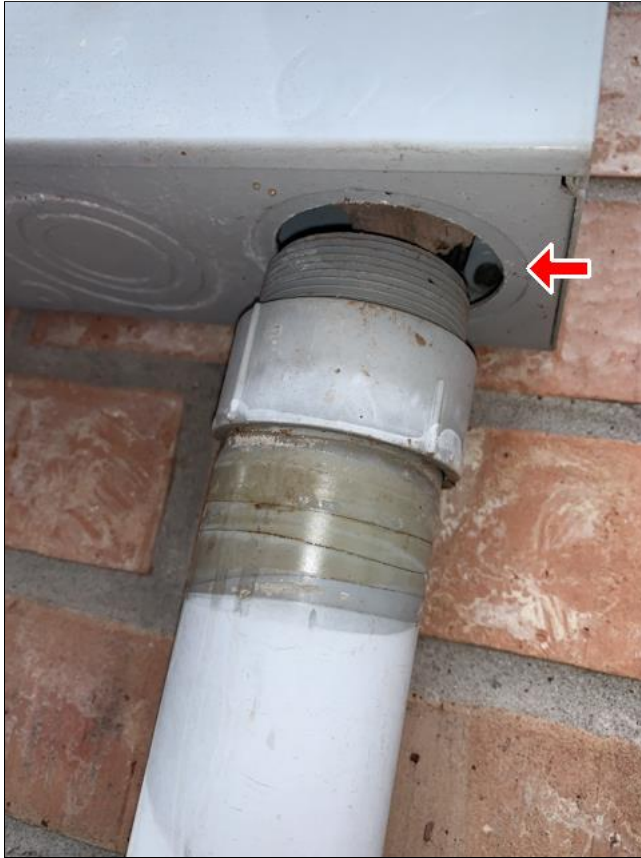
A. Item 3(Picture)

(3) Wire conduit has separated from meter box

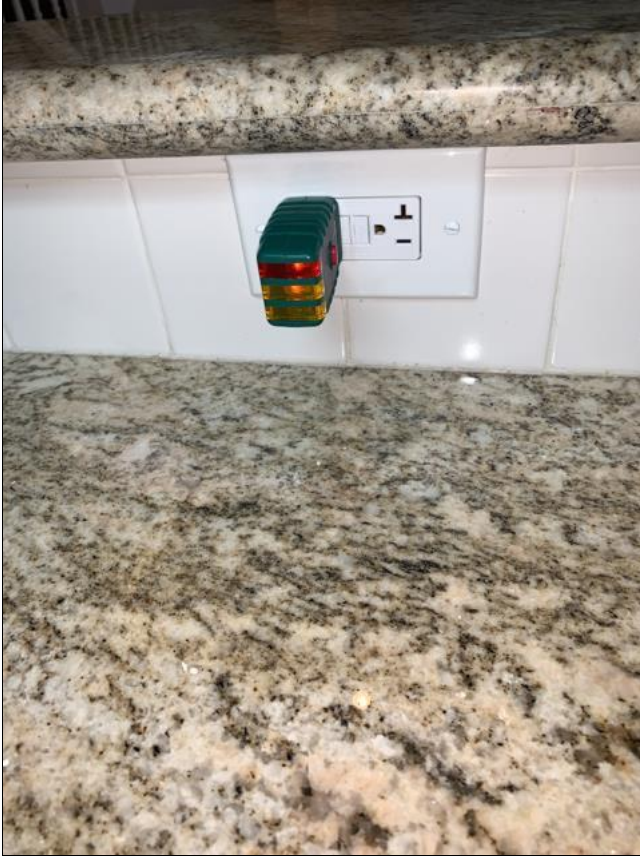
B. Item 1(Picture)

(2) The kitchen counter GFCI outlet to the right of the refrigerator has reversed polarity and does not test

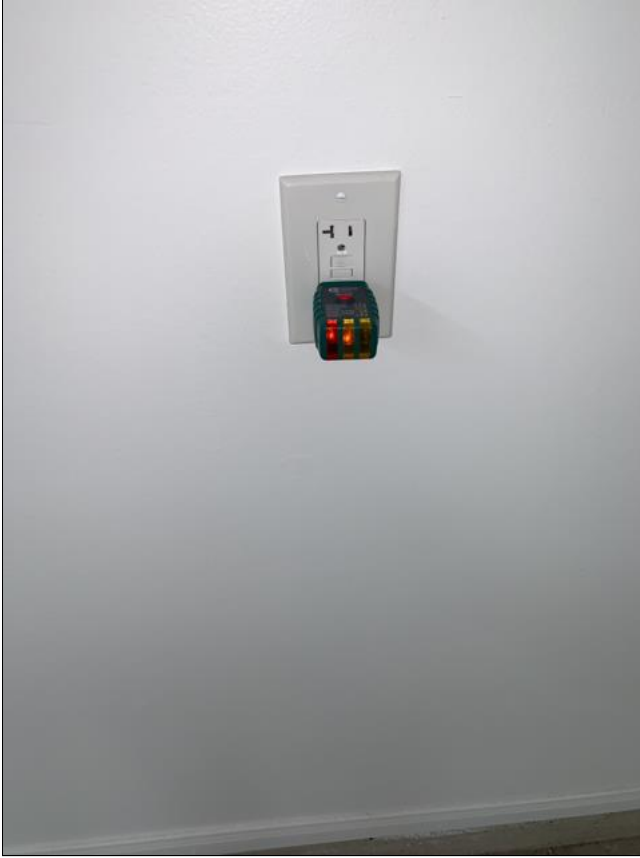
B. Item 2(Picture)

(3) The garage GFCI outlet has reversed polarity and does not test

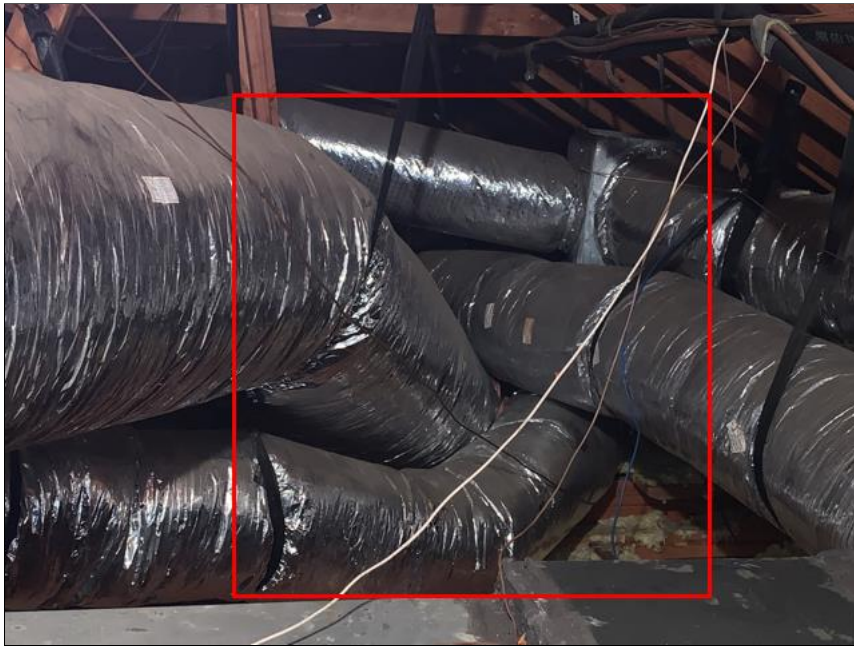
C. Item 1(Picture)

Ductwork is in contact with each other - 1" clearance is required

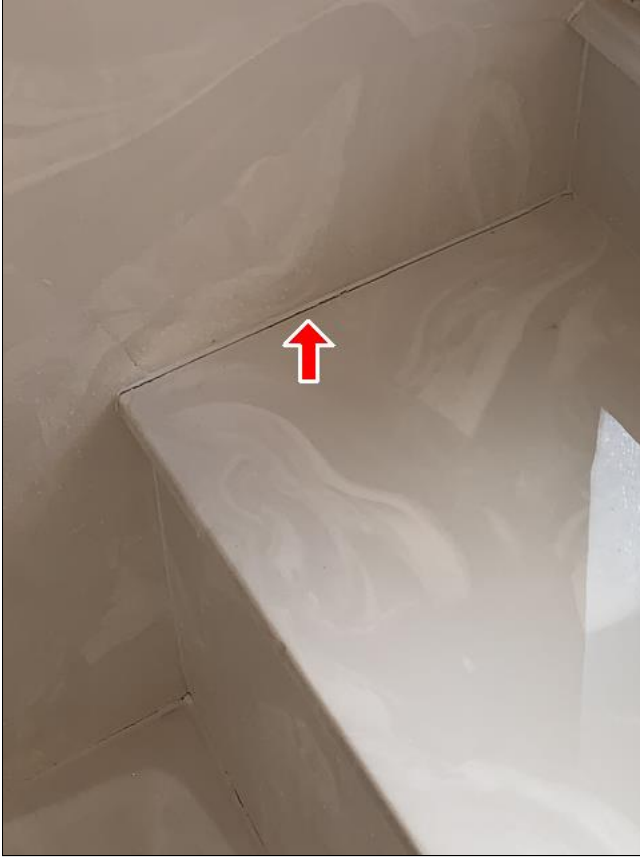
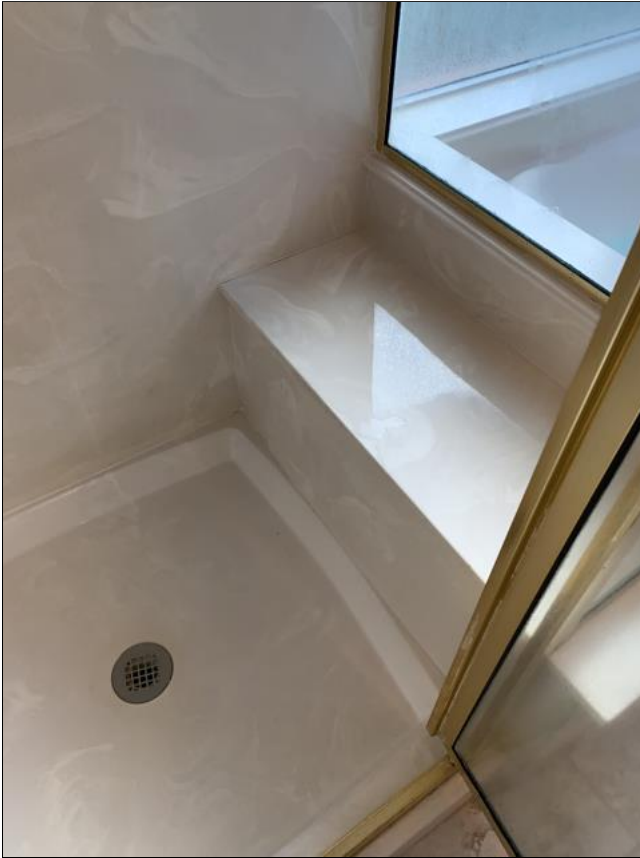
(2) Caulking is required at the master bath shower bench. Water appears to be leaking into this area of the shower. Further investigation is needed

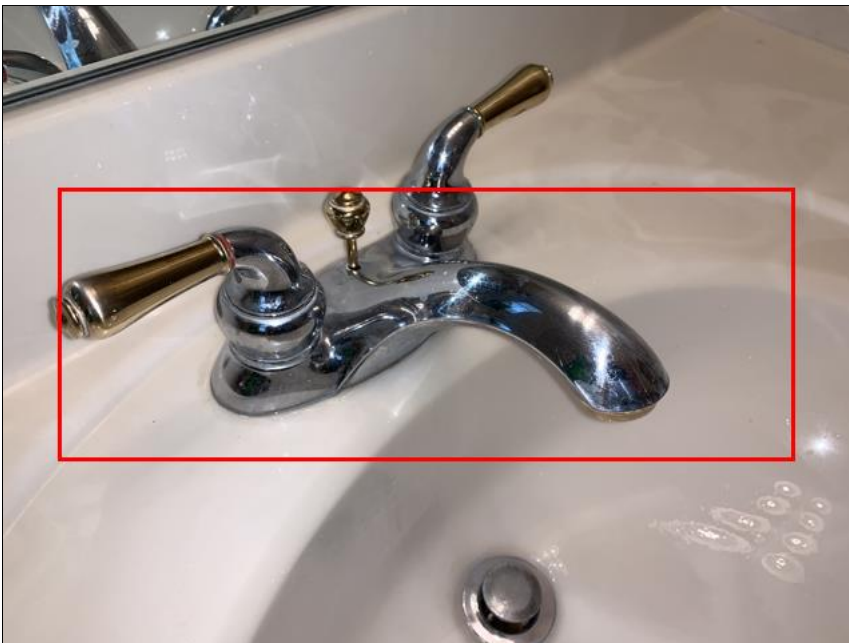
A. Item 3(Picture)

(3) The downstairs hall bath vanity faucet leaks

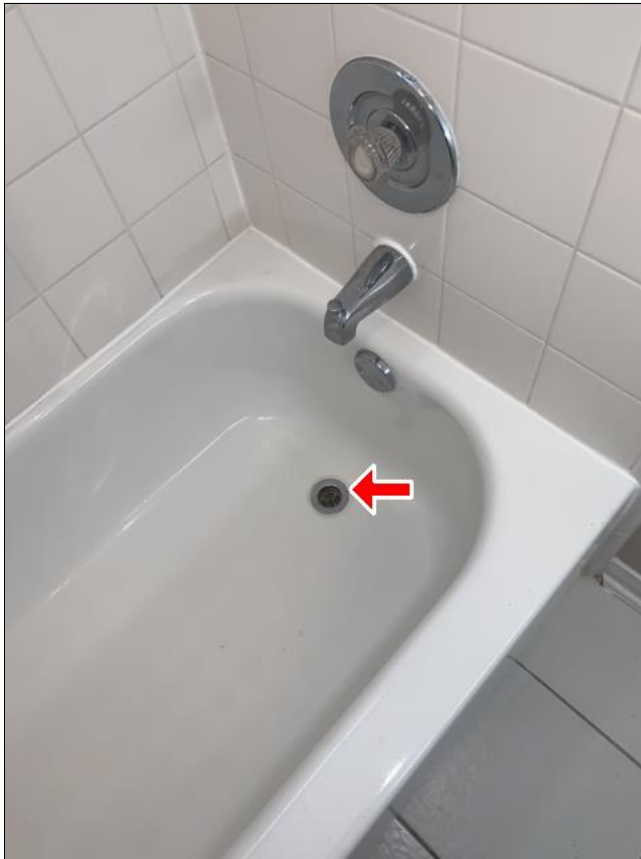
A. Item 4(Picture)

(4) The upstairs Hollywood bath tub stopper is broken

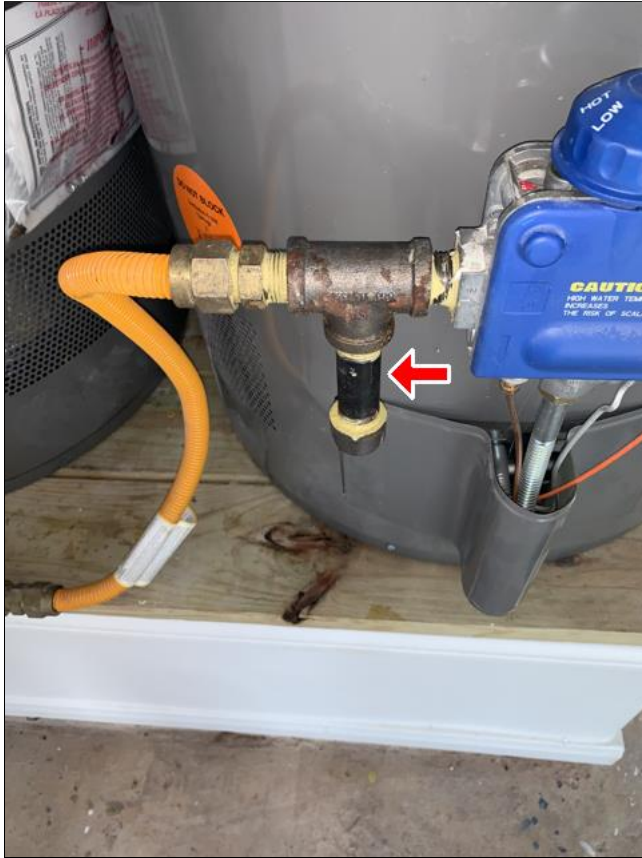
C. Item 5(Picture)

(2) Gas line sediment trap is improperly installed - Flow of gas must change direction through trap

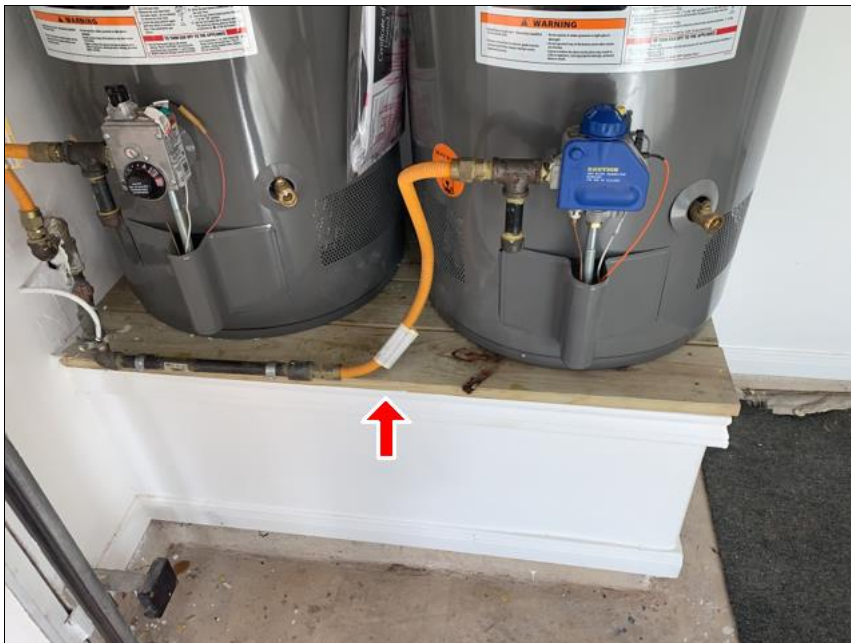
C. Item 6(Picture)

(3) No drain pan is installed underneath water heater

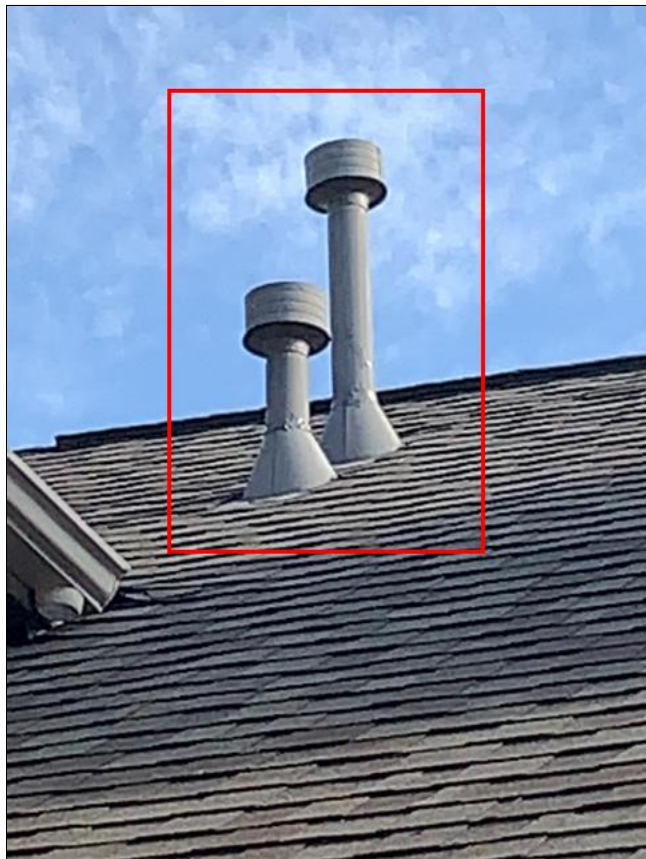
C. Item 7(Picture)

(4) The water heater vent pipe collars are missing at the roof jacks

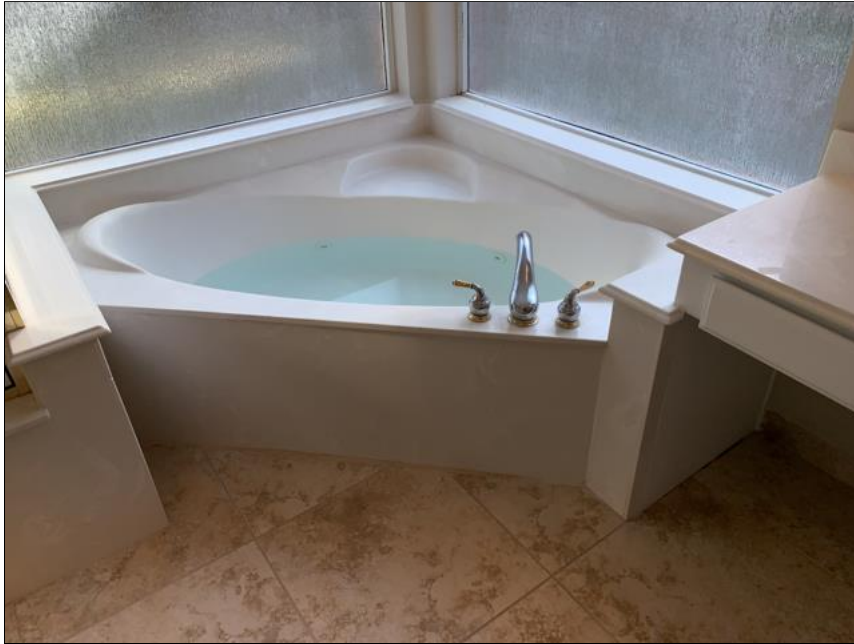
D. Item 1(Picture)

Jacuzzi tub motor not working - Further evaluation recommended

No visible access panel to jacuzzi tub equipment - Jacuzzi tub motor was not viewed

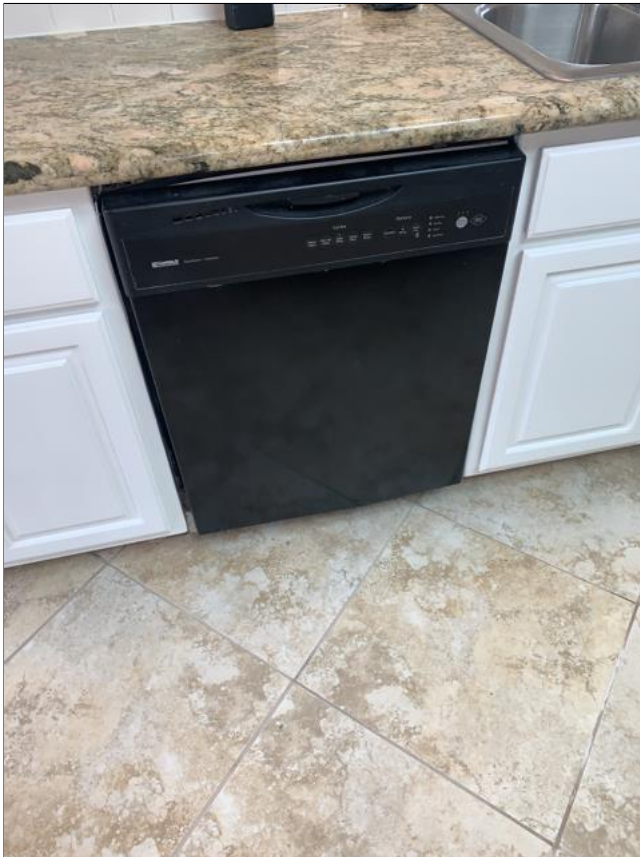
A. Item 1(Picture)

(2) No anti-siphon loop or backflow device installed
