Inspection Report ID : 117574

Facility Name: LL Flooring (CC)

Inspection Report

Problem Area: Throughout the home

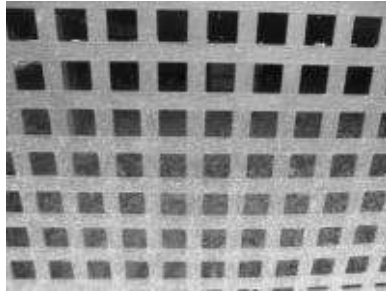
Room 2: Outside

Description 2: Photo showing no ground cover

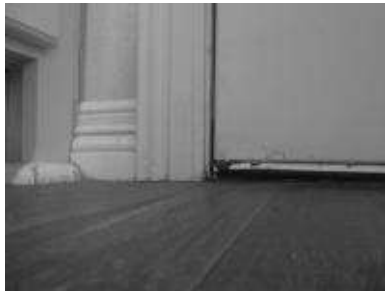
Room 33: Mudroom

- The buckled area found in the master bedroom resulted from the lack of proper subfloor flatness, the lack of perimeter expansion space, and a lock-in condition created by the flooring material installed tight to the baseboard and door jamb.
- The soft spots found throughout the installation resulted from the lack of proper subfloor flatness.

Description 33: Photo showing the tight installation of flooring material to a door jamb

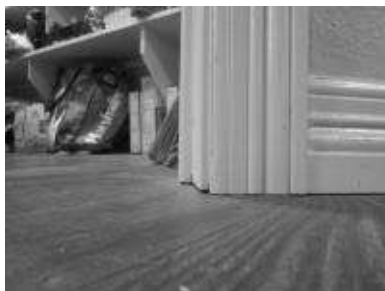
Room 34: Mudroom

Description 34: Photo showing the tight installation of flooring material to a door jamb

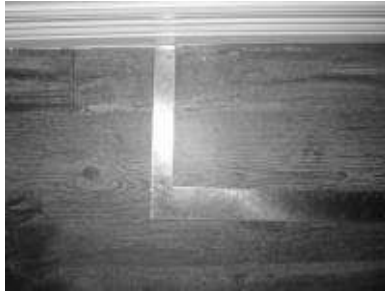
Room 47: Guest bedroom-2

Description 47: Photo showing the tight installation of flooring material to the baseboard

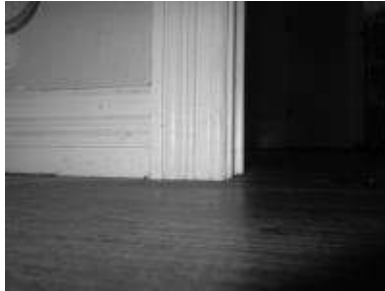
Room 50: Guest bathroom

Description 50: Photo showing the tight installation of flooring material to a door jamb

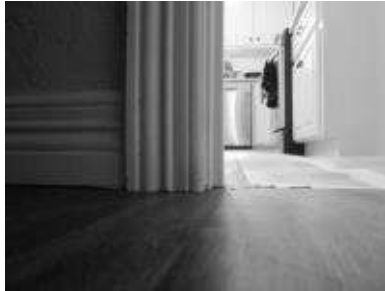
Room 56: Game room

Description 56: Photo showing the tight installation of flooring material to a door jamb

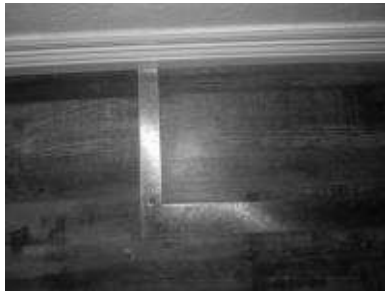
Room 57: Game room

Description 57: Photo showing the tight installation of flooring material to the baseboard

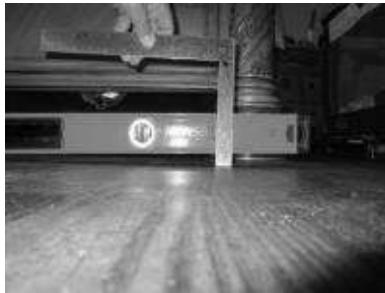
Room 60: Master bedroom

- Master bedroom:
 - A buckled area measuring 6' in length x 1' in width x 1 1/2" in height located 2' in from the bed.
- Kitchen:
 - Random dark spots found in the plywood subfloor ranging from 2" to 2' in diameter.
- Random dark spots were found on the back of the vinyl shower pan material used as the underlayment throughout the installation.
- Randomly located soft spots found when walking across the floors. These soft spots ranged from 6" to 2' in diameter.
- These spots were found in the dining room, game room, master bedroom, mudroom, guest bedroom-1, and guest bedroom-3.
- The planks are installed tight to the baseboards and door jambs in random areas throughout the installation.
- There were no planks exposed to direct sunlight.
- There were window coverings found on the windows.
- There were no signs of any failing locking mechanisms.

- Elevated moisture coming from below the flooring material's surface was a contributing factor to the buckled area in the master bedroom and the dark spots found on the plywood subfloor and vinyl shower pan material in the kitchen.

Description 60: Photo of the buckled area located in front of the bed

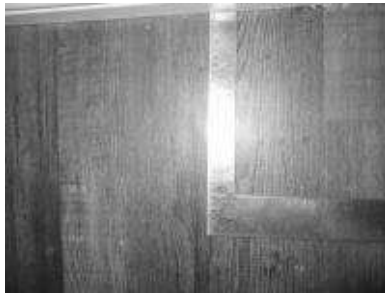
Room 63: Master bedroom

Description 63: Photo showing the tight installation of flooring material to the baseboard

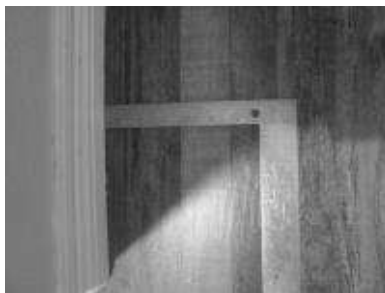
Room 67: Master bathroom

Description 67: Photo showing the tight installation of flooring material to the baseboard

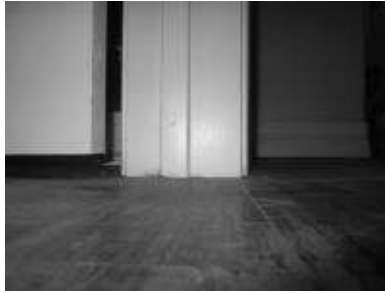
Room 71: Master closet

Description 71: Photo showing the tight installation of flooring material to a door jamb

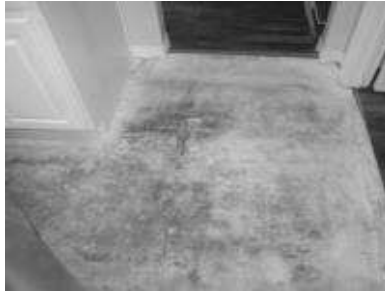
Room 83: Kitchen

Description 83: Photo showing the dark spot found on the plywood subfloor

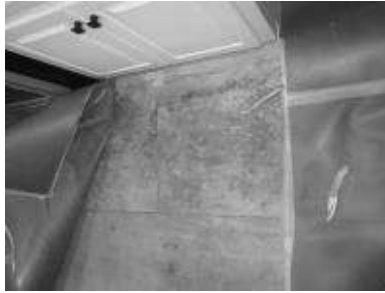
Room 86: Kitchen

Description 86: Photo showing the dark spot found on the plywood subfloor

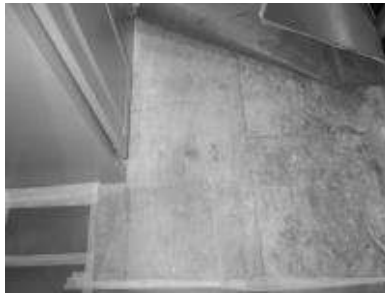
Room 87:

Description 87: Photo showing the dark spot found on the plywood subfloor

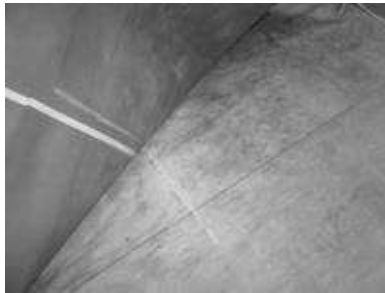
Room 90: Kitchen

Description 90: Photo showing the dark spot found on the underlayment

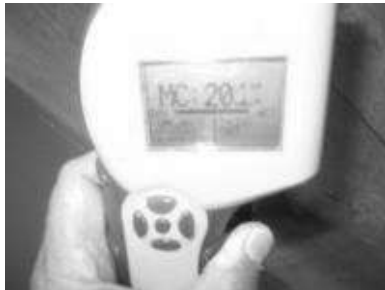
Room 91: Kitchen

- With the use of the Delmhorst wood invasive meter, the moisture of the plywood subfloor ranged from 19.6% to 22.7%
 - These readings are high for the setting of this meter.

Description 91: Photo showing the moisture of the plywood subfloor

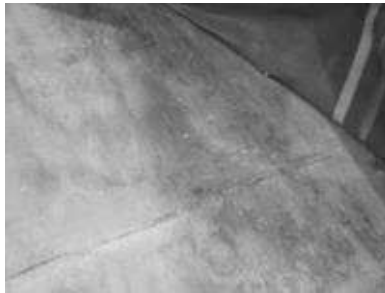
Room 93: Kitchen

Description 93: Photo showing the dark spot found on the plywood subfloor

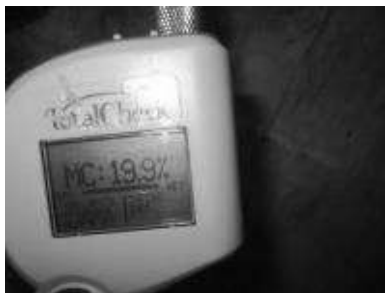
Room 94: Kitchen

Description 94: Photo showing the moisture of the plywood subfloor

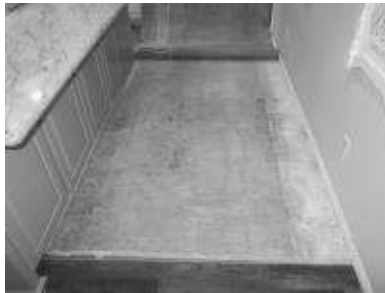
Room 96: Kitchen

Description 96: Photo showing the dark area found on the plywood subfloor
