PROPERTY INSPECTION REPORT

Concerning: 14426 Rosehill Estates Ln, Cypress, TX 77429
(Address or Other Identification of Inspected Property)

By: Daniel Beard, Lic #TREC #8004 07/09/2020
(Name and License Number of Inspector) (Date)

Report Identification: 20200709-01 Jerry Morton, 14426 Rosehill Estates Ln, Cypress, TX

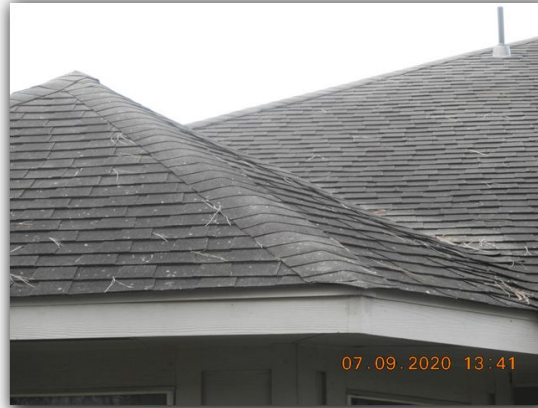
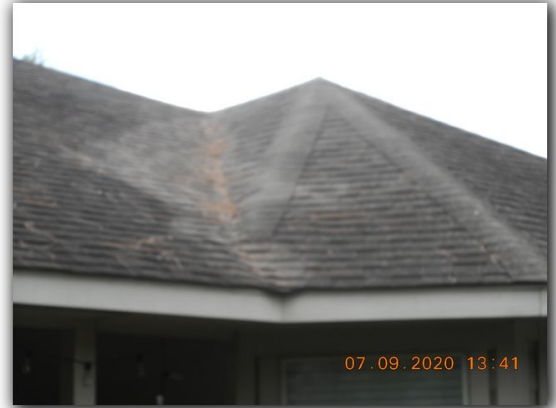
There appears to have been some hail storm damage to the roof evident by the numerous bruise dent marks on the shingles located at various areas of the roof slopes. It is difficult to determine if the damages warrant replacement or repairs which may be recoverable by the current owner's home insurance policy.

The shingles on the roof of the house are considered aged and are near there term of life expectancy. There is granule loss conditions present, feathering of the edges, which expose the fiberglass matting material. Some of the areas of the shingles have lost the adhesive seals under the tabs, which do not adhere to the underlying shingles as originally intended.

There are brittle and cracked shingles along the hip ridge. The excessive granule loss has exposed the matting and fiberglass materials. There are numerous exposed nail heads missing silicone sealant.

Under certain conditions high winds can cause improper lifting of the shingles.

◆ There appears to have been some hail storm damage to the roof evident by the numerous bruise dent marks on the shingles located at various areas of the roof slopes. It is difficult to determine if the damages warrant replacement or repairs which may be recoverable by the current owner's home insurance policy. Recommend having an insurance claim filed by the current owners insurance claims department in order to determine if the roof needs to be replaced or that the damages do not warrant replacement. The final written assessment should be passed to the client/buyer for future reference.

Recommend having an insurance claim filed by the current owners insurance claims department in order to determine if the roof needs to be replaced or that the damages do not warrant replacement. The final written assessment should be passed to the client/buyer for future reference.

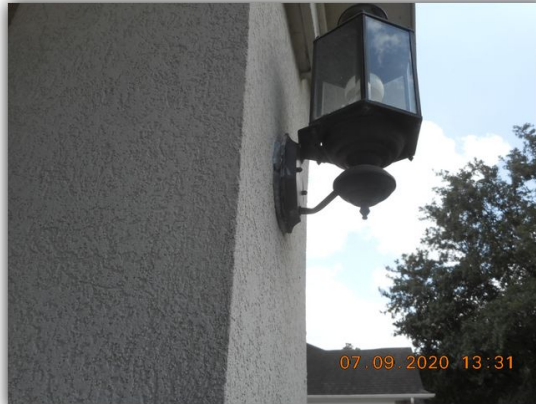
The perimeter of the exterior light fixtures are not sealed with silicone adhesive. The open perimeters will allow moisture and insect penetration.

- ◆ The perimeter of the exterior light fixtures are not sealed with silicone adhesive. The open perimeters will allow moisture and insect penetration.

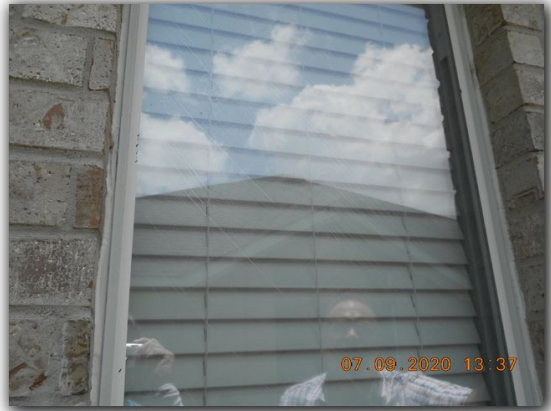
There are defects present in the glass panes located at several of the exterior windows most visible at the west wall.

The interior surfaces of the glass panes appear to have deterioration of the "transparent metallic oxide coating" or the reflective coating. This is considered a manufacture defect.

The windows are in need of further evaluation by the original manufacture or competent window manufacture in order to determine the cause of damage and repairs/replacement considered.

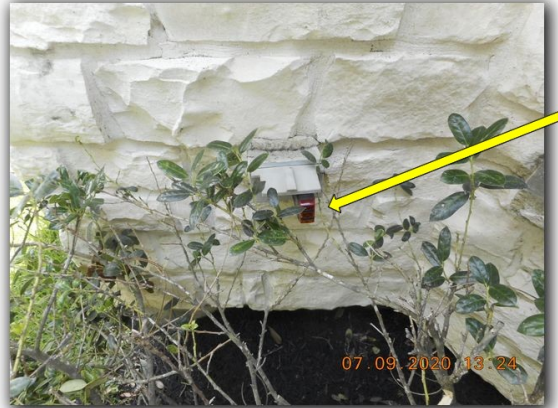
The gfci electrical outlet located at the front exterior wall did not have any electrical power. The gfci outlet would not reset.

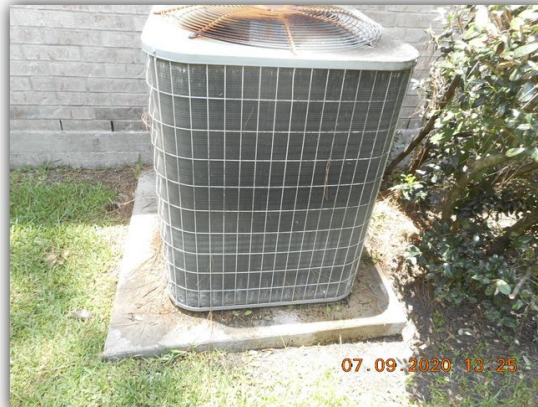
R-22 Equipment

The A/C unit installed in the home uses R-22 coolant. R-22 is being phased out and will be illegal to sell in the U.S. on January 1, 2020. The industry is now switching to R410a (Puron). Some units can be retrofitted to R410a and do not require complete replacement of the cooling equipment. Inspector recommends further evaluation by a licensed HVAC technician to confirm if the current system can be converted or if complete replacement is required. (This is not considered a deficiency and is purely FYI)

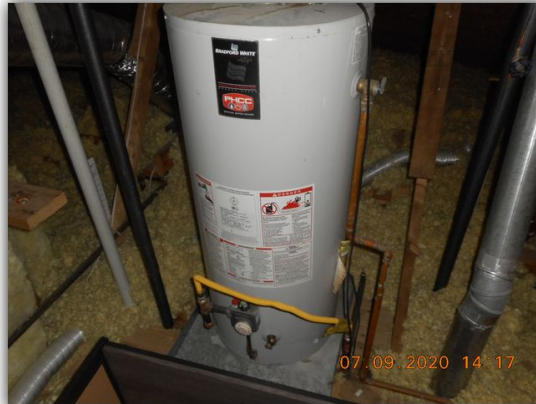
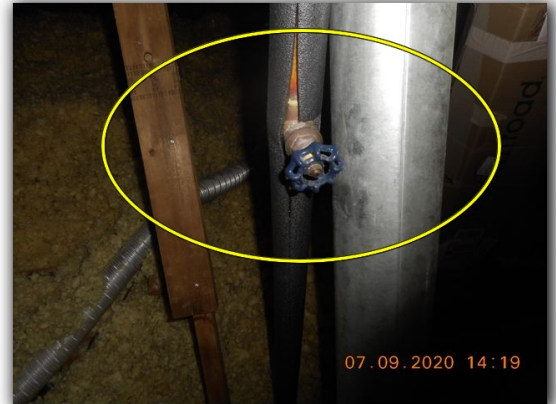
The water supply valve is defective for the water heater. The valve will not open and close as intended.

◆ The water supply valve is defective for the water heater. The valve will not open and close as intended.

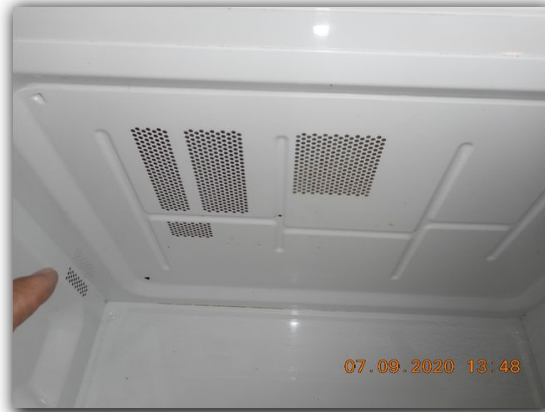
The light fixture inside the microwave did not function as intended.
