4210 Jackson

Property Inspection Report

6/30/2022 Date of Inspection	
_	
21668	
TREC License #	
TREC License #

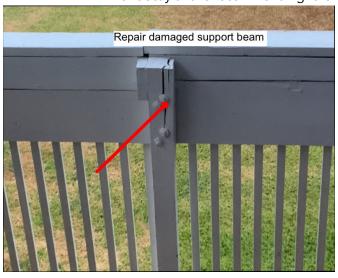
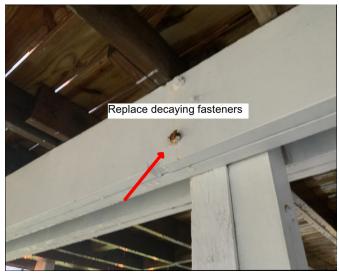
- Inspector viewed damaged anchor strap(s) , fasteners and or anchor plates. These areas need repairs to improve structural support
- Observation of wooden posts revealed decay. The inspector was unable to determine the level of decay and is recommending further professorial evaluation.

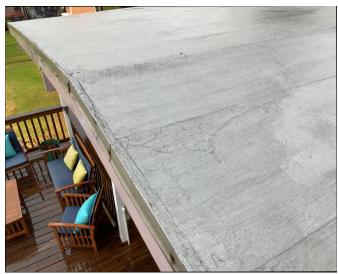
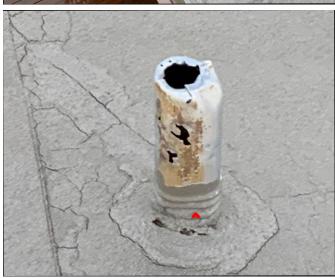
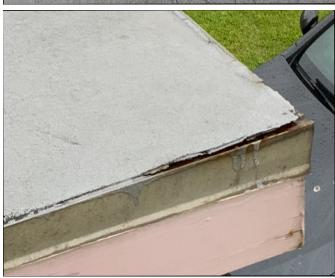
- Damaged roof jacks were found on the home. Repairs/replacement of said roof jacks are needed by a professional roofer to reduce the risk of further damage, and prevent water and/or pest entry to the home.
- The roofing is nearing the end of its life cycle. The membrane exhibits flaws (such as blistering, cracking, etc.) that are symptomatic of an older flat roof. More frequent maintenance should be anticipated. Replacement may become necessary in the near future, budgeting would be wise.

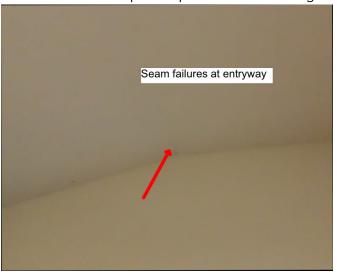
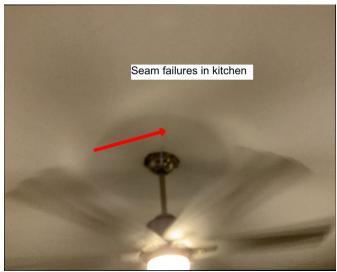
• Drywall seam failures observed. These are common with settlement deficiencies. Recommend repairs to prevent further damage.

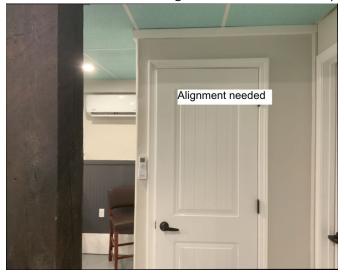
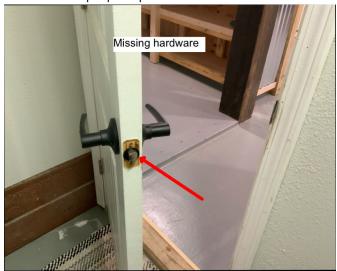
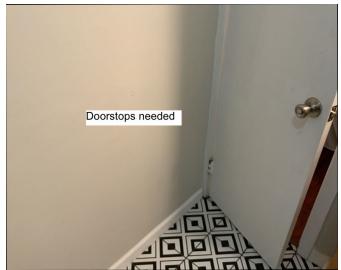
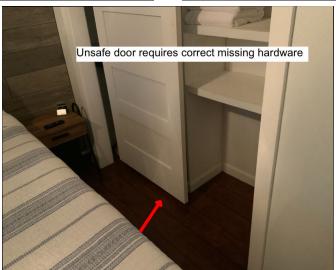
- Door(s) missing a door stop(s). A stop should be installed to prevent damage to the door or the nearby finishes.
- Doors should be trimmed or adjusted as necessary to work as intended
- Missing door hardware needs replacement to allow proper operation of the door.

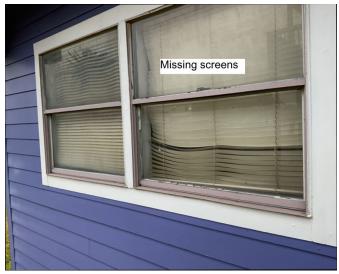
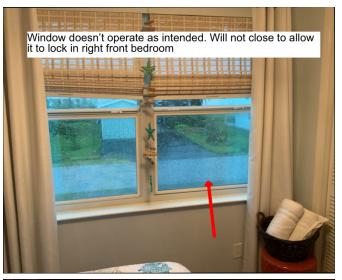
- At time of inspection, inspector was not able to operate all windows due to obstructions. Inspector is not required to move furniture, blinds or personal belongings. Inspector operates accessible windows to confirm that windows operate as intended.
- It may be desirable to replace window screens where missing. The owner should be consulted regarding any screens that may be in storage.
- The window(s) are inoperative. Improvements should be undertaken to allow normal operation of the window.
- Seal improvements are needed on the interior side of the windows to prevent moisture entry and potential moisture damage, along with improve energy efficiency by preventing drafts.

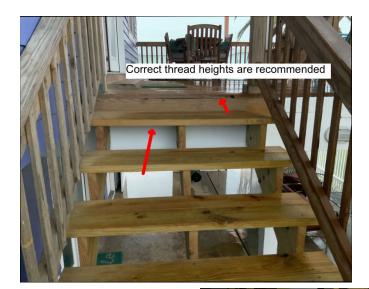
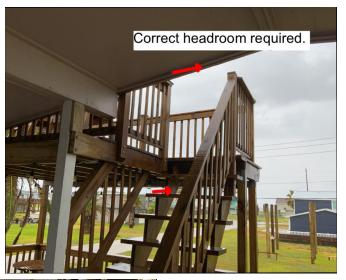
- There does not appear to be enough headroom in the stairwell. Under current building standards the minimum headroom in all parts of the stairway shall not be less than 6 feet 8 inches measured vertically from the slope of the plane adjoining the tread nosing or from the floor surface of the landing or platform
- The size and/or orientation of the stairway "risers" may make the stairway difficult to negotiate. This condition should be altered for improved safety. Maximum riser height is 7 3/4".
- Recommend corrections at stairways for safe use.

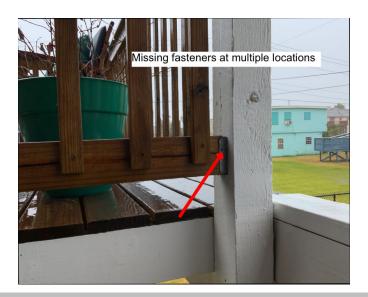
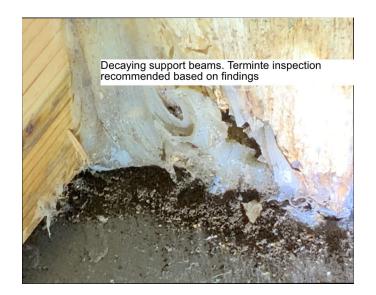
• The size and/or orientation of the step "risers" may make the stairway difficult to negotiate. This condition should be altered for improved safety.

• Install all missing fasteners at hangers

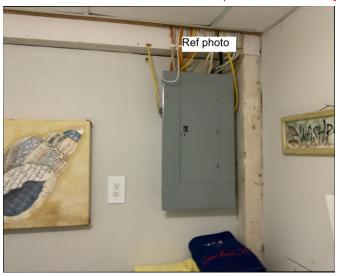
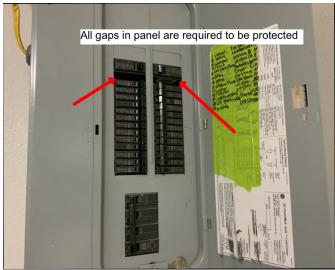
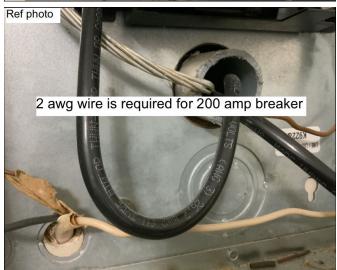
- Service panel had damaged or missing locking hardware. Hardware is required to keep panel closed protecting wires from water or pests. Replacement is required.
- Any openings in the main panel is required to be protected.
- Labeling improvements are needed as they are missing or difficult to read.
- A breaker was observed to have undersized wiring. Undersized wires pose the risk of overheating before the breaker trips as intended, as the breaker can withstand a higher currant than the wire. This is a fire safety hazard. Repairs are needed by a licensed electrician for safety purposes.
- Overheated wiring within the main distribution panel should be examined by a licensed electrician and repaired as necessary.

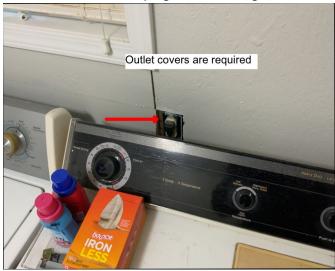
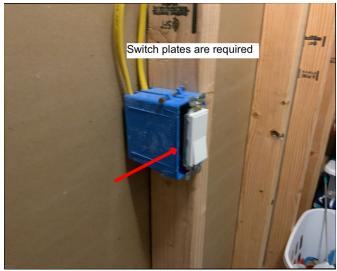
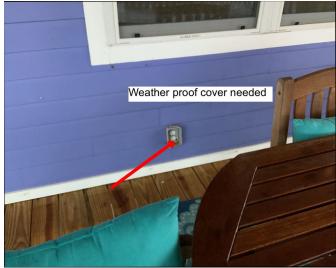
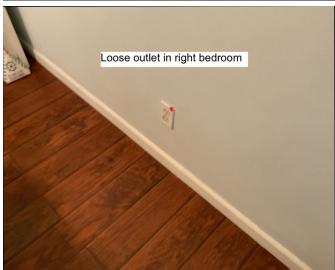
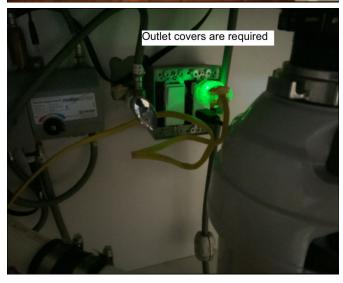
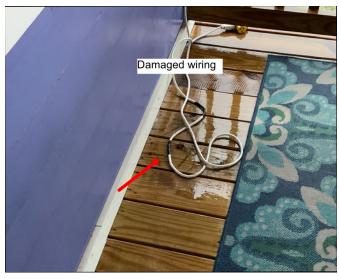
- Multiple outlets were found to be loose. Repairs are needed to reduce the risk of damage to the wire connections. Labeled with color Dots.
- Exterior outlets are required to be equipped with weather tight covers. Installation of covers is needed where missing.

- Missing and/or damaged outlet cover plates are required and should be replaced for safety
- Switch plates are required at ALL switches for safety. Replace ALL damaged and or missing switch plates.

- Damaged wiring should be replaced or appropriately repaired.
- Carbon monoxide detectors are required to be installed within the immediate vicinity of each sleeping room. Missing detectors need to be installed.

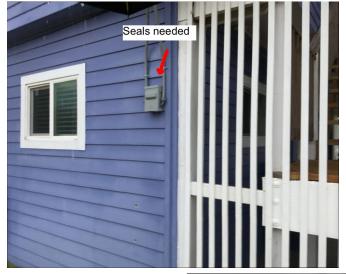
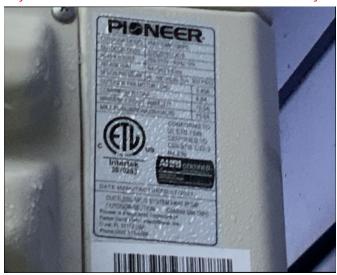
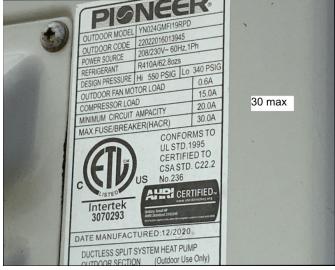
- Window units show signs of decay
- Seals are needed at service/disconnect panel(s) to prevent moisture entry and or damage.
- The breaker serving the condenser unit is oversized. Repairs are required by a licensed electrician, as this could pose as a fire safety hazard. This will also void manufactures warranty.

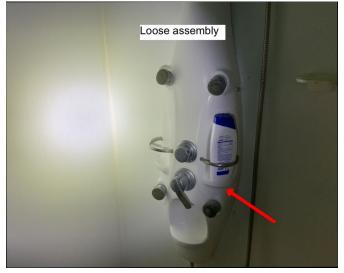
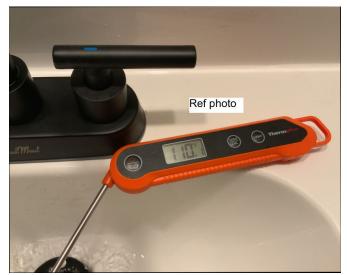
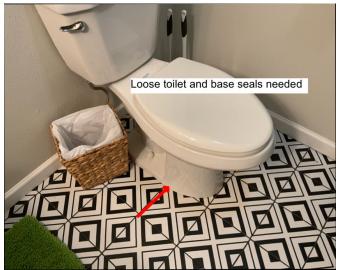
- Static water pressure reading: 63 psi
- Type of supply piping material: CPVC
- The inspector only reports on exposed supply lines visible at the time of inspection. If the inspector feels further evaluation is needed she will recommend a licensed plumber do so. Performance Inspections PLLC and it's employees take no responsibility for connections that are not visible at the time of inspection.
- The toilet is in need of a base seal improvement.
- The toilet is loose and should be re-secured to reduce the risk of damage and leaks.
- It is recommended that an anti-siphon device be added to the hose bib(s).
- Poor hot water supply to kitchen sink

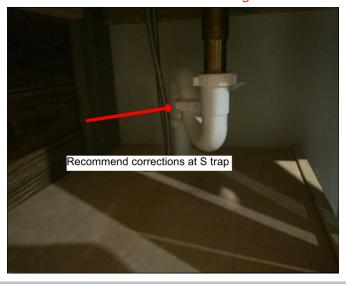
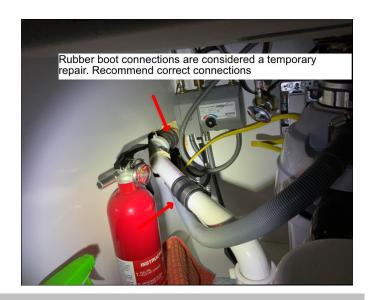
• An "S" trap has been used. Ideally, S traps should be replaced as they are subject to siphoning problems. S traps are common in older homes. Replacement is sometimes difficult and thus the S traps are usually tolerated. Care should be taken to keep the trap "primed". Fixtures should be monitored for sewer odor.

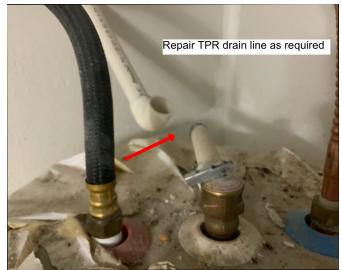
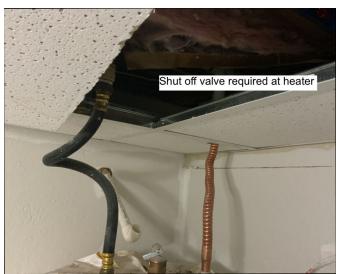
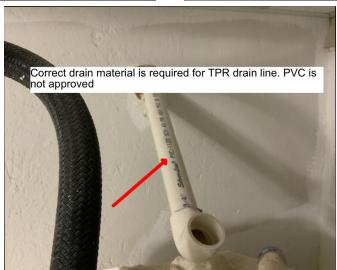
- Unable to view condition of water heater due to insulation on unit
- There is no shut off valve on the cold water supply to the water heater. It is suggested that one be installed.
- The TPRV (Temperature Pressure Relief Valve) is required to discharge to the exterior of the home on it's own dedicated line. Improvements are needed by a licensed plumber.
- Correct TPR drain line materials are required. See code for correct materials. PVC is not an acceptable material.
