**INSPECTION PROPERTY ADDRESS:** 16314 Concord Falls  
Sugar Land, Texas

**INSPECTION DATE:** 06/27/22

**INSPECTIONS ORDERED:**

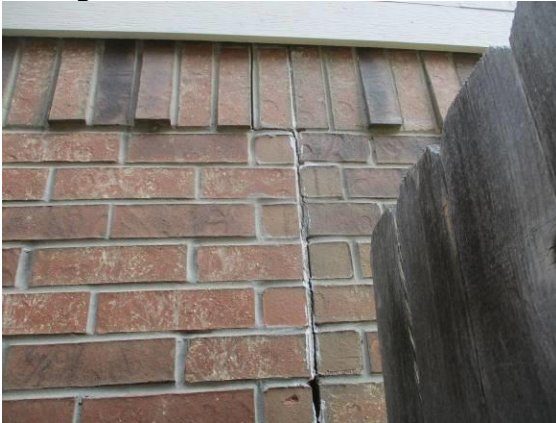
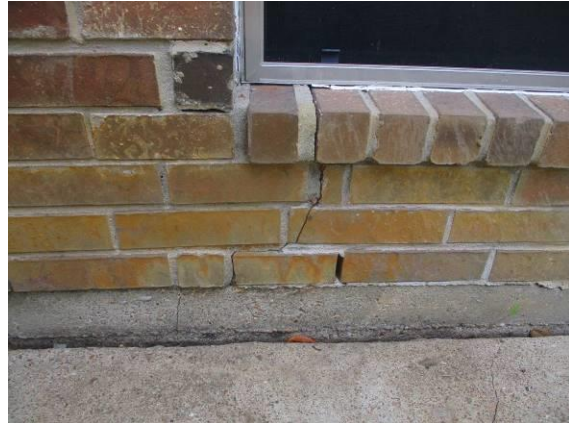
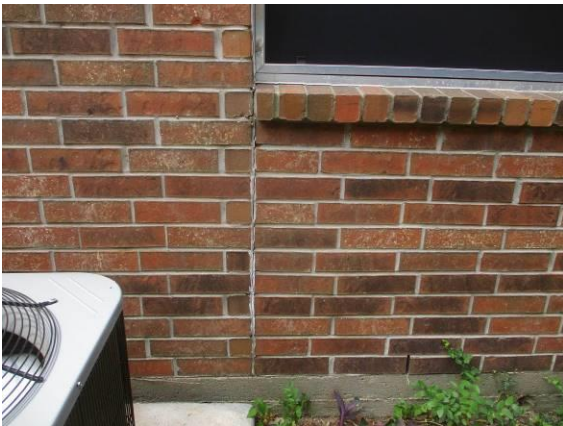
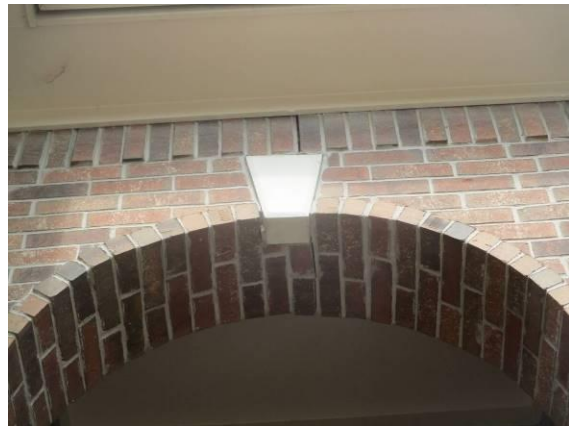
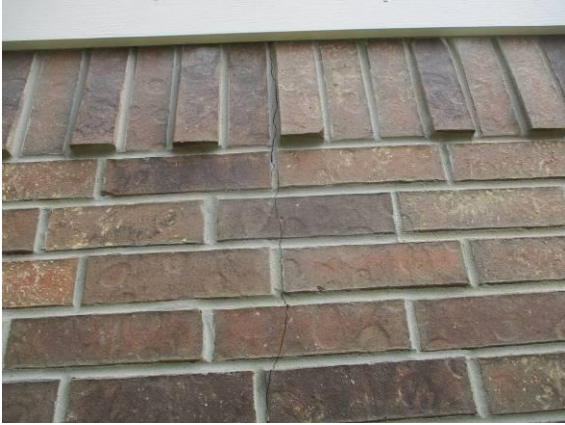
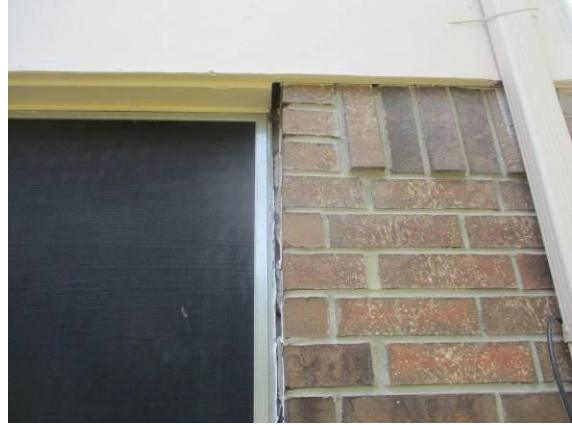
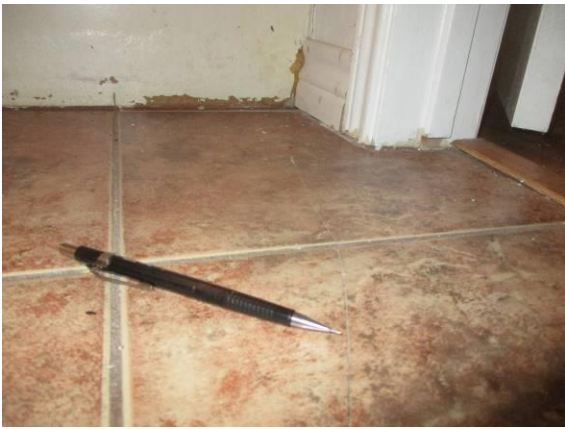
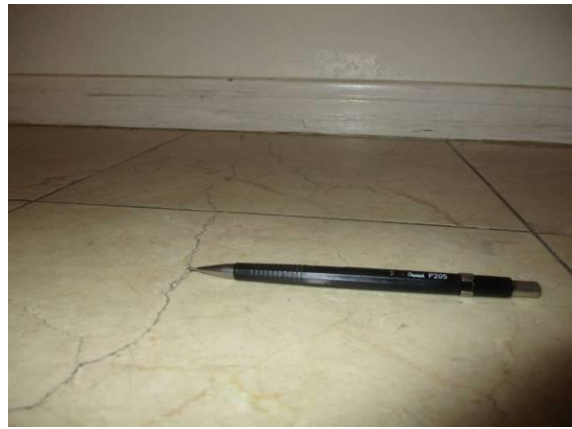
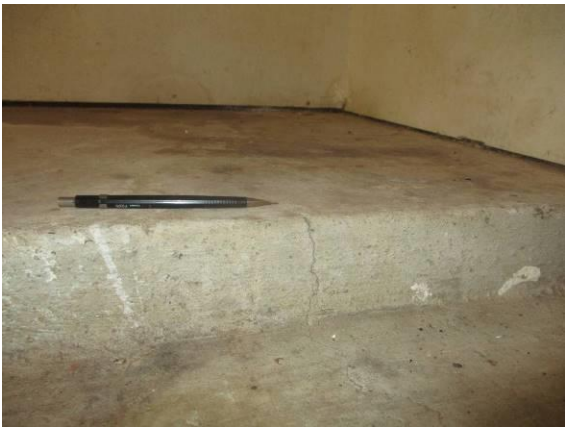
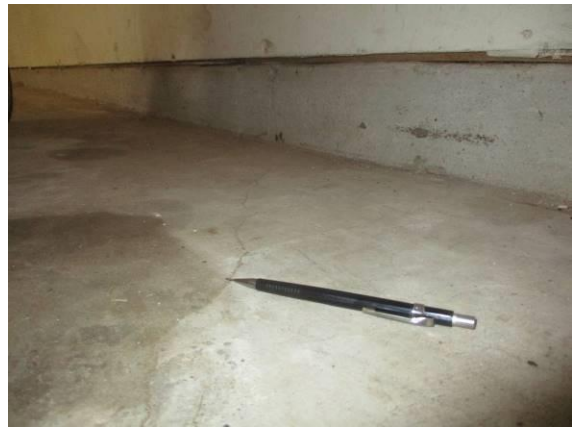
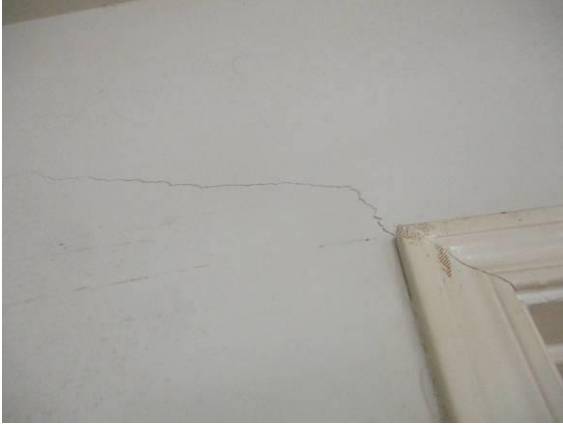
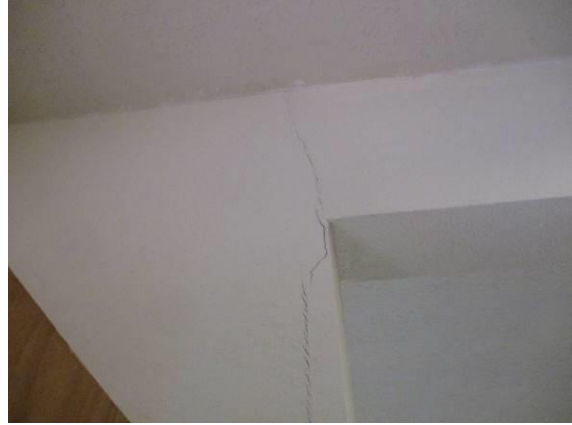
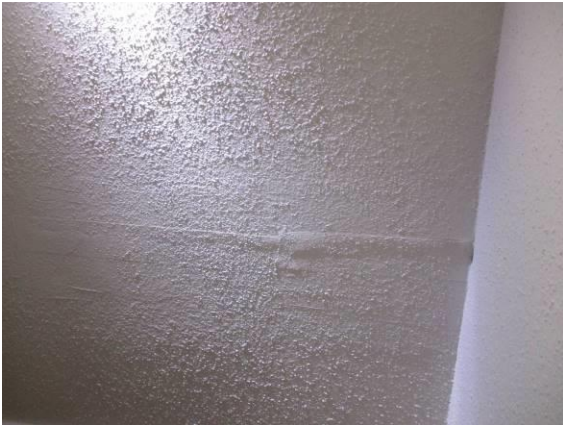
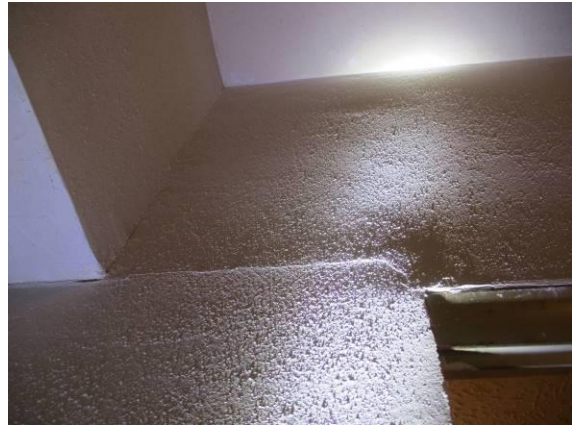
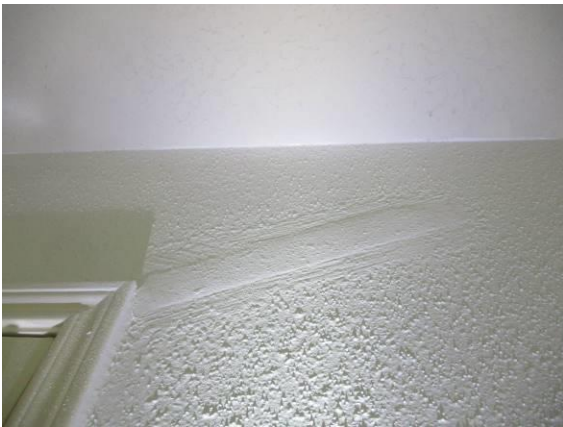
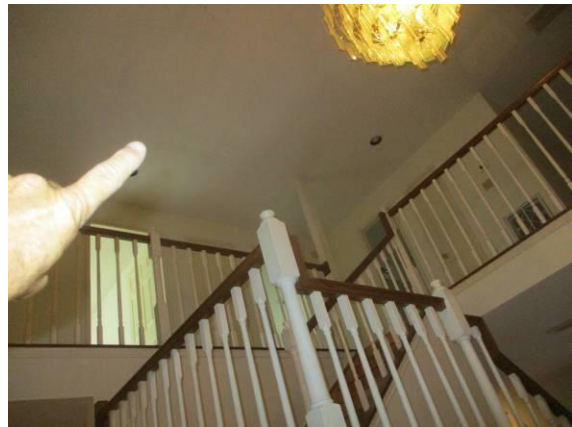
Observations revealed signs of moderate foundation movement. There were a few brick veneer cracks. There were minor separations at brick expansion joints. The brick lines were relatively straight, as visually observed from the exterior. There was separation of approximately  $\frac{3}{4}$ " at a left rear brick/window detail. Some cracks were observed at the perimeter of the foundation and at the exposed part of the concrete foundation at the garage. No floor coverings were removed to determined locations of all cracks in the concrete foundation. Cracks do not necessarily indicate a need for foundation repair. Interior observations revealed a few drywall cracks. There were several signs of drywall crack patches. There were a few signs of misaligned doors. Foundation levelness measurements showed some unlevelness. See drawing D-1. There was an overall foundation unlevelness that was measured at 2.2" from the high point to the low point. Original construction elevations were not available. Therefore, it was not possible to determine exactly how much of the unlevelness was a result of original construction and how much was a result of foundation movement.

Based on the limited visual observations and foundation levelness measurements, it appears that this foundation has experienced a moderate amount of movement. Although there are signs of movement, it is our opinion that the deflection and tilt of this foundation are within generally acceptable engineering limits. See attached deflection calculation. Although there are some signs of foundation movement, it is our opinion that foundation repair underpinning is not necessary at this time. **No representation is made to future performance.**

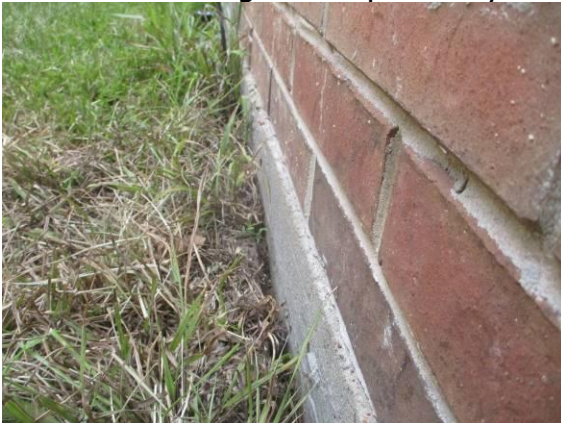
Some of the post-tension cable ends were exposed. These are in need of being grouted as a maintenance procedure in order to avoid further rusting.

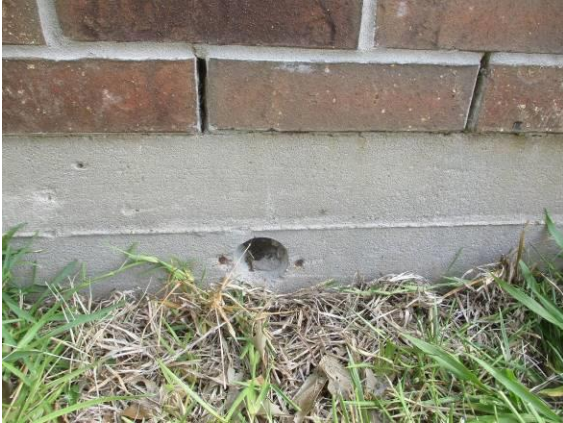
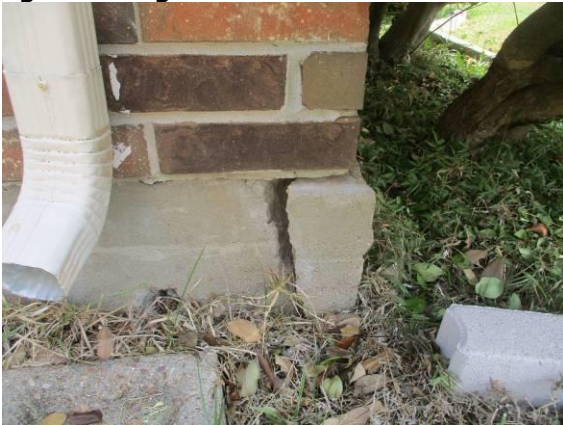
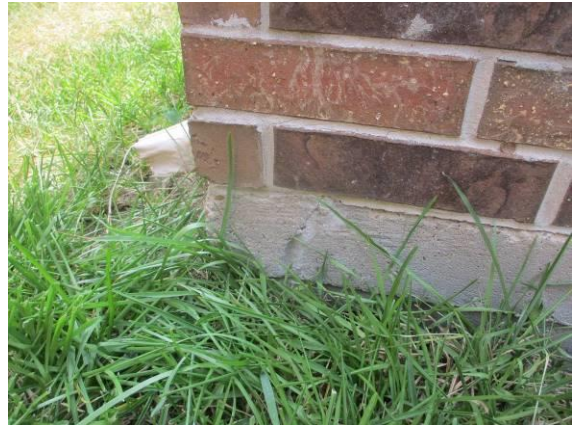
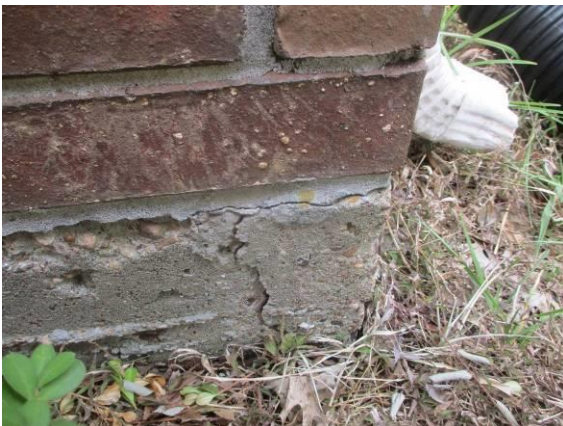
There were typical "wedge cracks" at the corners of the foundation. The wedge crack at the front left corner was relatively large. It is recommended that the front left corner of the concrete foundation be repaired by applying a bonding agent and grout.

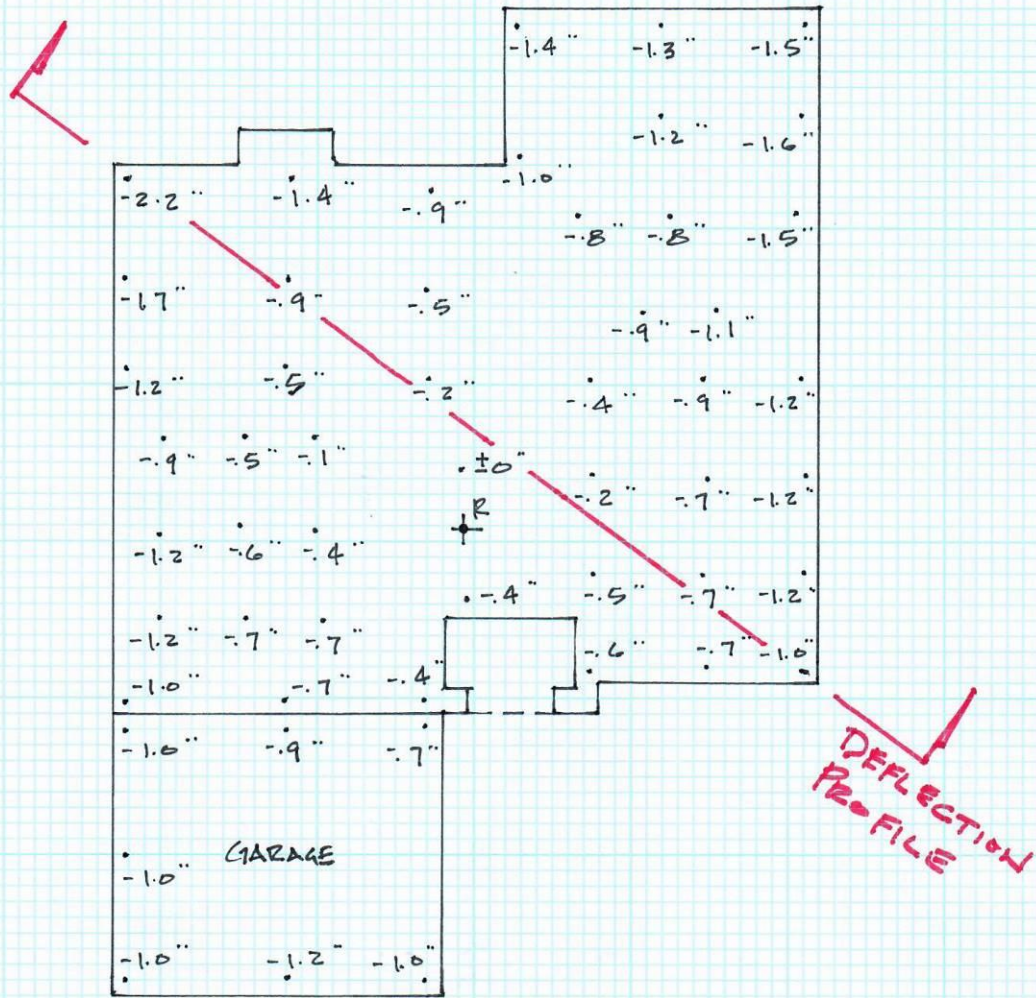
(D-1)

The limited foundation inspection consisted of interior and exterior visual observations as well as floor levelness measurements with a ZIPLEVEL. See drawing D-1. Since no formal engineering analysis or testing was performed, the conclusions of this report are based solely on this engineer's visual impressions as to the performance on this date. Should you desire engineering evaluations such as geotechnical analysis, concrete testing, concrete moisture testing, plumbing testing, or post tension testing (if applicable), please contact this office. No geotechnical study has been made to determine the soil characteristics of this property. However, much of the greater Houston area is known to have an active type soil that can adversely affect the performance of the foundation. No representation is made to the location of any geological faults. For the purpose of this report, the terms front, rear, right, and left are used when viewing the house from the front. No representation is made to any previous or future flooding.

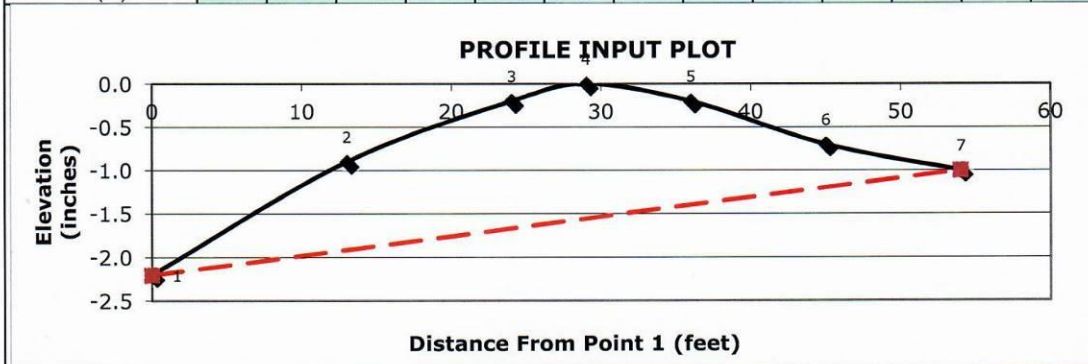
PERFORMANCE OUTPUT RESULTS					
	ACTUAL	RESULT	PT. 1	PT. 2	PT. 3
Deflection 1 =	L / 417	86% OF L/360 LIMIT	1	4	7
Deflection 2 =	L / 438	82% OF L/360 LIMIT	1	4	6
Deflection 3 =	L / 442	81% OF L/360 LIMIT	1	3	7
Tilt =	0.19 %	19% OF 1% LIMIT
