PROPERTY INSPECTION REPORT

Concerning: 15218 Tresch Ln., Houston, TX 77598
(Address or Other Identification of Inspected Property)

By: Randy Irwin TREC #5957 Nov 05, 2020
(Name and License Number of Inspector) (Date)

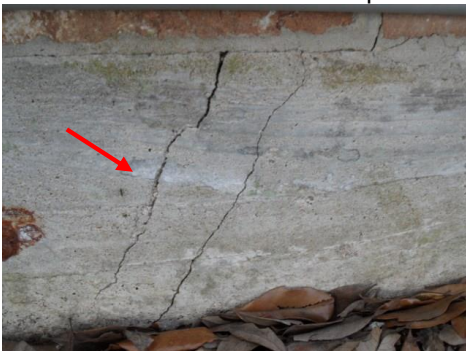
A crack on the foundation was observed on the front left side, under a window

Foundation fracture

We recommend that you consult with a reputable licensed foundation company or a Structural Engineer to determine if repairs may be needed, and or if a hydro static sewer test is needed.

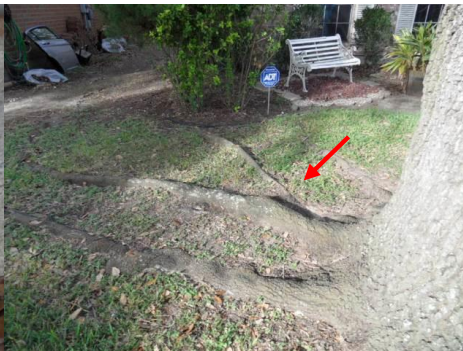
Trees with surface roots were observed in close proximity to the structure on the front and rear of the structure.

surface roots

You may want to consider installing root barriers between the trees and the structure.

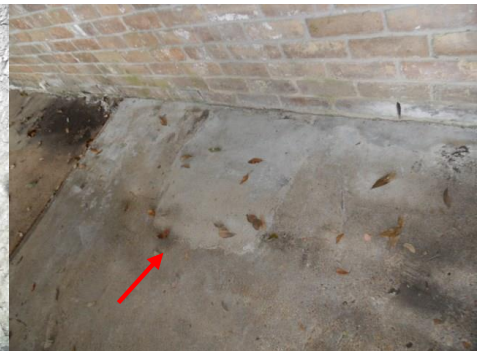
EVIDENCE OF PREVIOUS FOUNDATION REPAIRS WERE OBSERVED ON THE STRUCTURE. YOU SHOULD CONSULT WITH THE SELLERS TO DETERMINE IF PREVIOUS REPAIRS WERE PERFORMED, IF SO THEN YOU SHOULD CONSULT WITH THE FOUNDATION COMPANY THAT DID THE REPAIRS TO DETERMINE IF THE STRUCTURE HAS MOVED SINCE THE REPAIRS AND IF A HYDROSTATIC SEWER TEST WAS PERFORMED AFTER THE REPAIRS. YOU SHOULD GAIN AS MUCH INFORMATION ON THE REPAIRS AS POSSIBLE, AND DETERMINE IF ANY WARRANTIES ARE STILL IN EFFECT.

previous foundation repairs

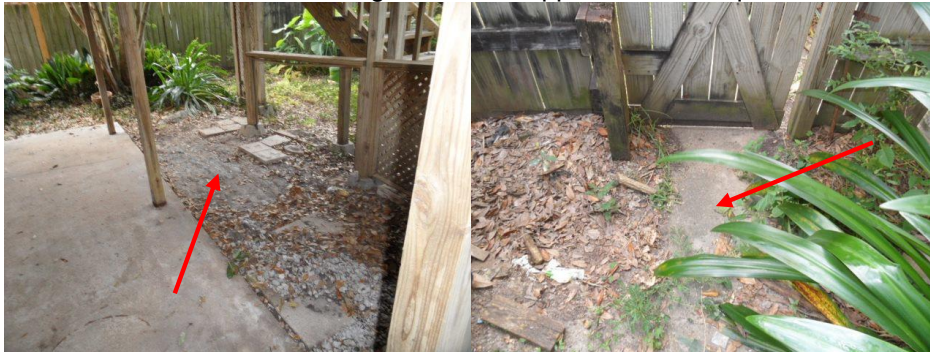
Evidence of previous ponding was observed on sides and rear of the structure.
 The grading did not properly slope away from the structure on the front and rear of the house.
 The areas should be monitored to determine if repairs are needed.
 No evidence of water penetration observed at this time

The area on the left side of the front porch does not appear it will drain properly and appears to be an area to hold water.

possible ponding areas

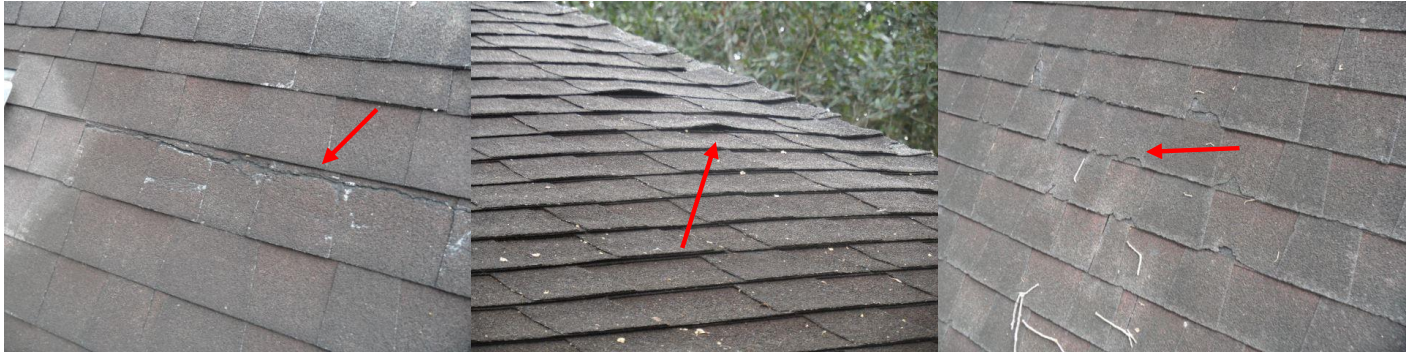
Aggregate loss with exposed fiber edges, bare spots, and damaged pits in the shingles were observed on the front and rear slopes.

Broken and damaged shingles were observed on the front and rear slopes

Broken singles

raised shingle edges

damaged shingles

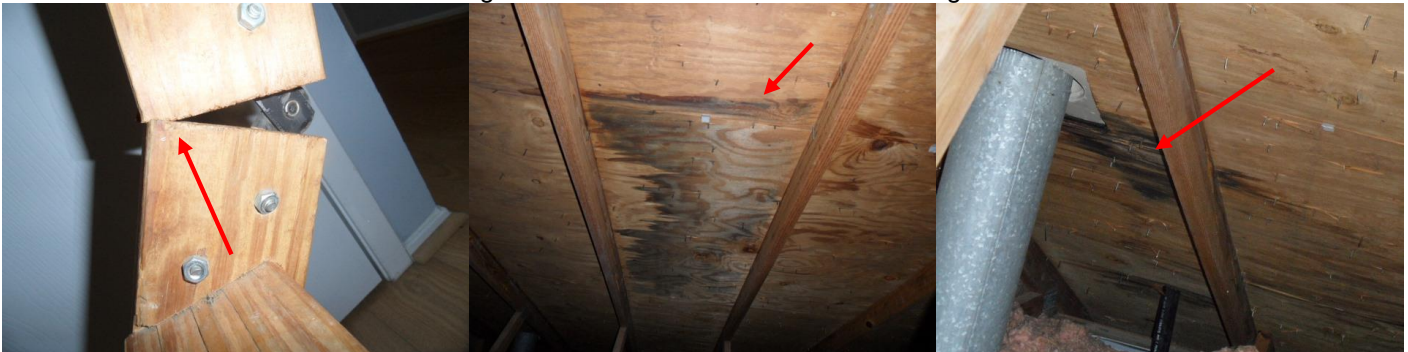
The attic ladder hinges do not fit together squarely to properly support weight, and they are loose. The attic ladder does not close and seal properly.

Moisture stains were observed on the roof decking in the south end of the attic.

Not a proper fit

moisture stains

The source of the stains is unknown and should be identified and repaired if needed.

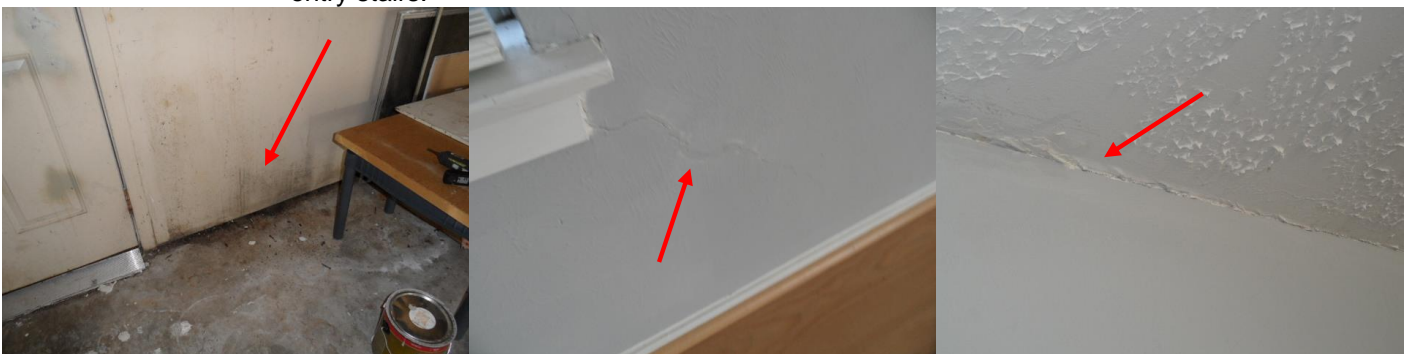
Sheetrock stress fractures were observed in the family room, bedrooms and various locations thru out the structure.

Black stains were observed on the sheetrock on the right side of the garage back door.

This may be evidence of possible previous moisture penetration.

Moisture penetration ???

stress fracture

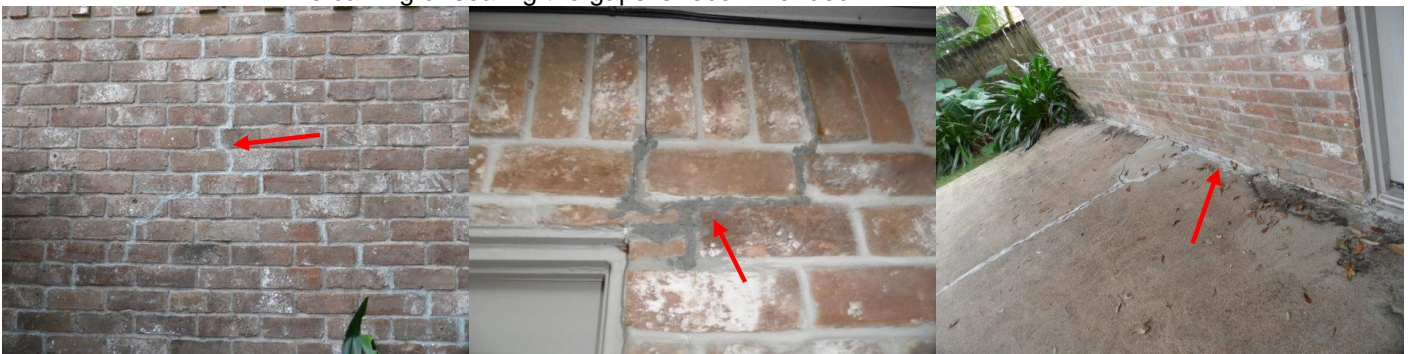
Brick mortar repairs were observed on both sides of the house and various locations around the structure.

Brick mortar repairs

previous repairs

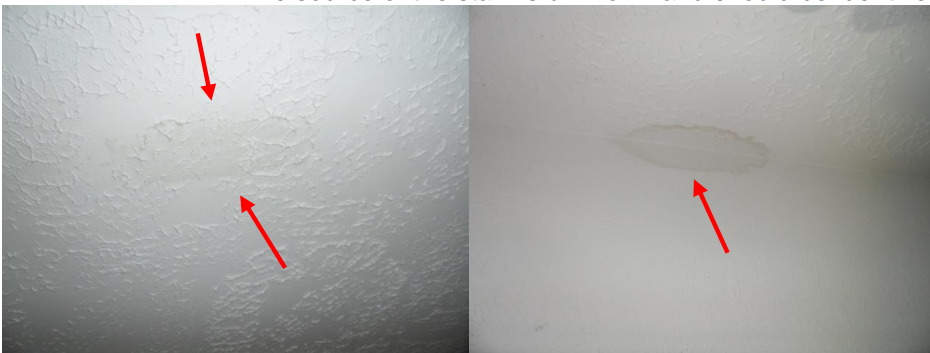
A Moisture stain is present on the bedroom and closet ceiling in the right rear bedroom.

Stain on bedroom ceiling

stain on closet ceiling

The source of the stain is unknown and should be identified and repaired of needed.

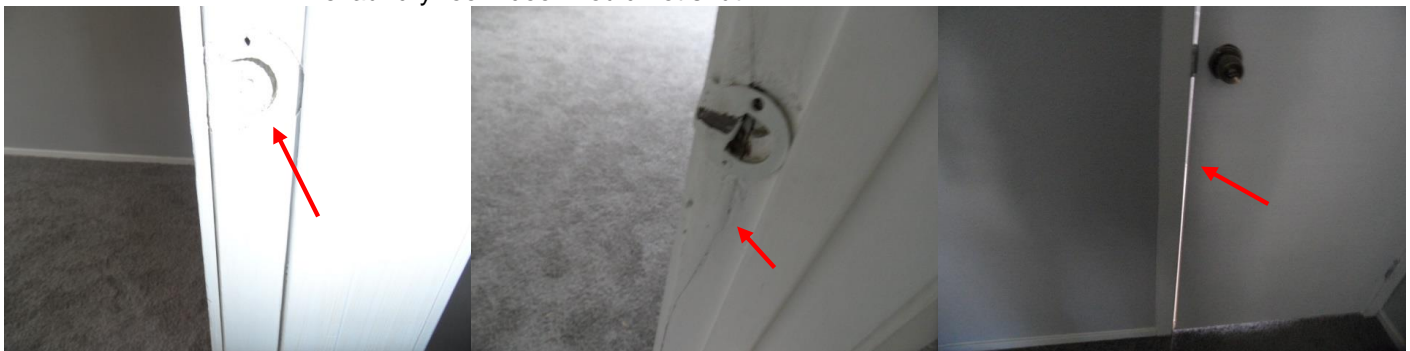
Strike plates are missing on the front corner bedroom and various doors thru out the structure.

The door frame is damaged in the upstairs front middle bedroom

Strike plate missing

damaged door frame

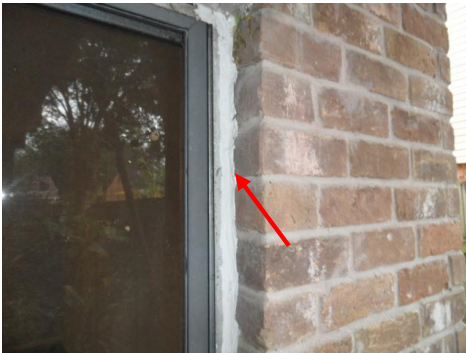
Caulking repairs were observed around the glass sliding door frame on the rear patio.

Calking repairs

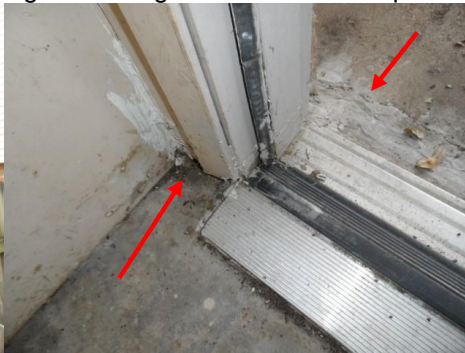
Previous repairs and evidence of previous moisture penetration was noted at the threshold of the garage back door.

threshold repairs

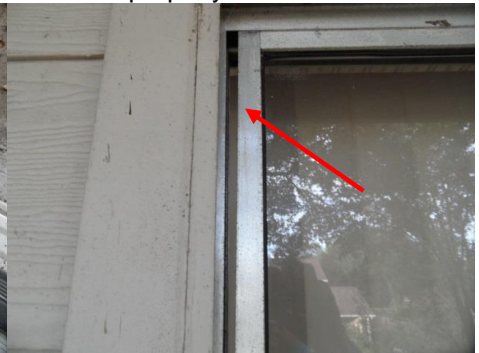
Both of the rear glass sliding doors are out of square and do not properly close and seal.

not close and sealed properly

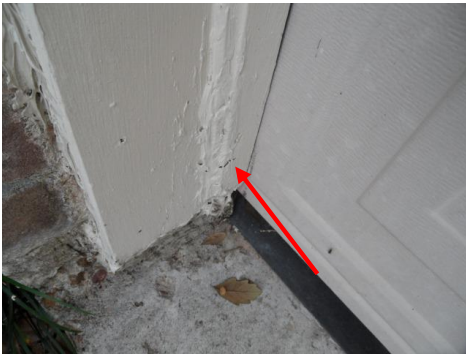
Moisture damage was observed on the bottom of the left garage door casing.

Previous repair

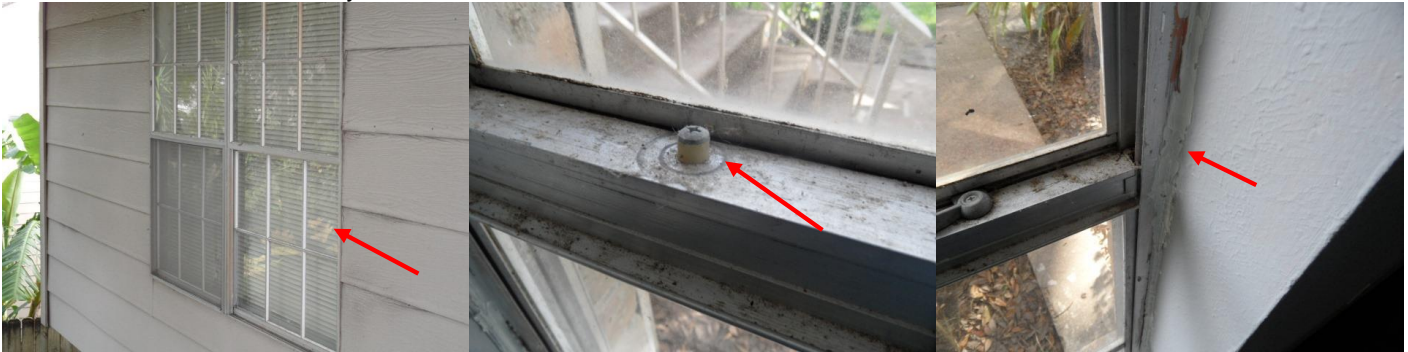
Window screens are damaged and or missing on various windows around the structure.

Locks are missing on the downstairs family room window.

Previous caulking repairs around the window frame, and casings are present in the downstairs family room.

Screen missing

lock missing

caulking repairs

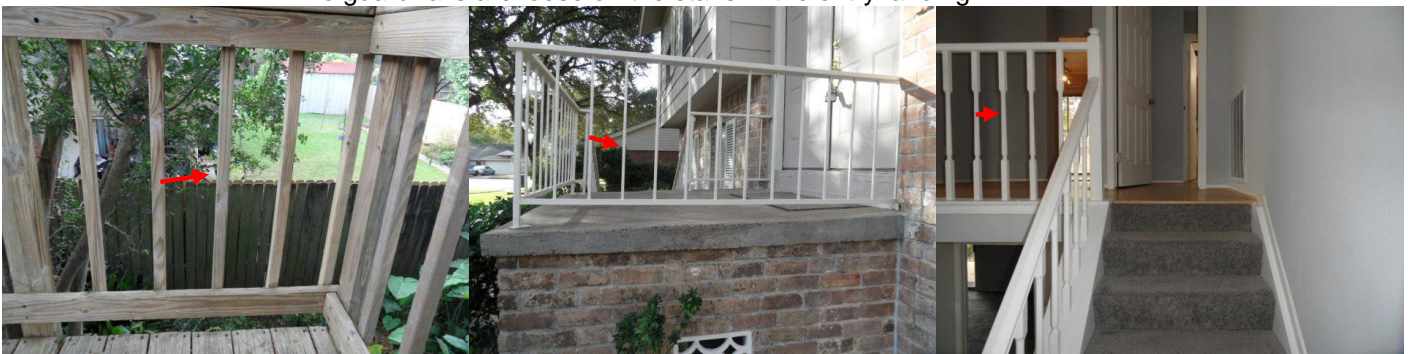
Baluster spacing on all staircase hand rails and balcony guardrails are greater than the allowable 4" maximum. This could be a hazard for small children.

Spindles over 4" apart

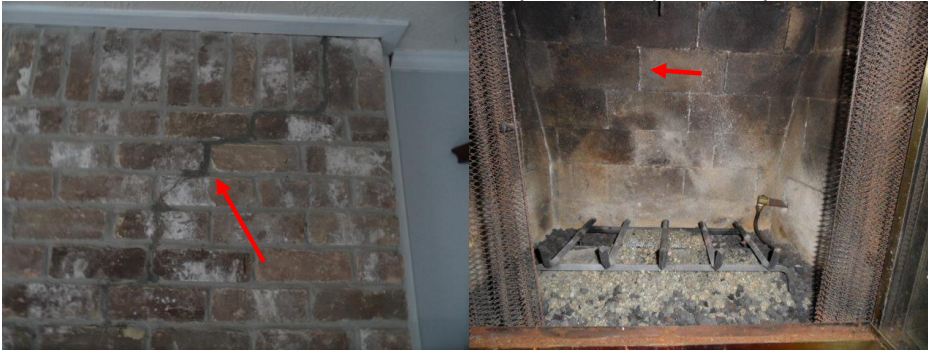
Comments:
 Type of fireplace Masonry
 Fuel Source: Gas
 Damper: Functional
 Firebox: gaps are present in the fire brick mortar
Chimney: No problem observed at the time of inspection.
 Brick fractures and previous repairs are present on the fireplace face brick above the mantel.

Settling repairs

gaps in brick mortar

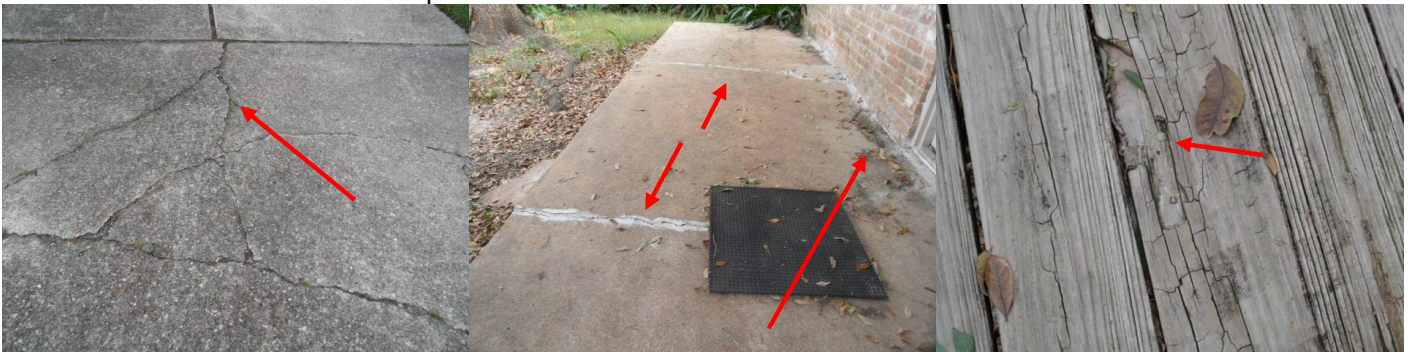
Area(s) of decking materials were decayed, deteriorated, and/or weathered.

Driveway fractures are present.

Concrete fractures , uneven expansion joints with trip hazards are present on the rear patio
 Evidence of previous water ponding and mortar repairs on the base of the brick wall are present on the rear patio.

Driveway fractures

patio fractures / water ponding ??

deteriorated decking

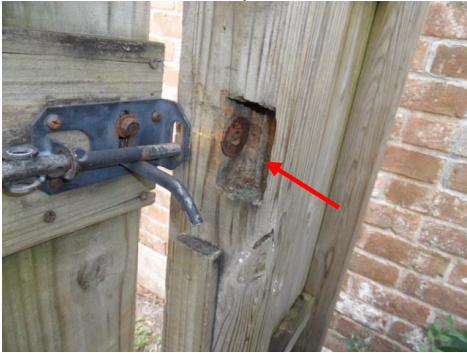
Part of the fence gate latch is missing.

Latch plate missing

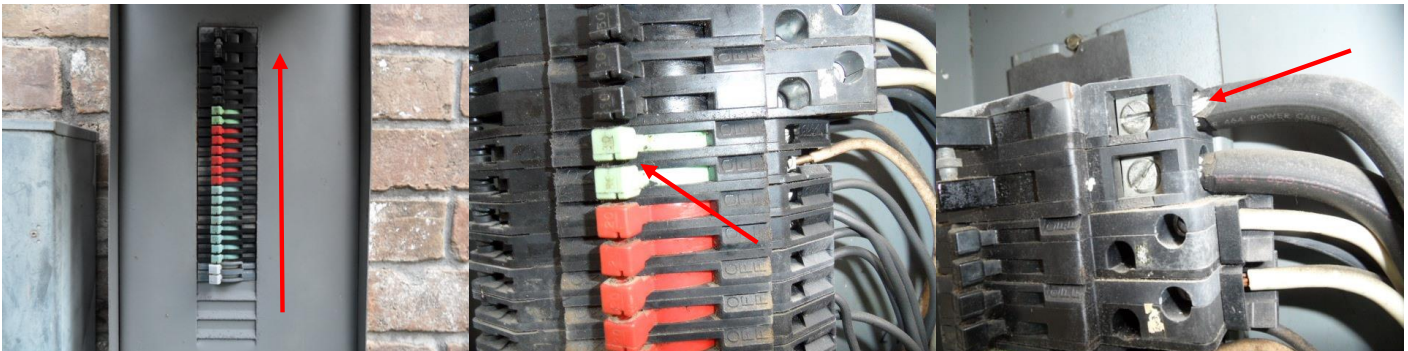
Trip ties are missing on a 2pole 30 amp breaker.

Breakers not labeled

trip tie missing

You may want to consult with a licensed electrical contractor for a full evaluation of the entire service.

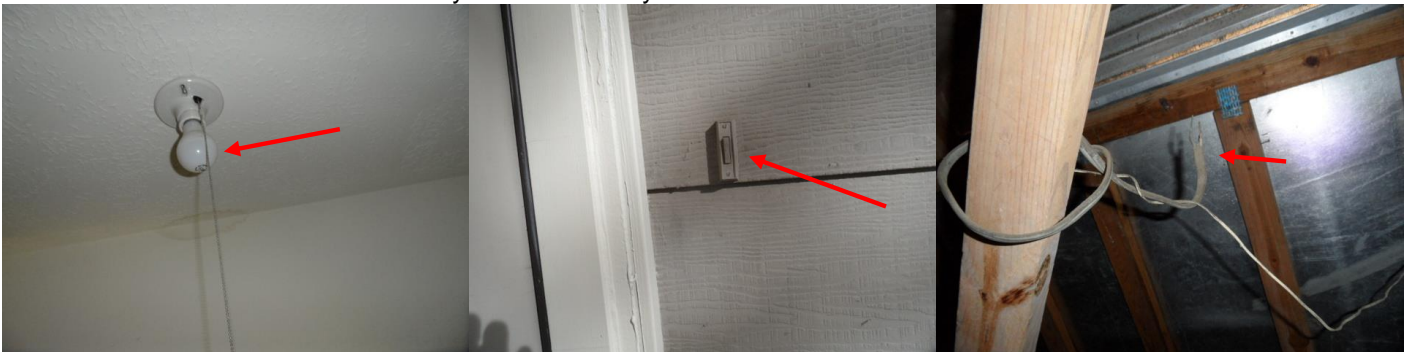
No globe on fixture

not functional

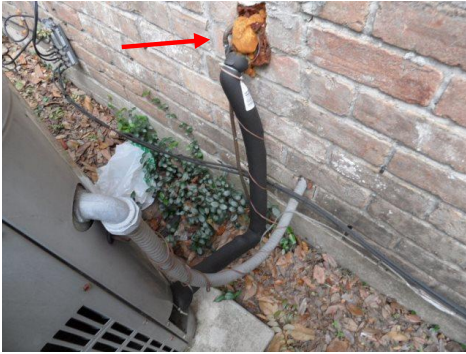
NO WALL FLASHING ON THE WALL WAS OBSERVED WHERE THE REFRIGERANT LINES ENTER THE STRUCTURE TO PREVENT MOISTURE PENETRATION

No wall flashing

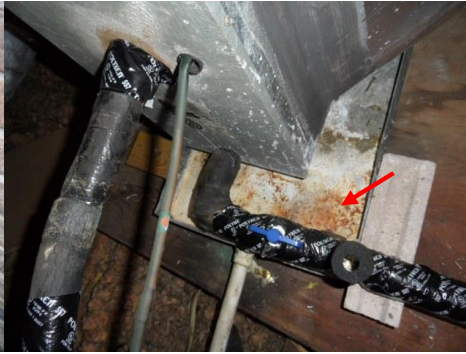
Rust was observed in the safety pan, this may be an indication that the primary drain has been clogged at some point in time.

recommend float switch in pan

Installing a float switch in the safety pan is recommended, in case the primary and secondary drains get clogged up. A float switch will cut the unit off to prevent the safety pan from overflowing.

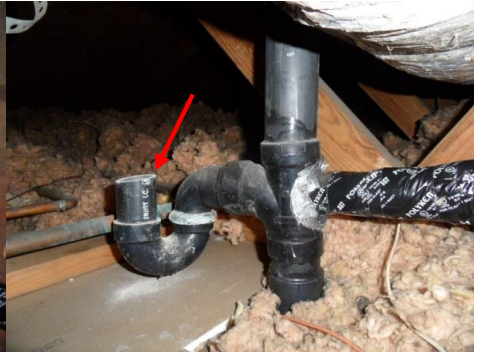
open vent

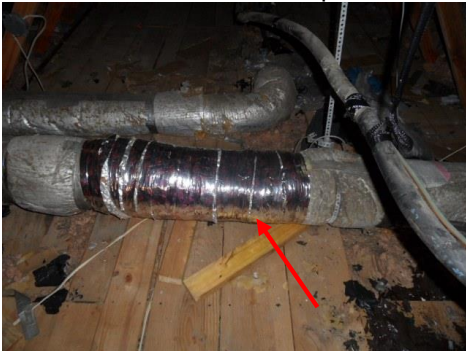
Previous duct repairs were noted.

Previous duct repair

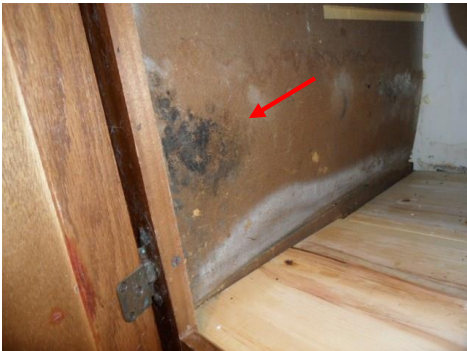
Kitchen Sink: The bottom of the base cabinet is moisture damaged.

Black stains

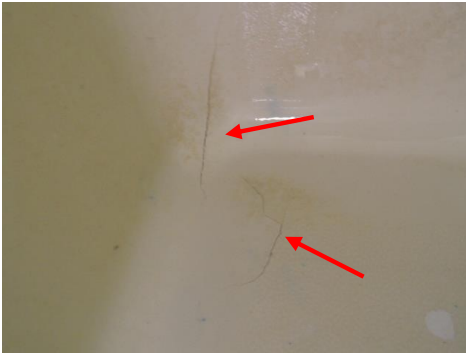
Shower: A small crack in the shower base is present.

Cracks in shower base

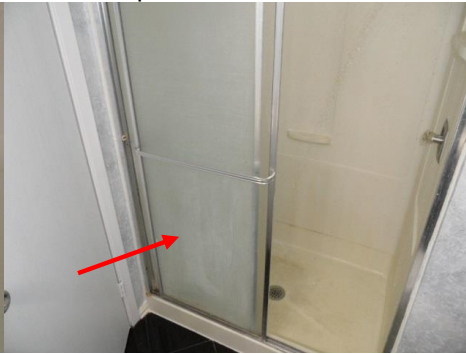
No safety glass level was observed on the shower glass door

no safety label observed

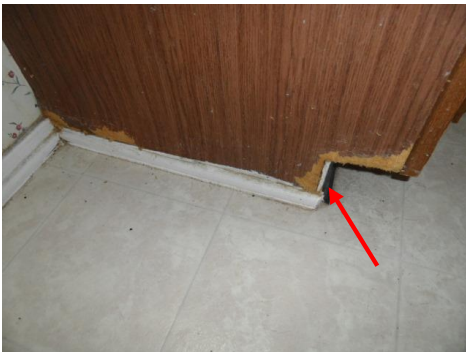
The left side of the sink base cabinet is damaged.

Moisture stains were observed on the bottom of the base cabinet, no leaks were observed

Damaged base cabinet

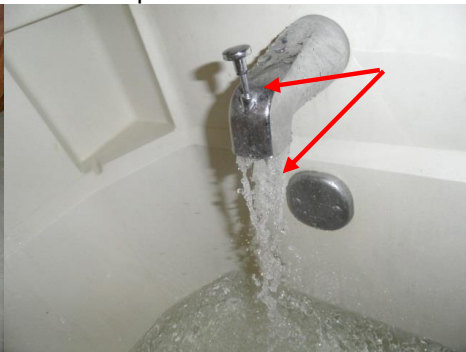
Shower: The diverter valve did not function properly.

diver not functioning

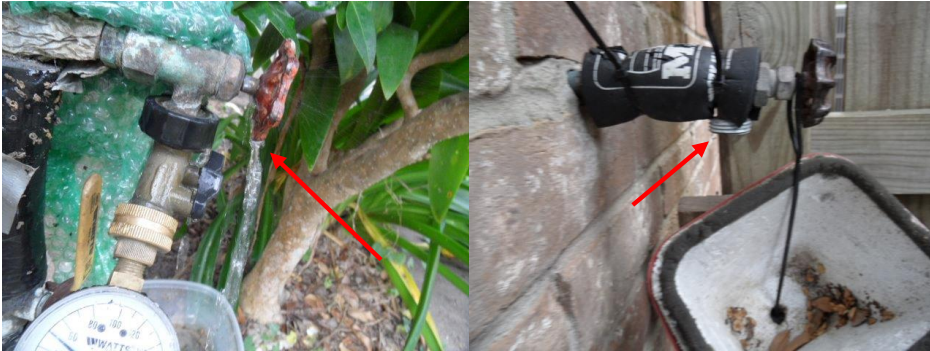
No anti-siphon protection observed on exterior hose bibs/faucets. This is a basic safety attachment to the end of faucets that will protect from a cross connection or back-flow of water into the house.

The front exterior faucet leaks at the valve stem handle when in use.

Valve stem leak

no anti siphon device

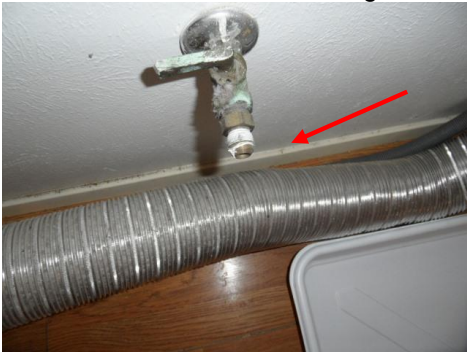
A gas valve in the laundry room is not capped off for safety.

Not capped off

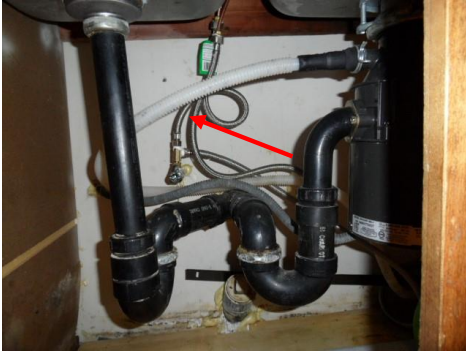
No air gap on the unit was observed. The drain line should be raised above the bottom of the sink to the top rim of the sink with a loop or sharp bend of the hose before terminating in the disposal tail piece. The hose appears to need raising, or a countertop air gap may be needed. This helps prevent the water in the sink from draining back into the dishwasher.

No air gap in drain line

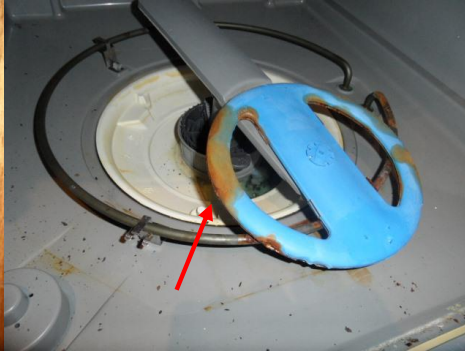
The unit did not function.
Rust was present inside the unit.

rust

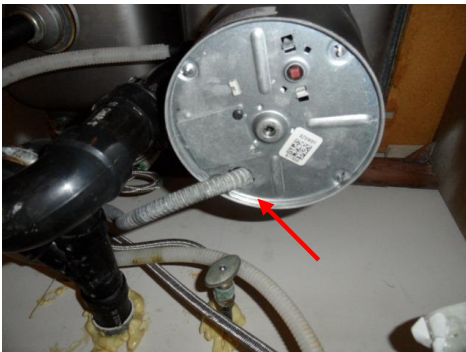
The flexible conduit is not properly connected to the connector on the bottom of the unit.
Electrical wires rub the metal edge of the connector.

Connector is missing

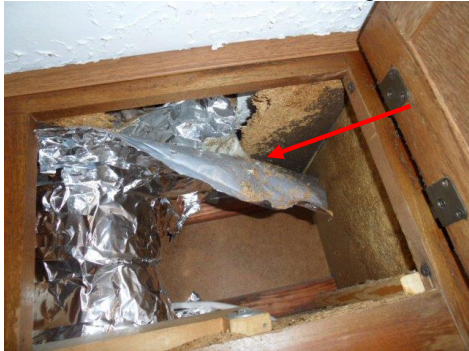
Comments:
Damaged vent hose and air leaks are present in the cabinet above the unit.

Damaged vent hose

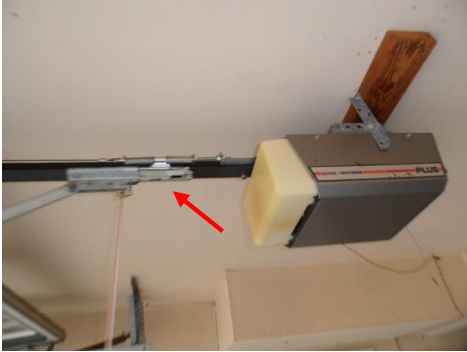
Comments:
 The left door opener is not plugged in.
 Neither door is connected to the door opener trolley.

Trolley not engaged
