## Property Inspection Report

10327 Glenfield Park Lane, Houston, Texas 77070  
Inspection prepared for: Steve & Cathy Hamlin  
Date of Inspection: 7/2/2020 Time: 1:00 pm  
Age of Home: 2004 - 14 years Size: 1,895 sq ft  
Weather: Sunny & 91 degrees  
This home was occupied at the time of inspection.

Concerning: 10327 Glenfield Park Lane, Houston, Texas 77070  
(Address or Other Identification of Inspected Property)

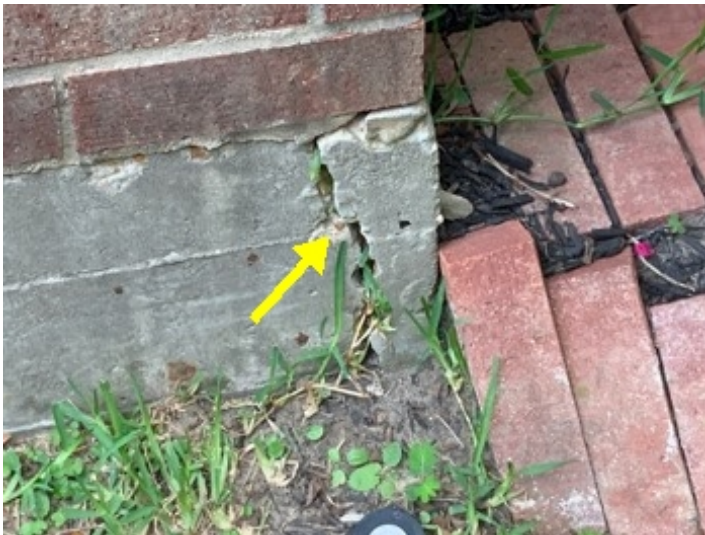
Corner pop on the left front corner of this home.

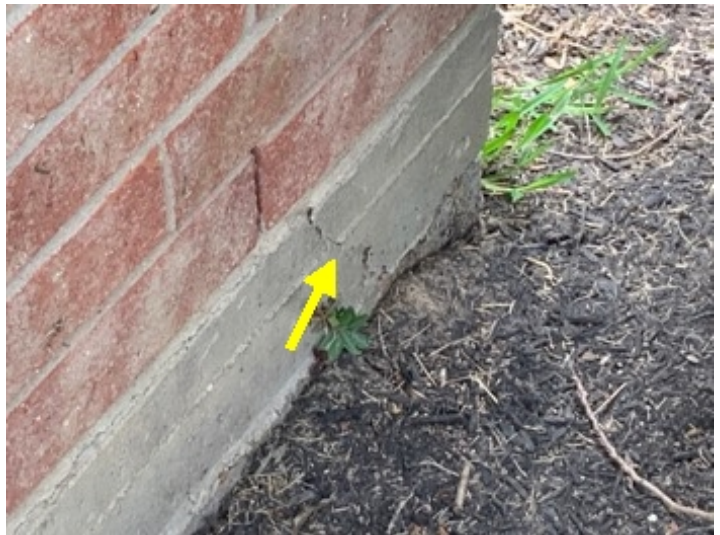
Crack on the right front corner of this home.

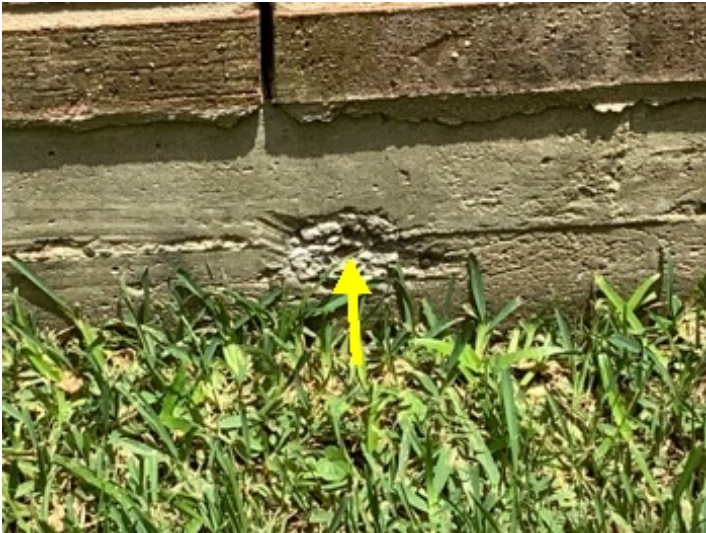
Exposed post tension cable end on the right side of this home.

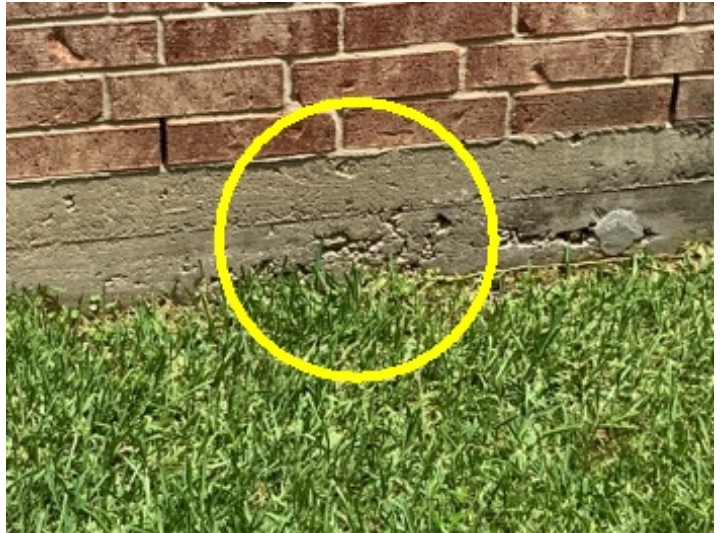
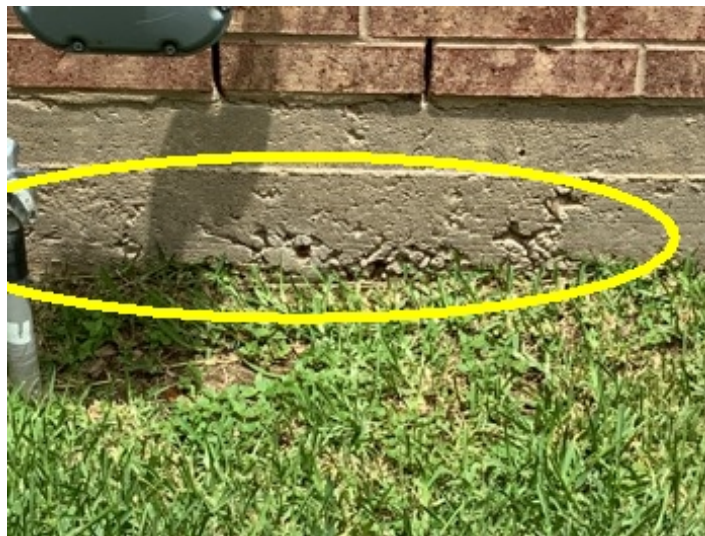
Honeycombing on the right side of this home.

More honeycombing on the right side of this home.

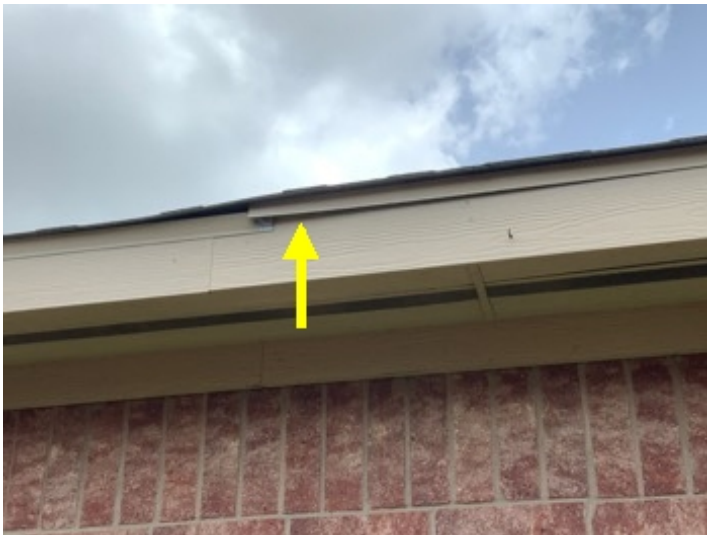
- Lifting drip edge flashing was found on the left side of this home. Recommend securing the drip edge flashing to the roof surface and flush to the fascia in order to prevent damage due to wind lift and moisture penetration.

Lifting drip edge flashing on the left side of this home.

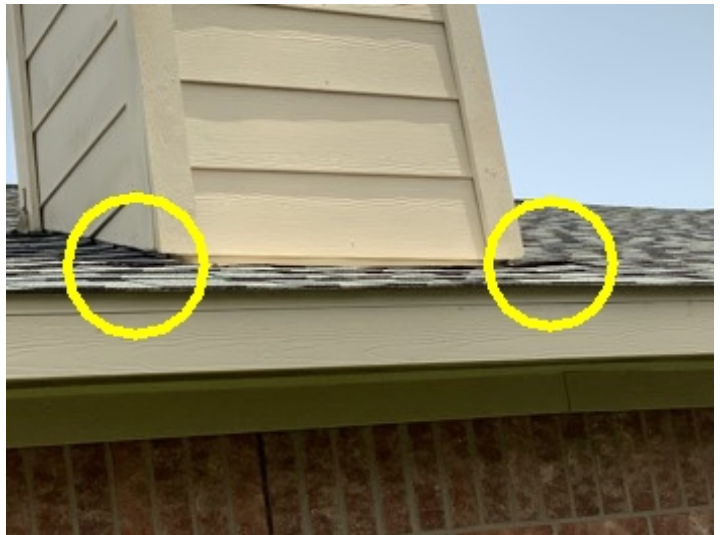
- Lifting counter and step flashing was found on the right side of this home. Recommend securing the lifting flashing to the roof surface in order to prevent damage due to wind lift and moisture penetration.

Lifting step and counter flashing at the chimney.

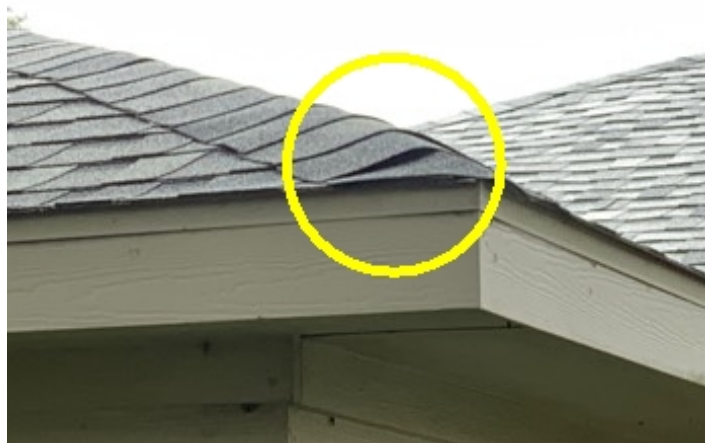
- A lifting hip shingle was found on the left rear corner of the patio. Lifting shingles were also found at several of the vent boots. Recommend securing the lifting shingles to the roof surface in order to prevent damage due to wind lift and moisture penetration.

Lifting hip shingle on the left rear corner of the patio.

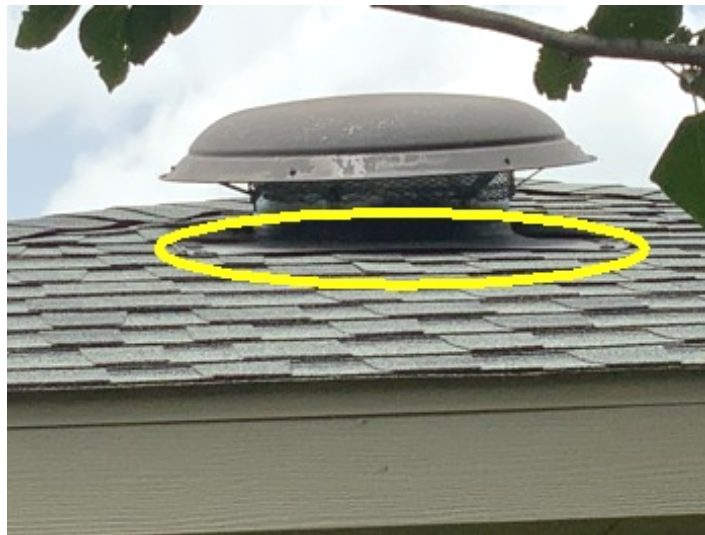
Lifting attic vent cover flashing on the rear of this home.

- Recommend consulting a general contractor for further evaluation and corrective action.

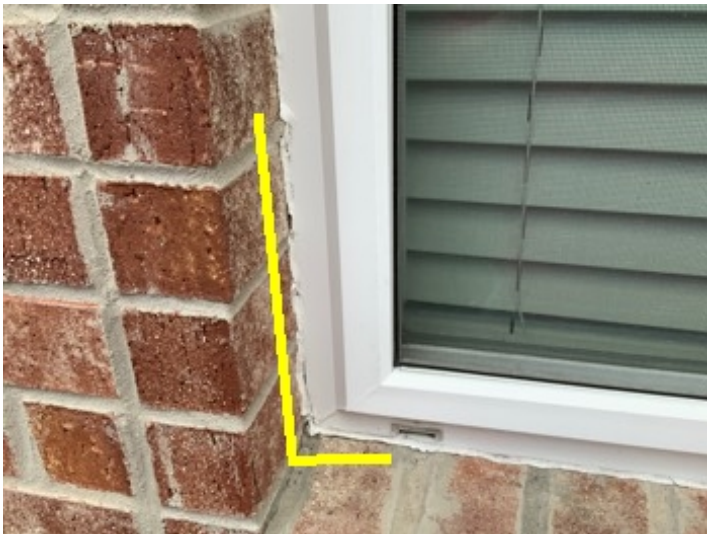
- Sealant gaps were found at several of the exterior wall penetrations. Recommend sealing these gaps in order to prevent pest access and moisture penetration.

Sealant gaps at the rear window on the left side of this home.

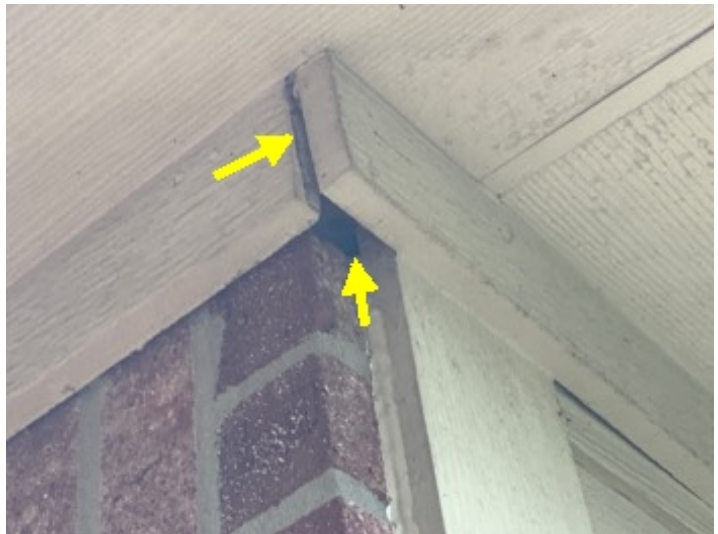
Gap between the brick and brick frieze on the right rear corner of this home.

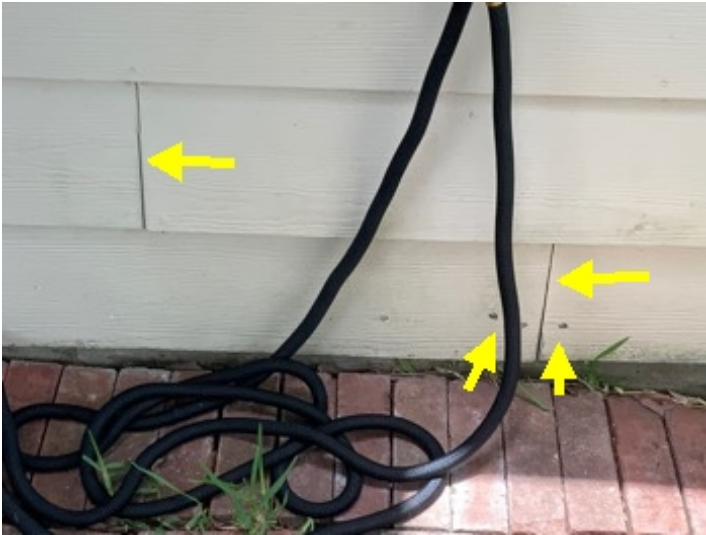
Gaps at the siding seams and exposed nail heads on the rear of this home.

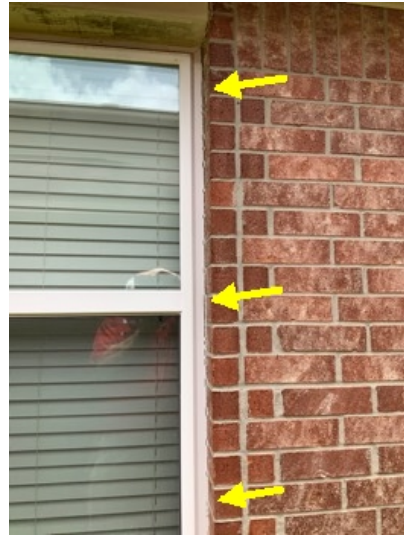
- Uneven gapping was found between the right rear family room window and bricks. This may be a sign of structural movement or settling. Recommend monitoring this area for further movement.

Sealant gaps and uneven gapping at the right rear family room window.

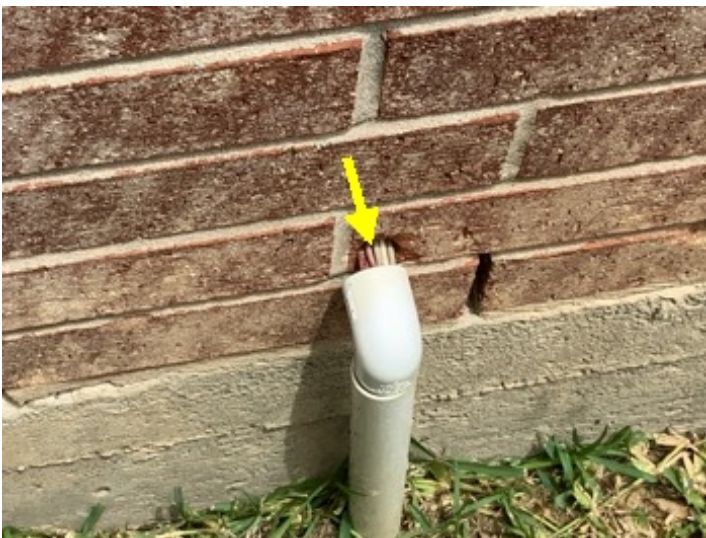
Gap around the sprinkler cable conduit on the right side of this home.

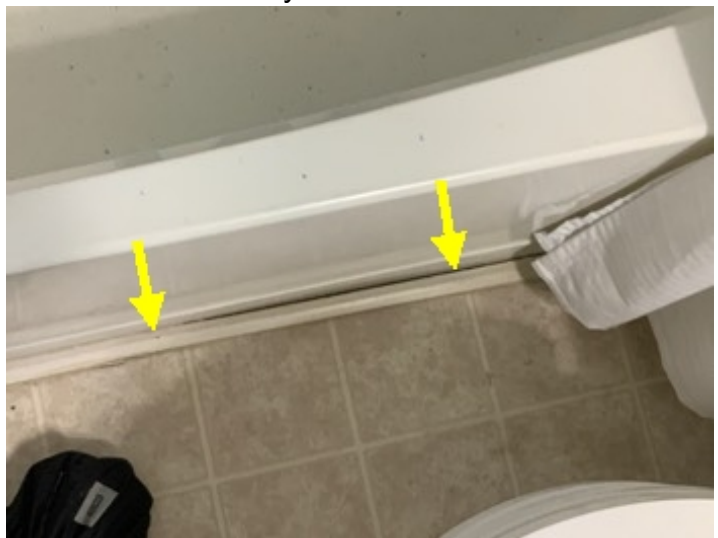
Loose trim at the front of the guest bathtub.

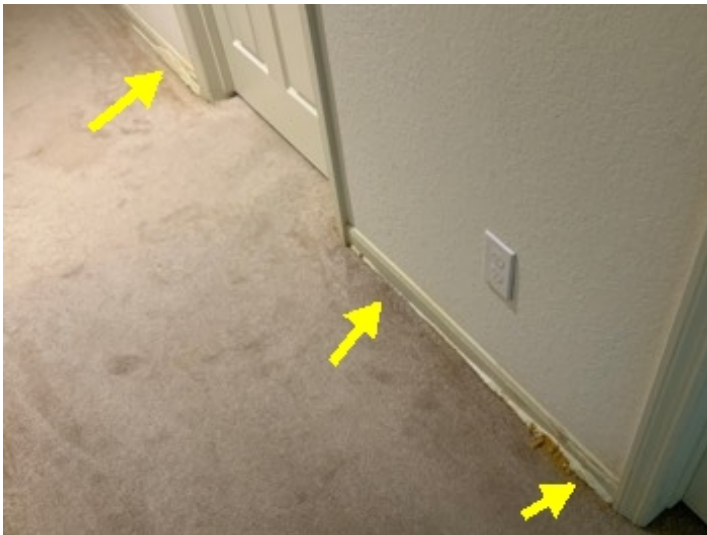
Damaged baseboards in the hall outside the guest bedrooms.

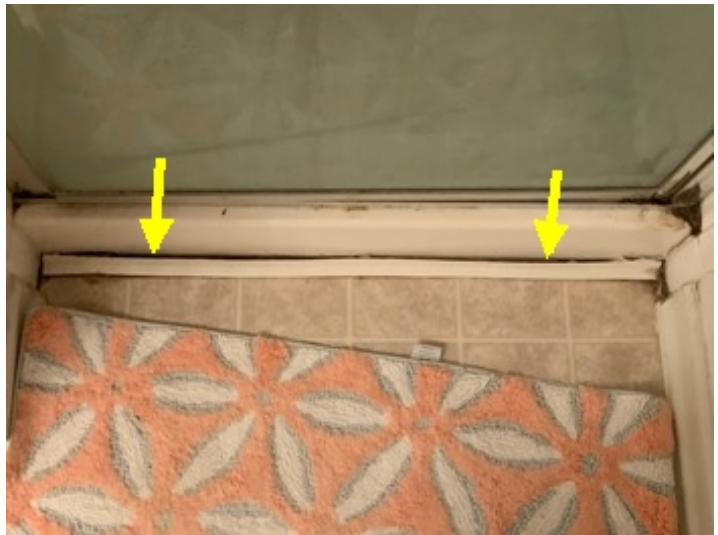
Loose trim at the front of the master shower.

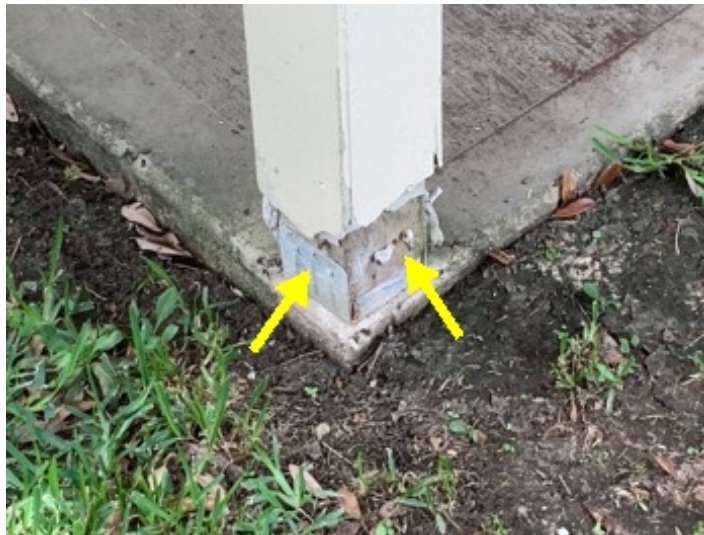
Comments:  
 • Damaged trim was found on both of the patio posts. Damaged siding was found on the left rear patio post. Recommend replacing the siding and trim.  
 • Recommend consulting a general contractor for further evaluation and corrective action.

Missing trim and damaged siding on the left rear patio post.

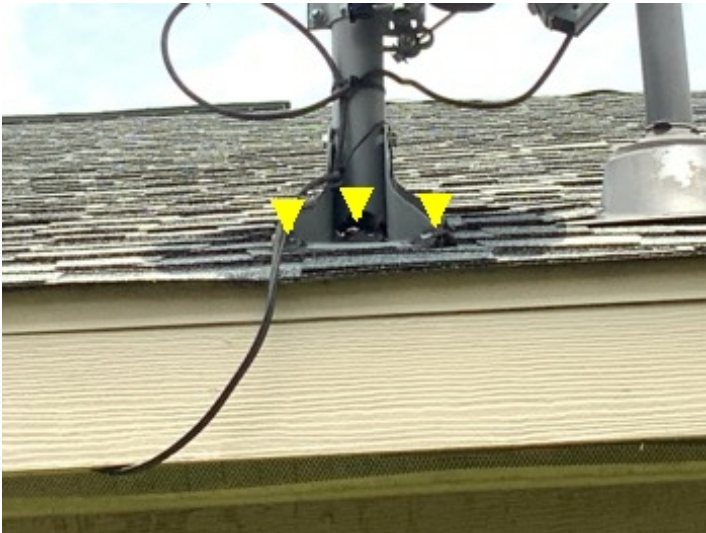
Exposed bolt heads at the satellite dish mount.

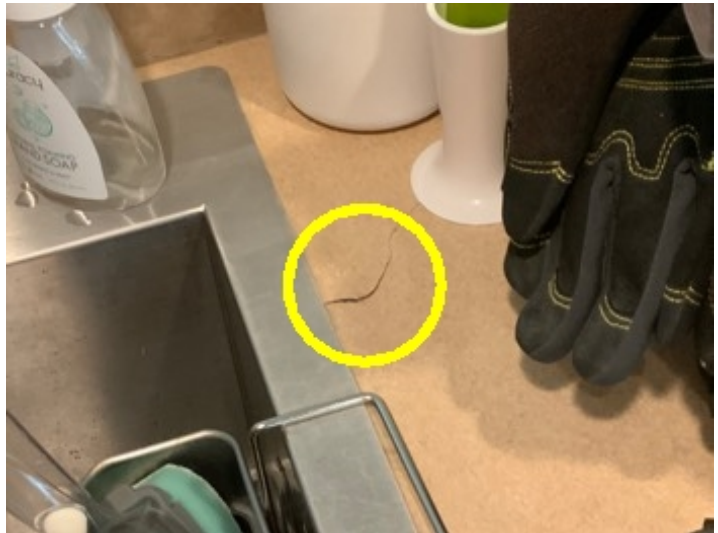
Damaged countertop at the kitchen sink.

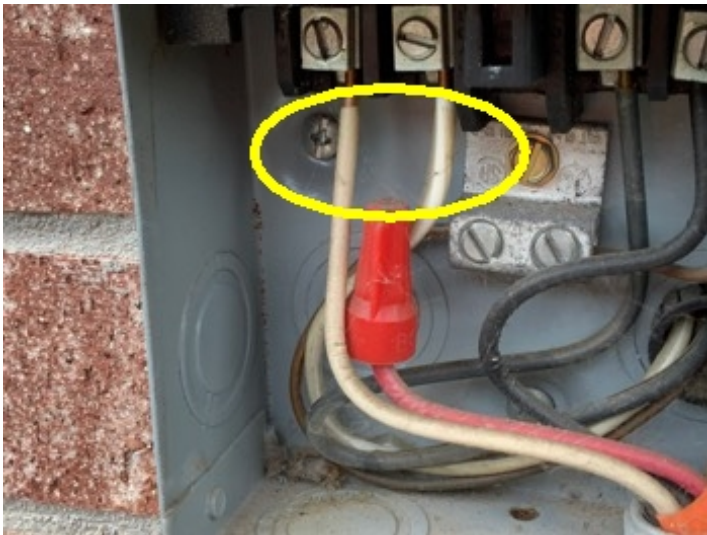
- There are "hot" or charged white cables in the condensing unit service disconnect which are not properly marked. These cables should be marked with black or red electrical tape near the breakers to indicate they are charged.

Unmarked and charged white cables in the condensing unit service disconnect.

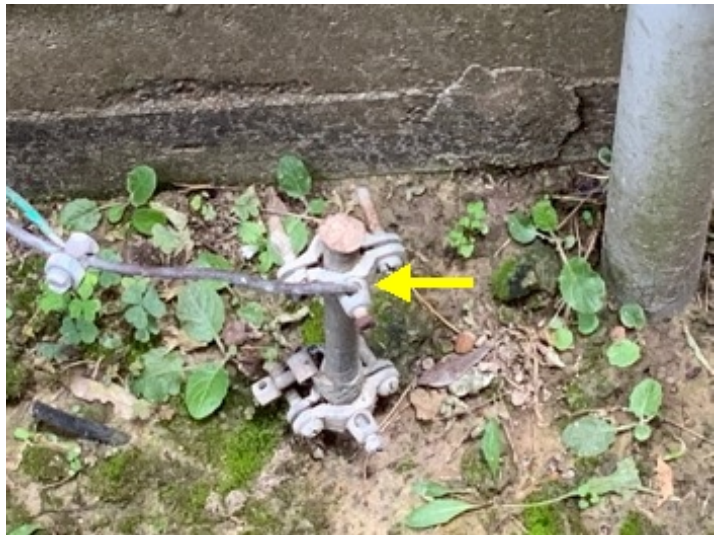
- A pipe clamp was used to secure the ground cable to the ground rod on the right side of this home. Recommend replacing the pipe clamp with an acorn ground clamp in order to secure the ground cable directly to the ground rod.

Pipe clamp on the ground rod.

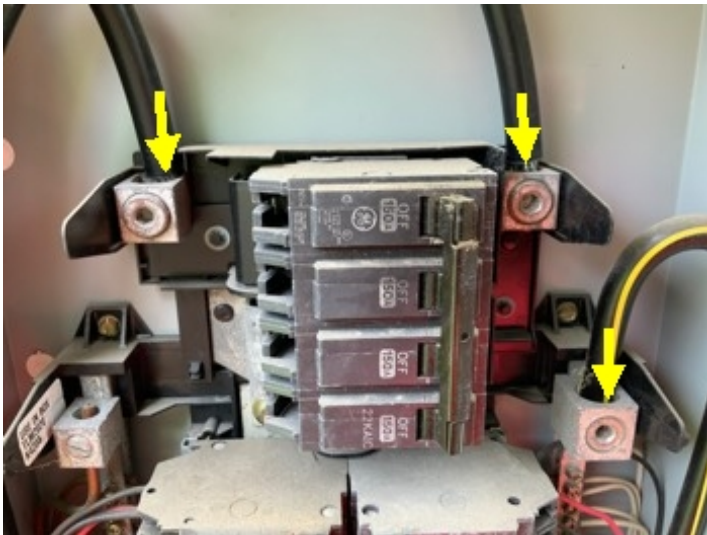
No antioxidant paste around the aluminum service entrance conductors at the terminals.

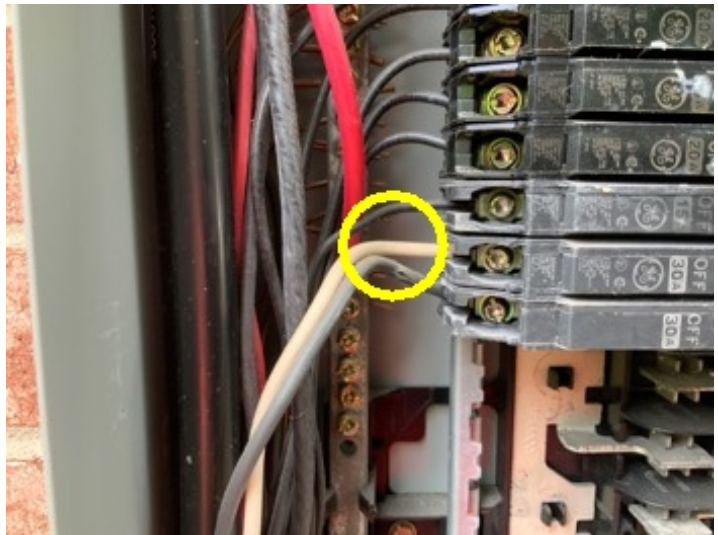
Unmarked and charged white cable at the AC breaker.

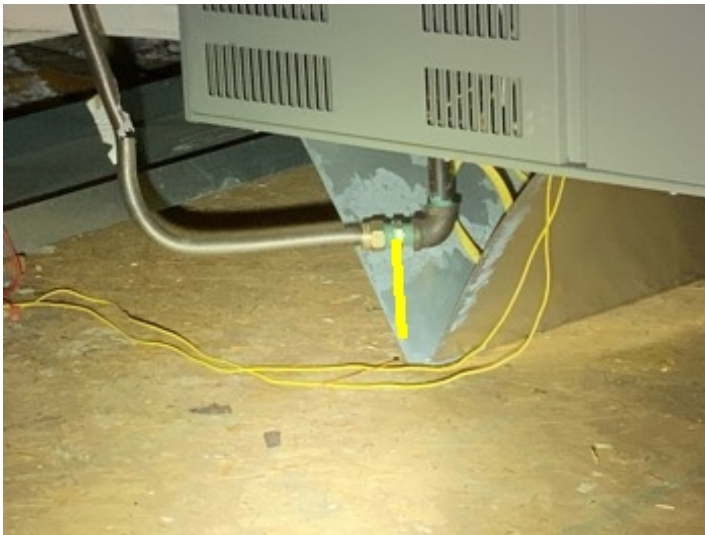
No sediment trap.

Page 16 Item: A	Heating Equipment	<ul style="list-style-type: none"> <li>There is no sediment trap present where the <b>CSSI</b> flex gas pipe transitions to the steel gas pipe at the unit. Recommend installing a sediment trap.</li> <li>Recommend consulting a licensed HVAC professional for further evaluation and corrective action.</li> </ul>
-----------------	-------------------	---

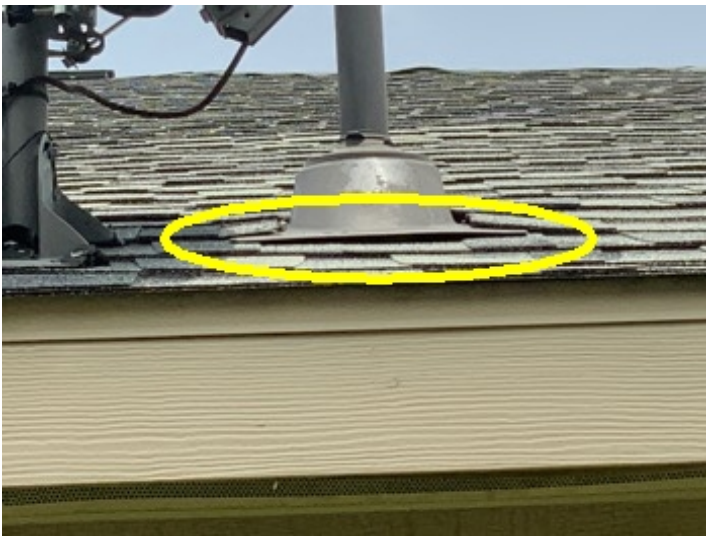
Lifting vent boot flashing on the right side of this home.

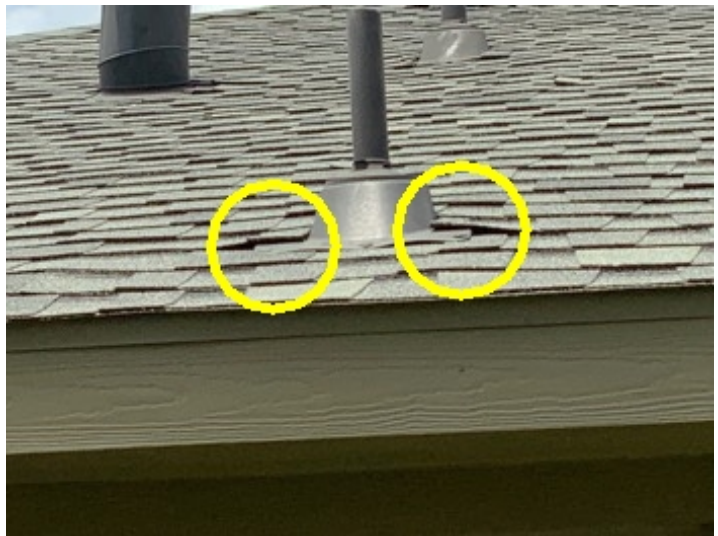
Lifting vent boot flashing and shingles on the rear of this home.

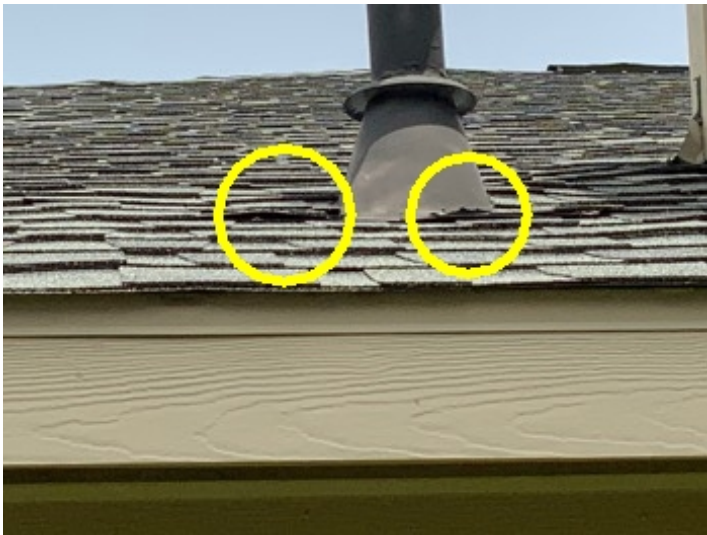
- Lifting combustion exhaust vent flashing was found on the right side of this home. Recommend securing the flashing to the roof surface and sealing the nail heads in order to prevent moisture penetration and damage due to wind lift. A roofing contractor should be consulted for corrective action.

Lifting combustion exhaust vent flashing on the right side of this home.

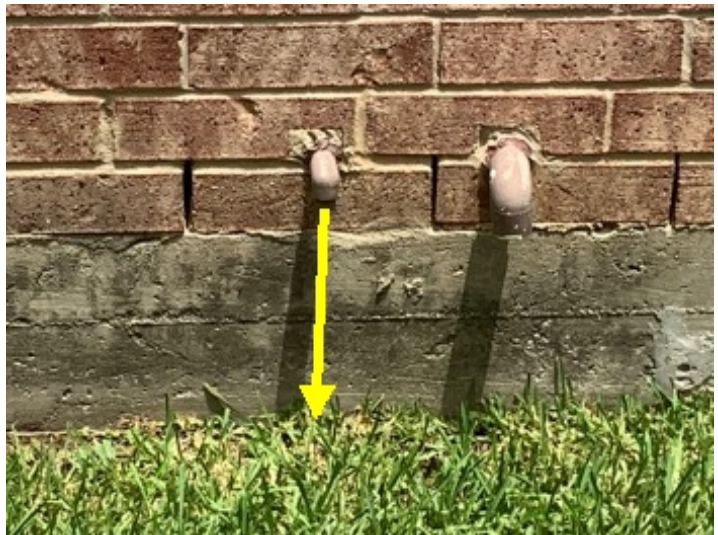
- The TPR valve drain pipe terminates greater than six inches above grade on the right side of this home. Recommend extending the drain pipe so it terminates within six inches of the grade.

TPR valve drain pipe terminates to far above grade on the right side of this home.

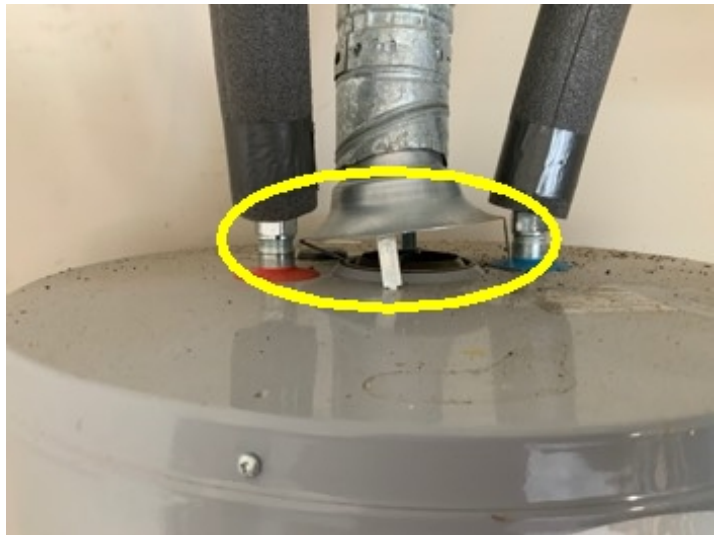
- The draft hood is damaged. Recommend replacing the draft hood.
- Recommend consulting a licensed plumber for further evaluation and corrective action.

Damaged draft hood.
