PROPERTY INSPECTION REPORT

Concerning: 807 Valley Ranch Dr, Katy, TX 77450
(Address or Other Identification of Inspected Property)

By: Scott Osborne, Lic #20555 11/09/2019
(Name and License Number of Inspector) (Date)

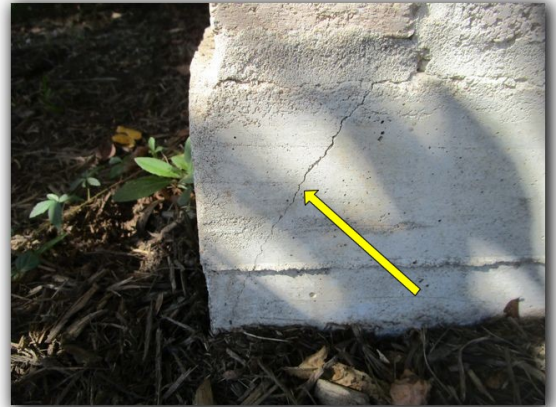
There are cracks at the corners of the foundation. Corner cracks are commonly found on slab foundations. They are generally cosmetic in nature. However, they may require minor repair to prevent water and pest penetration.

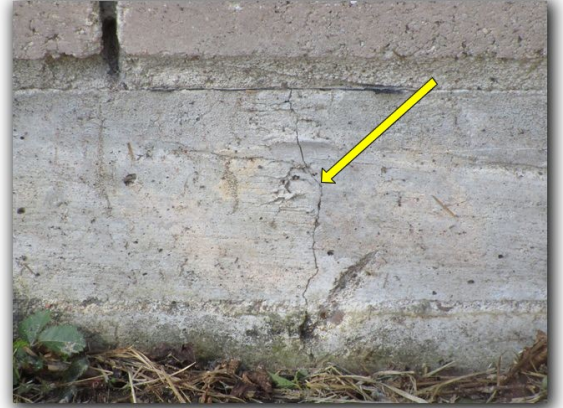
There is a hairline crack in the foundation on the right side of the home below the rear window.

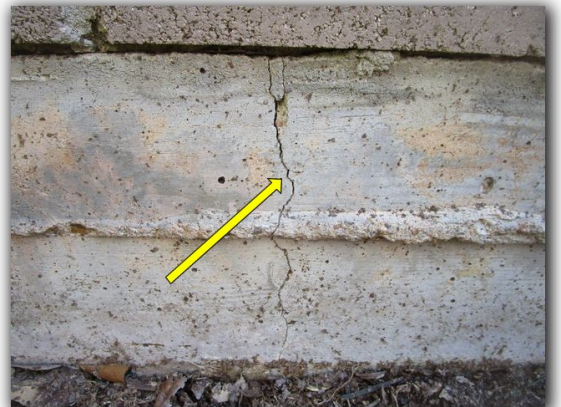
There is a hairline crack in the foundation on the left side of the home near the second window and near the fence / gate.

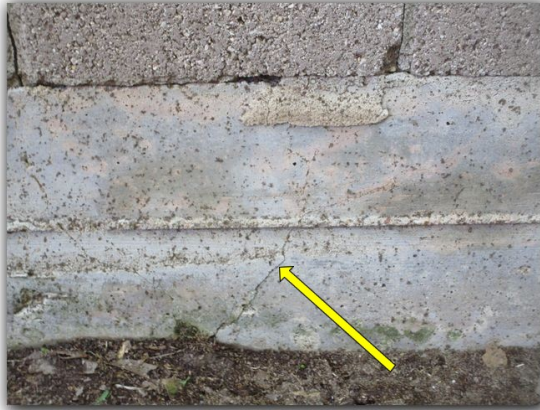
There is a hairline crack in the foundation on the left side of the home below the rear window.

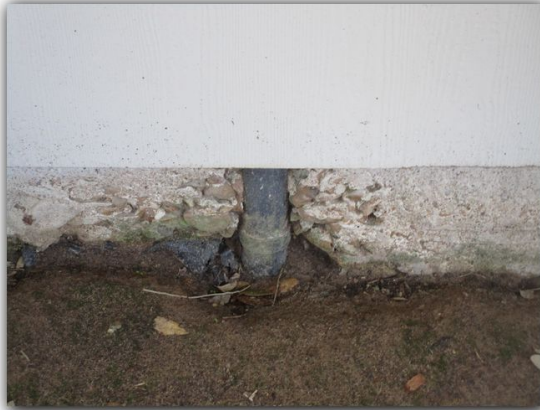
There is exposed aggregate with exposed plumbing at the rear of the home near the rear left corner.

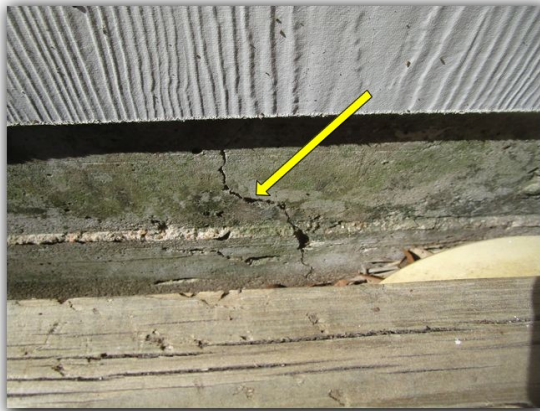
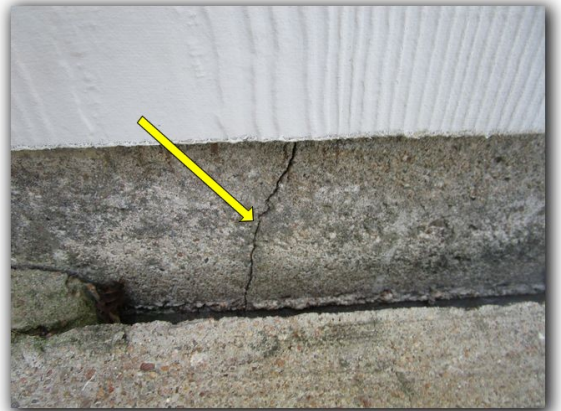
There are hairline cracks in the foundation along the left side of the rear patio near the rear corner and below the window (front right spare bedroom window).

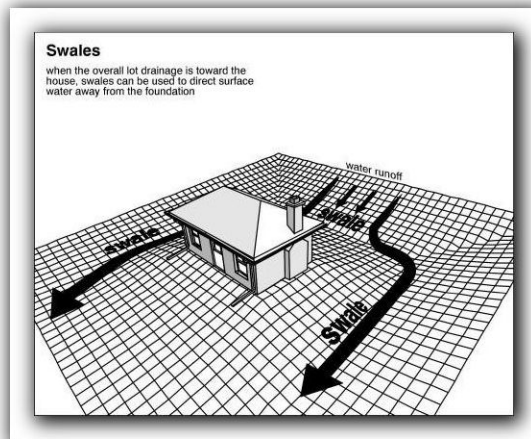
The lot did not appear to have the proper slope for drainage at all points around the perimeter of the home. The grading should slope at least 6" in the first 10' around the home. Inadequate slope may allow water to stand against the foundation and may lead to excess foundation movement.

NOTE: I recommend monitoring the drainage after rain to determine if there is an additional need for drains.

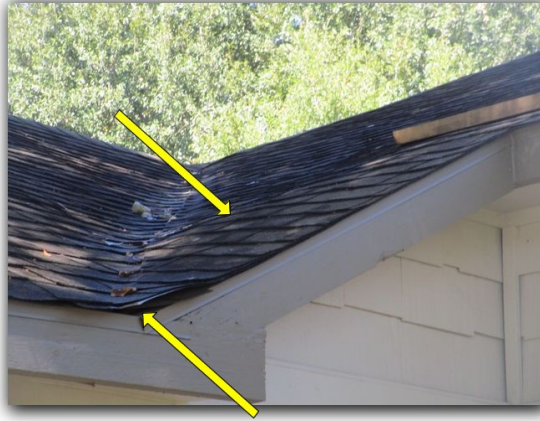
There are deflections / bumps in the roof along the front valley between the garage and front entry with a gap at the shingle / roof decking at the eave.

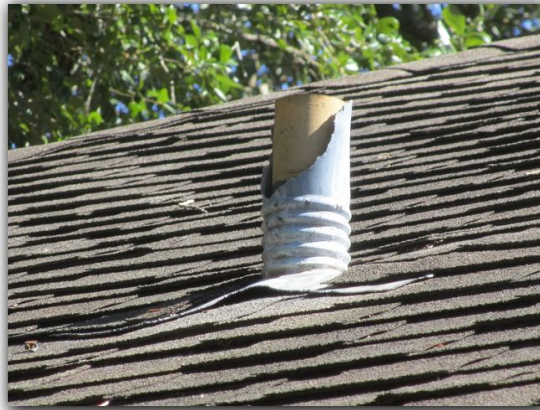
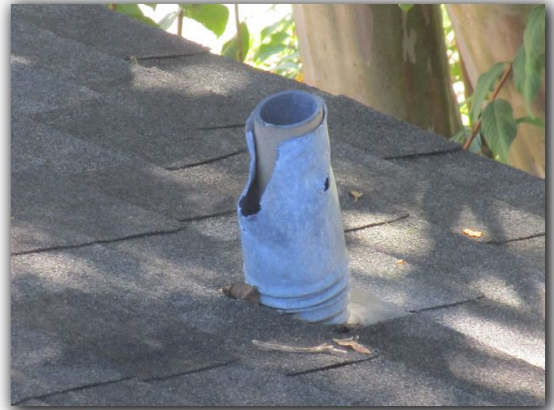
There are roof jacks that are damaged and need to be replaced at more than one location on the roof.

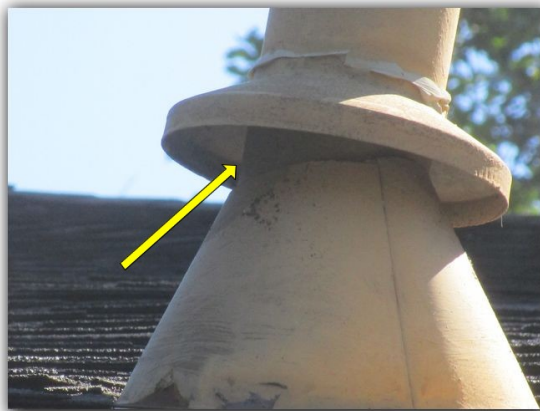
The rain collar is not fully / properly seated on the vent pipe.

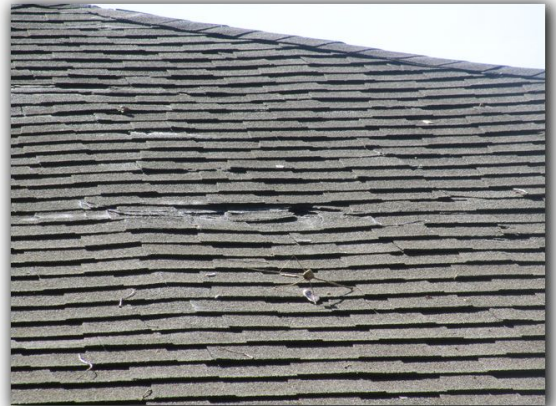
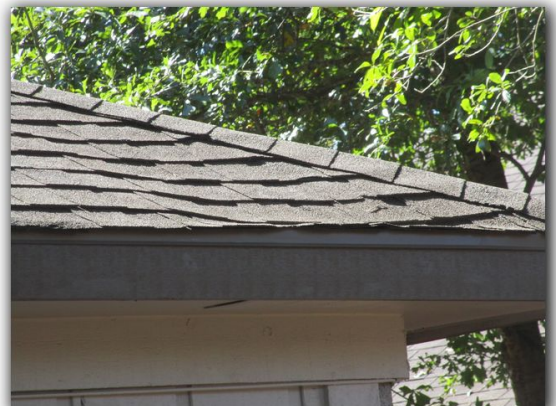
There is extensive damage to the roof at the rear of the home above the rear right bedroom and master bathroom areas.

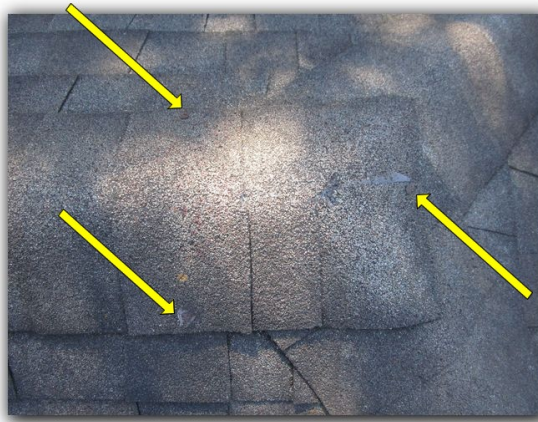
There are exposed nail heads on the roof. Nail heads should be sealed with roof caulking material. Over time, water may penetrate the roof around a rusted nail if they are not properly sealed.

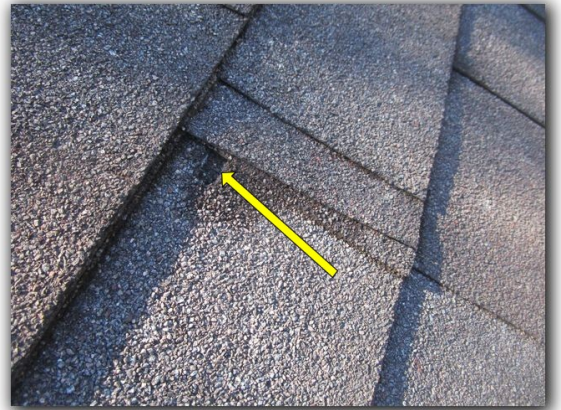
The shingles are showing signs of age with damage and wear, including loss of granular material.

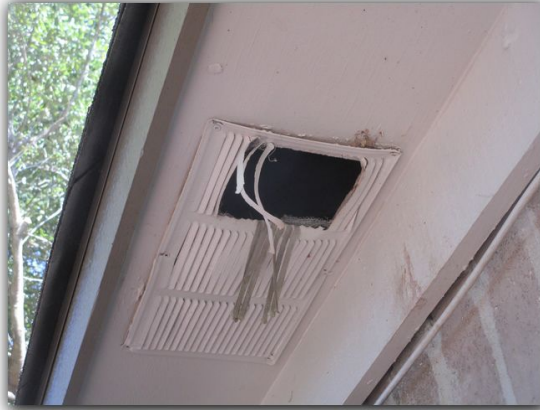
There is damage to the soffit vent screen at the left side near the rear corner. This is a potential pest penetration point.

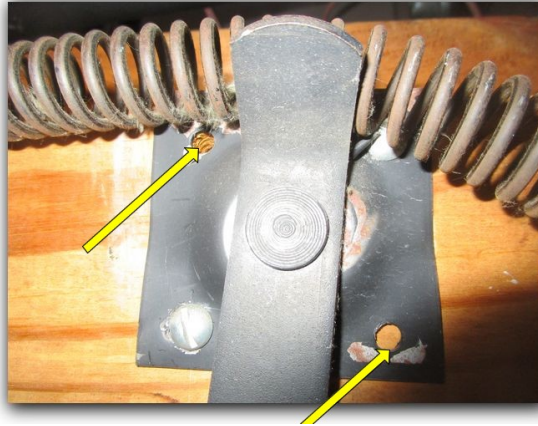
There are loose / missing bolts on the attic access ladders (both ladders). I recommend tightening all bolts periodically.
There are missing fasteners in the brackets at the top of the attic ladder where the ladder attaches to the framing in the hall attic ladder.

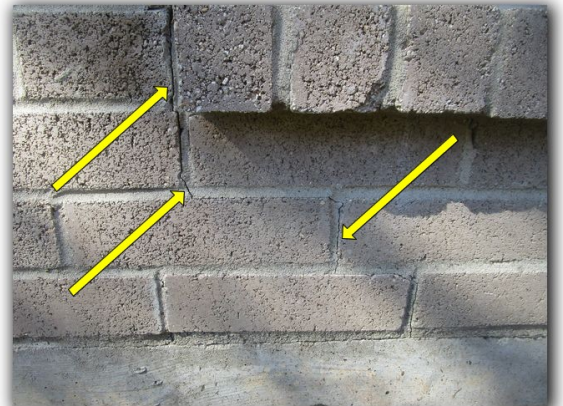
There are cracks in the brick on the right wall at the first and second windows.

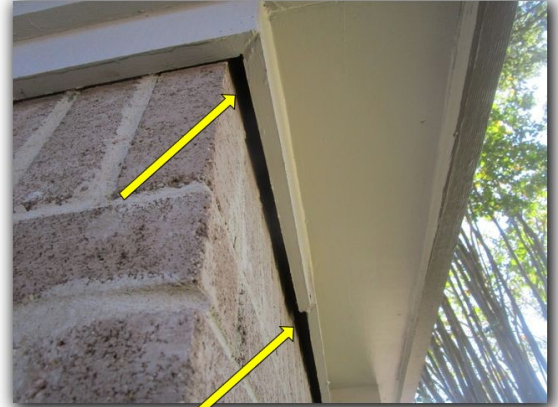
There is a gap at the frieze trim at the top of the front wall at the right and left sides of the kitchen box window frame. The trim appears to have shifted forward, creating an exposed opening into the wall cavity.

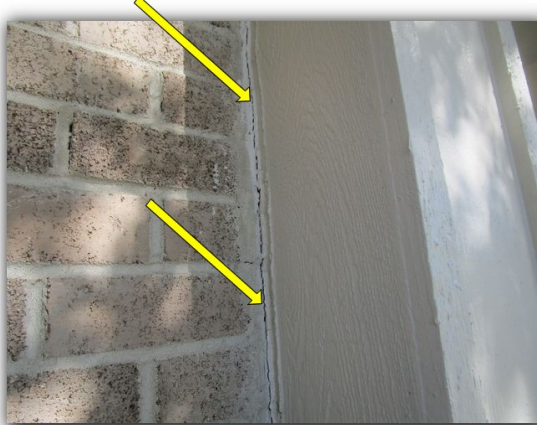
There is deteriorated caulking material at the brick / trim intersection at the kitchen box window frame trim.

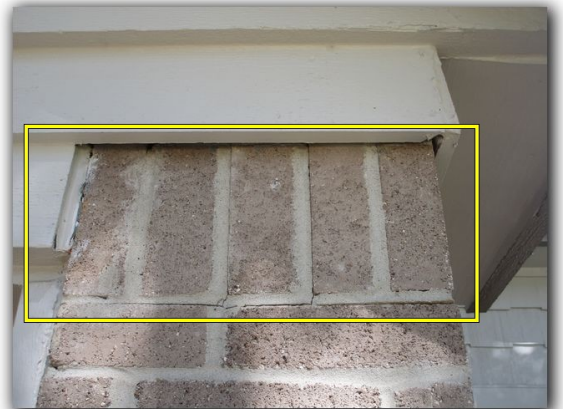
There is a mortar joint crack with loose bricks at the top front right corner of the garage.

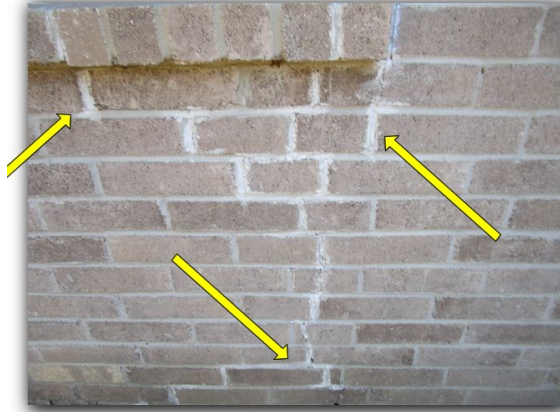
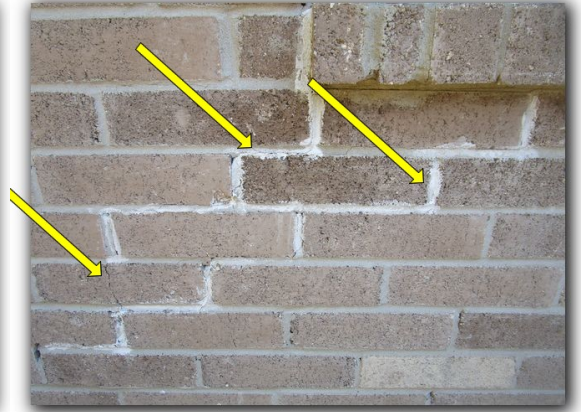
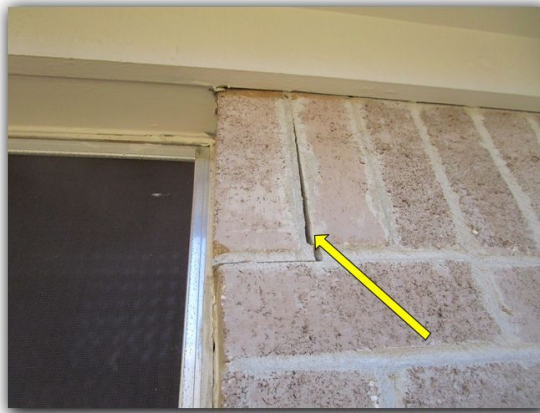
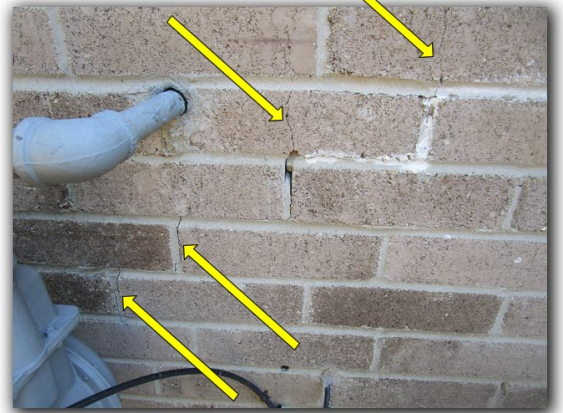
There are cracks on the left wall at the first window with evidence of separation along the window frame.

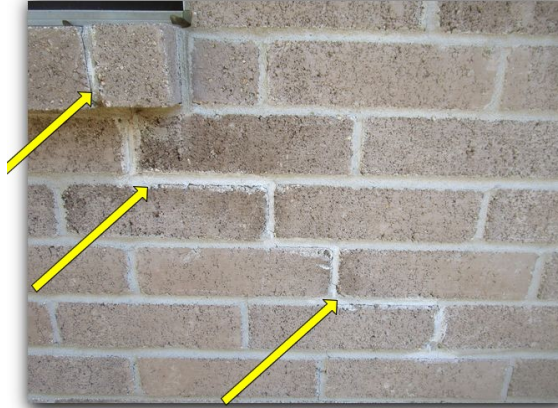
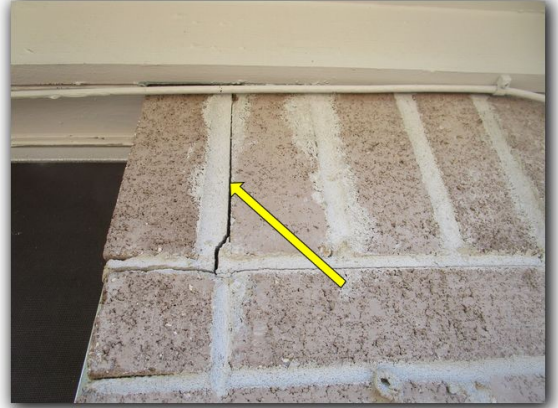
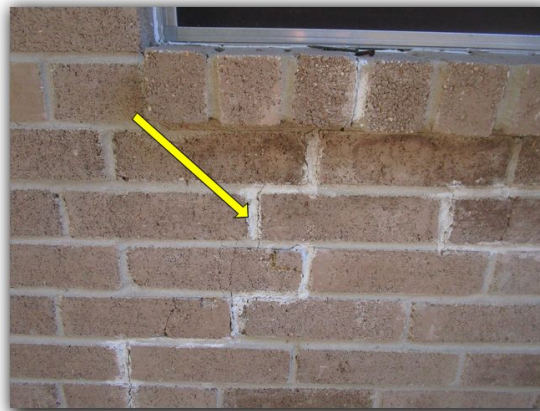
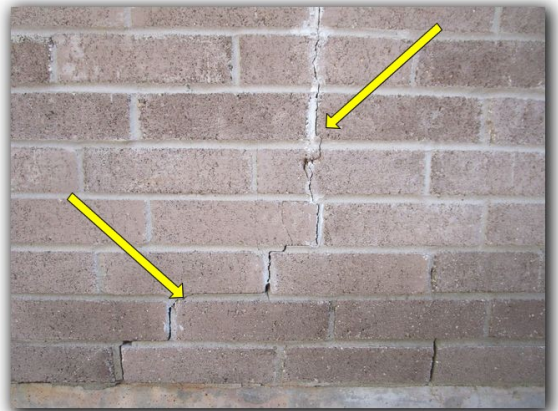
There are cracks on the left wall at the second window with evidence of separation along the window frame, and a loose brick at the top corner of the window.

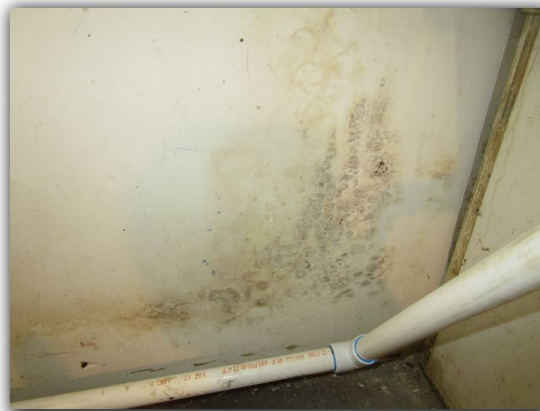
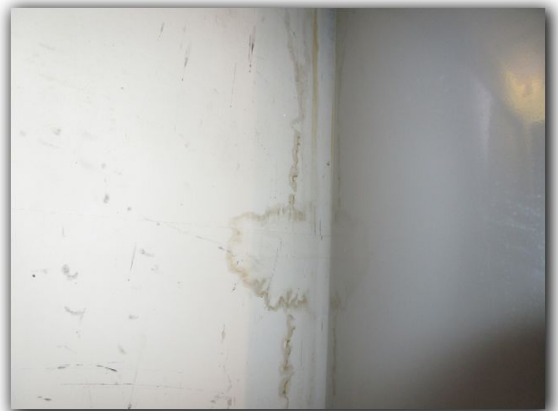
There are signs of moisture stains and microbial growth on the wall in the water heater closet at more than one location. I recommend further review and remediation by a qualified contractor.

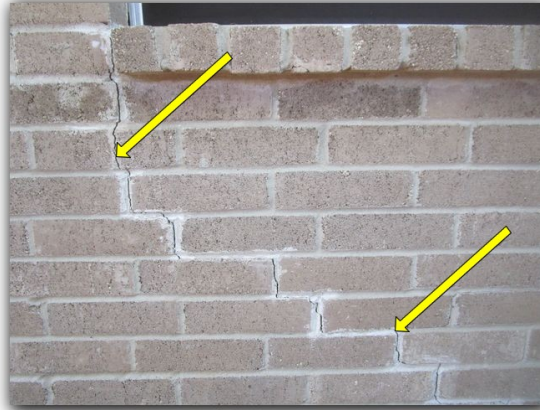
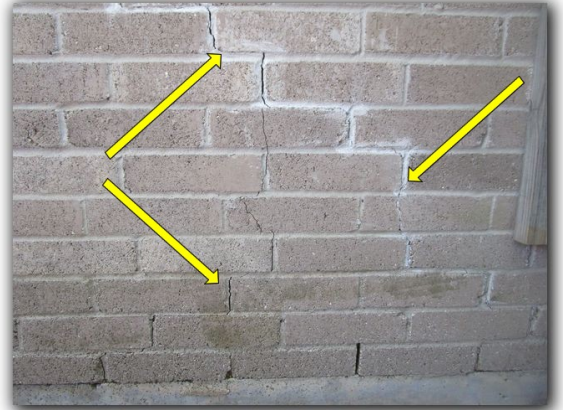
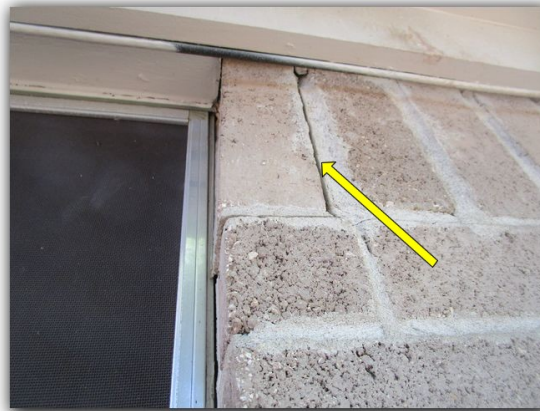
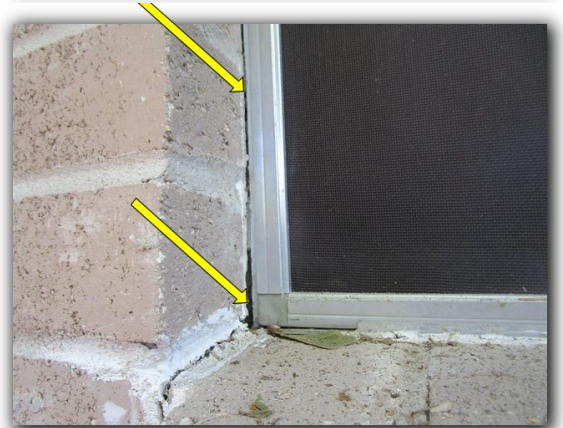
There are cracks on the left wall at the rear window with evidence of separation along the window frame, and a loose brick at the top corner of the window frame.

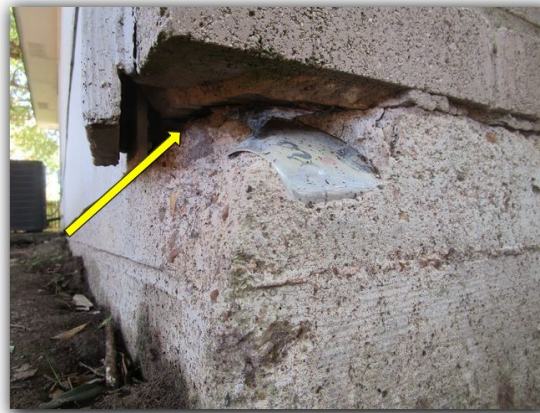
There is a gap at the bottom of the wall at the rear left corner (at the base of the wall).

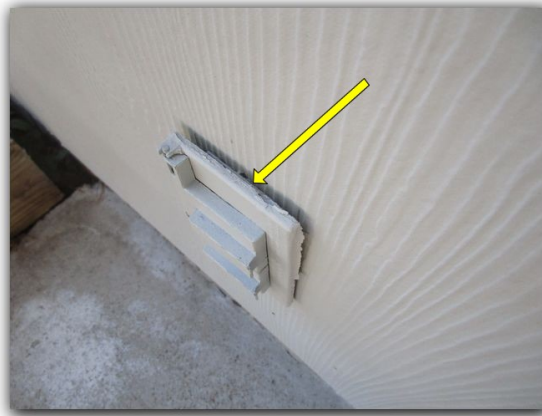
The exterior outlets are not properly weather sealed.

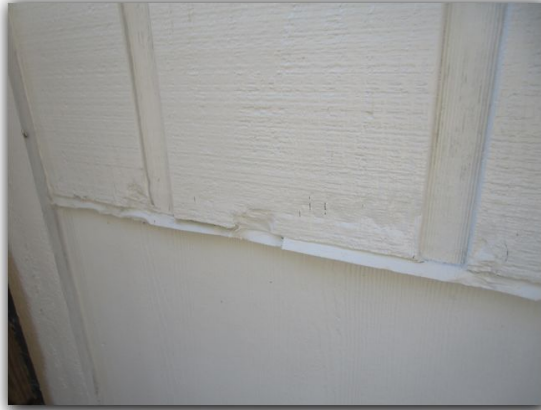
There is evidence of rotting wood on the siding at the rear of the home along the edge where the wood siding meets the replacement siding.

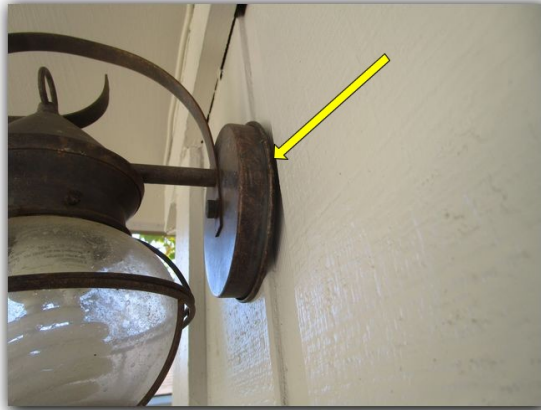
The exterior light fixtures are not properly sealed or secured to the wall. This is a potential moisture penetration point.

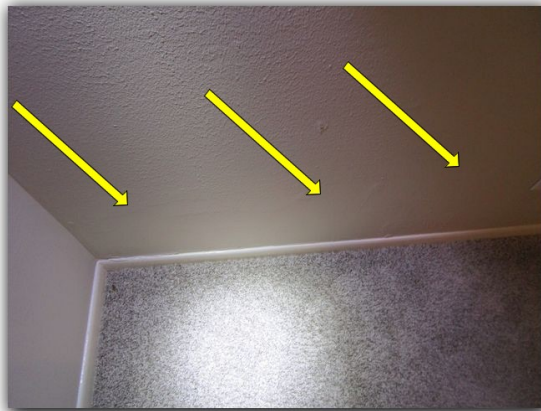
There is evidence of prior repair to the bottom of the wall in the rear right bedroom near the rear left corner. I recommend asking the seller for any additional information.

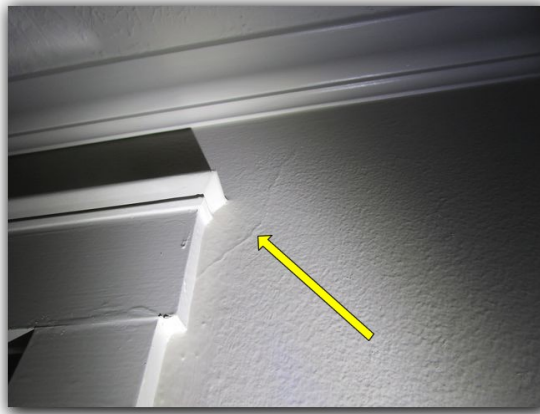
There is a crack on the wall in the dining room at the framed opening to the kitchen.

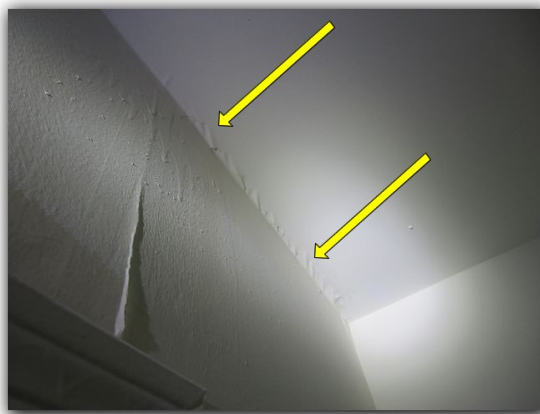
There is a rolling tape seam along the wall / ceiling intersection in the rear right bedroom closet at the rear corner.

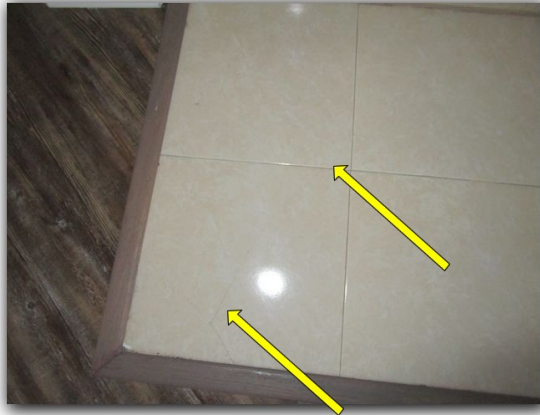
There are cracked tiles at the fireplace hearth extension.

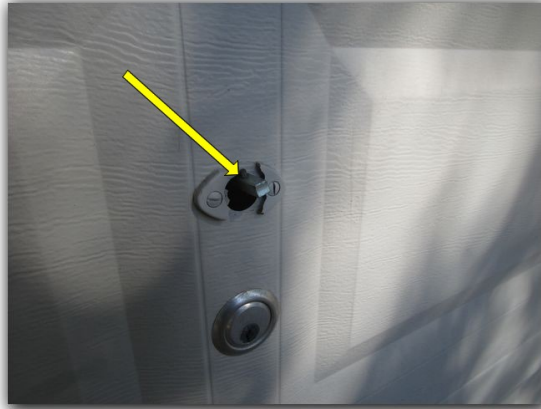
There is damage to the lock at the left garage door.

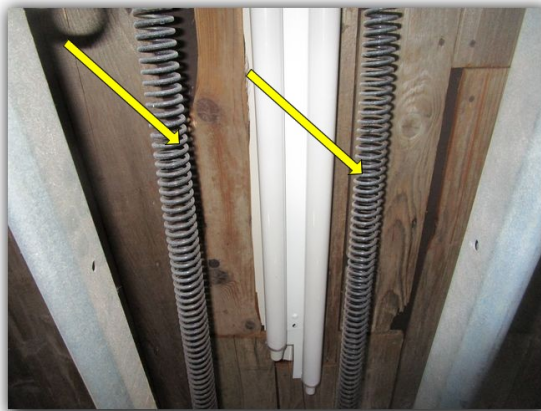
There are no safety cables in the garage door springs.

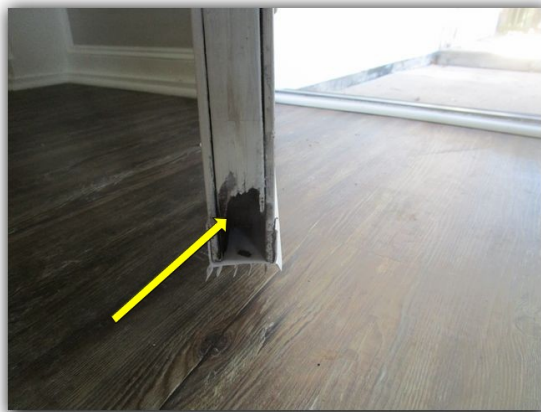
There is damage to the bottom of the rear entry door.

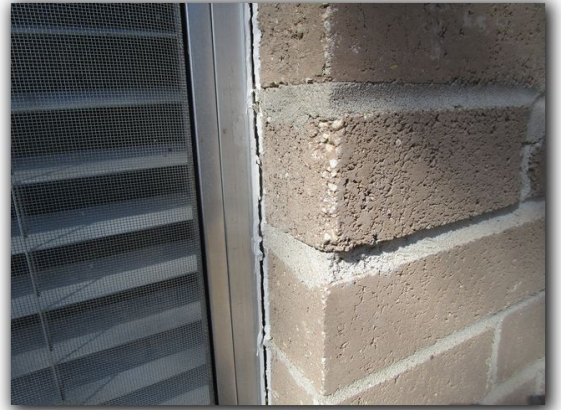
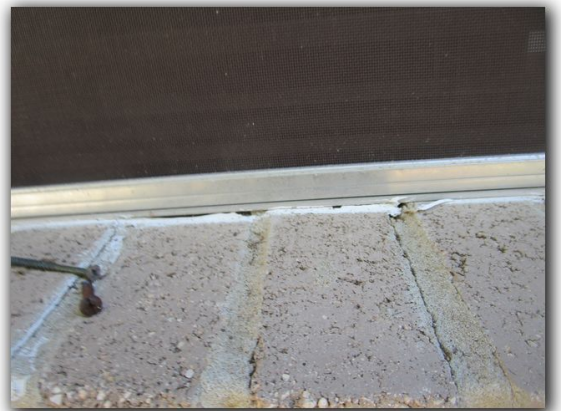
The caulking and glazing beads around the windows are showing signs of deterioration and may need to be replaced.

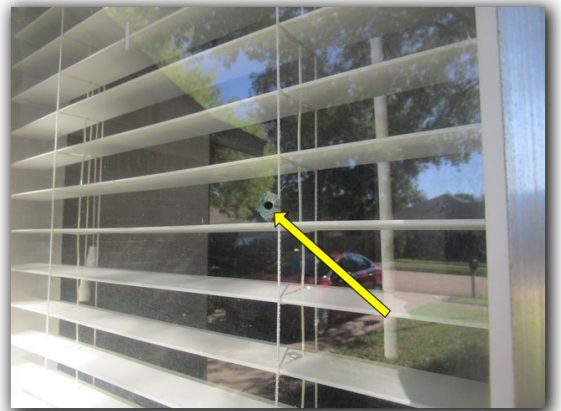
There are missing window screens.
There is a chip in the middle and left dining room windows.

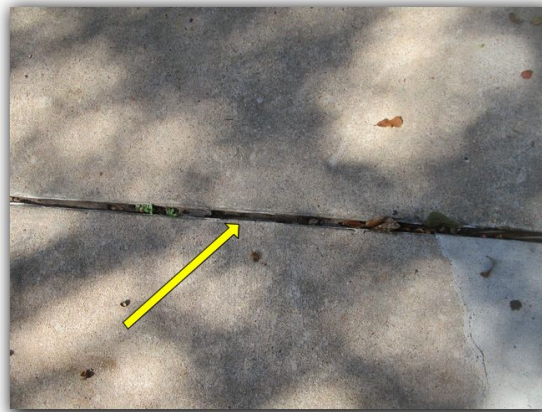
There are cracks in the rear patio concrete.

Without these expansion joint materials, the concrete may shift, creating a potential trip hazard.

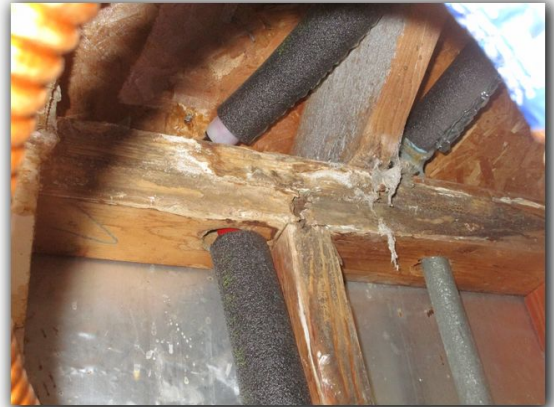
There are signs of moisture stains and damage, with evidence of prior wood destroying insect damage, in the garage above the water heater area at the exterior wall. I recommend asking the seller for any additional information.

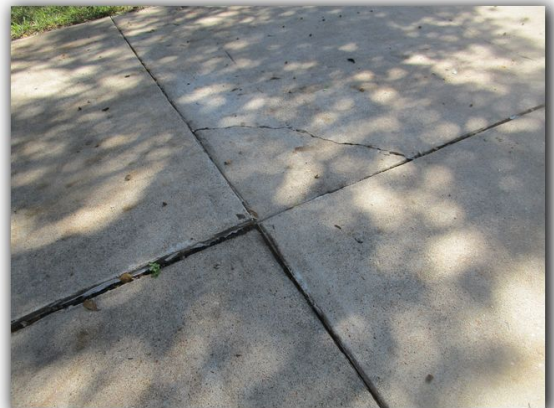
There are cracks in the driveway and the driveway has shifted, creating a potential trip hazard.

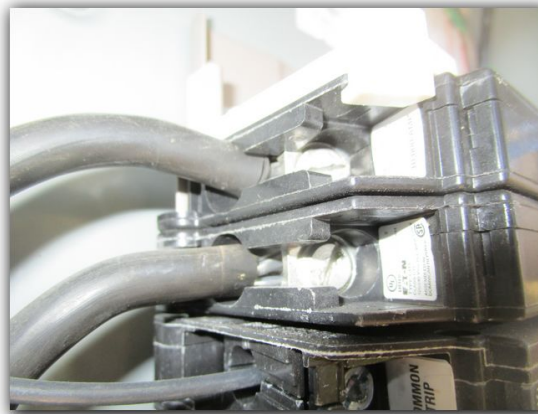
There is no anti oxidant paste on the aluminum service wires at the main lugs.

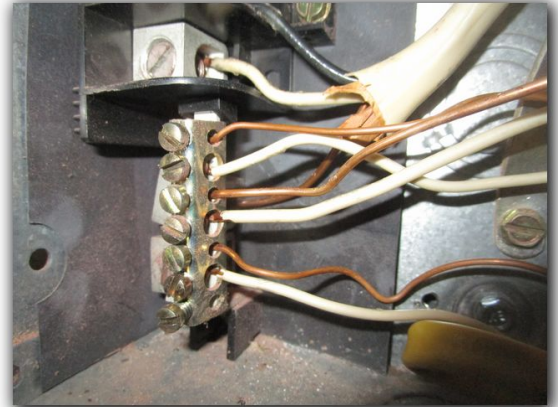
There is a ground and neutral wire attached to the same bus bar in the main and sub panels. Ground and neutral wires should be connected to separate lugs and separate bus bars to help prevent accidental injury or damage.

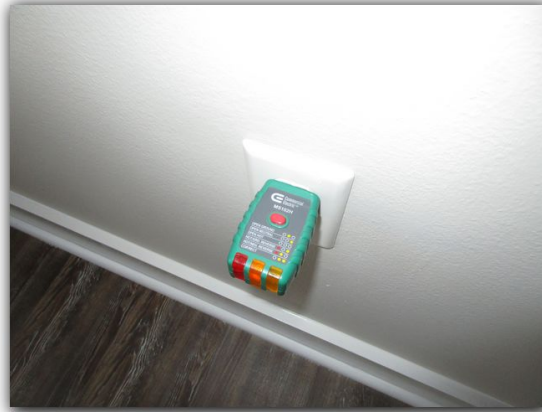
There are open ground outlets in the living room at the wall separating the living room and kitchen.

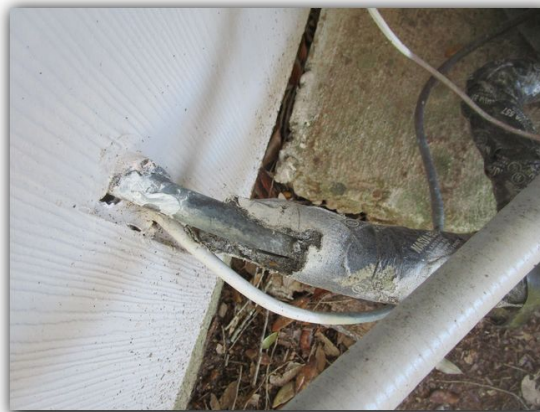
The information label is worn on the exterior condenser unit. The insulation on the copper lines at the exterior condenser unit is deteriorated and may need to be replaced or repaired.

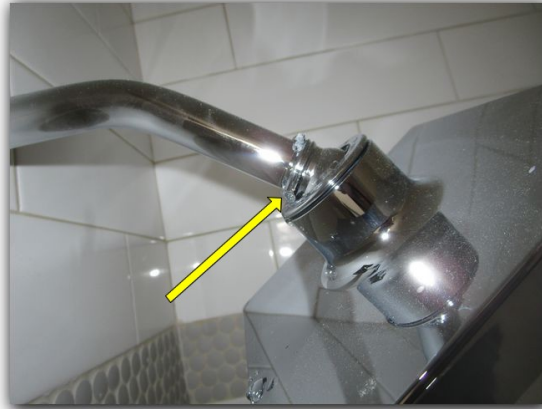
There is a leak at the shower head connection.

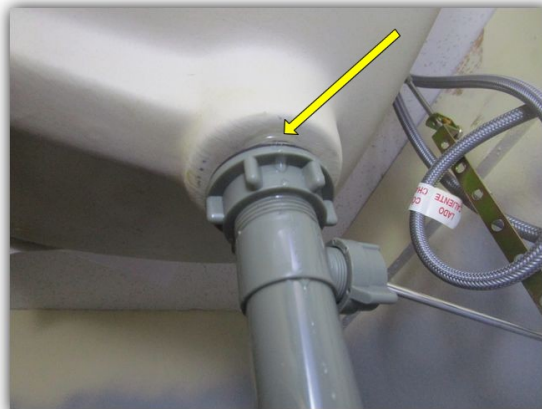
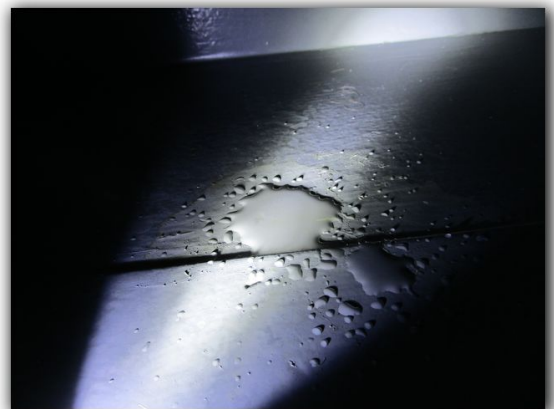
There is a leak at the plumbing connection under the sink.

I recommend having a licensed plumber review and repair the deficiencies.

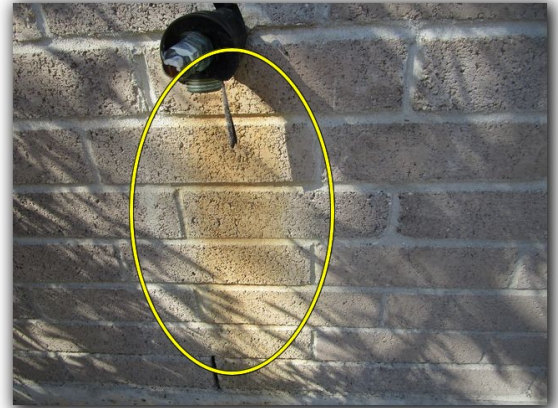
There is a missing control valve handle on the hose bib on the right wall, with evidence of a leak onto the wall.

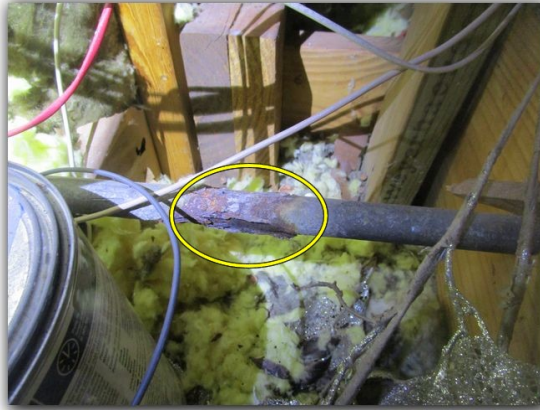
There is evidence of corrosion on the water supply lines in the attic above the garage near the opening.

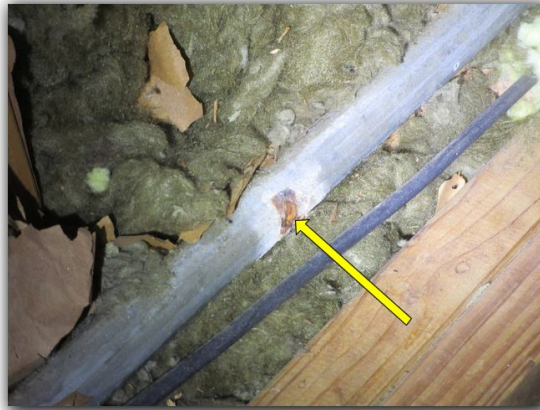
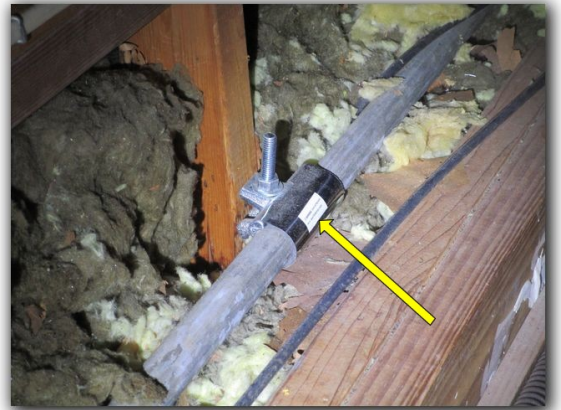
There is evidence of corrosion on the water supply lines in the attic above the hall with signs of prior repair to the supply lines at more than one location.

I recommend having a licensed plumber review and repair the deficiencies.

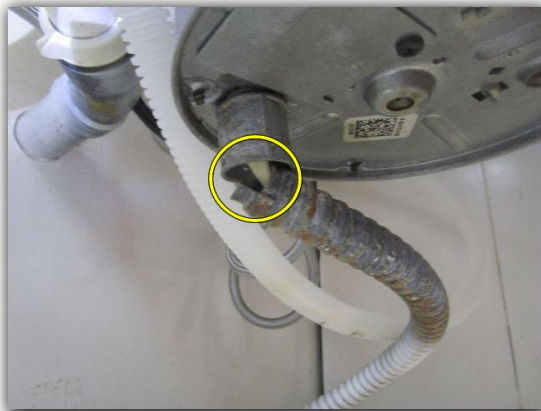
**There is rust inside the disposal unit.
There is damage to the conduit at the base of the unit, exposing the wires.**

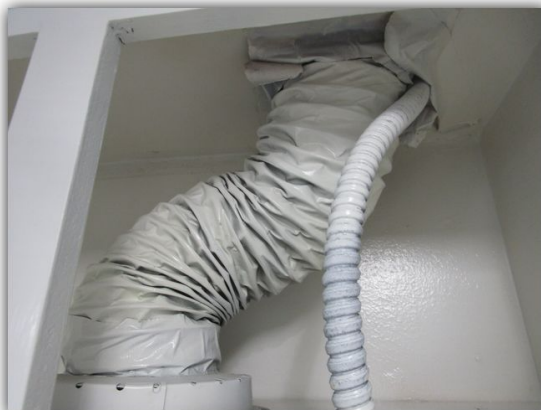
**The light is not working properly.
There is flexible vent pipe material to the hood vent. Only smooth wall vent pipe material should be used to help prevent debris or other greasy materials from obstructing the inside of the vent pipe.**
