**Mallisa Amo
4622 Ella Blvd
Houston, TX 77018**

PROPERTY INSPECTION REPORT

Concerning: 4622 Ella Blvd, Houston, TX 77018
(Address or Other Identification of Inspected Property)

By: Robert Ramirez, Lic #10013 06/10/2019
(Name and License Number of Inspector) (Date)

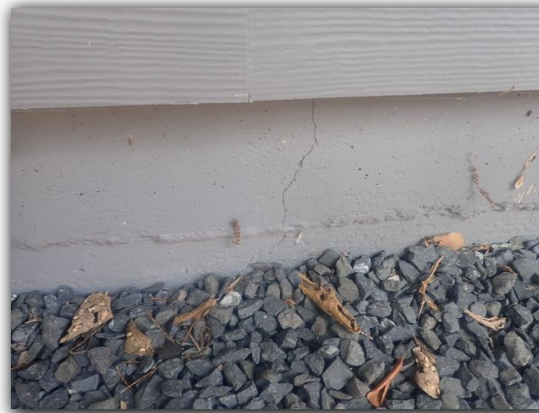
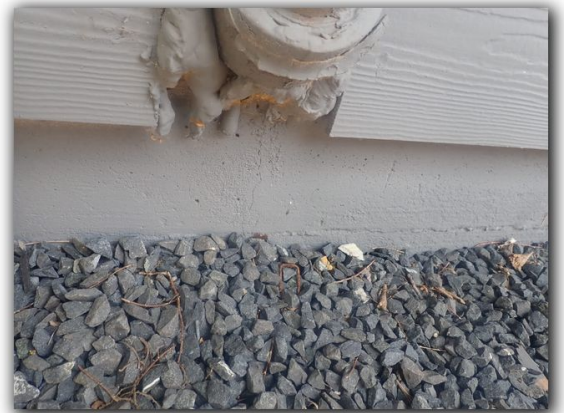
- Minor stress crack(s) were observed in the exterior foundation perimeter beam.
- **Note:** The exterior of the foundation has been painted. This condition could limit the inspectors visual observations and ability to render accurate opinions as to the performance of the structure.

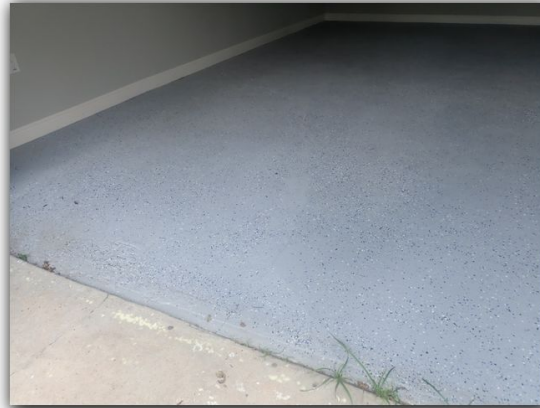
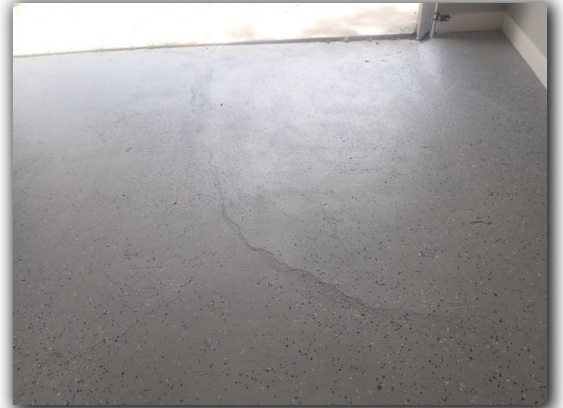
You should be aware that there is visible evidence of previous foundation repairs. You are strongly encouraged to consult the current homeowner on previous foundation work performed and warranty information. Since I have not reviewed the property prior to the foundation work and I was not present at the time the foundation work was performed, an opinion as to whether the work was performed properly and as to whether foundation movement will continue or, if so, the extent of such movement cannot be rendered. If any cause of concern is noted on this report, or if you want further evaluation, you should consider an evaluation by an engineer of your choice.

- Floor slopes and/or unlevelness were observed.
- Cracks were observed in the floor of the foundation.

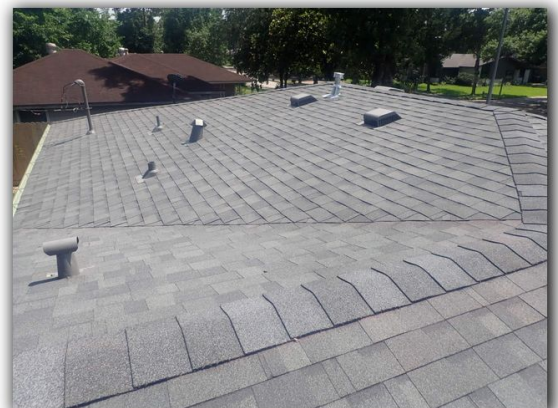
- The felt paper was observed to be installed under the lower metal drip edge flashing detail. The manufacturer installation requires the felt paper to be installed over the top of the metal drip edge flashing, in shingle like fashion, to help prevent water intrusion and/or damage to occur behind the fascia board and soffit/eave areas.

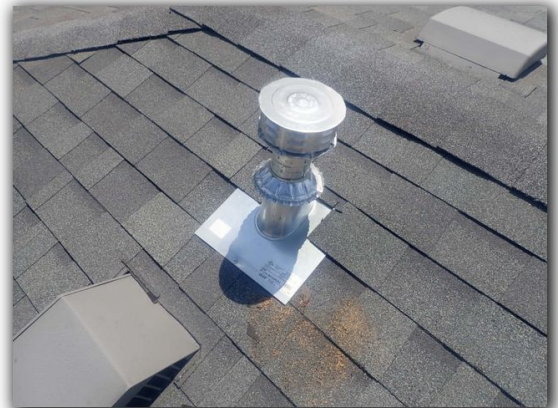
Note: Recommend removing unused gas flue and flashing. This area could allow water intrusion.

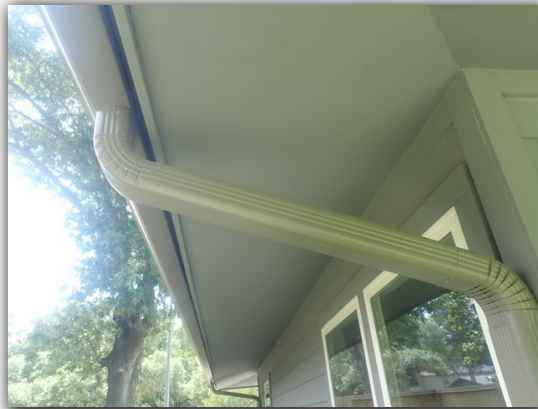
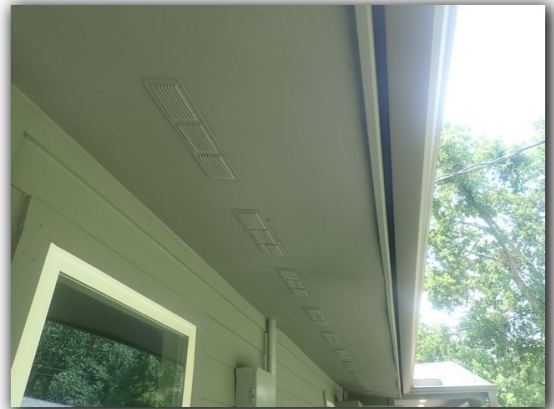
- The roof structure attic space does not appear to be adequately ventilated. It is recommended to increase the amount of lower and upper ventilation to help prevent heat buildup in the attic space area. This condition should be further evaluated and corrected as necessary.

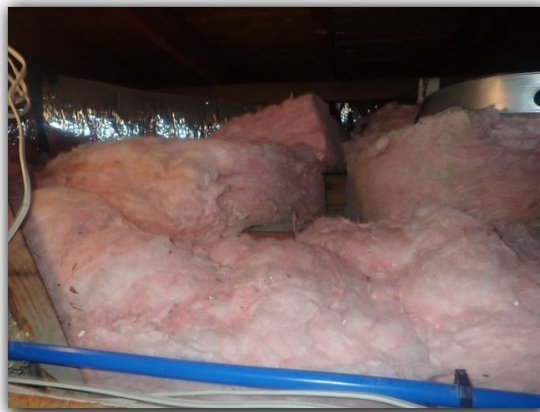
- The attic insulation has installed over the soffit vents. This condition should be corrected to help improve the cross ventilation that is required for the attic space.

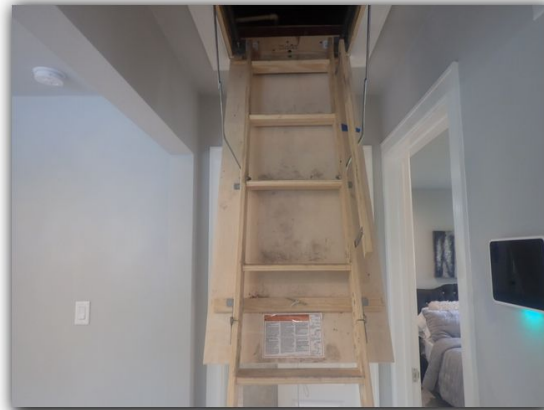
- The hatch door is not insulated at this time. This is an "As Built" condition that does not meet current energy standards. It is recommended to insulate the hatch door / opening after taking possession / ownership of the property.

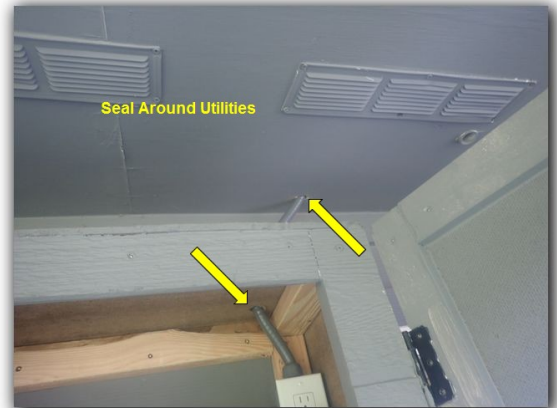
- The area between the exterior cladding / veneer and all of the wall penetrations / openings need to be properly sealed. Areas such as utility connections, downspouts, hose bibbs, lighting fixtures, receptacles etc. It is recommended to use an elastomeric caulking / sealant.
- There is no visible through wall flashing (head flashing) above the windows. Under current building installation standards, there should be through wall flashing continuously above all windows penetrations to help prevent water intrusion at these locations.

Note: The heavy foliage growing on, over or around the exterior walls of the structure should be trimmed back at least 18-inches. The heavy foliage will limit the inspectors visual observation of the exterior surfaces.

Note: The exterior masonry veneer has been painted. This condition could limit the inspectors visual observations and ability to render accurate opinions as to the performance of the structure.

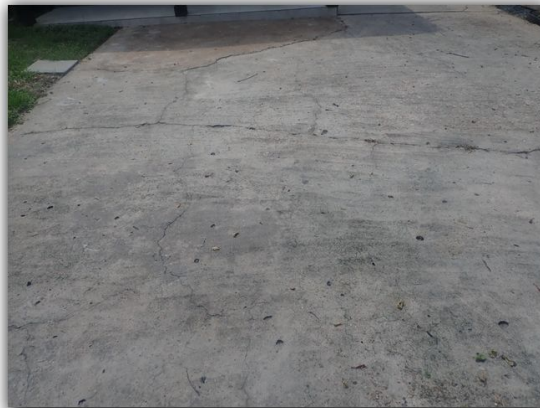
- Larger than typical cracks and/or deficiencies were observed in the driveway.

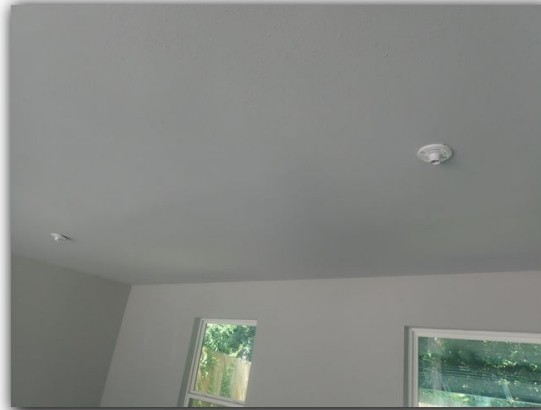
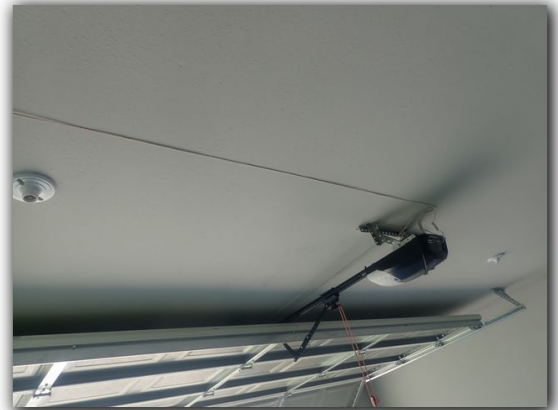
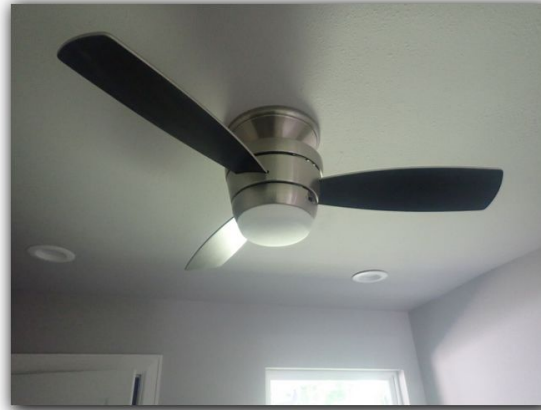
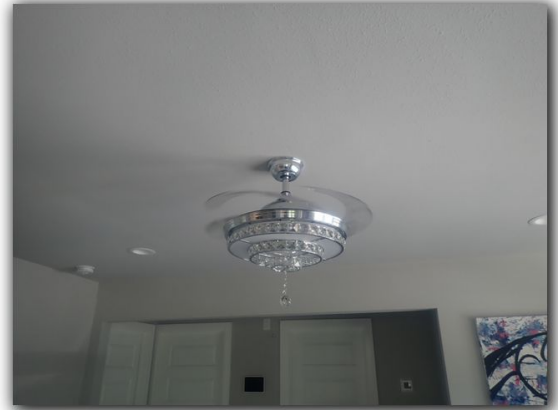
- One of the switches was observed to be installed up-side-down in the attic area.

- One or more of the light fixtures appear to be inoperative in the garage. This may be due to a bad bulb or some other unknown condition. This condition should be further evaluated and corrected as necessary.
- One or more of the light fixtures do not appear to be functioning properly in the living room.

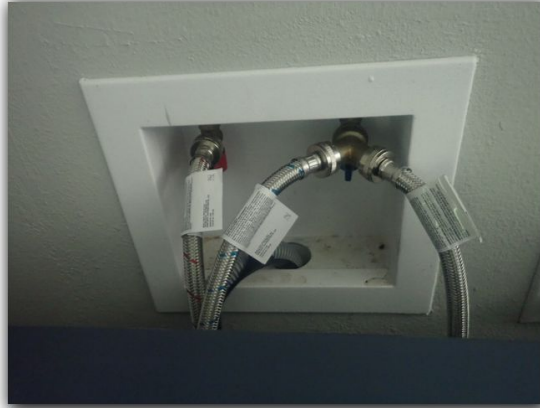
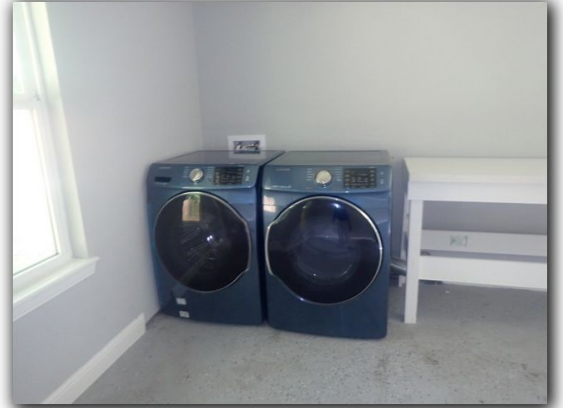
- The faucets hot/cold water orientation is reversed.

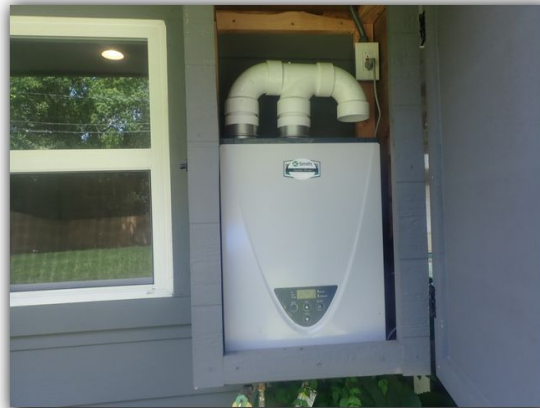
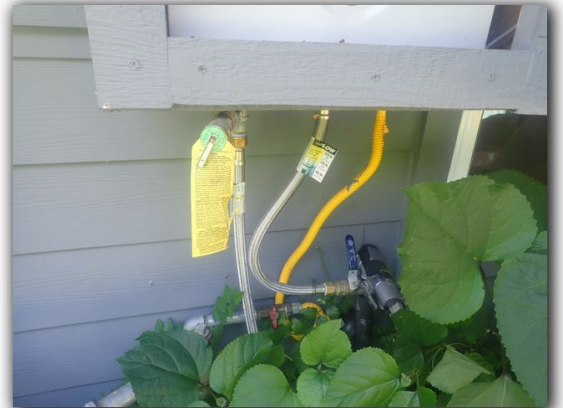
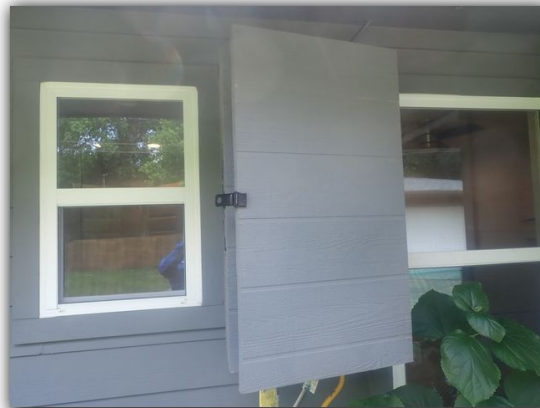
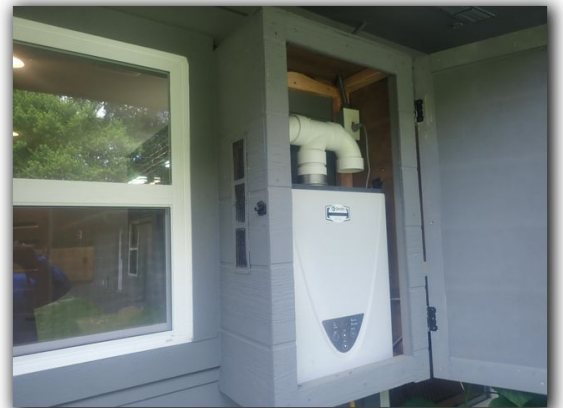
- The tankless water heater exhaust vent terminates too close to a window and soffit vent. This condition does not meet mechanical installation standards.
- The water heater compartment has inadequate combustion air ventilation. There should be a minimum of 100 square inches of combustion air ventilation provided within 12-inches of the top and bottom of the closet.

This water heater and associated components need to be checked and serviced by a Qualified / Licensed Plumber. The observations made to support the rendering of this opinion are listed but may not be limited to the following:

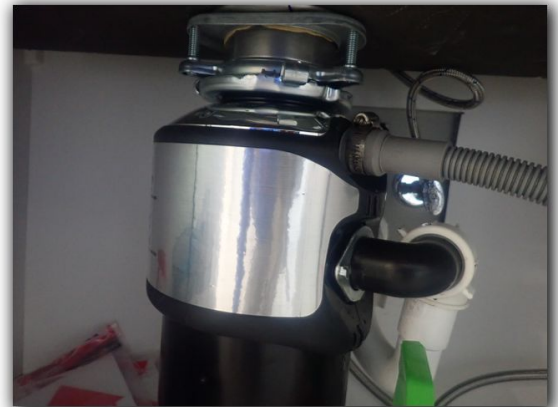
- The food waste disposer is leaking water into the cabinet area. This condition should be further evaluated and corrected as necessary.
