### HOME INSPECTION REPORT

**Concerning:** 11935 Briar Forest Dr, Houston, TX, 77077  
(Address or Other Identification of Inspected Property)

**By:** Bob Wiesner (# 22223) 3-15-2019  
(Name and License Number of Inspector) (Date)

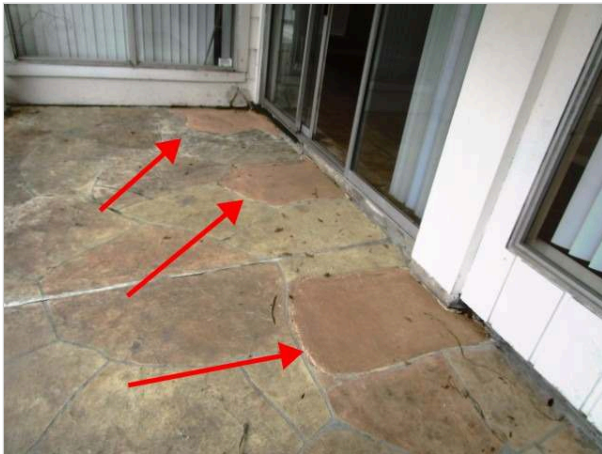
There were what appeared to be signs of previous repairs (pier marks) on the right side. There were signs of settlement inside, in our opinion, before the repairs were performed. There were no recent signs of settlement.

Pier marks - Porch behind living room

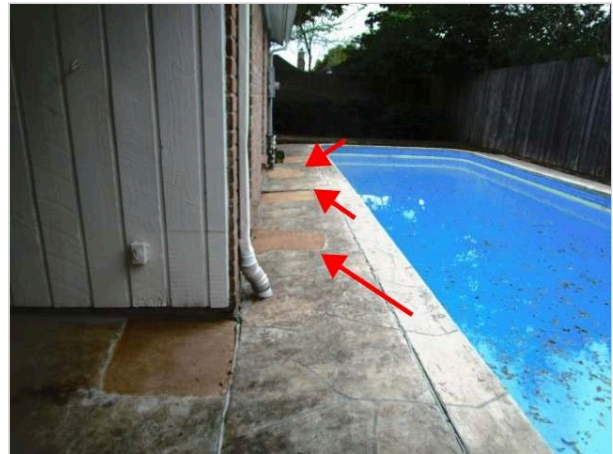
Pier marks - right wall

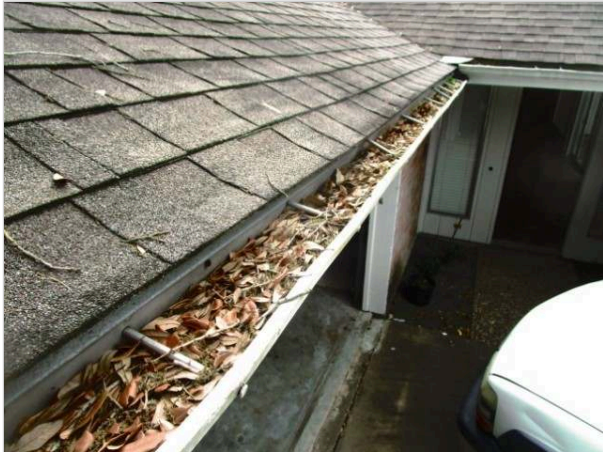
Debris in gutters

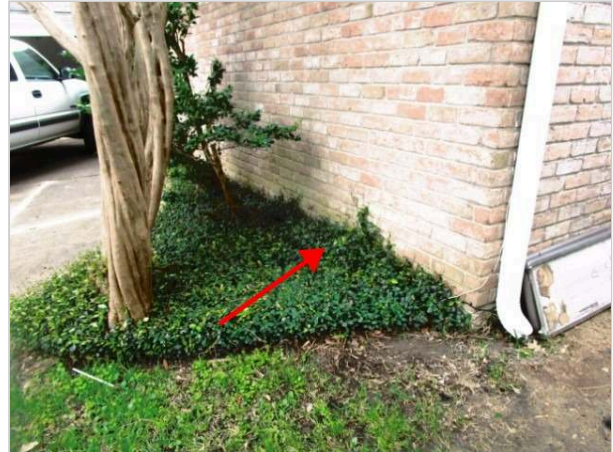
The soil was too close to the brick veneer or wood siding (cladding) in several areas on the front and left walls. Common industry practice recommends soil to be 4 inches below exterior cladding. Proper soil level helps in detecting termite and other wood destroying insect activity as well as potential water penetration issues.

Vegetation against the brick veneer

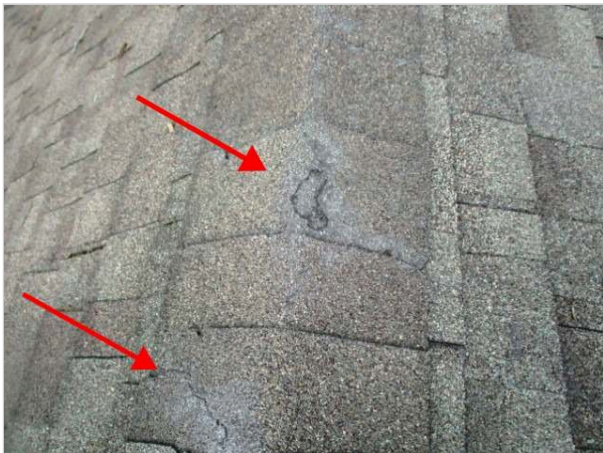
There were some damaged shingles and exposed nails.

Damaged shingles over garage

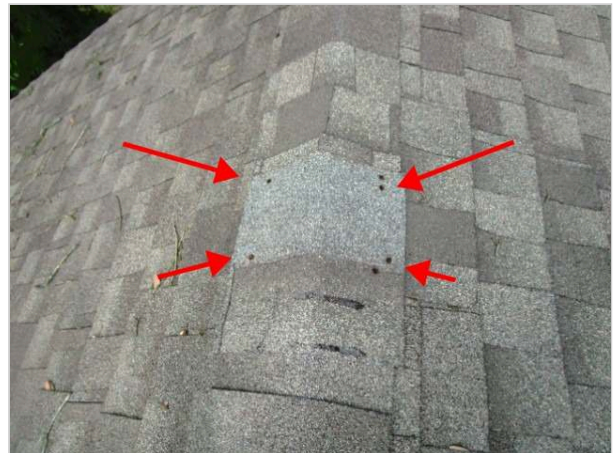
Exposed nails over garage

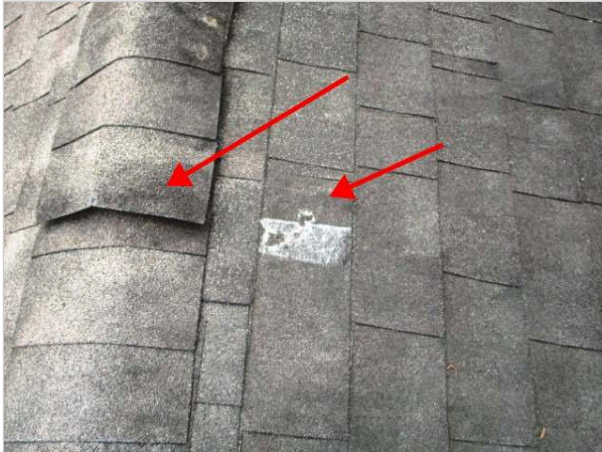
Damaged shingles - over master bedroom

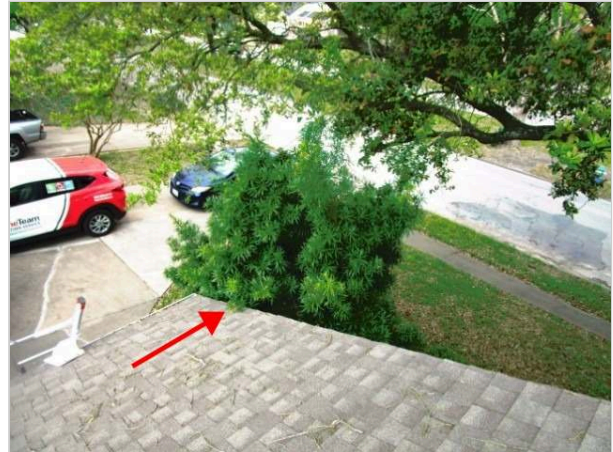
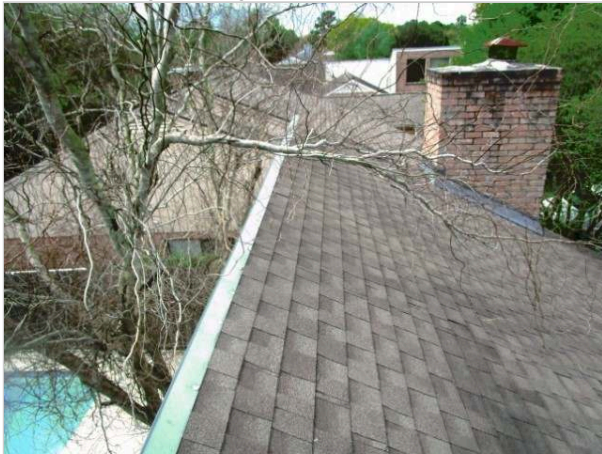
There were several areas around the roof in which tree limbs were in contact. It is recommended to cut tree limbs back to avoid contact with shingles to prevent shingle damage.

Tree limbs brushing shingles

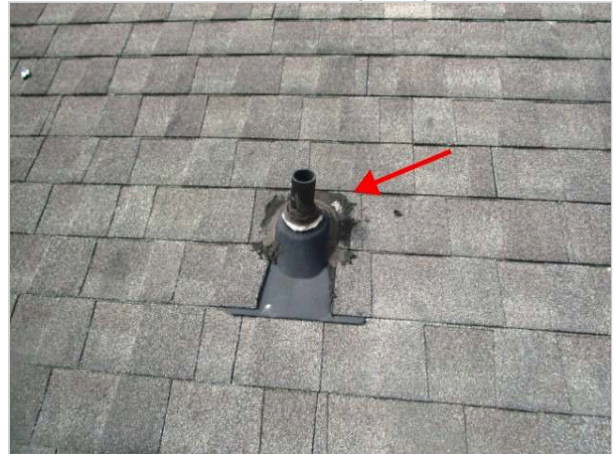
There appeared to be an excessive use of roofing tar around some of the plumbing vent boot jacks. Roofing tar over time tends to shrink and crack.

Roofing tar used around boot jacks

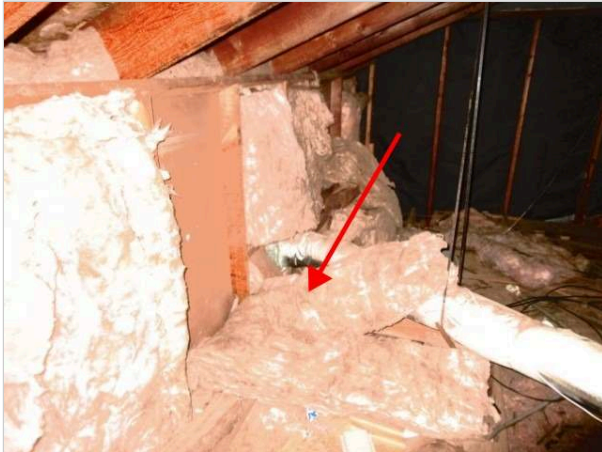
Fallen vertical insulation

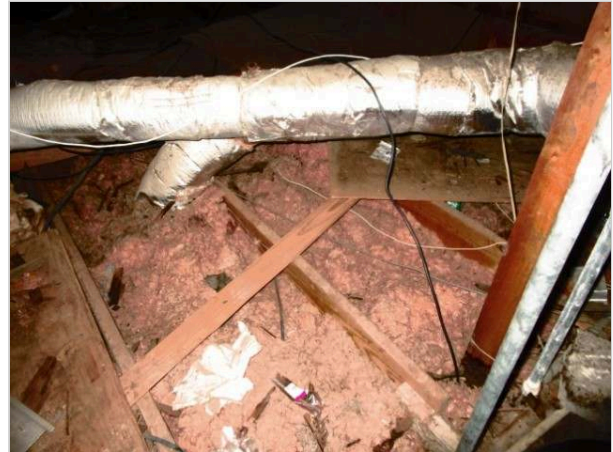
The blown insulation had been compressed by storage and age in some areas of the attic and did not appear to meet presently recommended energy requirements (R30).

Attic view - compressed blown insulation

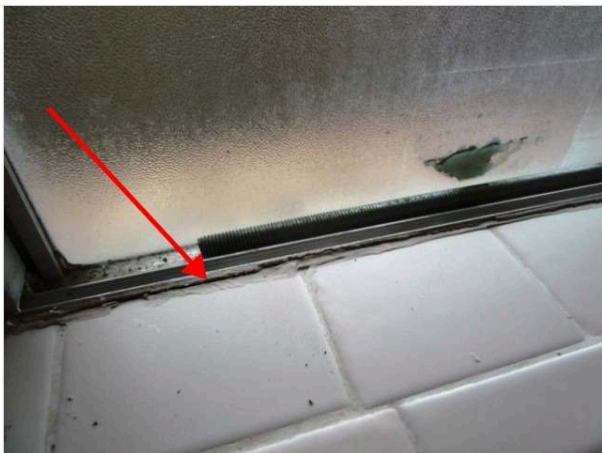
Gap between tile and window frame

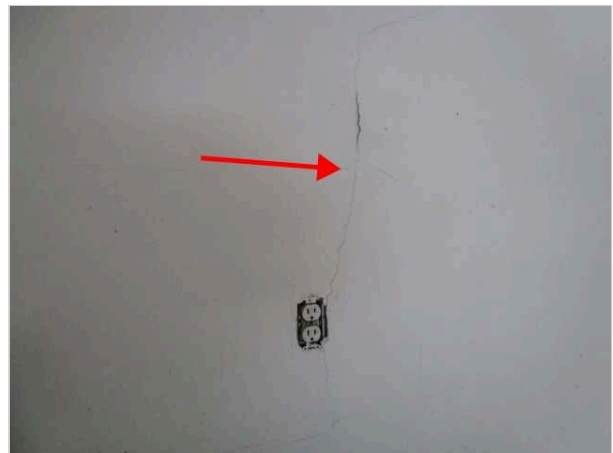
Crack - rear wall of the garage

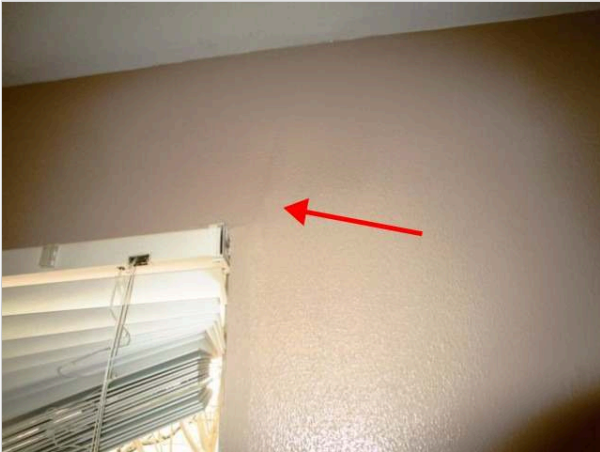
Shift in rear wall - middle bedroom

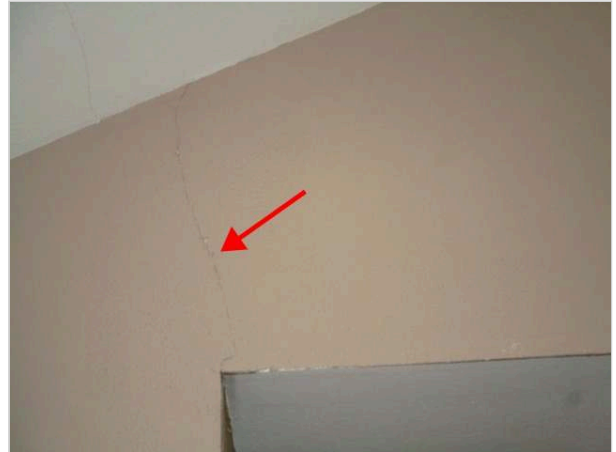
Crack in living room

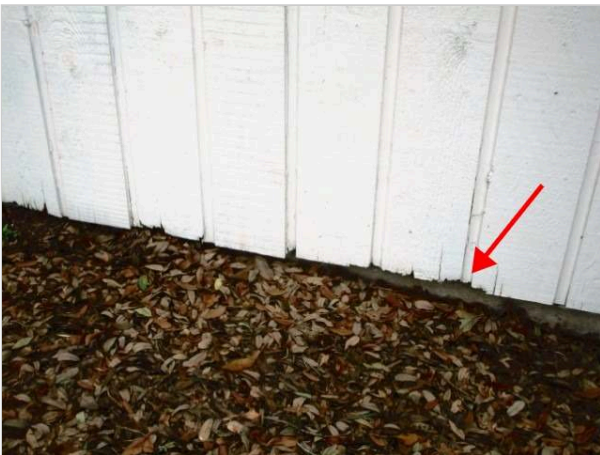
Wood damage - front wall of the garage

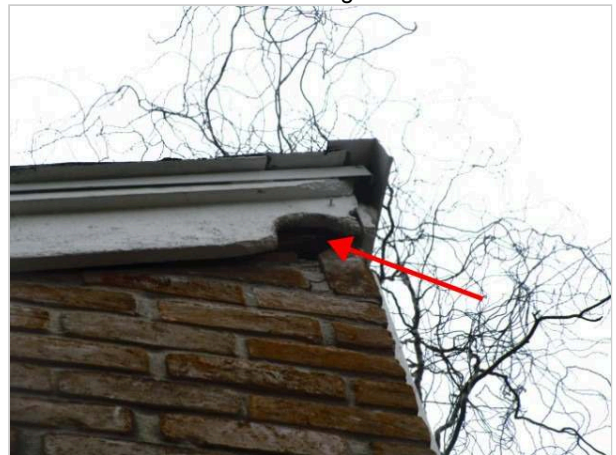
Hole in the brick wall - right side behind the chimney

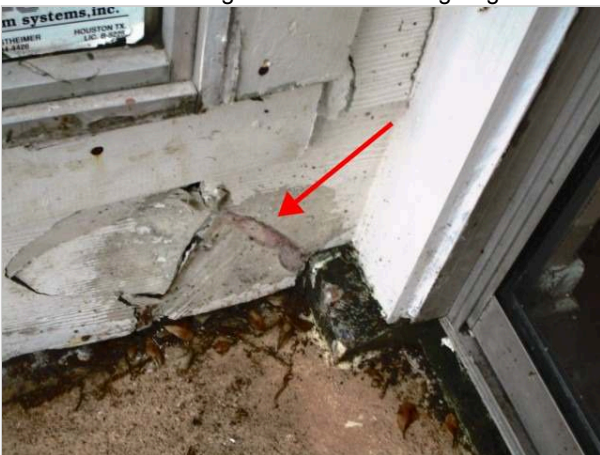
Damage - rear wall behind living room

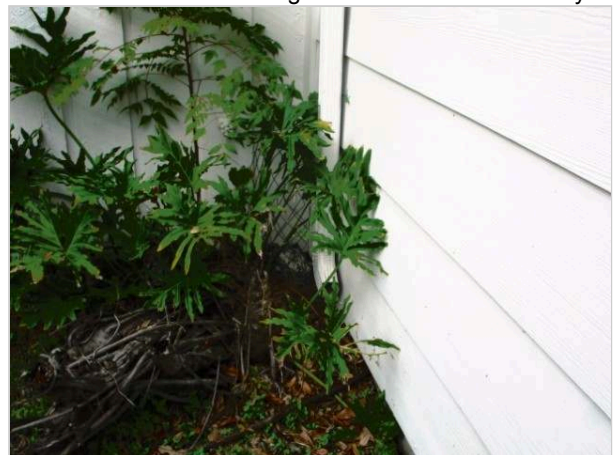
Vegetation in contact with walls

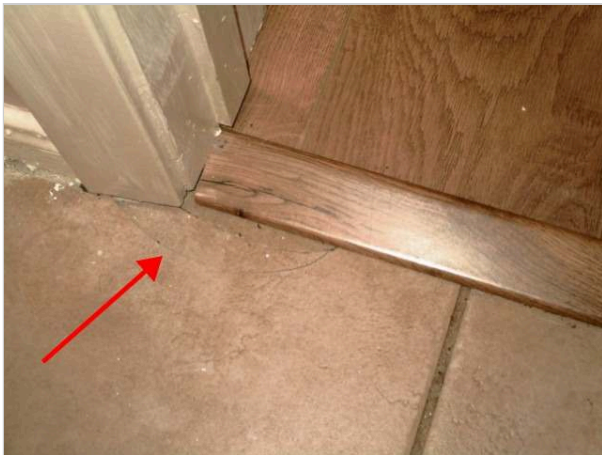
Crack in floor tile in master bathroom

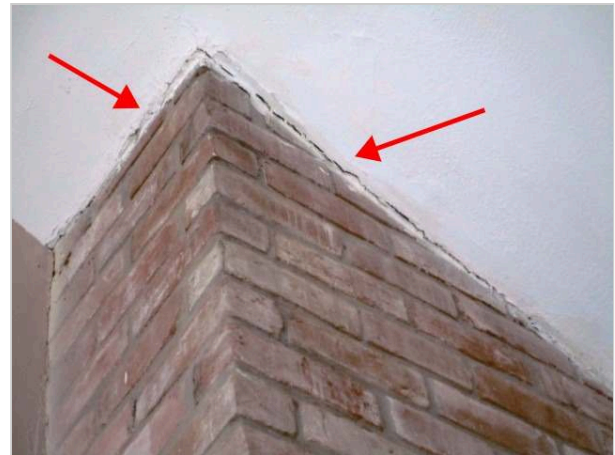
Crack at corner of ceiling and chimney

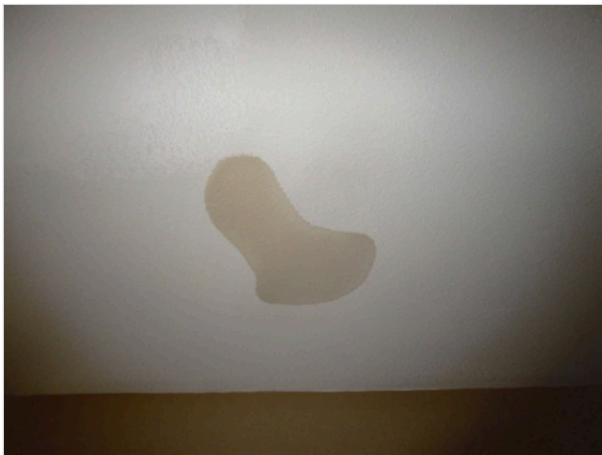
Indication of water penetration - back hallway ceiling

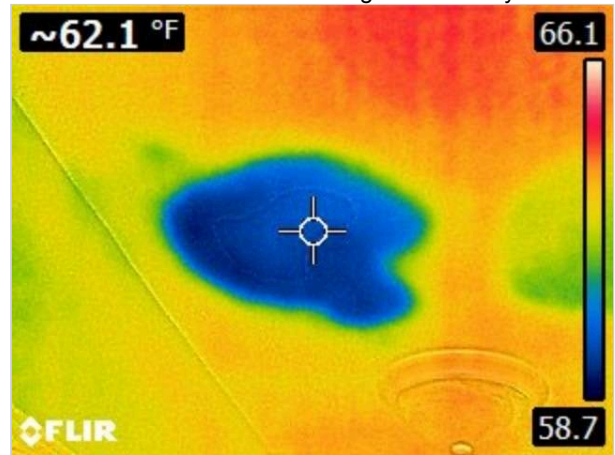
Thermal image of water penetration - indicating active moisture.

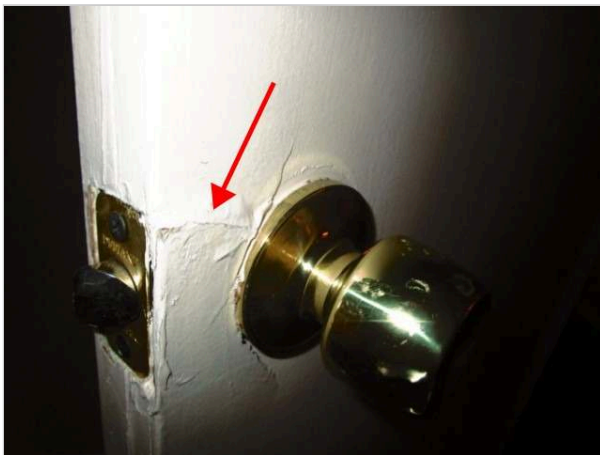
Damage - left bedroom door

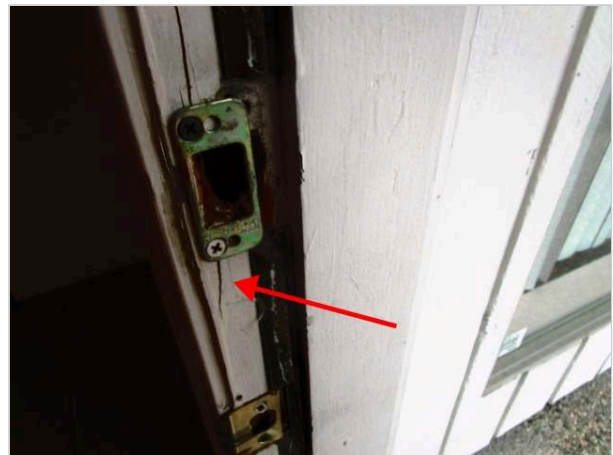
There was a crack in the frame around the strike plate to the exterior door from the kitchenette. Also, the weather stripping around the door was worn and leaving gaps.

Crack in door frame - exterior door from kitchenette

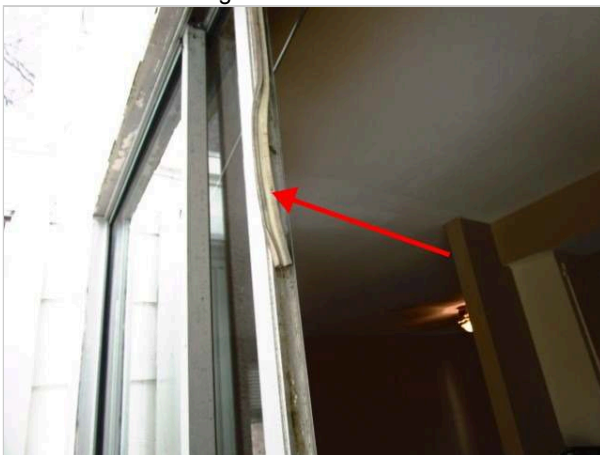
Weatherstripping - damaged / missing at the sliding glass door to right porch

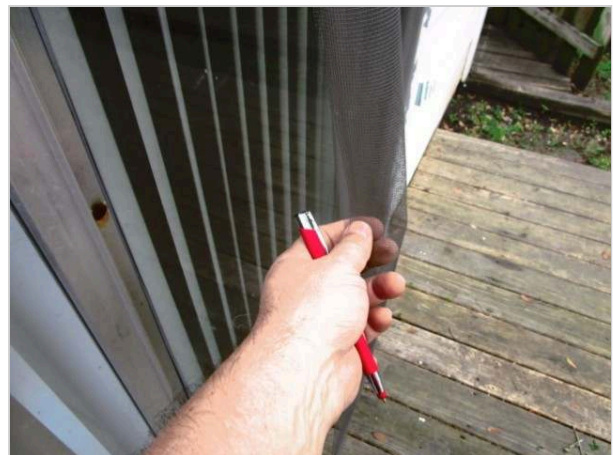
Damaged screen door - left bedroom sliding door

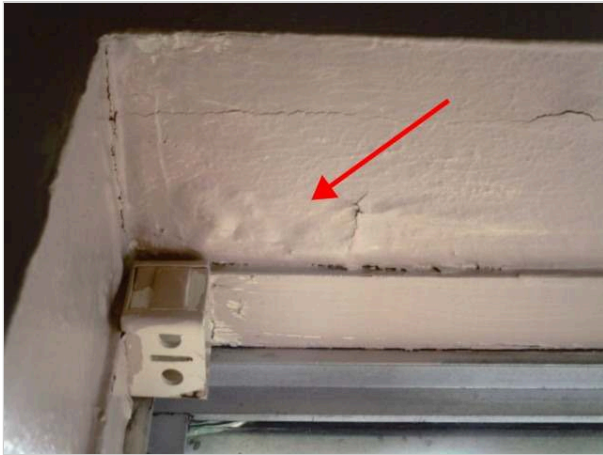
There was water penetration at the top of the center window in the living room.

Indication of water penetration - living room center window

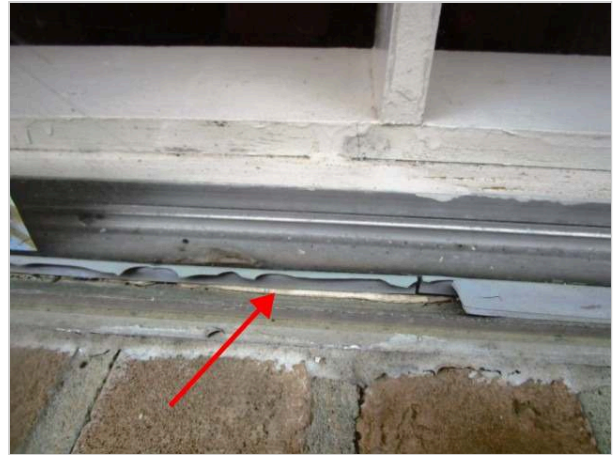
The windows in the kitchenette (behind the shelving) did not open. And, glazing bead on the outside surrounding the window was damaged.

Glazing bead damage - kitchenette window

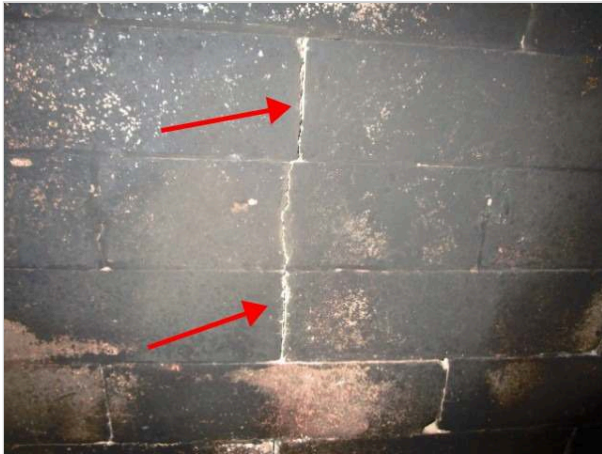
Crack in firebox

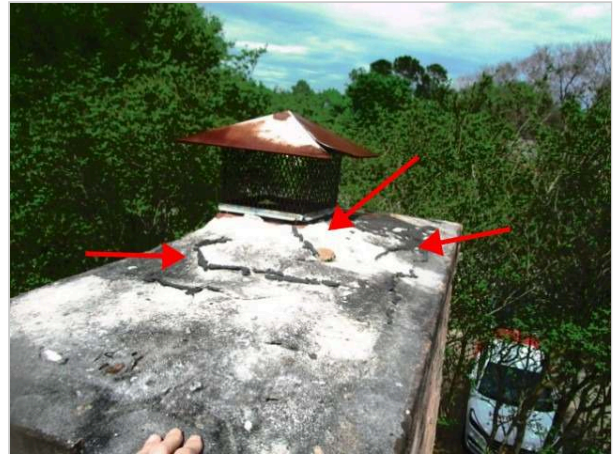
Indications of repair - Chimney crown

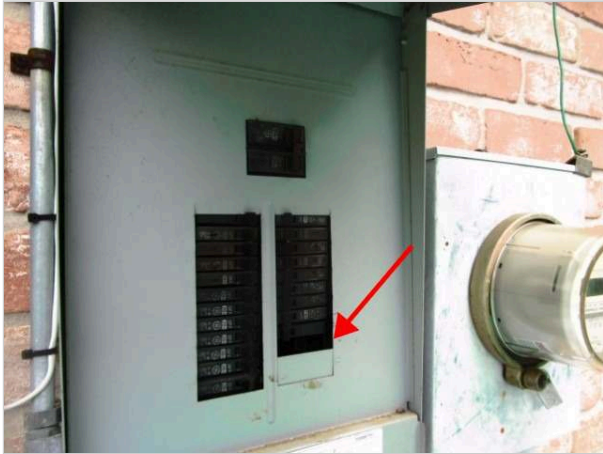
A knockout was missing.

Main Service Panel / Knockout missing

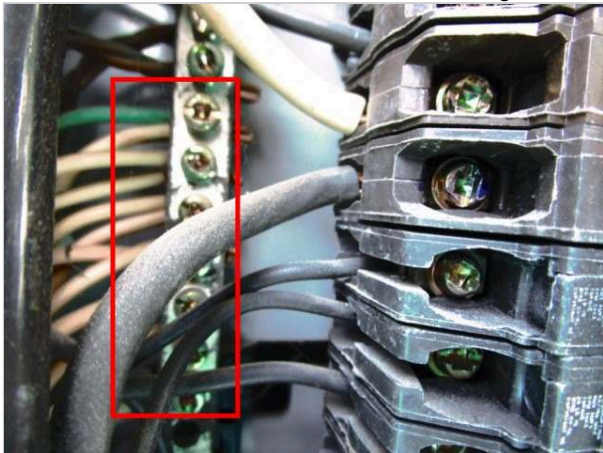
There were double lugged grounded conductors (neutrals).

Double lugged grounded conductors.

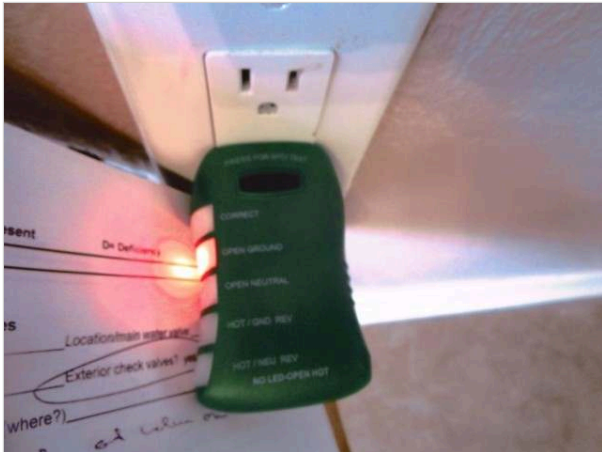
Indication of open ground - kitchenette rear wall

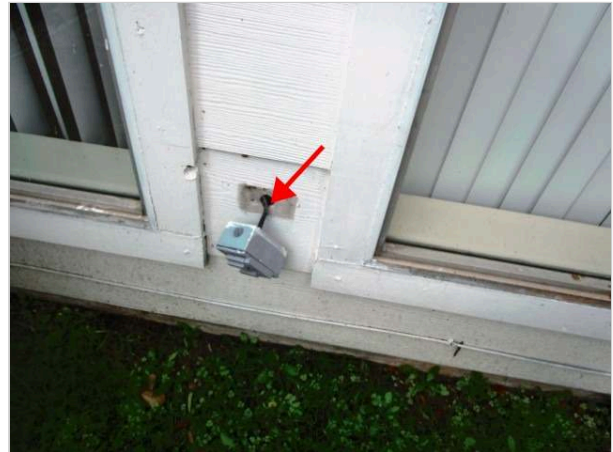
Exterior receptacle not mounted - behind living room

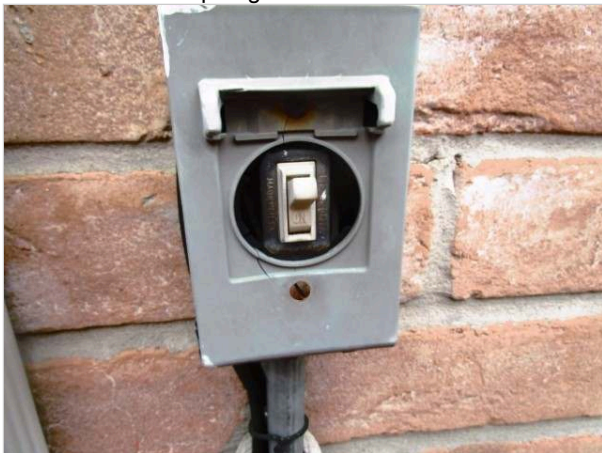
A switch on the exterior left wall by the pool equipment was missing a weather cover.

Exterior switch (left wall) missing weather cover

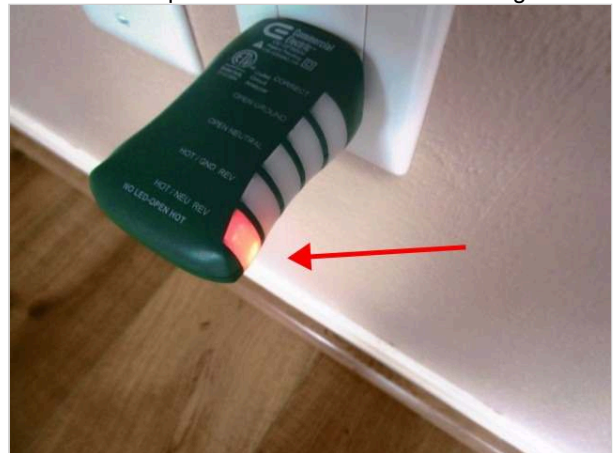
Indication of Reverse Polarity

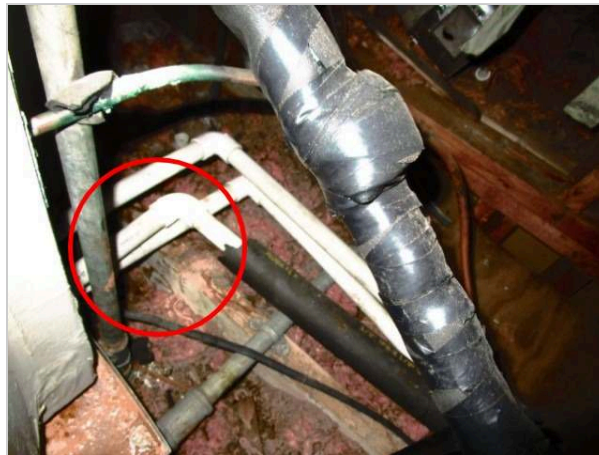
Needs insulation on the primary line at the evaporator coil

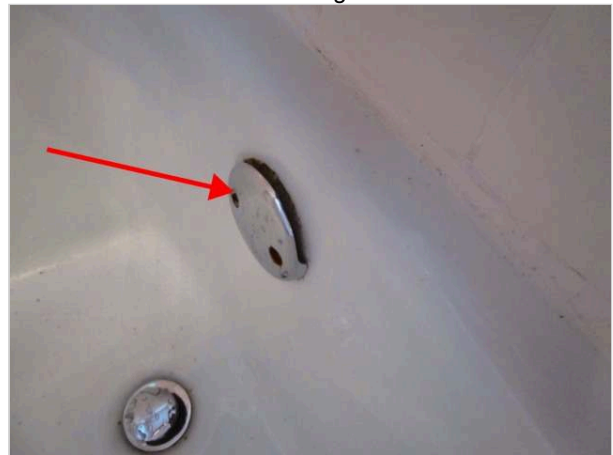
Overflow plate upside down

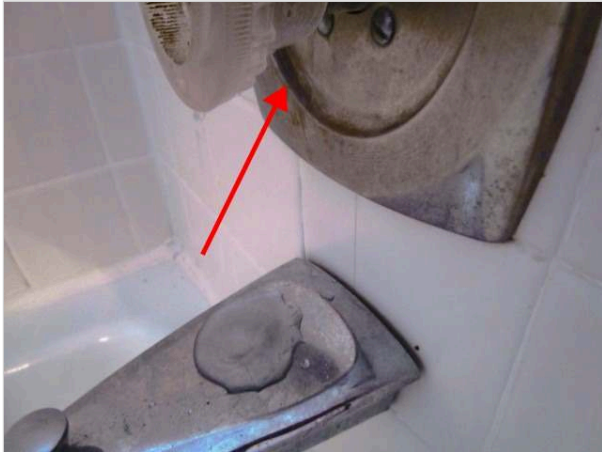
The control knob for the bathtub in the hallway bathroom was leaking.

Control knob leak - hallway bathroom bathtub

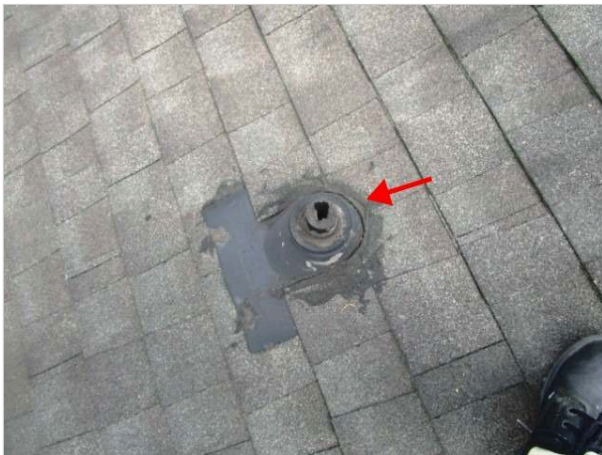
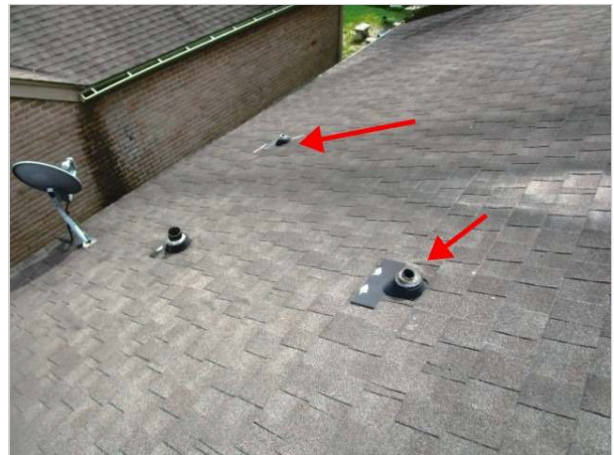
There were several vents that terminated on the roof that were shorter than 6" from the level of the roof.

Vent terminating less than 6" above the roof

Vents terminating less than 6" above the roof

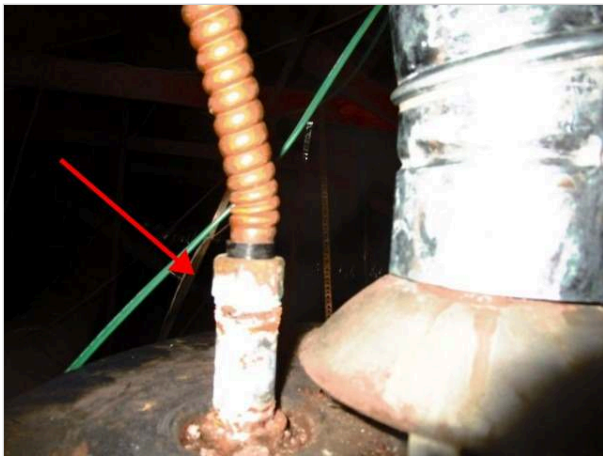
Both connections to the water heater were rusted / corroded.

Rusted / corroded connection

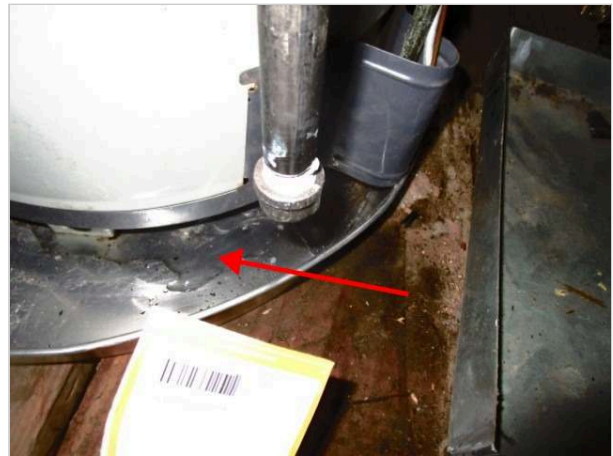
There was a small amount of water in the pan.

Water in the pan

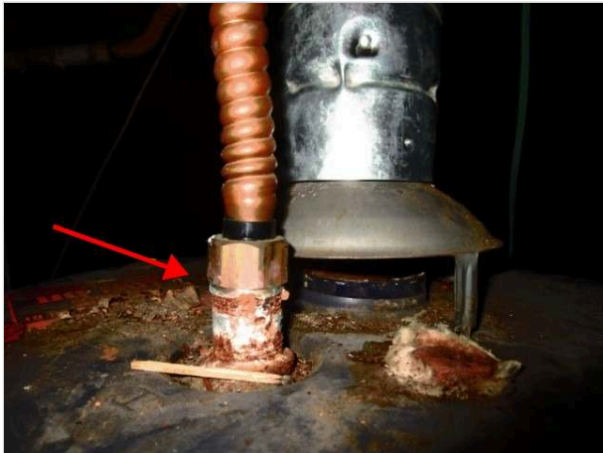
The burner chamber was rusted.

Rusted / corroded

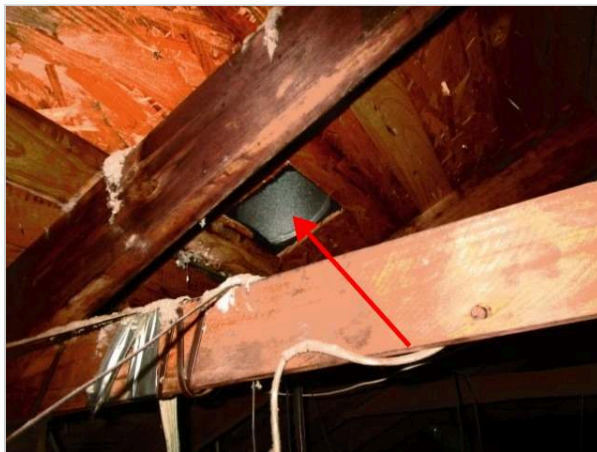
There is no exhaust pipe between the inlet area in the laundry room and the termination at the roof.

Dryer exhaust termination missing pipe

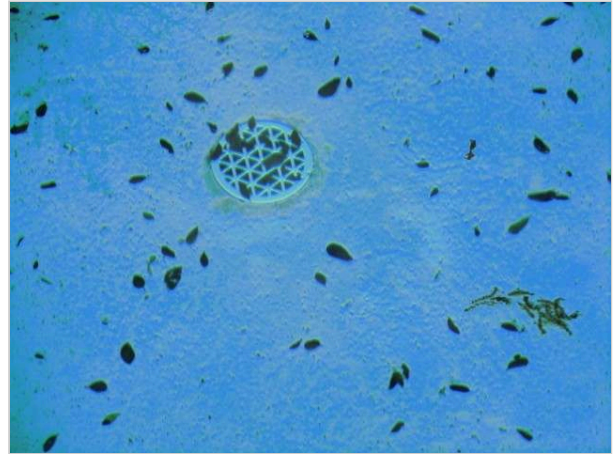
There was a single blockable main drain (potential entrapment hazard).

Single / Blockable drain

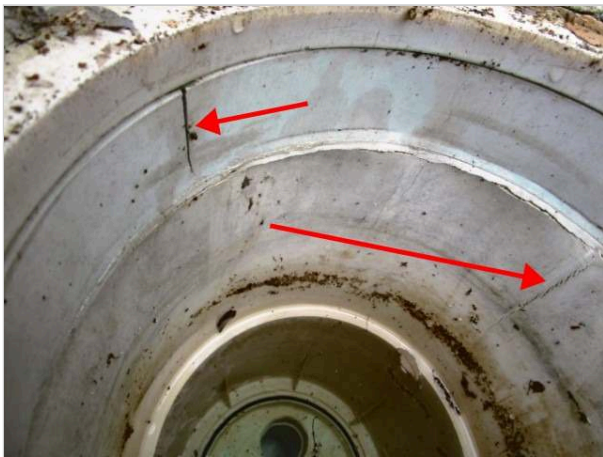
There were cracks in the skimmer wall.

Cracks in skimmer

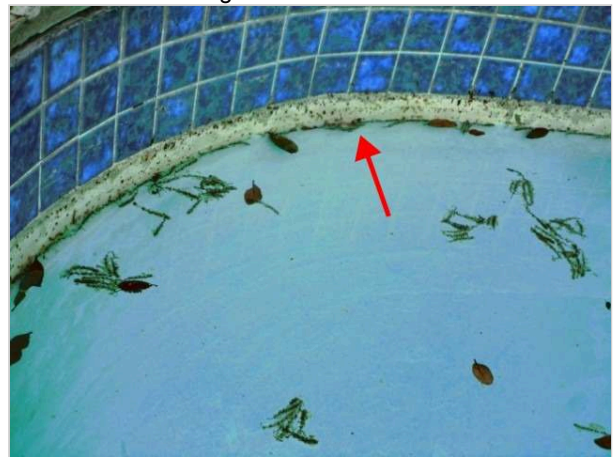
Water level too low

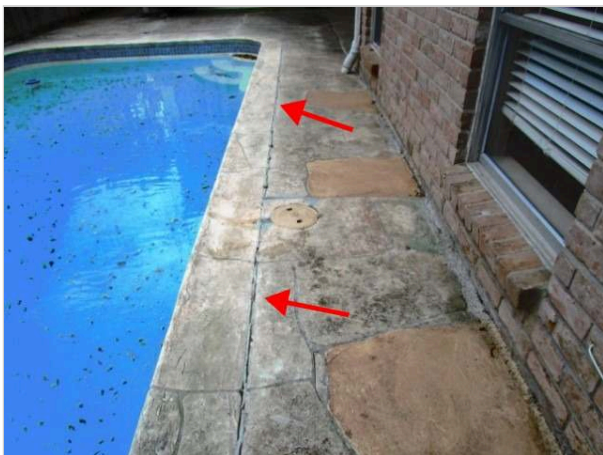
Cracked / shrunken sealant between coping and decking

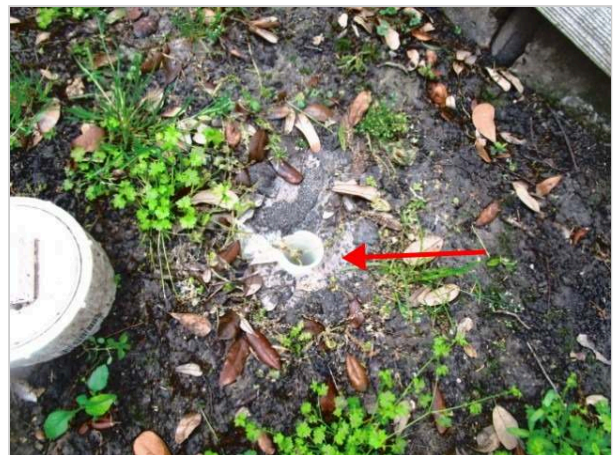
There was a pipe between the house rear wall and the sewer cleanout that was damaged (emitting water while pump was running).

Damage to pipe between pool and equipment

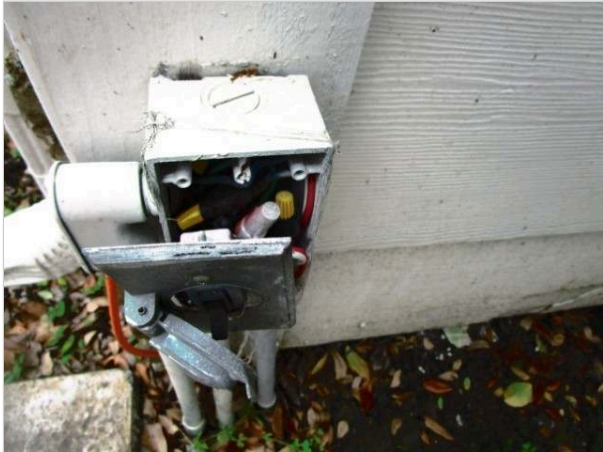
Front plate off light switch (splices exposed)

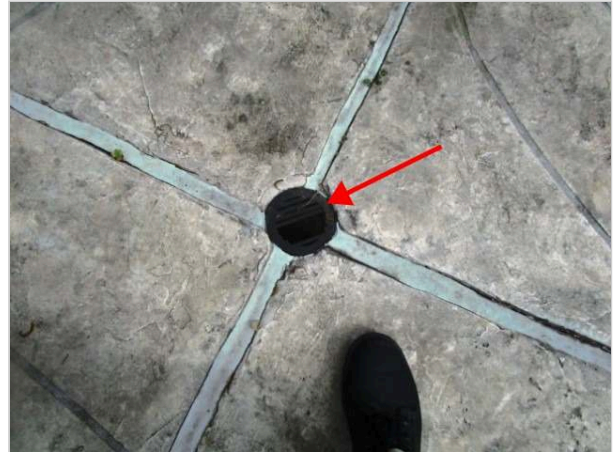
Drain grates were damaged at the drain between the house and the pool (between living room rear wall and pool). There appeared to be no drain channel between the left side of the pool and the house foundation.

Damaged grate
