FIG Services LLC d/b/a FOX INSPECTION GROUP
Property Inspection Report #190908SG-1108 Omar Street
8616 Daffodil St. Houston, TX 77063

PROPERTY INSPECTION REPORT

Concerning: 1108 Omar Street, Houston, TX 77009
(Address of Inspected Property)

By: Steven Gibson, RI #20994 09/08/2019
(Name and License Number of Inspector) (Date)

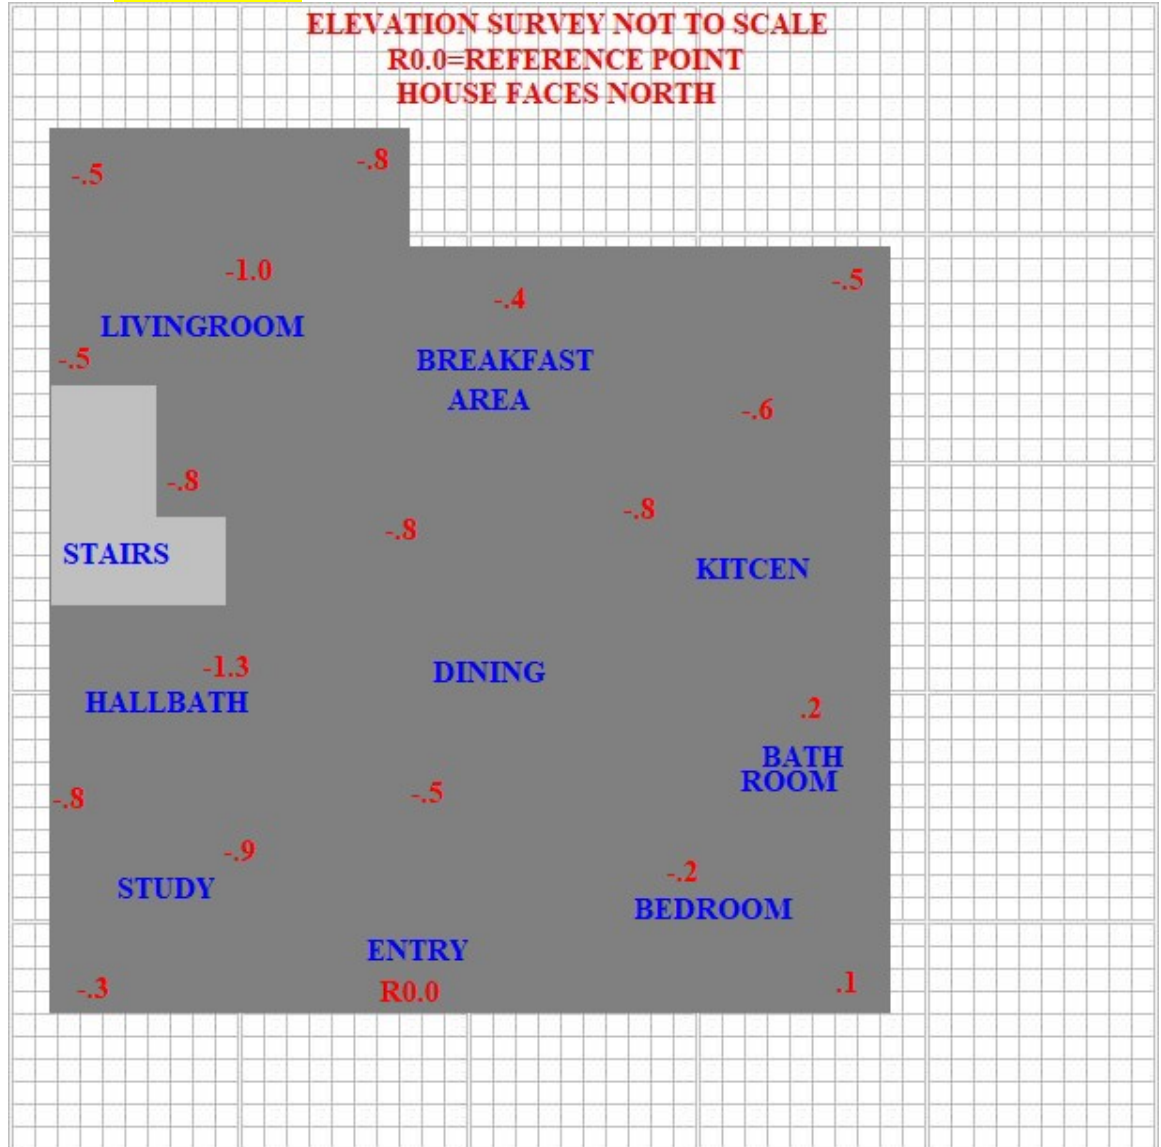
A foundation elevation survey was conducted during the inspection. The floorplan below represents data gathered using a Zip Level or similar instrument and adjusting for floor covering height differences. i.e. differences between tile, carpet and wood flooring. Measurements are listed to the nearest 1/10th of an inch. Greatest variance was **1.5 INCHES**

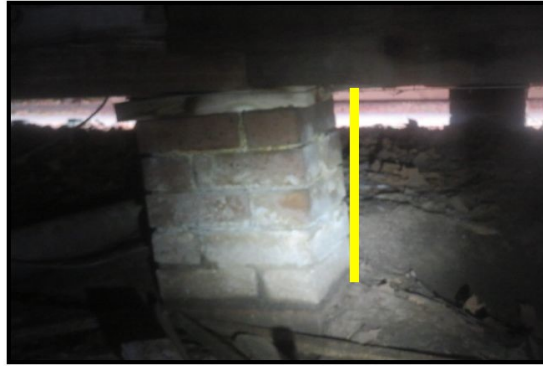
One or more piers not level/leaning under house.

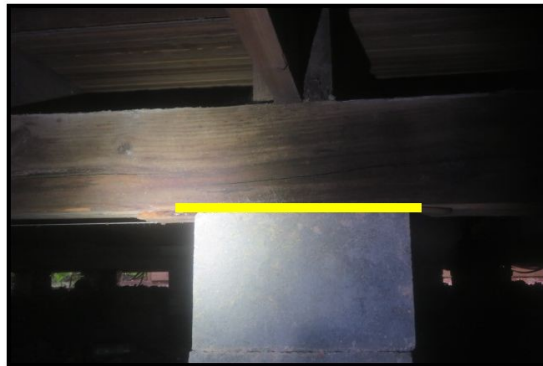
Missing metal cap flashing/termite shields at top of one or more piers.

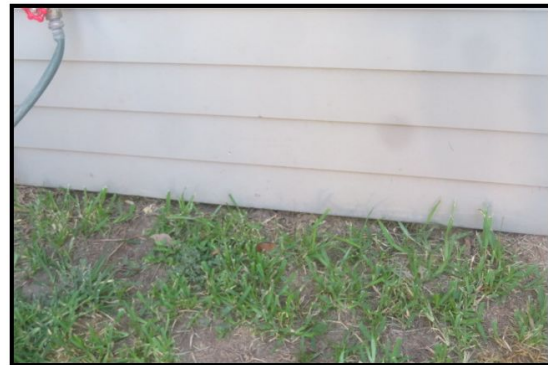
Soil level too high around areas with wood siding. Code and common industry practice requires a clearance of 6-8 inches from bottom of wood veneer to soil. High soil level near wood siding promotes water/termite penetration and wood rot.

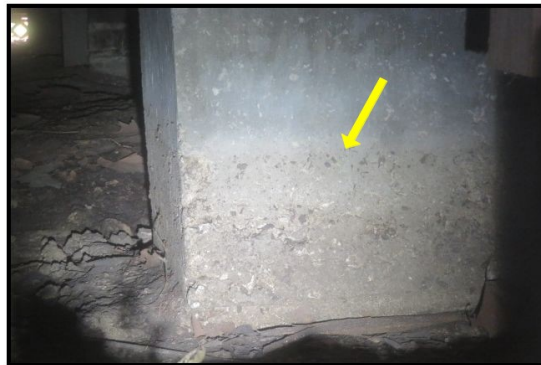
Evidence (water staining) below house indicates history of substantial standing water below house during rainy season, This condition is detrimental to adequate foundation performance of pier and beam foundation systems and should be corrected thru proper site drainage / grading.

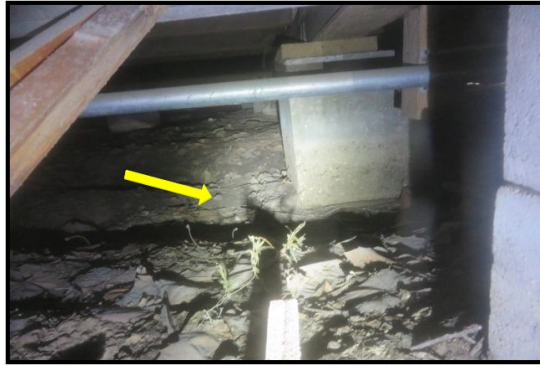
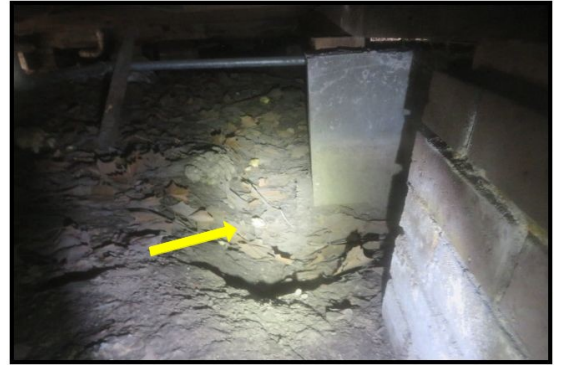
Low areas observed under house around one or more piers,

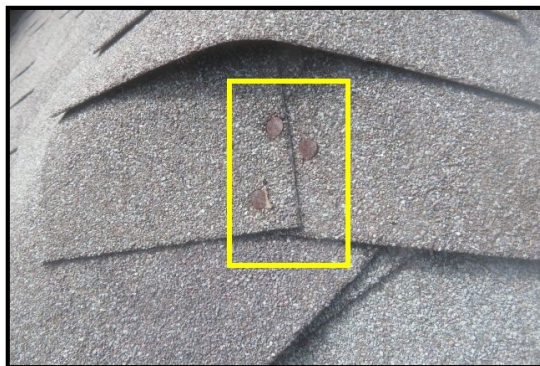
Exposed staples / nail heads / fasteners observed on roof are not properly sealed. Water entry possible.

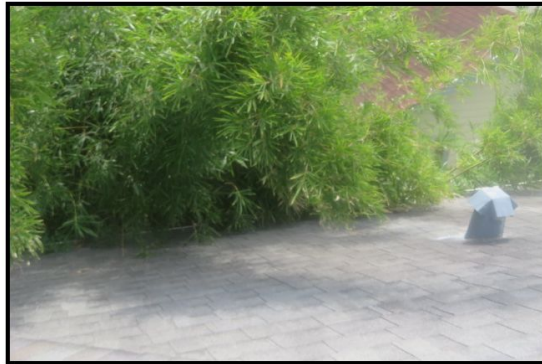
Tree limbs in contact with roof can/ will damage the roof.

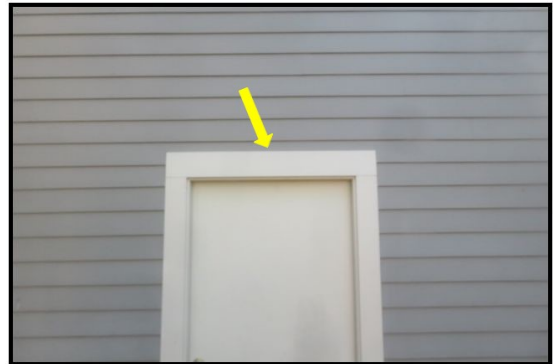
Head flashing missing over some windows / doors. Head flashing helps prevent water penetration. Without head flashing windows/ sealing must be maintained as the only defense against water penetration.

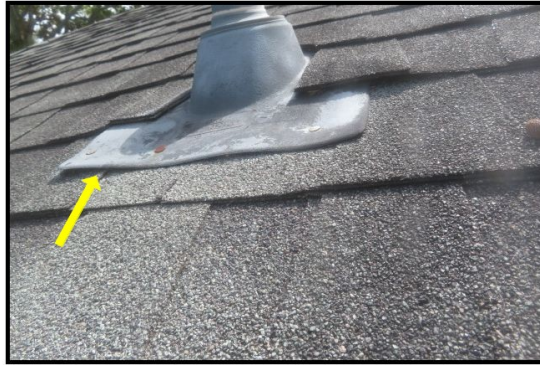
Lower side of drain waste vent flashing is not sealed down, wind driven rains can cause water penetration.

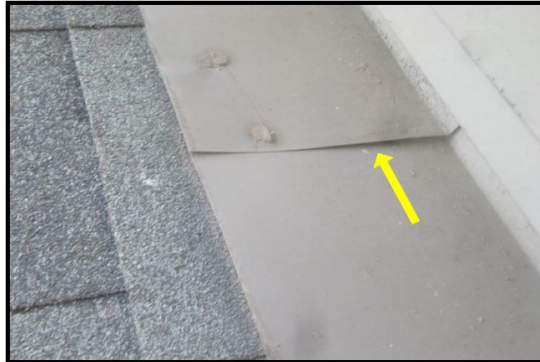
Flashing not properly sealed at seam.

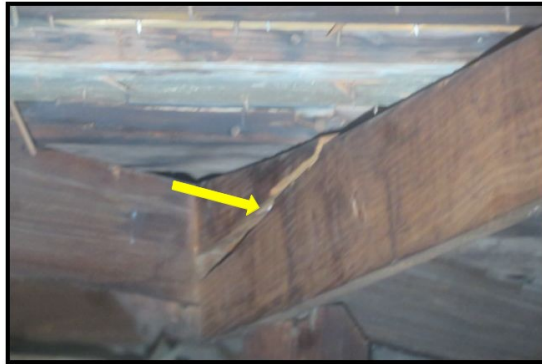
Cracked rafter(s);(Behind first floor HVAC unit.)

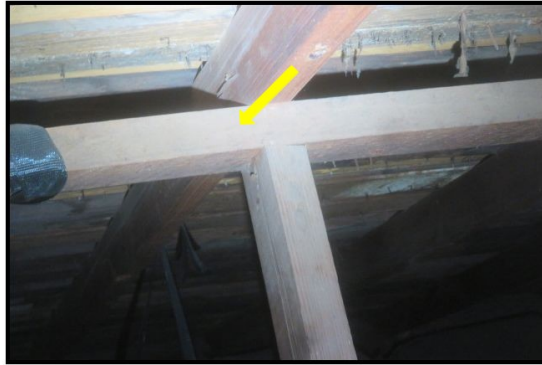
Observed purlin(s) {roof bracing} of improper / inadequate size and/or not installed on strength axis in attic, needs repair.

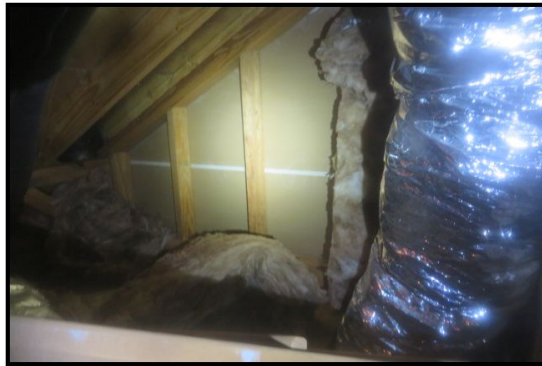
Vertical sections of insulation was observed to be missing and/or displaced on interior walls in attic.

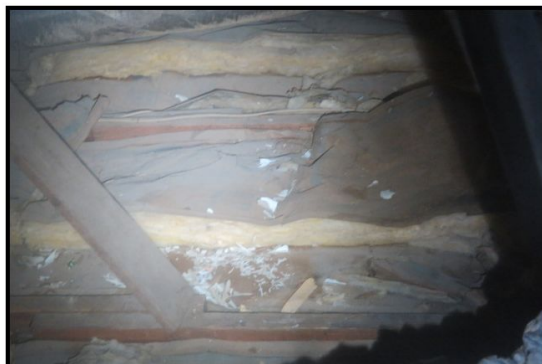
Insulation improperly installed. Vapor barrier not on “warm on winter” side.

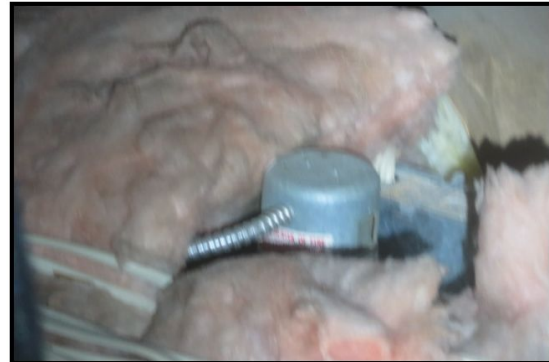
Potlights in insulated ceilings

Ensure insulation is maintained a minimum of 3 inches and wood a minimum of 1 inch from around all recessed lights to reduce possible fire hazard.

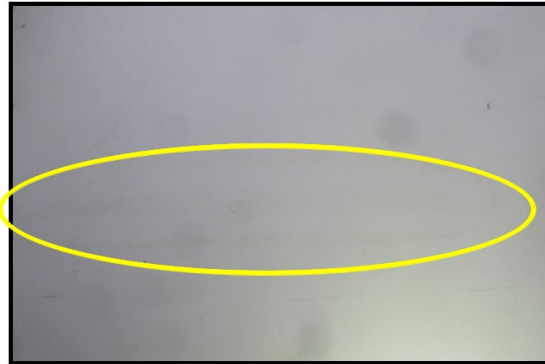
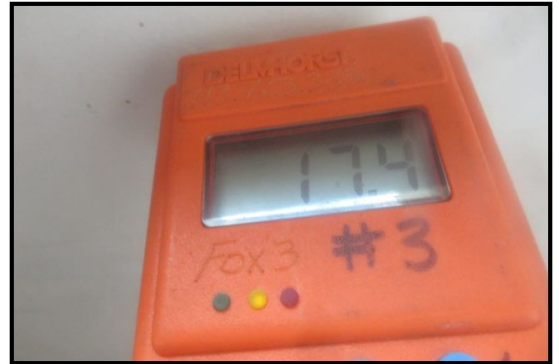
Moisture meter registers water stains as active; (Garage under window.)

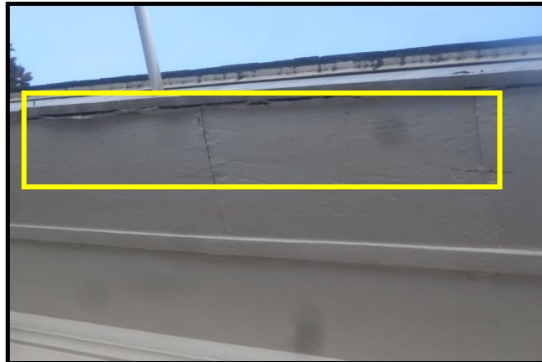
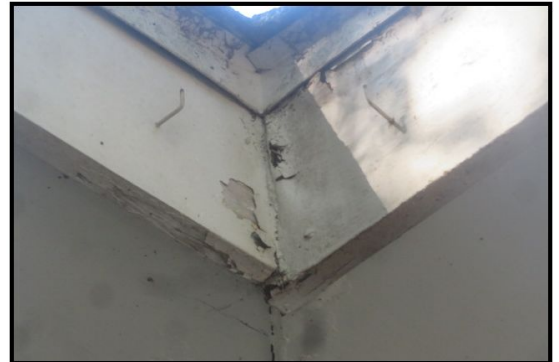
Wood rot or damage around exterior in fascia, soffit

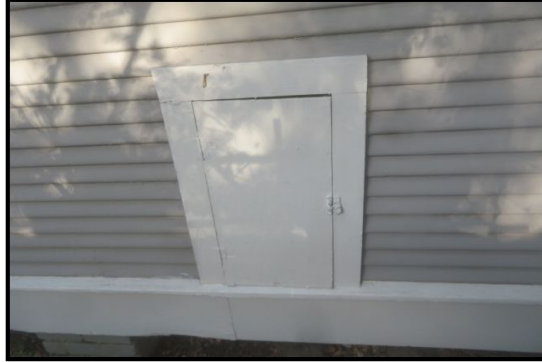
Bath tub access panel/door observed on east exterior of the house. Potential rodent and or water entry.

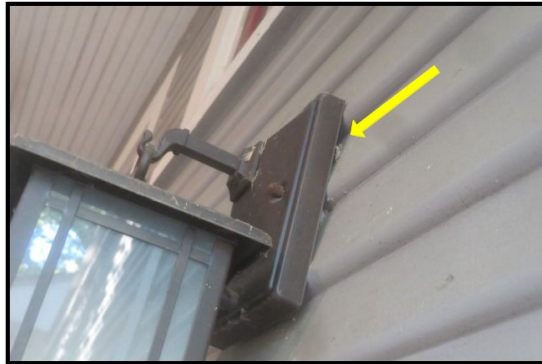
Need sealing / caulking around all holes and exterior siding penetrations on top and both sides, (leave bottom open) to prevent water entry. Including but not limited to dryer, bath and range top vents, light fixtures, etc.

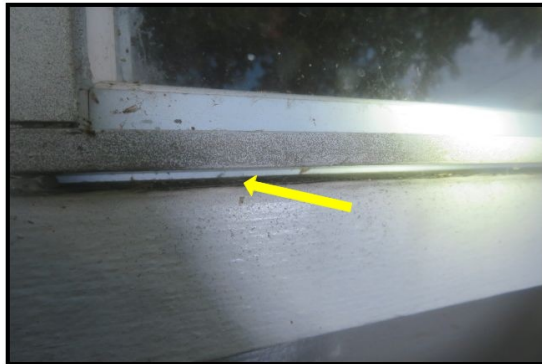
Caulking deficient around one or more windows, will allow water penetration during heavy / wind driven rains.

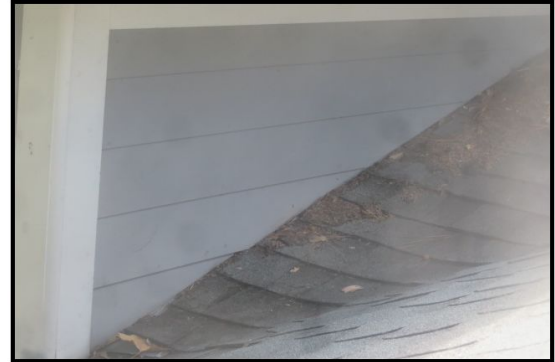
Most wood siding installation requirements specifically state “Leave a 2 inch clearance between roofing and bottom edge of siding to prevent wood rot.” Did not observe the normal 2” clearance from roof surface.

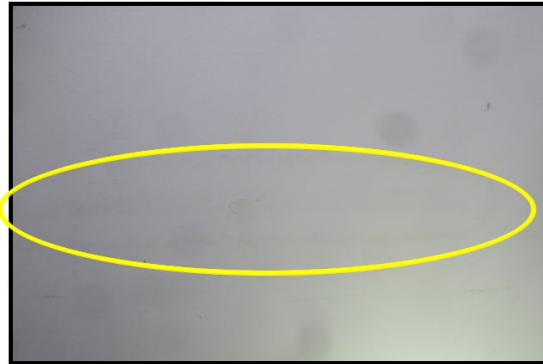
Water penetration observed at the following location(s): Water staining observed in garage under window.

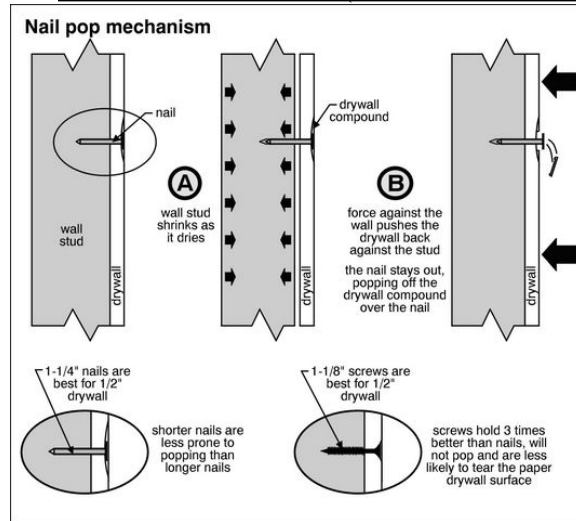
Nail heads were observed to be pushing through the interior finish in one or more locations of the home. (Kitchen over back window, Over stairway.)

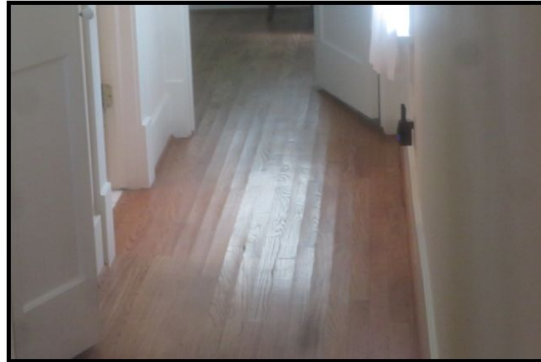
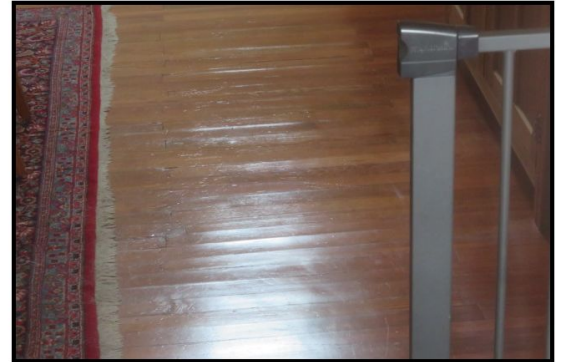
Water damaged wood flooring. Observed cupping / unevenness of wood flooring, indication of past or present high moisture conditions below wood flooring.

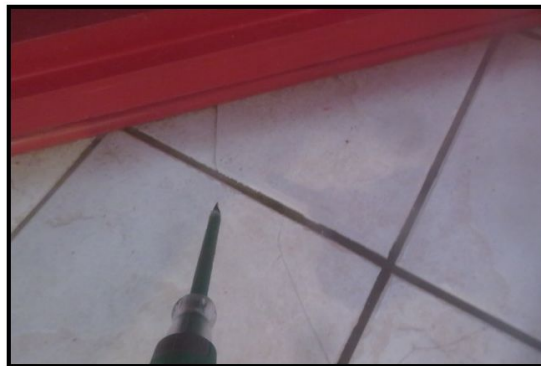
Cracks and/or loose floor tile observed in, (Kitchen)

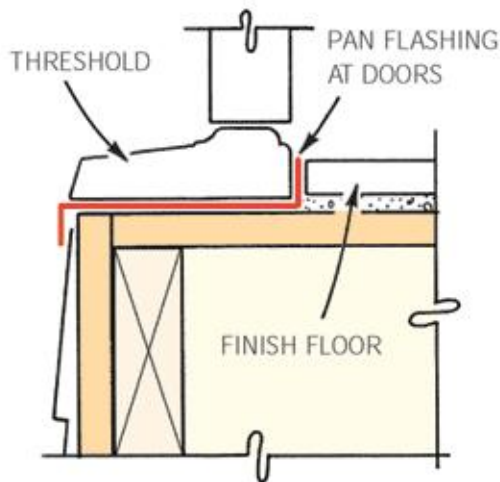
Did not observe door pan flashing at exterior door location(s). Properly installed door pan flashing helps prevent wind driven rain / water penetration from damaging interior building components. High risk areas include exterior doors with little to no roof or balcony overhang protection from the elements. It is not uncommon for Fox Inspection Group inspectors to observe evidence of water penetration (water damaged wood flooring or water stained carpet tack strip) at second floor balcony doors. For additional information you may watch a 5 minute video on flashing where the first few minutes shows door pan flashing by clicking this link [YouTube - Class Exterior Door Pan Flashing](#)

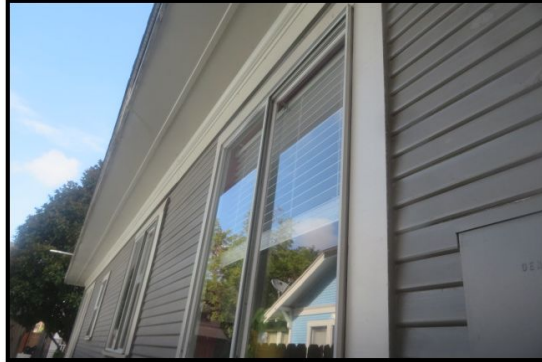
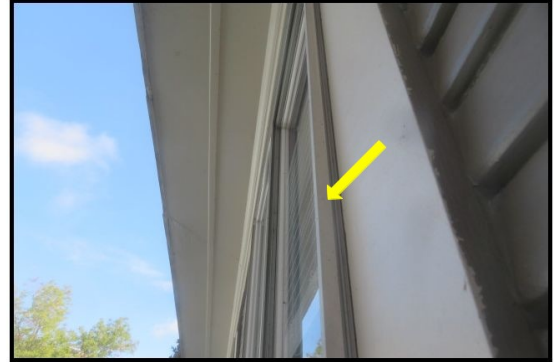
Windows on west side of house do not appear to be properly installed/seated into window frame.

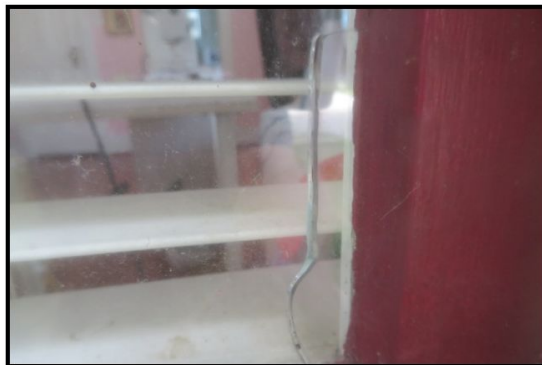
One or more windows had cracked / broken glass pane(s). (First floor front bedroom)

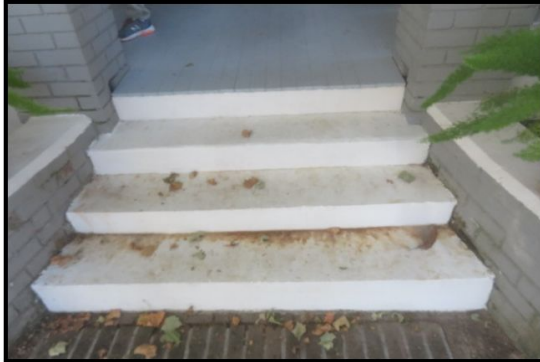
Stair steps having 4 or more risers should have a handrail for safety.

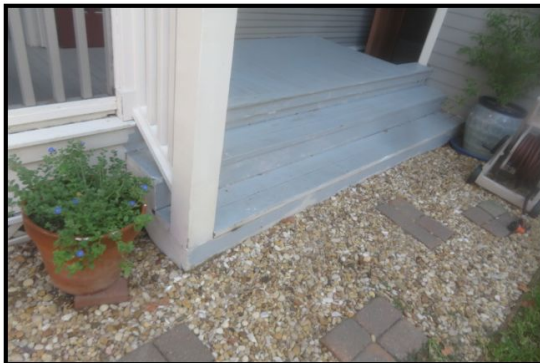
Earth wood contact in some areas, conducive condition to termite activity and wood rot.

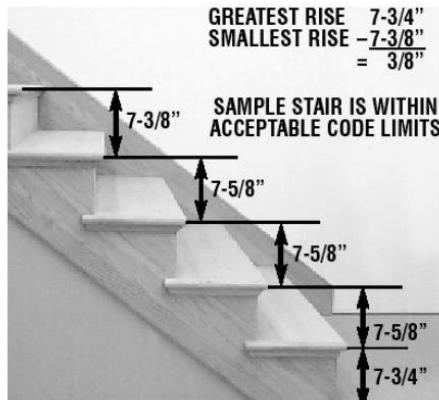
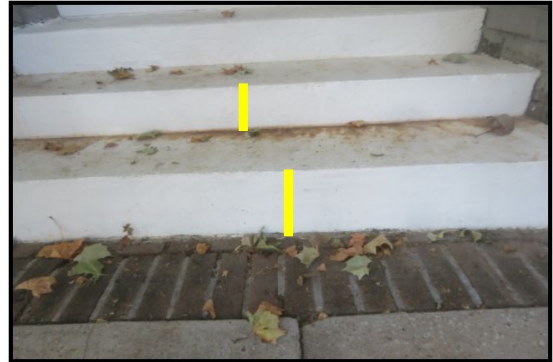
Stairway has tripping hazard, Risers are not same height along the entire height of steps. Stairway does not comply with current industry standard, (code). CABO 314.2 & UBC 1006.3 requires "The greatest riser height within any flight of stairs shall not exceed the smallest by more than 3/8 inch."

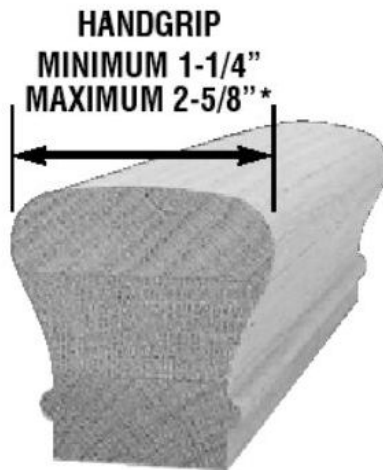
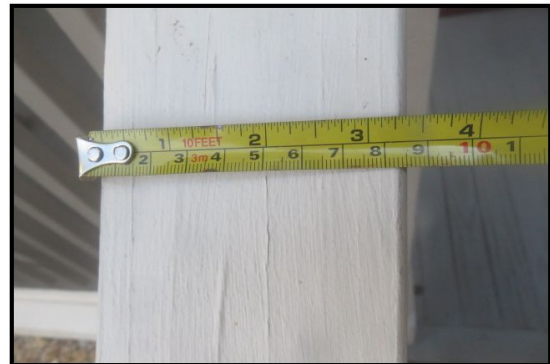
Section of gripable (proper size) handrail missing; Reference IRC R315.2 "the handgrip portion of handrails shall have a circular cross section of 1 1/4 inches minimum to 2 5/8 inches maximum."

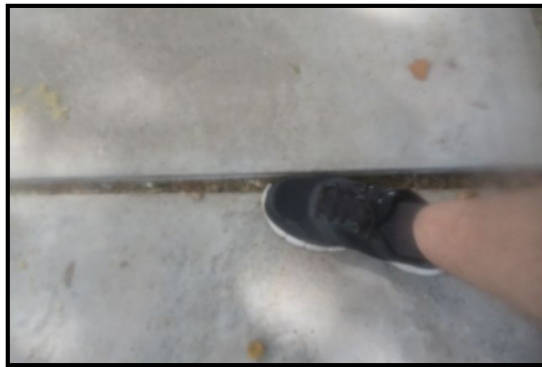
Tripping Hazard(s), walks and/or driveways are uneven.

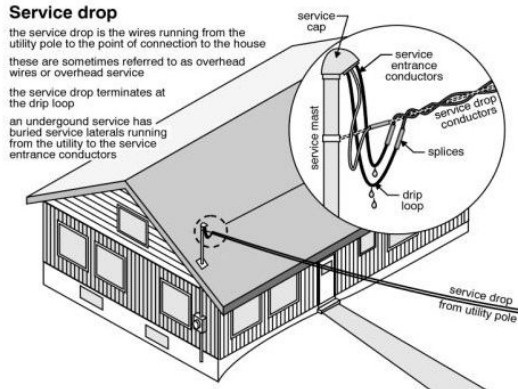
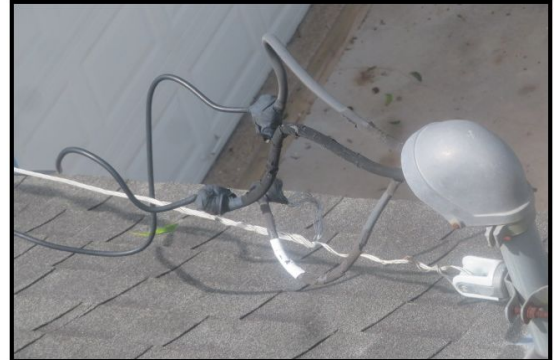
Drip loop of electrical service drop is not proper, rain water can run down conductors into weather head.

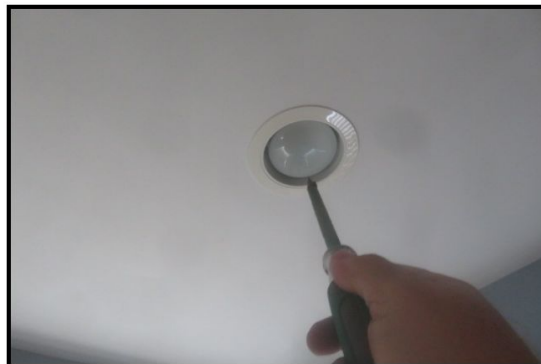
Excess noise and vibration observed at master bedroom light fixture, possibly from HVAC unit above.

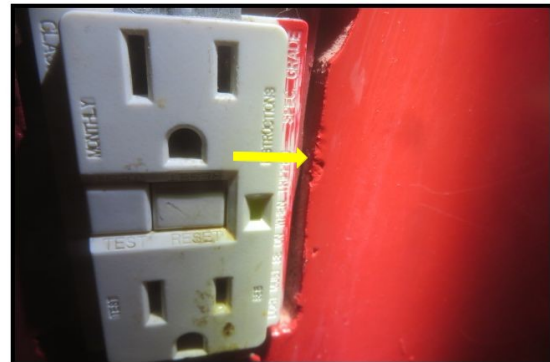
Outlets / switches / devices installed in / through combustable material were not flush mounted as required by code, space exists between face plate and edge of electrical junction box. Missing required spacer (spark ring) on following outlet(s): (Kitchen island) Reference NEC 370-20 & IRC E3806.5. In walls constructed of wood or other combustable material, cabinets (outlet & switch boxes) shall be flush with the finished surface or shall project there-from.

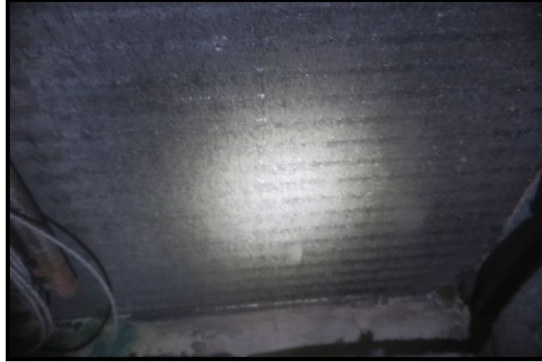
Coils are dirty, needs cleaning. Dirty coils reduce air flow thru the system and create high head pressures at the compressor, thereby unduly stressing and reducing life span of system components.

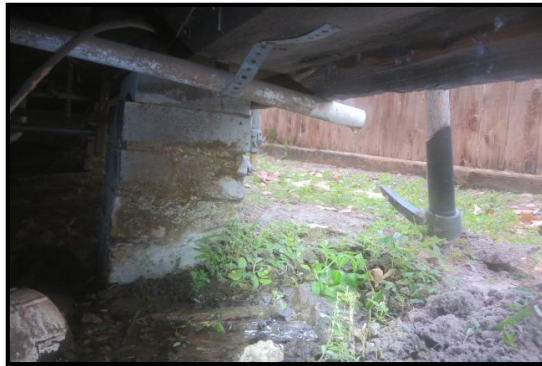
Primary drain line should not be allowed to discharge water right next to foundation.

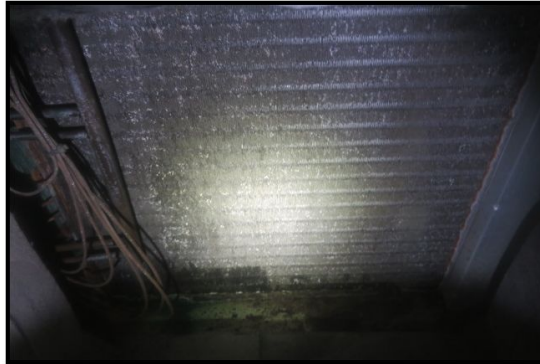
Coils are dirty, needs cleaning. Dirty coils reduce air flow thru the system and create high head pressures at the compressor, thereby unduly stressing and reducing life span of system components.

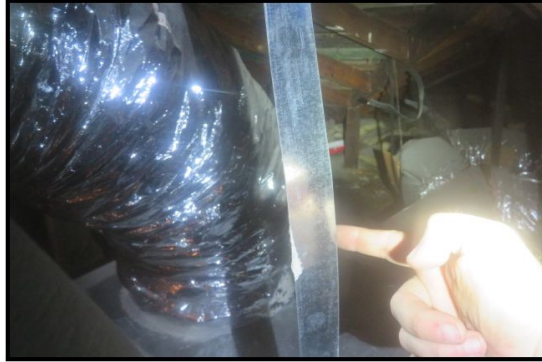
Metal straps that support the AC/Heating unit are required to be taped to help technicians from getting cut on the sharp sheet metal.

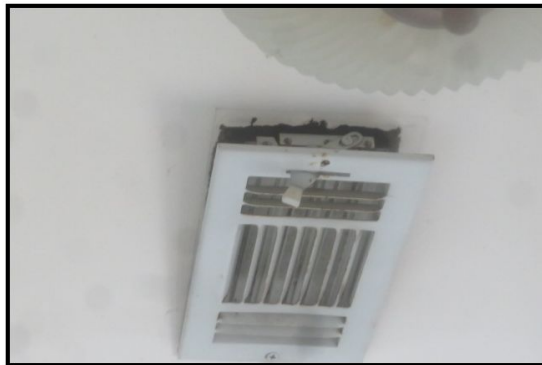
Register is loose, damaged, and/or missing; (First floor bedroom bath)

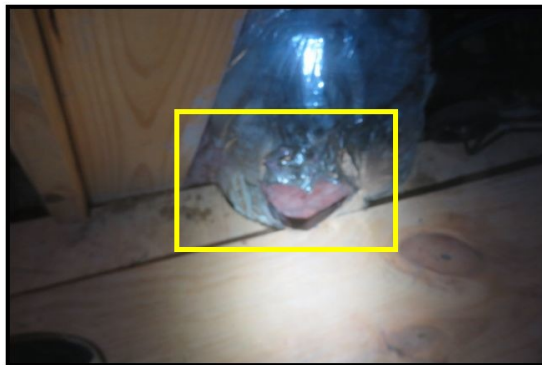
Some insulation missing and/or damaged on ducts in attic.

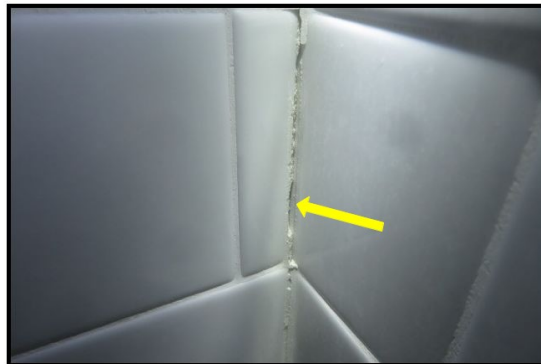
Grout / caulking needed at vertical tile corners, cracks in tile and/or mortar between tiles, and where tile meets tub to prevent water entry behind wall.

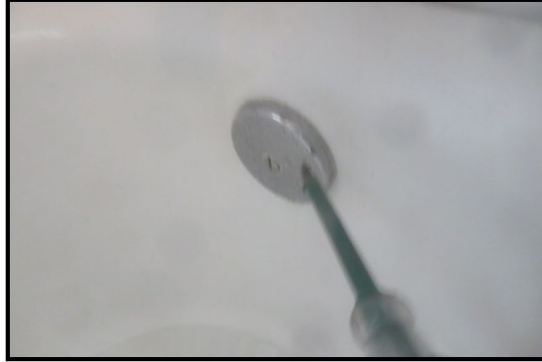
The overflow cover is loose. The overflow cover holds the overflow drain and gasket tight to the back of the tub. When it's loose, this joint can leak if the water level rises to the overflow. Check condition of gasket and tighten cover. (First floor hall bath)

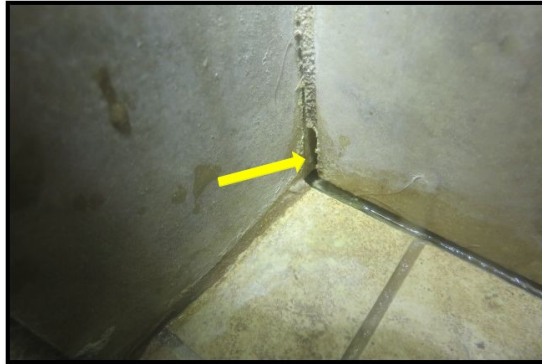
Grout / caulking needed at vertical tile corners, cracks in tile and/or mortar between tiles, to prevent water entry behind wall.

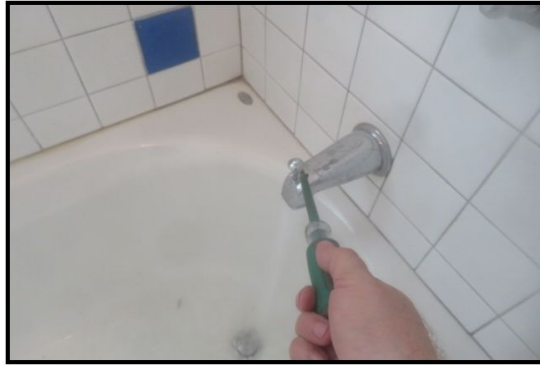
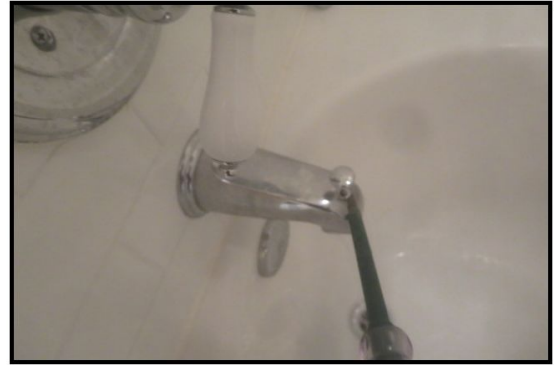
Shower diverter valve is not fully functional, does not direct all water to shower head during operation, (Hall bath, Frist floor bedroom bath, First floor hall bath)

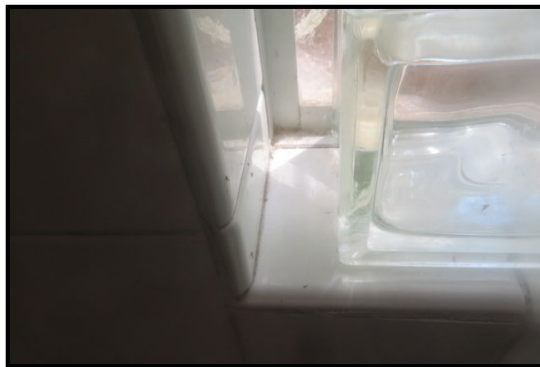
Observed level or improper sloping of shower window sill tile, sill should slope towards interior of shower not back towards window frame. (First floor hall bath)

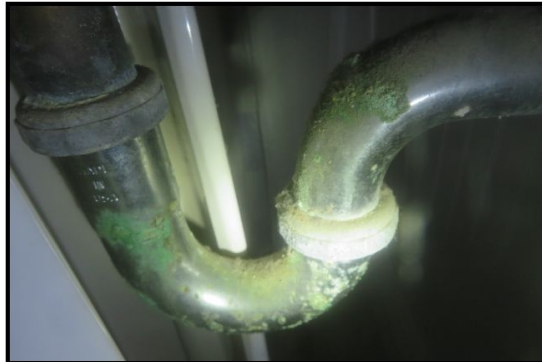
Corrosion noted at "J" trap and/or drain lines below one or more sinks. (First floor hall bath)

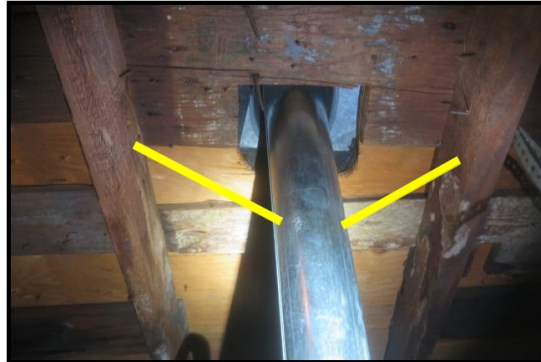
Vent pipe(s) is (are) not properly secured (strapped) in place.

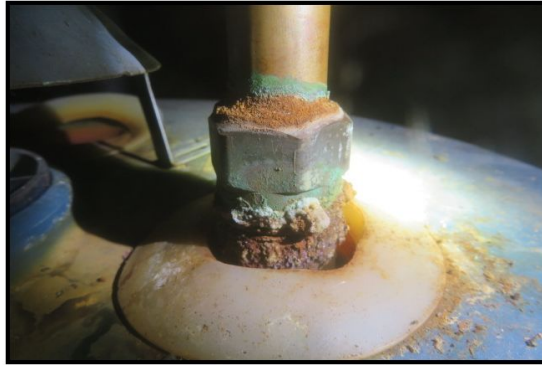
Corrosion observed at shut off valve and/or connections on top of water heater.

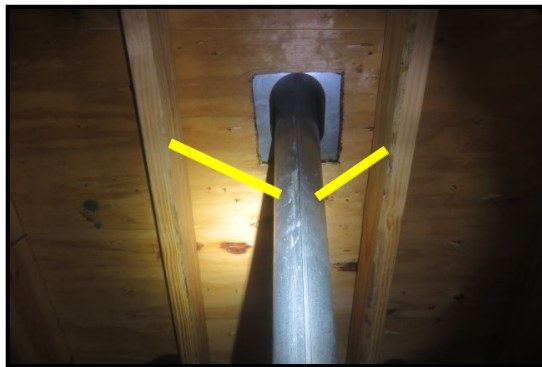
Vent pipe(s) is (are) not properly secured (strapped) in place.

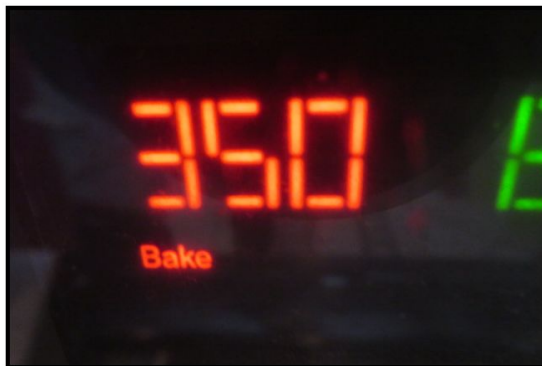
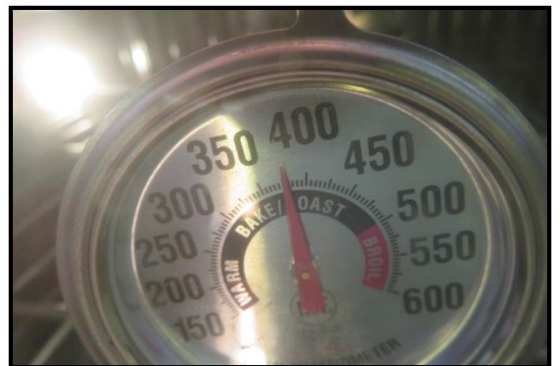
Thermostat / knob needs adjustment / replacement, when set at 350 degrees oven heats to approximately 375 degrees.
