Inspection Report

Property Address:
8151 Aleppo Pine Ln
Cypress TX 77433

Sunbelt Inspections

Date: 7/2/2022	Time: 01:00:00 PM	Report ID: 070222RC5
Property: 8151 Aleppo Pine Ln Cypress TX 77433	Customer: Han Nguyen	Real Estate Professional: Jeffrey Bottoms BHGRE Gary Greene - Cypress

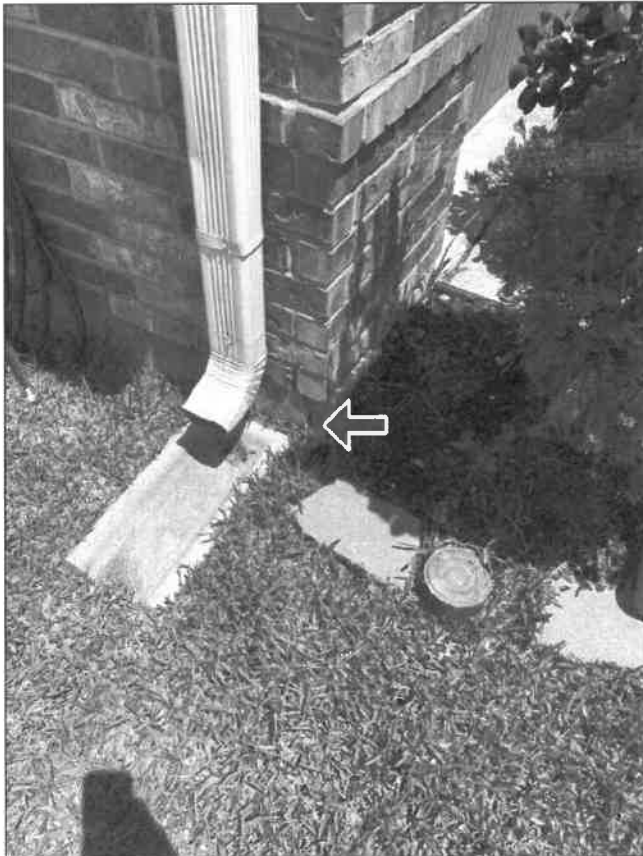
(2) Typical corner "pops" observed at foundation corners. This condition is cosmetic in nature and not structurally significant.

A. Item 1 (Picture) Typical corner "pops" observed at foundation corners. This condition is cosmetic in nature and not structurally significant.

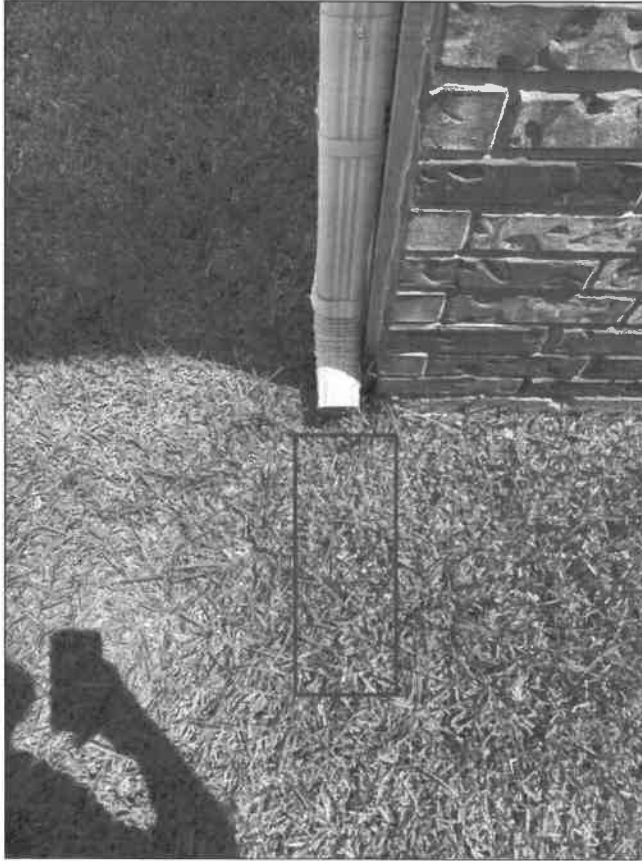
(1) Concrete splash blocks or downspout extensions, are absent at some gutter downspouts. Gutter downspouts should discharge a minimum of 18" away from the foundation.

B. Item 1 (Picture) Concrete splash blocks or downspout extensions, are absent at some gutter downspouts. Gutter downspouts should discharge a minimum of 18" away from the foundation.

- (1) Concrete splash blocks or downspout extensions, are absent at some gutter downspouts. Gutter downspouts should discharge a minimum of 18" away from the foundation.
- (5) A damaged gutter was observed at the front left corner of the home.

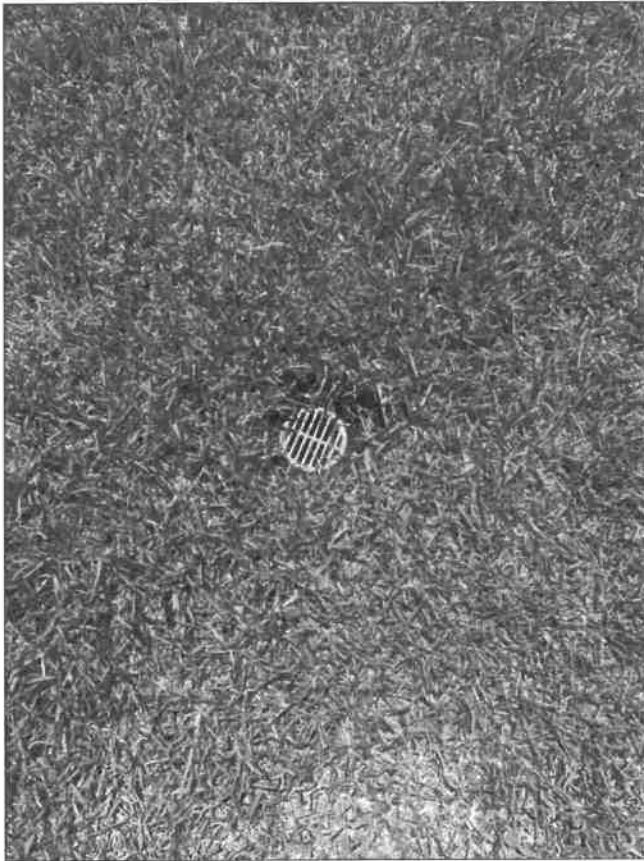
(2) An underground drainage system with catch basins and underground pipe has been installed to assist with drainage. I cannot determine the current effectiveness of this underground system.

B. Item 2 (Picture) An underground drainage system with catch basins and underground pipe has been installed to assist with drainage. I cannot determine the current effectiveness of this underground system.

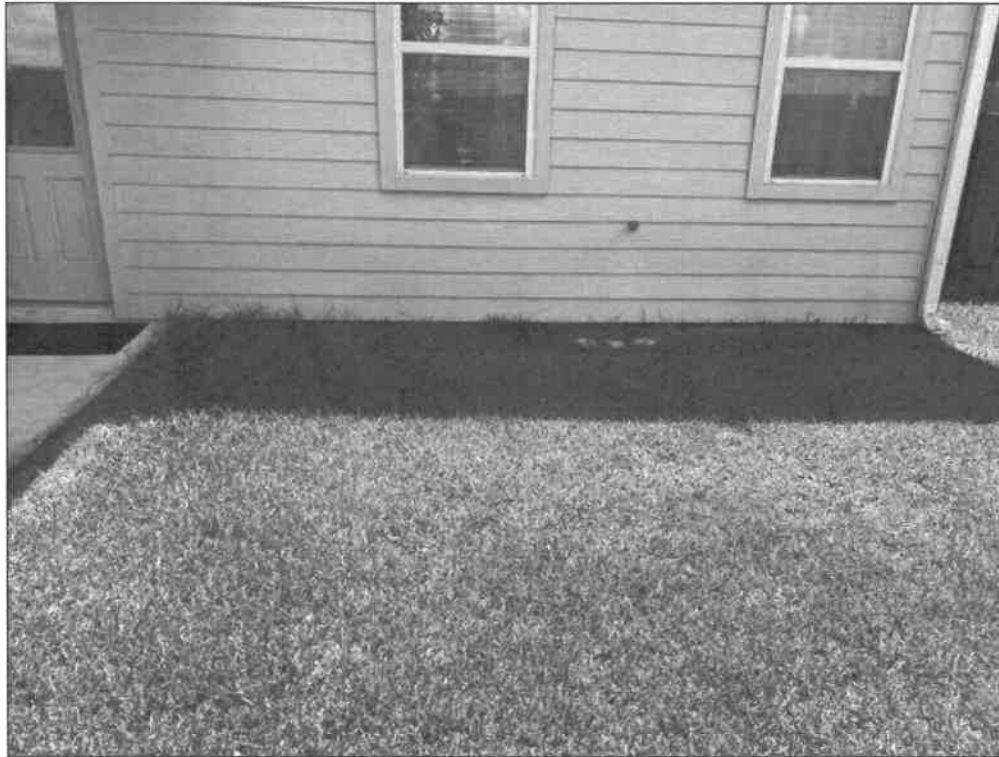
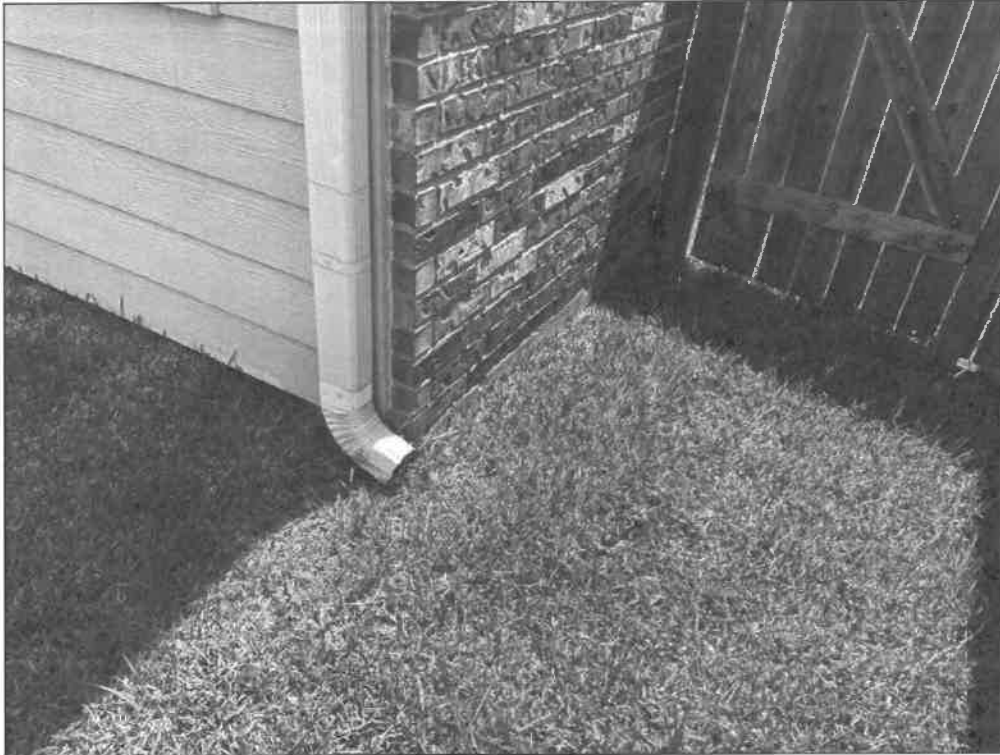
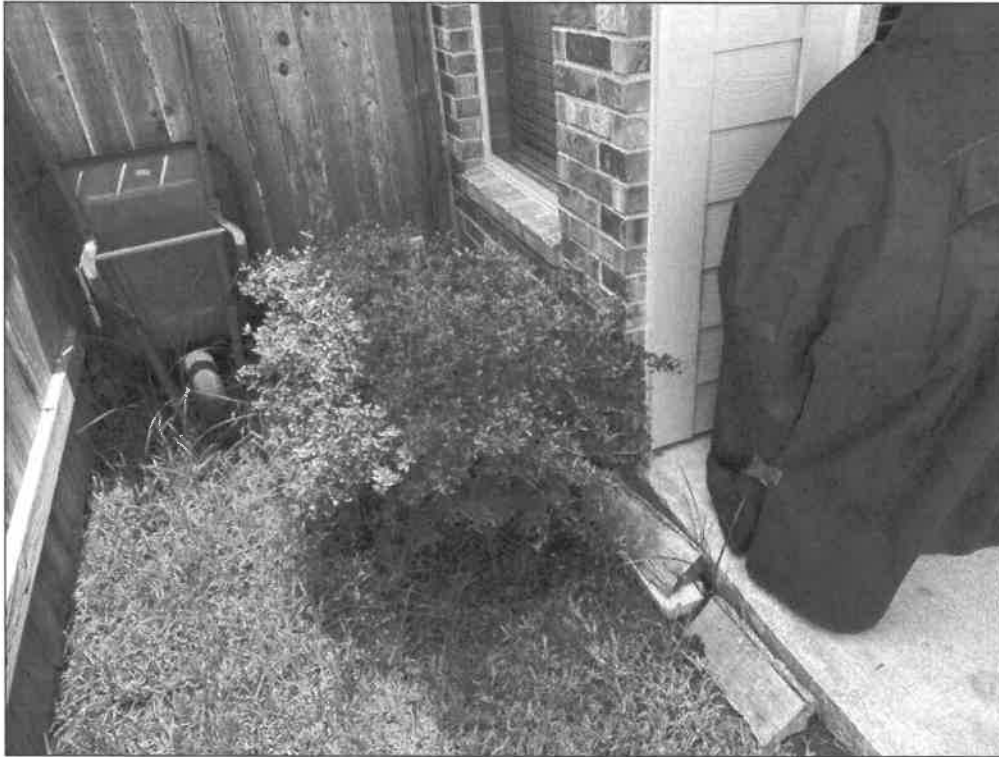
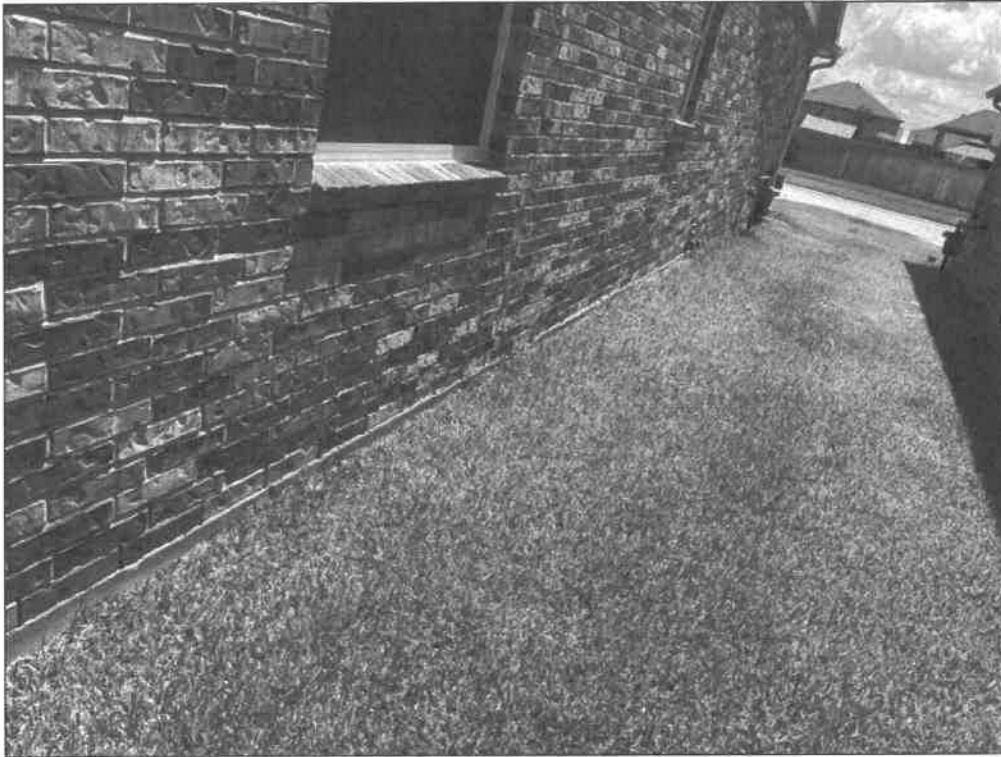
(3) High soil conditions observed at rear of home, right side (facing front), and left side (facing front). High soil conditions are conducive to wood destroying insects and should be avoided. I recommend a minimum six inch foundation side wall exposure around the entire perimeter of the foundation. High soil levels prevent a quality Termite inspection. Recommend correction.

B. Item 3 (Picture) High soil conditions observed at rear of home, right side (facing front), and left side (facing front). High soil conditions are conducive to wood destroying insects and should be avoided. I recommend a minimum six inch foundation side wall exposure around the entire perimeter of the foundation. High soil levels prevent a quality Termite inspection. Recommend correction.

B. Item 4 (Picture) High soil conditions observed at rear of home, right side (facing front), and left side (facing front). High soil conditions are conducive to wood destroying insects and should be avoided. I recommend a minimum six inch foundation side wall exposure around the entire perimeter of the foundation. High soil levels prevent a quality Termite inspection. Recommend correction.

B. Item 5 (Picture) High soil conditions observed at rear of home, right side (facing front), and left side (facing front). High soil conditions are conducive to wood destroying insects and should be avoided. I recommend a minimum six inch foundation side wall exposure around the entire perimeter of the foundation. High soil levels prevent a quality Termite inspection. Recommend correction.

B. Item 6 (Picture) High soil conditions observed at rear of home, right side (facing front), and left side (facing front). High soil conditions are conducive to wood destroying insects and should be avoided. I recommend a minimum six inch foundation side wall exposure around the entire perimeter of the foundation. High soil levels prevent a quality Termite inspection. Recommend correction.

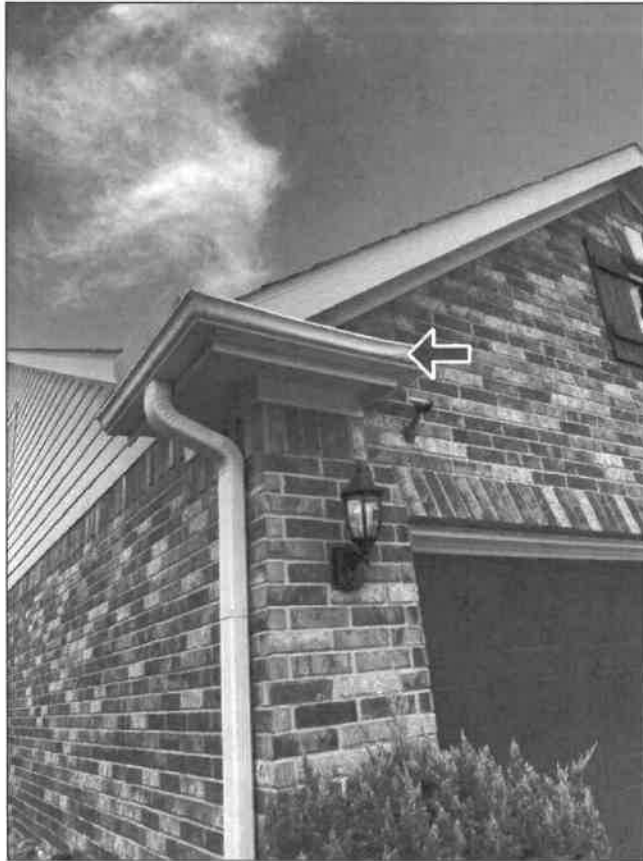
(5) A damaged gutter was observed at the front left corner of the home.

B. Item 7 (Picture) A damaged gutter was observed at the front left corner of the home.

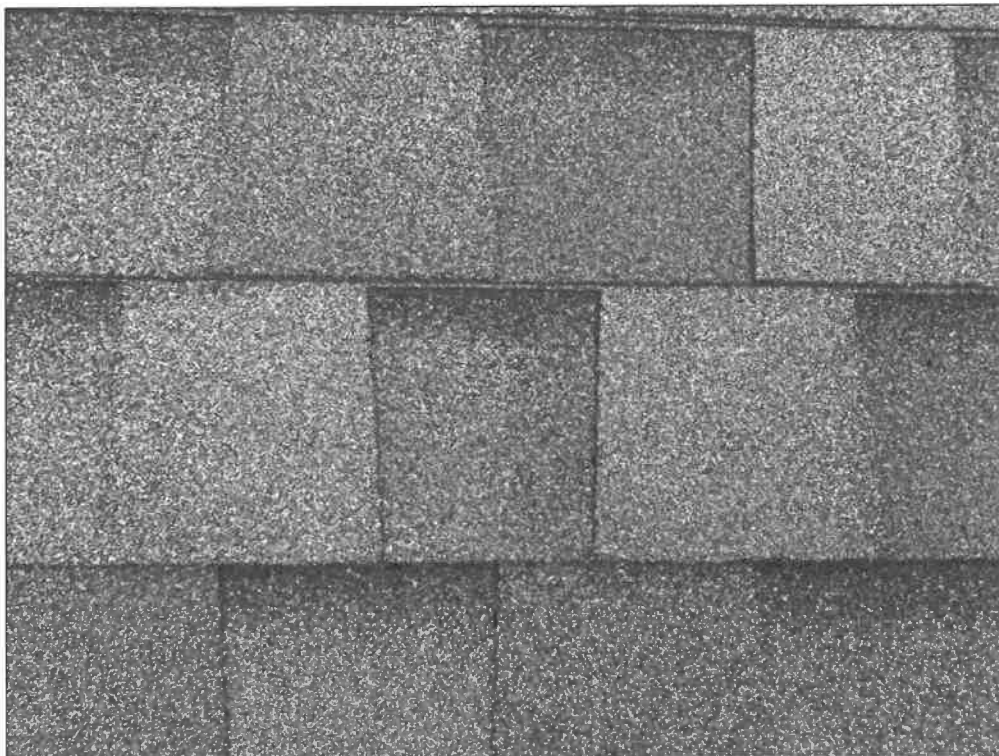
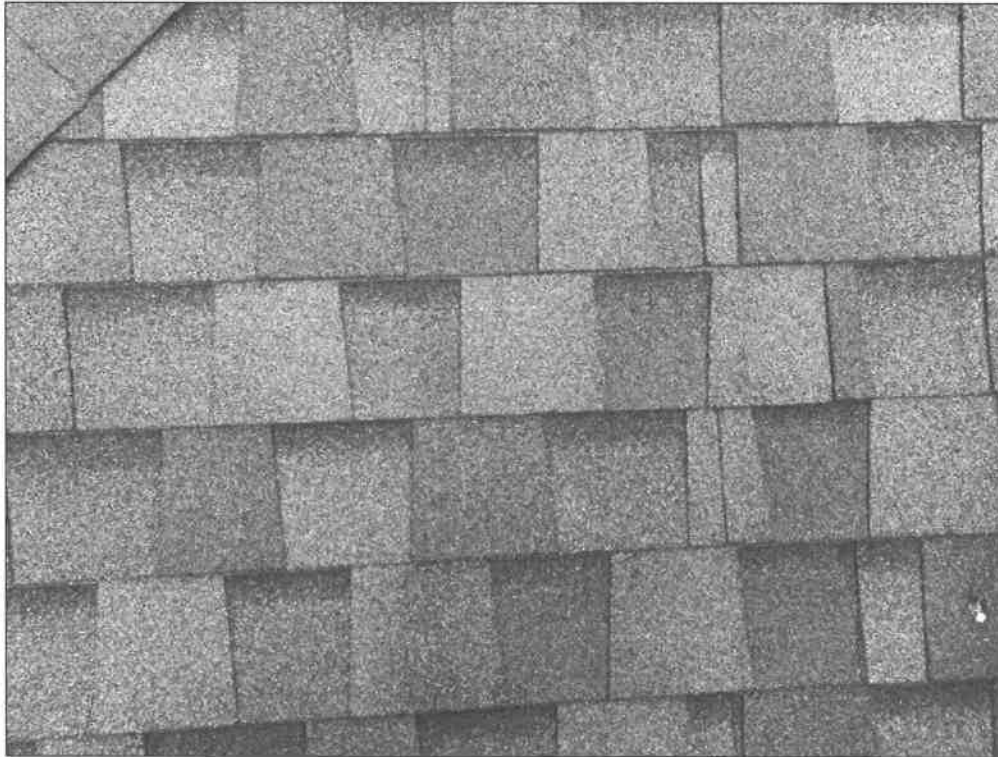
(1) The roof covering, is not new and shows signs of wear consistent with its age. The overall condition of the roof covering appears to be acceptable and no signs of any current moisture penetration into the structure were observed. This roof covering is probably around 7 years old. This type of architectural style composition shingles typically lasts about 20 years in this climate.

C. Item 1 (Picture) The roof covering, is not new and shows signs of wear consistent with its age. The overall condition of the roof covering appears to be acceptable and no signs of any current moisture penetration into the structure were observed. This roof covering is probably around 7 years old. This type of architectural style composition shingles typically lasts about 20 years in this climate. A general seal up of roof penetrations, exposed nail heads and flashings is recommended as routine maintenance.

C. Item 2 (Picture) The roof covering, is not new and shows signs of wear consistent with its age. The overall condition of the roof covering appears to be acceptable and no signs of any current moisture penetration into the structure were observed. This roof covering is probably around 7 years old. This type of architectural style composition shingles typically lasts about 20 years in this climate. A general seal up of roof penetrations, exposed nail heads and flashings is recommended as routine maintenance.

- (1) The roof covering, is not new and shows signs of wear consistent with its age. The overall condition of the roof covering appears to be acceptable and no signs of any current moisture penetration into the structure were

observed. This roof covering is probably around 7 years old. This type of architectural style composition shingles typically lasts about 20 years in this climate.

A general seal up of roof penetrations, exposed nail heads and flashings is recommended as routine maintenance.

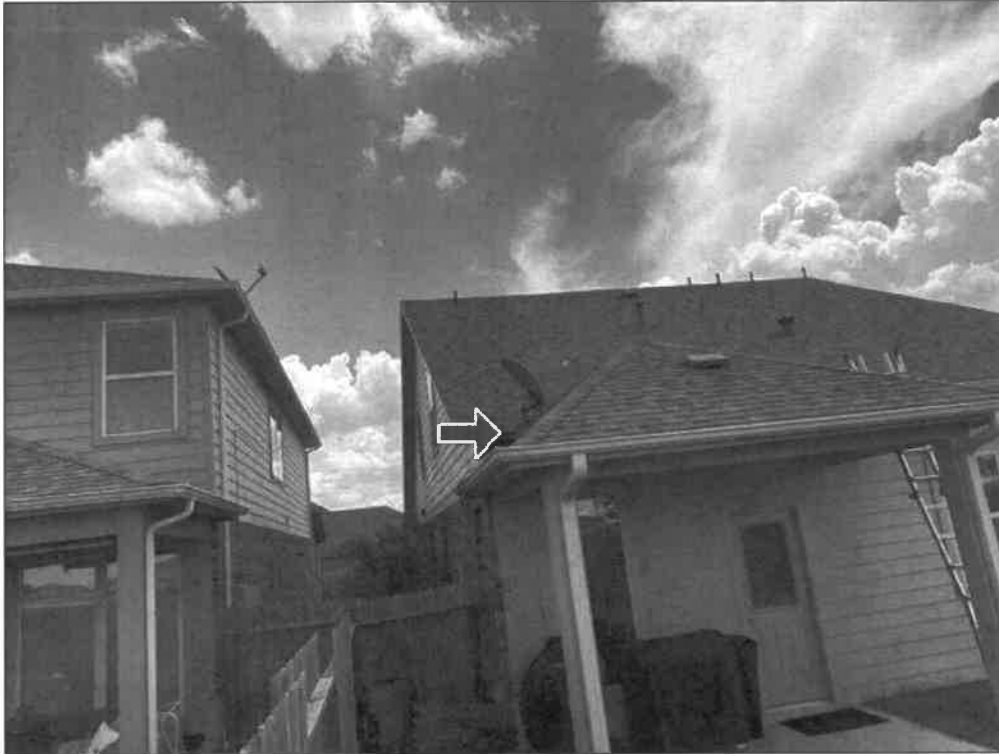
(3) The satellite dish was observed mounted on the roof covering. The securing screws penetrate the roof covering, underlayment and sheathing. Over time, this installation will most likely leak water into the structure causing water damage. A better installation might be to bolt the dish to a vertical structural element and seal the bolts/screws to insure that water does not penetrate the building envelope. If you choose to remove the dish from its current location, immediate repair to the roof covering is recommended.

C. Item 3 (Picture) The satellite dish was observed mounted on the roof covering. The securing screws penetrate the roof covering, underlayment and sheathing. Over time, this installation will most likely leak water into the structure causing water damage. A better installation might be to bolt the dish to a vertical structural element and seal the bolts/screws to insure that water does not penetrate the building envelope. If you choose to remove the dish from its current location, immediate repair to the roof covering is recommended.

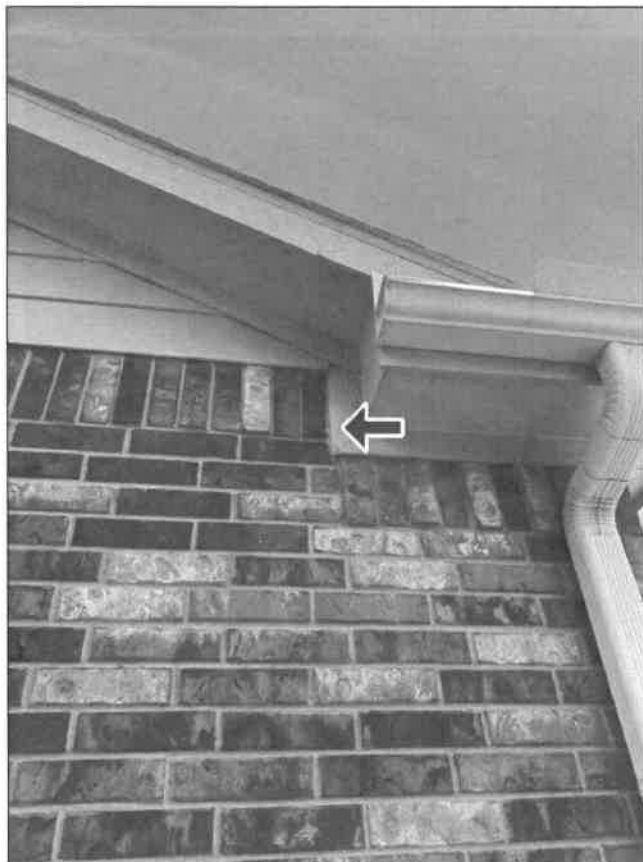
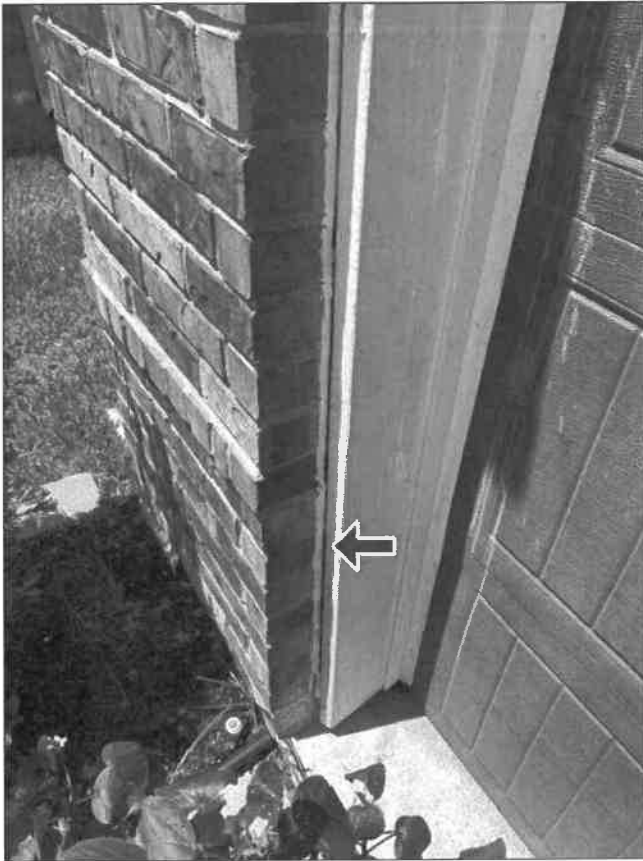
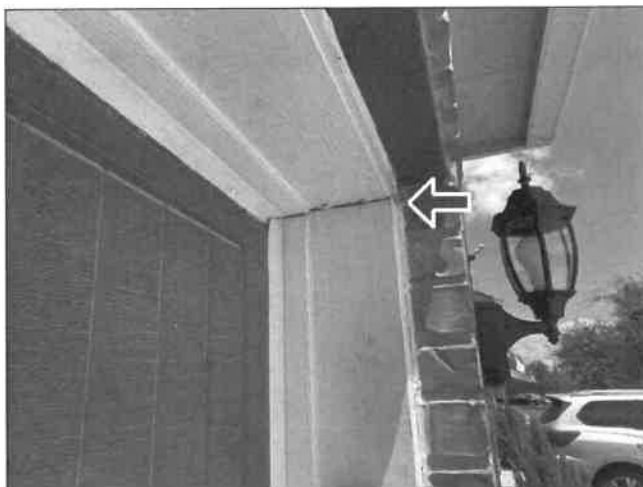
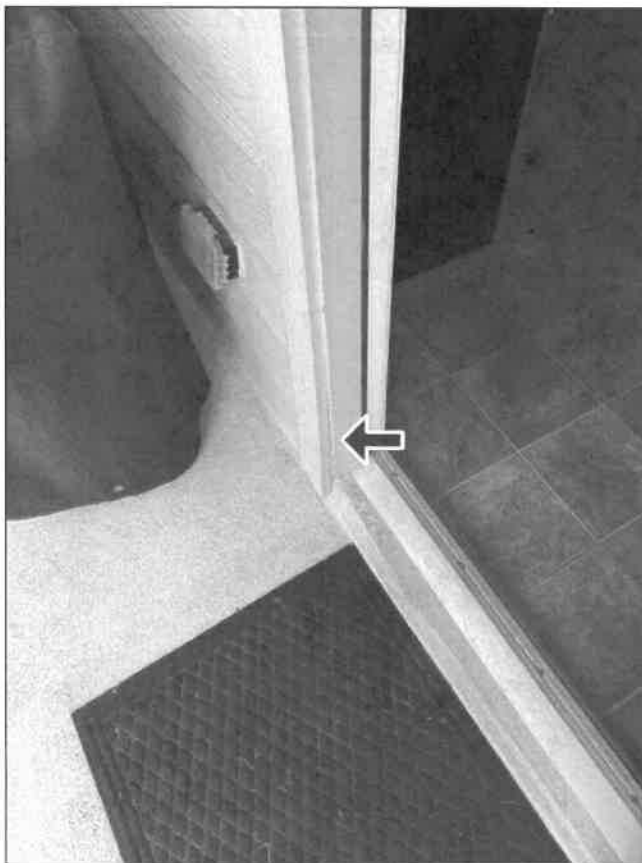
(1) Areas were observed where the brick, siding, and/or trim had gaps that need to be sealed with an appropriate sealant.

E. Item 1 (Picture) Areas were observed where the brick, siding, and/or trim had gaps that need to be sealed with an appropriate sealant.

E. Item 2 (Picture) Areas were observed where the brick, siding, and/or trim had gaps that need to be sealed with an appropriate sealant.

E. Item 3 (Picture) Areas were observed where the brick, siding, and/or trim had gaps that need to be sealed with an appropriate sealant.

E. Item 4 (Picture) Areas were observed where the brick, siding, and/or trim had gaps that need to be sealed with an appropriate sealant.

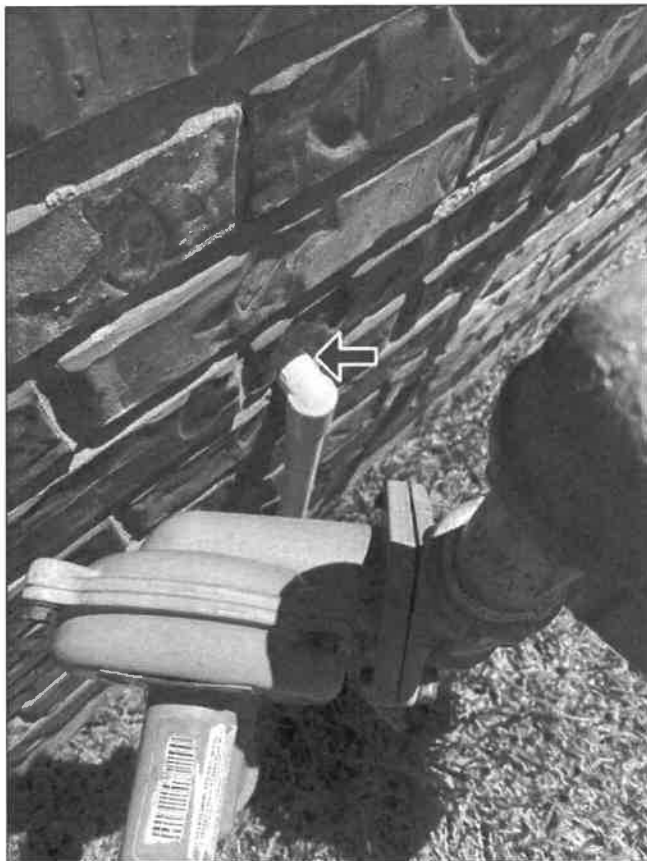
(2) Areas observed where wall penetrations, panels, outlets, and/or fixtures need to be sealed to the wall with an appropriate sealant.

E. Item 5 (Picture) Areas observed where wall penetrations, panels, outlets, and/or fixtures need to be sealed to the wall with an appropriate sealant.

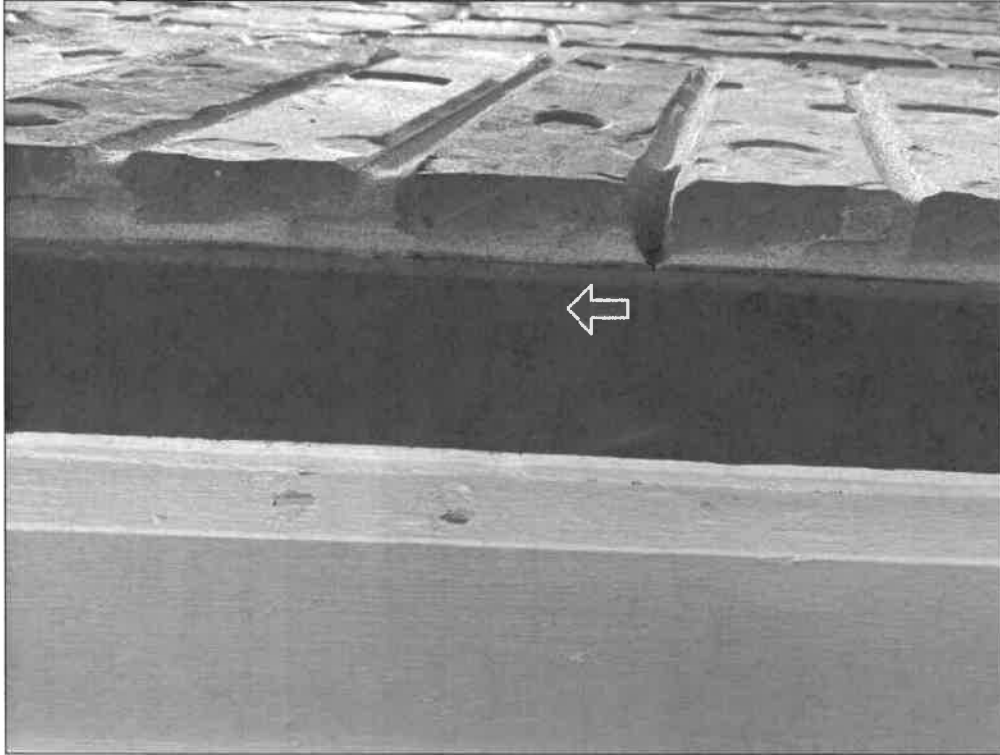
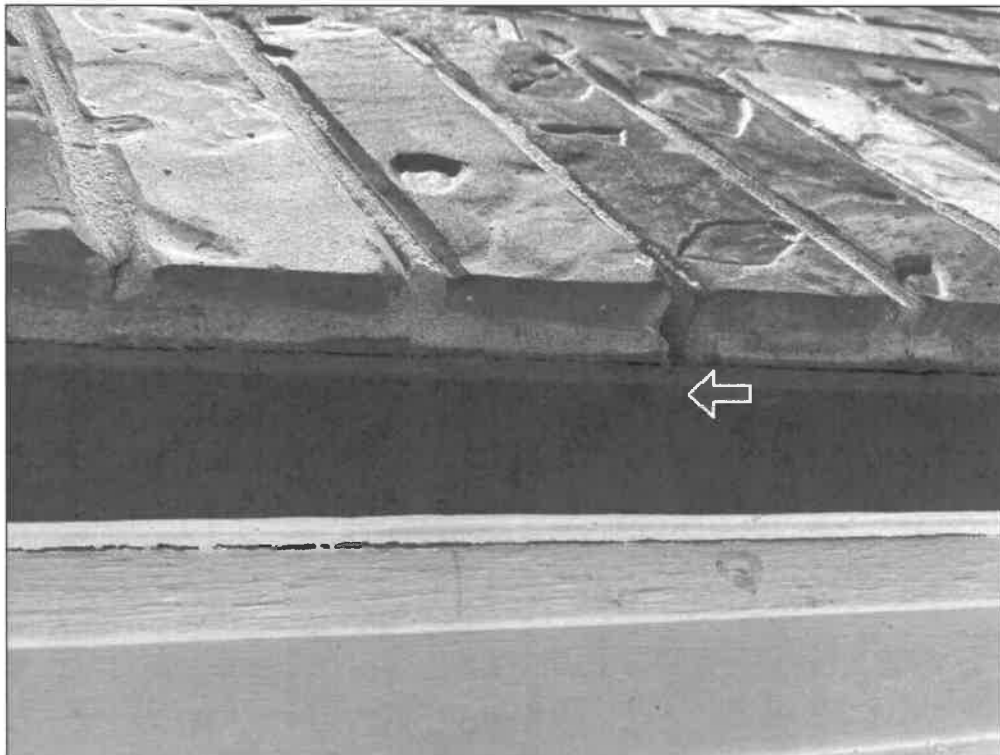
(3) Some brick lentils on the structure are showing signs of rust. I recommend these lentils be sanded, primed, and repainted to prevent deterioration of the brick support lentil.

E. Item 6 (Picture) Some brick lentils on the structure are showing signs of rust. I recommend these lentils be sanded, primed, and repainted to prevent deterioration of the brick support lentil.

E. Item 7 (Picture) Some brick lentils on the structure are showing signs of rust. I recommend these lentils be sanded, primed, and repainted to prevent deterioration of the brick support lentil.

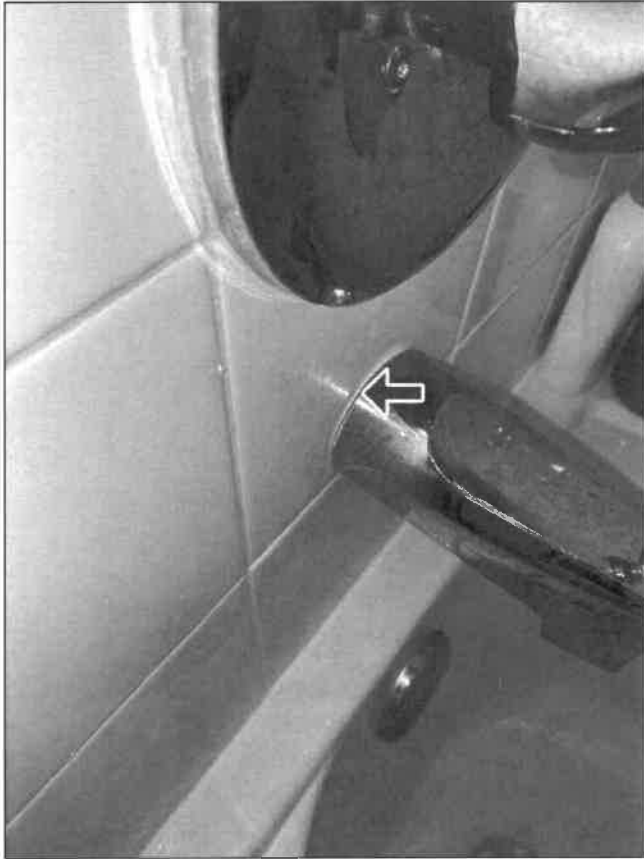
(4) In the upstairs hall bathroom, the tub spout needs to be sealed to the wall with an appropriate silicone-based sealant.

E. Item 8 (Picture) In the upstairs hall bathroom, the tub spout needs to be sealed to the wall with an appropriate silicone-based sealant.

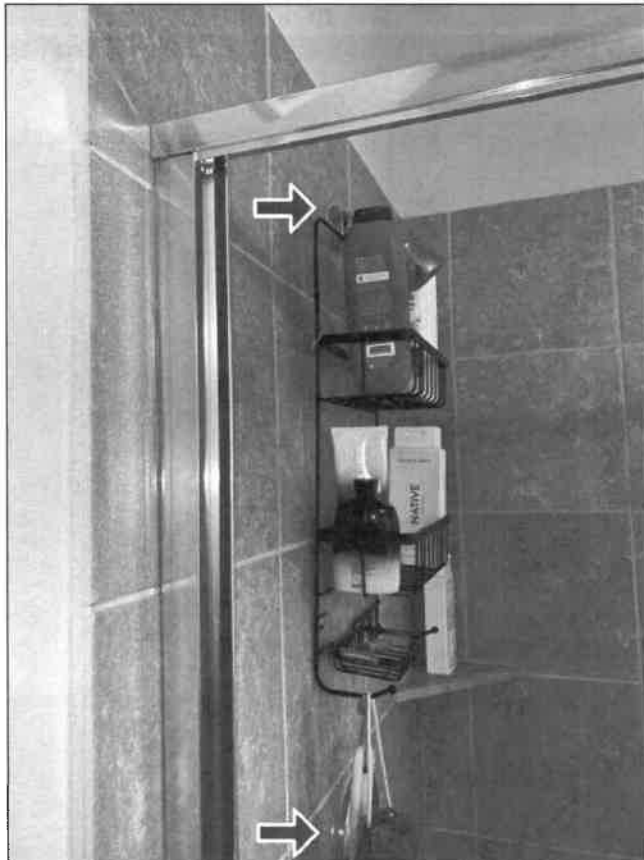
(5) In the primary bathroom, the shower head escutcheon and shower handle valve escutcheon need to be sealed to the wall with an appropriate silicone-based sealant.

E. Item 9 (Picture) In the primary bathroom, the shower head escutcheon and shower handle valve escutcheon need to be sealed to the wall with an appropriate silicone-based sealant.

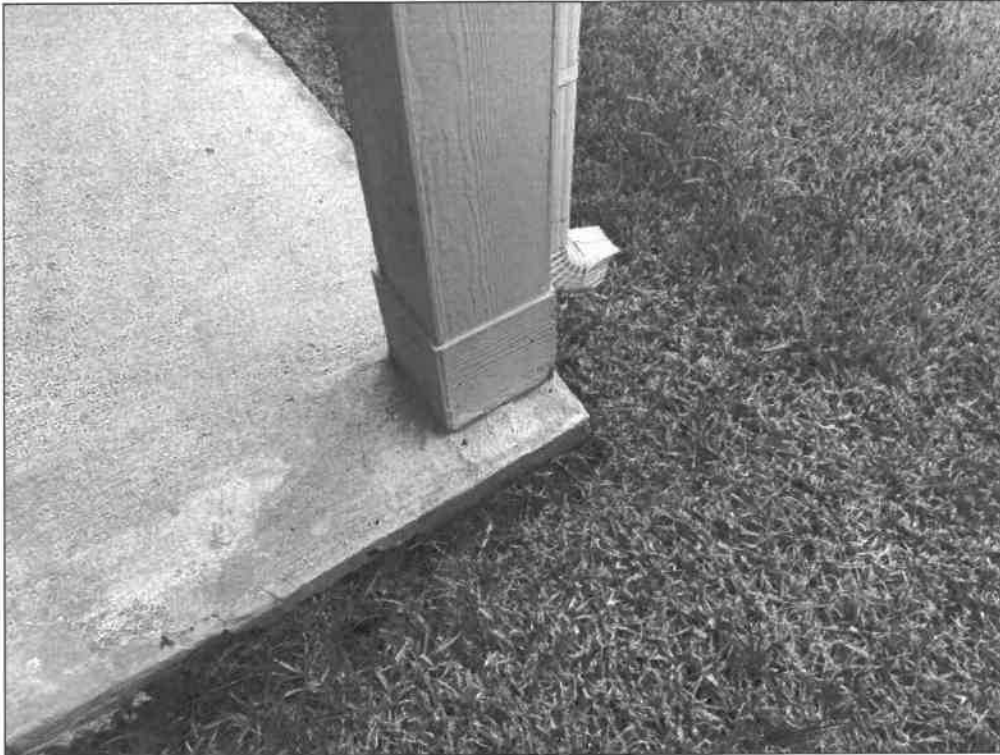
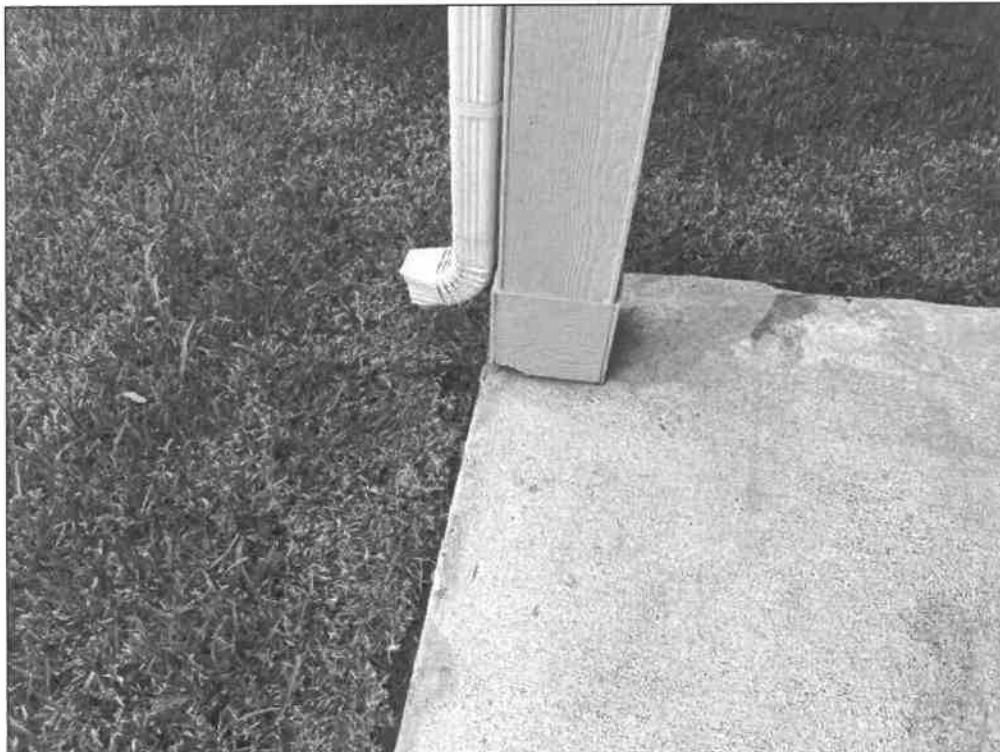
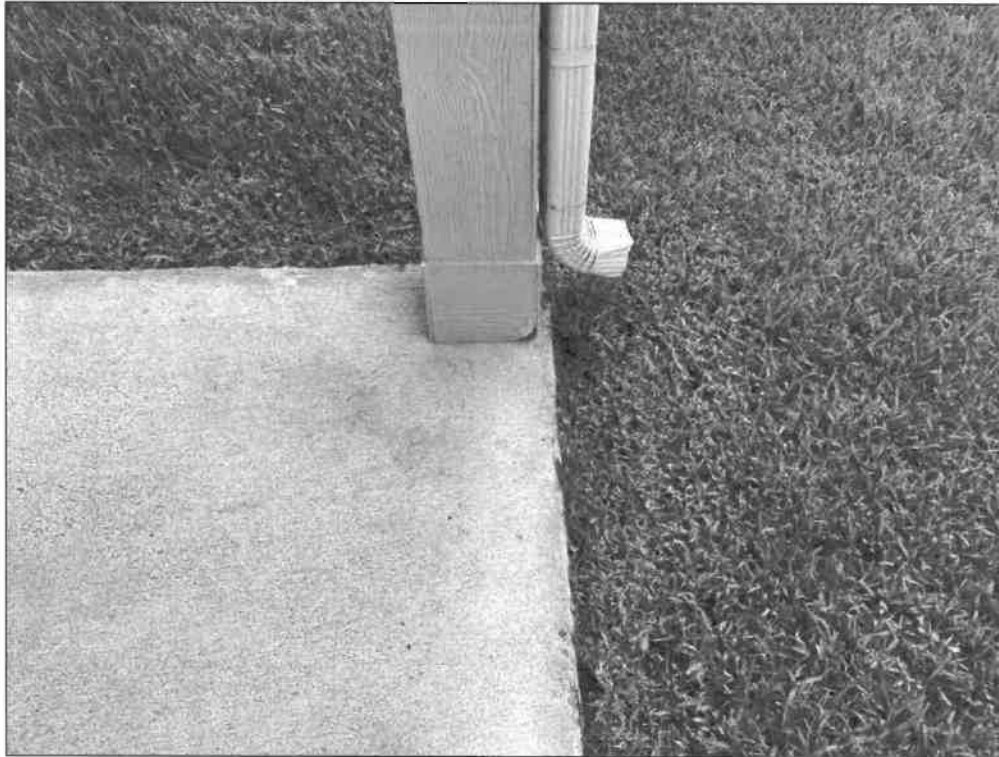
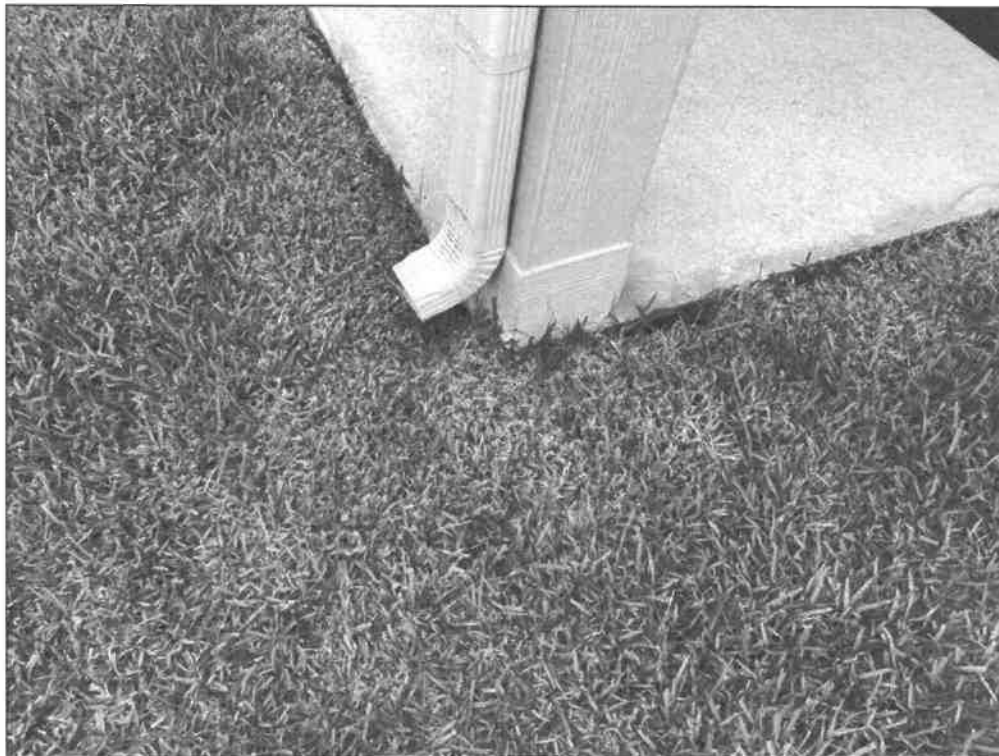
(6) Damaged siding was observed at the bottom of the columns in the backyard.

E. Item 10 (Picture) Damaged siding was observed at the bottom of the columns in the backyard.

E. Item 11 (Picture) Damaged siding was observed at the bottom of the columns in the backyard.

E. Item 12 (Picture) Damaged siding was observed at the bottom of the columns in the backyard.

E. Item 13 (Picture) Damaged siding was observed at the bottom of the columns in the backyard.

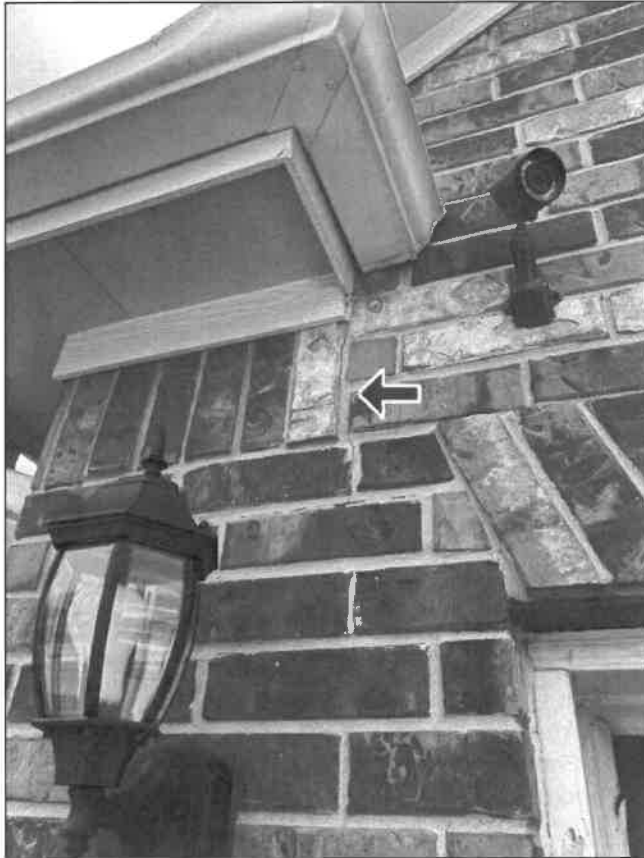
(7) Brick veneer mortar cracks were observed. This condition is cosmetic in nature and not structurally

significant. The cracking of the brick veneer is likely due to flexing of the foundation during repeated seasonal changes. The expansive clay soil in the area is prone to excessive swelling during rainy periods and shrinkage during dry periods.

E. Item 14 (Picture) Brick veneer mortar cracks were observed. This condition is cosmetic in nature and not structurally significant. The cracking of the brick veneer is likely due to flexing of the foundation during repeated seasonal changes. The expansive clay soil in the area is prone to excessive swelling during rainy periods and shrinkage during dry periods.

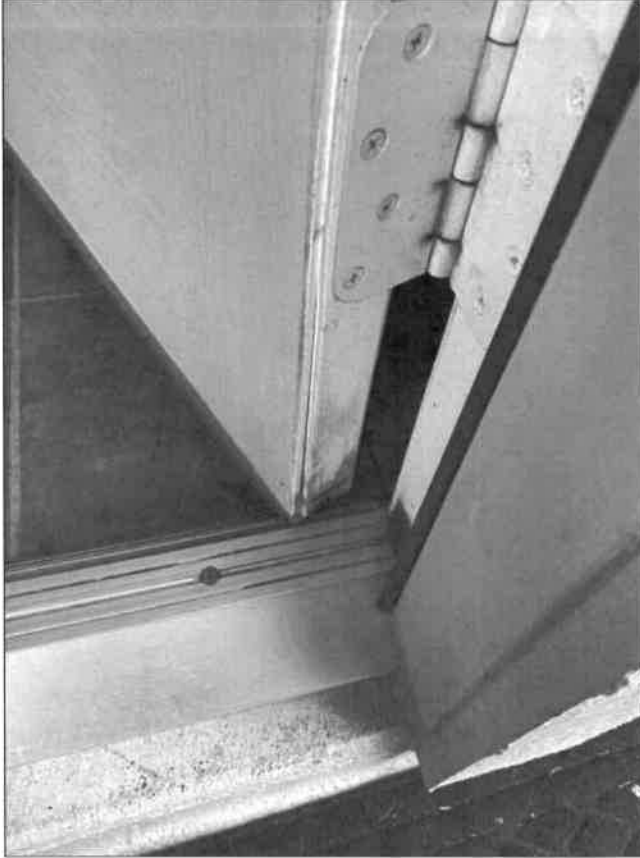
G. Item 1 (Picture) Water damage was observed at the bottom of the inside of the back door.

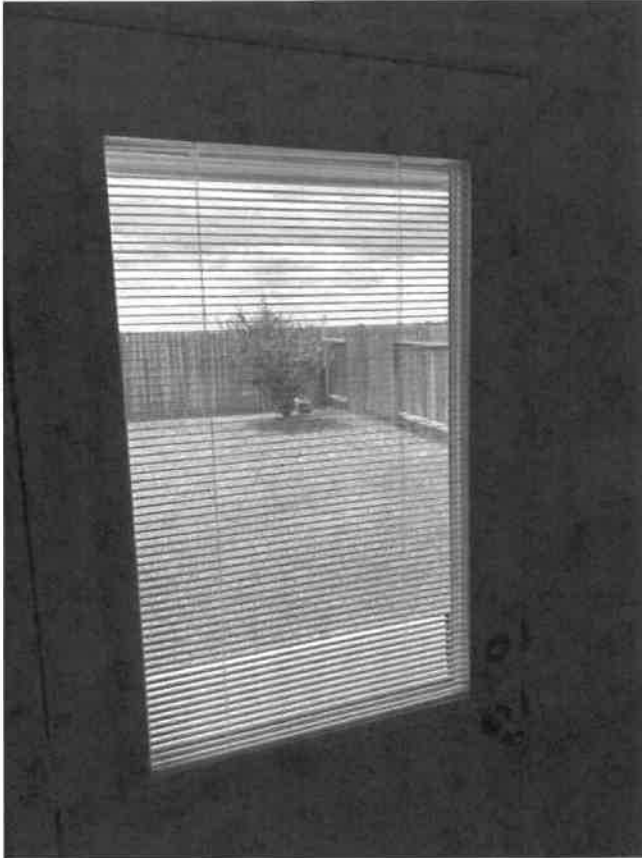
(3) The blinds built into the back door window do not function. Recommend correction.

G. Item 2 (Picture) The blinds built into the back door window do not function. Recommend correction.

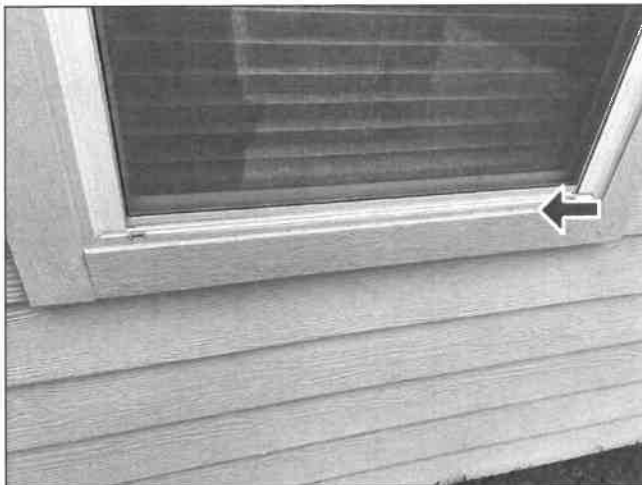
(1) The perimeter sealant, has failed on some windows.

H. Item 1 (Picture) The perimeter sealant, has failed on some windows.

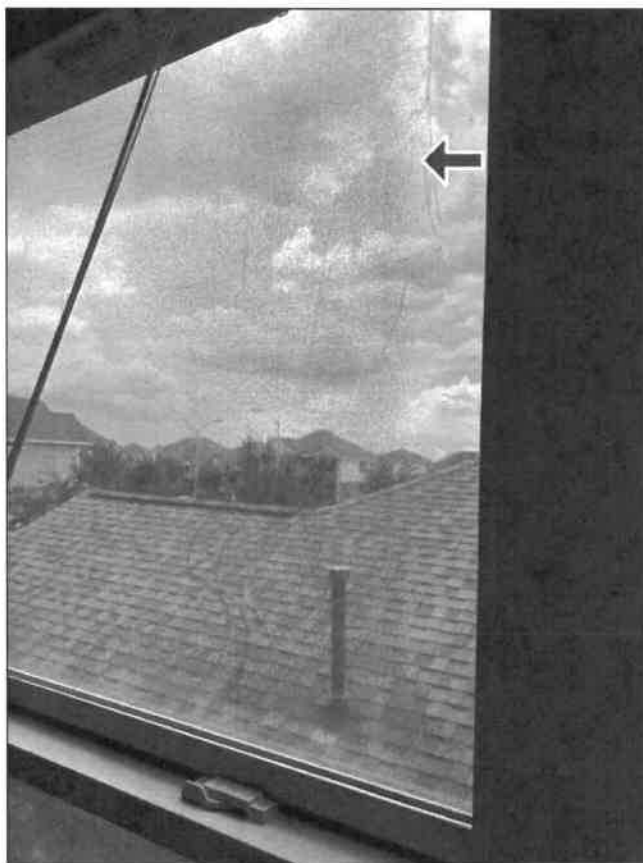
(2) Window seals appear to be compromised, as suggested by condensate and mineral deposits built up between the double panes of glass. I recommend further evaluation by qualified window contractor.

H. Item 2 (Picture) Window seals appear to be compromised, as suggested by condensate and mineral deposits built up between the double panes of glass. I recommend further evaluation by qualified window contractor.

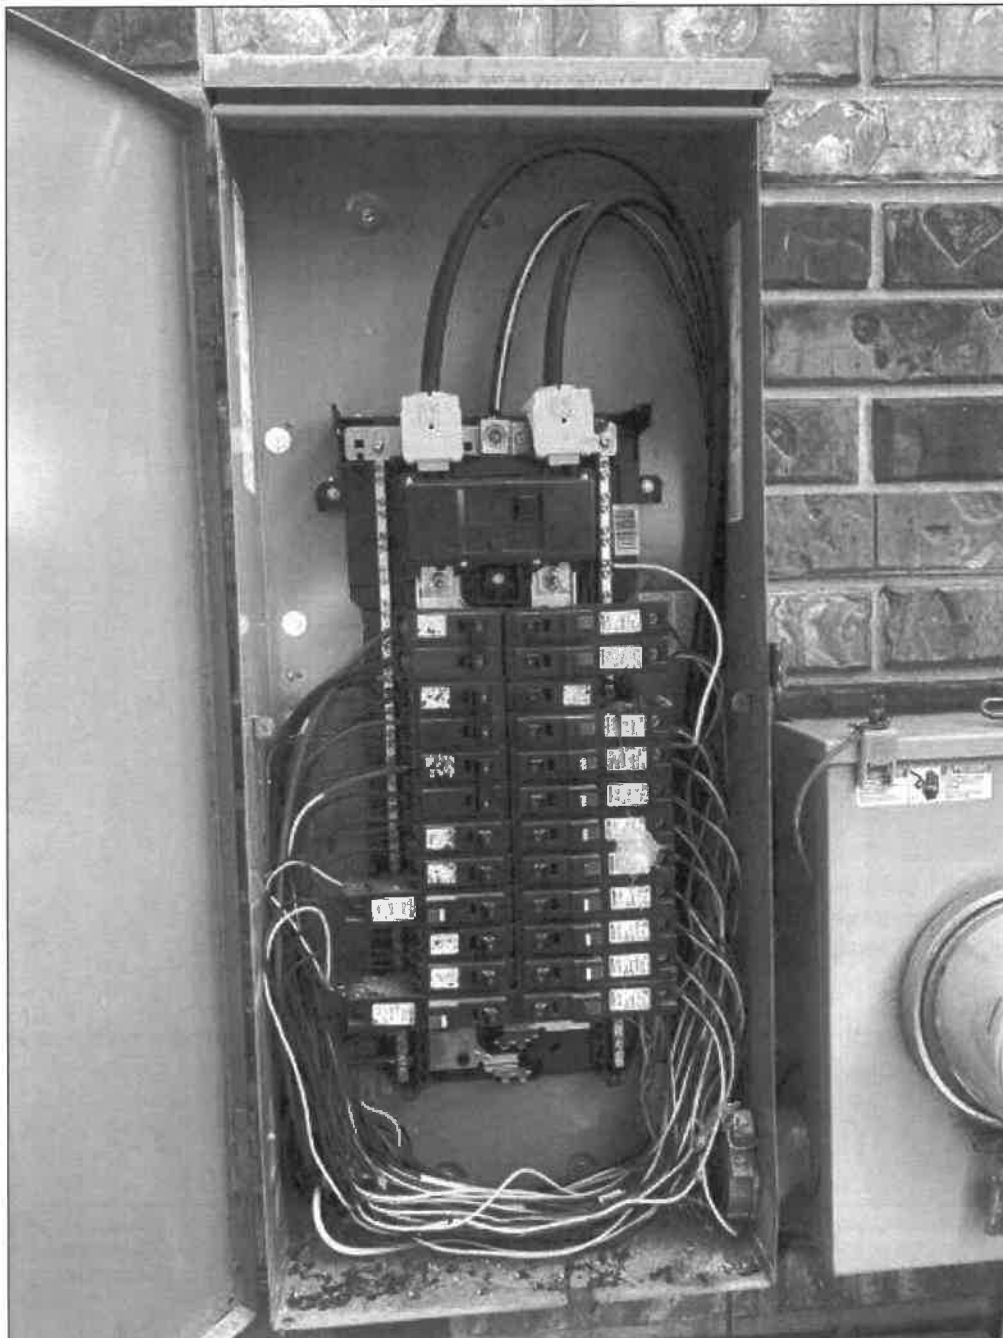
A. Item 1 (Picture) The main electrical service panel, shown with dead front cover removed for inspection purposes. The panel inspected okay.
