Inspection Report

Property Address:
8151 Aleppo Pine Ln
Cypress TX 77433

Sunbelt Inspections

Date: 7/2/2022	Time: 01:00:00 PM	Report ID: 070222RC5
Property: 8151 Aleppo Pine Ln Cypress TX 77433	Customer: Han Nguyen	Real Estate Professional: Jeffrey Bottoms BHGRE Gary Greene - Cypress

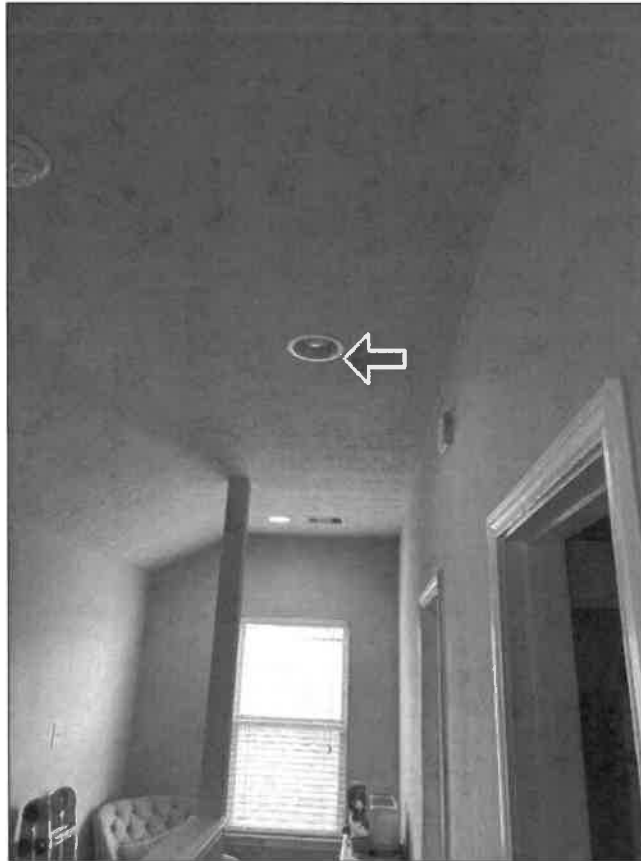
(1) One of the upstairs hall lights will not turn on at the switch. This could be a burnt out bulb or a wiring issue. Recommend correction.

B. Item 1 (Picture) One of the upstairs hall lights will not turn on at the switch. This could be a burnt out bulb or a wiring issue. Recommend correction.

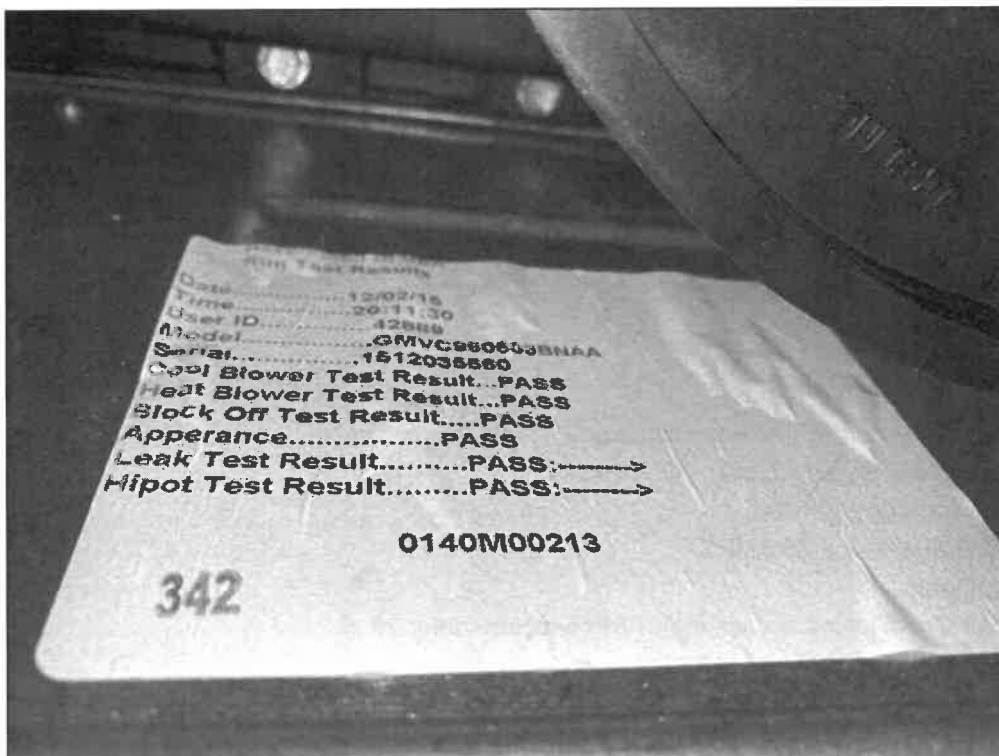
(1) Furnace service tag(s). Manufacture date: 2015.

A. Item 1 (Picture) Furnace service tag(s). Manufacture date: 2015.

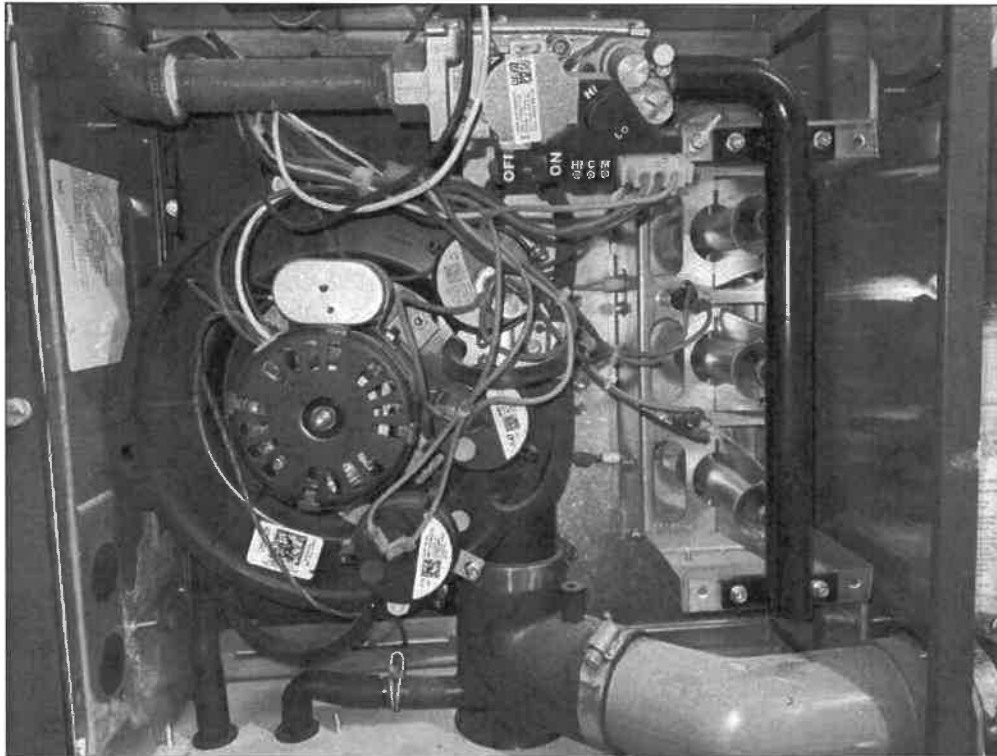
(2) The unit appeared to operate normally using the standard controls. I could not determine if the heat exchanger is cracked or not without dismantling the furnace. Dismantling of components is outside of the scope of a standard home inspection.

A. Item 2 (Picture) The unit appeared to operate normally using the standard controls. I could not determine if the heat exchanger is cracked or not without dismantling the furnace. Dismantling of components is outside of the scope of a standard home inspection.

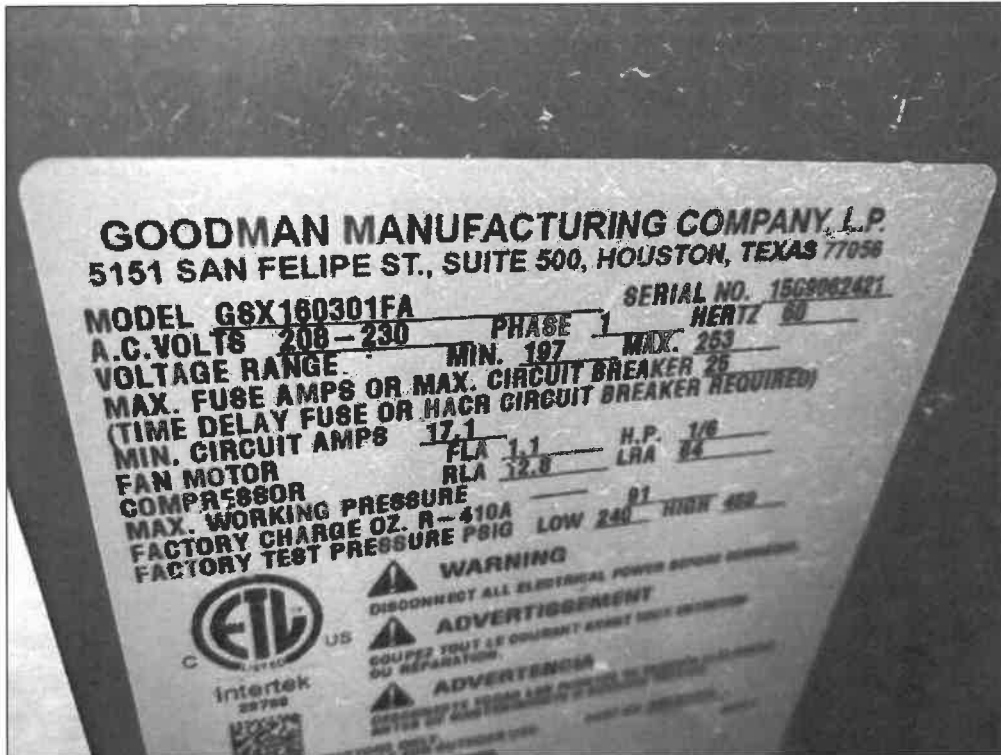
(1) Air Conditioning service tag(s). Manufacture date: 2015.

B. Item 1 (Picture) Air Conditioning service tag(s). Manufacture date: 2015.

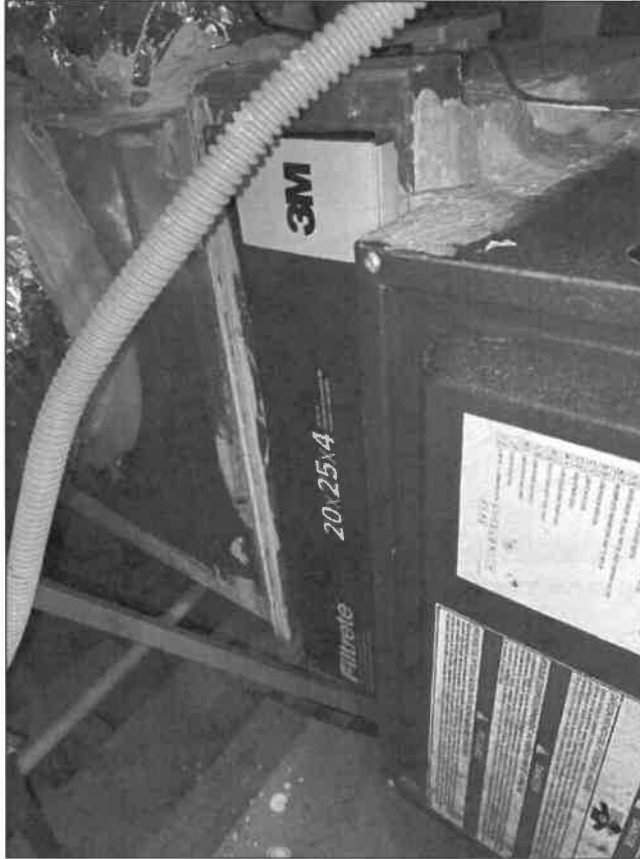
The filter location is in the attic. I recommend this type of filter should be changed every 6 months.

C. Item 1 (Picture) The filter location is in the attic. I recommend this type of filter should be changed every 6 months.

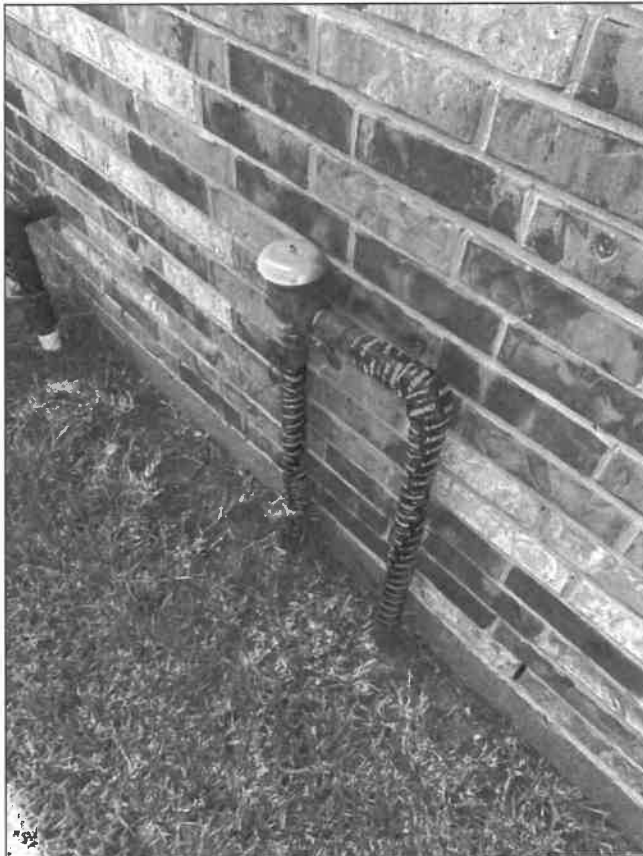
(1) The vacuum breaker for the irrigation system should be secured to the wall or secured to a vertical support (i.e. rebar or t-post).

A. Item 1 (Picture) The vacuum breaker for the irrigation system should be secured to the wall or secured to a vertical support (i.e. rebar or t-post).

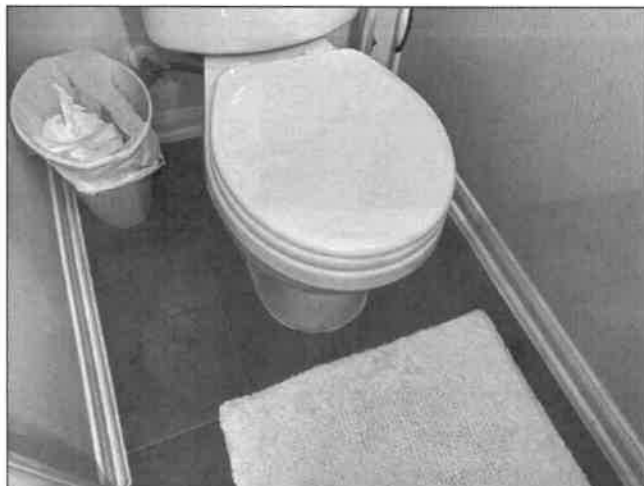
(2) In the first floor powder room the toilet is loose at the floor and needs to be sealed the floor. Repairs may involve re-setting the toilet on a new wax seal. I recommend a qualified licensed plumber repair or correct as needed.

A. Item 2 (Picture) In the first floor powder room the toilet is loose at the floor and needs to be sealed the floor. Repairs may involve re-setting the toilet on a new wax seal. I recommend a qualified licensed plumber repair or correct as needed.

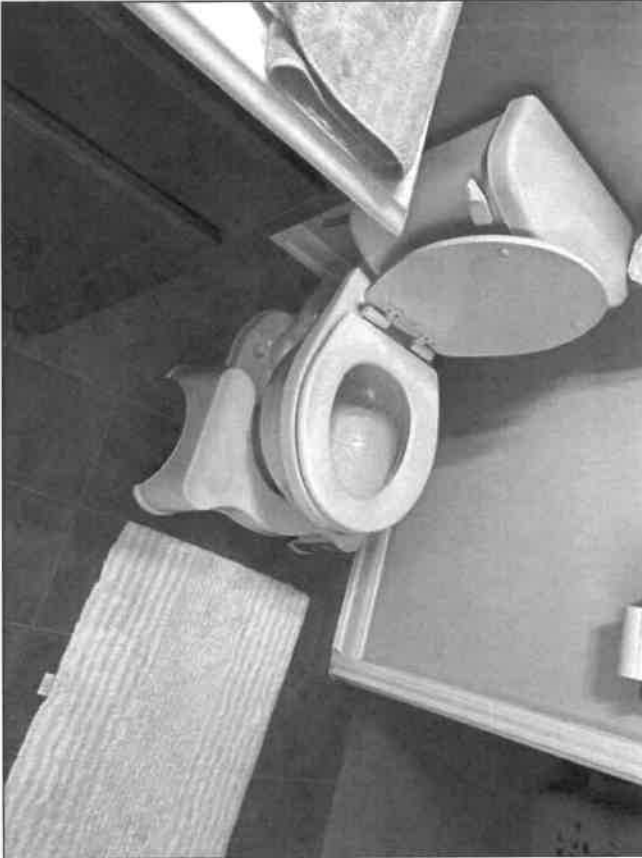
(4) The toilet is loose at floor at the primary bath. Repairs may involve re-setting the toilet on a new wax seal. I recommend a qualified licensed plumber repair or correct as needed.

A. Item 3 (Picture) The toilet is loose at floor at the primary bath. Repairs may involve re-setting the toilet on a new wax seal. I recommend a qualified licensed plumber repair or correct as needed.

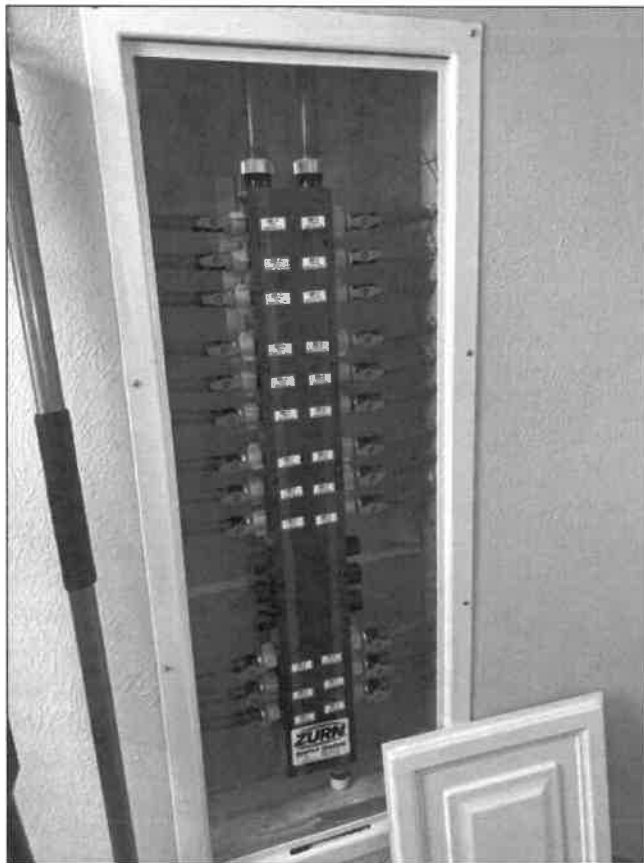
(5) A pex manifold for water distribution was observed in the laundry room.

A. Item 4 (Picture) A pex manifold for water distribution was observed in the laundry room.

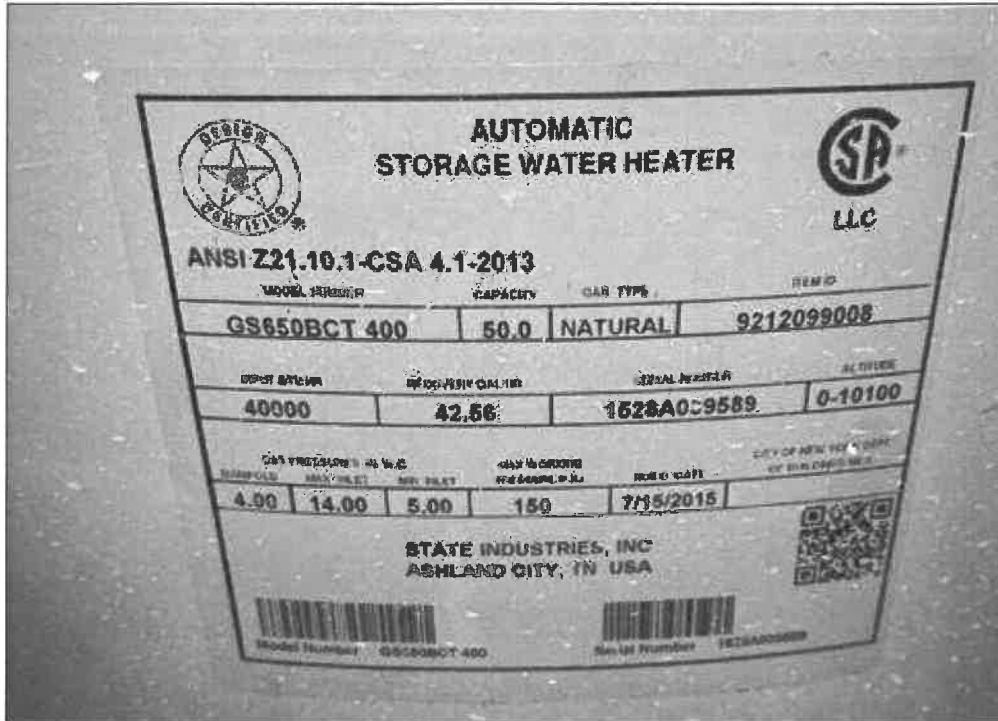
C. Item 1 (Picture) Water heater service tag. Manufacture date 2015.

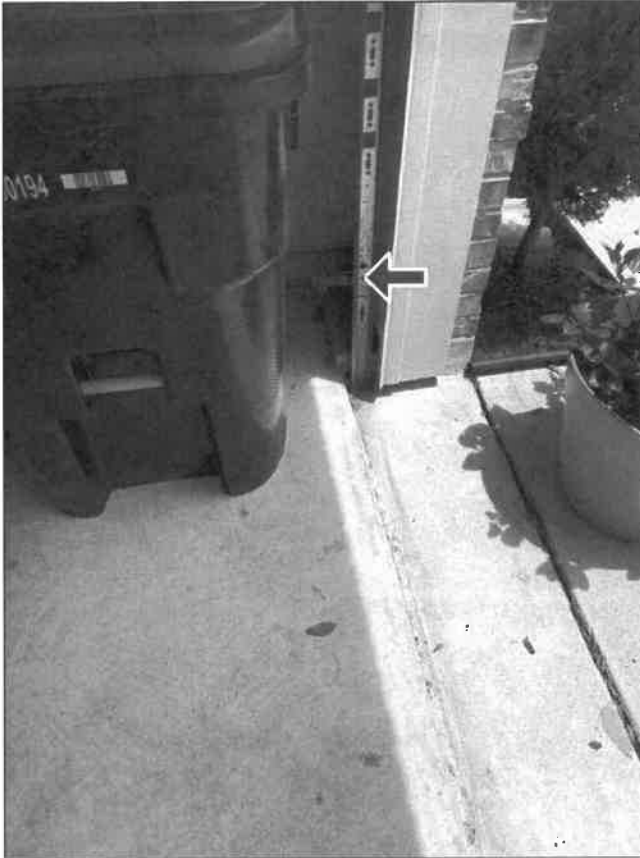
G. Item 1 (Picture) The door sensors appear mounted too high. Maximum height for sensors is generally no greater than 8 inches above the floor. Check the manufacturers' installation instructions for correct maximum height of sensors.

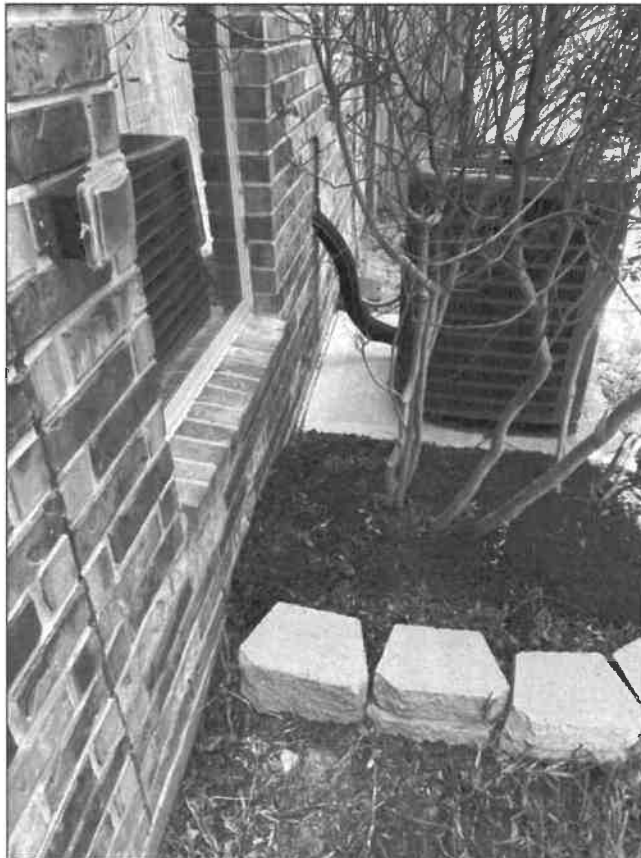
(1) The form boards for the AC unit were left in place after installation. This is conducive condition for termites. Recommend correction.

E. Item 1 (Picture) The form boards for the AC unit were left in place after installation. This is conducive condition for termites. Recommend correction.
