# *Texan Inspection Services LLP*

## **Property Inspection Report**

4418 Trailwood Dr., Sugarland, TX 77479  
Inspection prepared for: Shaiju Murithottathil Belsus Mini Skaria  
Real Estate Agent: Minal Vyas - RE/MAX Fine Properties

Date of Inspection: 2/19/2019 Time: 1:00 PM  
Age of Home: 1994 Size: 2798  
Weather: Cloudy/Rain/50 Degrees  
Interested Parties Present: Buyer and Buyer's Agent  
Home Occupied: Yes  
Seller's Disclosure Provided: No

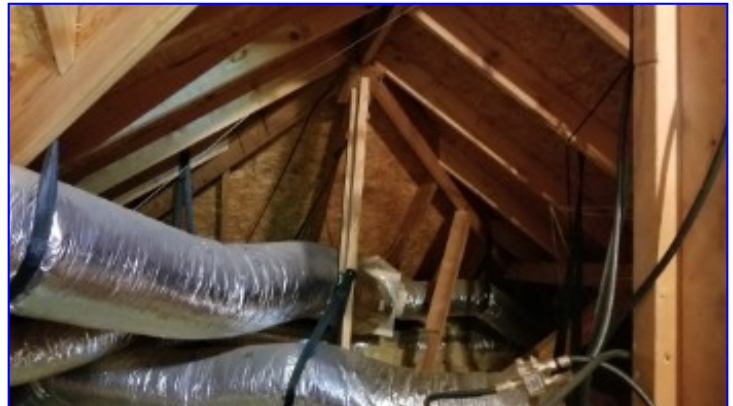
- Loose batting was observed in the right rear attic space. This area should be improved/repared to ensure a proper thermal boundary is maintained.

Loose batting was observed in the right rear attic space. This area should be improved/repared to ensure a proper thermal boundary is maintained.

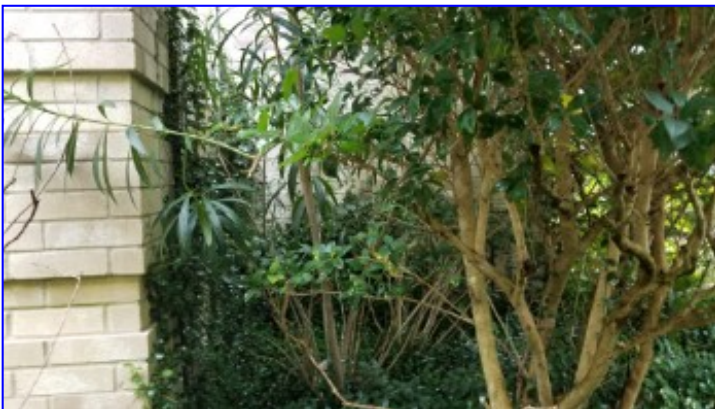
Vegetation is in contact with exterior walls. It is recommended vegetation be cut back at least 6 inches from exterior walls.

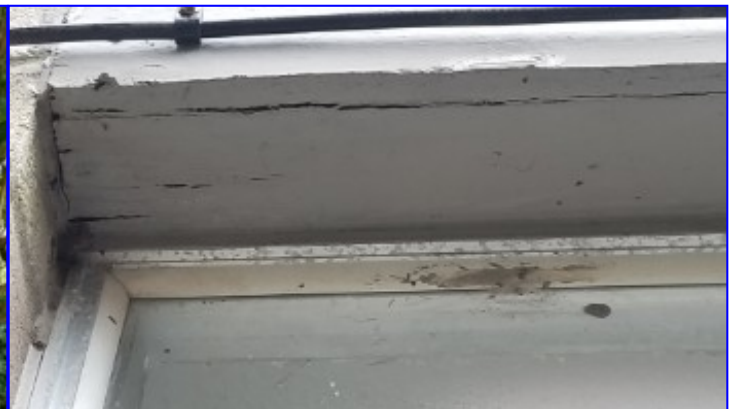
Water damage was observed above the left window on the left wall of the breakfast area. Repairs should be undertaken to prevent further damage.

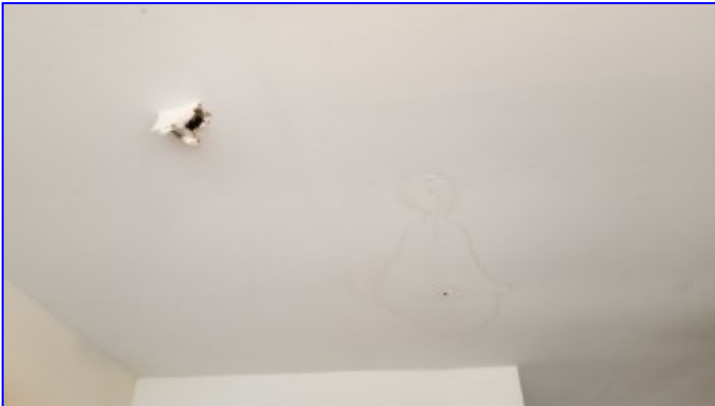
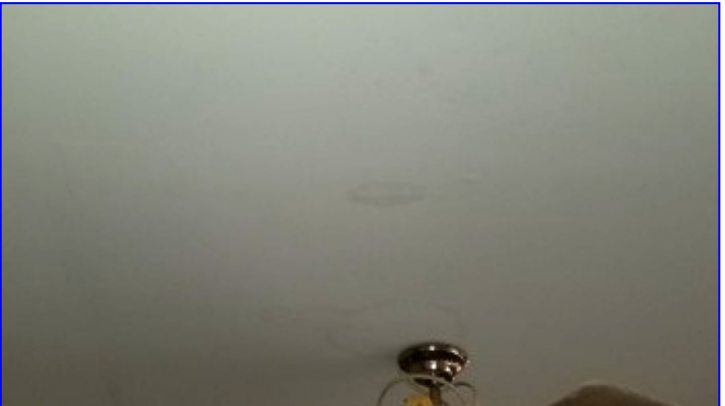
Water staining was observed in the garage. The cause/source should be determined and repairs undertaken, if necessary, to prevent further damage. Area dry at this time.

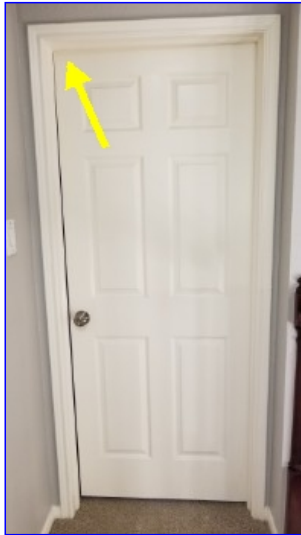
The right front guest bedroom door binds when operated. Adjustments to the door and or door hardware is recommended to ensure proper function.

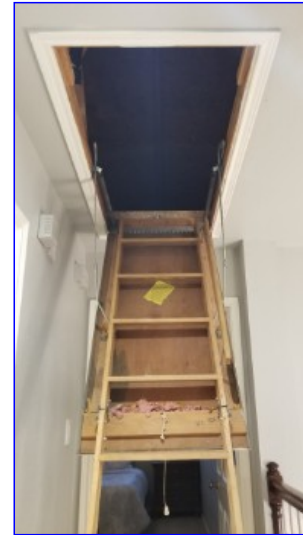
Current standards call for attic access doors/ladders to be insulated and weather stripped to provide proper fire blocking and thermal boundary.

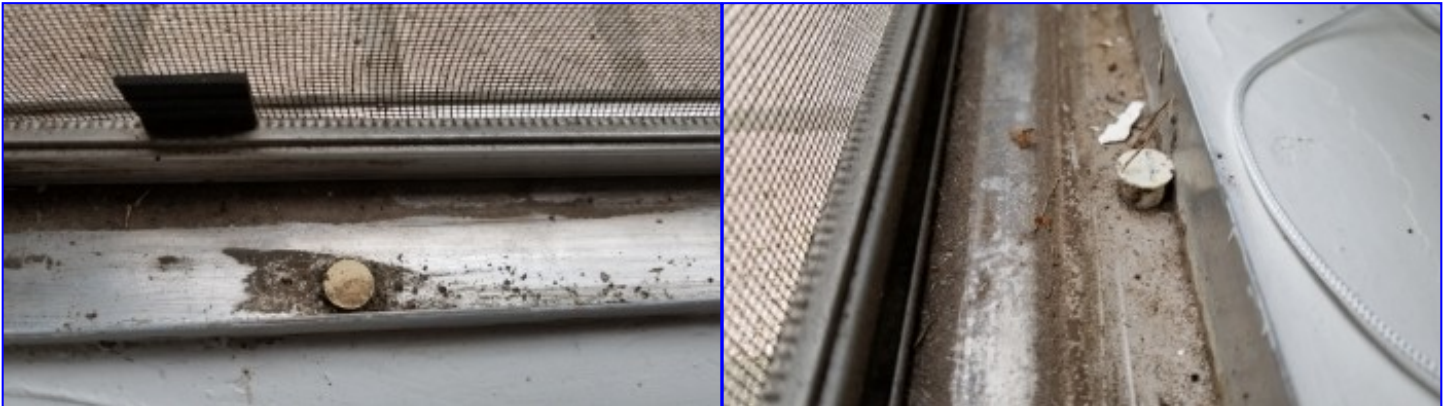
The alarm sensors in the window sills should be sealed to help prevent water intrusion into the wall below.

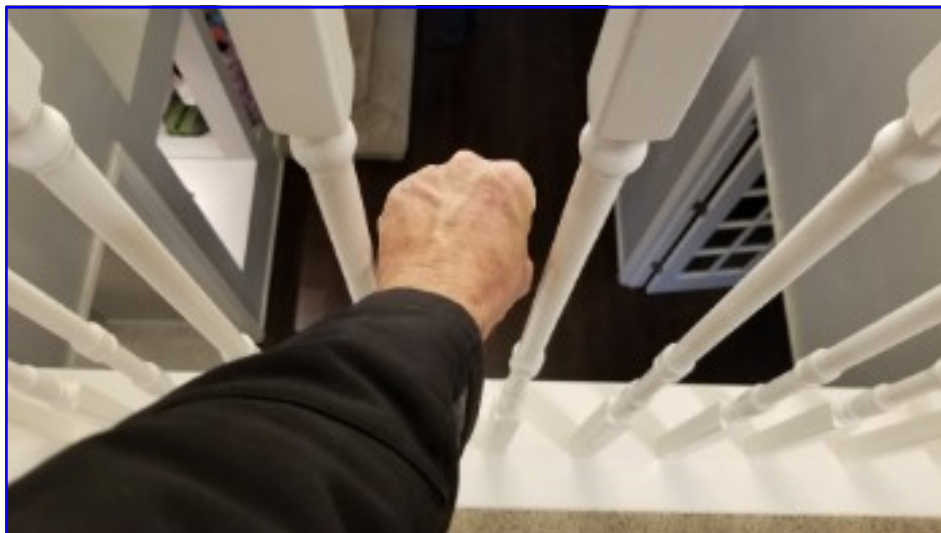
• The openings in the railing are large enough to allow an object larger than four inches to fall through. It is recommended that this condition be repaired for improved safety.

The openings in the railing are large enough to allow an object larger than four inches to fall through. It is recommended that this condition be repaired for improved safety.

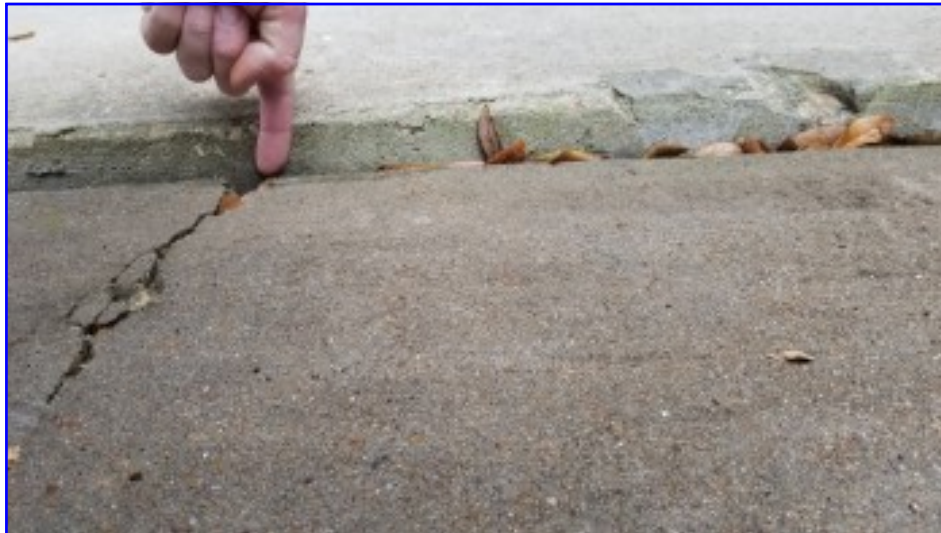
- Sections of the driveway have encountered differential movement (displacement) and a trip hazard is present. Repairs recommended for proper safety.

Sections of the driveway have encountered differential movement (displacement) and a trip hazard is present. Repairs recommended for proper safety.

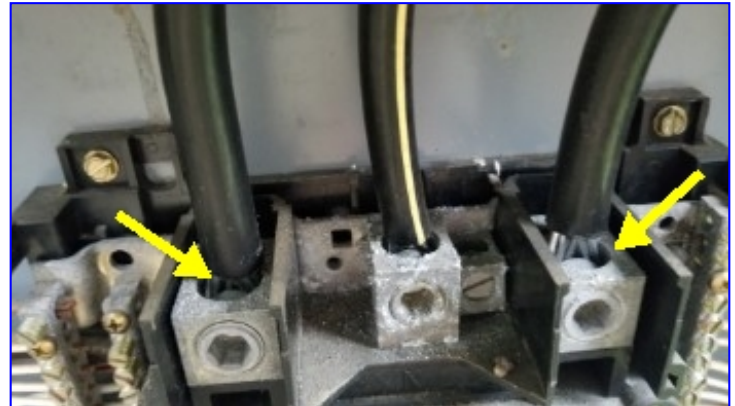
Antioxidant mastic is not applied to the aluminum main service feed wires to prevent oxidation. Repairs recommended.

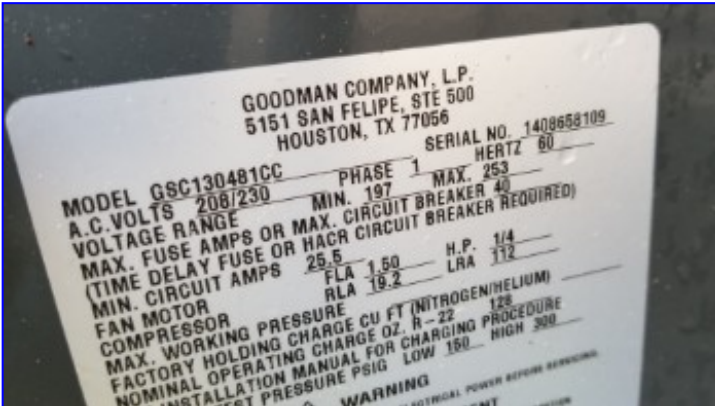
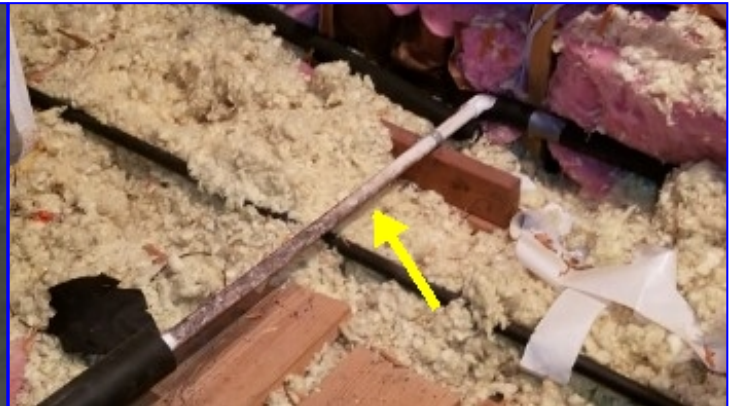
Missing insulation on primary condensate lines should be repaired/replaced to prevent moisture damage to the adjacent materials.

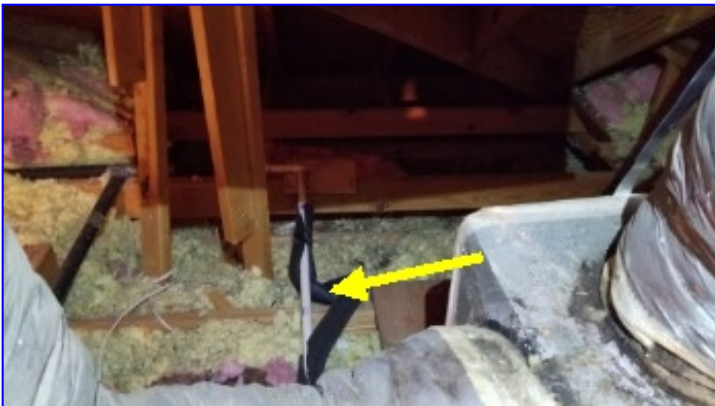
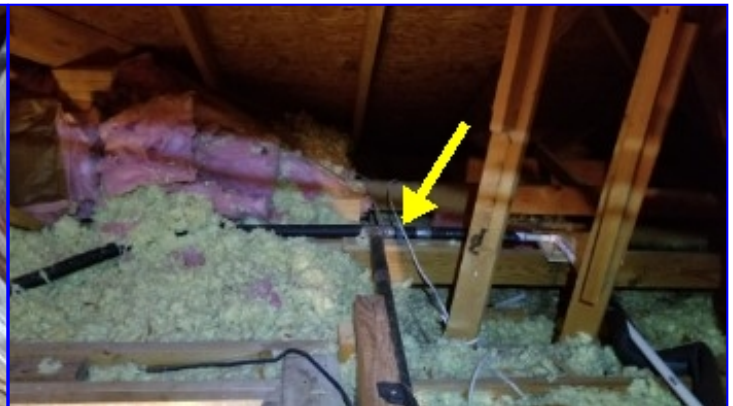
Missing insulation on primary condensate lines should be repaired/replaced to prevent moisture damage to the adjacent materials.

The primary condensate drain lines are tied together. This is not an ideal installation because if the line becomes obstructed, then both units are backed up. Recommend separating lines so that each unit is served by separate drain lines.

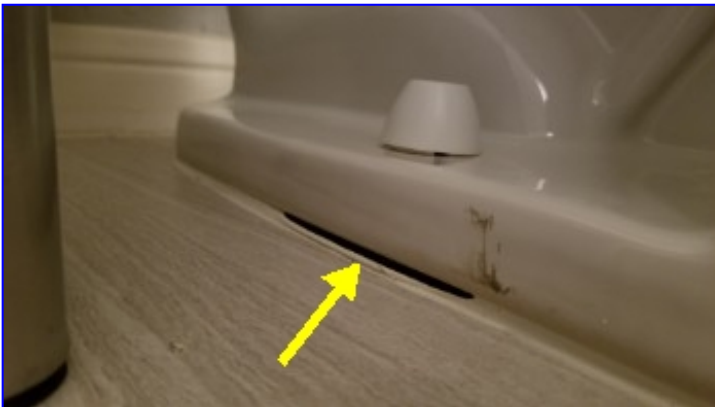
The commode in the right hand guest bathroom is not properly sealed at the floor. Improvements recommended to prevent the potential for sewer gasses entering the home.

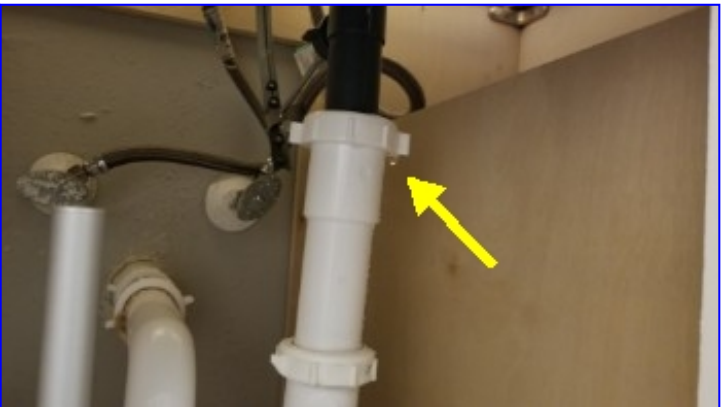
A leak was observed at the drain pipe connection under the left hand master sink. Repair recommended to prevent damage to the adjacent materials.

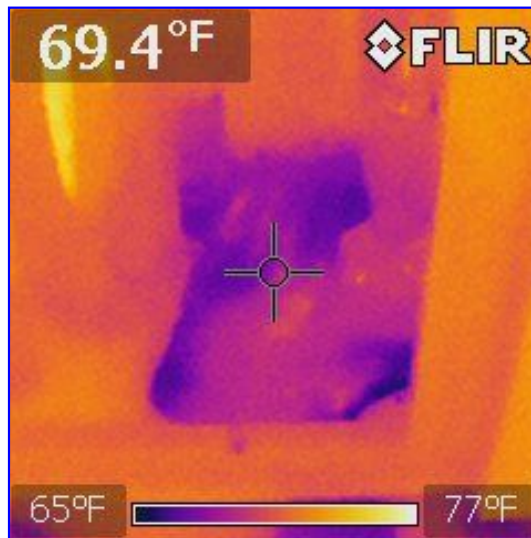
A leak was observed at the drain pipe connection under the left hand master sink. Repair recommended to prevent damage to the adjacent materials.
