Web Presentation

Property Address: 4906 Lone Oak Court, Baytown, TX

4906 Lone Oak Court

Inspections By Pat, LLC

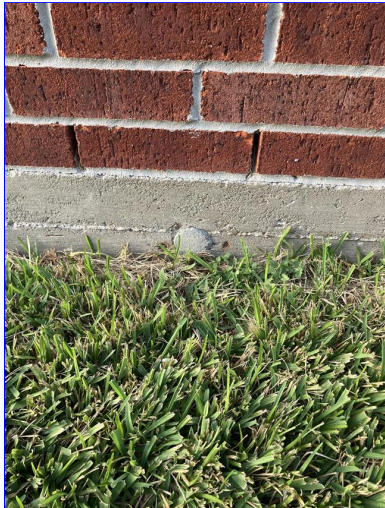
A. Item 1(Picture) Post tension anchor point

Functioning as intended. No deficiencies noted.

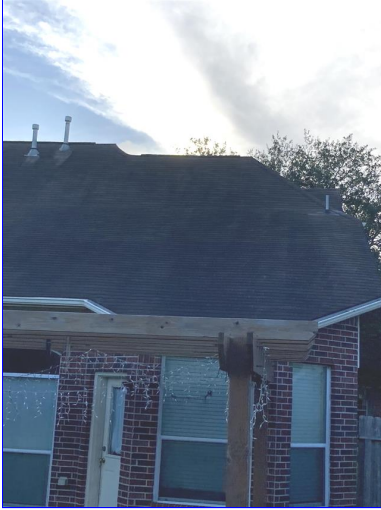
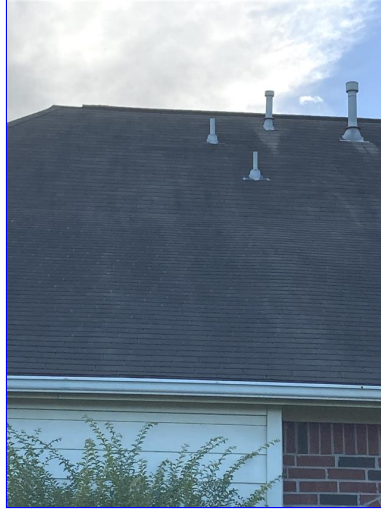
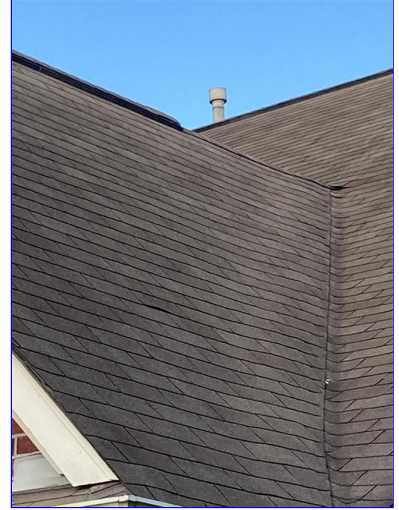
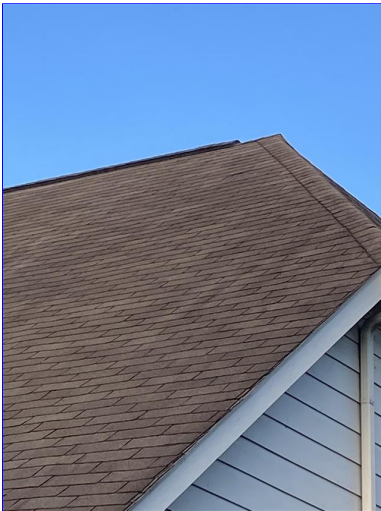
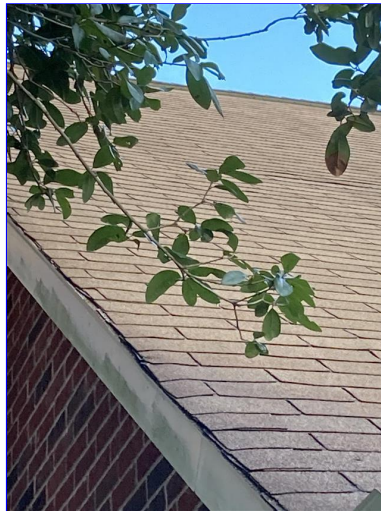
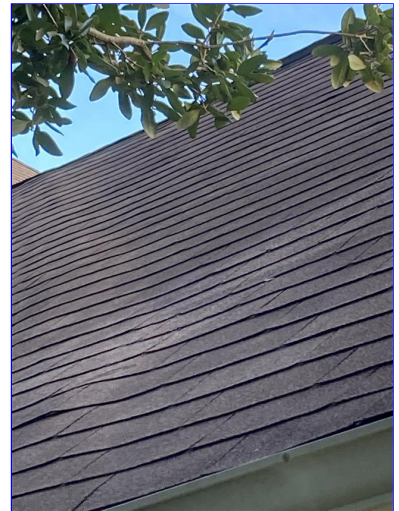
(1) Covering appeared in good condition. No leaks were active at time of inspection. Shingles appeared to be properly fastened.

(2) The roof was not walked due to the steep slope and height. Roof covering was viewed from ground level with binoculars. I could not see the backside of the chimney. If a more complete roof evaluation is desired, a roofing contractor should be retained.

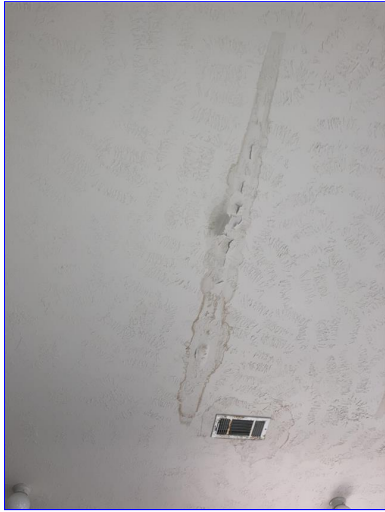
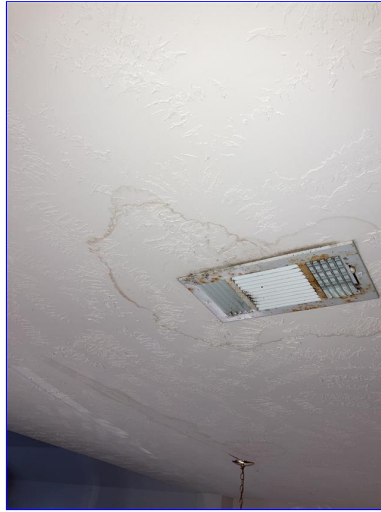
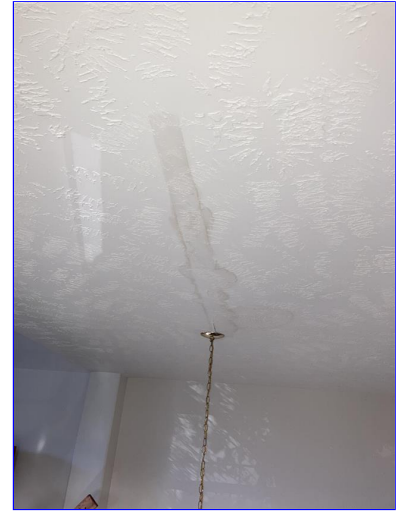
● Evidence of previous leaking observed by presence of stains on ceiling. Recommend query owner for history, damage and any repairs performed to prevent further water intrusion. If no repairs, evaluation and repairs by qualified contractor recommended. These stains are below the HVAC equipment and are likely the result of a pan(s) overflow. The pans are not equipped with emergency overflow float switches.

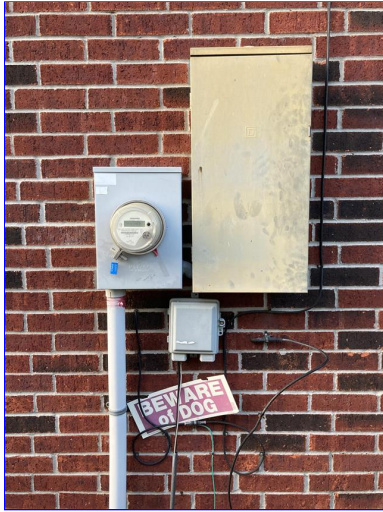
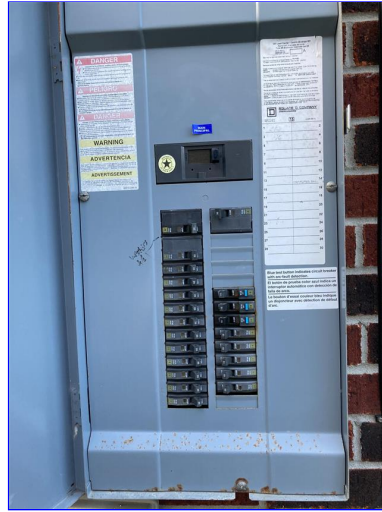
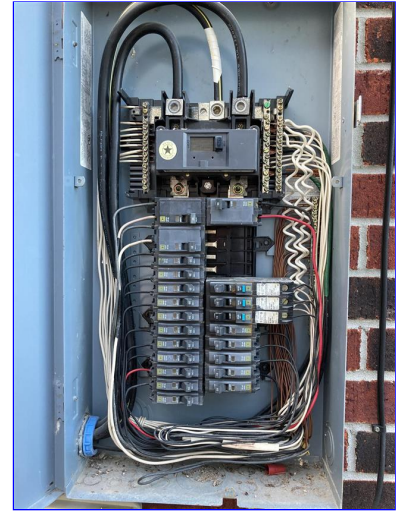
System panels installed correctly, grounded and bonded. No deficiencies of note.

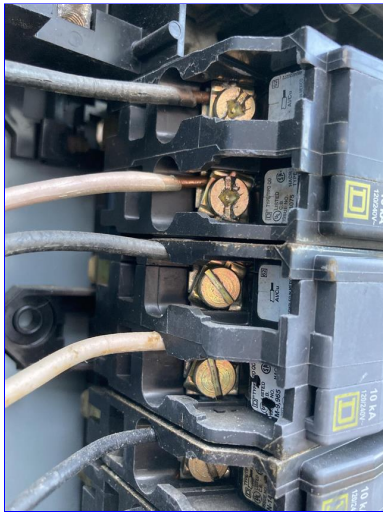
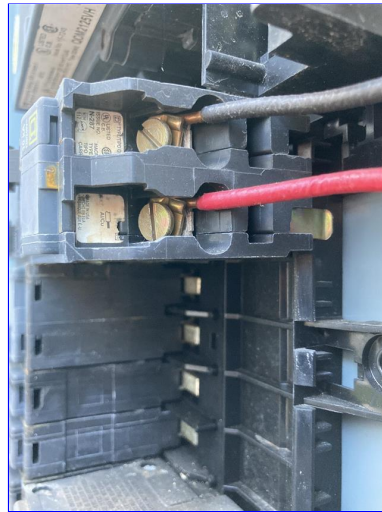
Copper wiring

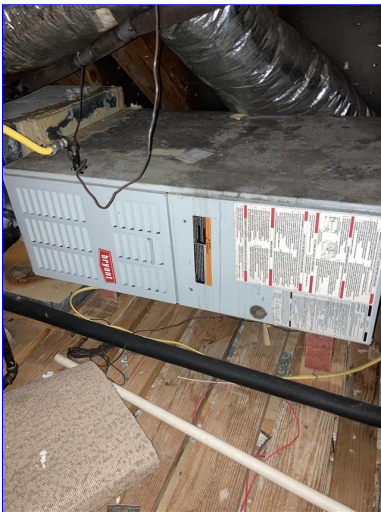
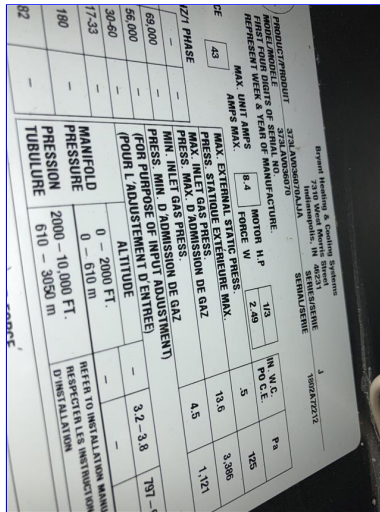
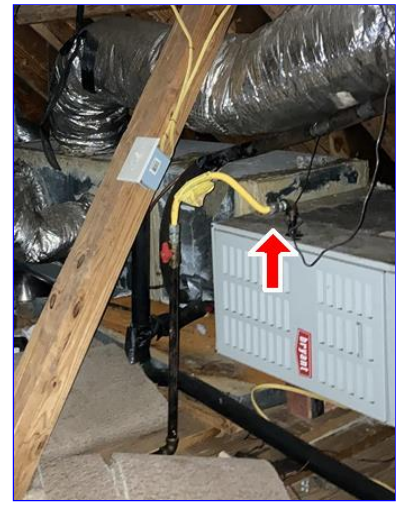
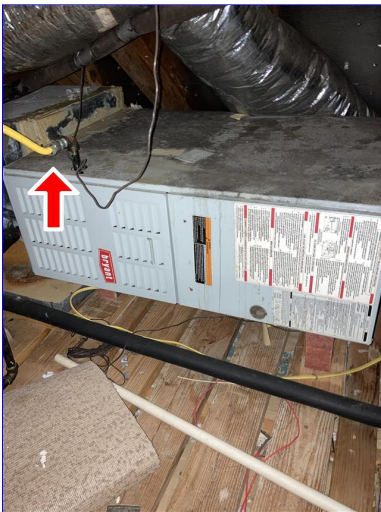
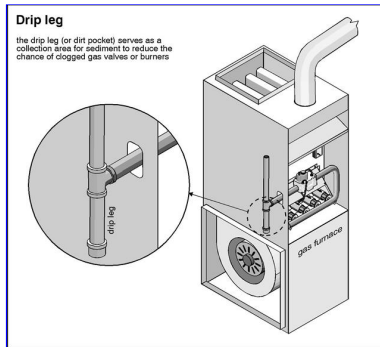
Missing settlement trap at gas supply to unit.

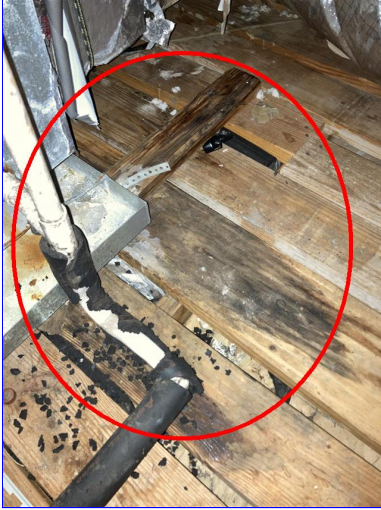
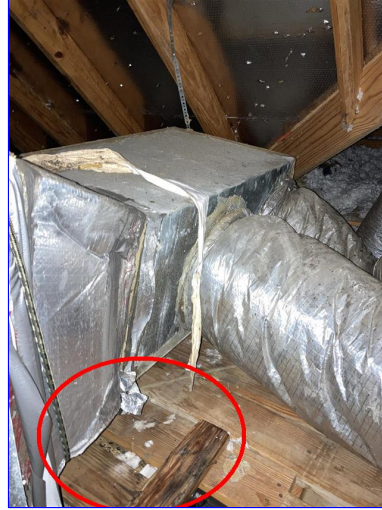
- (2) Previous water leakage observed from around the base of the indoor coil housing and or decking. The cause and remedy should be further evaluated and corrected if necessary.

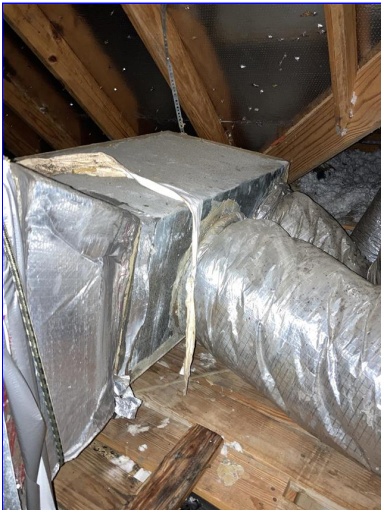
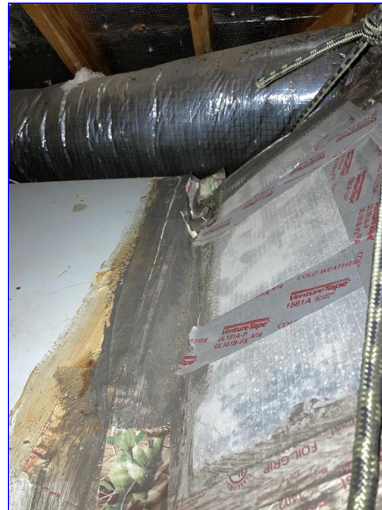
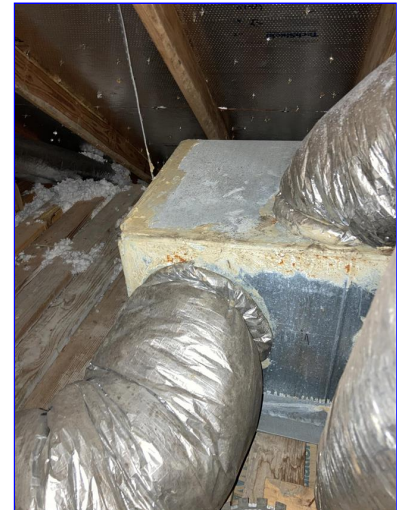
● ● (3) The cooling system plenum shows signs of past excessive moisture conditions (bio-growth stains). This is common for cooling systems that are installed in a interior closet. Ensure air flow is not restricted (dirty filters) and the condensation drain line is periodically flushed to prevent drain line blockage

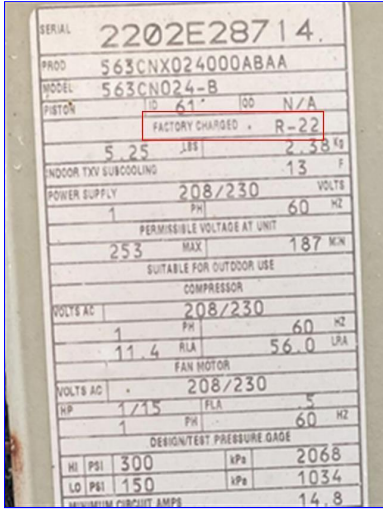
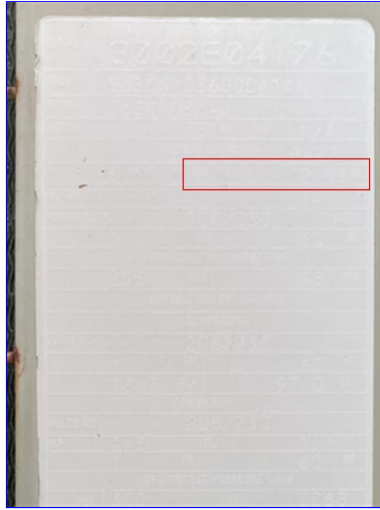
● ● (4) The AC condenser is charged with R-22 Refrigerant. This refrigerant is due to be discontinued in 2020. Recommend consulting a licensed hvac contractor to insure the systems is performance if needed.

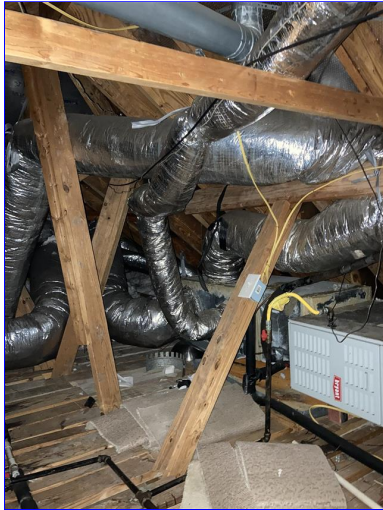
C. Item 1(Picture)

Ducts are properly hung and in good condition.

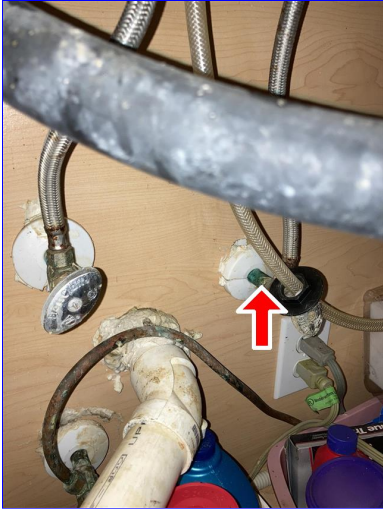
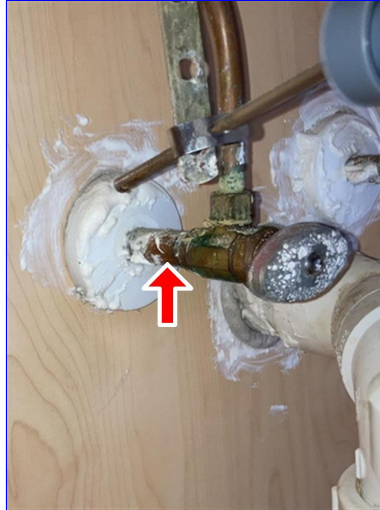
- The distribution piping all copper.

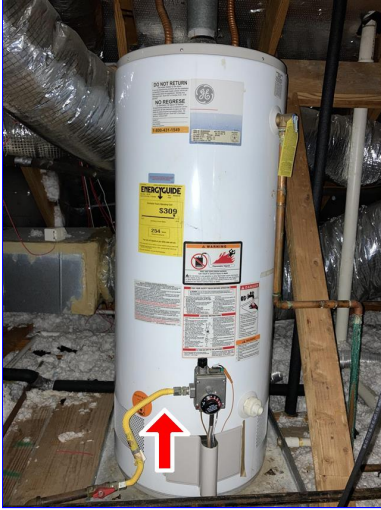
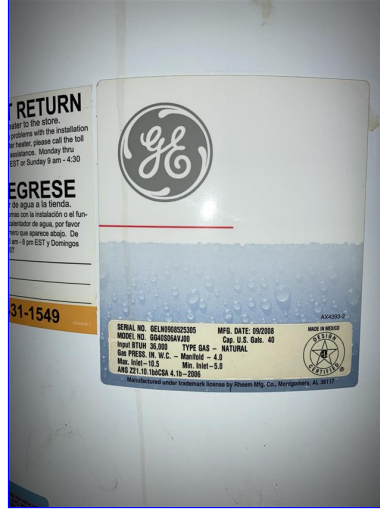
- Water heater is 12 years old. Gas supply line to unit missing settlement trap.
