Inspection Report

Property Address:
19088 Painted Blvd.
Porter TX 77365

PROPERTY INSPECTION REPORT

By: Jason Autrey T.R.E.C. #20981 / JASE Home Inspections 12/17/2020
(Name and License Number of Inspector) (Date)

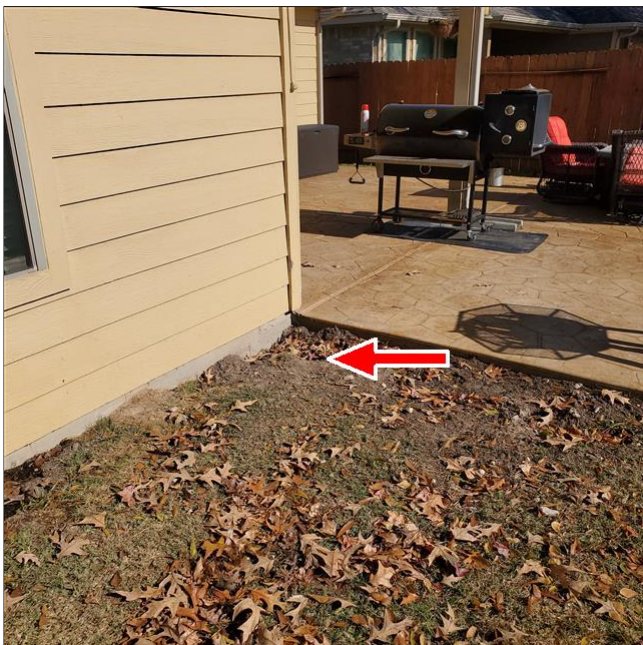
(1) There is a hole in the ground at the back near the back porch where water will not be able to drain away from the foundation. Corrections to the grade are needed at this area.

B. Item 1(Picture) Rain water will not be able to drain away from the home here.

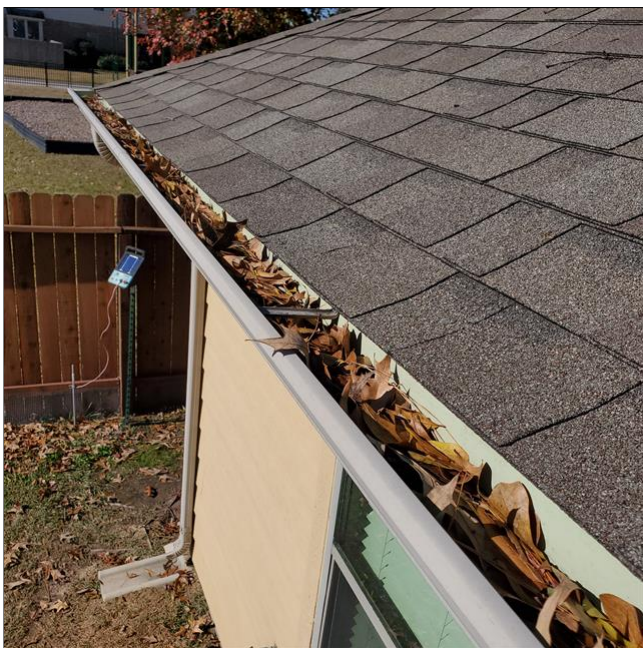
(2) The gutters are full of debris and are in need of cleaning.

B. Item 2(Picture) Gutters need to be cleaned.

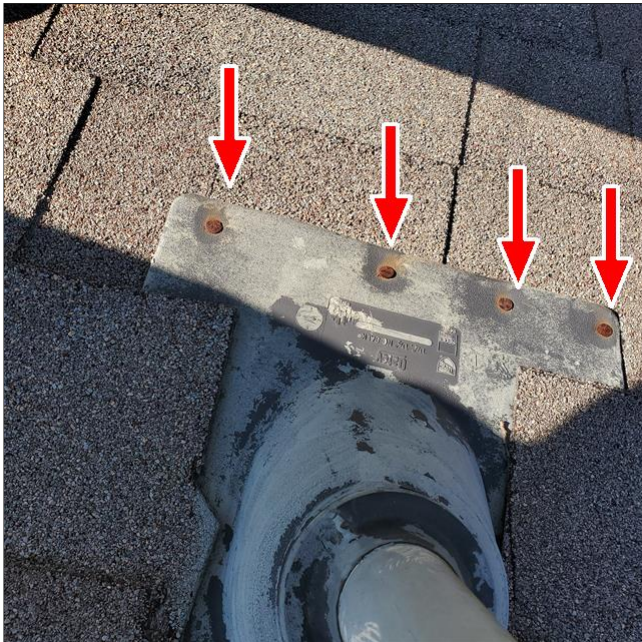
(2) Unsealed nails were observed on the roof at flashings and on shingles. If nails are used at flashings, these nails should be sealed so they are not exposed to the elements are less likely to rust over time. Rusting nails will become loose and may allow water penetration into the attic space. I recommend sealing all nails that are exposed on the roof.

C. Item 5(Picture) Nails need to be sealed.

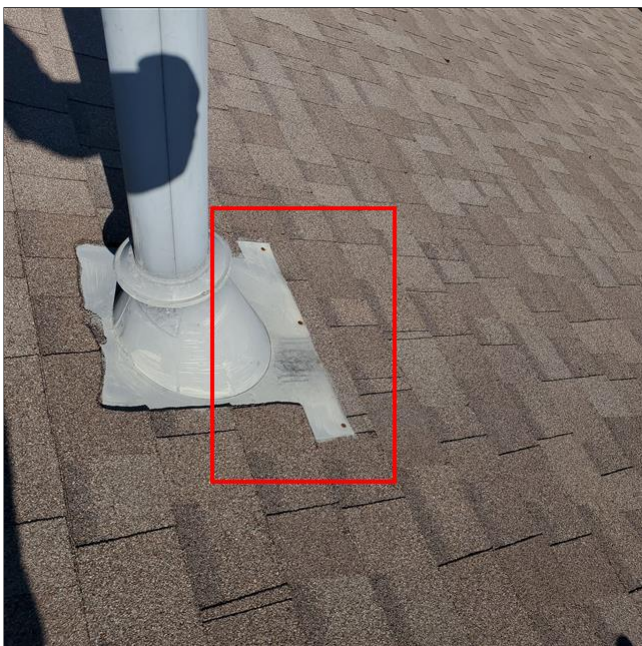
C. Item 6(Picture) Nails need to be sealed at all flashings.

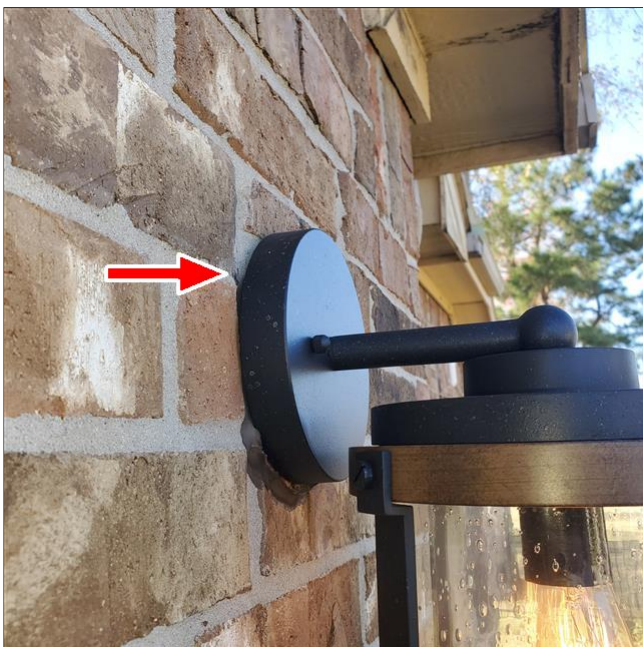
(1) All wall penetrations at the exterior of the home need to be sealed to the walls to keep unwanted moisture from entering the walls at these locations. The following photos are not inclusive of all wall penetrations that need to be sealed.

E. Item 1(Picture) Need to seal all light fixtures to the wall.

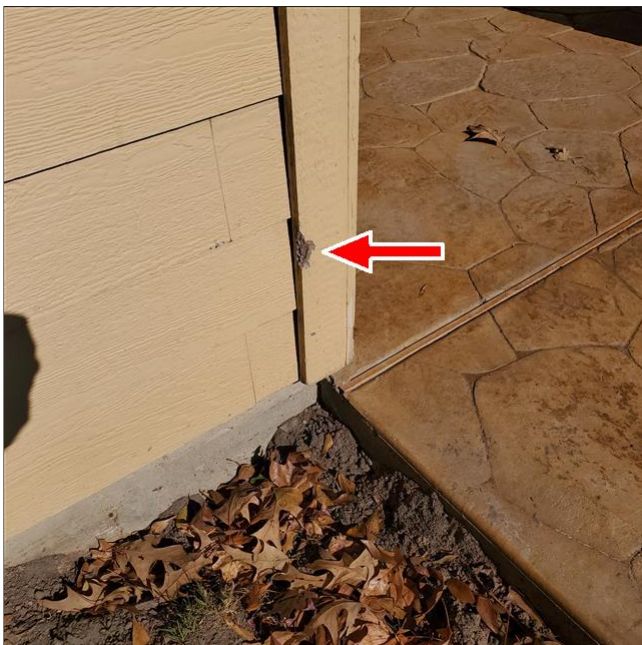
(2) Cosmetic damages were noted at a piece of vertical trim at the siding at the back of the home. The damages need to at least be sealed and painted to protected the material.

E. Item 2(Picture) Need to seal and paint siding trim to protect from deterioration.

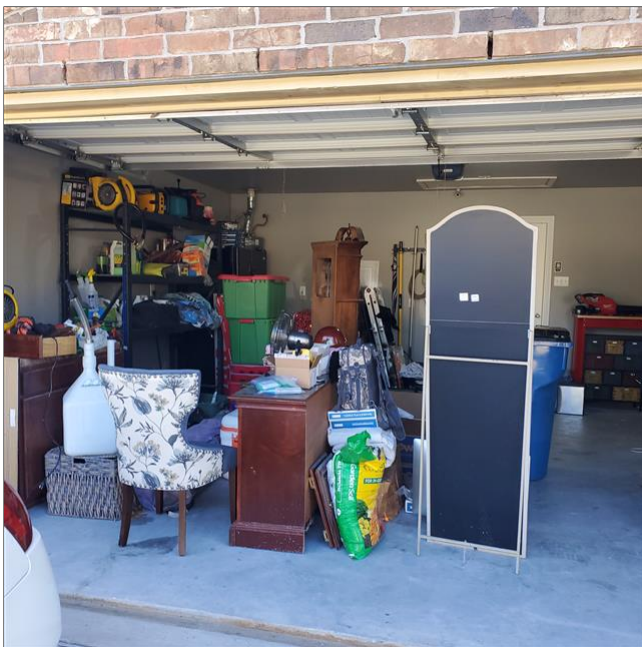
(3) The inspector was unable to perform a full evaluation of the garage walls and floors due to the large amount of personal items being stored.

E. Item 3(Picture) Overview of garage.

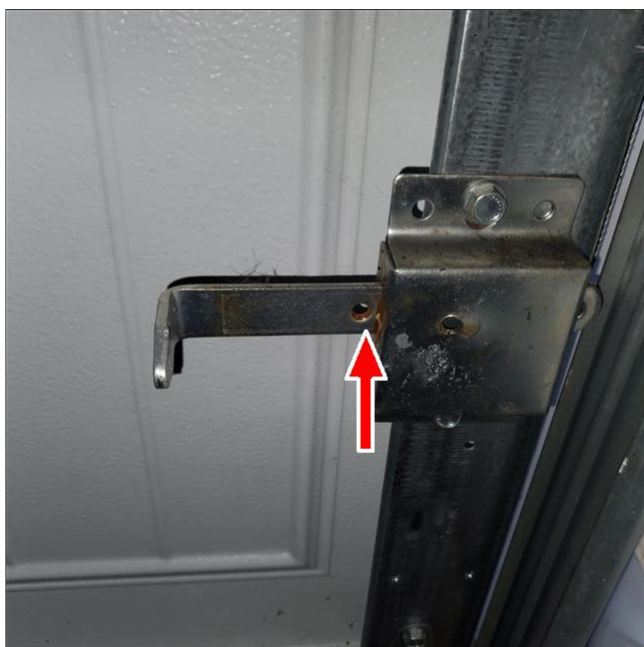
(1) The Texas Real Estate Commission requires inspectors to report as deficient a garage door lock assembly that is not disabled if a garage door opener is installed for the door. Operating the garage door opener with a garage door locked can cause significant damage to the door. It is recommended that a bolt be inserted into the hole on the assembly in the photo provided.

G. Item 1(Picture) Install a bolt here to disable the lock.

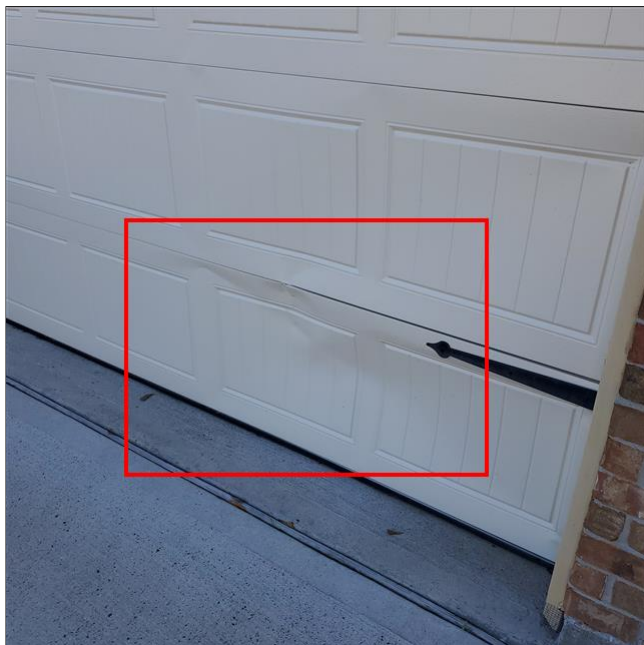
(3) Impact damage was observed to the garage door. This has not affected the door being functional. Replacement of the damaged door can be completed by a qualified professional.

G. Item 2(Picture) Damage to garage door.

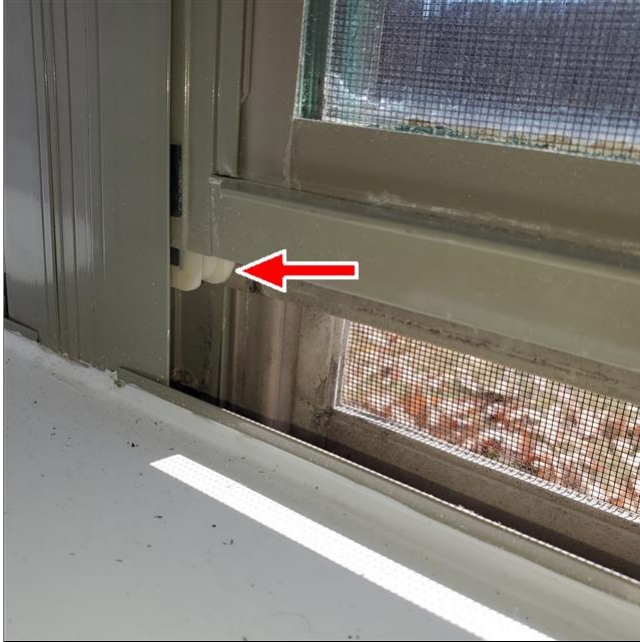
(2) A balance rod is loose at the right side window in the master bedroom. This made the window difficult to operate. A qualified window professional can repair as needed.

H. Item 1(Picture) Photo shows bottom of rod is visible.

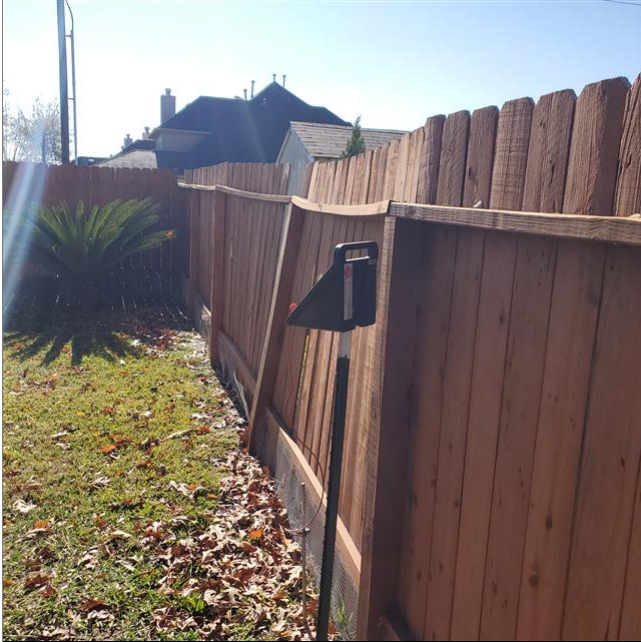
The fence is leaning in the backyard at the right side. This is a potential safety hazard and needs to be repaired.

L. Item 1(Picture) Photo of leaning fence.

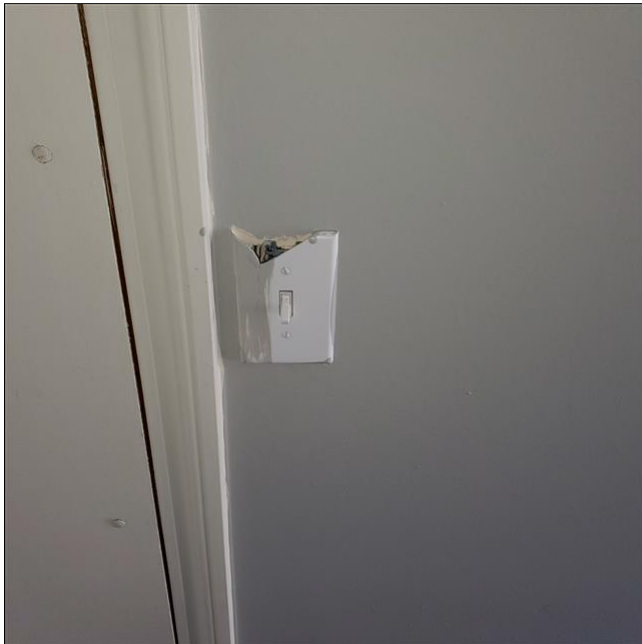
(2) The cover plate for the attic light switch which is in the garage is damaged.

B. Item 1(Picture) Photo of damaged cover plate.

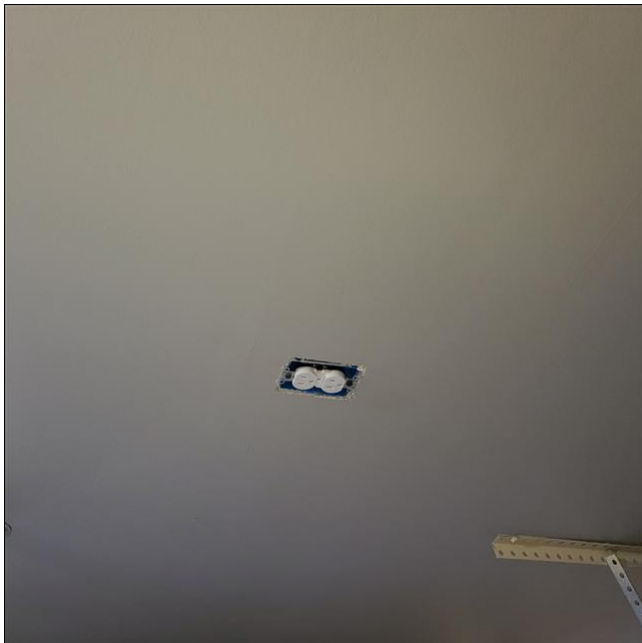
(3) An outlet at the ceiling in the garage is missing a cover plate and needs to have one installed.

B. Item 2(Picture) Outlet missing a cover plate.

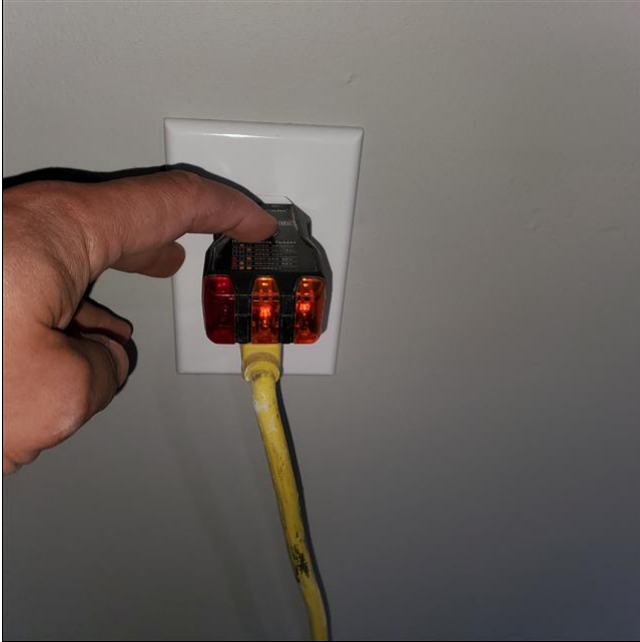
(4) Current building standards state that all garage outlets should be GFCI protected. There were numerous outlets in the garage that are not GFCI protected. A licensed electrician can upgrade.

B. Item 3(Picture) Garage outlets did not trip when tested.

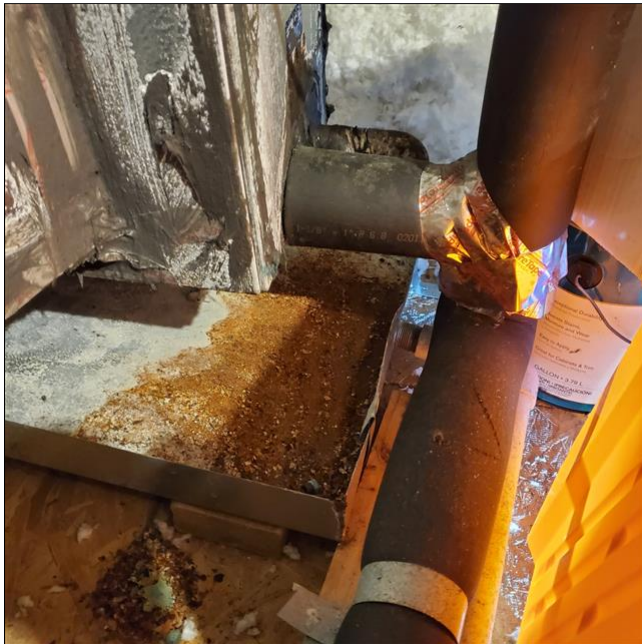
(2) The inspector observed a good amount of rust in the emergency drain pan under the evaporator coils. This is a sign that the primary drain line has clogged in the past and water has entered the pan as a result. After further investigation it was noted that the rubber primary drain line at the guest bathroom is very kinked and is likely not keeping up with the amount of condensation that is draining which is causing water to enter the pan. A LICENSED PLUMBER should repair the drain line to ensure proper drainage of the condensation.

B. Item 3(Picture) Photo of drain pan.

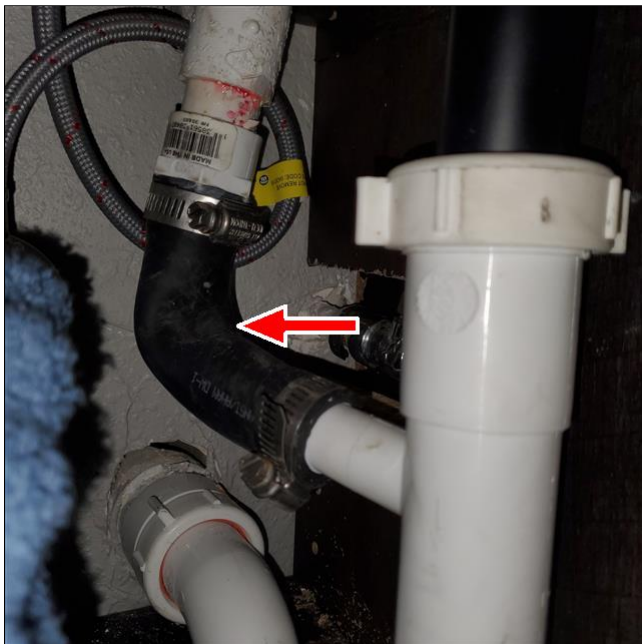
B. Item 4(Picture) Rubber drain is kinked.

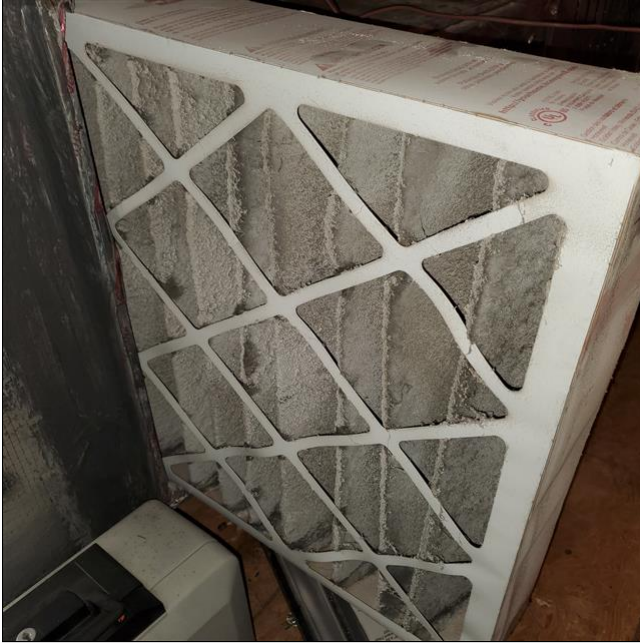
(2) The media air filter in the attic is extremely dirty and is in need of replacement.

C. Item 3(Picture) Photo of dirty air filter.

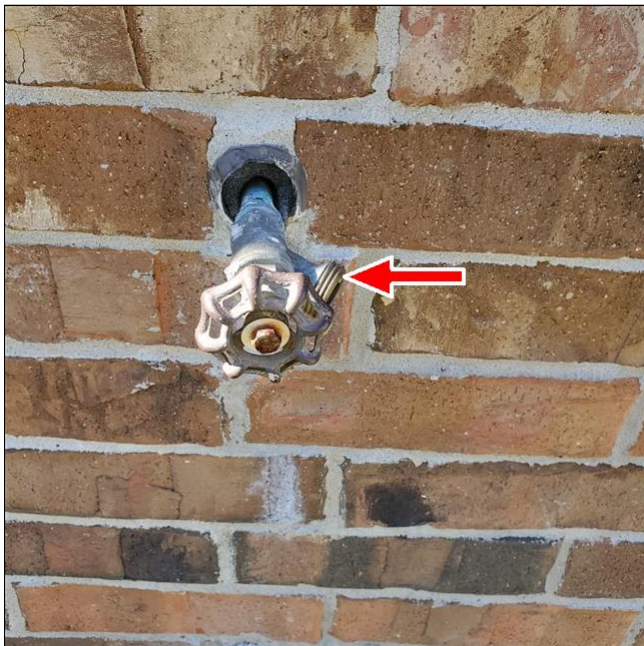
(1) The hose bib at the left side of the home is not installed properly as it is not facing the ground.

A. Item 1(Picture) Hose bib faces to the side.

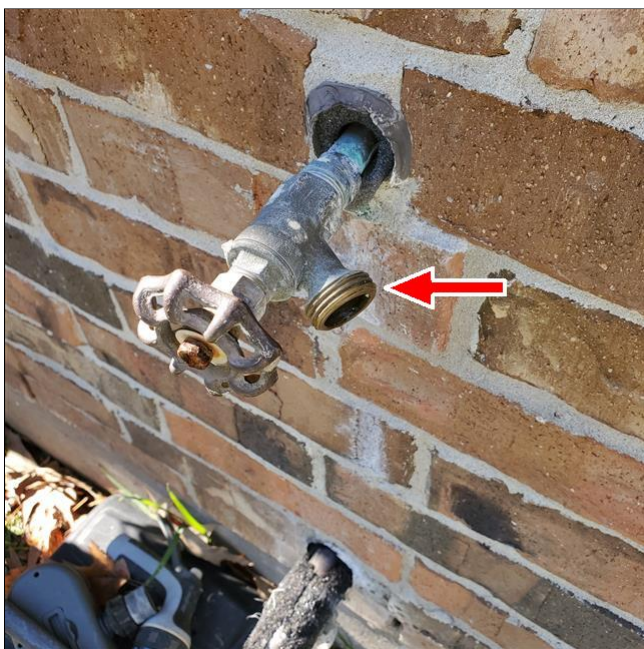
(2) Vacuum breakers were not installed at the hose bib at the left side of the home. It is recommended that vacuum breakers be installed at all hose bibs to prevent the back flow of potentially contaminated water to the drinking supply.

A. Item 2(Picture) No vacuum breaker at this hose bib.

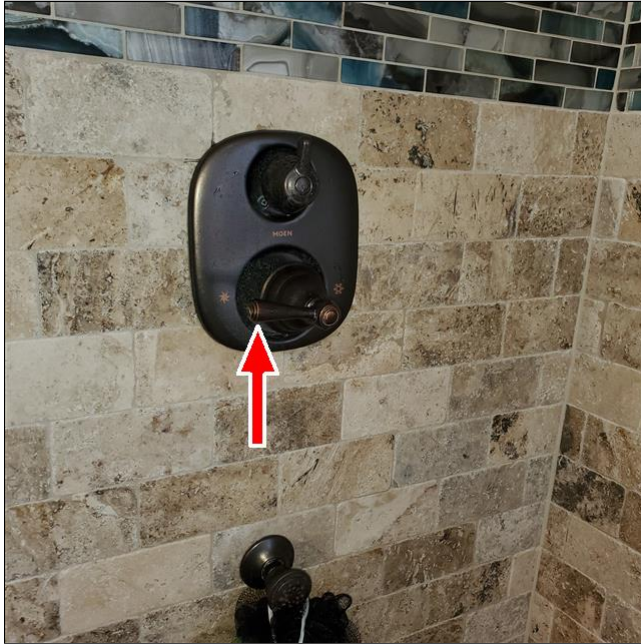
(3) Hot and cold water is reversed at the master shower front mixer valve. When the valve is opened to the left hot water should be supplied and cold water should be supplied. A licensed plumber should make corrections.

A. Item 3(Picture) Valve is opened to the left and cold water was incorrectly supplied.

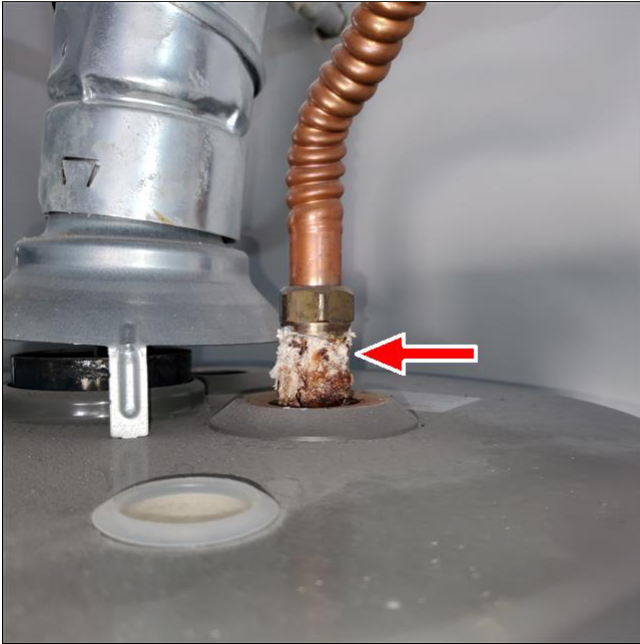
(2) Rust/corrosion was observed at the cold water connection at the galvanized nipple at the top of the water heater. It was discussed during the inspection that rust/corrosion at this location will lead to a leak in the future if not repaired. It is likely that when a plumber attempts to loosen the connection the galvanized nipple will break and a new water heater will be needed.

C. Item 2(Picture) Photo of rust/corrosion.

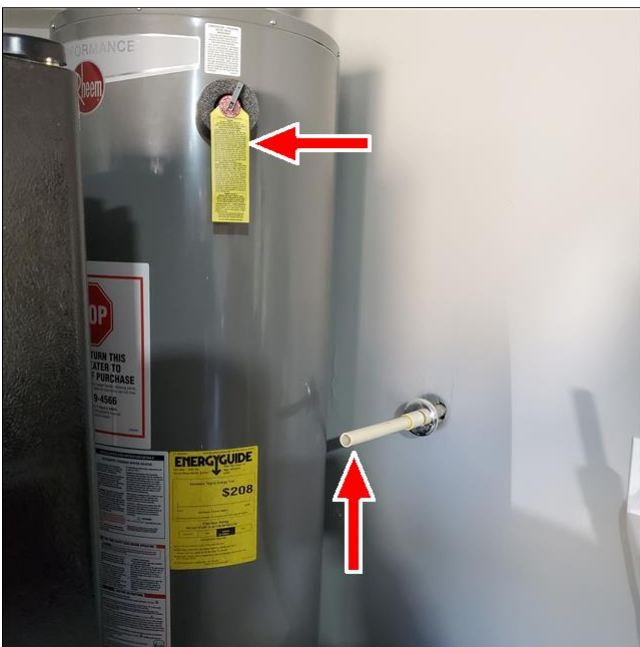
(3) The temperature/pressure relief (TPR) valve had no discharge pipe installed. If the valve were to activate while a person was nearby, that person could be badly burned. The Inspector recommends that a properly-configured TPR discharge pipe be installed by a qualified plumbing contractor. The TPR VALVE SHOULD NOT BE TESTED UNTIL A PROPER DISCHARGE PIPE HAS BEEN INSTALLED!

C. Item 3(Picture) PVC pipe should be connected to the TPR valve.

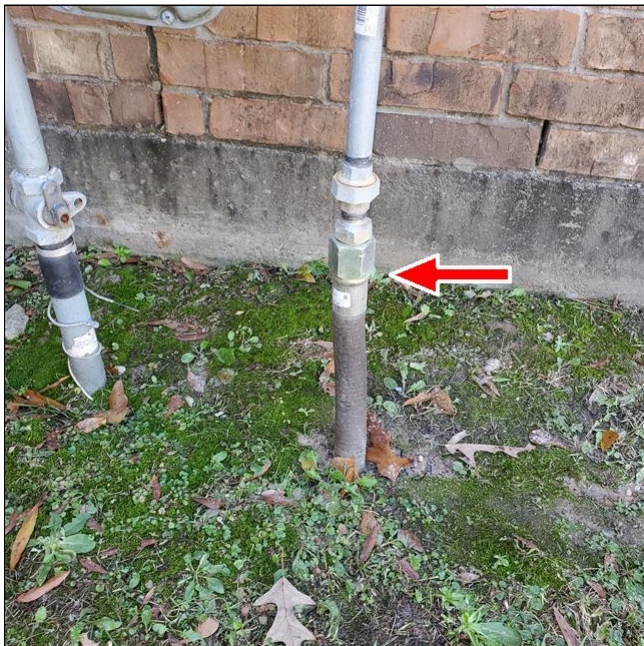
There was an obvious smell of gas that was observed at the gas meter during the inspection. It is strongly recommended that the utility company be contacted to make repairs to the potential gas leak as soon as possible.

H. Item 1(Picture) Gas smell was present in this area.
