Saji # Spections LLC

21611 Live Oaks Spring Dr, Katy, TX 77450
Inspection prepared for: Mike Rothchild
Date of Inspection: 2/28/2022 Time: 11:00 AM
Age of Home: 1993 Size: 2434 Sq Ft
Weather: Clear & Cool
Order ID: 194

PROPERTY INSPECTION REPORT

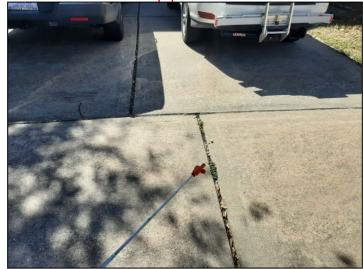
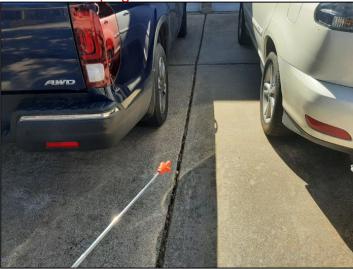
- Minimal damage / deterioration were noted present at the wooden expansion joints between various driveway or walkway sections. Maintaining this seal will help prevent uneven section and excessive sloping.

EXPANSION DETERIORATION

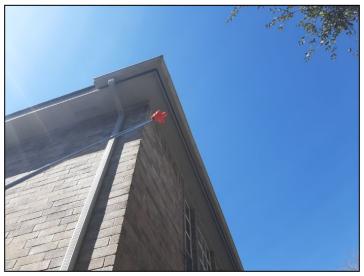
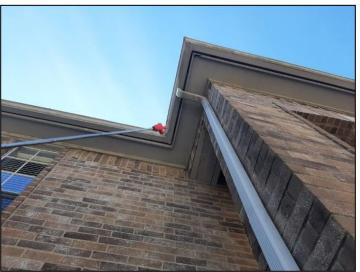
WOOD ROT

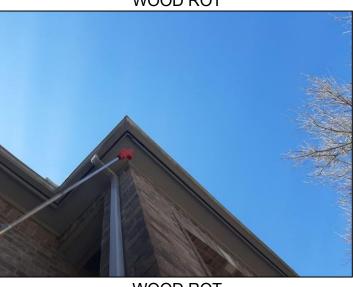
WOOD ROT

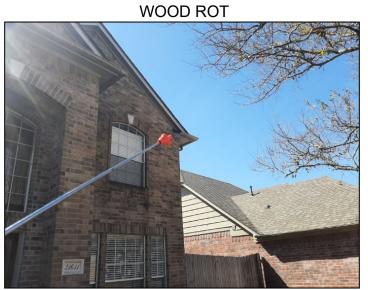
- All deficiencies noted in red OR captioned in the pictures should be further evaluated by a qualified professional.
- Insufficient insulation was noted in the attic space per today's current standards. Improvements to the insulation may increase energy efficiency.
- The attic stairway is NOT insulated. This is a point of energy loss.
- Wood Rot / Deterioration were noted at various areas of the fascia / soffit boards.
- Missing / Damaged moisture wrap or barrier was noted present at the inside the the attic area. Moisture buildup and intrusion CAN be a factor leading to mold and high humidity.
- Gap(s) are present where the fascia board meets the roof line due to vermin activity. Ensure all areas are sealed as needed.

OPENING TO ATTIC AREA DUE TO VERMIN ACTIVITY

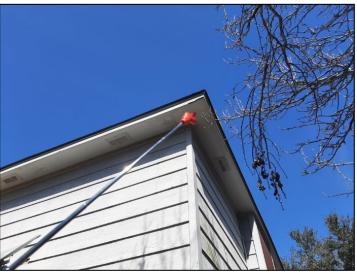
WOOD ROT

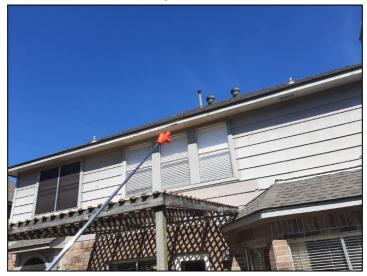
WOOD ROT

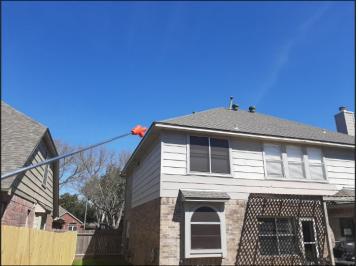
WOOD ROT

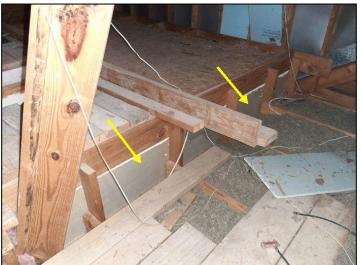
MINIMAL INSULATION PRESENT

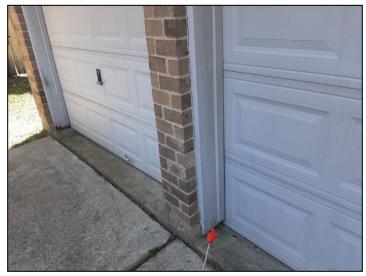
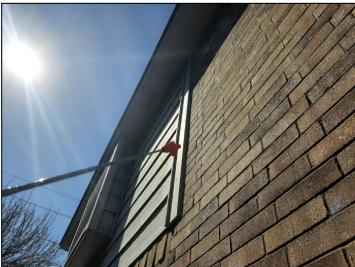
WOOD ROT

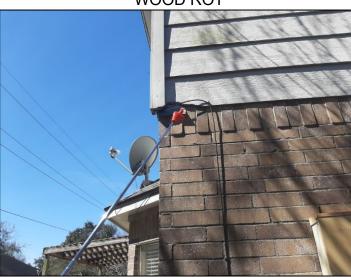
SEAL DETERIORATION

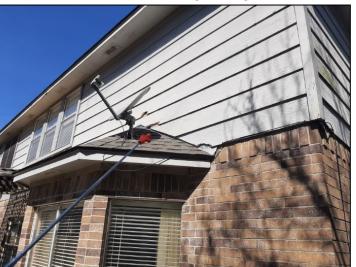
WOOD ROT

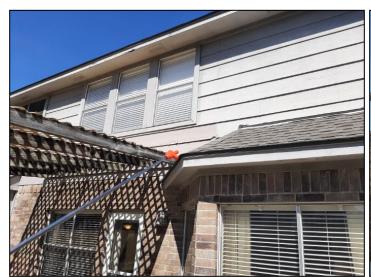
- Maintain all exterior finishes, caulking, and other sealants at any dissimilar material abutments and all penetrations to the walls and roof. This inexpensive task aids in the prevention of moisture intrusion and saves on costly repairs.
- All deficiencies noted in red OR captioned in the pictures should be further evaluated by a qualified professional.
- Seal deterioration / Unsealed areas were noted at one or more exterior siding intersections. Ensure all areas are properly sealed to help prevent issues and water intrusion.
- Signs of paint deterioration / fading or unpainted areas were noted at one or more spots of the exterior siding.
- One or more locations on the exterior cladding showed evidence of paint peeling, fading, blistering and/or cracking and repairs should be considered.
- The exterior siding was found damaged and deteriorated at one or more locations.

DAMAGED SIDING

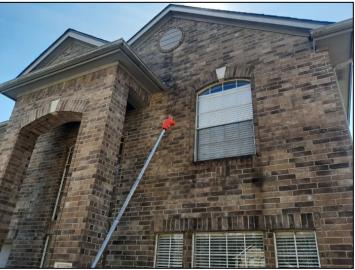
MINOR WALL STAINING DUE TO LEAKING GUTTERS

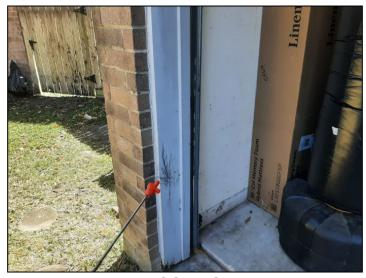
WOOD ROT

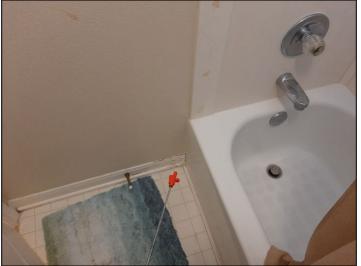
MINOR DAMAGE AT WALL

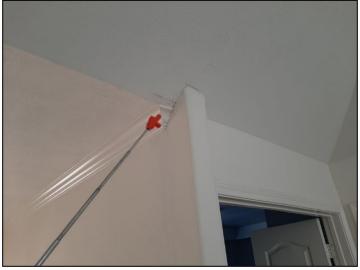
MINOR DRYWALL CRACK

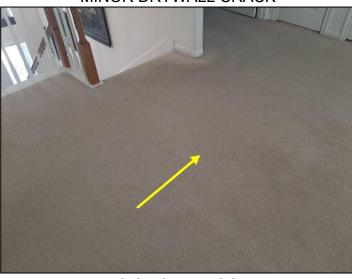
NOISY SUB FLOOR

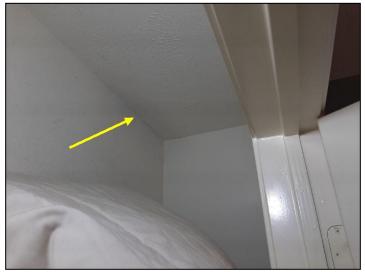
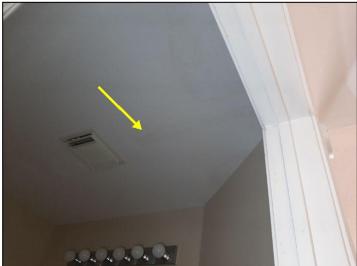
OLD WATER STAIN NEEDS TO BE PAINTED

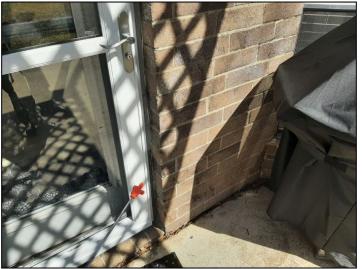
DETERIORATION TO DOOR FINISH

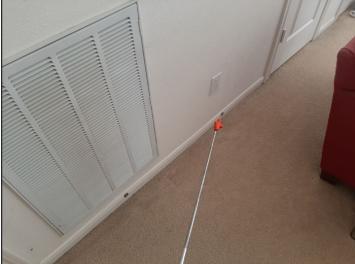
INOPERABLE HARDWARE

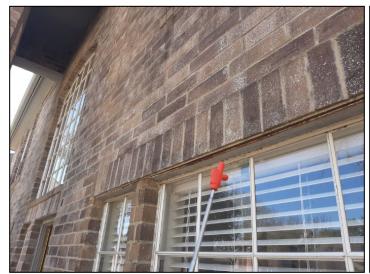
RUSTED LINTEL

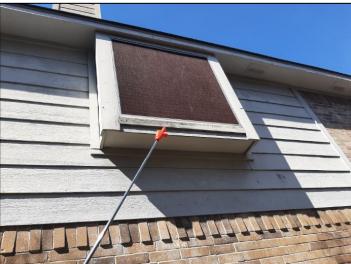
WOOD ROT

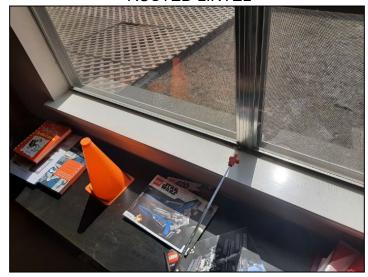
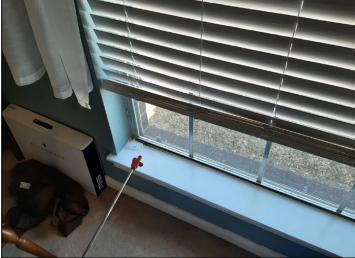
DAMAGED WINDOW SILL

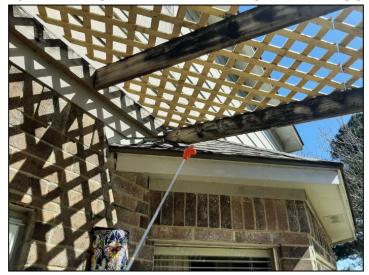
DAMAGED / UNSECURED PORCH COVER SECTION

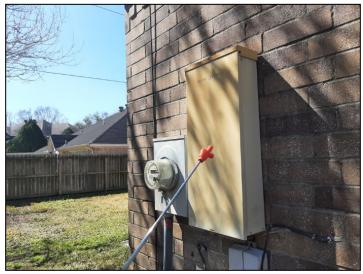
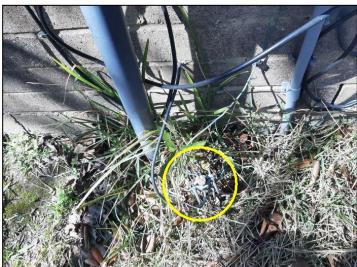
- All deficiencies noted in red OR captioned in the pictures should be further evaluated by a qualified professional.
- Dead front removed from service panel. No deficiencies to report at the time of the inspection.
- Missing antioxidant paste for aluminum service entrance conductors at the exterior service panel.
- Service panel not properly sealed to exterior wall. This can allow moisture penetration in to panel enclosure and wall.
- Signs of deterioration and rusting noted at the exterior electrical panel.

MINIMAL DETERIORATION AT PANEL

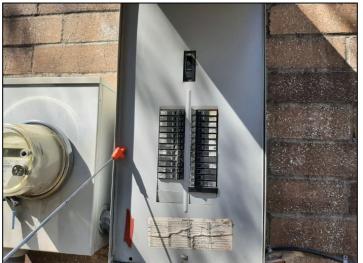
UNSEALED AREAS

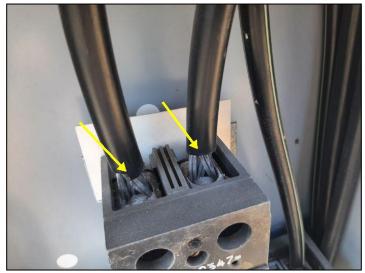
MISSING ANTIOXIDIZER

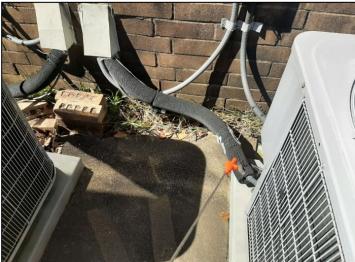
INSULATION DETERIORATION

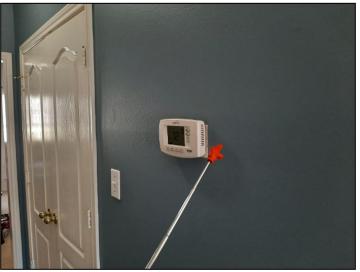
LOOSE / UNSECURED THERMOSTAT

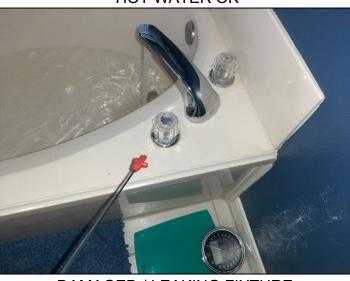
DAMAGED / LEAKING FIXTURE

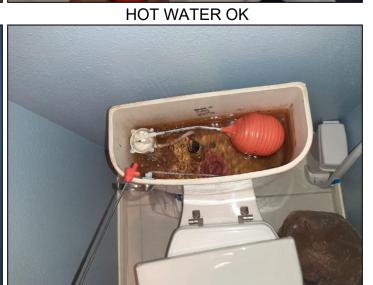
DAMAGED / LEAKING FLUSH VALVE

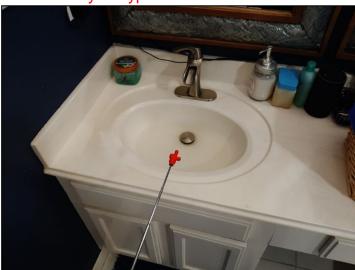
SLOW / CLOGGED DRAIN

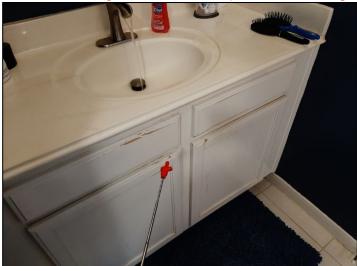
• The white plastic covering for the cabinets were noted peeling or coming loose at multiple areas. Although minor some repairs or securing may be needed.

DETERIORATION / PAINT CHIPPING

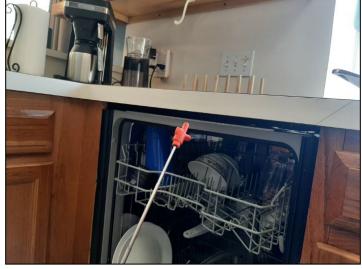
LOOSE / UNSECURED APPLIANCE

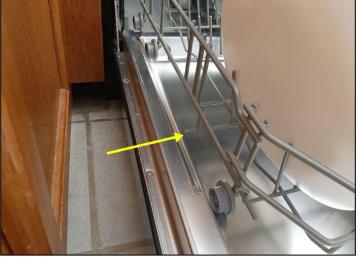
- The dishwasher was operated in 'Normal' mode and performed as intended. No deficiencies to report at the time of the inspection.
- Loose / unsecured or missing rollers were noted present at the tray or drawer. Some repairs or securing may be needed.
- Unit is not properly fastened or is loose / unsecured. Recommend securing to countertop using the appropriate length screws to prevent tip from exiting top of counter causing damage and preventing issues with the dishwasher and also adjusting the legs as needed to prevent movement when door is loaded or opened / closed.

DAMAGED / MISSING ROLLER

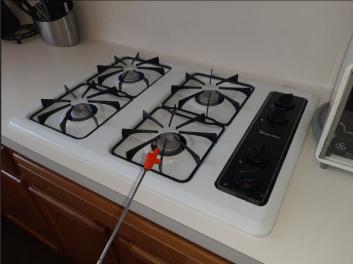
- Cooktops: natural gas
- Oven : electric
- Oven operated when tested and achieve proper temperature settings. Oven is tested at 350 degrees F
- The following gas burners were noted damaged / inoperable or not igniting from the pilot. Some repairs or updates will likely be needed: FRONT RIGHT

INOPERABLE BURNER

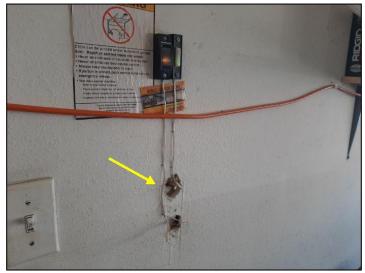
EXPOSED WIRES / DAMAGED WALL SECTION

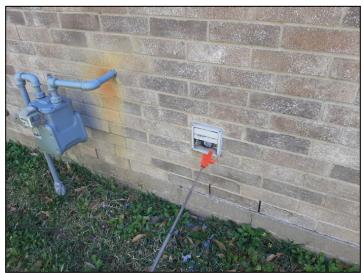
DAMAGED EXTERIOR VENT COVER

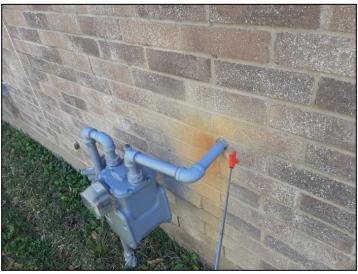
MISSING BONDING

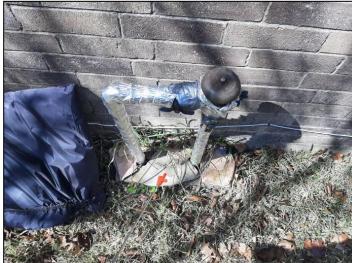
LOOSE / UNSECURED CONDUIT
