FIG Services LLC d/b/a FOX INSPECTION GROUP
Property Inspection Report #200414SG-1035 West 24th Street
8616 Daffodil St. Houston, TX 77063
(Office) 713.723-3330 (Email) office@foxinspectiongroup.com

PROPERTY INSPECTION REPORT

Concerning: 1035 West 24th Street, Houston, TX 77008
(Address of Inspected Property)

By: Steven Gibson, TREC PI 20994 04/14/2020
(Name and License Number of Inspector) (Date)

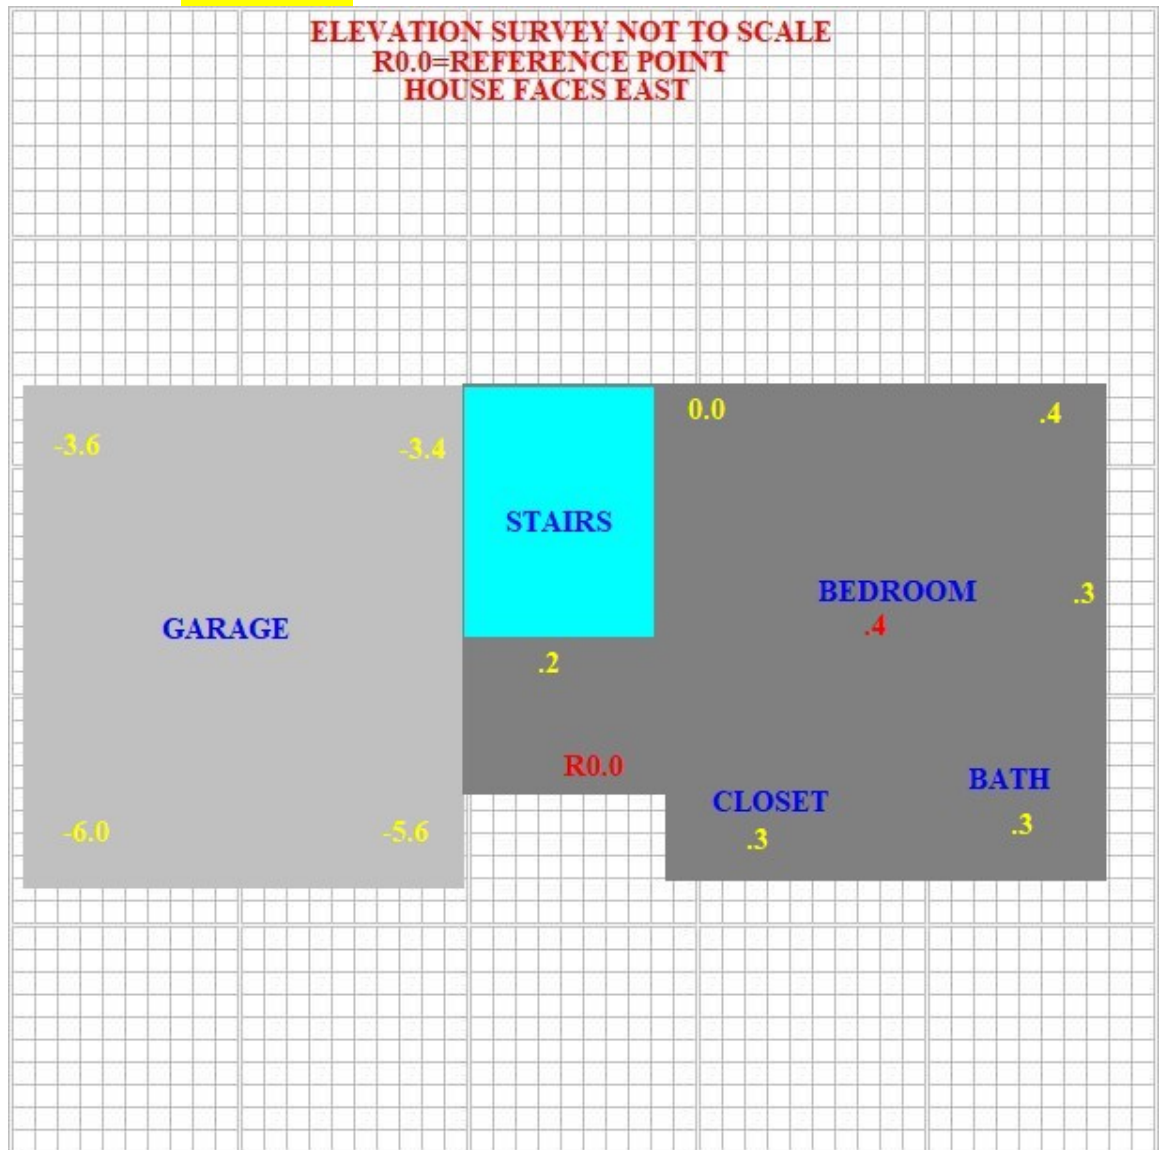
A foundation elevation survey was conducted during the inspection. The floorplan below represents data gathered using a Zip Level or similar instrument and adjusting for floor covering height differences. i.e. differences between tile, carpet and wood flooring(except step down to garage). Measurements are listed to the nearest 1/10th of an inch. Greatest variance was **.4 INCHES**

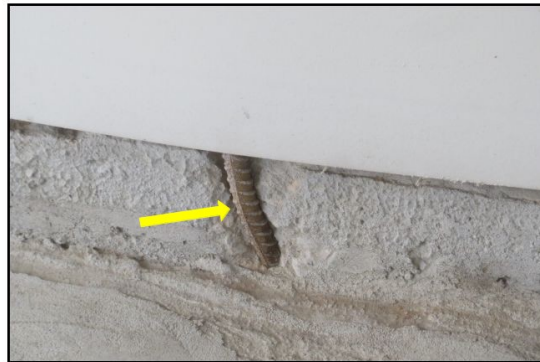
Exposed steel observed at one or more locations needs repair. (Garage)

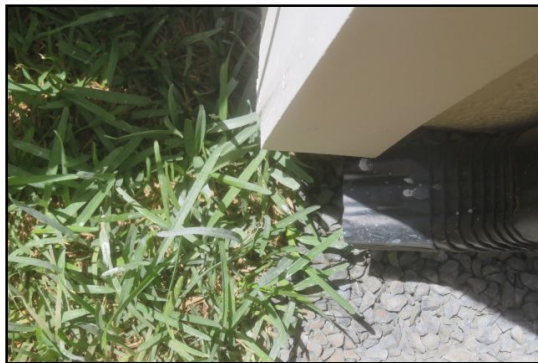
Downspouts need splash blocks at bottoms to prevent soil erosion.

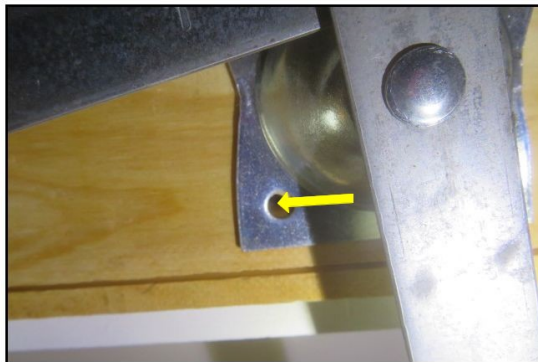
Inadequate nailing used to secure the frame of the stairway into ceiling opening.

Not installed per manufacturer's installation instructions. Missing securing nails/lag bolts in holes of metal pivot points and corner braces.

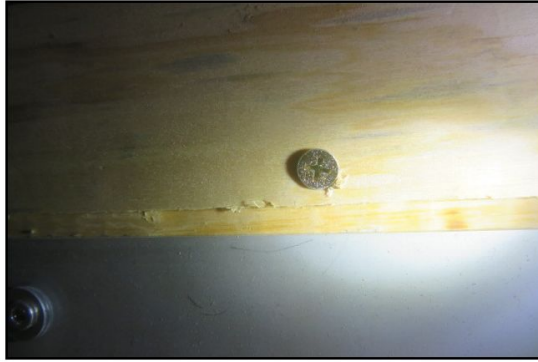
Stairway frame is inadequately secured into ceiling opening with screws, recommend complying with manufacturer's specifications calling for 16d nails or 1/4 inch diameter lag screws be added to secure stairway frame to the ceiling at specific locations.

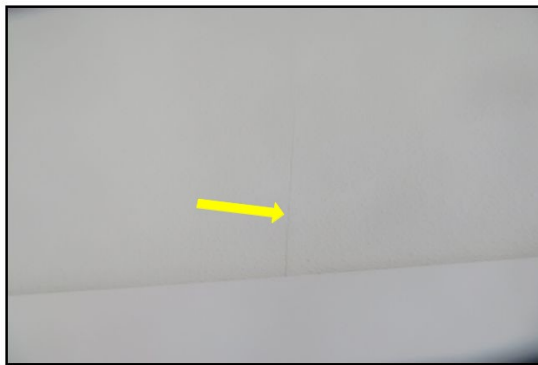
Crack in living room wall sheetrock over balcony door.

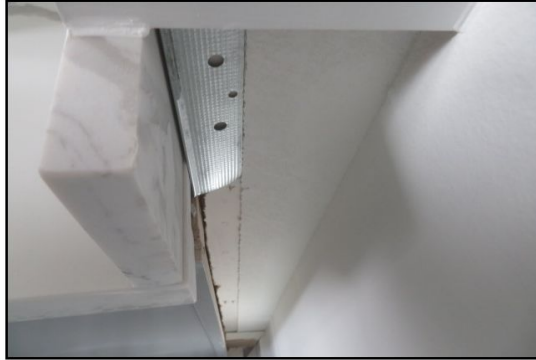
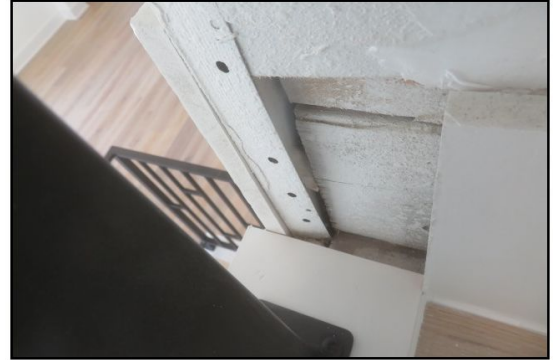
Base board/trim missing on stairway and powder room.

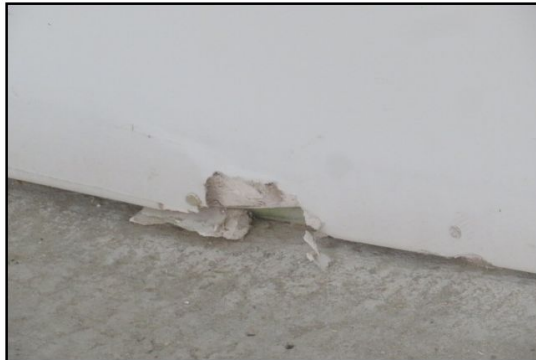
Cosmetic sheetrock damage observed in one or more areas bottom of garage wall.

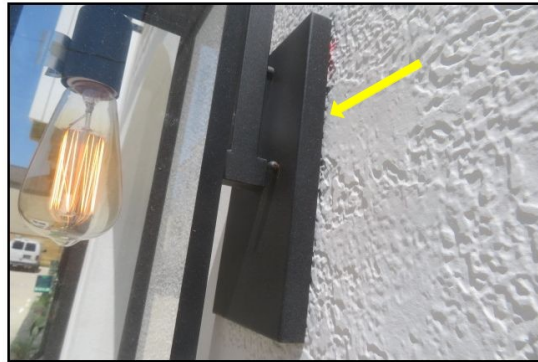
Need sealing/caulking around all holes and exterior siding penetrations on top and both sides, (leave the bottom open) to prevent water entry. Including but not limited to dryer, bath and range top vents, light fixtures, etc.

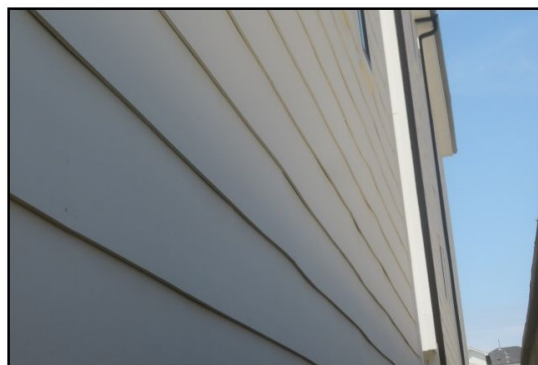
Observed some wavy cement board siding in one or more locations. Possible improper installation.

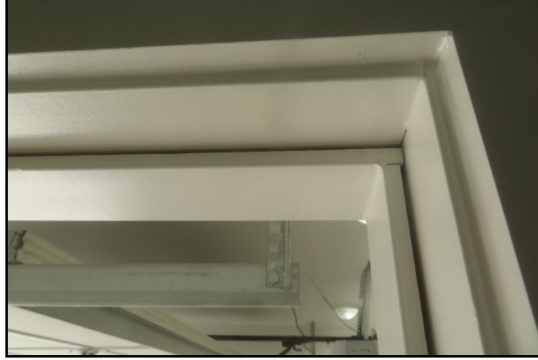
Weather-stripping torn/damaged and/or missing on one or more exterior door(s). (To garage)

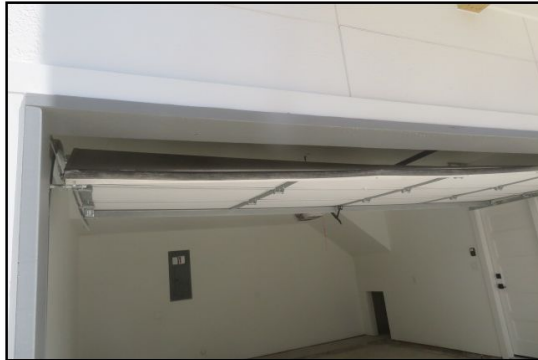
Garage door is damaged, is in need of repair.

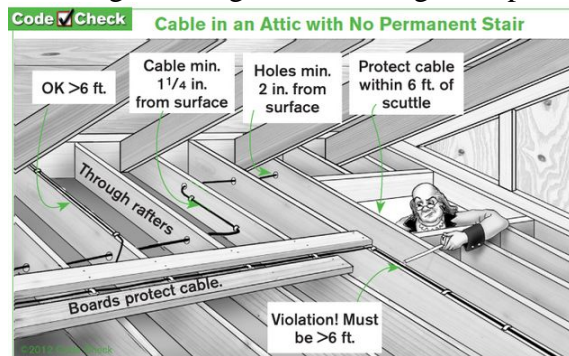
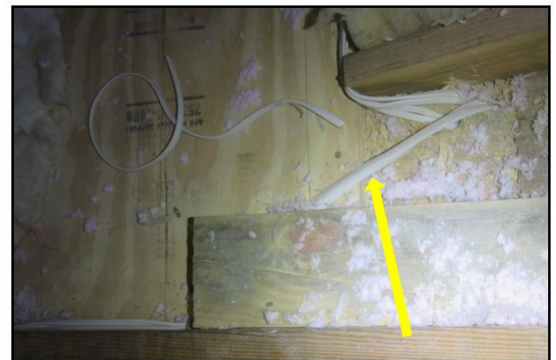
Electrical wiring run/routed too close to the attic access opening. This condition encourages damage to the wiring from personnel accessing the attic.

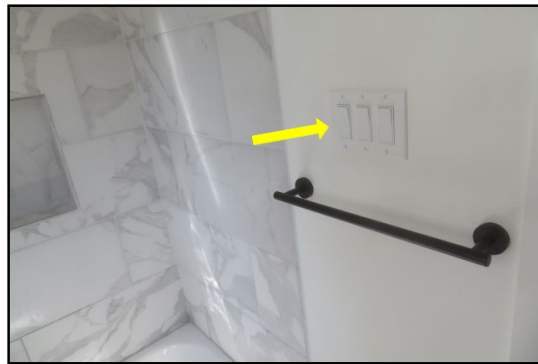
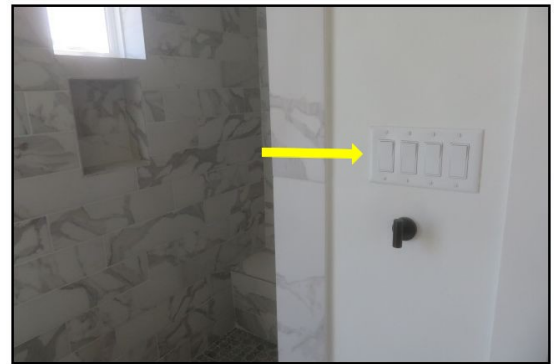
Switch/outlet can be operated while standing in tub/shower, shock hazard. Install switch on the backside of the wall or just ensure it is not operated while standing in the tub. (Master bath, First floor bath)

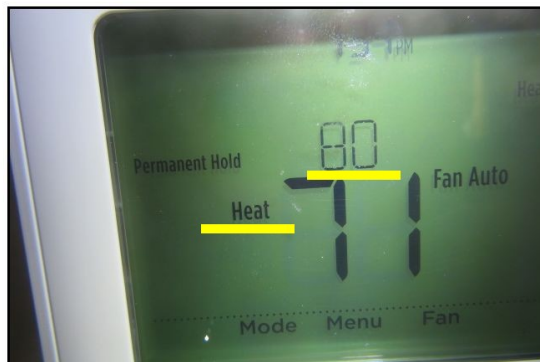
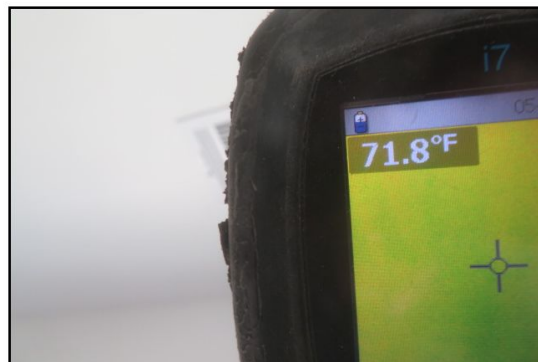
The unit was not operational, not performing its intended function, in need of repair/replacement.

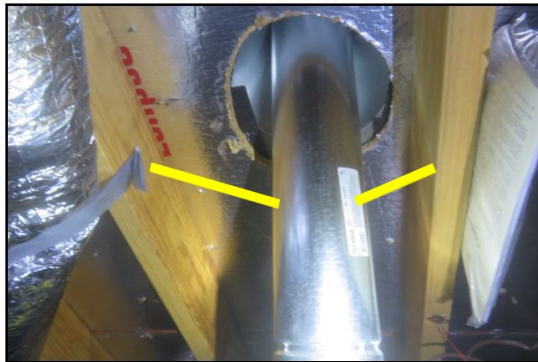
Vent pipe(s) is (are) not properly secured (strapped) in placed.

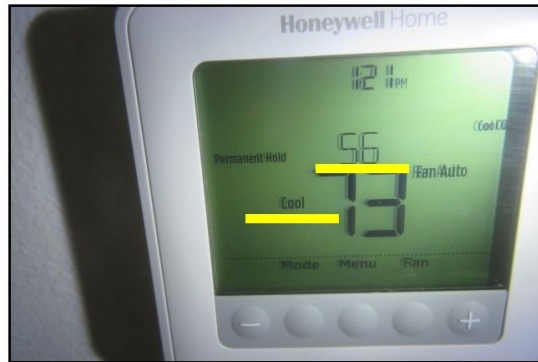
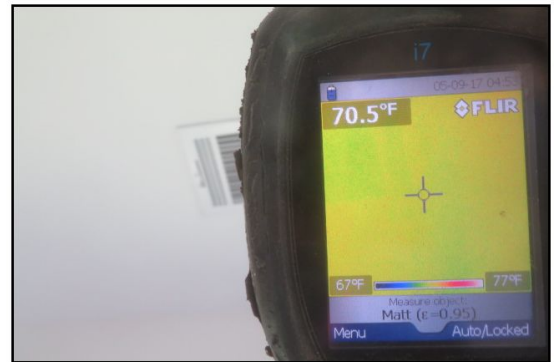
The unit was not operational, not performing its intended function, in need of repair/replacement.

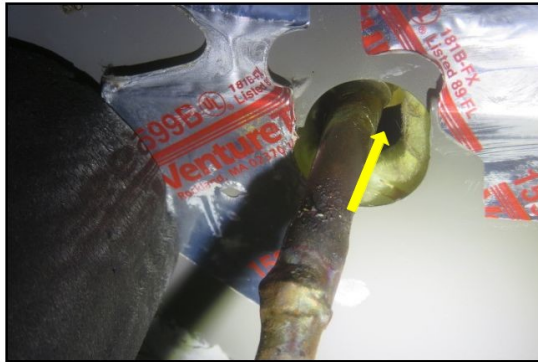
Excessive air loss at evaporator coil around drain and Freon line connections.

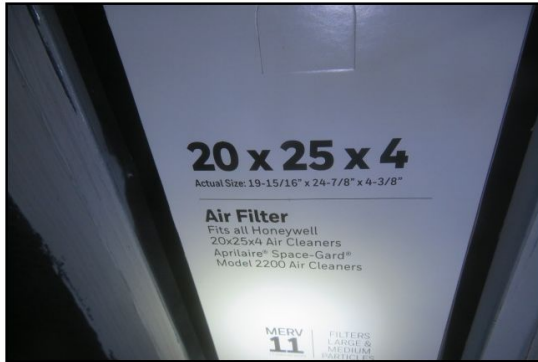
Media air filter(s) located in the attic that requires changing/cleaning every 6 months, recommend checking guide for proper maintenance information.

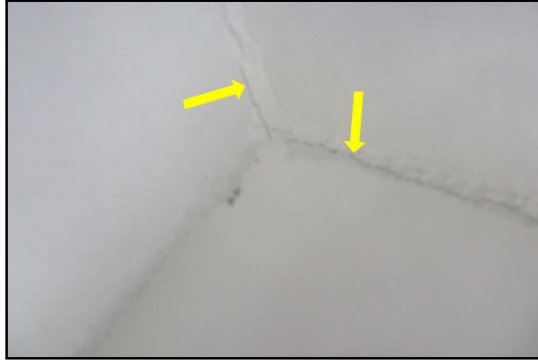
Grout/caulking needed at vertical tile corners, cracks in tile and/or mortar between tiles, and where tile meets tub to prevent water entry behind the wall.

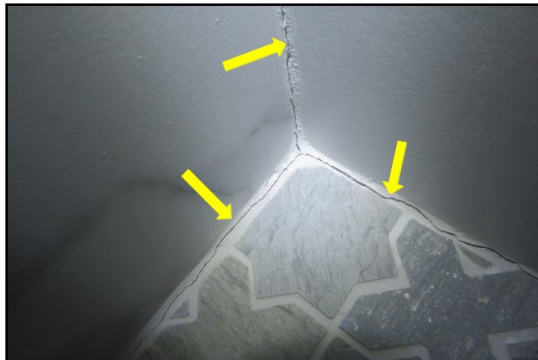
Grout/caulking needed at vertical tile corners, cracks in tile and/or mortar between tiles, to prevent water entry behind the wall.

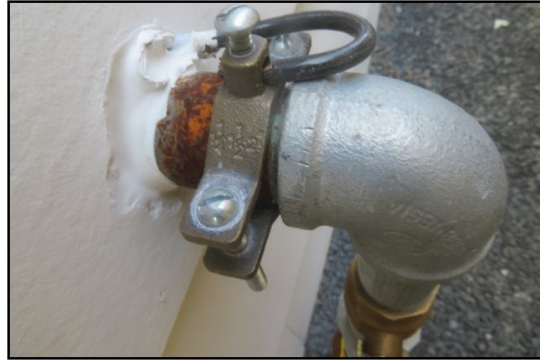
Exposed exterior gas piping not protected from corrosion as required per IRC 2603.3

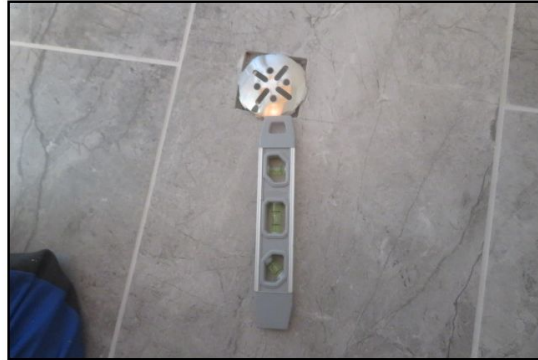
Laundry room floor does not slope properly towards center floor drain and/or drain inlet is above floor level making drain not operational/ineffective when needed. The floor needs curbs along perimeter of the laundry room and the floor needs to slope down towards the center drain for proper operation of the floor drain. An alternative is to install a metal drain pan below the washing machine with a drain line routed to the floor drain.

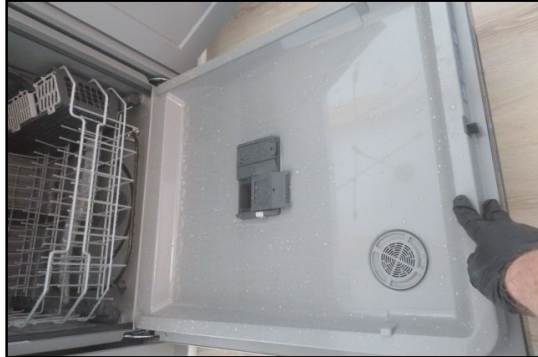
Not properly secured to the underside of the kitchen countertop. Excessive movement observed when pressing on unit.

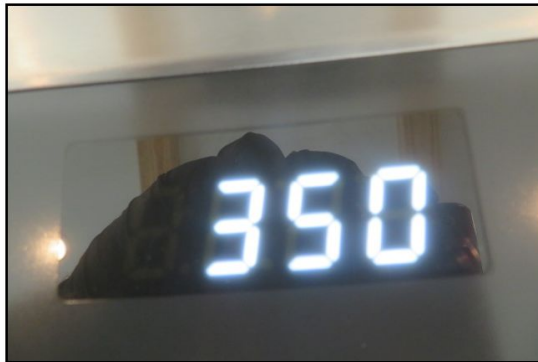
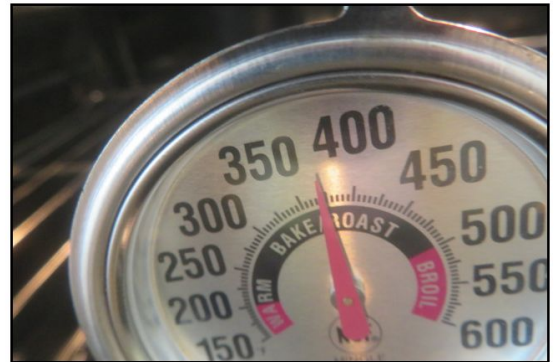
Thermostat/knob needs adjustment/replacement, when it is set at 350 degrees oven heats to approximately 375 degrees.
