Name Karen Hinojosa Date 4.22.22
 Location 2421 Laura Ln,
Pearland, TX 77581
 Phone 713.240.3719
 Email karenyoungcsr@hotmail.com

Stories 1 Exterior Brick Footer Depth 18in.
 Type of Foundation Slab on Grade

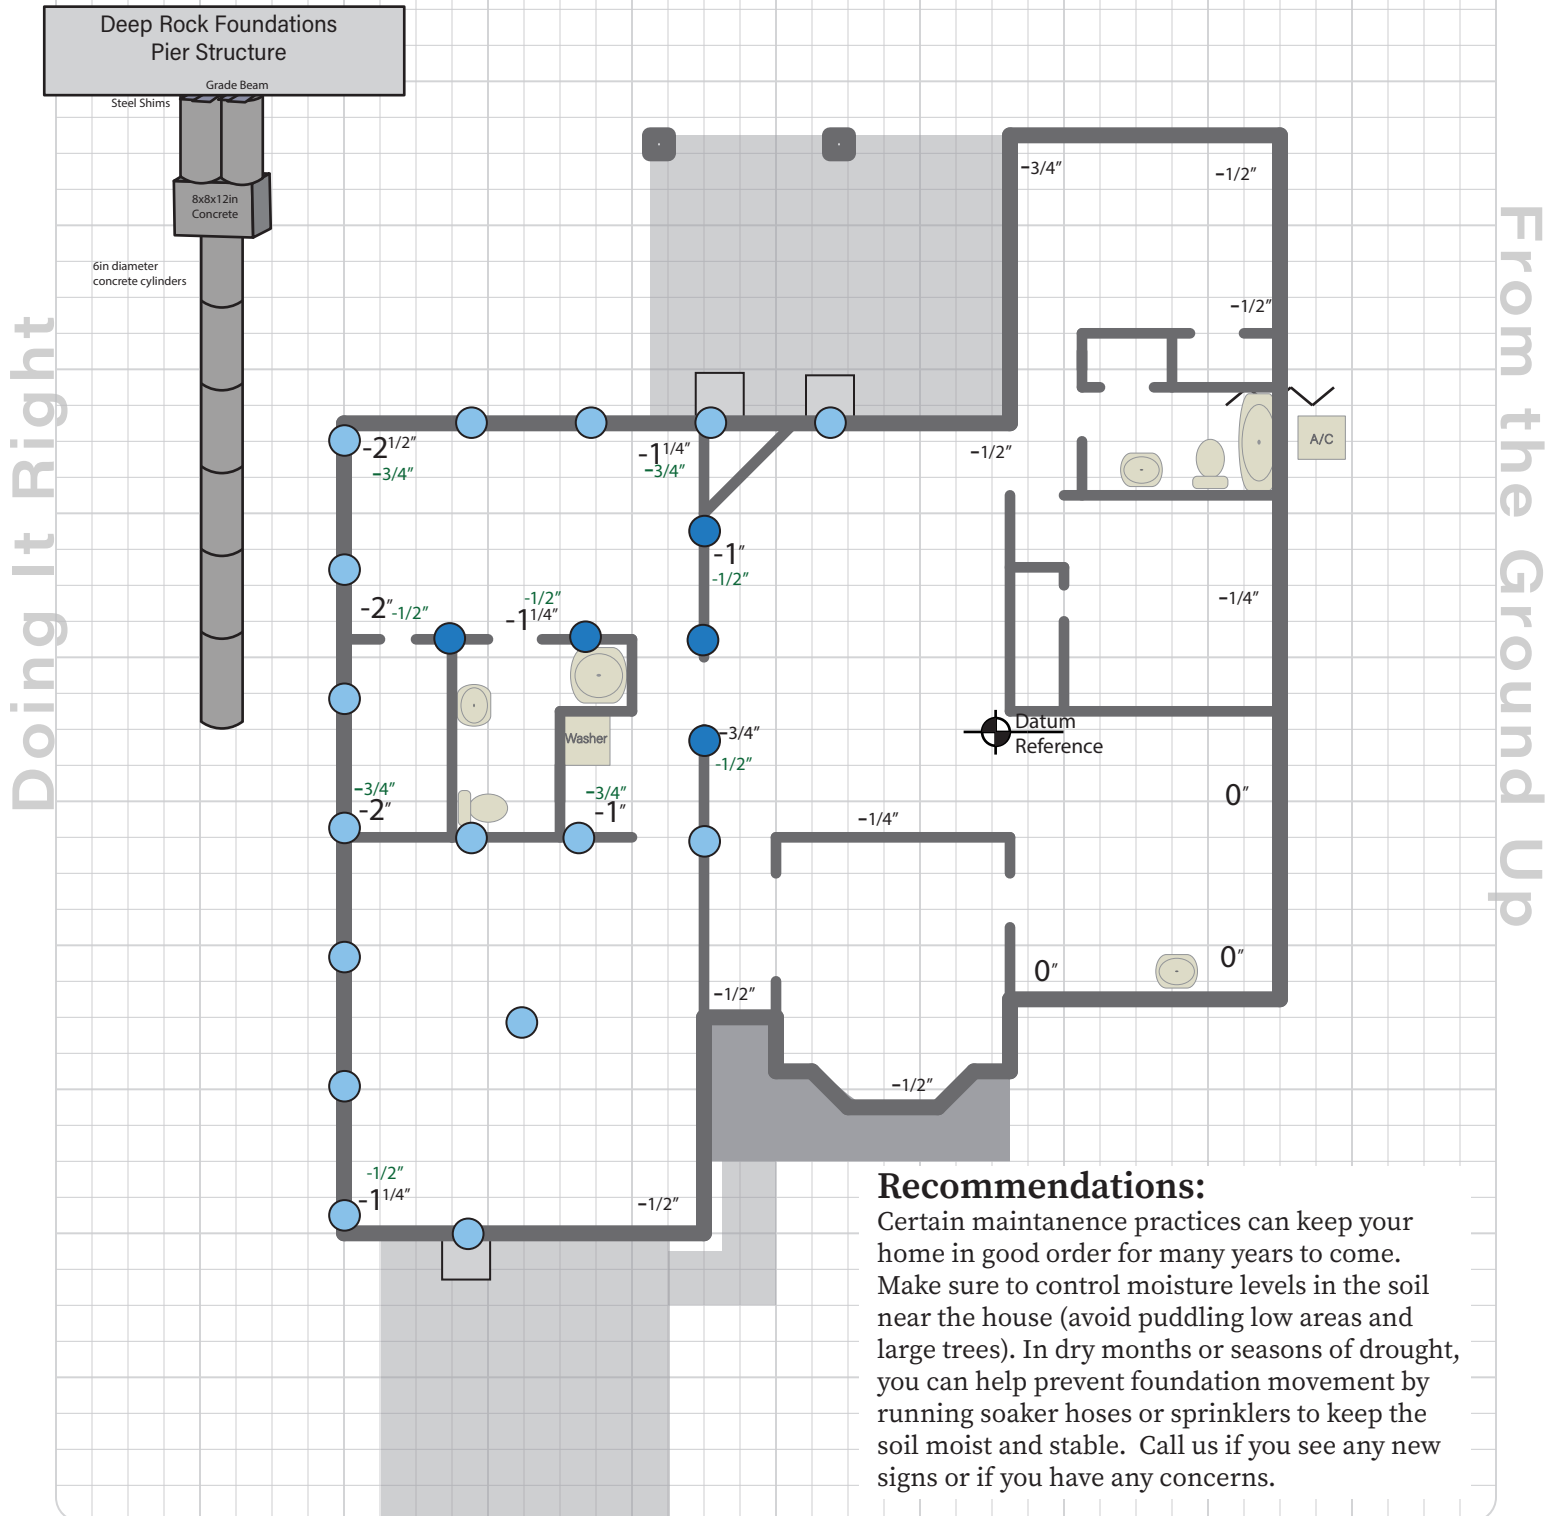
Leveled Elevations:

See new elevations recorded in green (ex. 1/4"). The elevations at your house prior to our repair were recorded in black. We have leveled your house to the green elevations.
