## PROPERTY INSPECTION REPORT FORM

Jeremy Hope <i>Name of Client</i>	05/16/2022 <i>Date of Inspection</i>
4430 Rusk Street , Houston, TX 77023 <i>Address of Inspected Property</i>	
Ron Grant <i>Name of Inspector</i>	<i>TREC License #</i>
<i>Name of Sponsor (if applicable)</i>	<i>TREC License #</i>

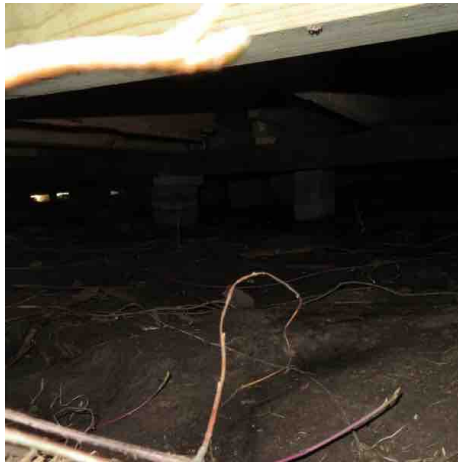
- No insulation observed under the subfloor at the crawl space. Adding insulation will promote the desired comfort level in the home and reduce utility costs.

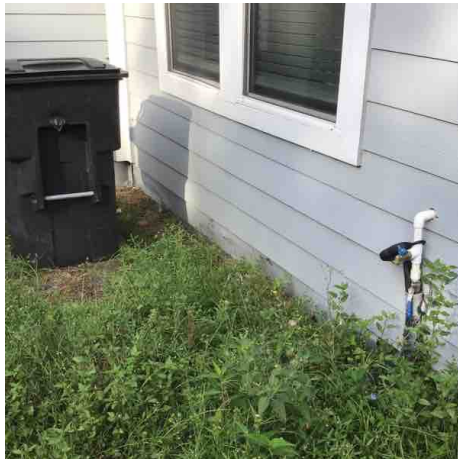
- Crawl space was inaccessible at time of inspection. No means of access could be found. Recommend installing a minimum 18" high x 24" wide access panel, as required by the International Residential Building Code. (Throughout)

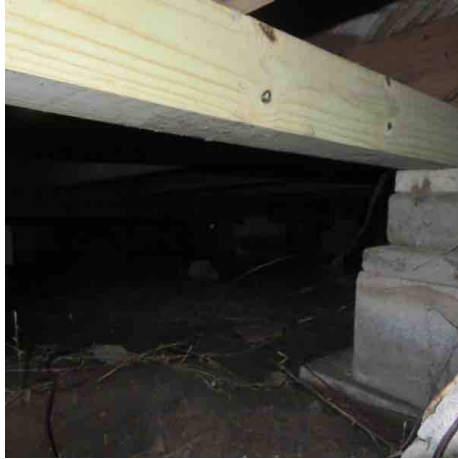
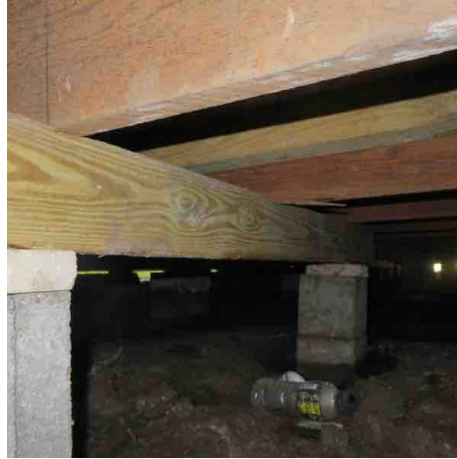
- The foundation has signs of previous foundation repairs. Buyers should obtain all transferable warranty information regarding repairs from the seller.

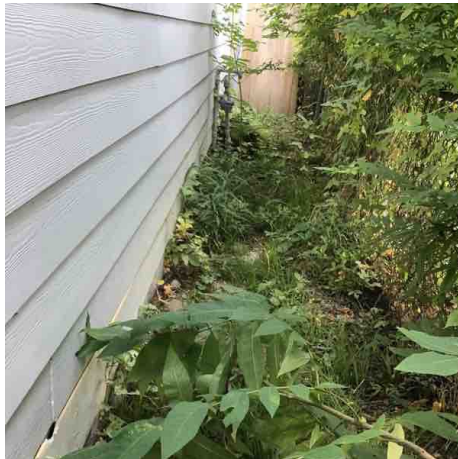
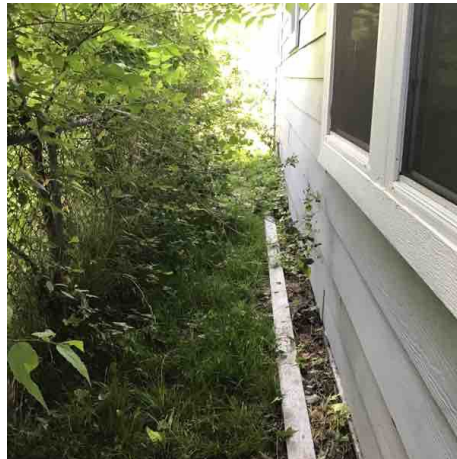
- Normal industry standards indicate water can pond in yards during rainstorms, but if the water does not dissipate within 48 hours after the rain stops from either soil absorption, or natural drainage runoff then a ponding issue exists.
- **The Inspector noted the lack of slope around the property. Healthy drainage occurs when the slope is between 2 percent and 5 percent, which equates to 2 to 5 inches of drop-off for every 10 feet. Recommend corrections by a qualified contractor.**

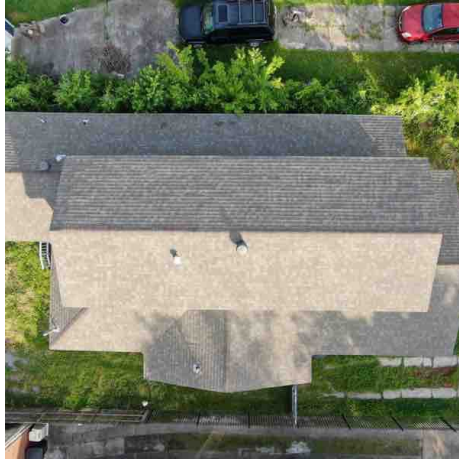
- 30 year roof covering noted. Buyer's should consider having all penetration points and transitions re-sealed/caulked initially and every 3 to 5 years.

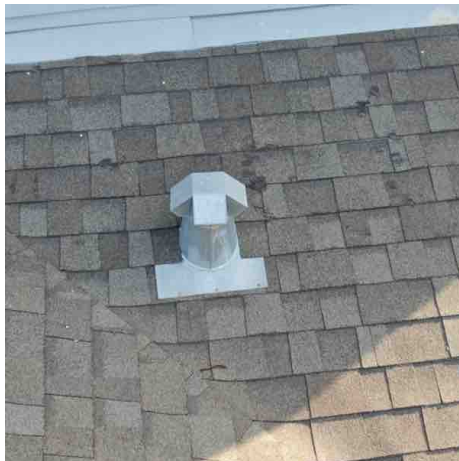
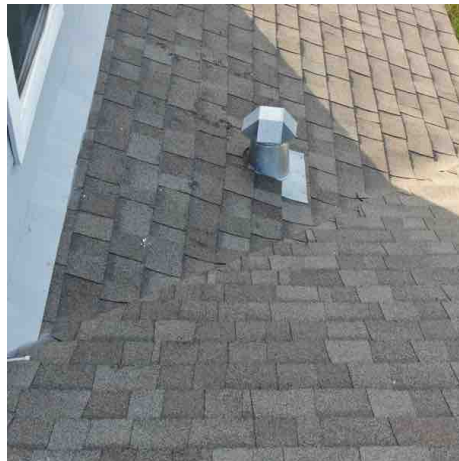
- **Observed un-painted portions of flashing at the front elevation roof covering. Painting of flashing will provide necessary UV and storm protection and prevents rusting.**

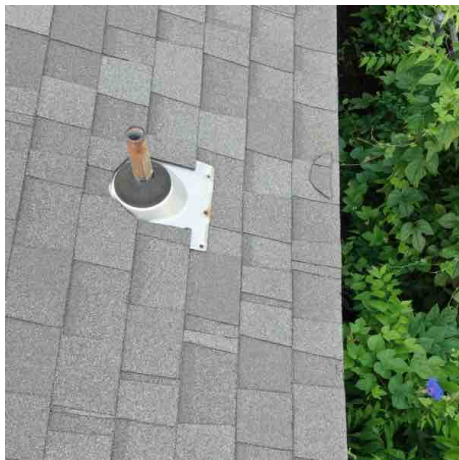
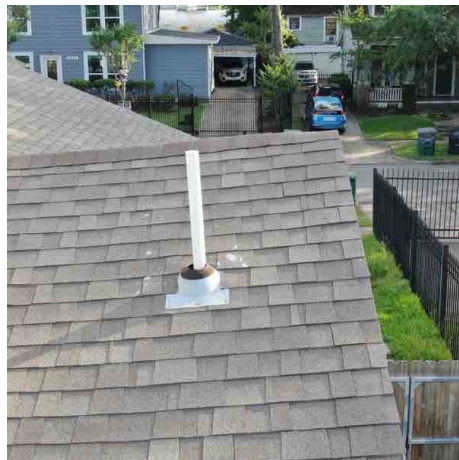
- **Observed un-painted portions of vent stacks through-out the roof covering. Painting of vent stacks will provide necessary UV and storm protection.**

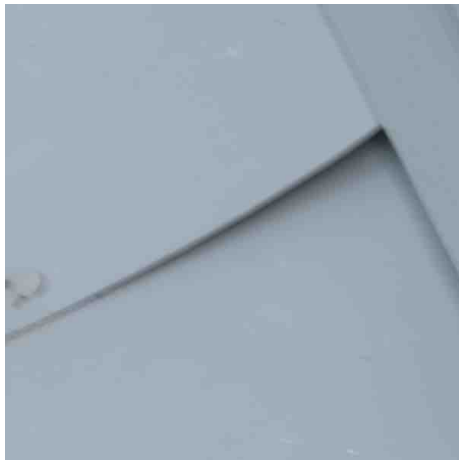
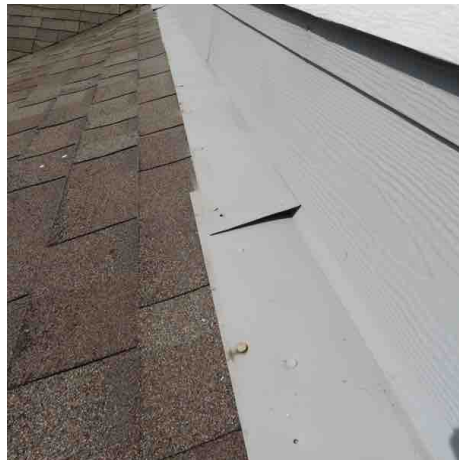
• **Flashing not sealed at several locations around the structure. Recommend repair by a qualified roofing contractor. (Throughout)**

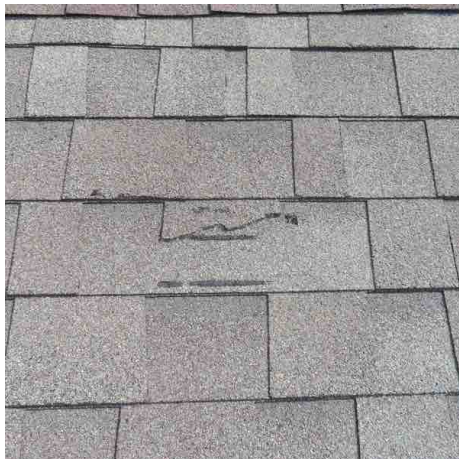
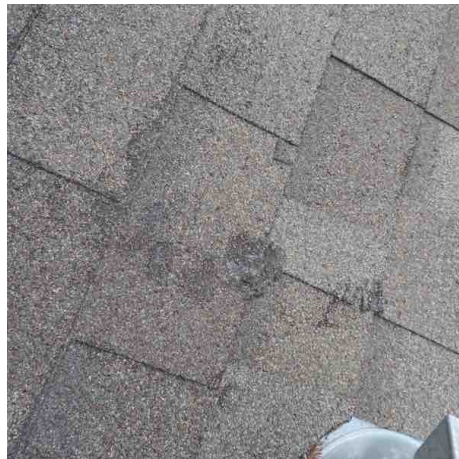
• **Damaged and deteriorated shingles observed at the right side roof covering (see photos below). A qualified roof contractor should examine shingles to determine if shingles are still considered serviceable. (Various)**

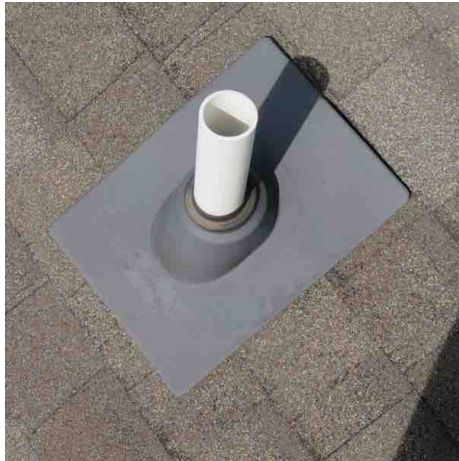
- **Plumbing boots not nailed to roof. Recommend repair by a qualified roofing contractor. (Exterior Rear)**

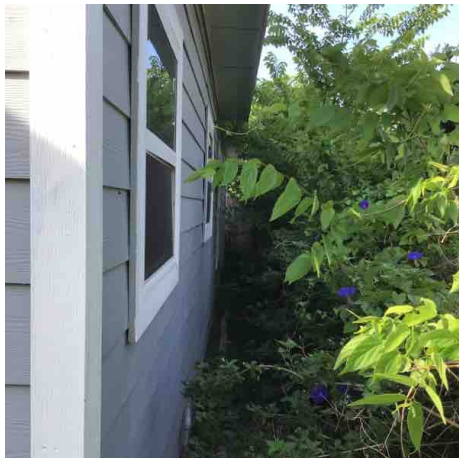
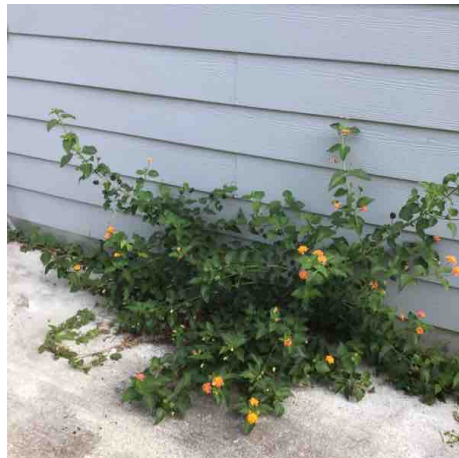
- The walls are inspected for structural performance and water penetration. Specifically excluded from this report is the presents of cosmetic concerns such as paint, minor cracks, scuffs and dings.
- Vegetation was in direct contact with the structure at several locations around perimeter of the residence creating a conducive condition for potential pest infestation. Recommend pruning / cutting back vegetation so that a minimum of 6 - 8" of distance exists between the structure and the vegetation.

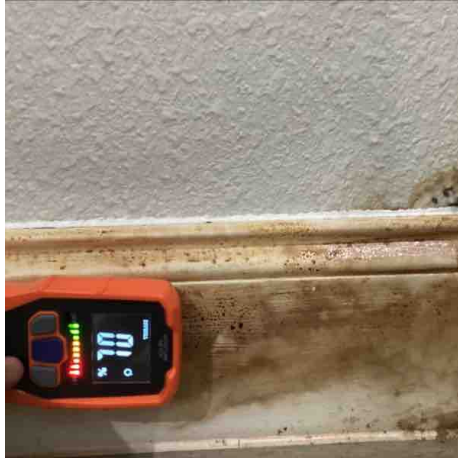
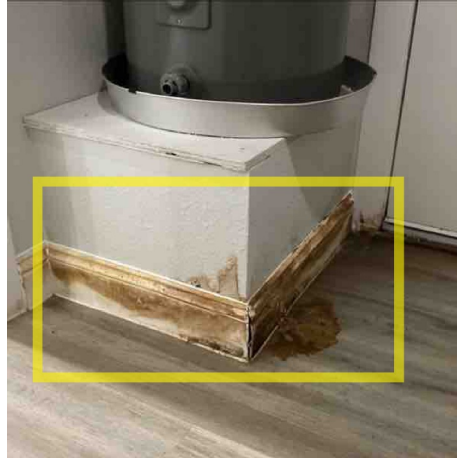
- **Active moisture noted at the water heater base (verified with a moisture meter). Recommend repairs at the source and proper remediation at the drywall by qualified contractors. (Utility Room)**

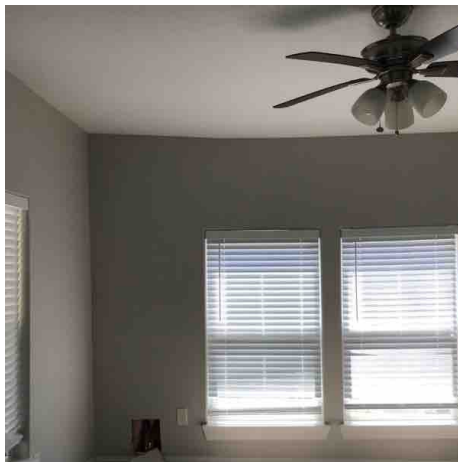
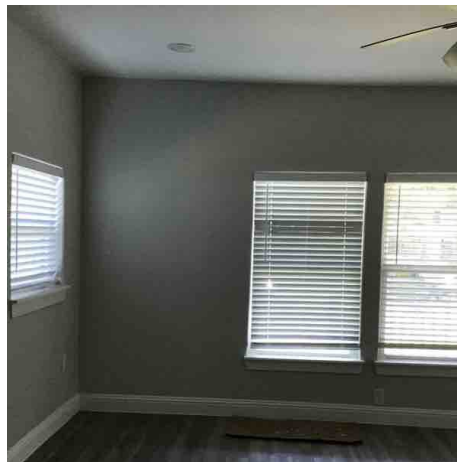
- Ceiling finish is drywall. Floor surfaces are tile and carpet. Floor structure is concrete slab on the first floor and standard wood framing on the upper floors. All appear to be in good condition. No problems were found.
- **Floors and ceilings are un level and out of square. Recommend further investigation and evaluation for repairs by a qualified general contractor. (Throughout)**

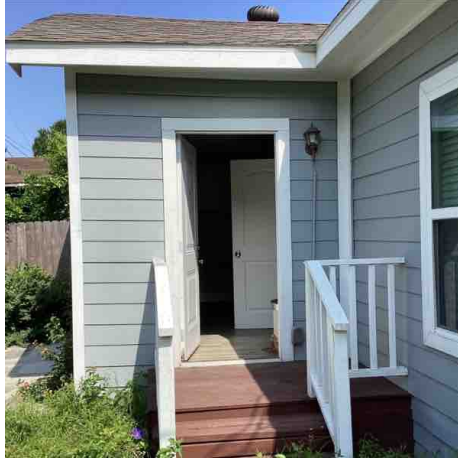
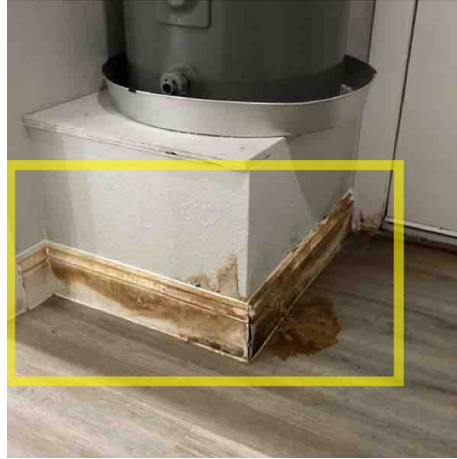
- The construction of the rear door has allowed storm water runoff to intrude around the threshold. There are several options to mitigate this issue (gutters, roof diverter or shed roofing). Recommend consulting a general contractor for best path forward.

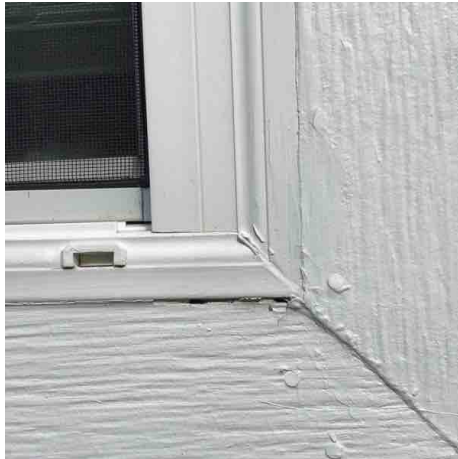
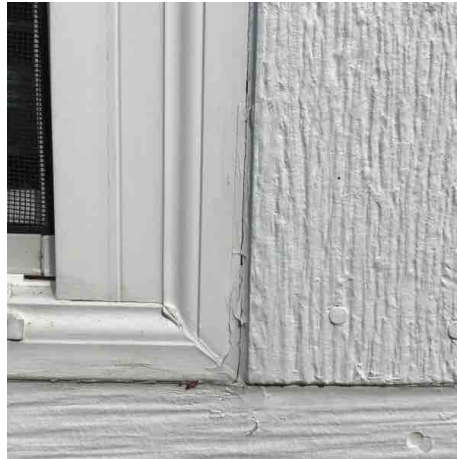
- Windows around the structure have missing and deteriorated caulking. Caulking windows with a good exterior grade caulking will prevent storm water intrusion. (Various)

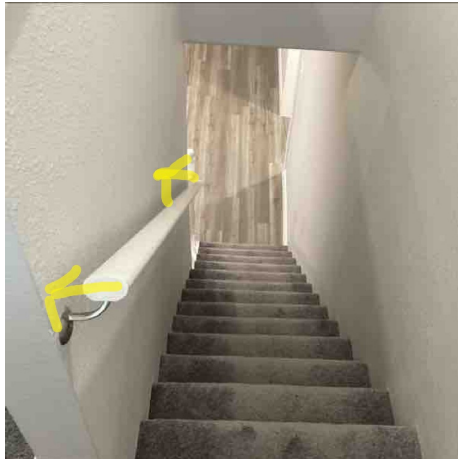
- **Wall mount handrails does not meet compliance standards for stairway handrails (see photo). Codes require handrails to extend full length of the stairway and curve inward and return to the wall to prevent snagging of clothing. Recommend corrections made by a qualified trim contractor.**

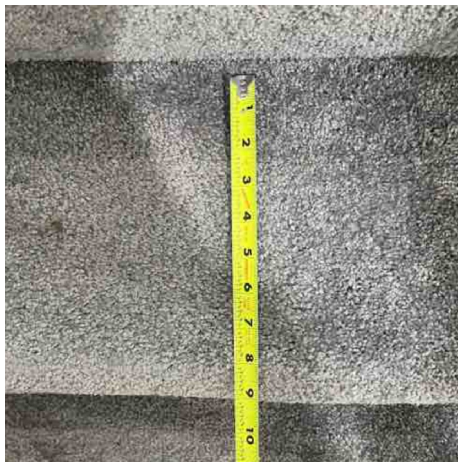
- **Stair tread depth is 9". Code requires treads to be at least 10" with nosing. Recommend a qualified trim contractor construct stair in accordance with current stair safety codes. Prior to repairs home occupants should use extra care when traveling down stairs.**

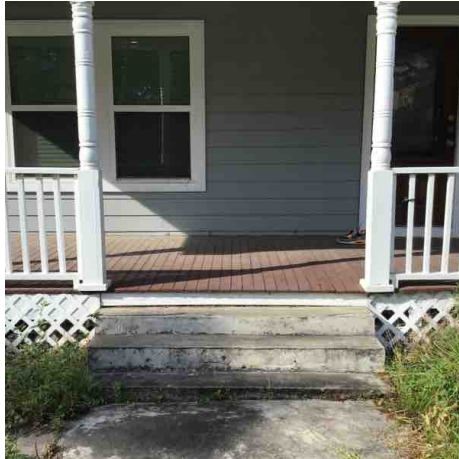
- Handrails are missing at the exterior stair system. Recommend handrail installation by a qualified trim contractor. (Exterior Front)

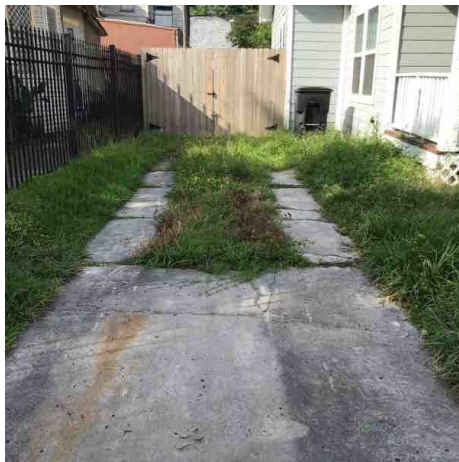
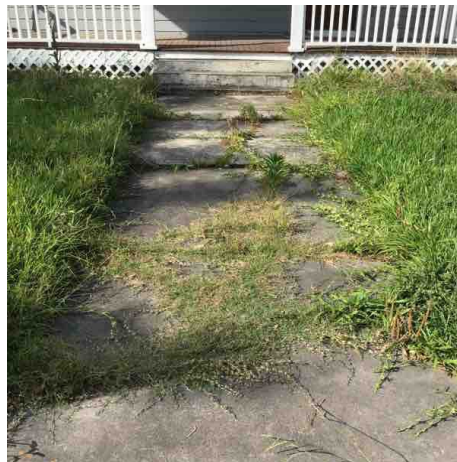
- Broken driveway and private walk section noted. Repairs should be made by a qualified concrete contractor as needed.

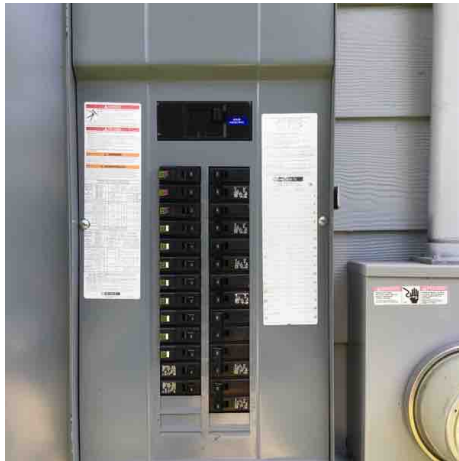
- Service panel was not labeled properly at the time of the inspection (see photo). Recommend labeling by a qualified person or electrician. (Exterior Rear)

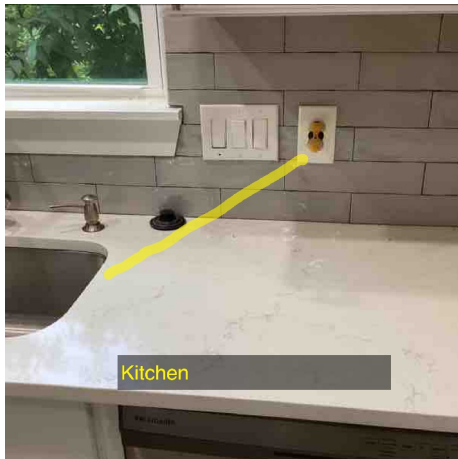
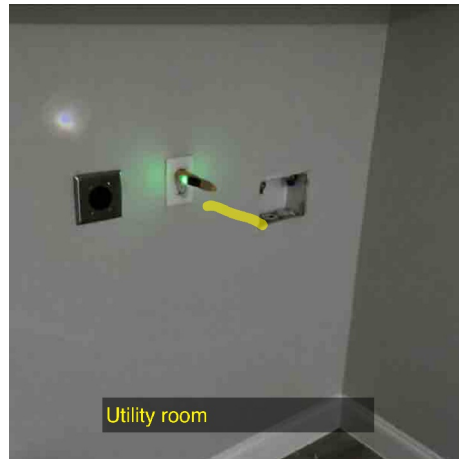
• It is recommended that this home be equipped with ground fault circuit interrupters (GFCI) at all required locations (exterior, garage, bathrooms, kitchens and within 6 feet of the outside edge of a sink). The purpose of a GFCI circuit is to provide positive protection against a shock hazard since it will “trip” almost instantaneous if it detects moisture.

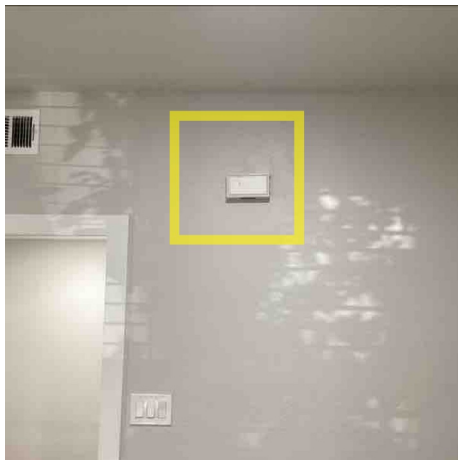
• Doorbell chime was not functioning properly at the time of the inspection. Recommend repair or replacement as needed.

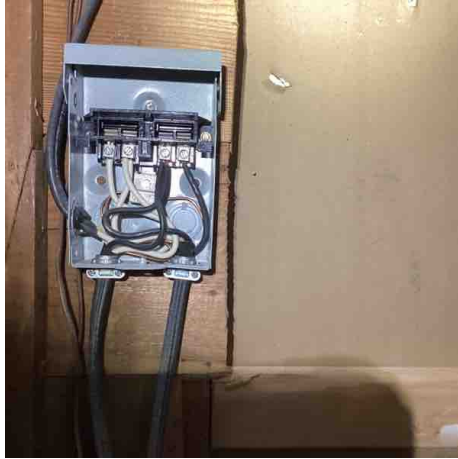
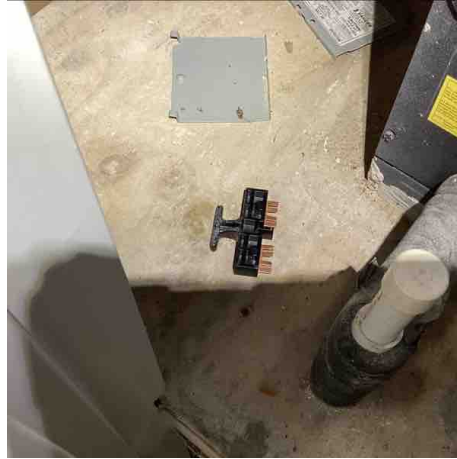
- Inspector noted the power to the downstairs furnace was not operational at the time of the inspection. Recommend further investigation and repairs by a live HVAC contractor.

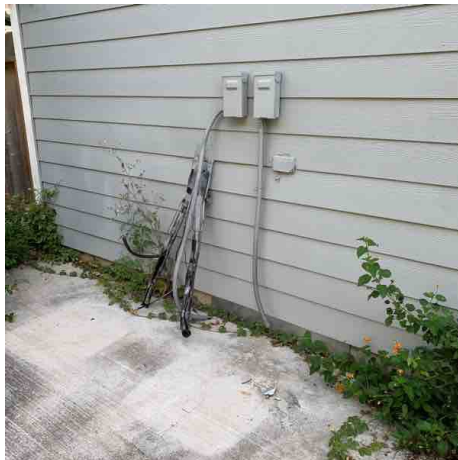
- Condensing unit not installed. Hall installation by a licensed mechanical contractor. (Exterior Rear)

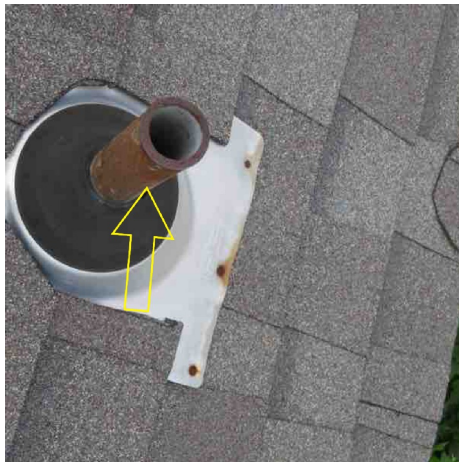
• It appears this home has some cast iron drain lines. Cast iron sewer pipes are very common in homes built from 1900 to 1970's. As a result of what runs through cast iron sewer pipes, corrosive actions take place within the pipe. As the pipe corrodes; scale, calcification, and rust forms. This scale continues to accumulate slowly over time. When scale builds to a certain level, it will decrease the diameter of the pipe. Consequently, drain clogs and sewer backups occur more frequently. Problems with the plumbing waste pipes under the slab can only be detected by an under-slab plumbing leak test, which should be obtained as a precaution.

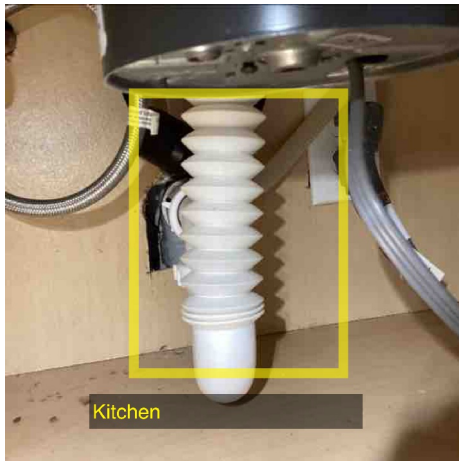
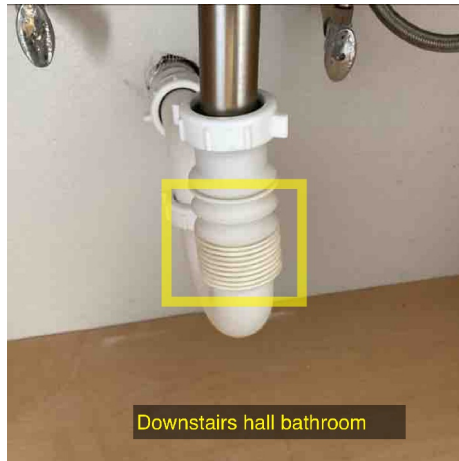
• Observed the use of a non-professional drains installed under several sinks (see photos). Drainage fittings shall have a smooth interior waterway of the same diameter as the piping served. Recommend a licensed Plumber for corrective actions.

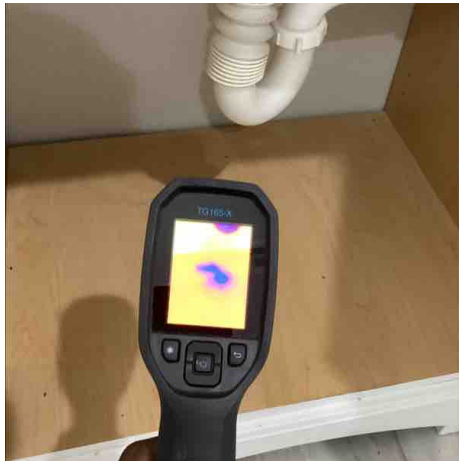
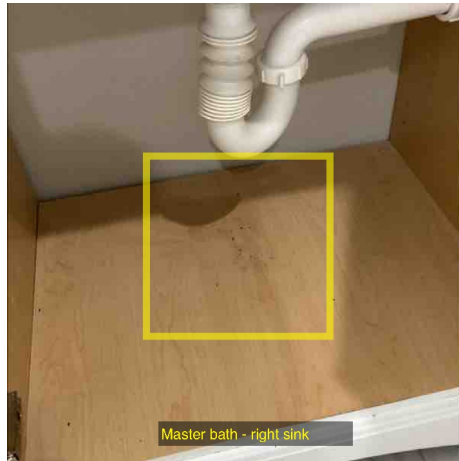
- Leak observed under multiple sinks (see photo). Recommend repairs by a licensed Plumber.

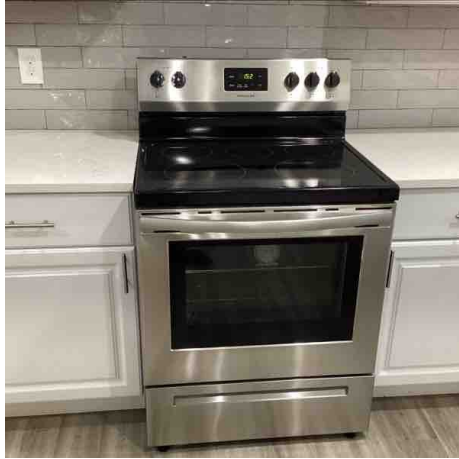
- Anti-tip mechanism on the range was not performing or not installed which is considered a safety hazard. Recommend a qualified technician for corrections as needed. (Kitchen)

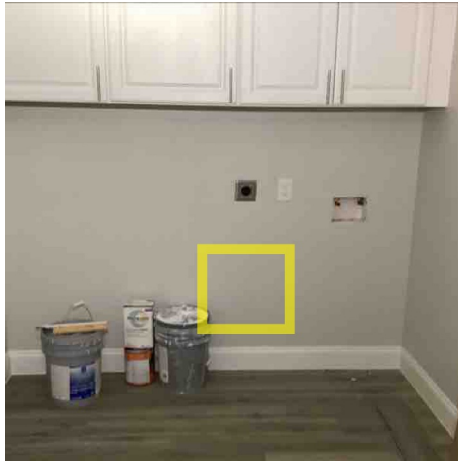
• Inspector noted an incomplete dryer exhaust vent located on the interior wall. Recommend corrections by a qualified contractor.
