REDSTAR RESIDENTIAL INSPECTION REI 7-6

4221 Ohara
Alvin, TX 77511

PROPERTY INSPECTION REPORT FORM

Ron Allison & Cindy Allison <i>Name of Client</i>	04/06/2022 2:00 pm <i>Date of Inspection</i>
4221 Ohara, Alvin, TX 77511 <i>Address of Inspected Property</i>	
Devin Evans <i>Name of Inspector</i>	TREC #22225 <i>TREC License #</i>
Jeremy Benefiel TREC # <i>Name of Sponsor (if applicable)</i>	8595 <i>TREC License #</i>

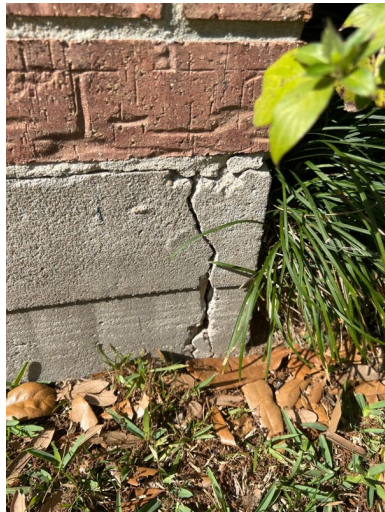
2: Foundation Crack

Cracks in the foundation were observed at the time of inspection, evaluate and correct as needed.

Recommendation: Contact a qualified professional.

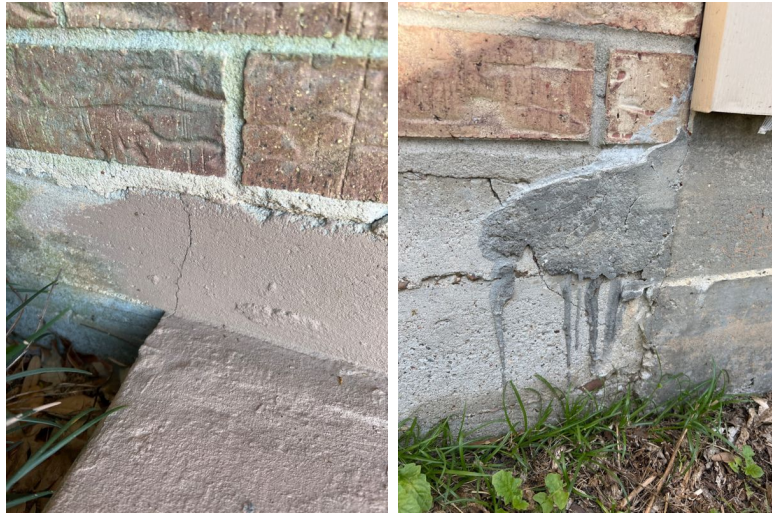
3: Foundation: Sloping and Settlement Observed

Sloping and settlement of the foundation was observed at the time of inspection. The inspector did observe a crack in the brick at the right exterior and two cracks in the foundation sidewalk. Zip level readings taken at the time of inspection show deflection of the foundation in excess of 2.2". These issues, measurements and locations are indicative of heaving/settling. (Below are the zip level reading. From the kitchen sink to the back door was over 2" of deflection)

It is the inspectors opinion that these issues are indicative of excessive movement of the foundation and I recommend further evaluation by a qualified professional to render a foundation performance evaluation.

- Recommend consulting with a qualified foundation company.
- Recommend correction of all issues stated in the Grading and Drainage section of this report to promote health of the foundation.
- Recommend consulting with a qualified plumber to evaluate the condition of the underground plumbing drain lines, as these lines often become damaged from foundation movement.
- Recommend you budget for repair of above stated issues and any other related items with foundation movement/repair.

Recommendation: Contact a qualified professional.

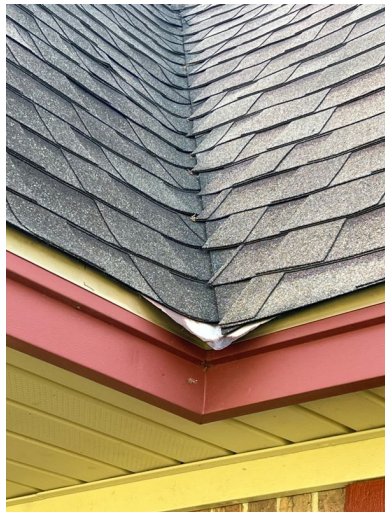
3: Shingles: Granule Loss Noted

Moderate granule loss of the asphalt roofing shingles was observed at some locations. This condition is typical for an aging roof, and does not seem to be affecting the performance of the roof covering at this time. Recommend regular monitoring and inspection of this condition. Consult with roofing contractor if you desire further evaluation of this condition.

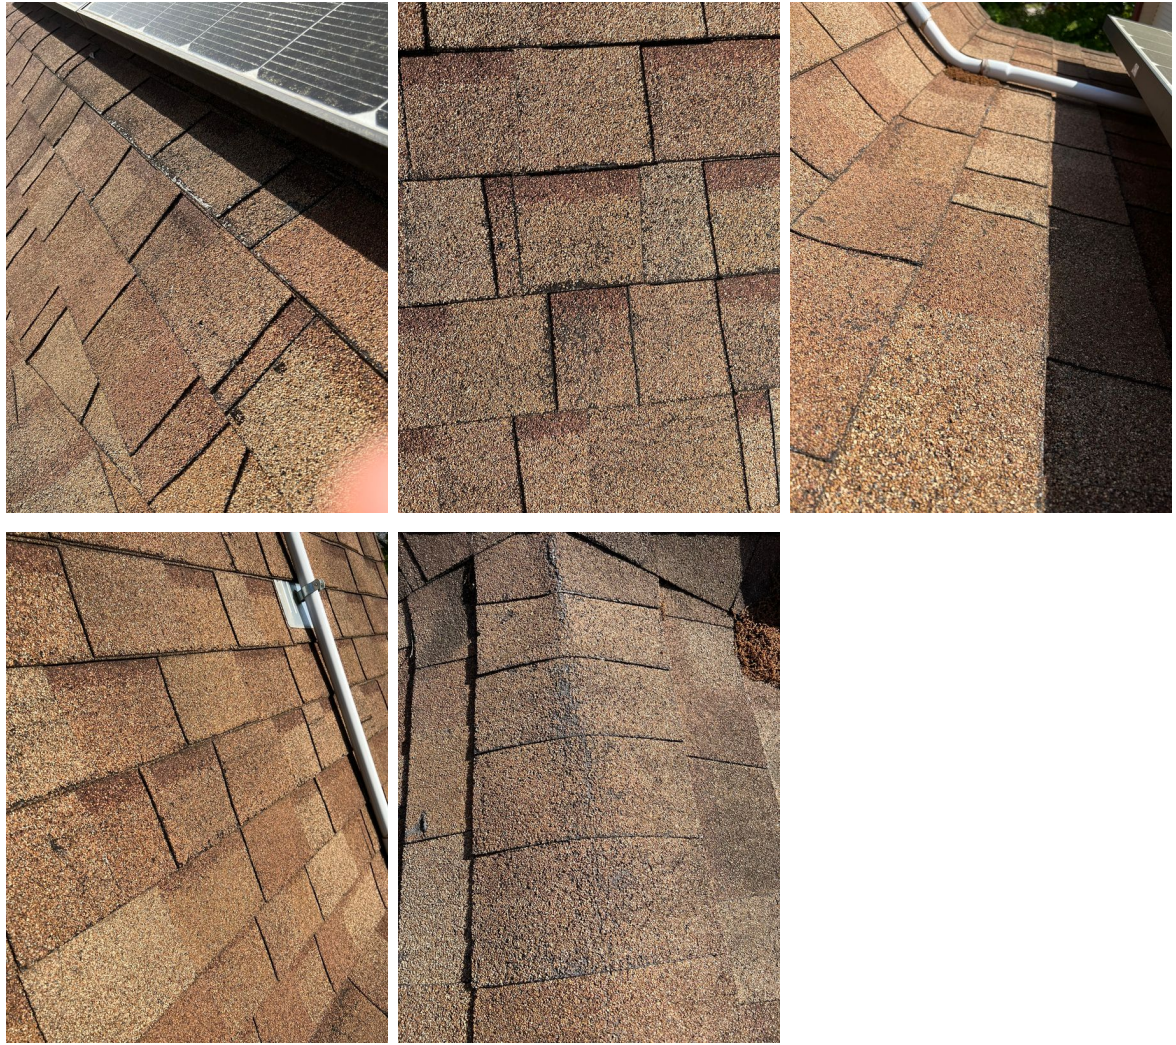
4: Shingles: Damaged/Missing

Damaged/missing shingles were observed on the roof covering. Due to damaged shingles exposed nails were observed at various locations also. These conditions can compromise the integrity of the roof covering, and I recommend further evaluation by qualified contractor to determine the extent of needed repairs.

Recommendation: Contact a qualified roofing professional.

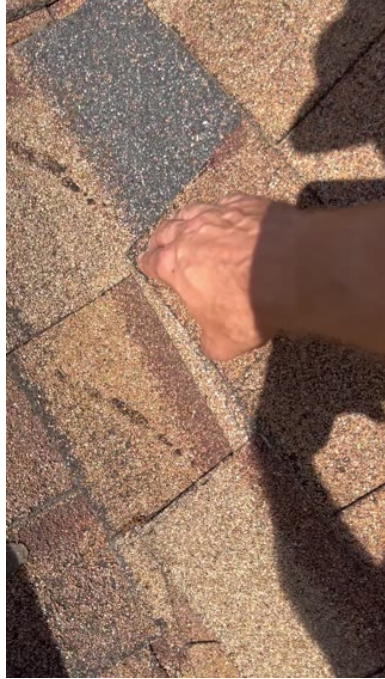
6: Flashing: Loose/Raised Flashing

Raised or loose flashing areas were observed around the roof covering. This condition leaves the covering exposed to potential moisture or pest intrusion. Recommend all areas be evaluated and secured/sealed as needed.

Recommendation: Contact a qualified roofing professional.

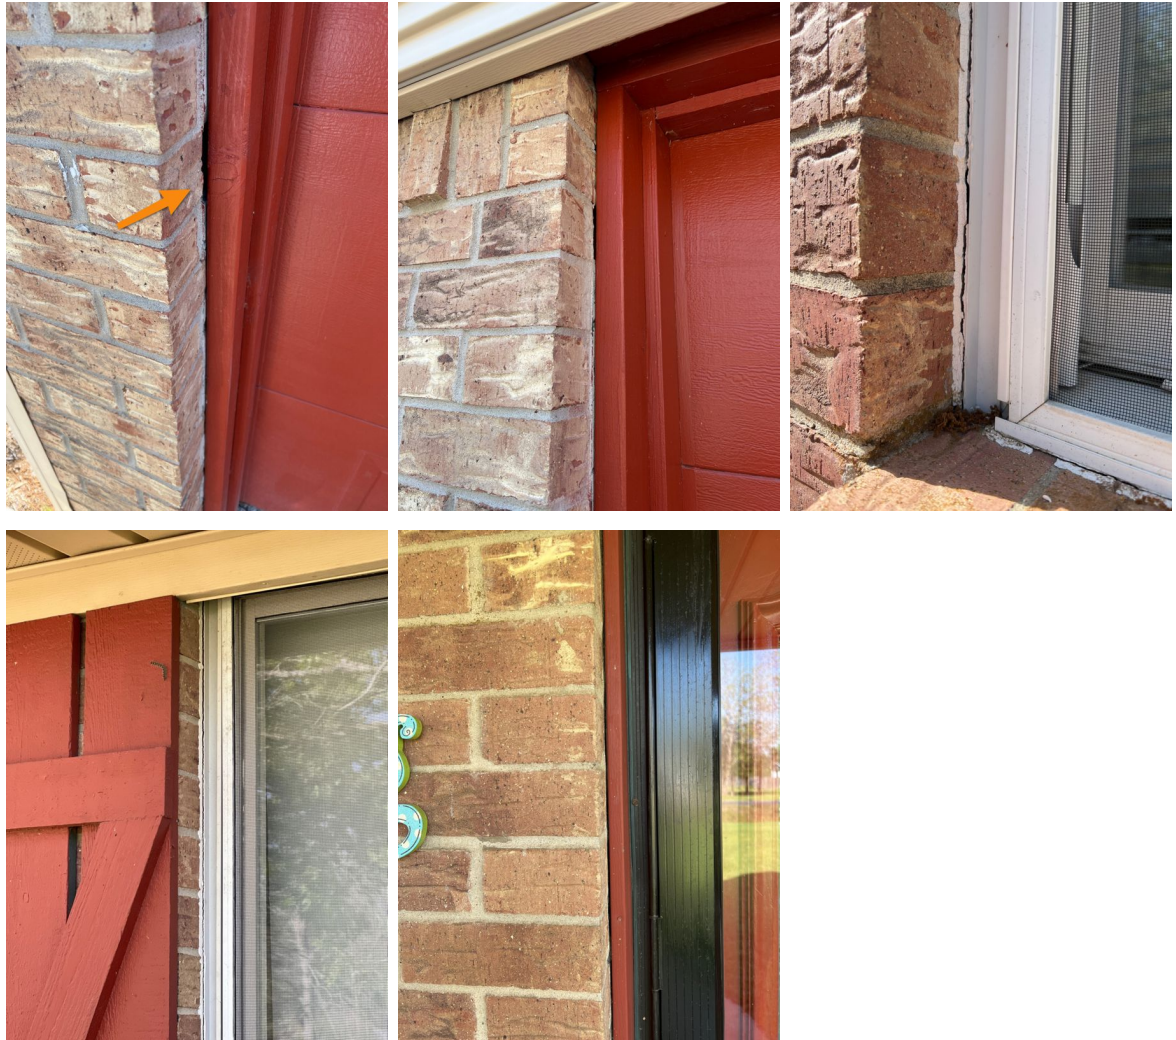
2: Masonry: Moderate Cracks/Separations

Moderate cracks and/or separations were observed in the masonry walls around the exterior of the home. Common areas of issues include around windows, doors, and/or expansion joints. These cracks and separations are excessive and I recommend further evaluation to determine extent of necessary repairs.

Recommendation: Contact a qualified masonry professional.

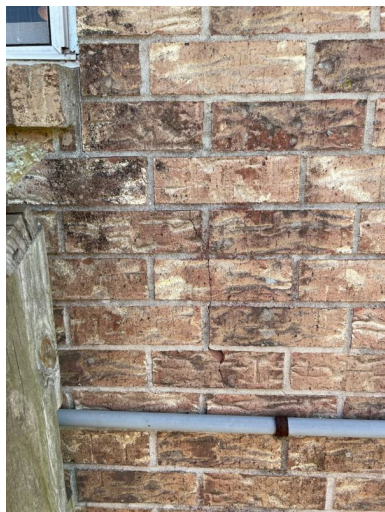
3: Masonry: No weep holes at lintels

Weep holes were not installed in brick above steel lintels over windows and or doors. Modern practices often utilize weep holes to prevent rusting of steel lintels supporting brick.

Recommendation: Contact a qualified professional.

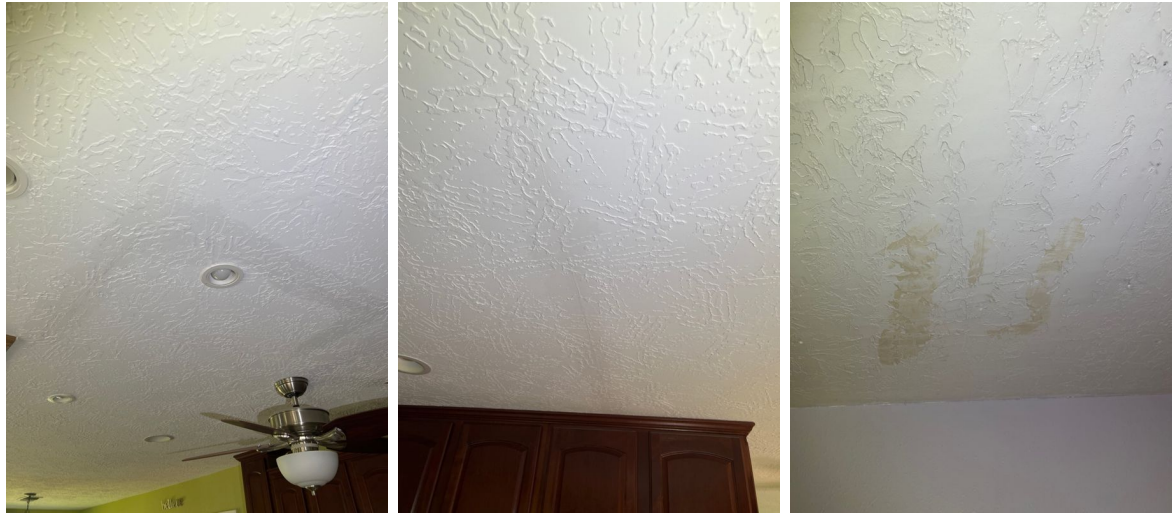
2: Ceiling: "Popped" Nails

"Popped" (loose) drywall nails were observed at the time of the inspection. Nails pops often occur because of ceiling design, and heat in the attic area. This condition is not related to a structural issue. Repair as desired.

Recommendation: Contact a qualified painting contractor.

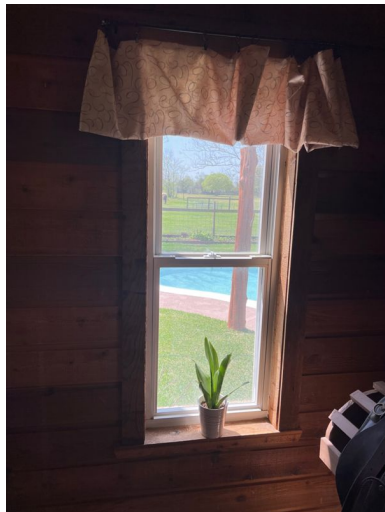
2: Windows do Not Lock

The inspector observed one or more windows that did not lock properly and are in need of adjustment or repair. Recommend further evaluation by a window installer or qualified contractor.

Recommendation: Contact a qualified professional.

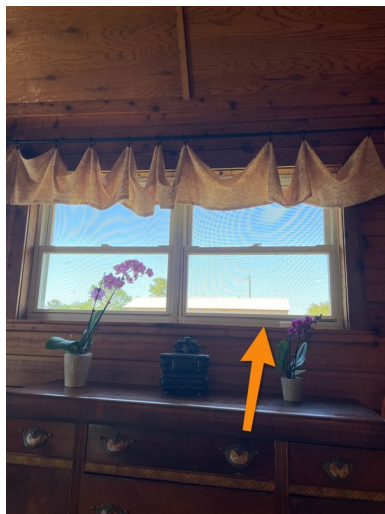
3: Windows: Difficult to Operate

Windows were difficult to operate at the time of inspection. Evaluate and correct as needed by a qualified contractor.

Recommendation: Contact a qualified professional.

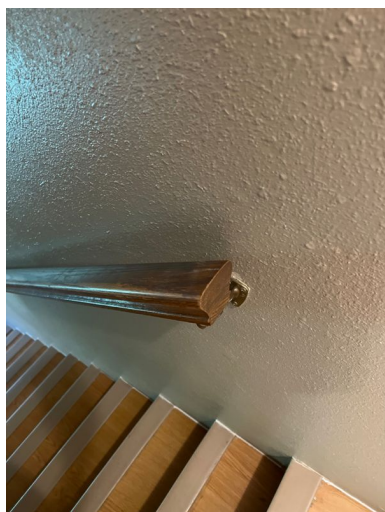
2: Handrails: Loose

The handrail was observed to be loose. The handrail height also does not meet today's standards. Repair as needed for safety purposes.

Recommendation: Contact a qualified professional.

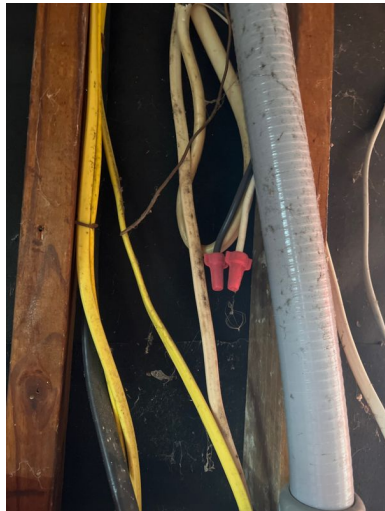
12: Wiring: Open Junction Box

Open junction box observed. Recommend concealing or replacing.

Recommendation: Recommended DIY Project

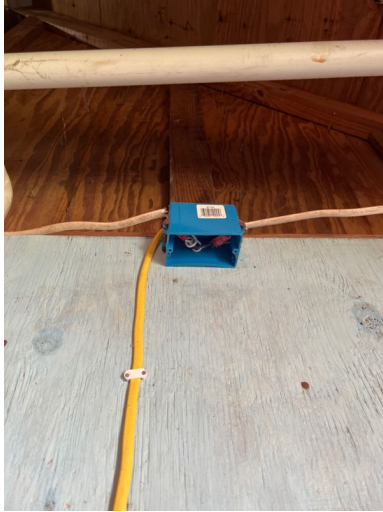
13: Wiring: Abandoned Wires

Abandoned wires were observed. Further evaluation to verify if they are properly disconnected and to determine if they can be removed is necessary.

Recommendation: Contact a qualified electrical contractor.
