PROPERTY INSPECTION REPORT

Concerning: 2319 Avenue M , Galveston, TX 77550
(Address or Other Identification of Inspected Property)

By: Danny Marlow Lic.#: 23187 10/05/2018
(Name and License Number of Inspector) (Date)

Inspection No. 521350-71

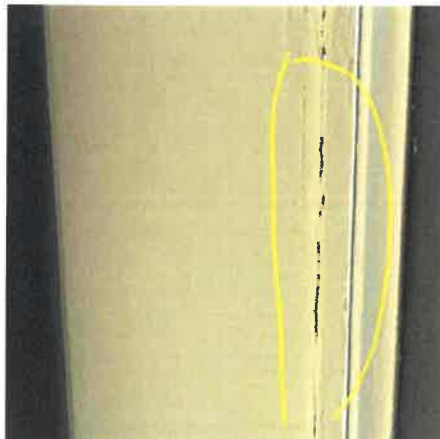
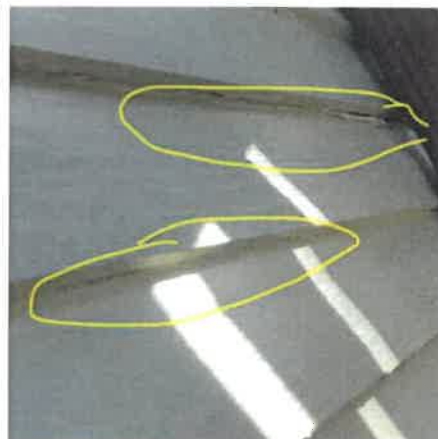
- Wood siding. There are areas on exterior walls that have minor rot damage. Have repairs made to prevent further water penetration. Wood siding. Caulking has failed in several areas. Recommend re-caulking as needed to prevent water penetration and further damage.

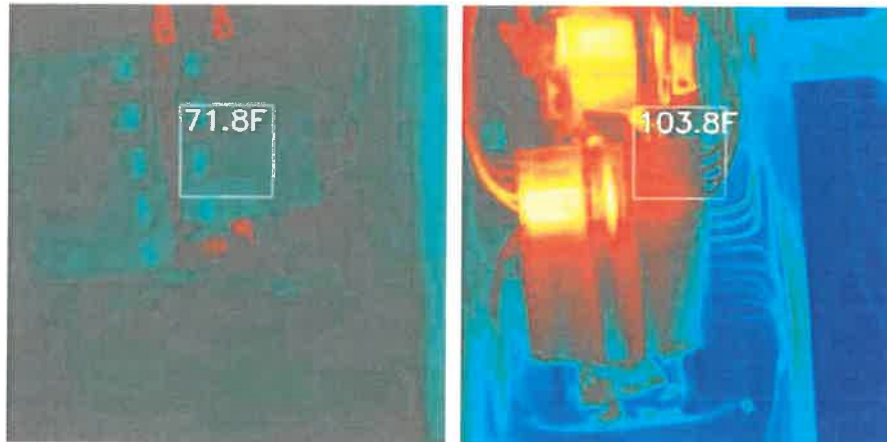
- Normal operating temperatures observed with a thermographic camera on the day of the inspection.
- There is a 60 amp panel in upstairs bedroom and a 200 amp panel on exterior by electric meter.
Grounding is through grounding rod to earth.

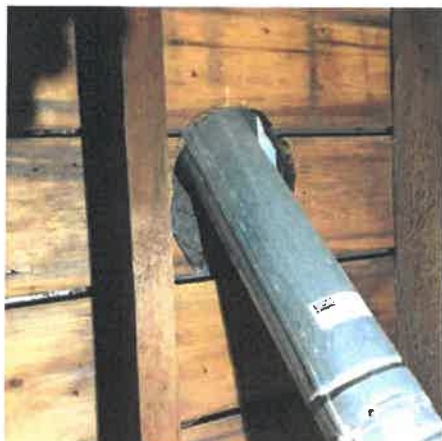
- Forced air furnaces, Natural gas energy source. (3)
Furnace vent clearance to combustible material is insufficient and is a fire hazard (unit in attic)The vent is required to maintain a 1” gap to all combustible materials.
The drip leg on the gas lines are missing on all 3 units.

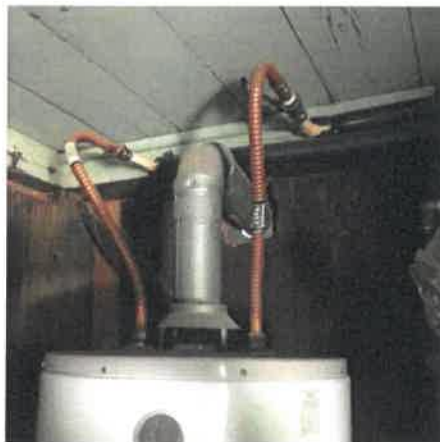
- 50 gallon natural gas water heater.
- Water lines coming out of water heater should be insulated for at least the first 18".
- The drip leg on the gas line is missing.
