# RESIDENTIAL INSPECTION REPORT

8318 White Willow Ln Baytown, TX 77523

Concerning: <u>8318 White Willow Ln</u>, Baytown, TX 77523 (Address or Other Identification of Inspected Property)

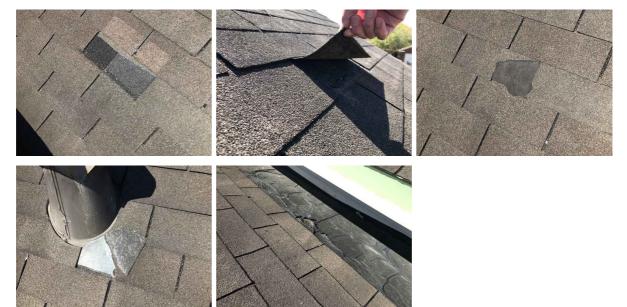
### 1: Multiple Roof Covering Defects Observed Recommendation

Examples include:, Loss of Adhesion, Missing Shingles, Exposed Fasteners, Torn Shingles, Damaged plastic at front valley -

Due to multiple deficiencies with the roof covering materials further evaluation by a qualified roofing professional is recommended.

Recommendation: Contact a qualified roofing professional.
