# PROPERTY INSPECTION REPORT FORM

# PROPERTY INSPECTED: 3815 Avenue North 1/2 Galveston, TX 77550

DATE OF INSPECTION: 07/13/2022 Inspection No. 521350-1201

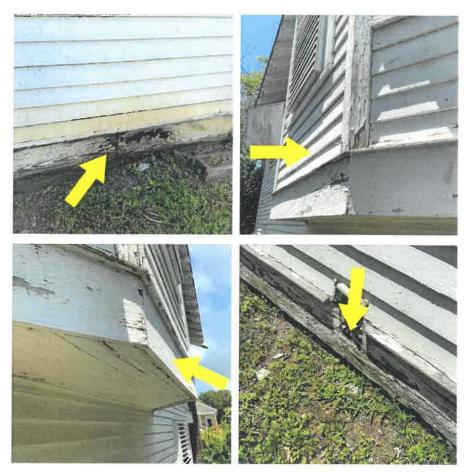
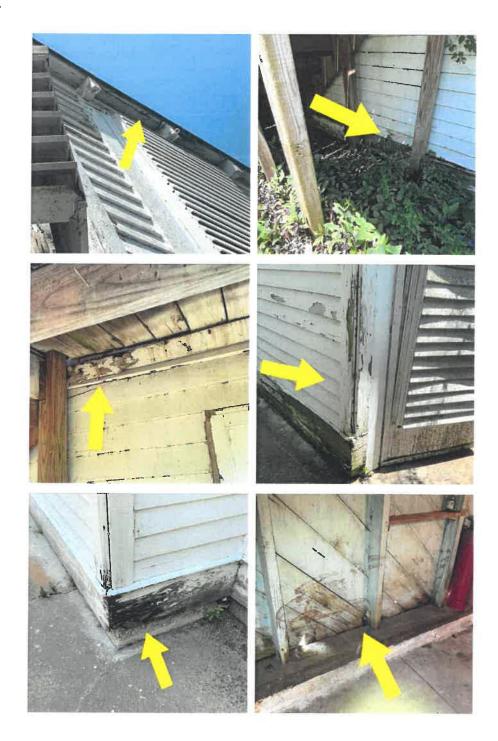
E. Walls (Interior and Exterior)

- Wood siding with wood trim (exterior) Wood walls with wood trim (interior).
- There we're multiple areas where siding and trim were showing various stages of wood rot. Recommend having qualified contractor evaluate the extent of damages and repair as needed to prevent further deterioration and damages.
- There we're multiple wall studs in downstairs area that were showing signs of wood rot/deterioration/ possible previous insect related damages noted. Recommend having qualified contractor evaluate the extent of damages and repair as needed.

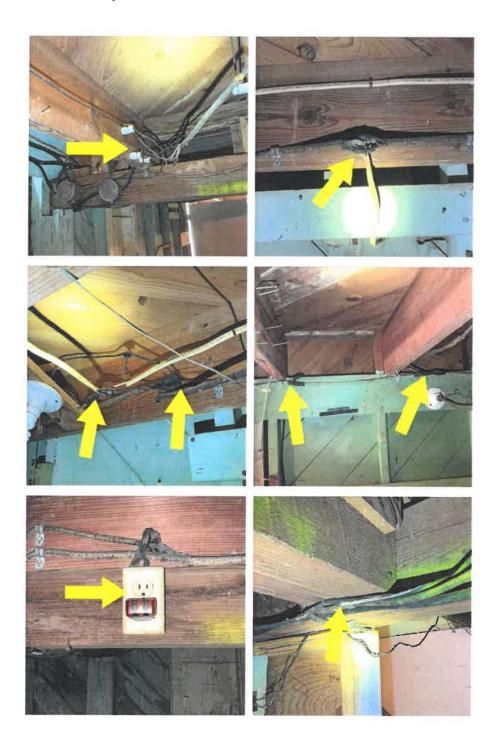
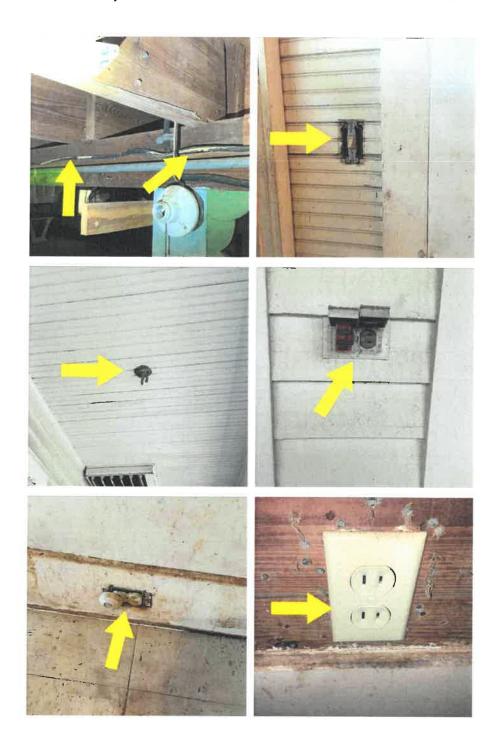
- B. Branch Circuits, Connected Devices, and Fixtures Comments:
  - Knob and tube wiring was noted as being present, further evaluation by licensed electrician is required to determine the presence and full extent of concealed knob and tube wiring throughout house and the associated cost of removal. Knob and tube removal may be required by your insurance company.

- Excessive wire splices are present. This is a non-standard dangerous electrical practice creating a potential fire hazard. Recommend further evaluation and correction for safety.

- Multiple receptacles are not GFCI protected in required ares. Receptacles in wet areas, outside and in garage are required to be GFCI protected to reduce the risk of electrical shock.

- Replace switch/receptacle cover plates to reduce hazards associated with exposed/accessible wiring.
  - Ungrounded two-prong receptacles were found. This should be corrected to prevent electric shock injuries.

- Multiple receptacles were noted to be showing open grounds when tested.
  - Improperly terminated wires were noted at back porch. Recommend installing fixture or terminating wires in a closed junction box.

- Damaged wire sheathing was noted at multiple area's throughout the home. Recommend having licensed electrician evaluate the extent of damages and replace as needed for safety.
