PROPERTY INSPECTION REPORT

Prepared For: Jeff Mitchell
(Name of Client)

Concerning: 5421 Verdome Lane, Houston, TX 77092
(Address of Inspected Property)

By: Steven Gibson, TREC PI: 20994 03/25/2021
(Name and License Number of Inspector) (Date)

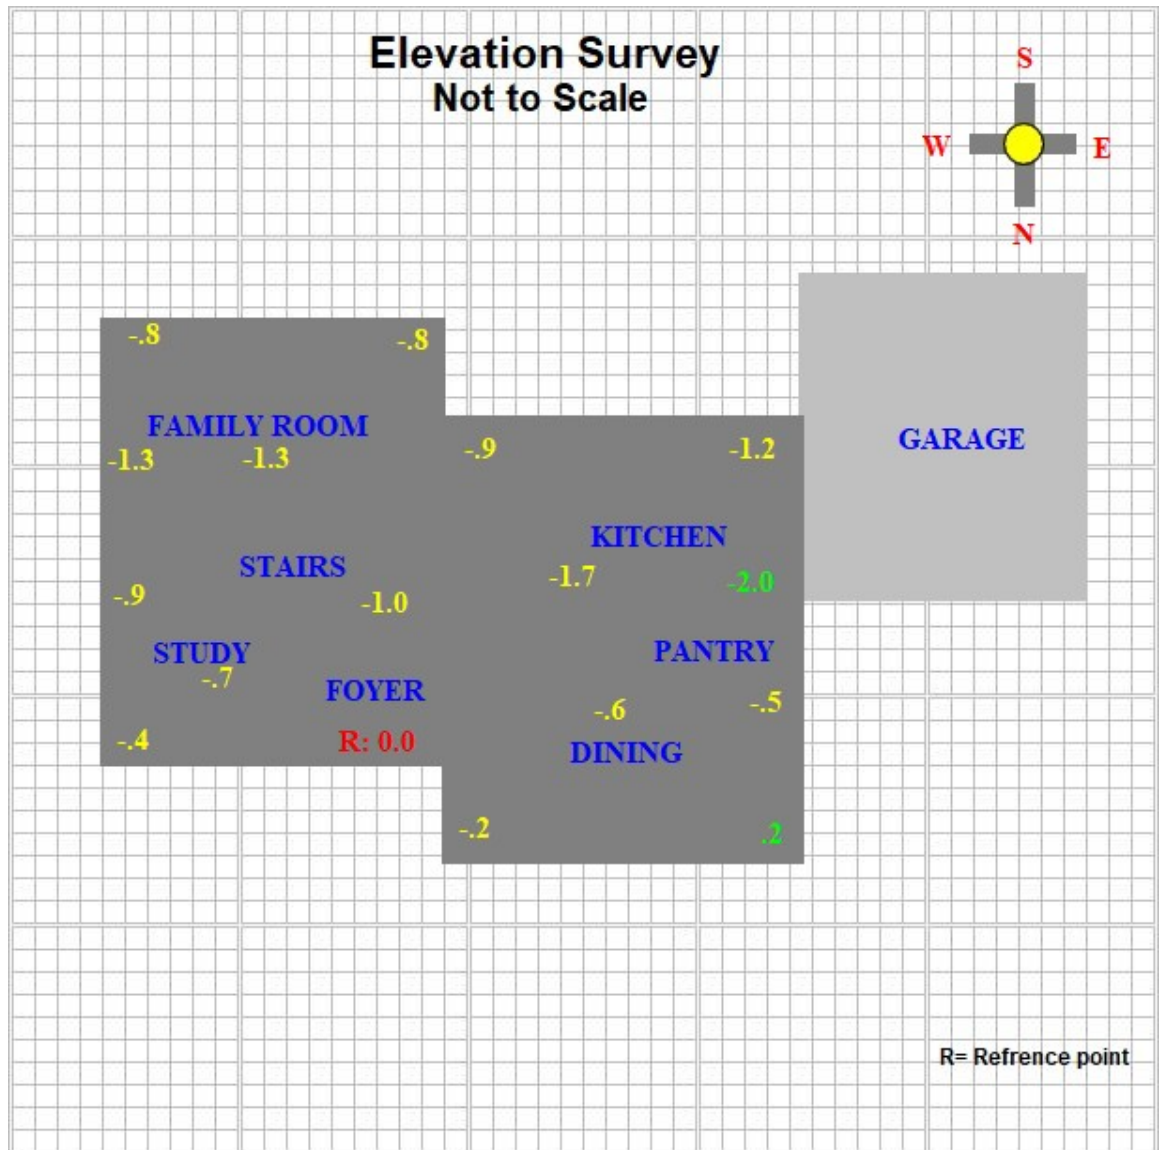
A foundation elevation survey was conducted during the inspection. The floorplan below represents data gathered using a Zip Level or similar instrument and adjusting for floor covering height differences. i.e. differences between tile, carpet and wood flooring(except step down to garage). Measurements are listed to the nearest 1/10th of an inch. Greatest variance was 2.2 INCHES

Differential movement/settlement observed; indicated by one or more of the following observed conditions; **Elevation readings**, Cracks in brick veneer and/or foundation, Cracks in sheetrock over doors and windows, doors that are not square in the jamb, etc. In my opinion, the distress patterns observed at the time of inspection are/were not severe enough to recommend repair. Acceptance of present and future condition/performance/maintenance rests solely with the buyer/client.

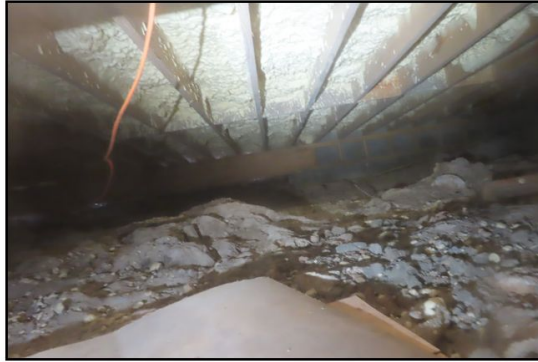
There appears to be an inadequate number of piers under the house. Recommend further evaluation by a licensed structural engineer.

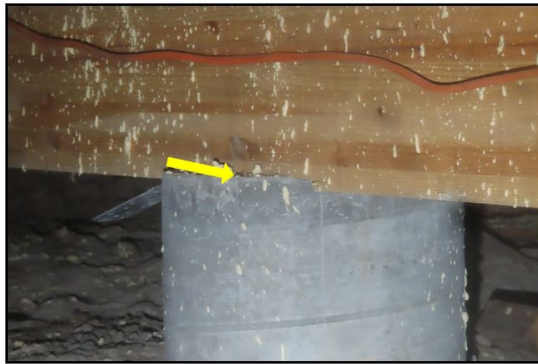
Missing metal cap flashing/termite shields at top of piers.

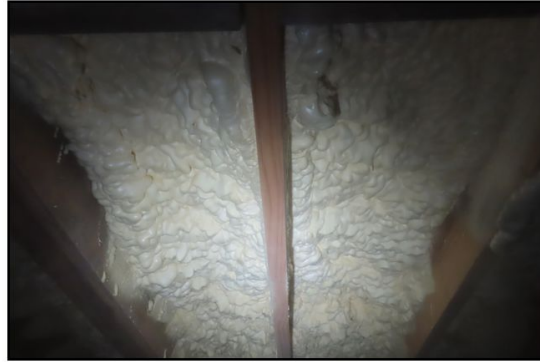
Spray foam insulation improperly installed in crawl space. Recommend additional application to increase thickness to provide a proper vapor barrier and covering the floor joists to decrease the possibility of heat transference through the conduction of the wood. Don't build-in a moisture sandwich. When the structure is air-conditioned the moisture sandwich is created by the extreme differences in temperature in the crawl space and the interior of the home. This condition may/will damage the sub-floor and finished floors.

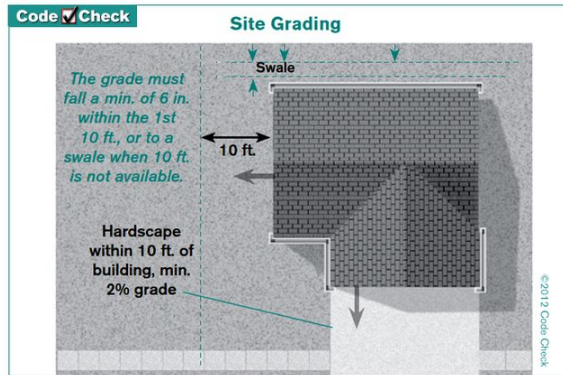
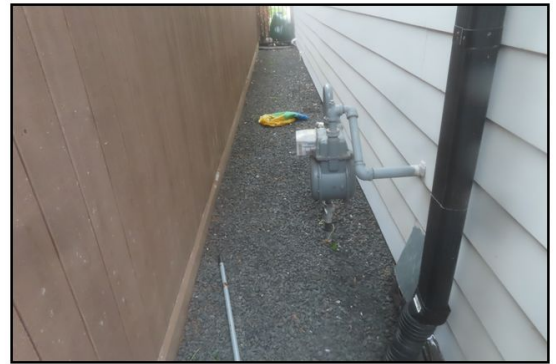
Soil grade and drainage patterns around some areas of the house do not appear to properly direct water away from the foundation to aid in controlling runoff water and could cause differential movement of the foundation or water penetration during heavy rains.

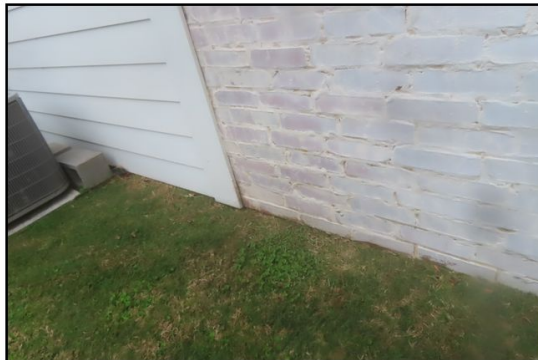
Soil level too high, in contact with wood siding and/or at/above brick weep holes at one or more locations around the house/garage. Promotes wood rot and is considered a conducive condition to termite activity.

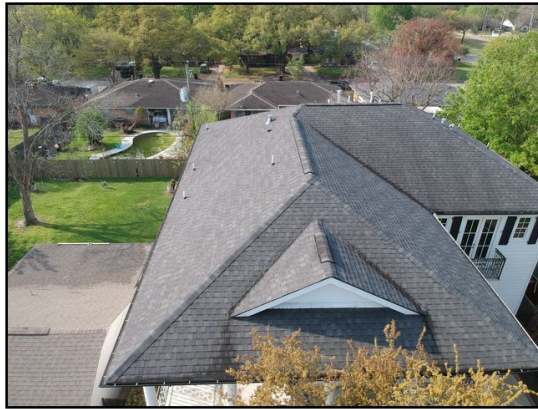
Due to the lack of safe access to the roof and/or to prevent damage to the roof surface the inspector did not physically walk on the roof. a drone was used to observe the roof surface for significant issues. The client is advised that aerial observation from a drone will not show all possible deficiencies. If this is a concern, recommend the client retain the services of a qualified roofing specialist at additional cost.

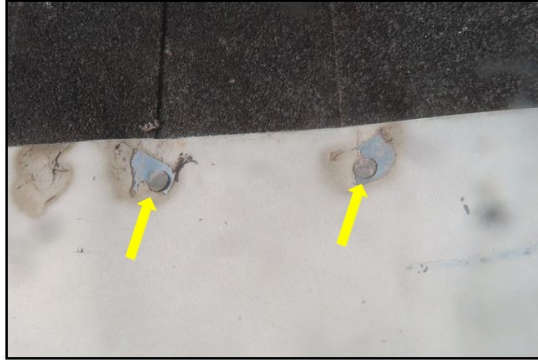
Exposed staples/nailheads/fasteners observed on the roof are not properly sealed. Water entry possible.

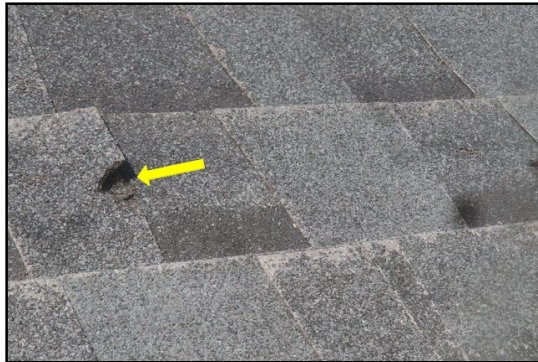
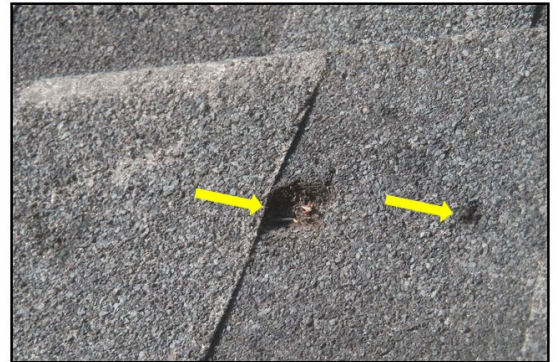
Observed evidence roof may have been subject to a hail storm in the past and/or blistering, which is a factory defect. Recommend inquiry of seller regarding any/all information (full disclosure) available and investigate if insurance may cover some / all cost of replacement.

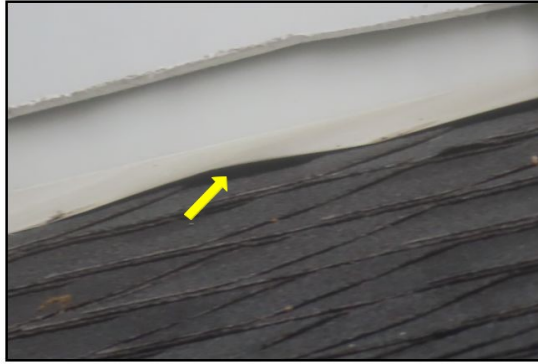
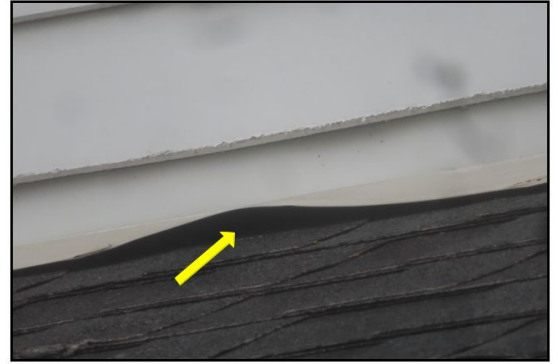
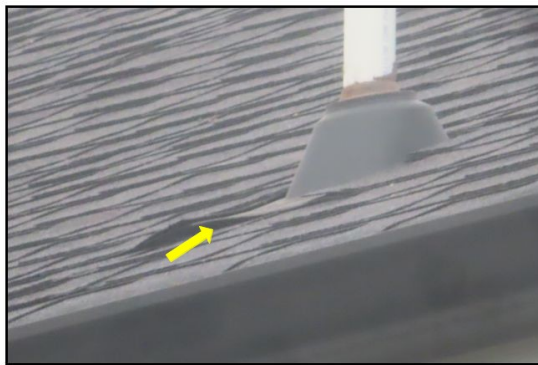
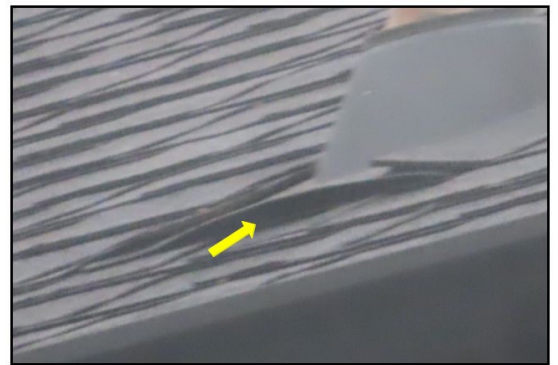
The lower side of flashing is not sealed down, wind-driven rains can cause water penetration.

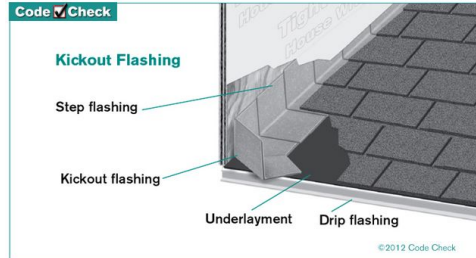
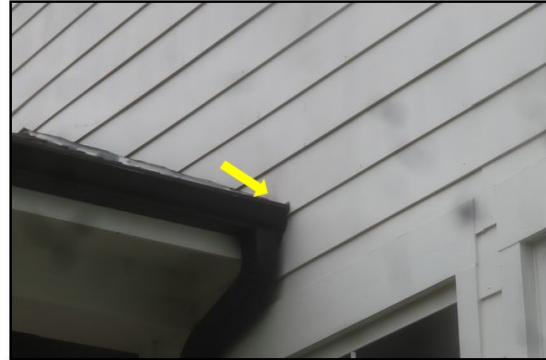
Did not observe "kick out" flashing where the roof terminates along a vertical wall. Kick out flashing encourages rainwater running down the roof to be diverted / "kicked out" away from a vertical wall and reduce water running down a vertical wall.

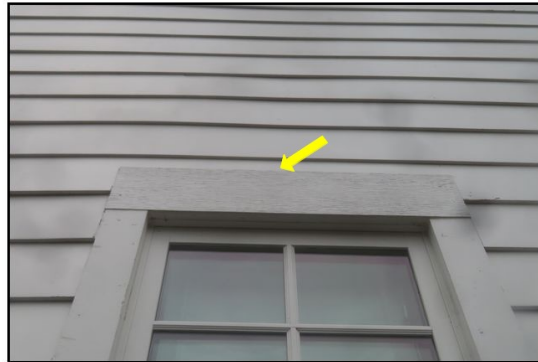
Head flashing missing over some windows/doors. Head flashing helps prevent water penetration. Without head flashing, window sealing must be maintained as it is the only defense against water penetration.

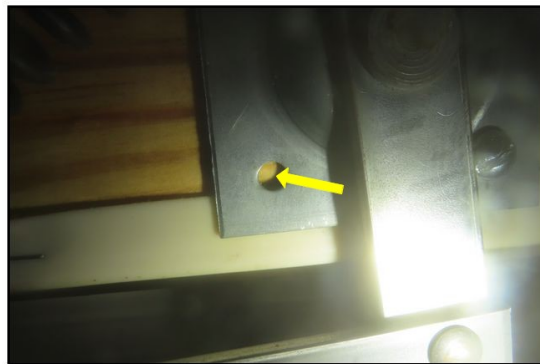
Not installed per manufacturer's installation instructions. Missing securing nails/lag bolts in holes of metal pivot points and corner braces.

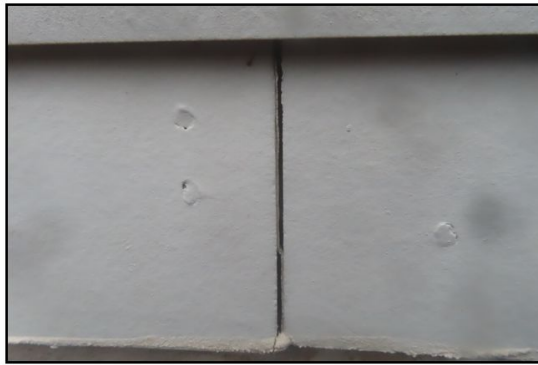
Caulking missing and/or deficient at vertical joints in the siding; may allow wind-driven rain entry.

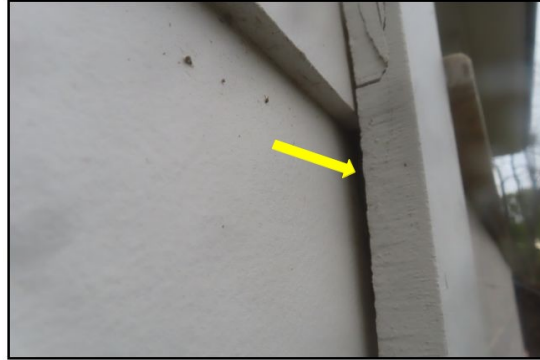
Caulking missing and/or deficient around vertical trim boards may allow wind-driven rain entry.

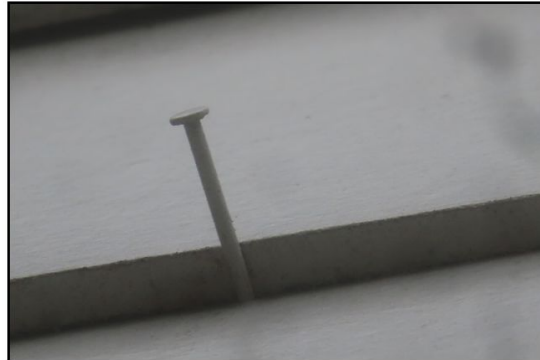
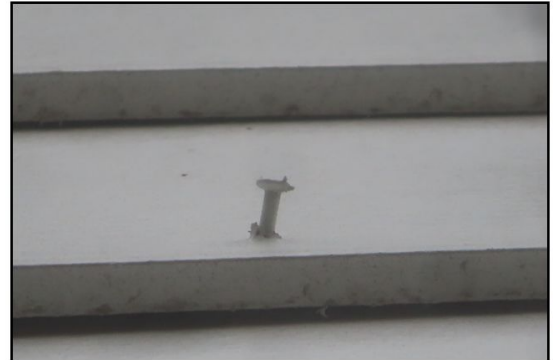
One or more loose fasteners observed in cement board siding.

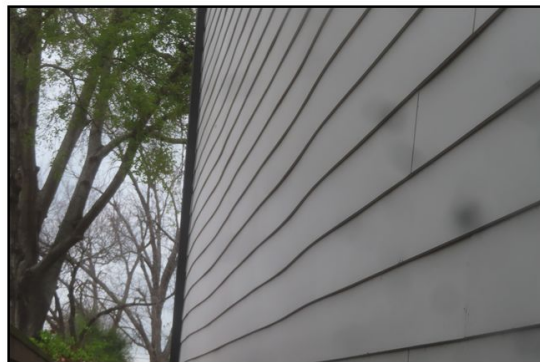
Observed some wavy cement board siding in one or more locations. Possible improper installation.

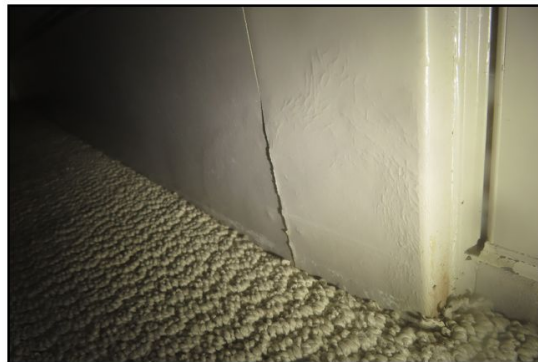
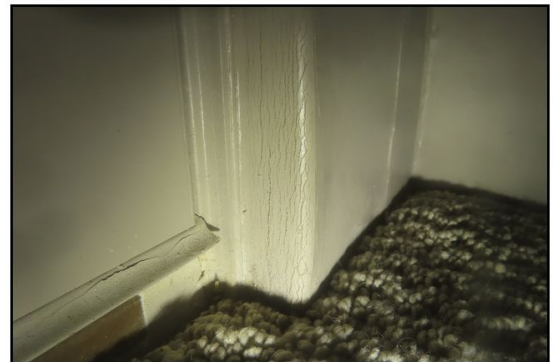
Wood rot of lower door and/or jamb; (**Bedroom balcony**)

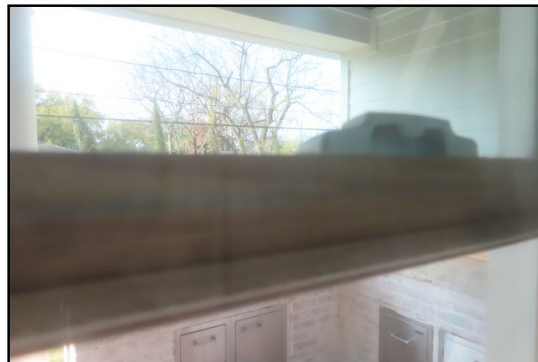
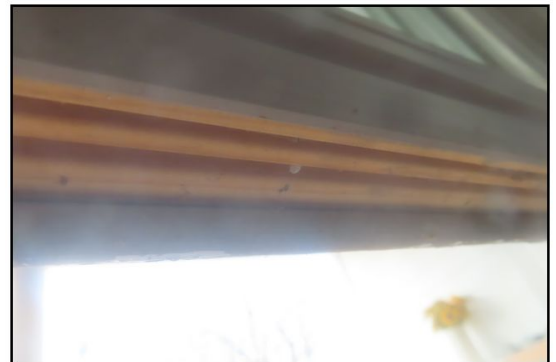
Multiple windows are not properly sealed against moisture absorption and potential wood rot, Recommend having all edges [top, bottom, and sides] of all exterior windows sealed to extend the life of wood frames and comply with manufacturer's warranty.

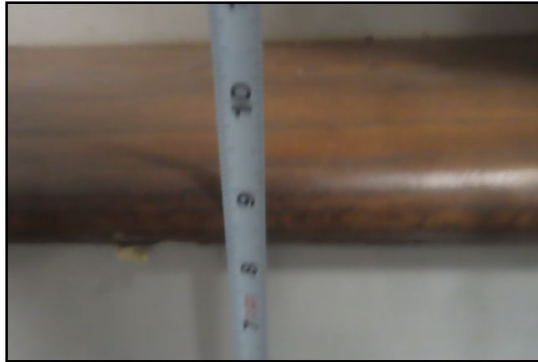
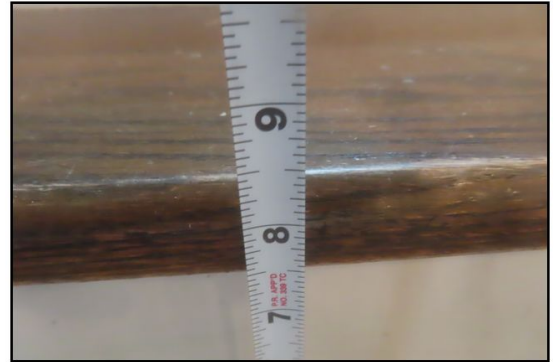
Stairway does not comply with the current industry standard, Per IRC 311.4.3.1. requires "The maximum riser height shall be 7-3/4 inches."

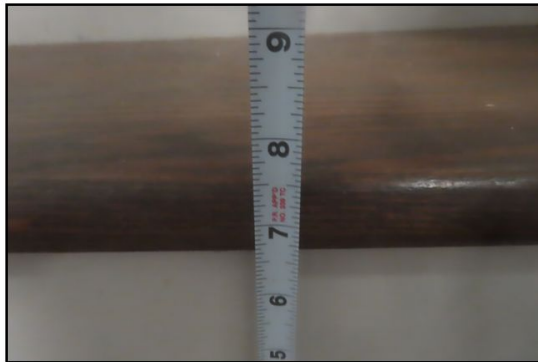
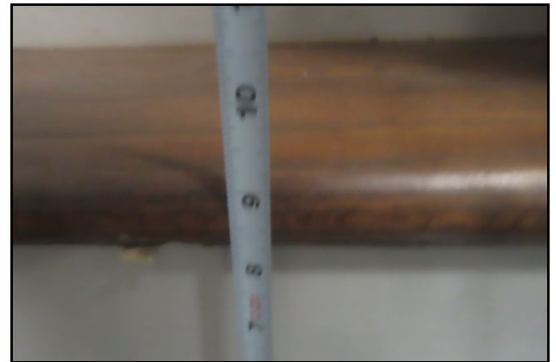
The stairway has a tripping hazard, Risers are not the same height along the entire height of the steps. Stairway does not comply with the current industry standard, Per IRC 311.5.3.1 & UBC 1006.3 requires "The greatest riser height within any flight of stairs shall not exceed the smallest by more than 3/8 inch."(Garage)

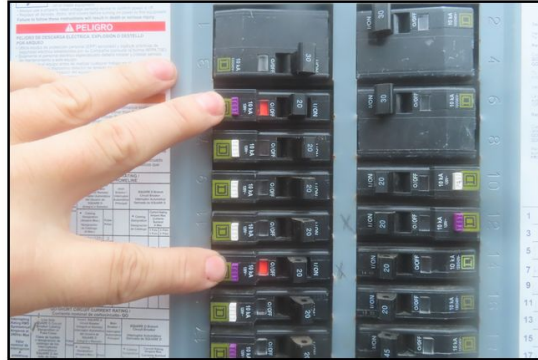
One or more breaker(s) were off at the time of inspection. Inspector does not turn on breakers found in off position due to potential short/electrical problem, recommend inquiring seller regarding information regarding any/all breaker(s) found in the off position.

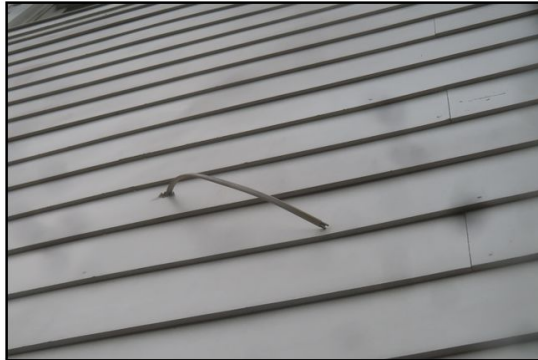
Wire improperly terminated, including but not limited to the following location;(East exterior)

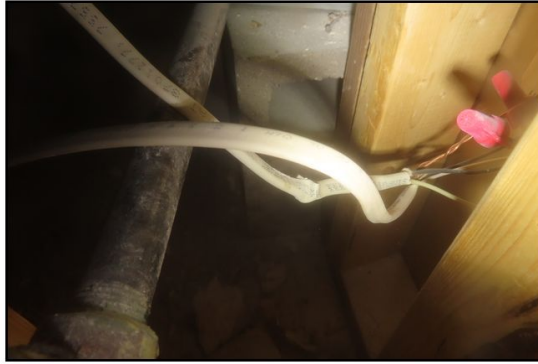
Electrical wiring in contact with gas line inside master bedroom fireplace gas starter compartment.

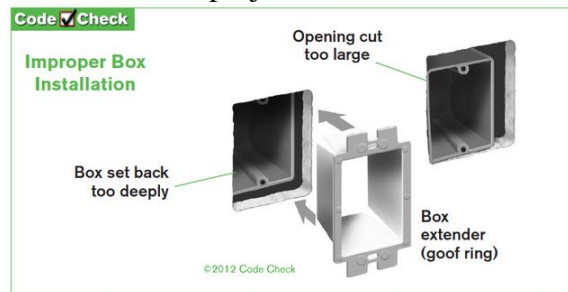
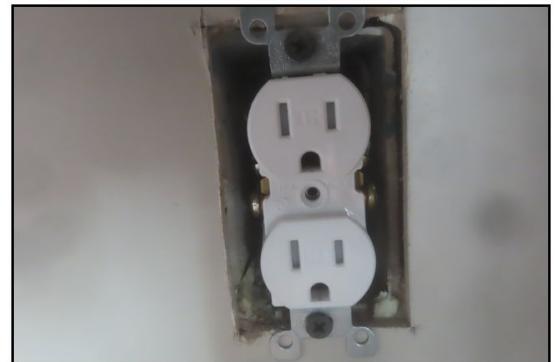
One or more outlets/switches/devices installed in/through combustable material were not flush-mounted as required by code, space exists between the faceplate and the edge of the electrical junction box. Per IRC E3806.7. In walls constructed of wood or other combustable material, cabinets (outlet & switch boxes) shall be flush with the finished surface or shall project there-from.

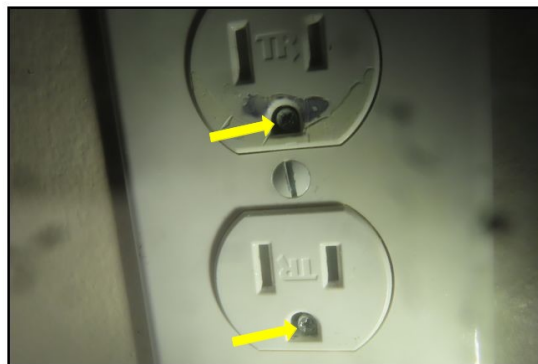
Screws observed inside foyer outlet receptacles.

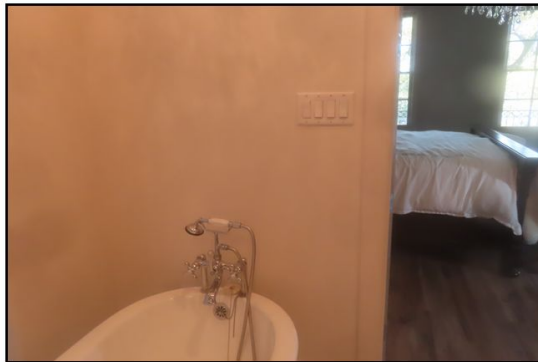
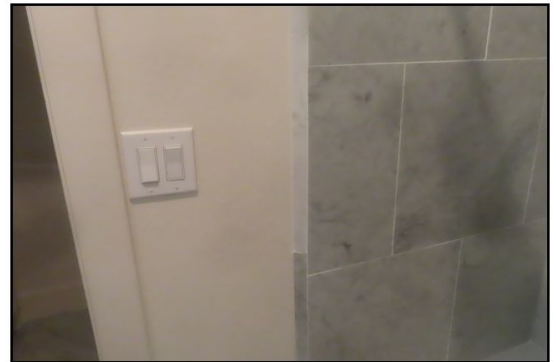
Switch/outlet can be operated while standing in tub/shower, shock hazard. Install switch on the backside of the wall or just ensure it is not operated while standing in the tub.(West bedroom bath, Master bath)

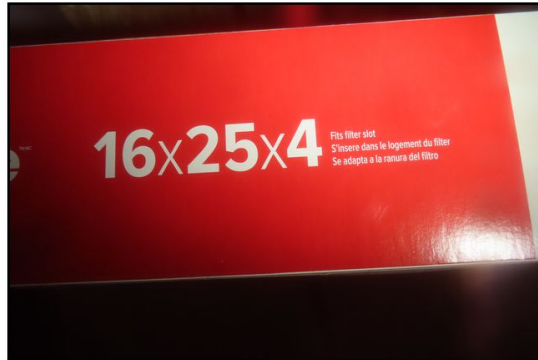
Media air filter(s) located in the attic that requires changing/cleaning every 6 months, recommend checking guide for proper maintenance information.

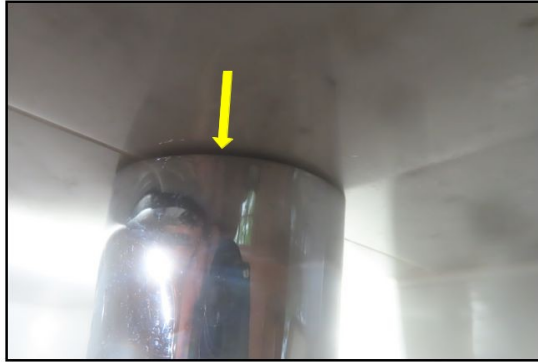
Recommend caulking around all tub/shower faucets and spouts to prevent water entry behind the wall.

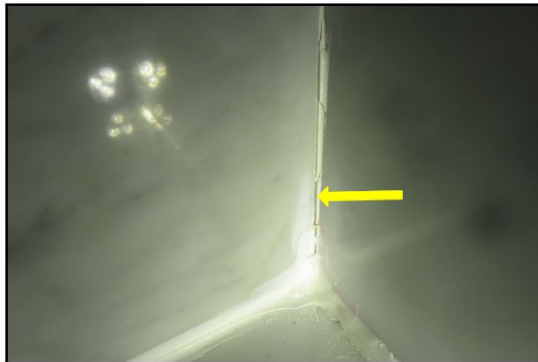
Grout/caulking needed at vertical tile corners, cracks in tile and/or mortar between tiles, and where tile meets tub to prevent water entry behind the wall.

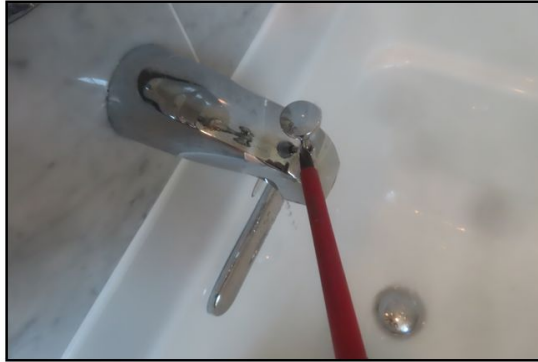
The shower diverter valve is not fully functional, does not direct all water to shower head during operation, (West bedroom bath, Jack and Jill bath)

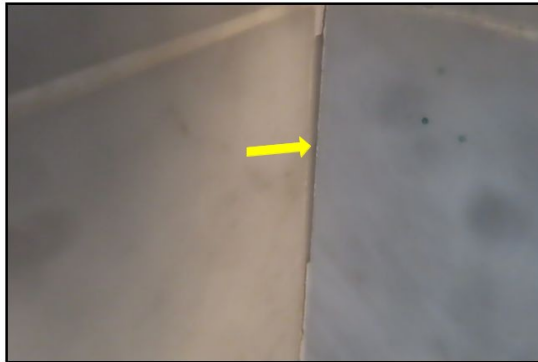
Grout/caulking needed at vertical tile corners, cracks in tile and/or mortar between tiles, to prevent water entry behind the wall.

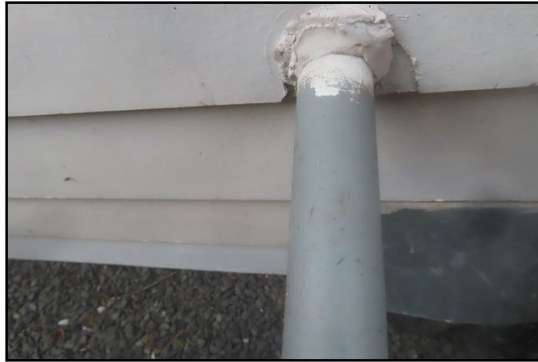
Exposed exterior gas piping not protected from corrosion as required per IRC 2603.3

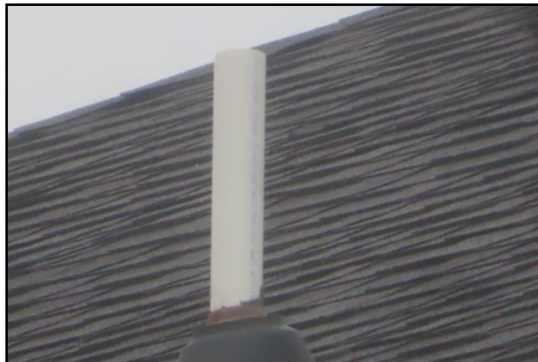
Painting of exterior plastic PVC vents above the roofline required to prevent UV damage.

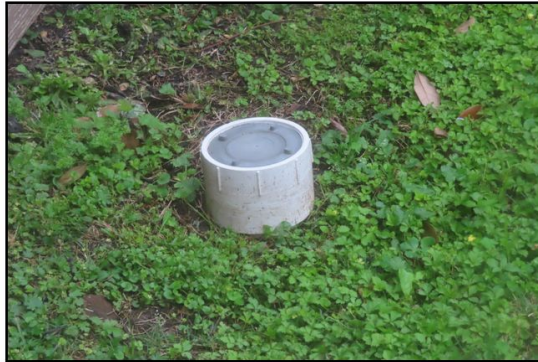
Recommend lowering sewer cleanout access to minimize damage from lawn equipment.

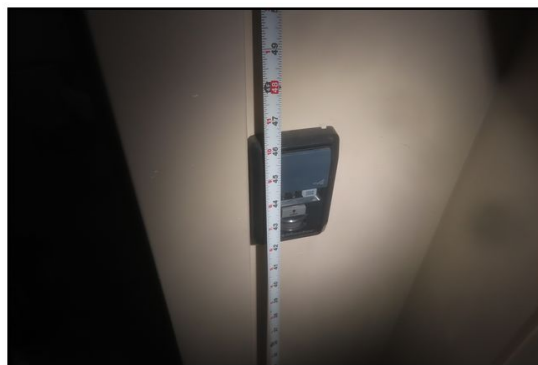
The garage door operator control button is improperly located. Federal safety standard for automatic residential garage door openers states “Locate control button: (a) within sight of the door, (b) at a minimum height of 5 feet so small children cannot reach it, and (c) away from all moving parts of the door.”

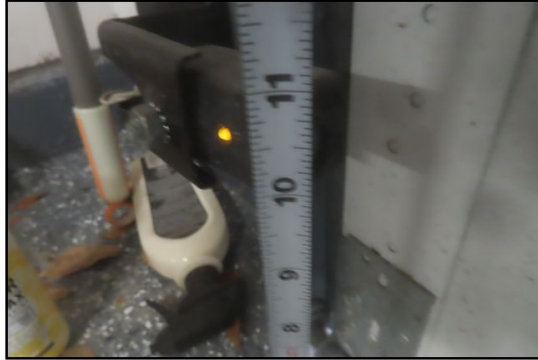
Electronic sensing eyes are improperly installed; they should be no more than 6 inches above the floor.

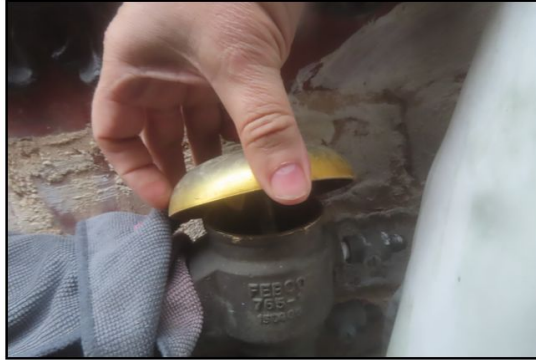
Back flow prevention device damaged. (System operation not checked/inspected.)

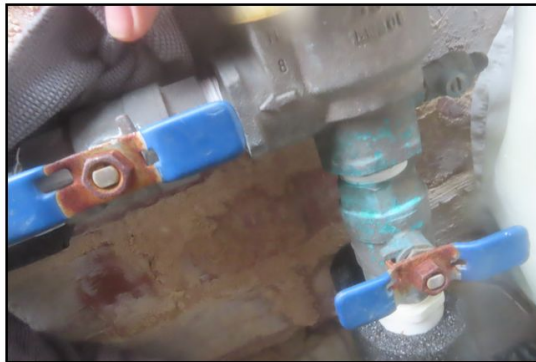
Corrosion on back flow prevention device water shut off handles.
