**Concerning:** 5602 Ivory Mist Lane, Houston, TX 77041

**By:** Vernon Gibson

JULY 20, 2022

## PROPERTY INSPECTION REPORT

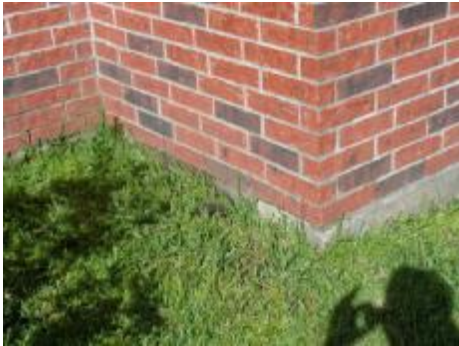
*Comments: The corners are popped on the left front side, right garage, and the right front. Grout popped corners.*

Popped corner left front

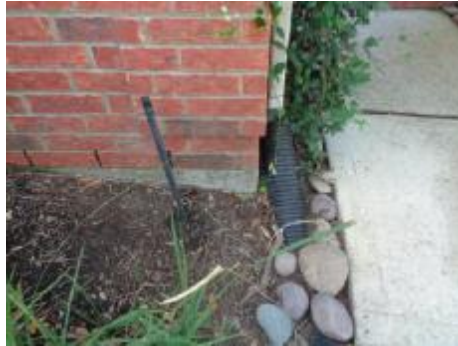
Popped corner right garage

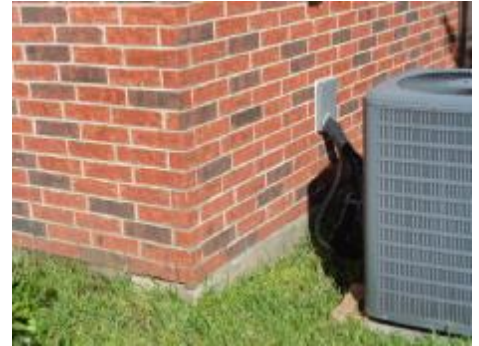
Popped corner right

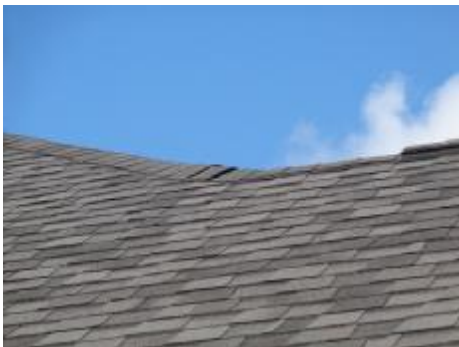
*Comments: The roof has raised shingles on the back left, back ridge cap and the left side. Repair raised shingles. The roof has a damaged shingle on the front garage area. Repair/replace damaged shingles.*

Roof raised shingle back left

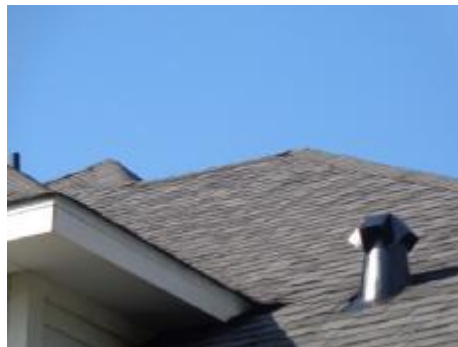
Roof raised shingle back top

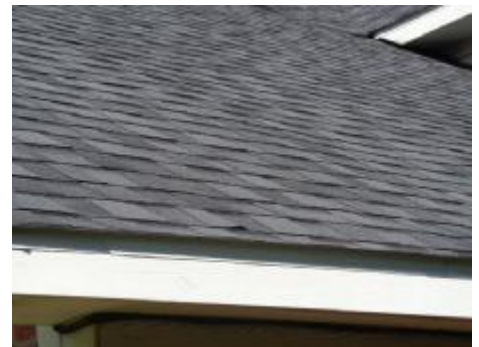
Roof raised shingle left

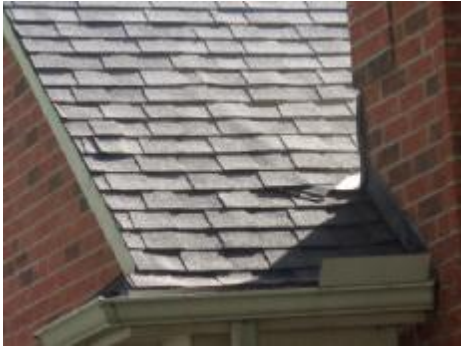
Roof shingle damage front garage

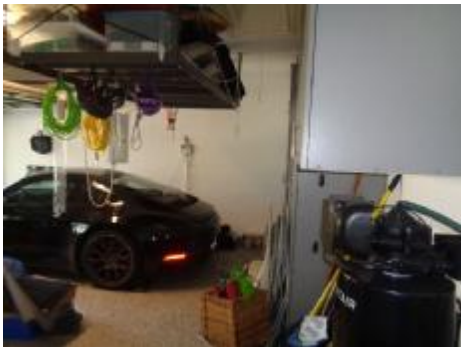
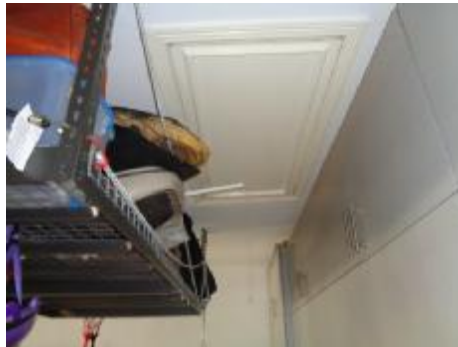
Attic unable to access

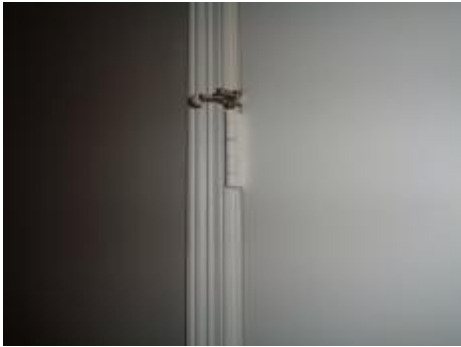
- G. Doors (Interior and Exterior) –**  
 Comments: Garage barrier door is not self-closing. Install self-closing device. The downstairs bathroom door will not close. Repair downstairs door.  
 Is garage barrier door self-closing?  Yes     no     N/A

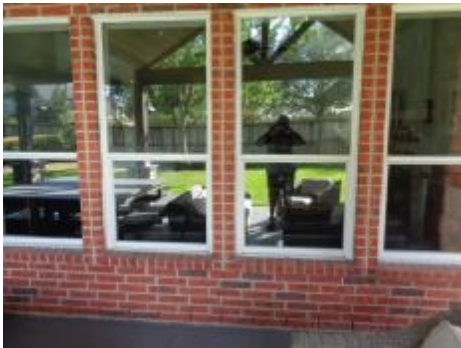
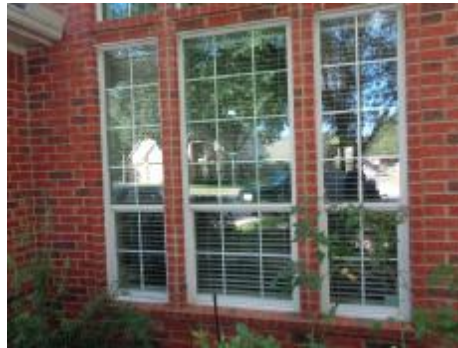
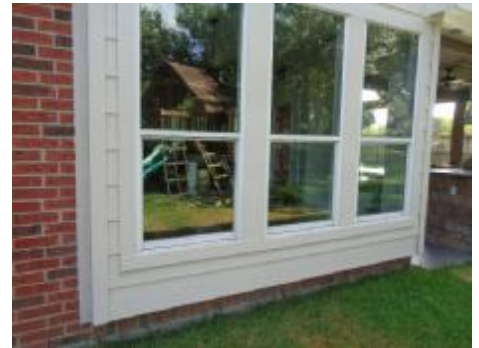
*Comments:* All operable windows do not have screens. Install screens. The primary bathroom window is fogged. Repair or replace fogged window. There is a cracked window on the front of the house and on the right wall. Repair or replace cracked windows.

Windows missing screens

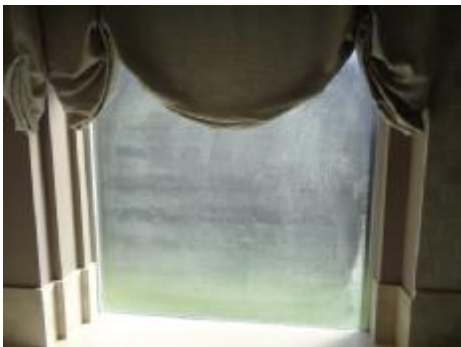
Window fogged

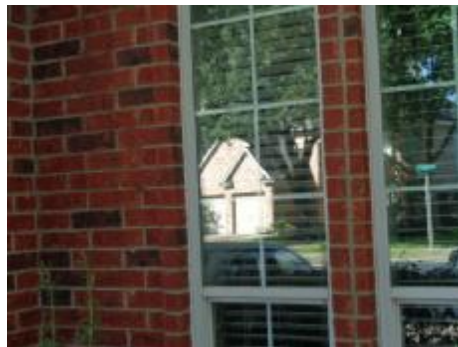
Window cracked front

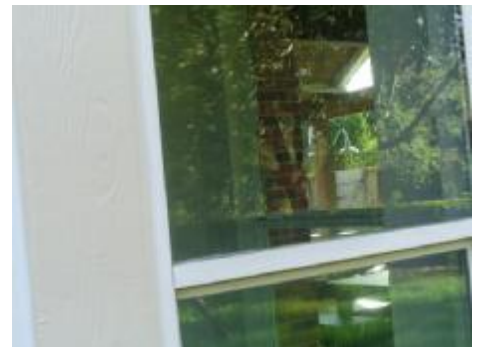
Window cracked right

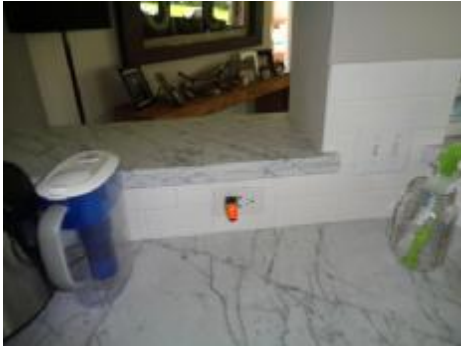
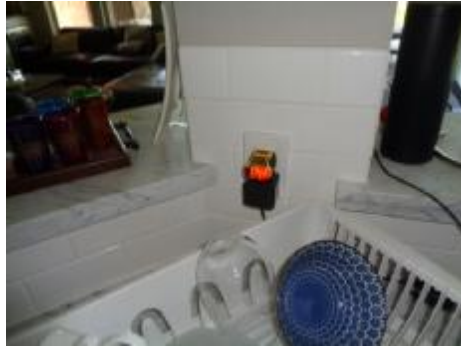
- Wiring/Boxes/Conduit/Gutters
- Grounding/Bonding
- Equipment Disconnects
- Improper use of extension cords
- Receptacle(s) & Switch (es) Lights, Fans, Etc.)
- Are receptacle(s) tamper resistant  yes  no (***if no, Install tamper resistant outlets***)
- Lights, Fans, Etc.)
- Smoke detectors  near kitchen  in bedroom  in halls to bedrooms
- Carbon Monoxide  present  Not Present  Install near sleeping rooms
- Ark fault Circuit Interrupter(s) present  yes  no
- Ground Fault Circuit Interrupter(s) GFCI is missing in the in the kitchen and at the exterior front door. Install GFCI protection.  
 Bathroom(s)  Kitchen  Garage  Exterior  Pools  Other

GFCI missing kitchen

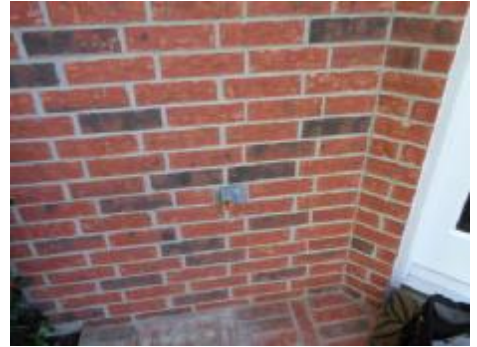
GFCI missing exterior front door

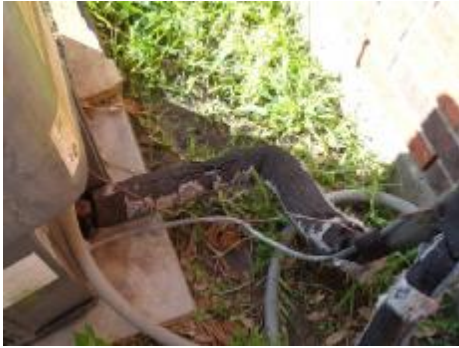
- Supply: 51 °F Return 67°F Temperature Differential: 16 ° Δ
- Condensate Drain (s)
- Piping Insulation    Piping insulation is damaged. Repair or replace piping insulation.
- Unit Clearances

AC 1 insulation

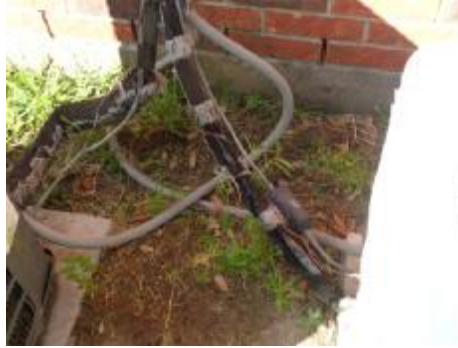
- Supply: 52 °F Return 68°F Temperature Differential: 16 ° Δ
- Condensate Drain (s)
- Piping Insulation    Piping insulation is damaged. Repair or replace piping insulation.

AC 2 insulation

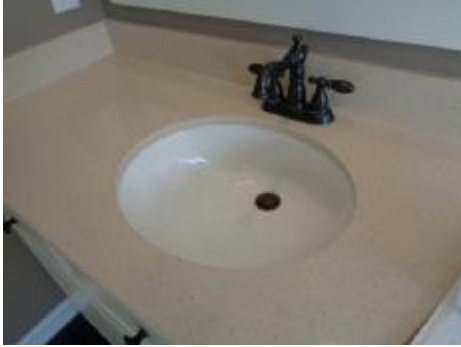
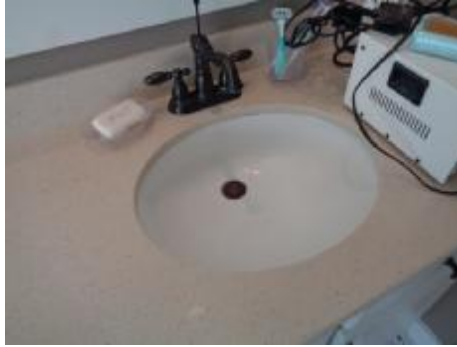
In both lavatories, the drain stops are not working properly. Repair

Primary drain stop

- drain stops.
- Tub and Shower Units
- Faucet Assembly(s)/Supply Pipes/Valve

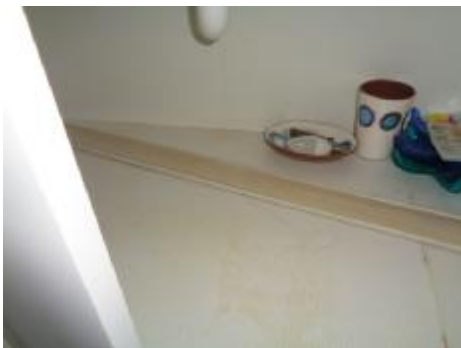
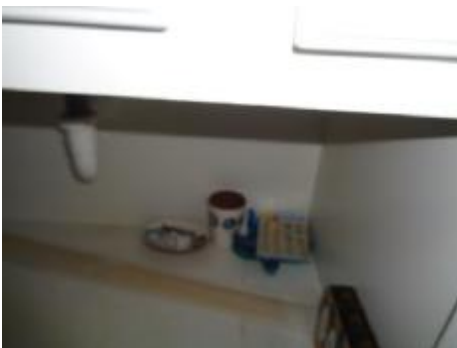
Pipes are leaking underneath the sink. Repair or replace pipes.

Leak under bathroom sink

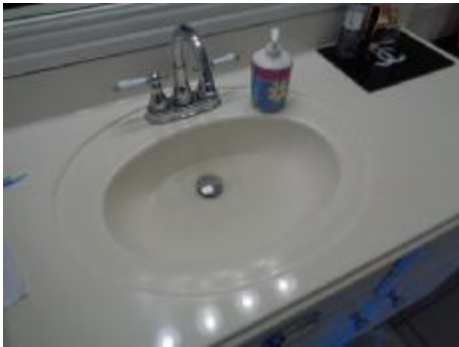
Drain stop is not working properly. Repair or replace drain stop.

Hall drain stop

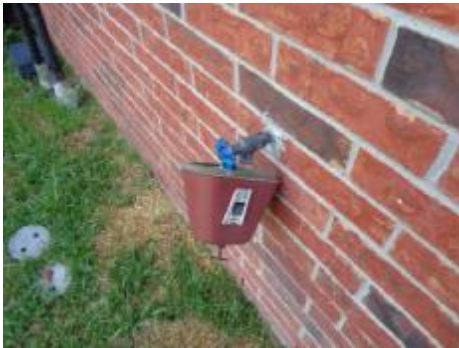
Backflow missing right

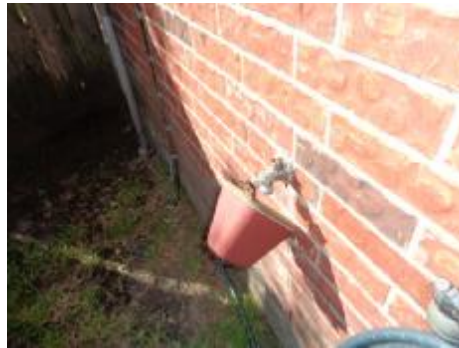
Backflow missing left

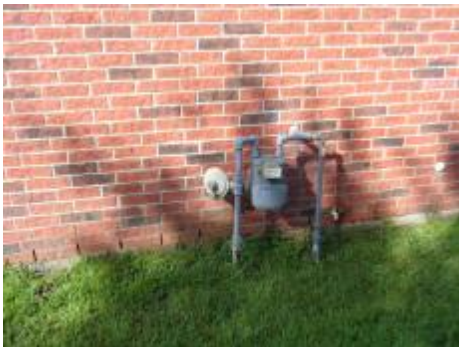
*Are gas lines bonded     yes     no    Gas meter is not bonded. Bond gas meter.*

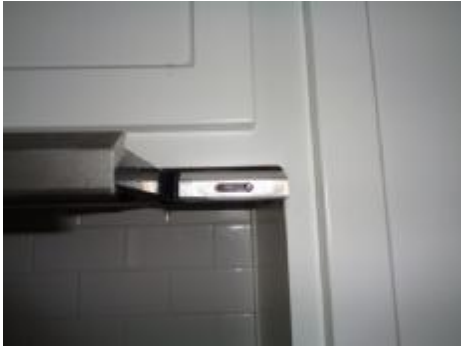
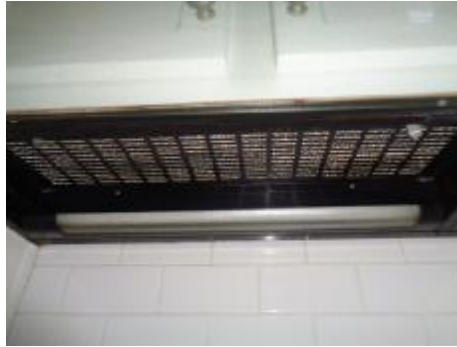
Hood vent

- Vented  recycling  down draft
- Operation of Filter, Switches & Blower                      Vent will not turn on. Repair range hood.

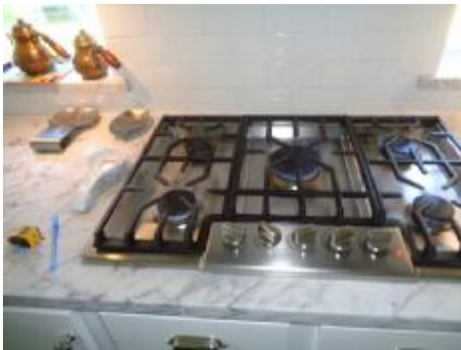
*Comments: The stovetop's back left burner did not turn on. Repair burner.*

Stovetop burner
