## PROPERTY INSPECTION REPORT FORM

L RES CORP <i>Name of Client</i>	07/20/2022 <i>Date of Inspection</i>
11899 Algonquin Drive , Houston, TX 77089 <i>Address of Inspected Property</i>	
Dan Romero <i>Name of Inspector</i>	5674 <i>TREC License #</i>
<i>Name of Sponsor (if applicable)</i>	<i>TREC License #</i>

## Home Inspection Report

PROPERTY INSPECTED:  
11899 Algonquin Drive  
Houston, TX 77089

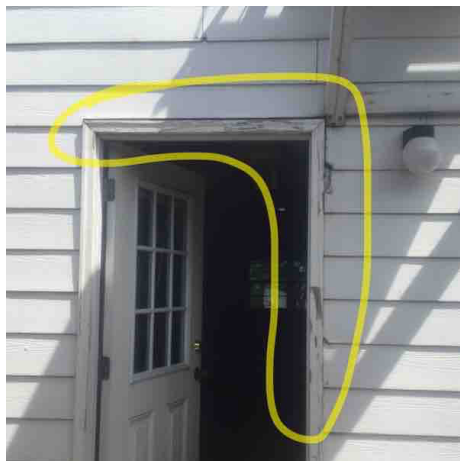
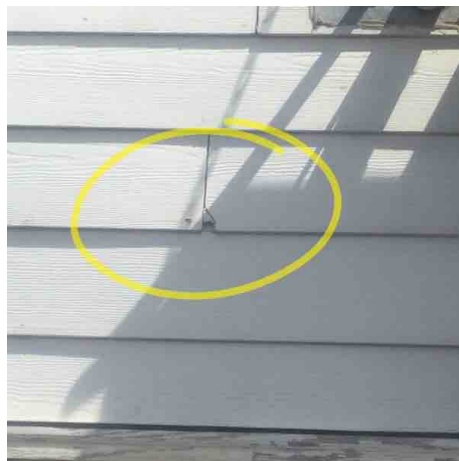
Observed open gaps damaged siding along the back entry door and back wall.

Observed damaged siding along the back wall along the garage door. Repairs and corrections are recommended and advised.

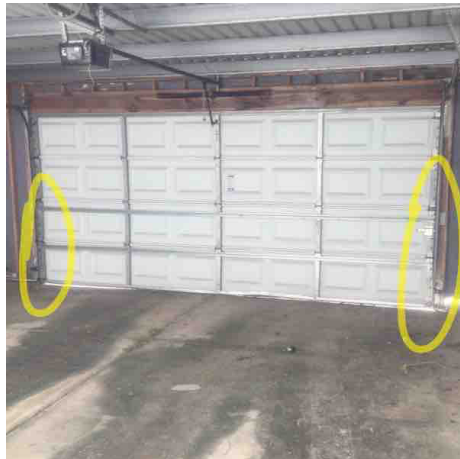
**Observed damaged garage door as the rollers had come out of the railings and would not properly operate and close.**

**Repairs and corrections are required by a qualified contractor specialist.**

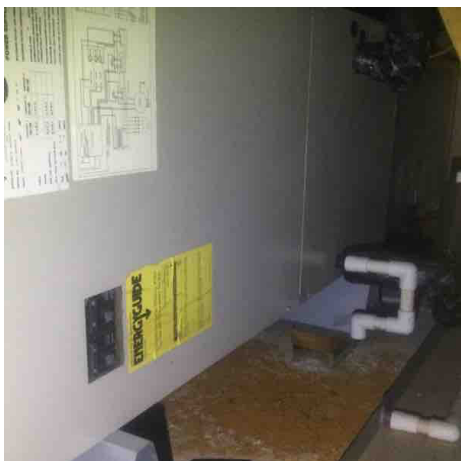
- The home was equipped with one electric furnace located in the attic space of home. At the time of the inspection the electricity was not connected and so the unit could not be properly inspected or tested. Further evaluation is required and advised.

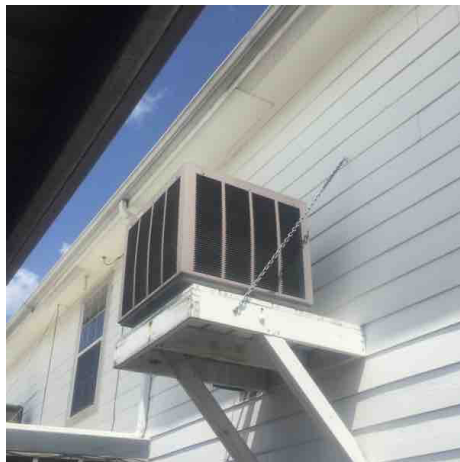
Observed rust and corrosion in the drain pan.

This is a typical indicator that the unit is in need of a service check by a licensed HVAC company.

Further evaluation, repairs, and corrections are required and advised.

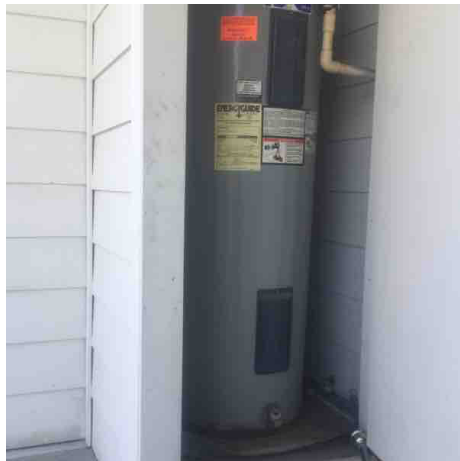
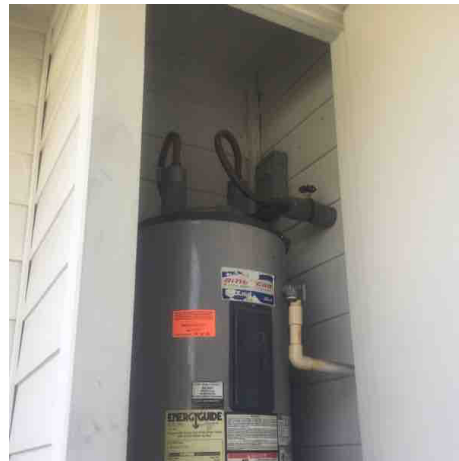
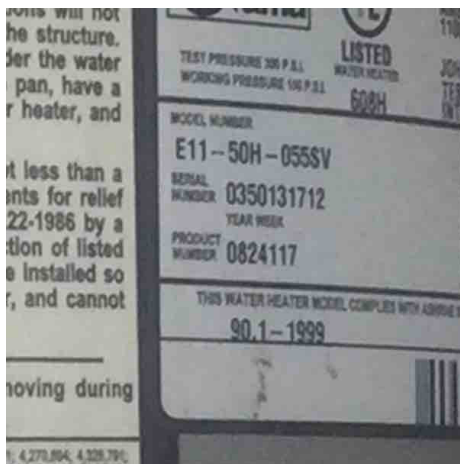
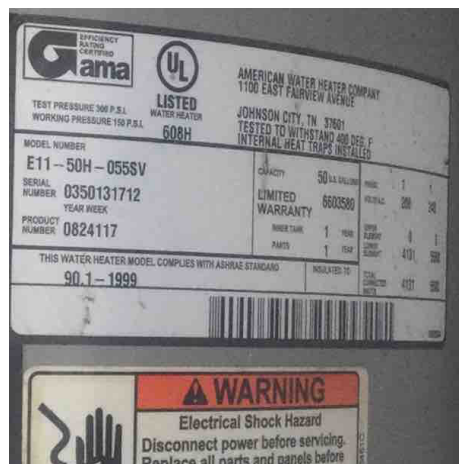
Observed damaged drain pan.

Further evaluation by a licensed specialist is required and advised.

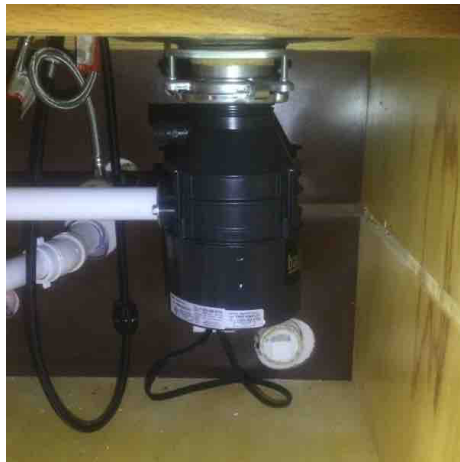
*Comments:*  
• **NAME: BADGER**  
**At the time of the inspection the electricity was not connected and so the unit could not be properly inspected or tested. Further evaluation is required and advised.**
