Moisture Assessment Report

4515 Floyd Street Unit E
Houston, TX 77007
07/28/2021

Anne-Marie & Ed McMichael

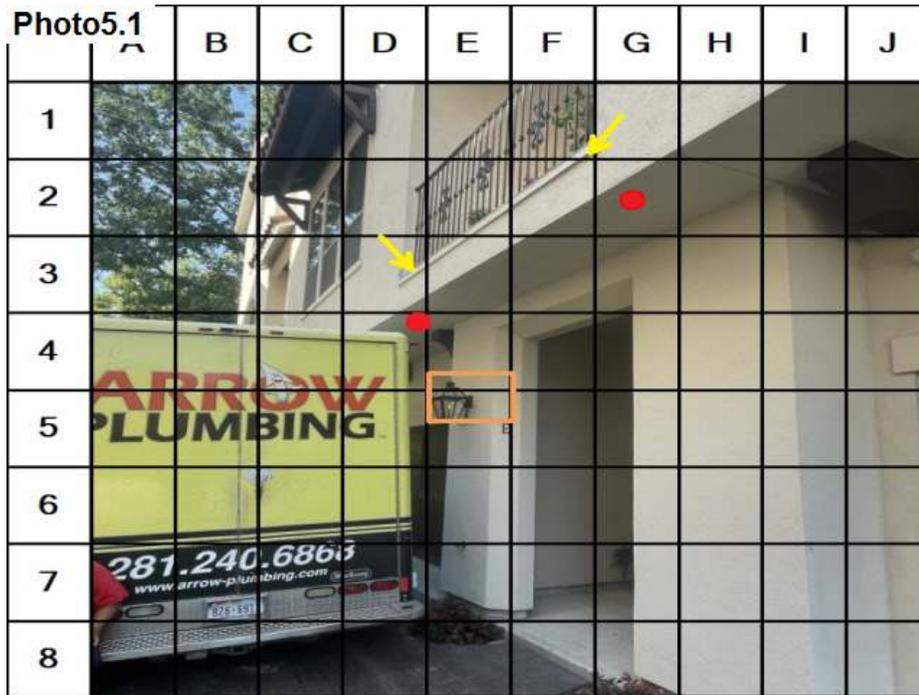
| Grid Location | Item Description | Moisture Readings | Substrate Condition | Observations-Photo #5.1 | Chapter Reference |
|---|---|---|---|--|---|
| D4 | Below Balcony Flashings | 40% | Semi-Soft | Elevated moisture reading was made at bottom of wall below balcony flashings. Semi-soft substrate noted. Repair all possible substrate damage as needed. | |
| G2 | Below Balcony Flashings | | NONE | Moisture reading was made at bottom of wall below balcony flashings. No resistance noted. Repair all possible substrate damage as needed. | |
| Yellow Arrows | Balcony Flashings | | | Balcony flashings are failing and not performing properly. Corrosion noted at perimeter flashings. It is suggested to rework balcony flashings and repair all possible substrate damage as needed. See details #5.2, #5.3, and #5.4. | Ch 3.5 |

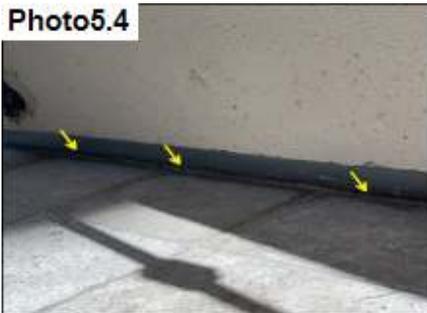
Galvanic corrosion noted at balcony flashings.

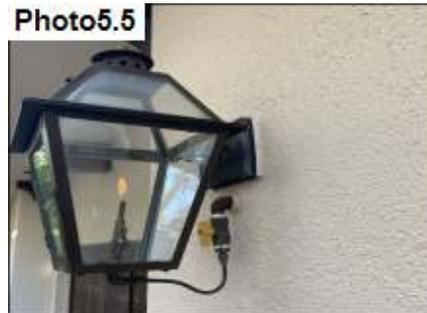
Light fixtures are sealed.

| Grid Location | Item Description | Moisture Readings | Substrate Condition | Observations-Photo #5.1 | Chapter Reference |
|---|---|---|---|--|---|
| Orange Square | Light Fixture | | | Light fixture penetration is sealed properly. It is suggested to always maintain the polyurethane caulking as needed. See detail #5.5. | Ch 3.1 |

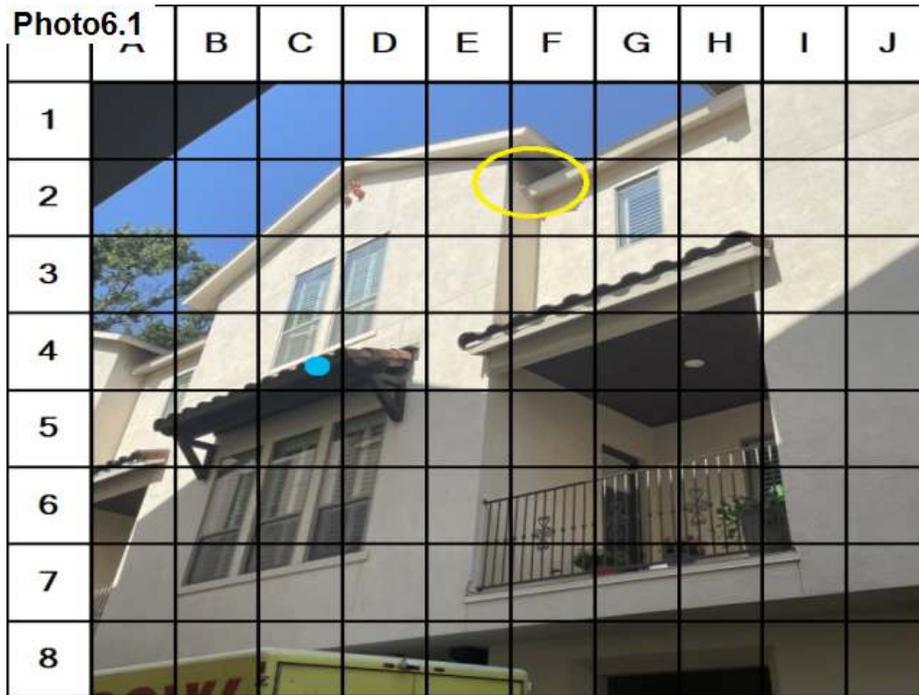
| Grid Location | Item Description | Moisture Readings | Substrate Condition | Observations-Photo #6.1 | Chapter Reference |
|---|---|---|---|---|---|
| C4 | Below Windows | 15% | Firm | Moisture reading was made below windows. | |
| Yellow Circle | Kickout Flashing | | | Kickout flashing is present and sealed properly at the secondary roof termination. It is suggested to always maintain the polyurethane caulking as needed. See detail #6.2. | Ch 3.4 |

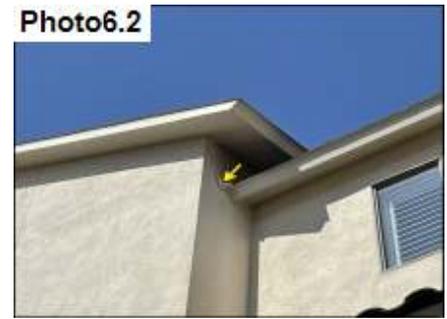
Always maintain proper sealants at kickout flashing.

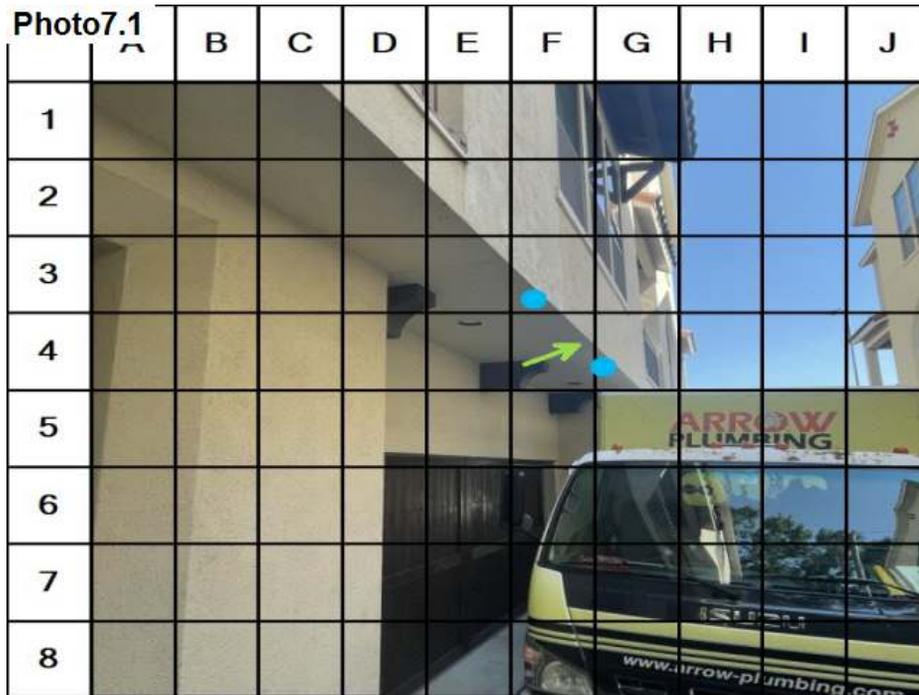
| Grid Location | Item Description | Moisture Readings | Substrate Condition | Observations-Photo #7.1 | Chapter Reference |
|---|---|---|---|--|---|
| F3 | Bottom of Wall | 13% | Firm | Moisture reading was made at bottom of wall below windows above. | |
| H4 | Bottom of Wall | 17% | Firm | | |
| Green Arrow | Weep Relief | | | No weep relief present at the bottom of the wall. Weep relief is a favorable detail that allows for proper moisture drainage of the wall(s). It is suggested to install a continuous weep relief at bottom of wall after stucco repairs have been made. See detail #7.2. | |

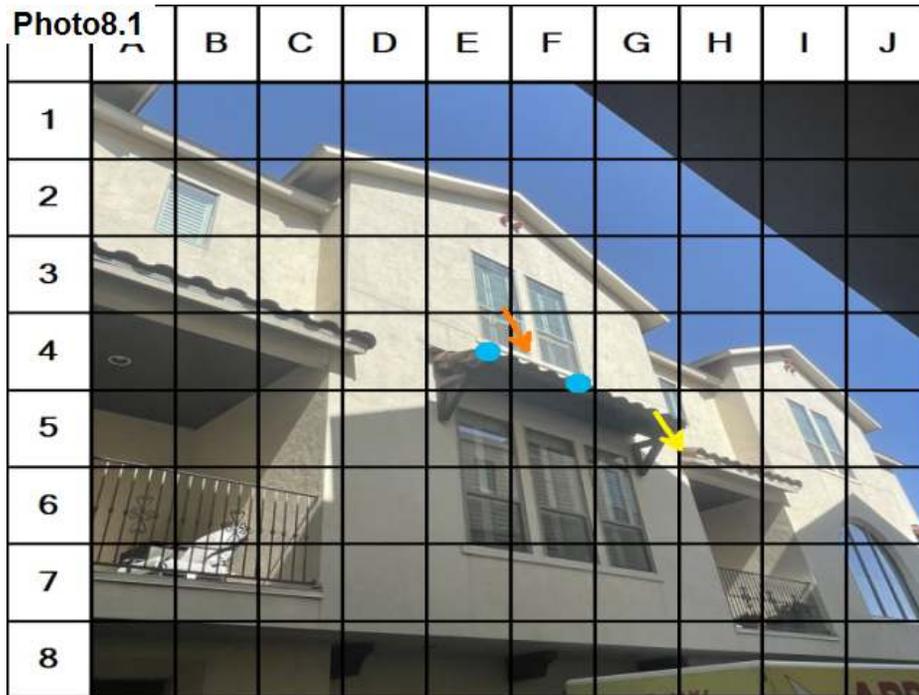
| Grid Location | Item Description | Moisture Readings | Substrate Condition | Observations-Photo #8.1 | Chapter Reference |
|---|---|---|---|---|---|
| E4 | Below Window | 15% | Firm | Moisture reading was made at window lower left. | |
| F4 | Below Window | 15% | Firm | Moisture reading was made at window lower right | |
| Orange Arrow | Window Sealants | | | Window frames are sealed properly. It is suggested to always maintain the polyurethane caulking as needed. See detail #8.2 | Ch 3.2 |
| Yellow Arrow | Fascia Board Terminations | | | Fascia board terminations are sealed properly. It is suggested to always maintain the polyurethane caulking as needed. See detail #8.3. | Ch 3.4 |

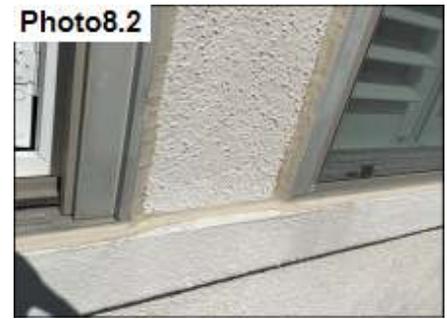
Window frames are sealed.

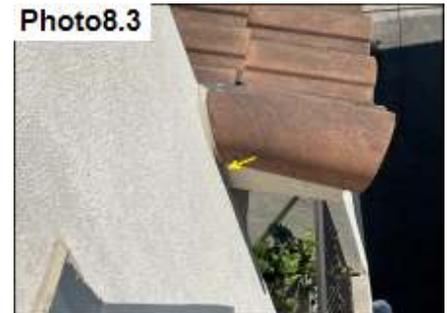
Fascia board terminations are sealed.
