PROPERTY INSPECTION REPORT

Concerning: 4515 Floyd Street unit E , Houston, TX 77007
(Address or Other Identification of Inspected Property)

By: Terrence Foster Lic.#: TREC #5182 07/24/2021
(Name and License Number of Inspector) (Date)

Home Inspection Report

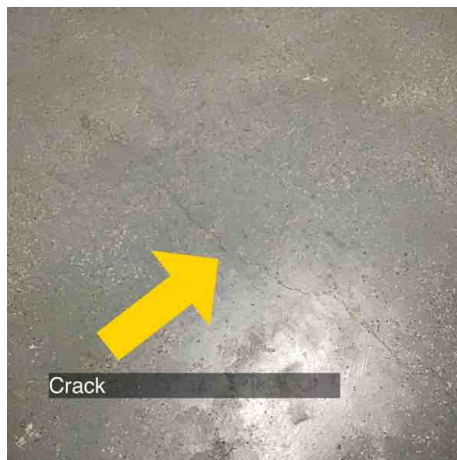
- **There are several hairline cracks in the garage floor surface that in the opinion of this home inspector does not appear to be causing serious structural issues at this time, recommend to seal cracks and monitor. Sometimes these types of cracks are from concrete shrinkage and others can be from foundation movement. If you have concerns about the garage cracks, you may want to have evaluation by a qualified foundation contractor or structural engineer. All cracks need to be filled in and monitored for any further cracking. If future cracking occurs, a foundation contractor or structural engineer will need to evaluate the foundation further.**

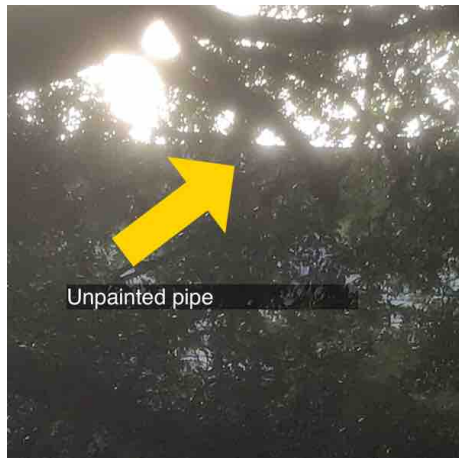
- Composition asphalt roof shingles, appears to be an older roof. There is also a clay tile roof on part of the east side.
Roof too high to climb, inspected from the ground with binoculars and inside the attic. Very little could be seen of the east side of the roof and only part of the west side was visible because of trees blocking the view.
- **The white PVC pipes sticking up out of the roof for the plumbing vent pipes are not painted, need to be painted to reduce sunlight damage to them. Also the metal boot jacks are not painted, need to be painted to reduce chances of rust damage to them.**

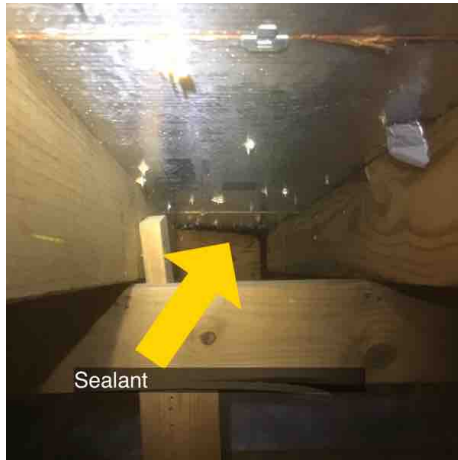
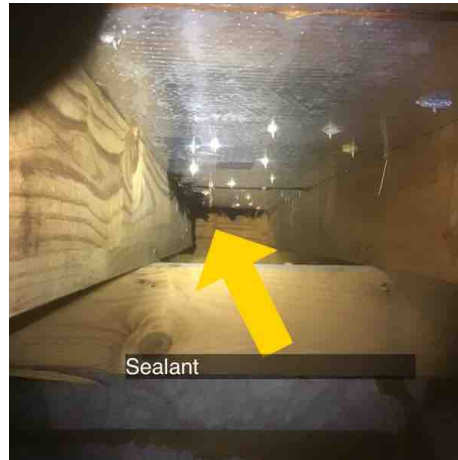
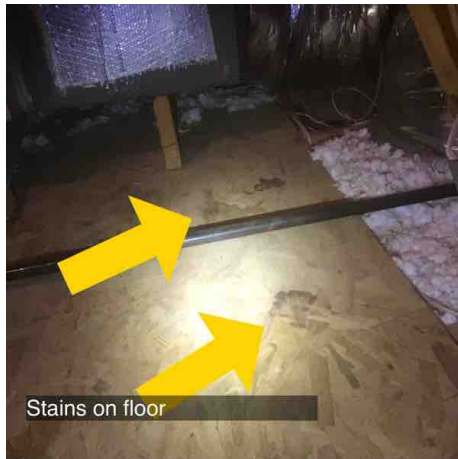
• There are signs of roof leaks because of several stains seen on the attic floor decking and also part of the valley area on the east side has been sealed, patched, no visible leak seen at this time, recommend further evaluation by a qualified roof contractor to see if any further repairs are needed.

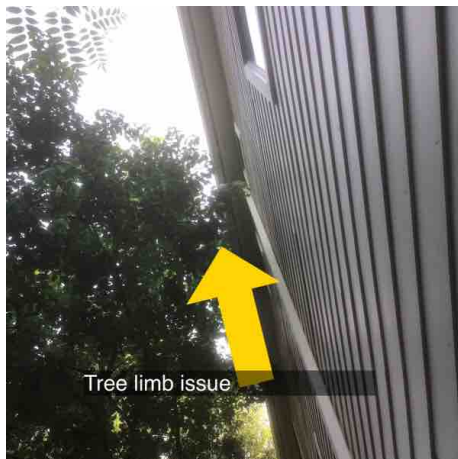
• Need to cut the tree limbs back away from the west side of the house.

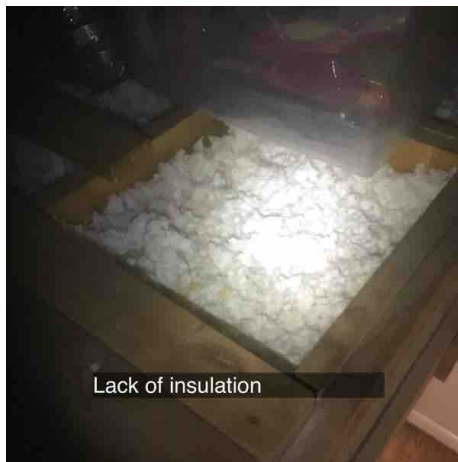
- Attic ventilation is soffit vents and ridge vents. Insulation prevents visual inspection of pipes, wires, fixtures and structural components underneath. The radiant barrier type foil material installed on the underside of the roof decking prevents visual inspection of the roof decking for possible water leak issues.
- **Need to install more insulation in the attic to reduce energy costs and provide added comfort, there are many areas with less than 4 inches of insulation. Average attic insulation in new homes is appx. 12 inches or more of loose/batt insulation.**

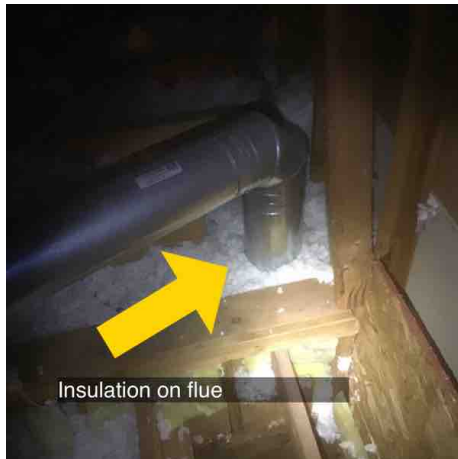
- **There is insulation touching the chimney flue pipe in the attic that should be moved back away from the pipe for fire safety reasons.**

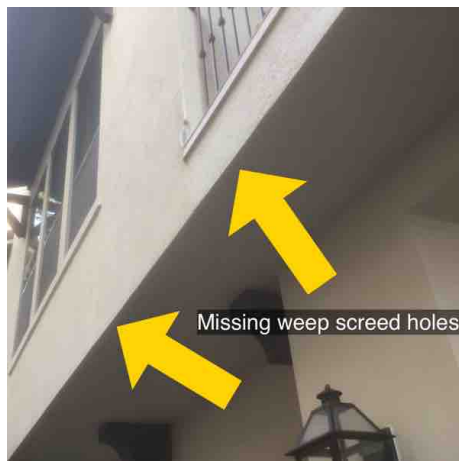
- **Missing weep screed holes at the bottom of the stucco wall overhang areas, needs evaluation and repair as needed by a qualified stucco contractor to reduce the chance of water damage inside the walls.**

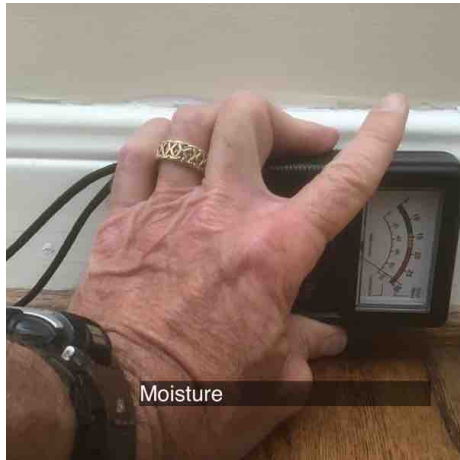
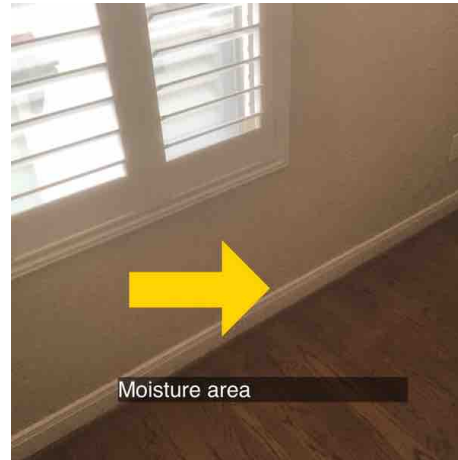
- Detected over 25% moisture using a Tramex moisture meter on the baseboard in the primary bedroom under the right side window area, need to evaluate the exterior wall by a qualified stucco contractor to find the source of moisture, recommend evaluation of the interior wall area also for possible water damage and check other wall areas also.

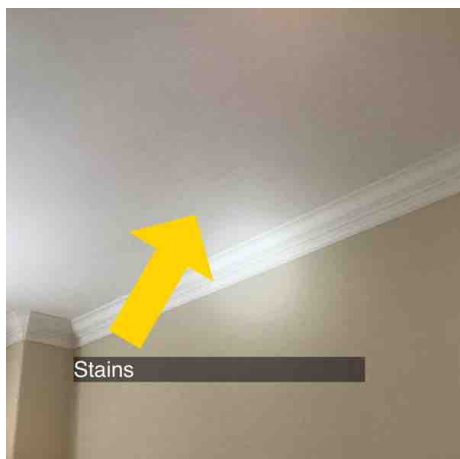
- Ceilings are sheet rock. Floors are wood and tile.
- The fir down ceiling near the bottom of the first floor stairs and near the 3rd floor are not high enough above the stairs, should not be less than 6 feet 8 inches, it is less, this is common on older homes, should be repaired.
- One of the floor tiles in the first floor bath is cracked and there are several cracked floor tiles in the primary bath, which may be from issues with the sub floor moving some.
- Several stains noted on the primary bedroom ceiling above the bed area that appears to have been from a previous roof leak issue, repaint the ceiling and monitor. No moisture detected at this time.

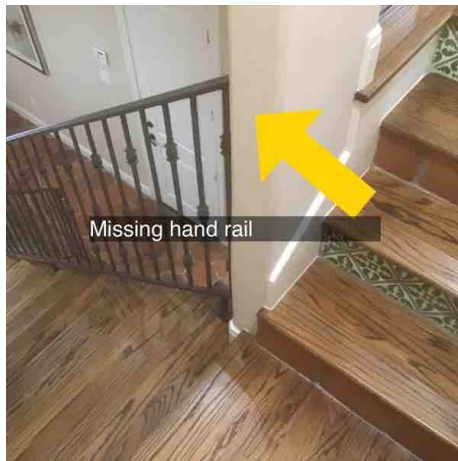
- **Missing a hand rail at the second landing top step corner going up and near the 3rd floor landing near the top, needs repair.**

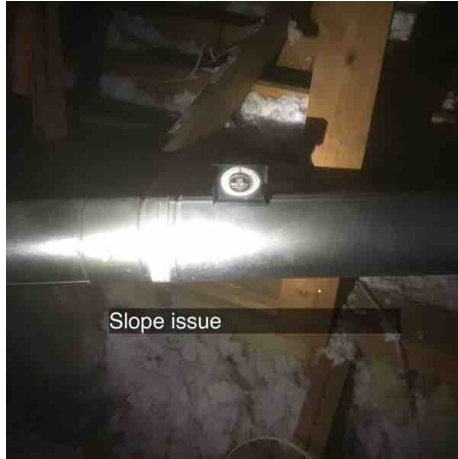
- The exhaust pipe in the attic has a horizontal section that does not have a slope upward, needs to slope up properly for flue gases to exhaust properly, needs evaluation and repair as needed.

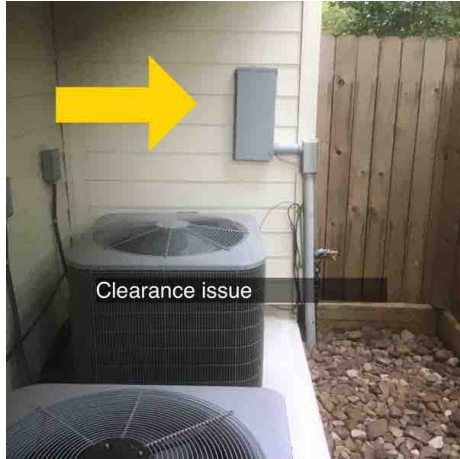
- **The main breaker panel does not have proper clearance in front and sides of it for safety reasons when servicing it, needs further evaluation and repair as needed by a qualified contractor.**

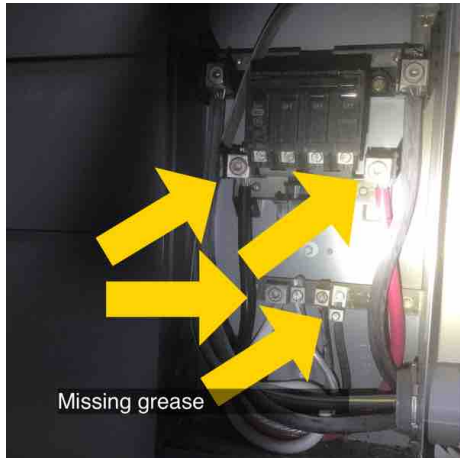
- **The main breaker aluminum supply wire connections in the main panel do not have anti-oxidant grease on them, needs to be applied to reduce chance of oxidation issues, needs repair by a qualified electrical contractor. This is a very common issue with almost all houses.**

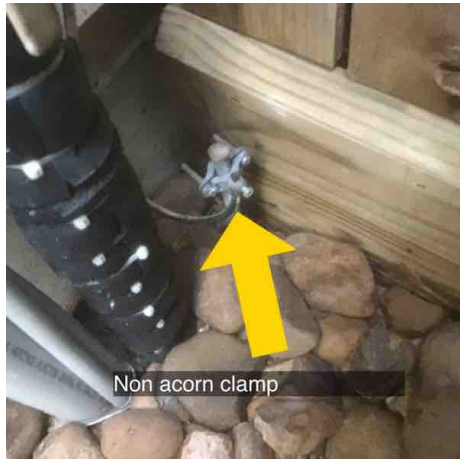
- Should replace the main ground rod clamp with a acorn type clamp instead of the pipe type clamp that is being used to reduce chance of loose connections in the future.

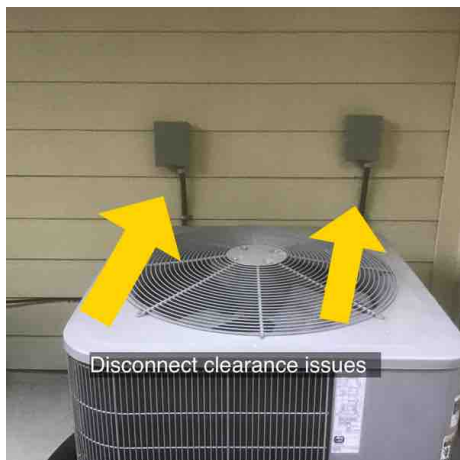
- **The service disconnects on the exterior for the A/C compressors do not have proper clearance on the front and sides for safety reasons when servicing them, needs further evaluation and repair as needed.**

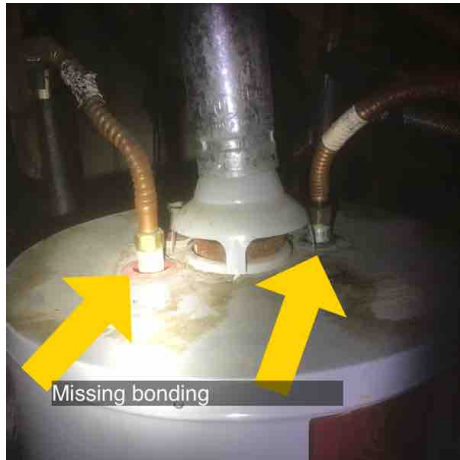
- Only one of the two outlets in the garage is GFCI protected, all should be, needs repair.
- 6 smoke alarms. Smoke alarms need to be tested at least once a year and batteries changed.
- There should be a ground/bond connection at the hot water tank, did not appear to have one to connect the hot and cold water pipes together over the top of the tank, this is a current requirement, should be evaluated and repaired as needed by a qualified contractor.

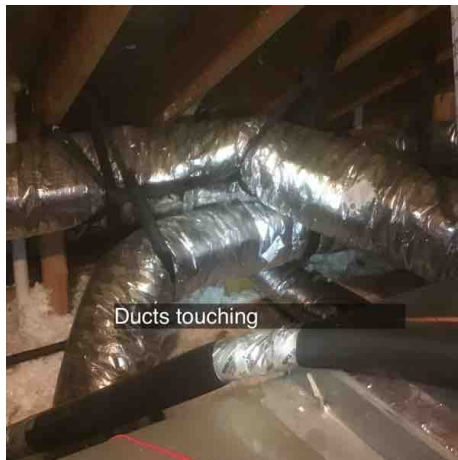
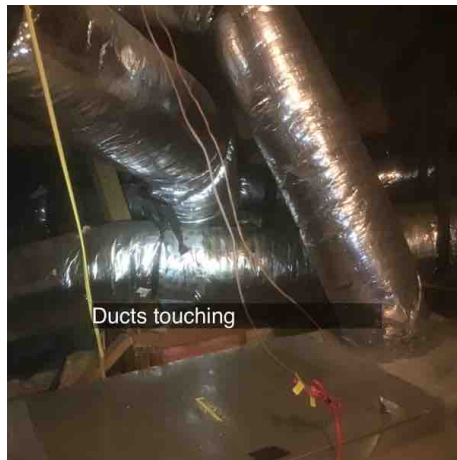
- **Some of the ducts in the attic do not appear to be properly strapped because of them touching each other which can cause air flow restrictions and condensation issues, need to be repaired.**

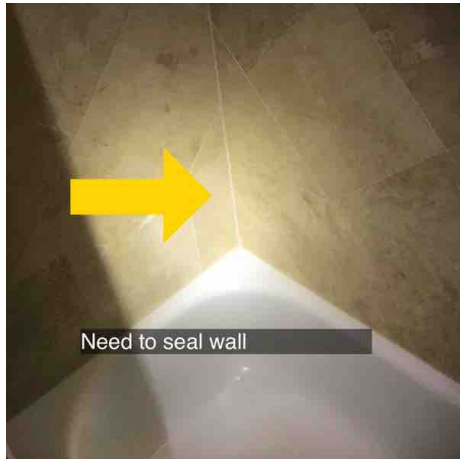
- Main supply pipes appear to be CPVC plastic where visible.
- **Open places in the corner of the tile wall in the first floor bath needs to be sealed.**

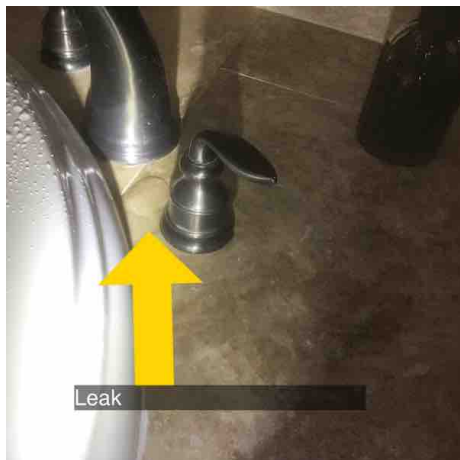
- **Water leaks from the cold water handle onto the bathtub surface on the primary bathtub when the water is running, or could also be from water splashing off of the top of the tub from the faucet hitting it, needs repair.**

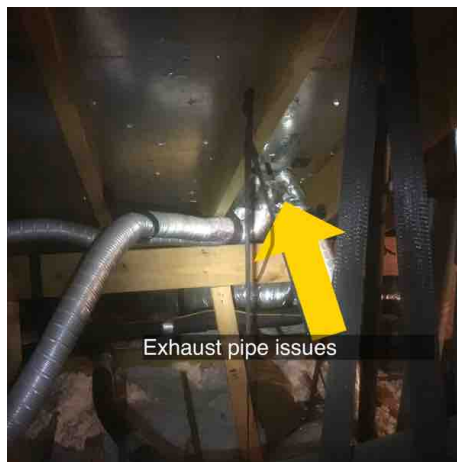
- Turned on exhaust fans, appear to perform their intended function at this time.
- **The bath exhaust ducts have fallen down some from the roof jack area, need to be resecured up to the jack.**
