# Fittz & Shipman

August 9, 2022

**RE: STRUCTURAL ENGINEERING SERVICES  
FOUNDATION OBSERVATION  
408 Crescent Drive  
Bridge City, Texas  
Project No. 22001-0054**

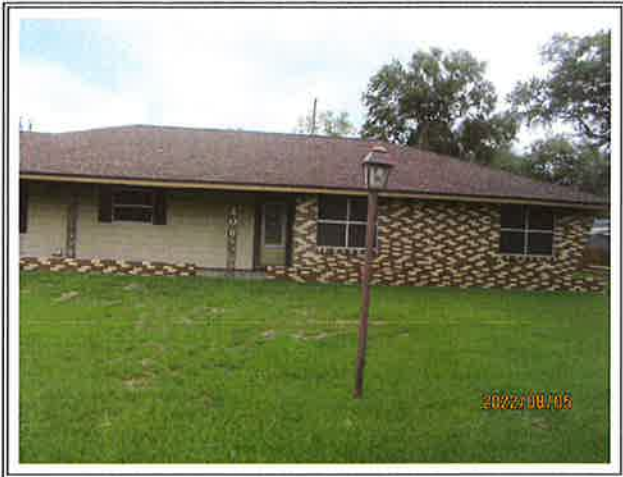
**Photograph No. 1**

408 Crescent Drive  
Bridge City, Texas

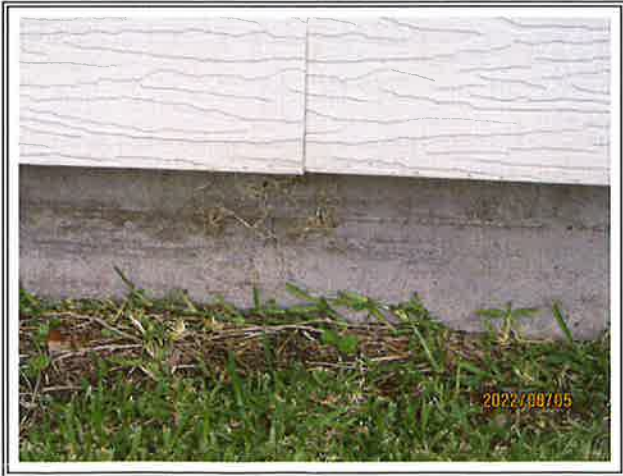
**Photograph No. 2**

The residence has experienced differential soil movement in the past. The movement is a result of highly expansive soils, which are common to the area. The soil shrinks or swells with changes in moisture content. As the soil dries, it shrinks; as it becomes moist, it swells. If the shrinking and swelling is not uniform then foundation distress and possible foundation failure can occur. As the moisture content of the soil changes differentially, the slab foundation deflects causing damages such as those listed in Items No. 2, and 4 through 11 under Observation. The settlement is limited to the front right corner and is the result of the live oak tree on the adjacent property. These roots will pull moisture from below the foundation, leaving these soils drier than others under the foundation and causing consolidation. The tree observed and noted in Item No. 13 under Observations appear to have had a major influence on the performance of the foundation. The installation of drilled footings will only result in re-settlement of the foundation unless the tree influence is neutralized. The tree belongs to the neighbor to the immediate right of the property. The only solution is to install a root barrier.

Right Elevation - Foundation crack near front right corner

**RECOMMENDATIONS:** Since footing installation will only result in resettlement, the only solution is to install a root barrier. The enclosed plan and root barrier detail shows the recommended root barrier location and construction. The foundation should experience some re-bounce after one year has elapsed from date of root barrier installation.

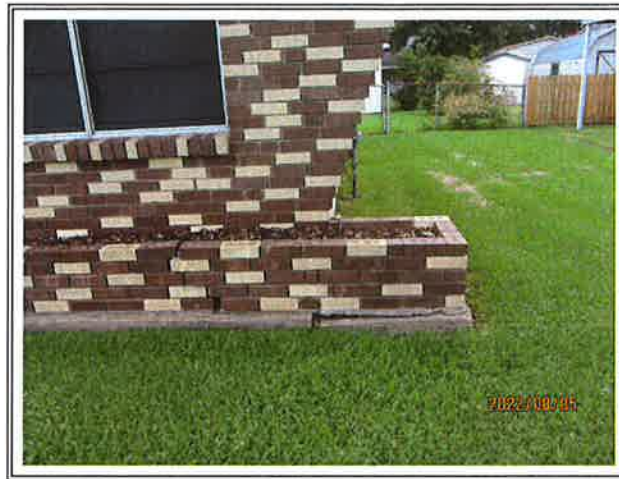
**Photograph No. 3**

**CONCLUSIONS:** The brick planter crack at the front right corner is not impacting the main foundation of the property and is cosmetic in character.

Front Elevation - Brick planter support failed (does not affect the residence's foundation)

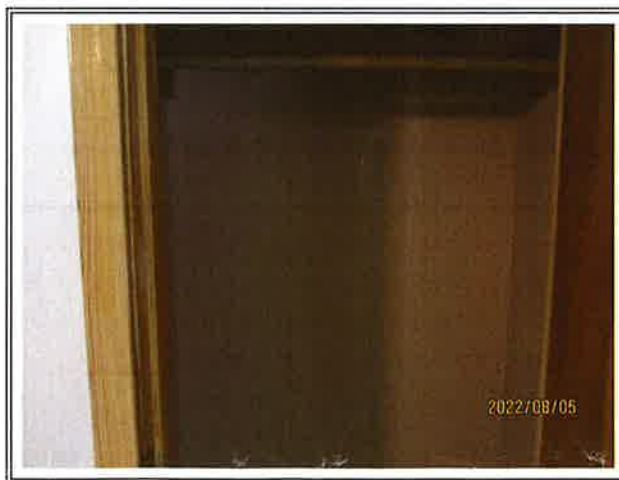
**Photograph No. 4**

Front Left Bedroom - Sheetrock corner tear in closet

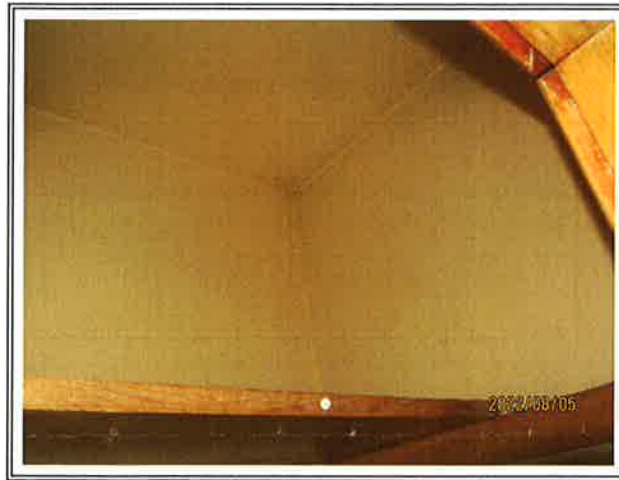
**Photograph No. 5**

Front Left Bedroom - Sheetrock corner tear in closet

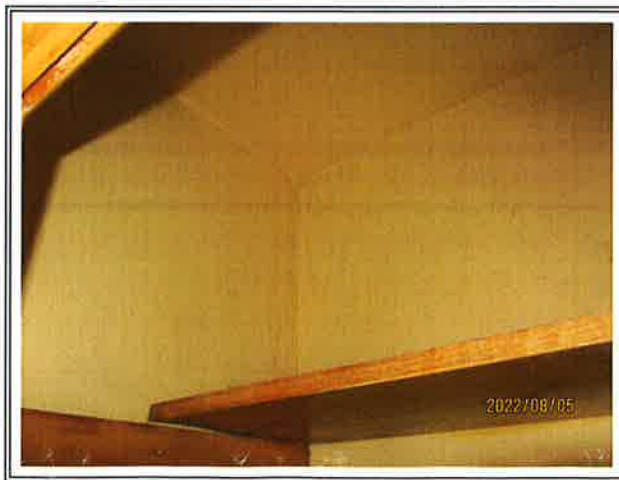
**Photograph No. 6**

Front Left Bedroom - Sheetrock corner tear in closet

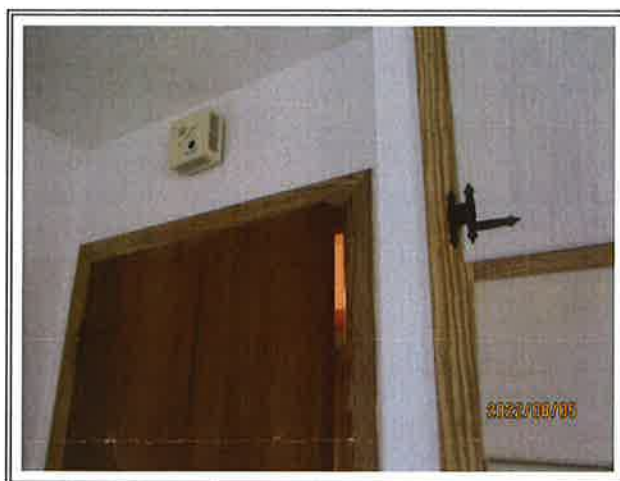
**Photograph No. 7**

Front Right Bedroom - Door will not close completely

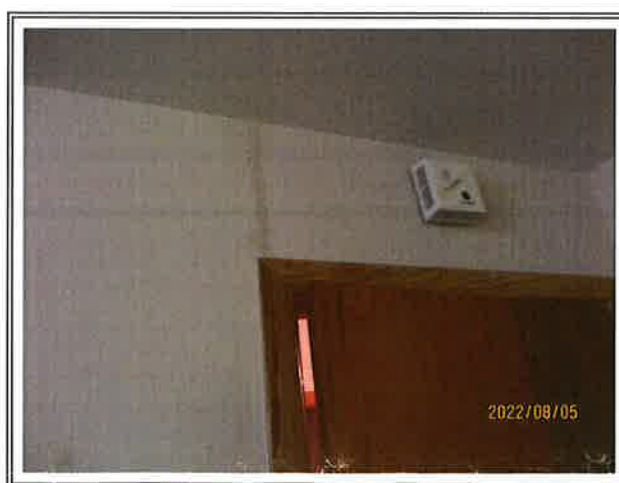
**Photograph No. 8**

Rear Right Bedroom - Door will not close completely

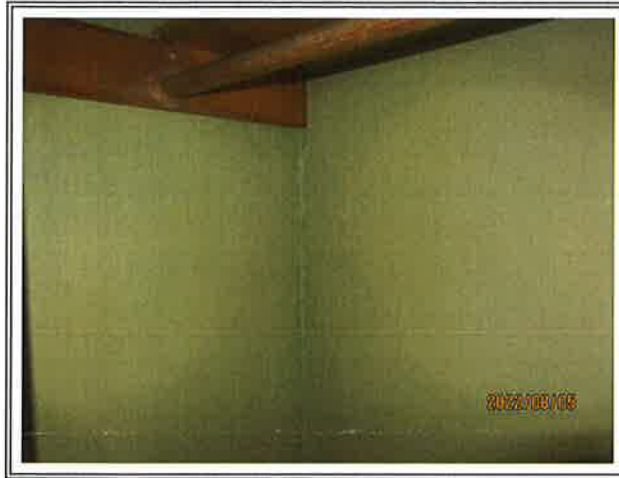
**Photograph No. 9**

Rear Right Bedroom - Sheetrock corner tear in closet

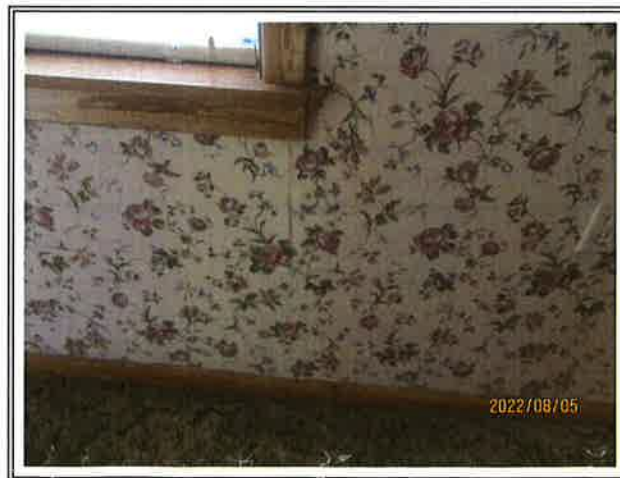
**Photograph No. 10**

Rear Right Bedroom - Vertical sheetrock tape joint separation below side window

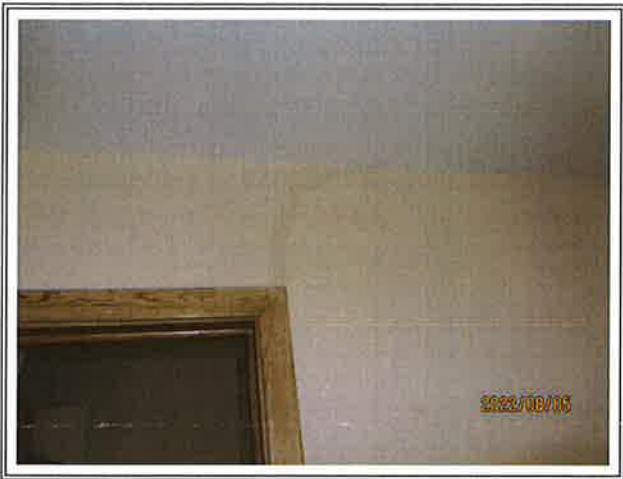
**Photograph No. 11**

Rear Right Bedroom - Diagonal sheetrock crack  
above master bathroom door (reported to be  
remodel construction damage)
