### HOME INSPECTION REPORT

Heath Mills	12-29-2022
<i>Name of Client</i>	<i>Date of Inspection</i>
819 S Illinois Avenue, League City, TX 77573	
<i>Address of Inspected Property</i>	
Team One (# ) Tyler Holley (# 24609)	
<i>Name of Inspector</i>	<i>TREC License #</i>
Tyler Holley	
<i>Name of Sponsor (if applicable)</i>	<i>TREC License #</i>

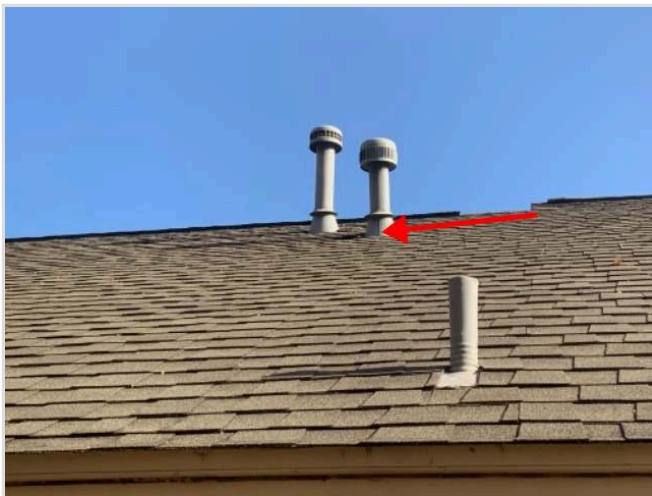
Rear middle side exterior

Flashing was uplifting in one or more locations during the inspection.

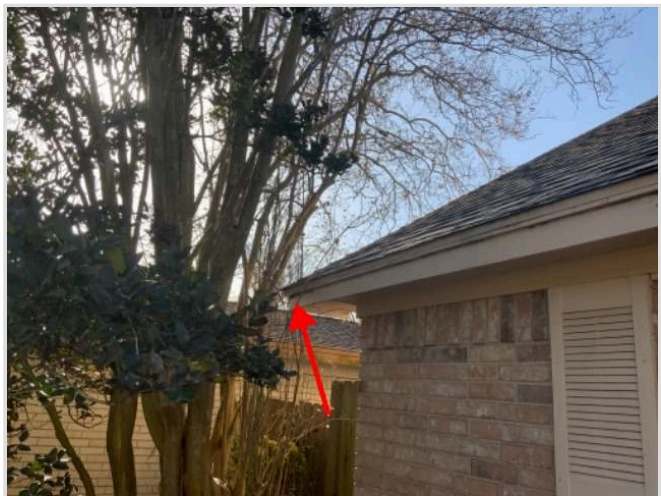
Front left side

Tree limbs were coming in contact with the roof in some locations. It is recommended to have them cut back 4 feet or more from the home.

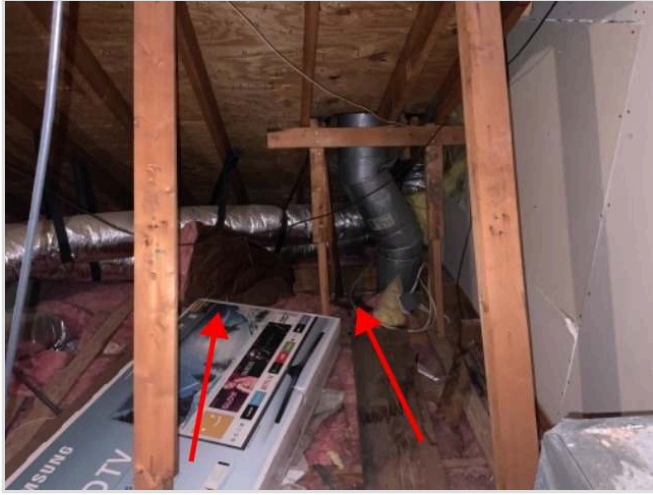
Attic space insulation was low/missing in some locations due to being pulled up.

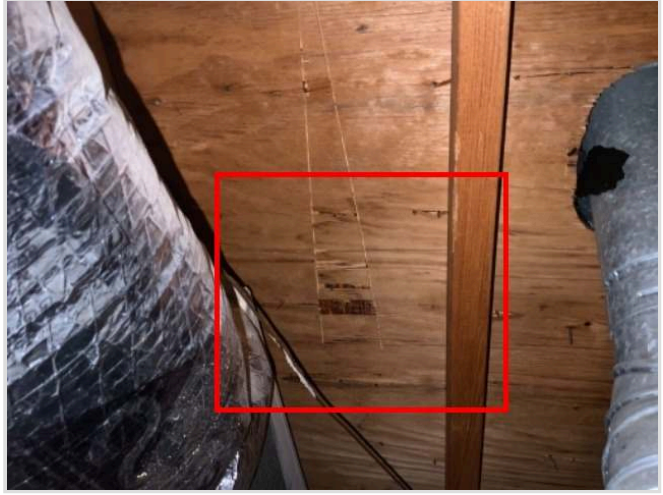
Above upstairs heating unit

Moisture staining was observed on the underside of the roof covering in some locations. Possibly due to previous or current roof leaks.

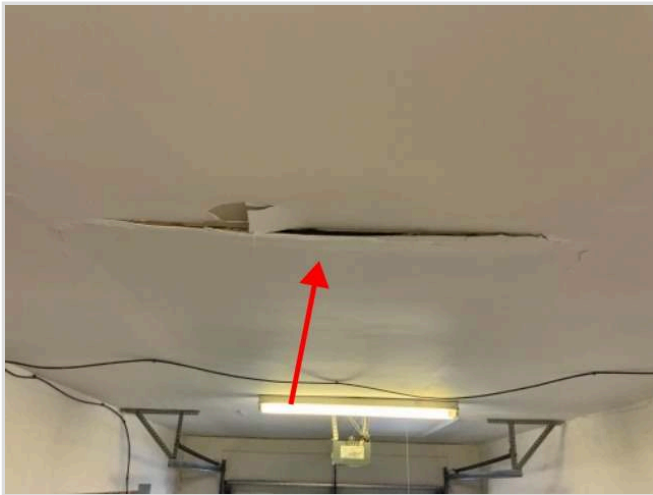
Garage ceiling

Damage to the interior sheet rock walls and ceilings were observed in some location.

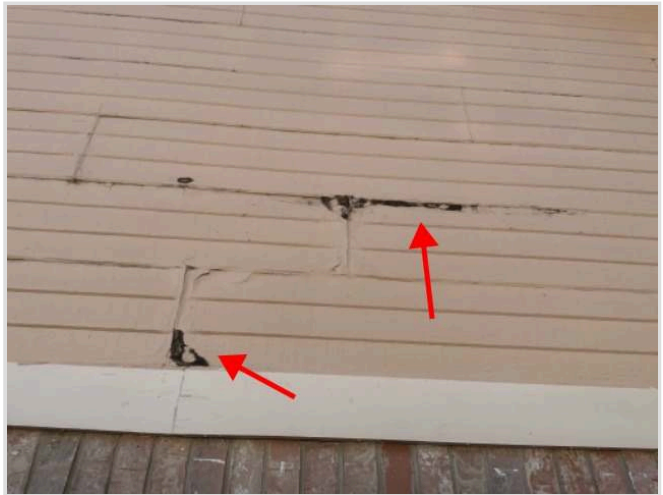
Right side exterior

Moisture staining or organic growth was observed on some of the exterior walls during the inspection.

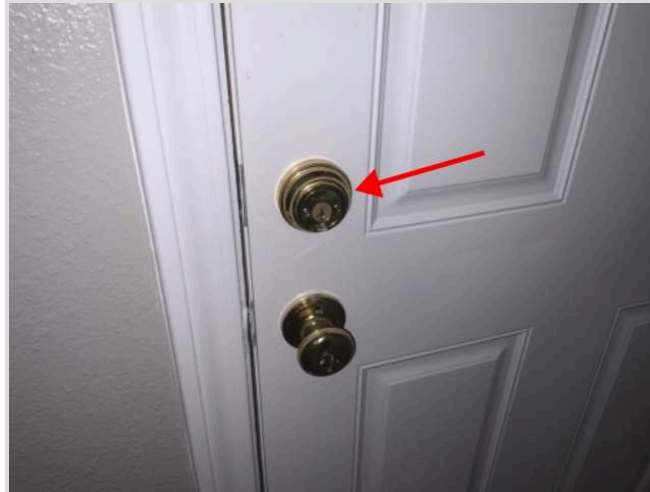
Rear exterior door

The rear exterior doors did not have a keyless deadbolt on the interior side. The Texas real estate commission considers this to be a safety deficiency because in the event of an emergency escape a person would first need to find the key before they could unlock the door.

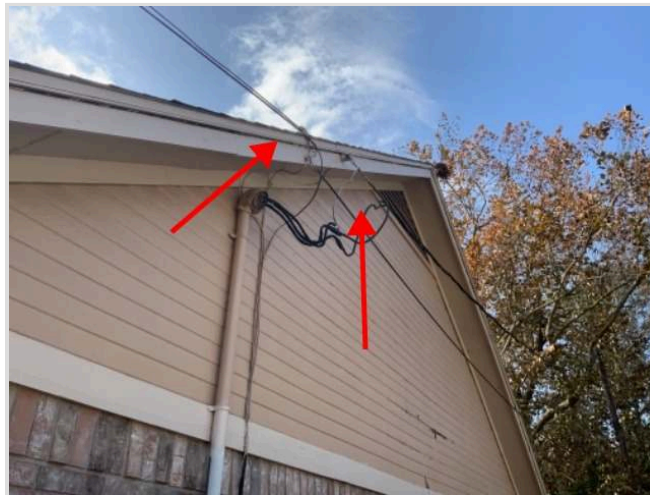
Right side exterior

The exterior powerlines we're coming in contact with/too close to the roof.

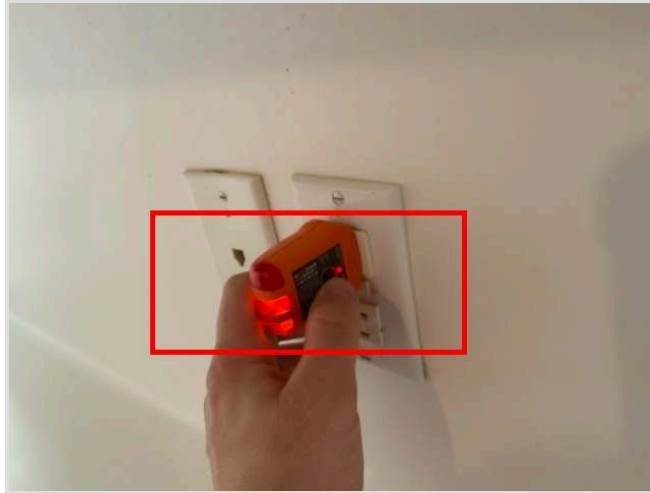
Kitchen electrical receptacle

The kitchen and laundry room GFCI receptacle was non-functional during the inspection.

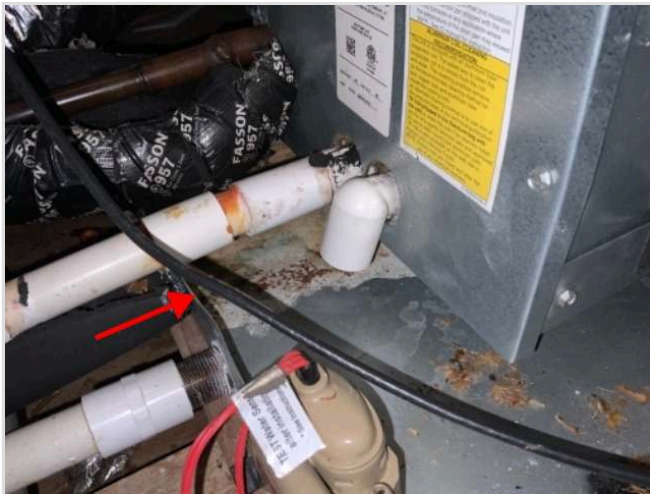
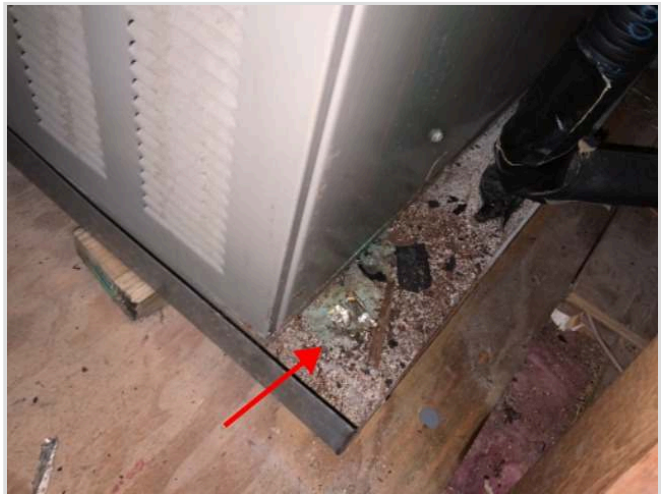
Both heating units had slight rust in the drain pan. Most likely due to being improperly sloped to the side.

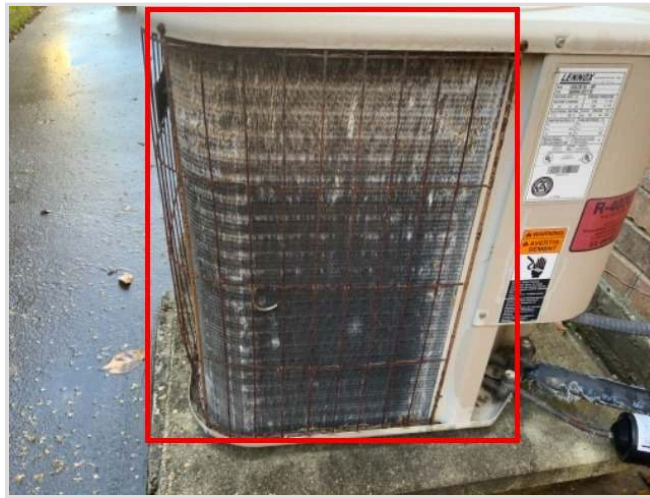
Right side exterior

Damage to the exterior cooling unit coils was observed.

As a note, the older AC unit used a refrigerant known as R-22 which is no longer manufactured in the US and this can make repairs sometimes more costly than replacement.

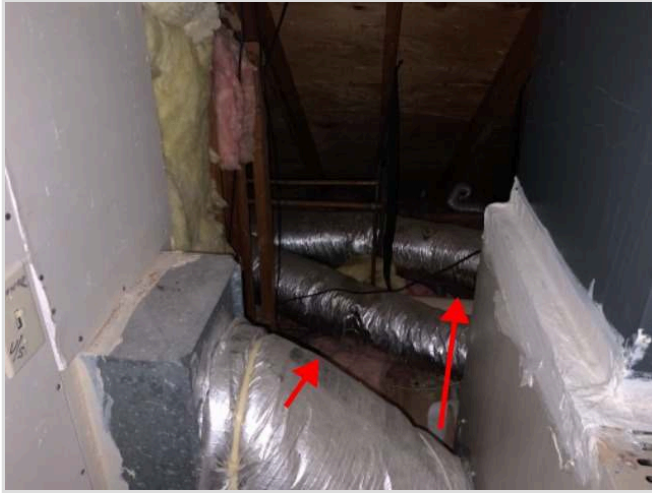
Attic space duct work

HVAC duct work was laying on the insulation in some locations. It is recommended to have the ductwork elevated 4 inches or more above the insulation.

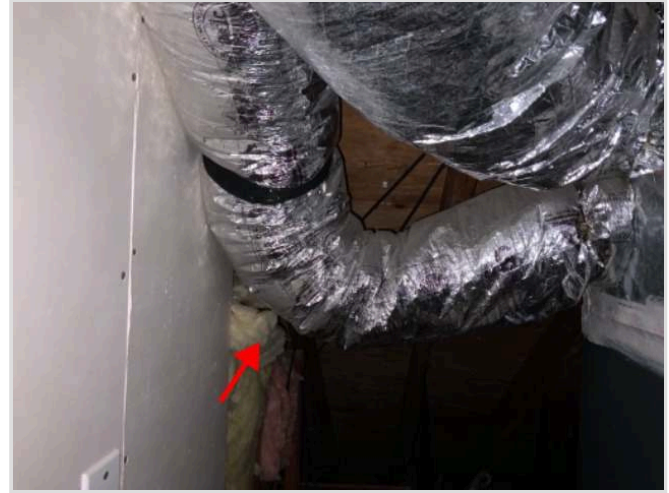
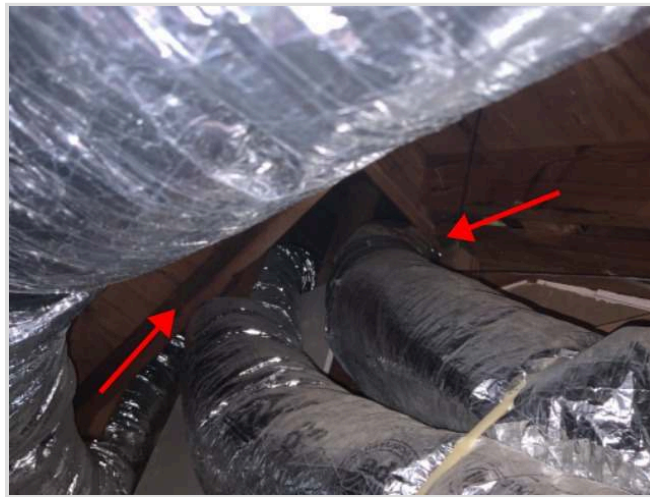
Portions of the flex duct were improperly installed. Sharp bends around corners, framing and/or other items reduces the airflow of the duct and may affect system performance. As a general rule a 90° turn can decrease the airflow by about 60%.

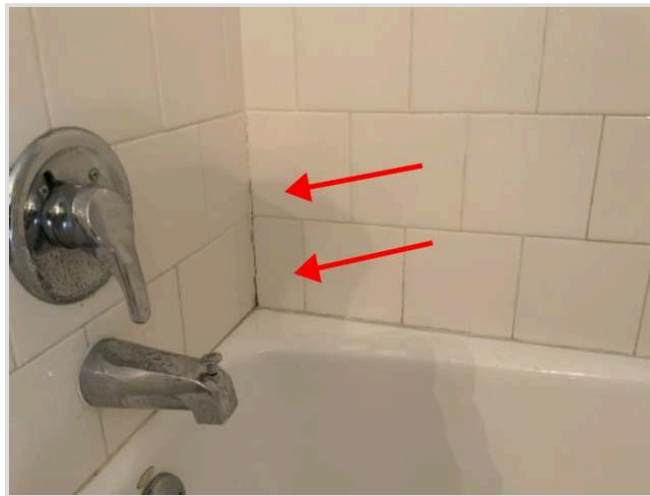
Upstairs hallway bathroom

The tub surround of some showers and tubs needed to be re-sealed and some locations.

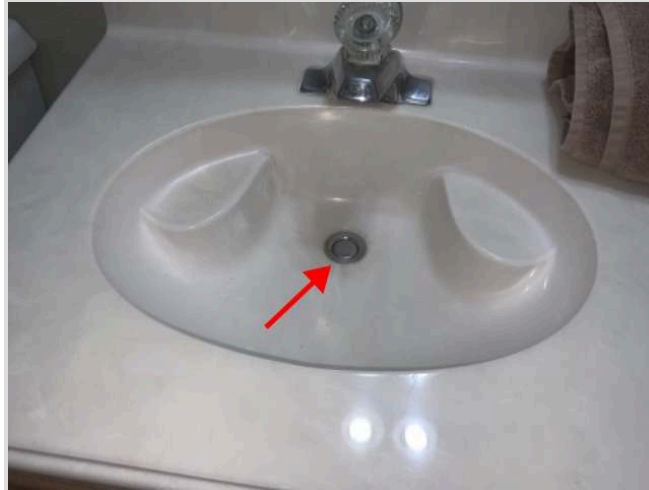
Master bathroom sink

The drain stopper in the master bathroom for the sink was nonfunctional in the inspection.
