HEDDERMAN SERVICES

MECHANICAL INSPECTION

11003 Riverview Dr
Houston, TX 77042

PROPERTY INSPECTION REPORT FORM

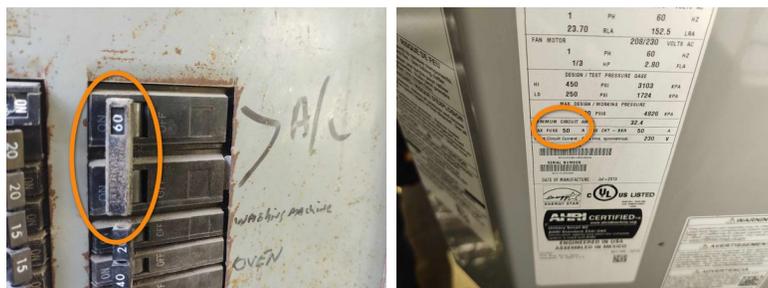
5: Breakers Oversized - A/C condensing unit replaced

The circuit breakers for air conditioning condensing unit was rated higher than the maximum size allowed by the manufacturer of the condensing unit. The breakers should be replaced by the size listed on the

manufacturer's nameplates located on the condensing unit.

Obtain Cost Estimate

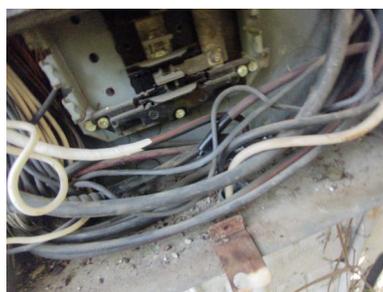
6: Wires - Terminated improper

Wires that were improperly terminated were observed in the box.

Obtain Cost Estimate

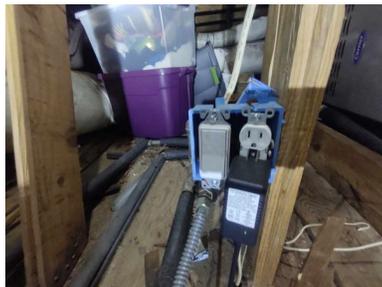
2: Cover Plate - Damaged/Missing **replaced**

A missing or damaged cover plate was observed.

Obtain Cost Estimate

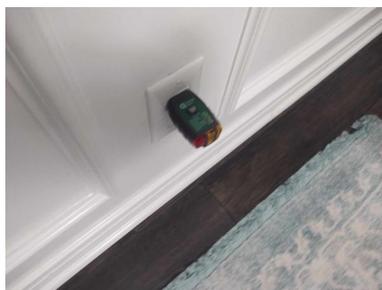
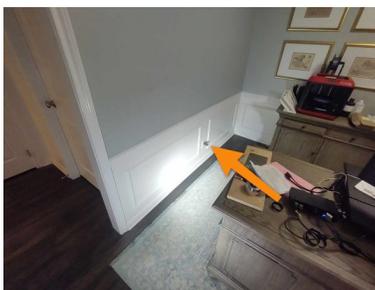
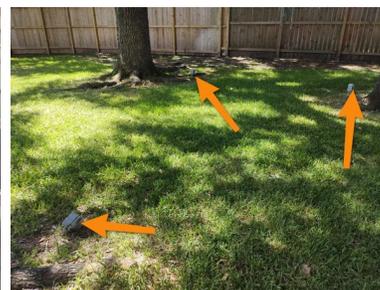
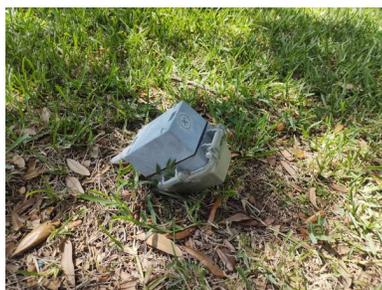
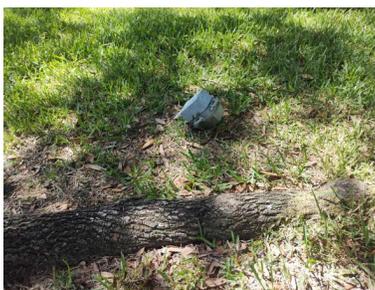
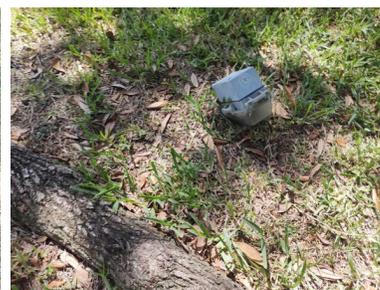
3: Outlets- Nonfunctional

repaired; backyard outlet required switch to be on. Functional now.

An outlet was observed that was nonfunctional at the time of the inspection. The reason for the condition was not determined with certainty. Have an electrician find the source of the problem, and make any necessary repairs.

Obtain Cost Estimate

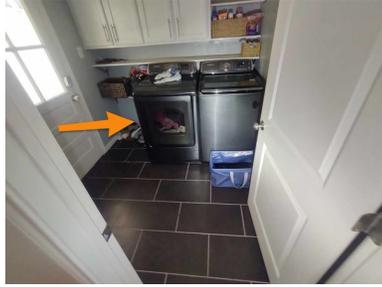
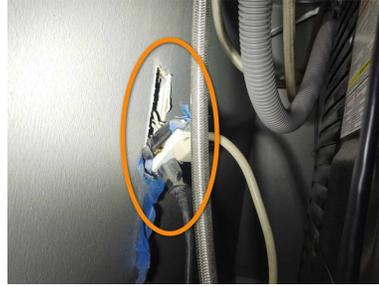
4: Outlet - not secured to wall

An outlet was not secured to the wall and needs repair.

Behind dryer

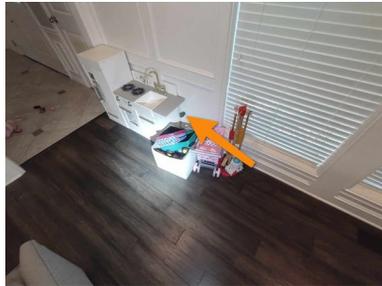
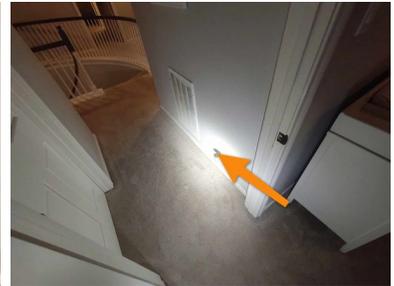
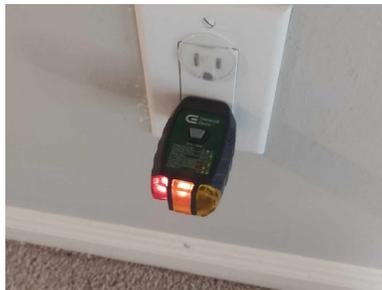
5: Outlet - Reversed polarity

An outlet in which the hot and neutral (black and white) wires were reversed, causing reversed polarity.

Obtain Cost Estimate

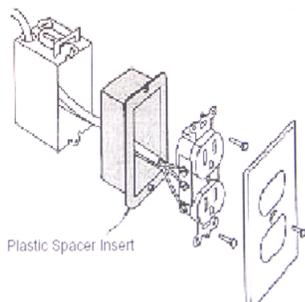
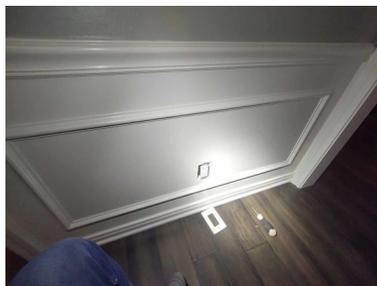
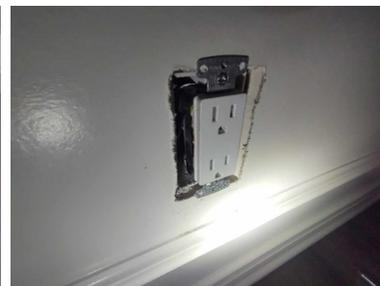
6: Outlets - Box extenders needed

Junction box extenders were not installed at the outlets and/or light switches at several locations around the house where a gap greater than 1/4 inch was observed between the electrical junction box and the cover plate. Junction box extenders should be installed at all the needed devices to prevent the wall cavity from exposure to hazardous electrical conditions inside the junction boxes. It is recommended that an electrician be contacted to remove the device cover plates and to install junction box extenders at all of the needed locations.

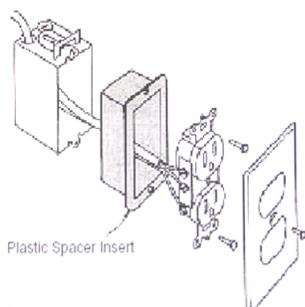
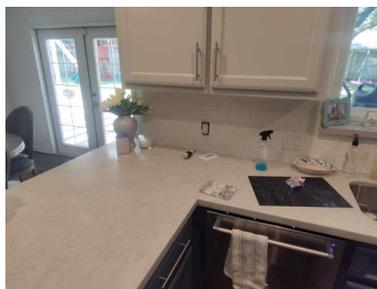
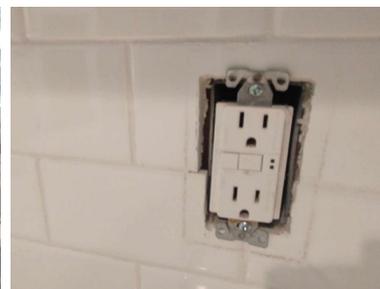
7: Outlets - Box extenders missing at backsplash installed

We observed outlets located in countertop backsplashes that were not protected by extender boxes. This is considered to be a fire hazard, and it is recommended that the extender boxes be installed.

Obtain Cost Estimate

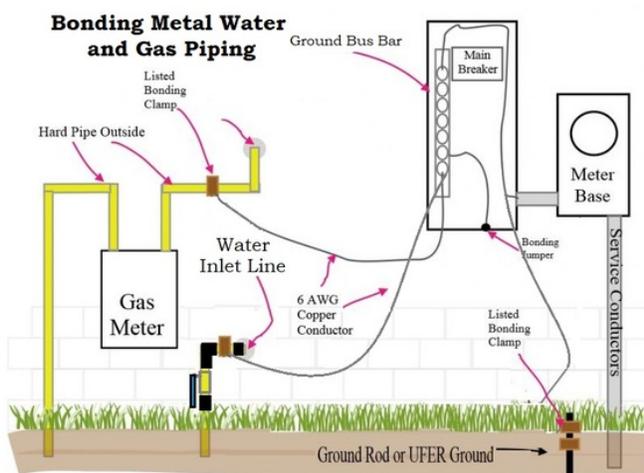
11: Gas Piping - Bonding not visible repaired

The location where the gas supply piping was bonded back to the electrical ground system was not visible at the time of the inspection. It is recommended that an electrician be contacted to determine if the plumbing in the house is properly bonded and to make any needed repairs.

Obtain Cost Estimate

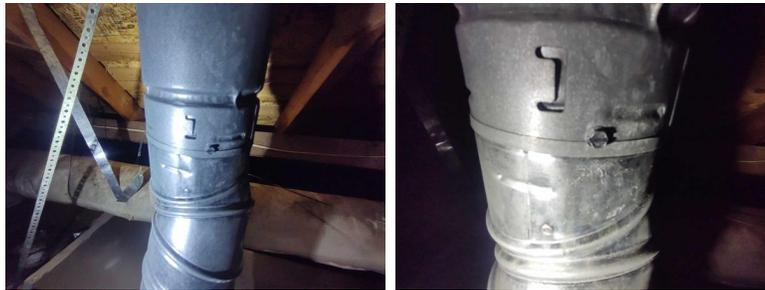
The vent pipe was fastened with screws, which is improper. The vent is designed to connect without fasteners, as screws holes can allow carbon monoxide to seep from the vent pipe. The portions of the vent pipe that were damaged with screws should be repaired.

Obtain Cost Estimate

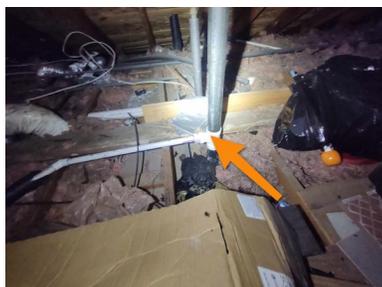
The primary condensate drain line for the unit terminated into a plumbing vent pipe in the attic. This can allow sewer gases to backup into the living space, which is a hazard. It is recommended that the primary drain line be rerouted and terminated in an approved manner.

Obtain Cost Estimate

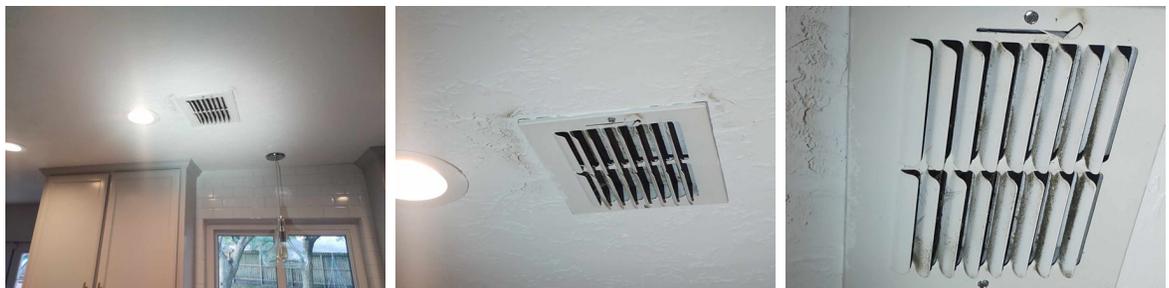
2: Registers - Dirty cleaned

The registers and adjacent ceiling areas were covered with debris that has passed through the air conditioning duct work. Have a service company check the inside of the duct work to determine if there is a build-up of debris, and to clean the ducts if necessary.

Obtain Cost Estimate

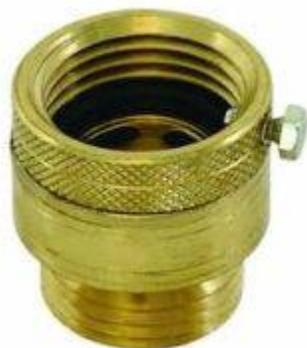
2: Vacuum Breaker - Missing

The atmospheric vacuum breaker devices were missing at one or more of the hose bibbs, and it is recommended that they be installed to prevent cross connections, which can allow contaminated water to enter the potable water supply.

Obtain Cost Estimate

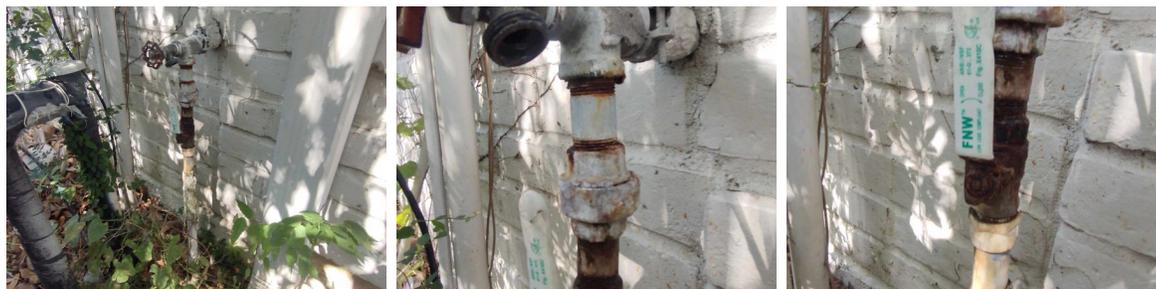
The main inlet water line was observed to be galvanized steel piping and was severely rusted. It is recommended that the rusted/corroded piping be replaced. It is pointed out that the pipe was not leaking at the time of the inspection, however repairs will become necessary in the future.

Obtain Cost Estimate

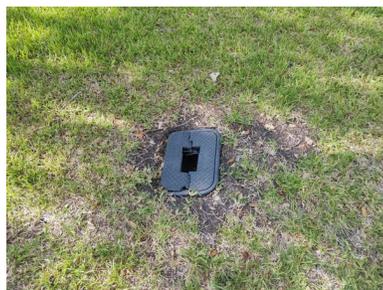
6: Water Meter - Cover damaged request made to COH for replacement

The cover was damaged at the water meter, and the lid was not covering the opening properly. This is a hazard to foot traffic and needs to be corrected.

Obtain Cost Estimate

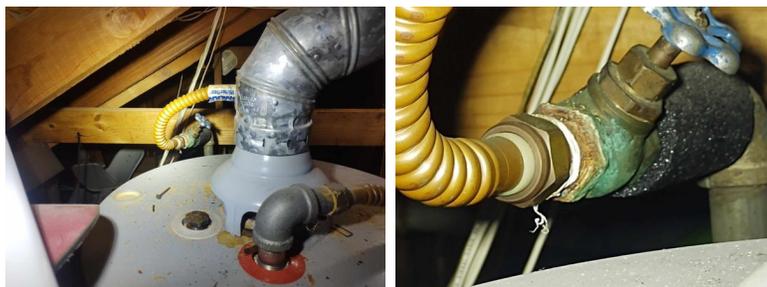
The water shut off valve on the inlet water line was significantly corroded and needs to be replaced.

Obtain Cost Estimate

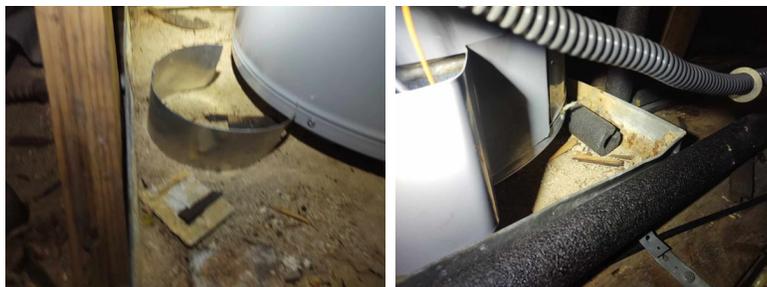
5: Overflow Pan - Remove Insulation/debris

Insulation and/or debris was observed in the overflow pan and needs to be removed.

Obtain Cost Estimate

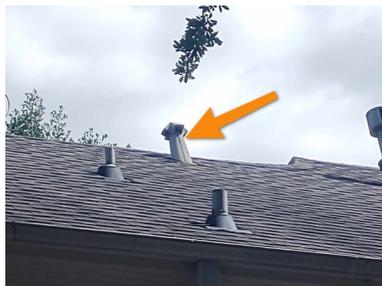
The vent pipe did not have an approved Type-B roof jack, where the vent pipe extends through the Type-B roof jack, to be vented to the outside. This can allow the hazardous combustion gases to be routed back to the attic, and repair is needed.

Obtain Cost Estimate

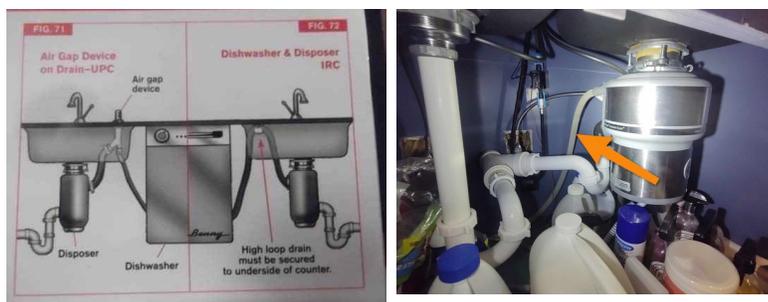
The drain line under the sink was not equipped with an anti-siphon device, nor was it looped up so that the top of the loop is at least six inches above the entrance of the drain line into the disposal. It is recommended at least that the drain line be looped to prevent the water from the garbage disposal from siphoning back into the dishwasher, or an anti-siphon device installed.

Obtain Cost Estimate

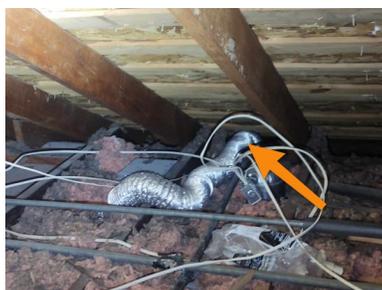
We observed one or more bath vent fans that were not terminated outside. The most current building code requires the vent fan to be vented to the outside of the house, and it is recommended that the vent be extended to the outside of the house.

Obtain Cost Estimate

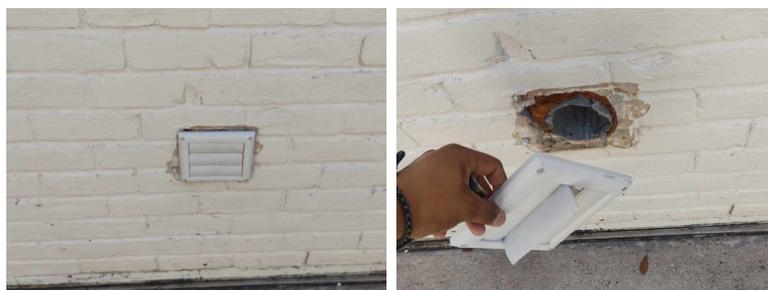
The dryer vent cap was loose and needs to be secured properly.

Obtain Cost Estimate
