STRUCTURAL INSPECTION

11003 Riverview Dr
Houston, TX 77042

JULY 6, 2022

REF: CONDITION OF PROPERTY SURVEY

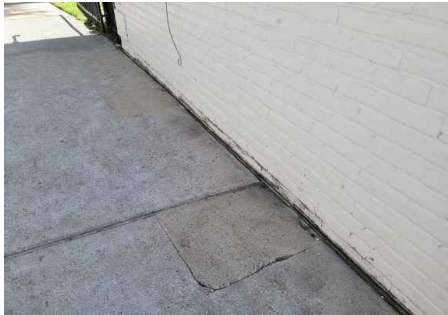
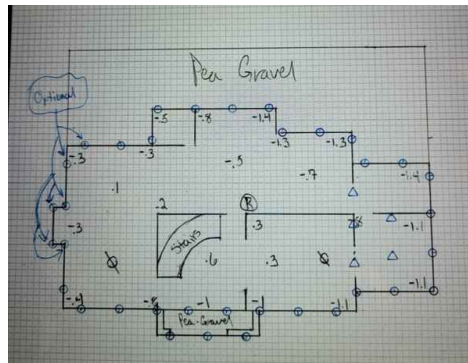
It was observed/disclosed that the foundation of this house has been repaired previously in 2017. The scope of the repairs reportedly included piers installed as shown in the sketch below provided to HEI. It is pointed out that HEDDERMAN ENGINEERING, INC. cannot and does not take any responsibility for the adequacy and/or future performance of the repair work. Any opinions given in this report concerning the levelness of the house are for the day of the inspection only, and are not a warranty against future foundation movement of the house. It is recommended that you obtain all available information and warranties from the homeowner relating to the foundation repair(s).

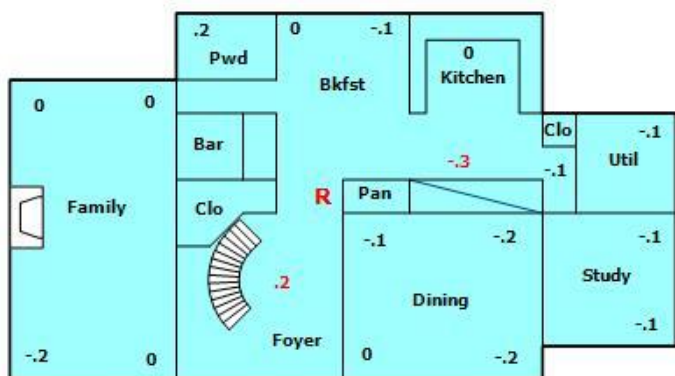
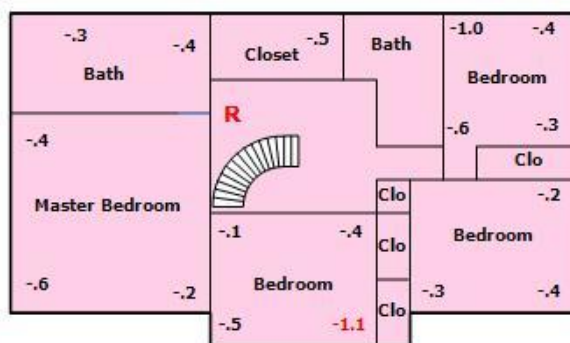
Elevation Readings
11003 Riverview Road

See our field sketch below showing the elevation readings for this structure. Note that the "R" on the sketch is our randomly chosen starting reference point, where the elevation is 0, and all other elevation readings are taken relative to the reference point, and are measured in inches to the nearest 1/10 inch. Height adjustments were made for variations in the height or thickness of the various floor coverings. If there is a step up or a step down into an area such as a garage, sunken room, balcony/patio area, or raised rooms, the elevation readings will have larger numbers due to the amount of the step.

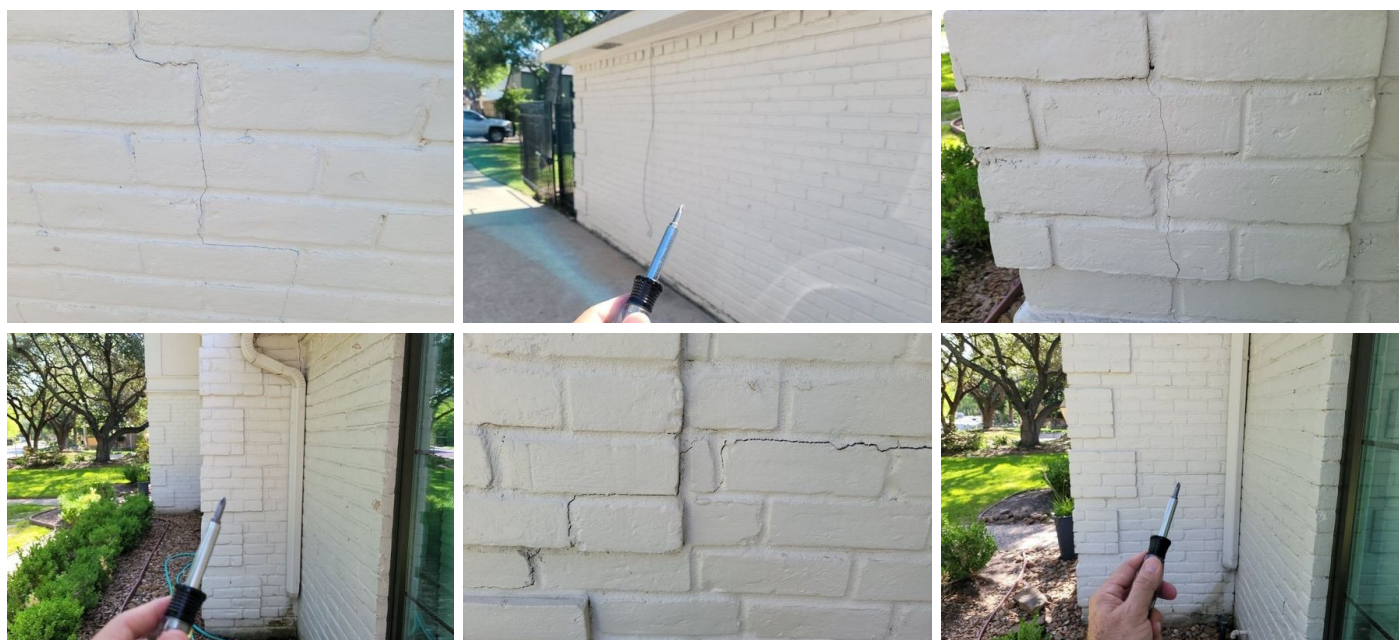
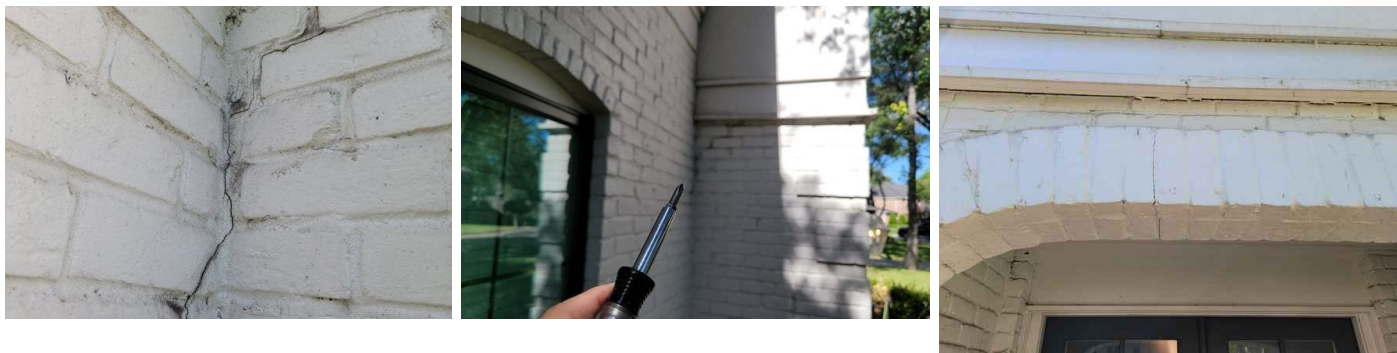
Veneer - Cracks/Patches

Cracks and/or patches were observed in the exterior veneer at the time of the inspection, including at the locations shown in the photos. It is recommended that the cracks be repaired for cosmetic purposes.

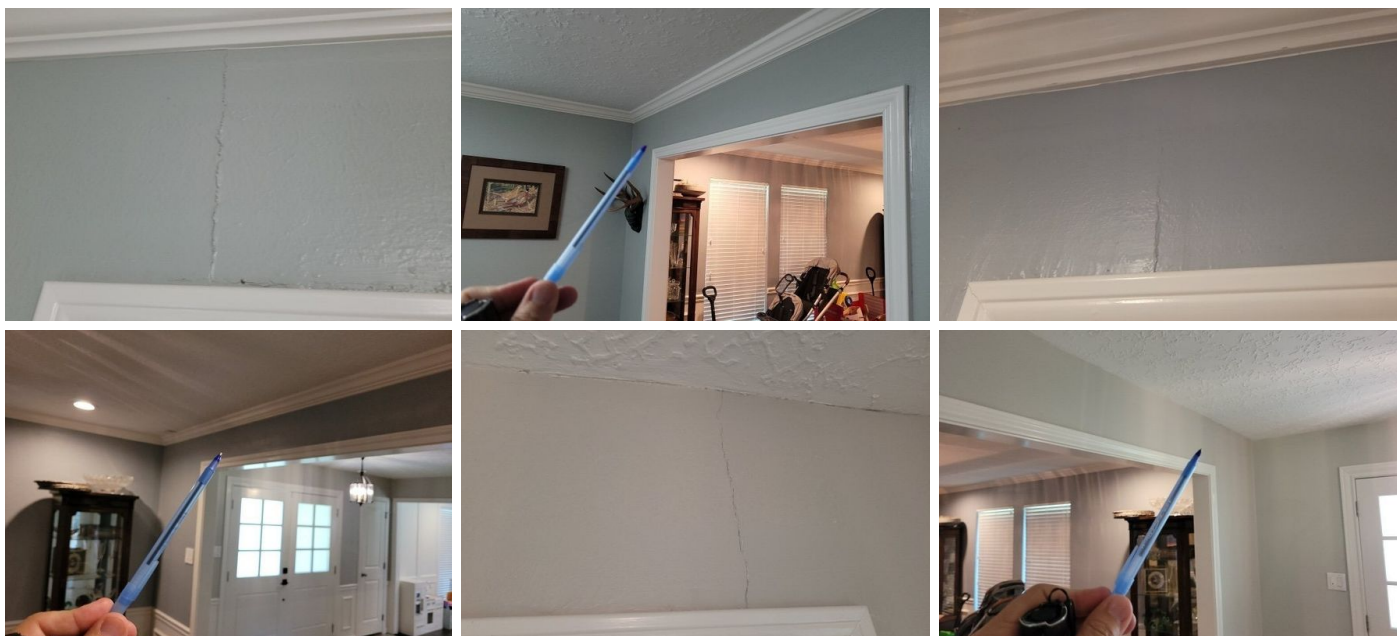
Sheetrock Cracks/Patches/Compression ridges

Sheetrock cracks, patches, and/or compression ridges were observed in the house during the inspection, including at the specified locations. It is recommended that the cracks be repaired.

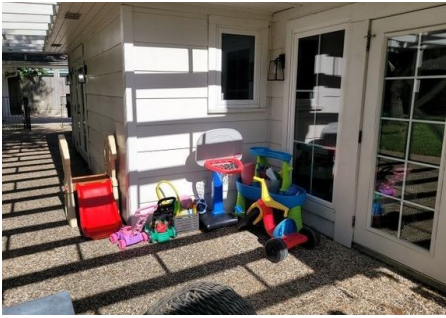
Slab not Visible - Patio

It is pointed out that a portion of the foundation concrete could not be viewed due to the concrete patio that adjoined the foundation.

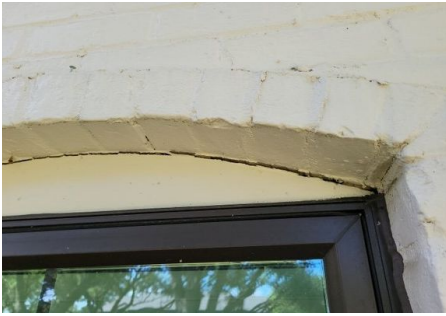
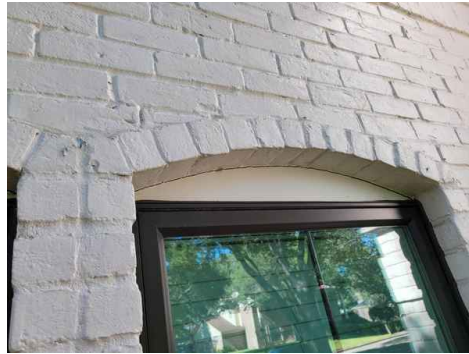
Separation of Materials: Window frame

The window frame was separated from the exterior brick veneer apparently due to movement.

caulked & painted

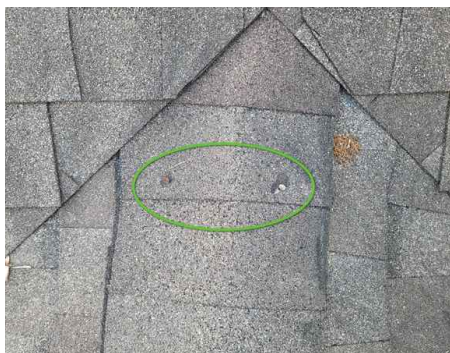
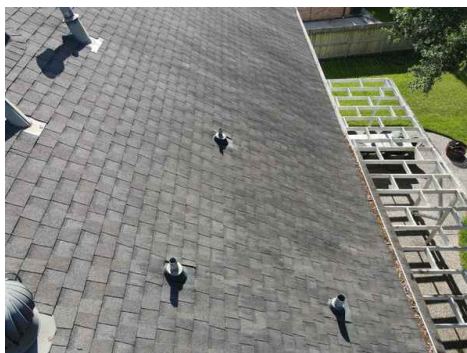
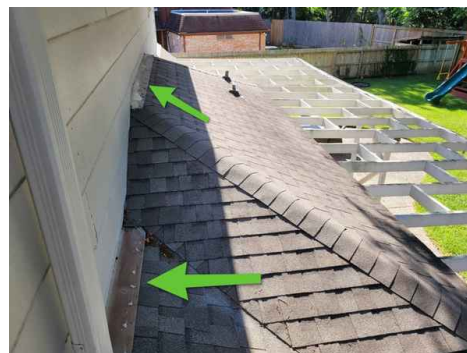
Wear and Deterioration: Composition - Some

Discolored, Nail Heads not Sealed, Rusted flashing details

The composition roof surface was showing evidences of some deterioration of the roof surface as described above and shown below.

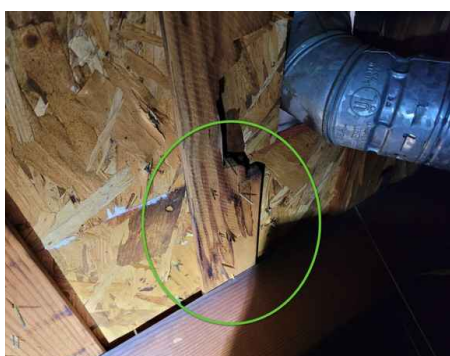
Roof Leaks: Attic stains appear to be from previous leaks

After observing the interior of the structure, evidences of current roof leaks were not visible. The absence of evidences of roof leaks does not guarantee that roof leaks were not present; rather, that no evidences of leaking were visible at the time of the inspection. Some stains were visible in the attic, but the stains appeared to be related to previous roof leaks. It is recommended that you check with the owner and/or a service company concerning the stains.

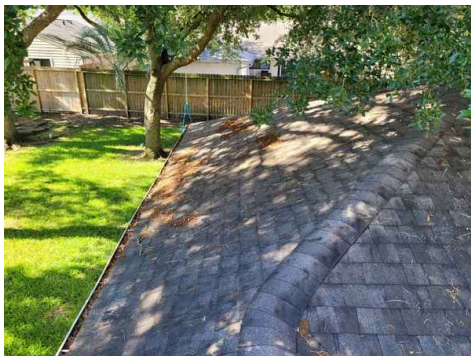
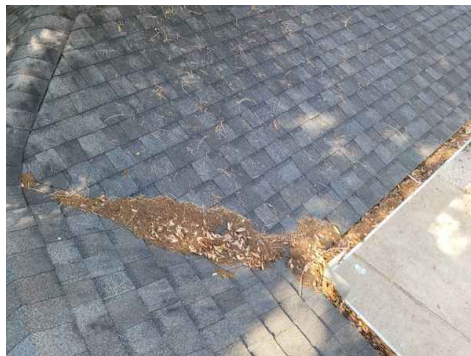
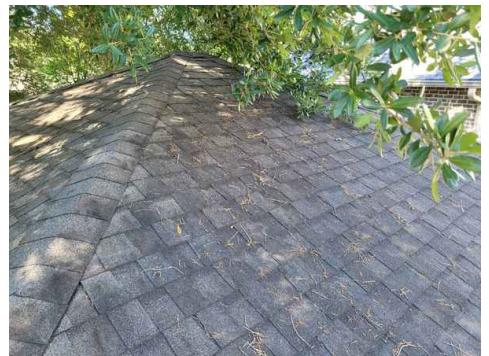
We observed some miscellaneous items related to the surface of the roof, including the items listed above. Have a roofing contractor provide a cost estimate to make any needed repairs.

The roof appears to be in generally serviceable condition at this time with some repairs needed for the item(s) shown above. Have a roofing contractor provide a cost estimate to make all necessary repairs to bring the roof into a completely serviceable condition.

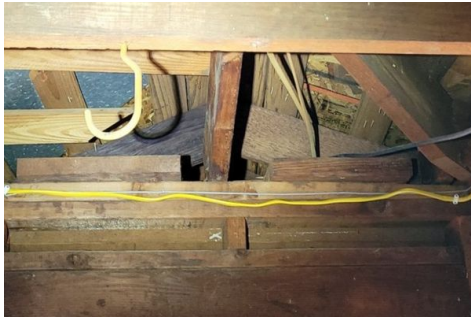
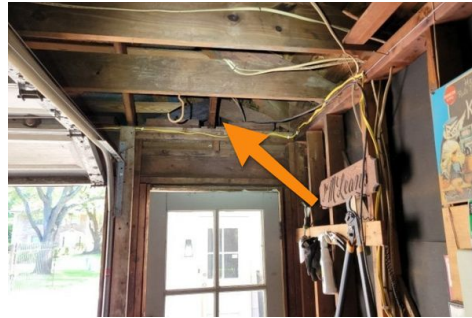
FIRESTOP MISSING BETWEEN GARAGE AND HOUSE

No firestop has been provided in the garage at the breezeway to prevent a fire from spreading between the garage and house.

installed

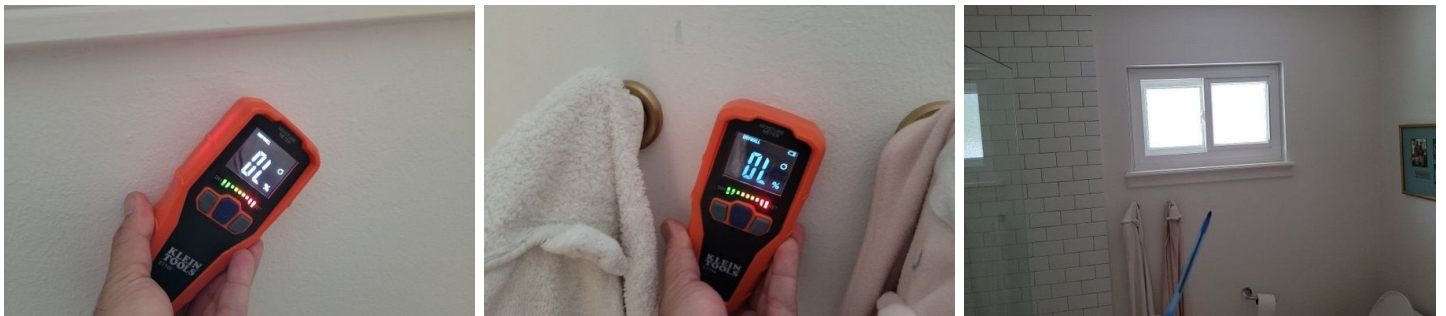
MOISTURE METER - HIGH READING

Evidences of possible water penetration to the interior of the structure were observed, including the following conditions shown below. Further investigation is recommended with service companies to determine the source(s) of the water penetration along with any secondary damages, and also to provide a cost estimate for any needed repairs.

Our moisture meter showed a higher than normal reading.

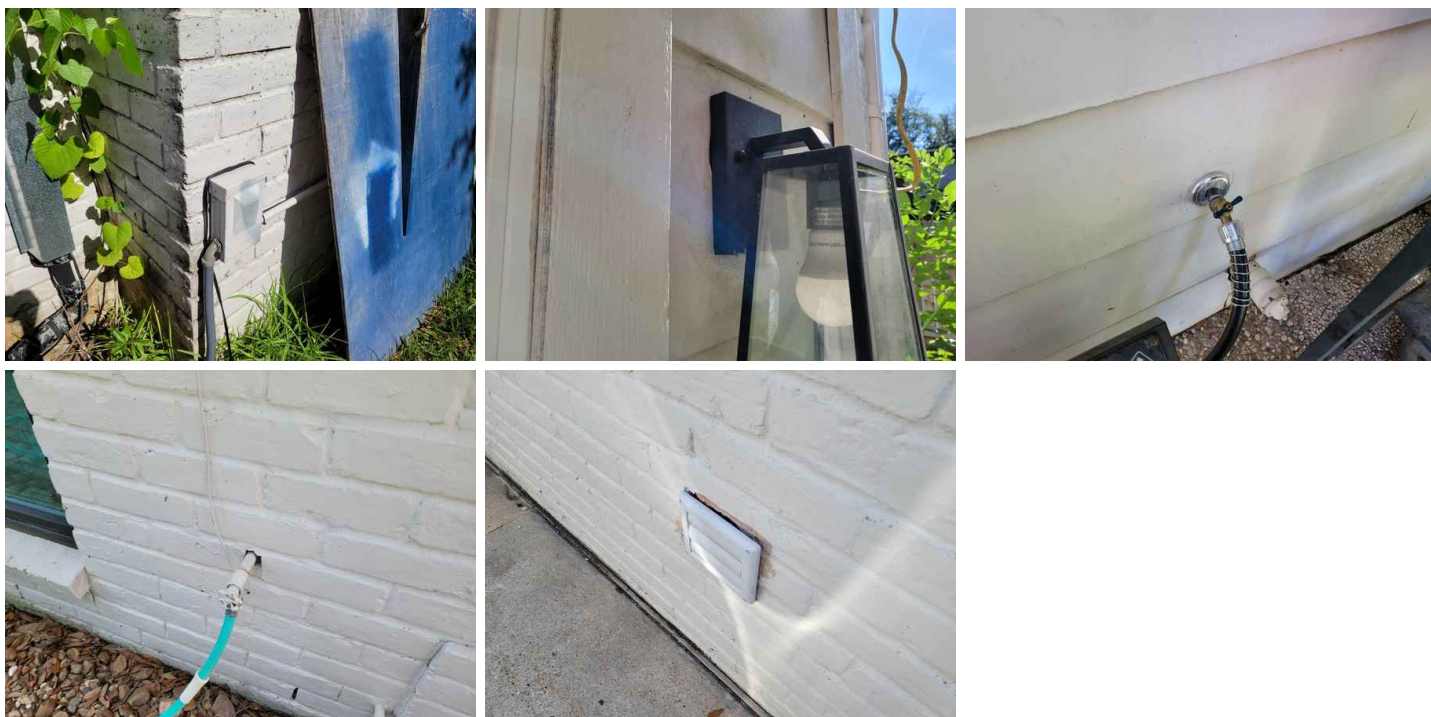
7.1.2 Water Penetration

A substantial vulnerability to water penetration was observed at penetrations/openings through the exterior building envelope, and it is recommended that all penetrations/openings be sealed against water penetration. Typical examples on a structure may include light fixtures, air conditioning refrigerant lines, water piping, gas piping, vent caps, windows, doors, expansion joints, etc. Below is a representative sample of locations and/or photographs showing some, but not necessarily all, locations where there is a vulnerability to water penetration. Have a contractor provide a cost estimate to seal all vulnerable areas on the exterior building envelope against water penetration and/or open up any clogged weepholes in the veneer.

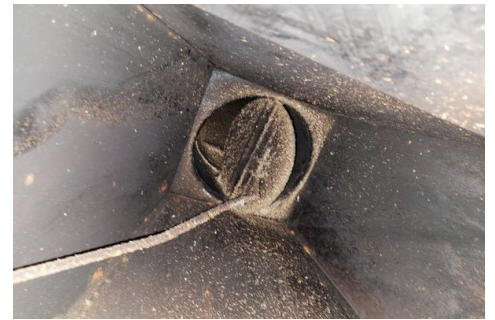
DAMPER C CLAMP MISSING **installed**

It is pointed out that the damper was not equipped with a spacer device to prevent the damper from closing completely. This device keeps the damper open slightly, even when it is in the closed position, to prevent combustion gases from building up in the living space should the gas log be operated when the damper is closed. It is recommended that the clamp be installed for safety purposes.

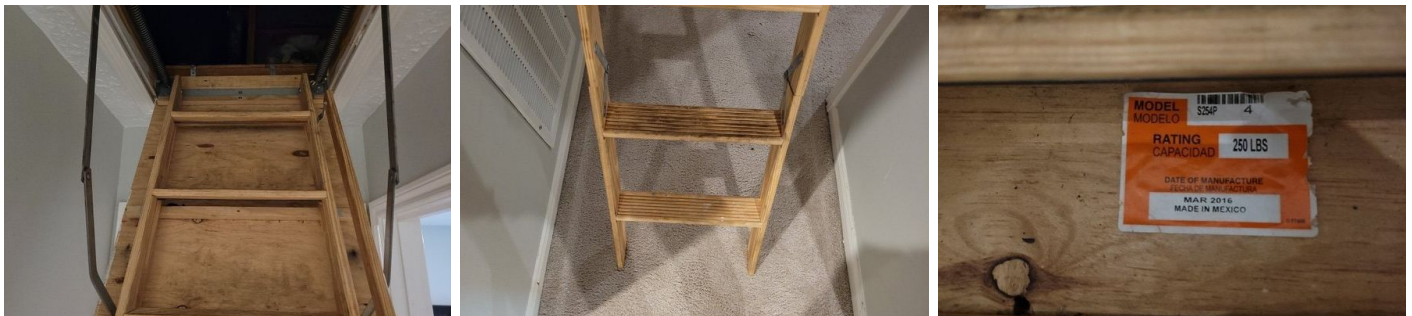
Ladder: Ladder - 250 Lb. rating

The ladder was labeled to indicate the rated capacity of the ladder into the attic is 250 pounds. The ladder does not meet current code requirements for ladders into attics. Consideration should be given to replacing the ladder with a ladder that meets current code requirements.

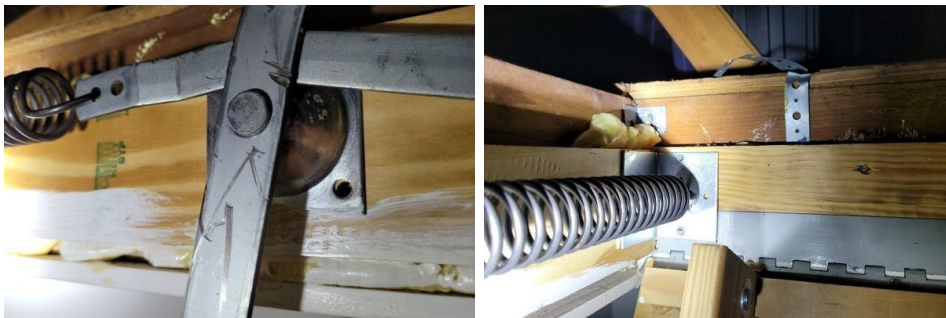
LADDER ATTACHMENT IMPROPER

Less than sixteen 16d nails or 1/4 X 3" lag screws, Nail(s) missing in spring arm pivot(s), Nail(s) missing in corner bracket(s)

The stair assembly was not properly installed or secured to the framing members, and repair is needed for safety purposes. The condition(s) can be a safety hazard, and repair is needed, as an improperly installed stair assembly can possibly collapse.

repaired

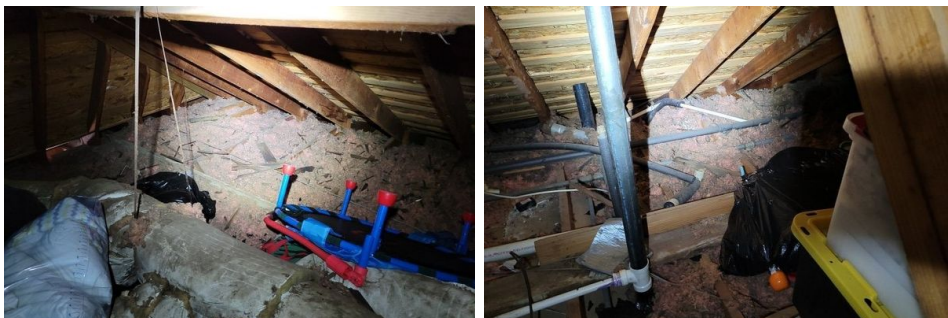
The insulation in the attic was thin by today's standards. This attic appeared to have approximately 4-6 inches of insulation in the ceiling. It is recommended that consideration be given to installing additional insulation. Current construction standards for new homes have insulation that is a minimum of an R-38 rating.

Table 1102.1.1

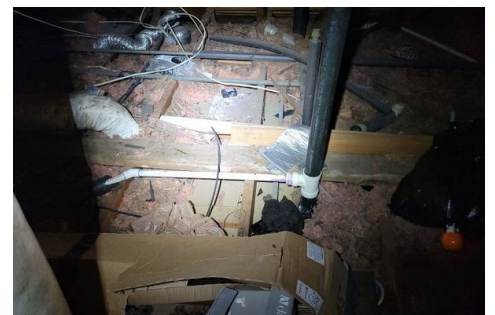
INSULATION MISSING - BETWEEN JOISTS

The insulation in the attic was missing from between some of the joists. Have a service company provide a cost estimate for repairs.

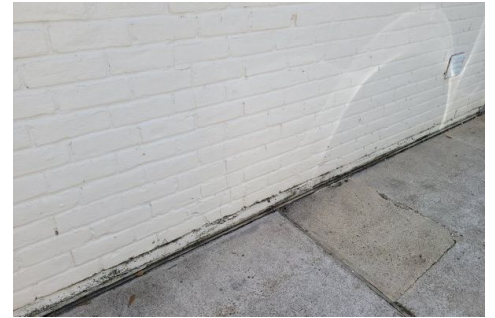
10.1.1 Brick/Stone Veneer

The weepholes at the bottom of the brick wall were clogged with mortar. Weepholes are intended to be gaps left in the bottom course of bricks on a brick wall, typically every second or third brick (approximately 33 inches), to allow moisture behind the bricks a path to exit the wall cavity, and also to allow for some ventilation inside the wall cavity. However, it has been our experience that during the original installation of the brick veneer, enough brick mortar falls off the back sides of the brick into the wall cavity to clog the weepholes and inhibit their proper function. It is recommended that further investigation and repairs be done by a contractor to provide functional weepholes.

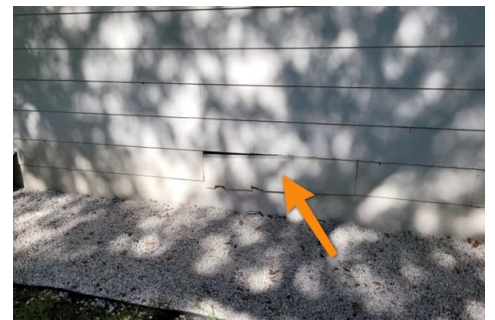
10.8.1 Wood Siding

LOOSE

The wood siding was loose and needs to be resecured. Have a contractor provide a cost estimate to make all needed repairs.

replaced

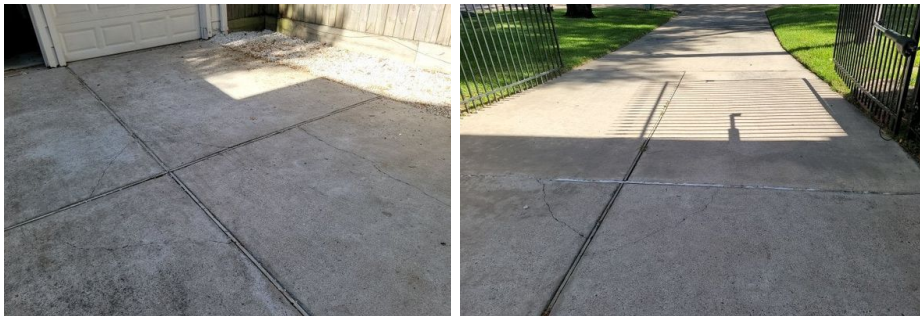
Flatwork Concrete/Patios/Walkways: Cracks Driveway

Cracks and some separations were observed in the driveway concrete. In our opinion, the driveway is still in serviceable condition at this time.

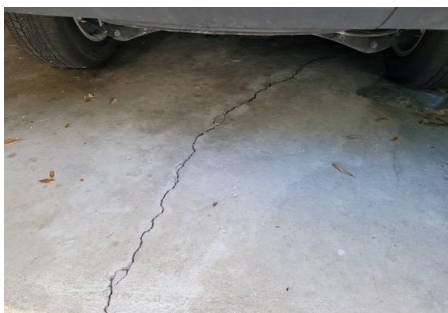
Garage: Foundation cracks

We observed cracks in the garage foundation. The foundation was still functional at the time of the inspection and not in need of repair.

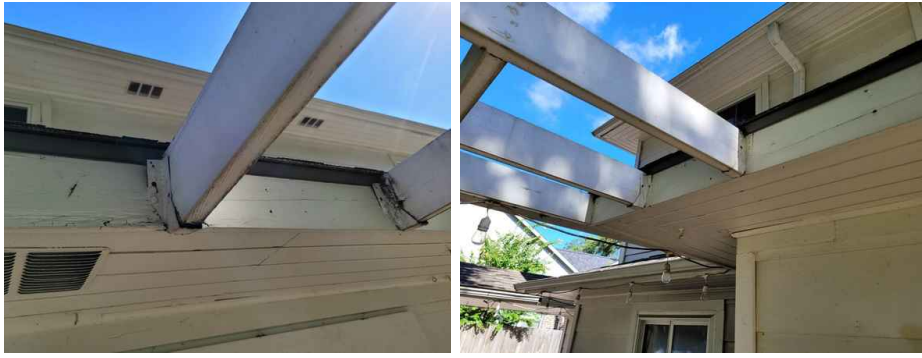
Miscellaneous Exteriors: Pergola OK

The pergola was in generally good condition, with no significant repairs needed. Some minor repairs are recommended at the joints with the fascia.

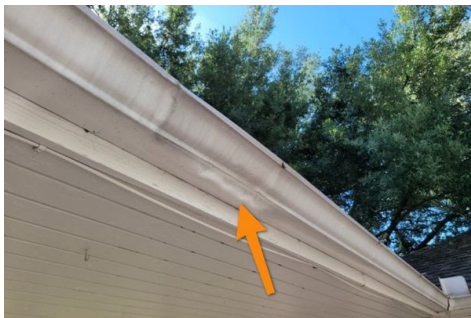
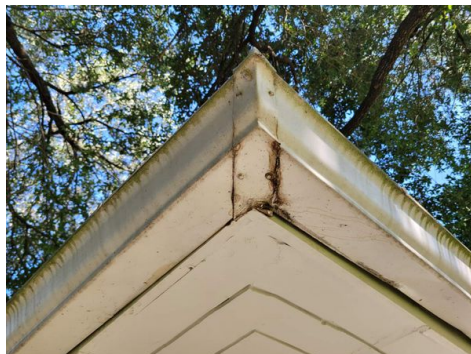
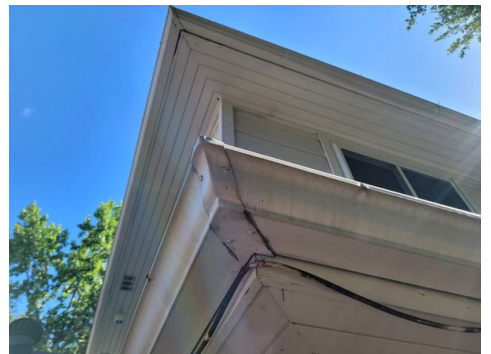
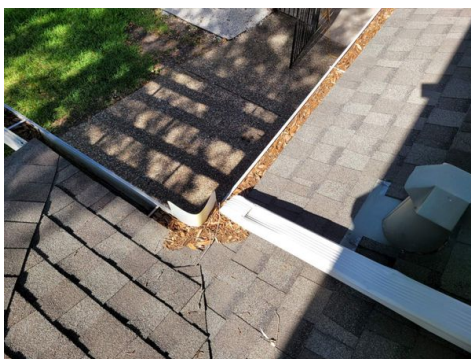
11.2.1 Gutters and Downspouts

Debris, Damaged, Leaking/Jts., Screens missing

The gutters had item(s) in need of repair.

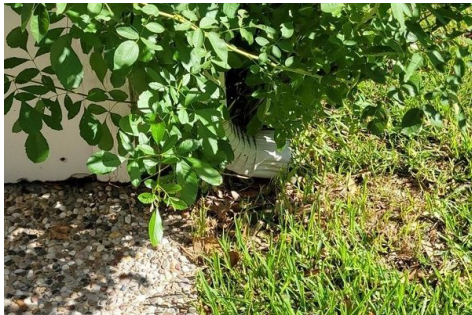
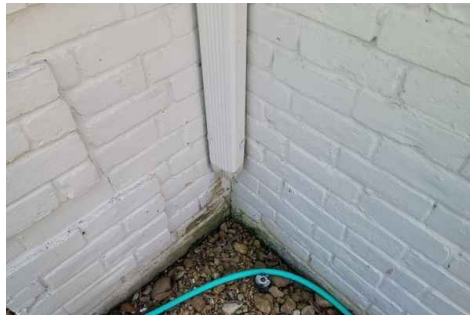
11.2.2 Gutters and Downspouts

Splash block missing

The downspouts had item(s) in need of repair.

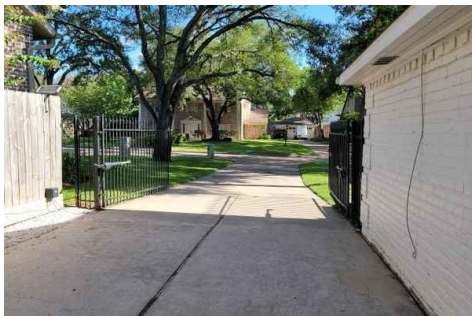
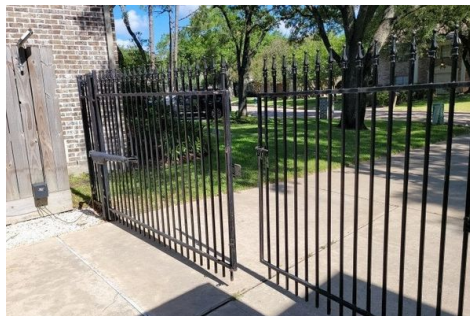
The electric gate was operational but sticking and not fully opening / closing at the time of the inspection. Have a service company find the source of the problem, and make any necessary repairs.

repaired

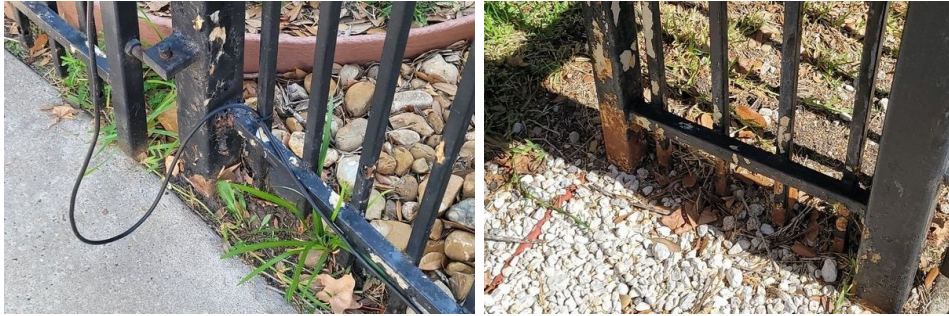
11.3.2 Gates and Fences

Rusted

The wrought iron gate was in need of some repairs.

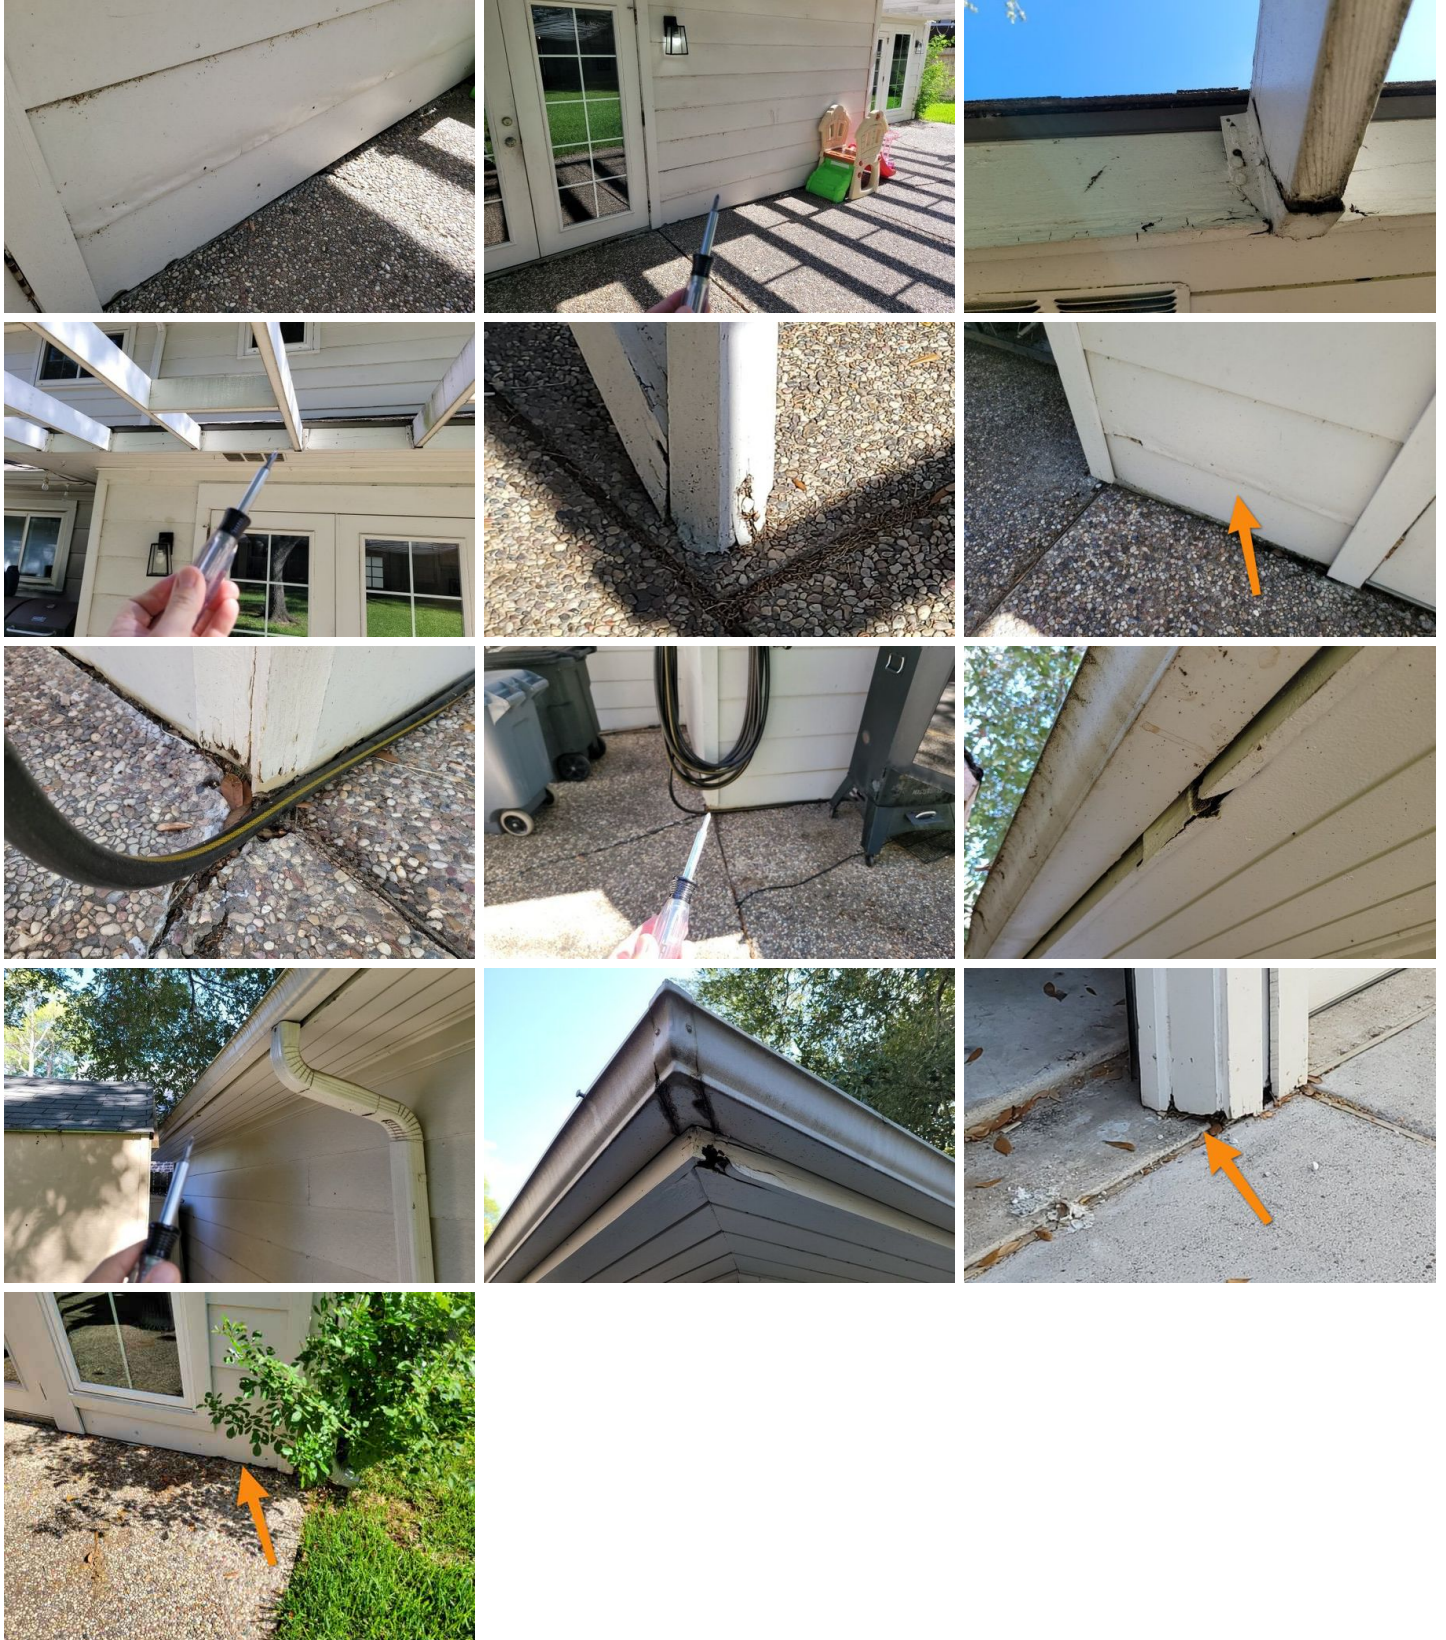
11.4.1 Wood Rot

We observed evidences of wood rot and it is recommended that all rotted wood be replaced. Have a contractor provide a cost estimate to determine the entire scope of the wood rot, and provide a cost estimate to replace all rotted wood in the house.

most rotten wood replaced

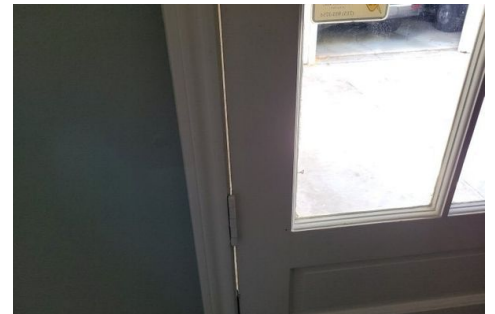
We observed daylight at the exterior door when in the closed position, and the condition needs to be repaired.

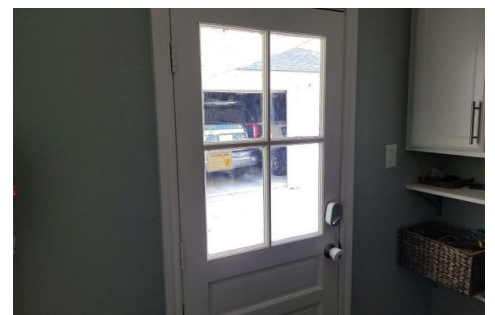
12.1.4 Doors

The glass in the door was not marked as being safety glass as required. Contact a service company to make the needed repairs.

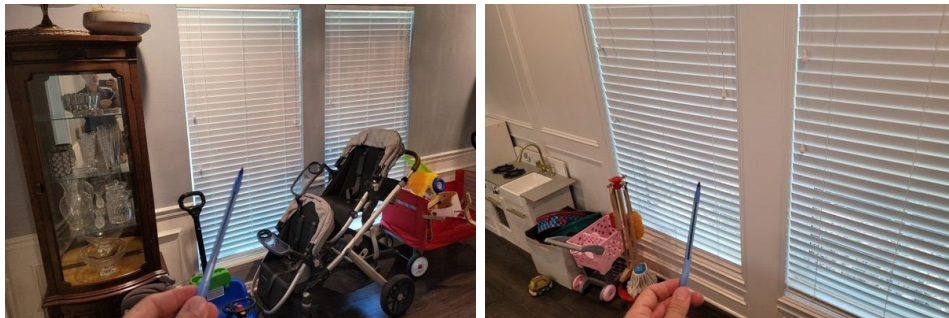
12.2.1 Windows

Windows that were stuck and hard to open were observed.

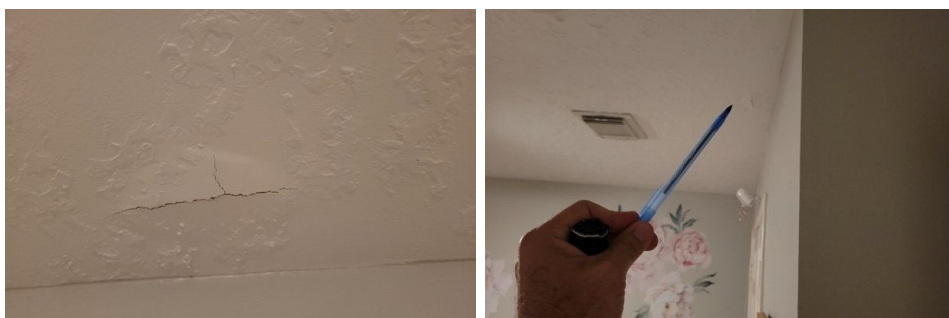
The sheetrock was damaged and needs to be repaired.
