## Summary Only

Property Address:  
4541 Sunrise Dr  
Chandler TX 75758

Reynolds Professional Real Estate Inspections  
Allen Allcorn TL#24382  
19294 Hiddenlake Dr  
Tyler, Texas 75703  
903-360-9794  
aallcorn@reynoldsinspectiongroup.com

This is not the complete home inspection report. It is only the Summary Items.

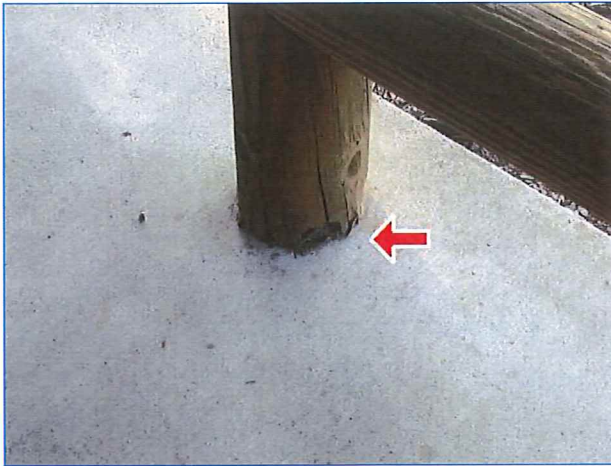
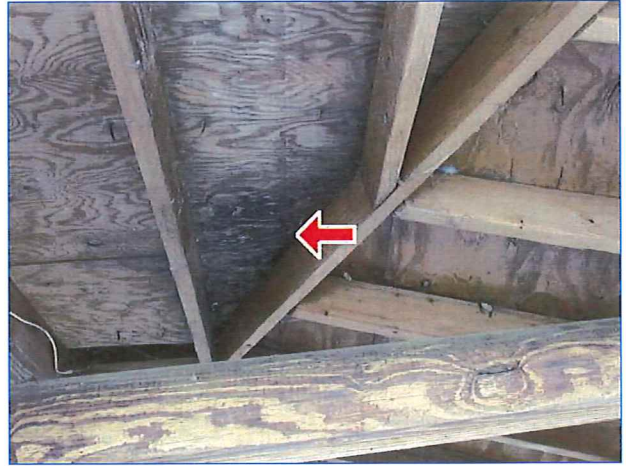
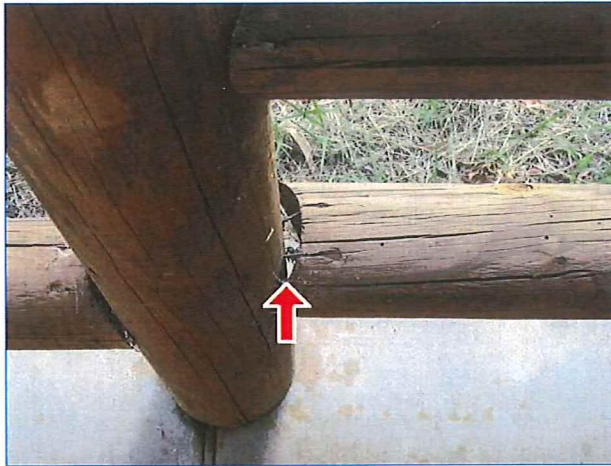
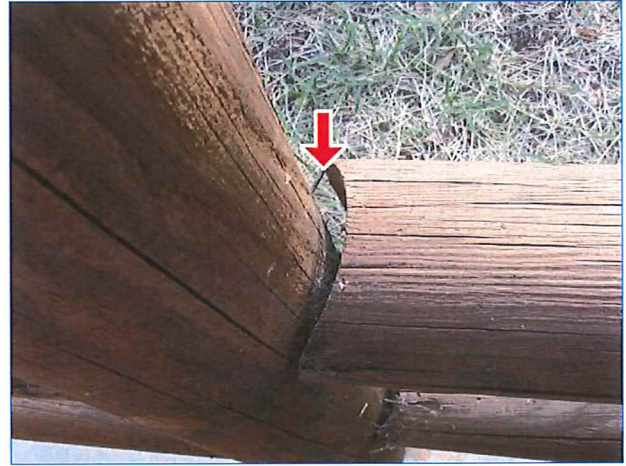
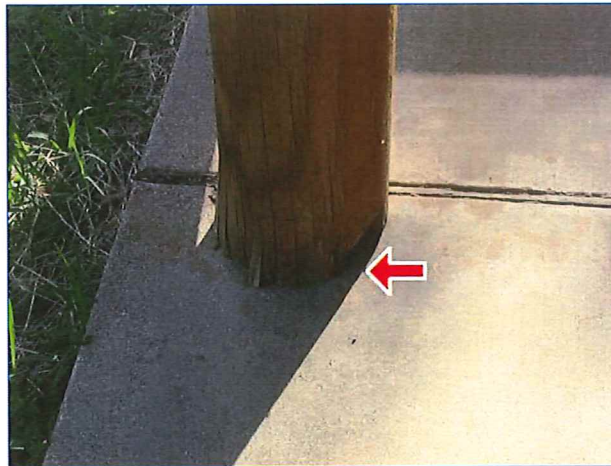
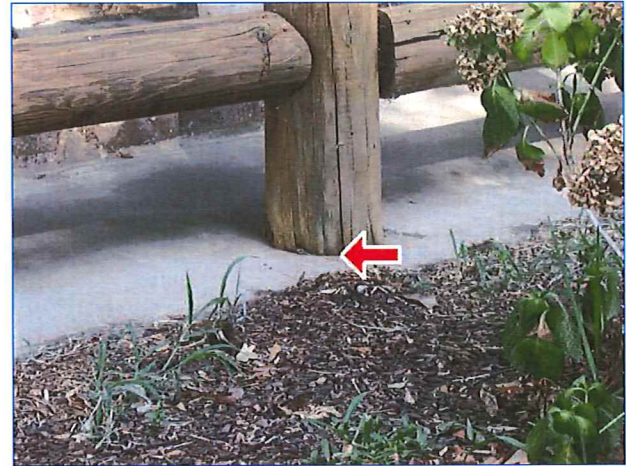
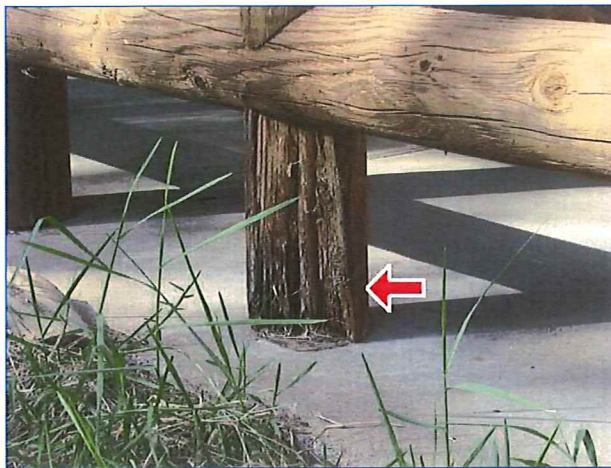
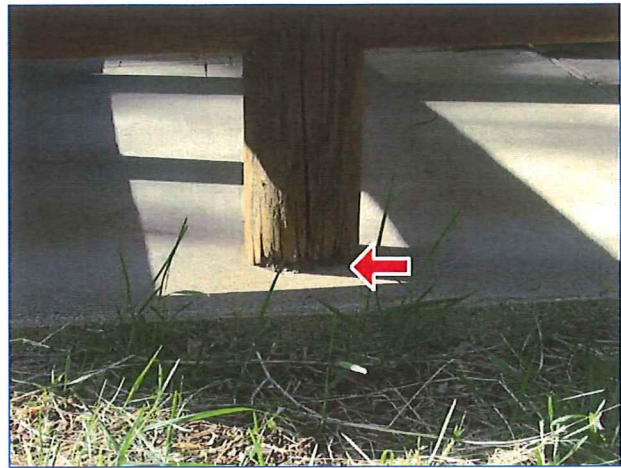
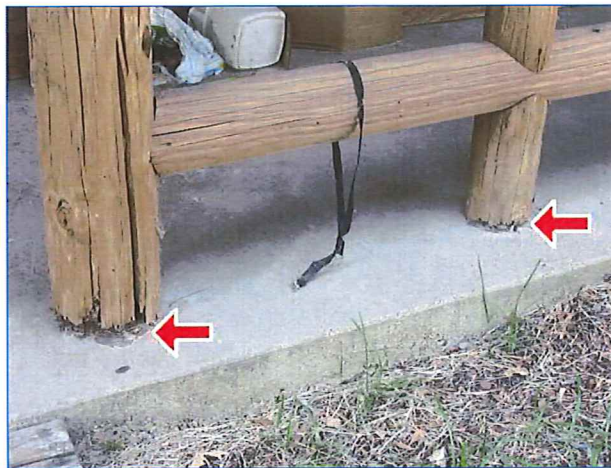
Porches have many areas of wood to ground contact. Many of the support posts have water damage along ground line, leading to some crushing/settling at bases. Porch railings are loose in several spots do to this.

Water staining noted on porch ceiling. Appears to be aged. Unable to verify. Moisture reading was normal but no rain in awhile.

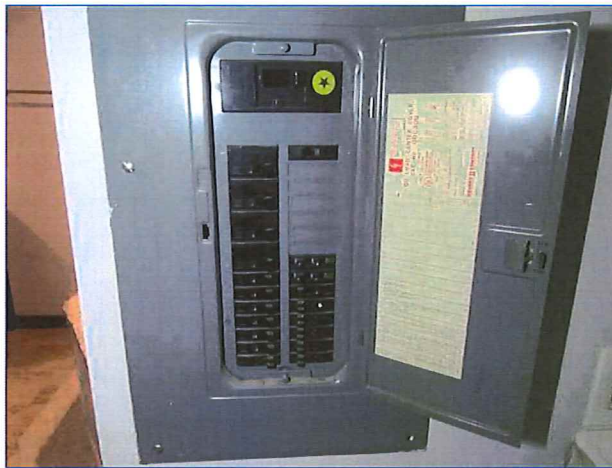
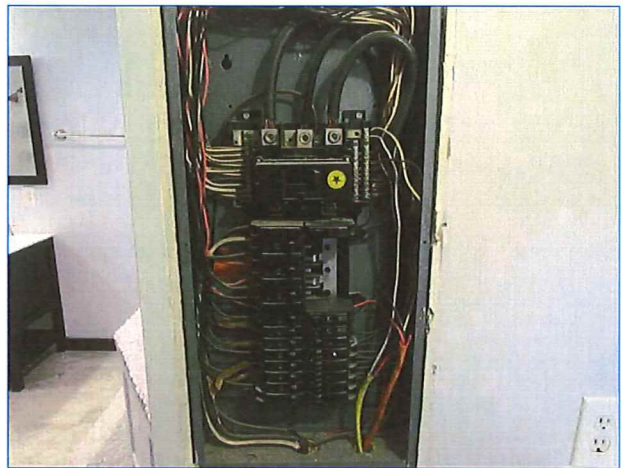
**E - MAIN** - The main panel is NOT clearly labeled throughout on all breakers.

**E - AFCI** - The panel does not have AFCI breakers for bedrooms, study, hallway and other areas as required by today's safety standards and today's required defect inspection report comments. **HOWEVER - this structure**

Effective in 2020 - A Type 1 or Type 2 surge protective device (SPD) is required for homes. The SPD may be installed inside or adjacent to the panel. **Your house is grandfathered and NOT required to meet this code**, if any updates are made to the panel it will be required to be updated to code. We are required to comment on the lack of and as defective when SPD is not present.

Effective in 2020 - This house has an interior electrical panel, new NEC code requires an exterior emergency disconnect for interior panels. **Your house is grandfathered for this code and NOT required to meet this code**, if any updates are made to the panel it will be required to be updated. We are required to comment on the lack of and as defective when exterior shut off is not present.

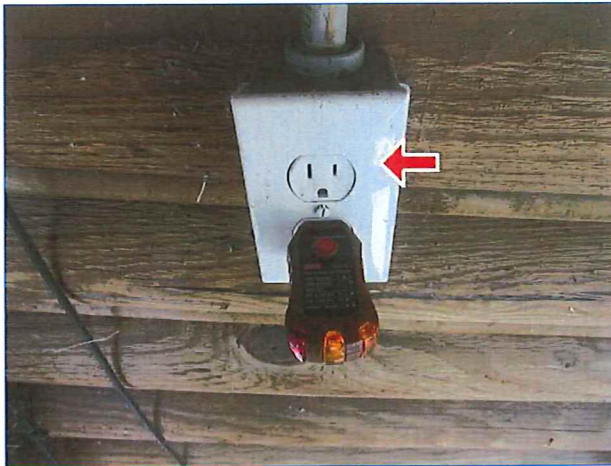
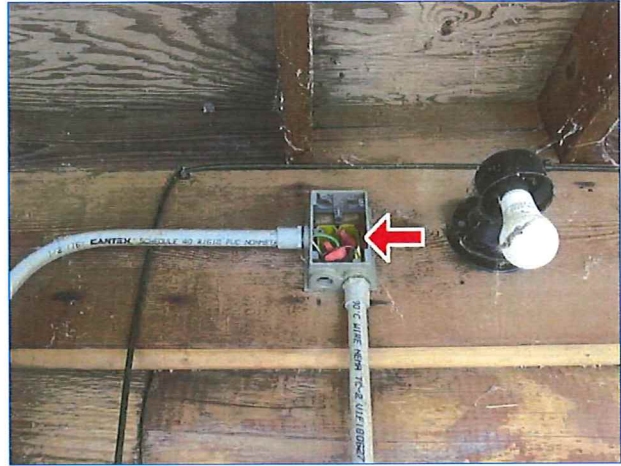
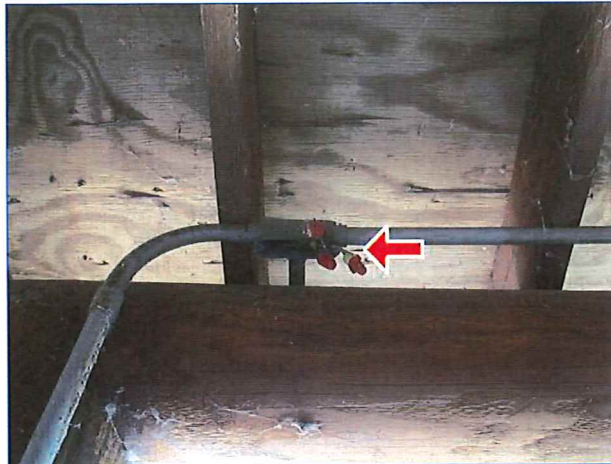
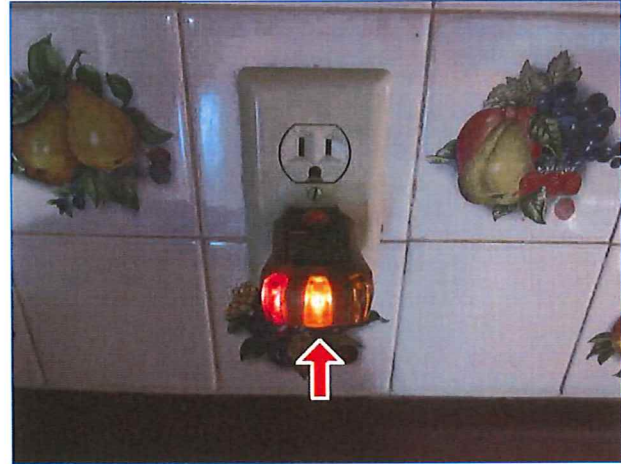
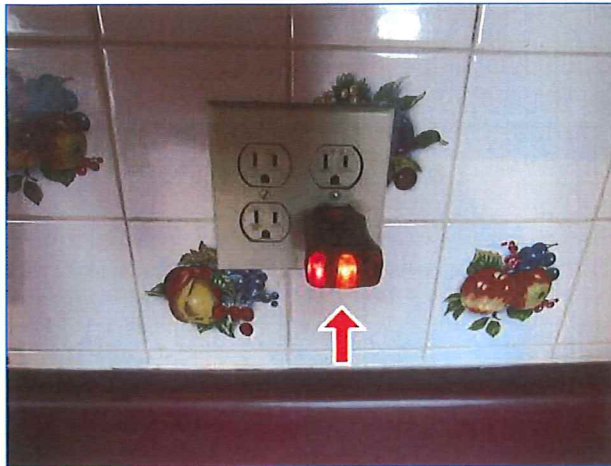
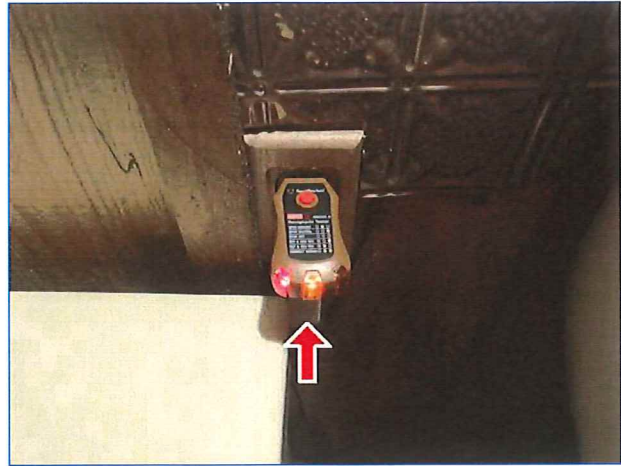
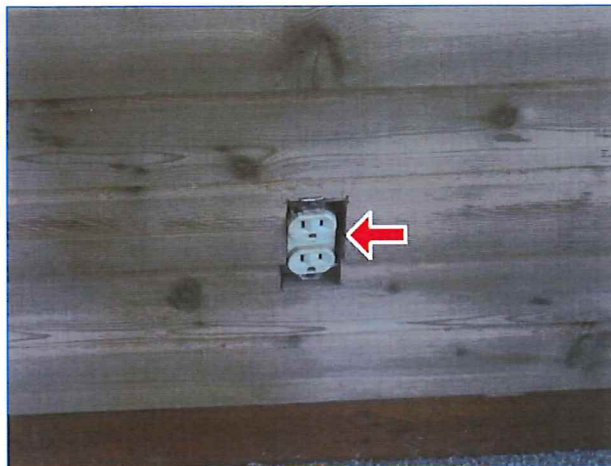
**BE - Incandescent bulbs in closets could be considered fire hazards based on proximity of storage. Consider covered fixtures.**

**BE - Several lights did not function and may be due to bad or missing bulb(s).**

**BE - ALL kitchen, bathroom, laundry room, exterior and any receptacles within 6' of a sink do not have GFCI safety protection outlets as required by current standards.**

**BE - Reverse polarity reading at many outlets randomly throughout the house as per test equipment.**

**All exterior outlets don't have weatherproof covers as required.**

Fridge outlet and one outlet in master bedroom are missing cover plate.

**BE - The outside weatherproof outlet cover is damaged/or missing and needs repair or replace.**

**BE - Exposed splices noted on the back porch - recommend general sweep to ensure all splices are contained in proper J boxes.**

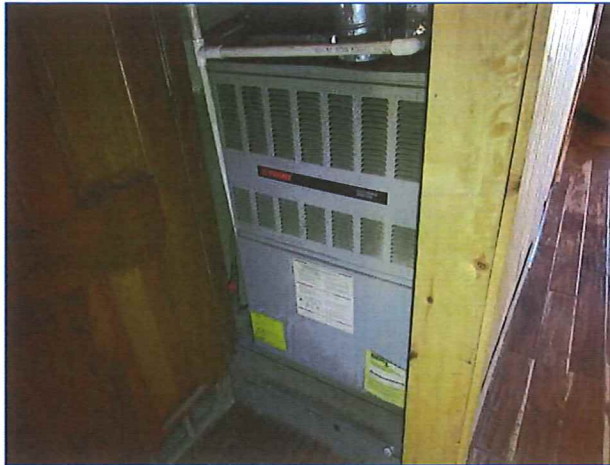
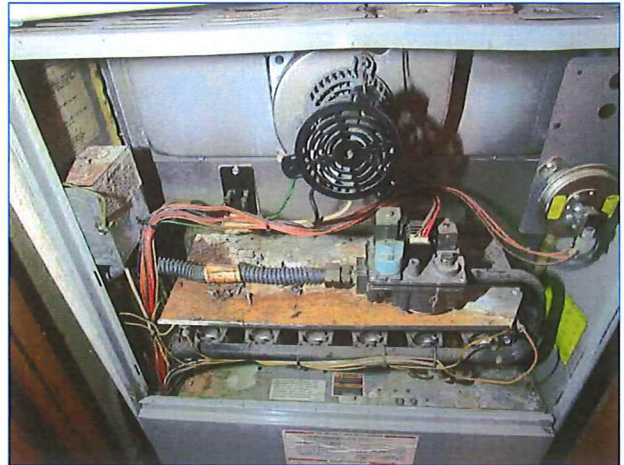
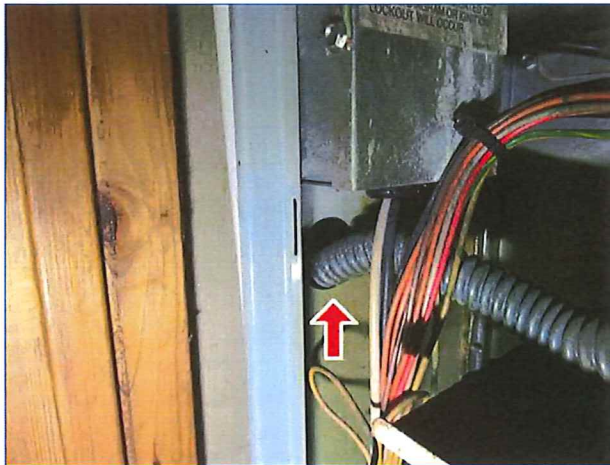
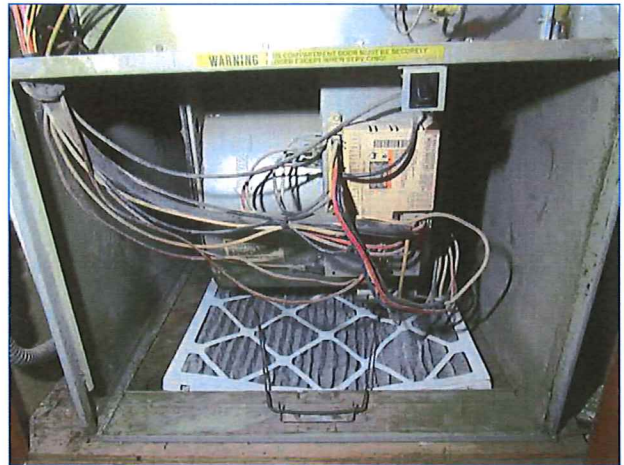
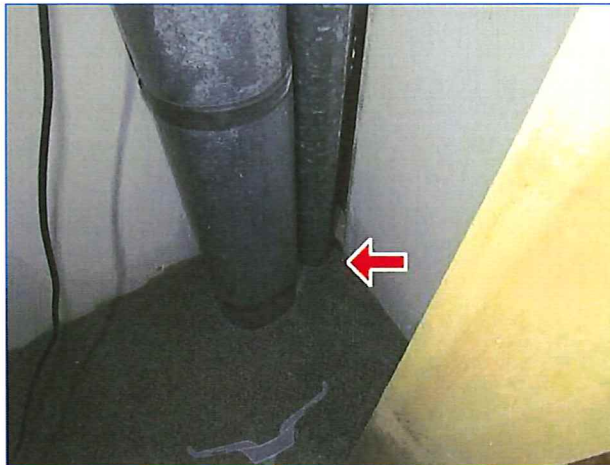
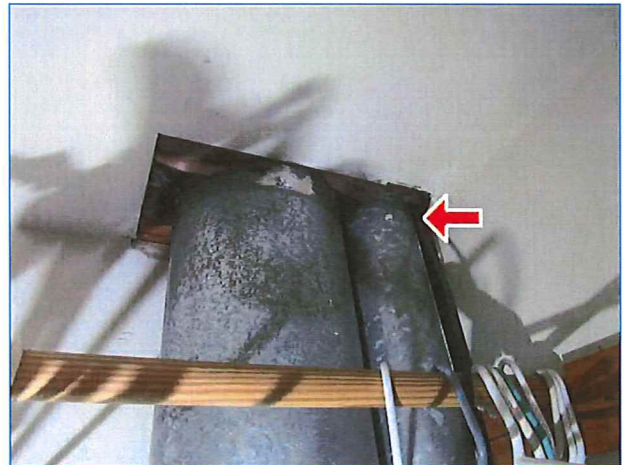
F - The furnace was **visually inspected** only due to local temperature at time of inspection and possible damage that could occur from operating at temperatures over 65 degrees. The unit is generally clean and appear to be installed properly. The interior of the unit has some rust noted.

**F - The gas line into the furnace is a flexible line. This line should be a solid pipe through the housing. Only solid gas piping should be installed inside furnace cabinet.**

**Furnace heater has a Type B exhaust pipe vents, this type pipe has a recommend 1" clearance gap from all**

**combustibles. Recommend pulling away all combustibles that are in contact with pipe.**

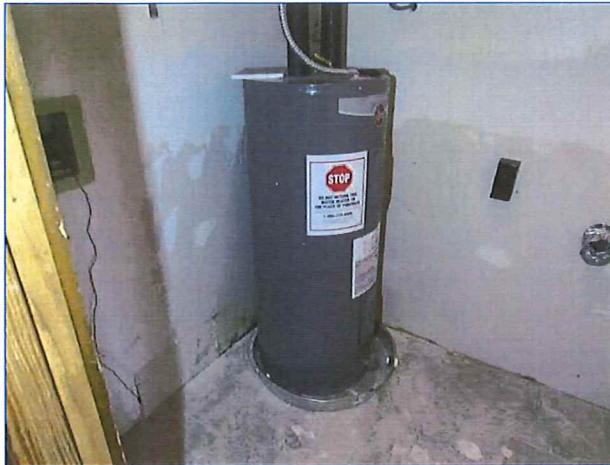
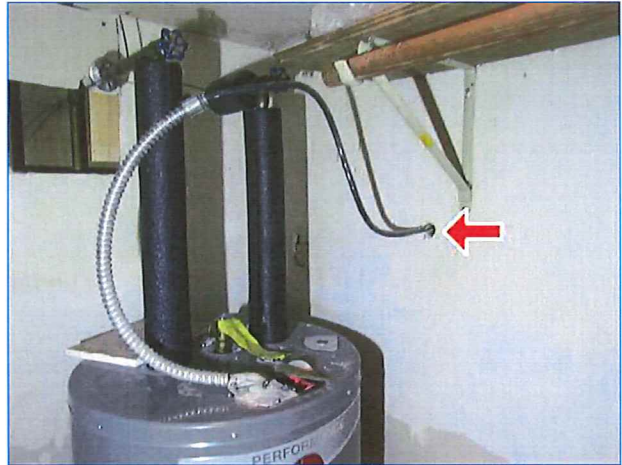
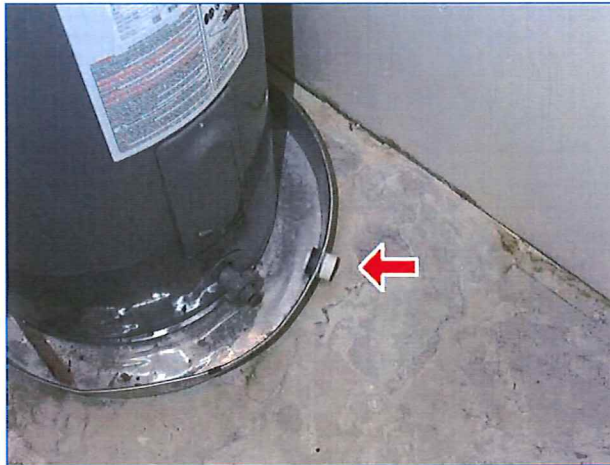
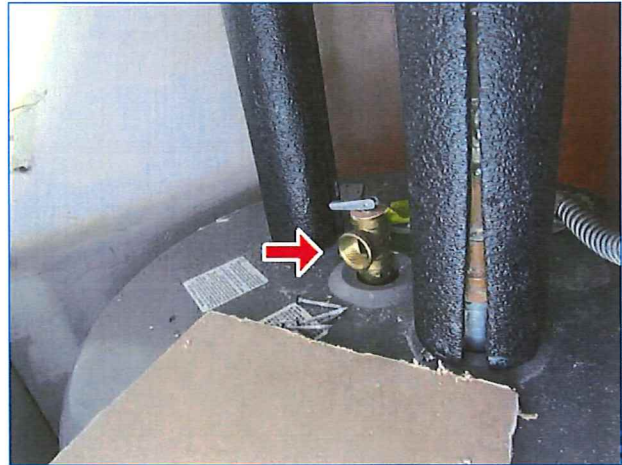
**WH - Defected for installation comments - unit did appear to function and operate properly.**

**Drain pan should terminate over a drain or on the exterior of structure.**

**The TPR valve pipe is not installed. The TPR (Temperature/Pressure Release) valve on water heater needs a 3/4" pipe to extend within 6 inches of floor for safety. (PVC is not approved for hot water use). I recommend repair by a qualified person.**

**WH - E - Electrical shut off is not local as required**

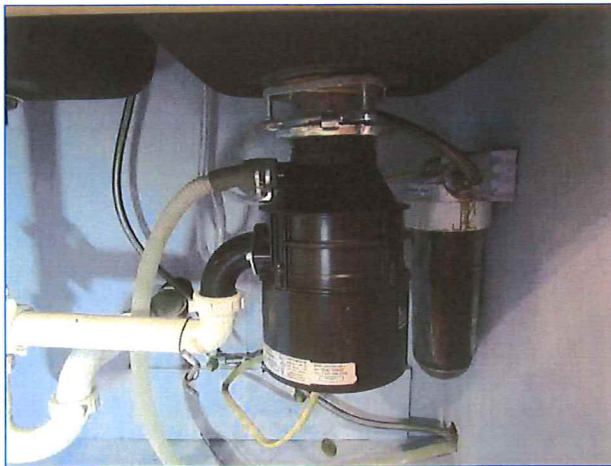
B. Item 1(Picture)

**Unit did NOT function as intended at time of inspection.**

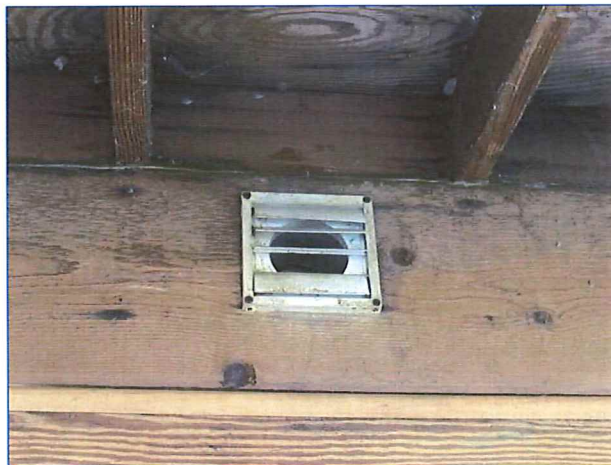
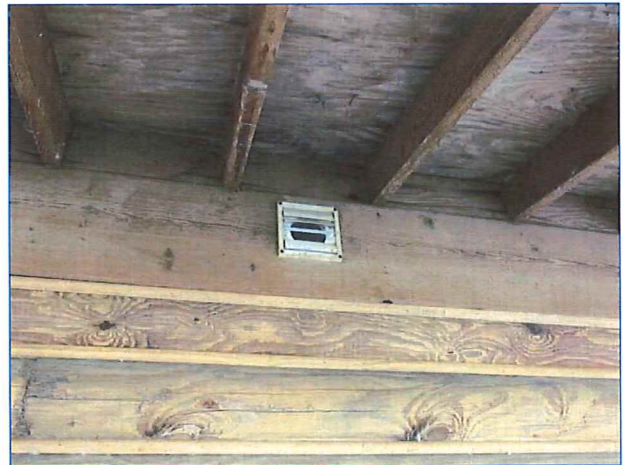
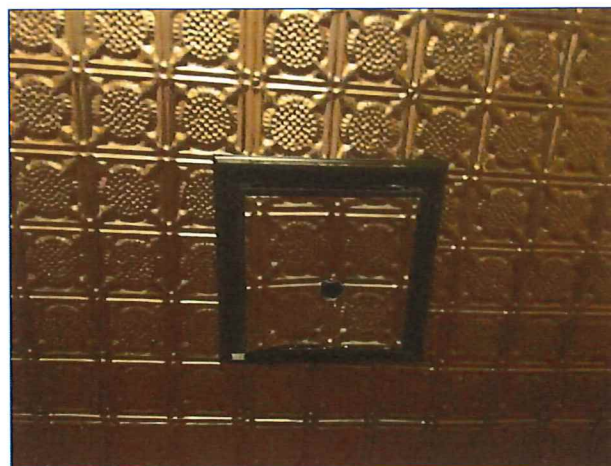
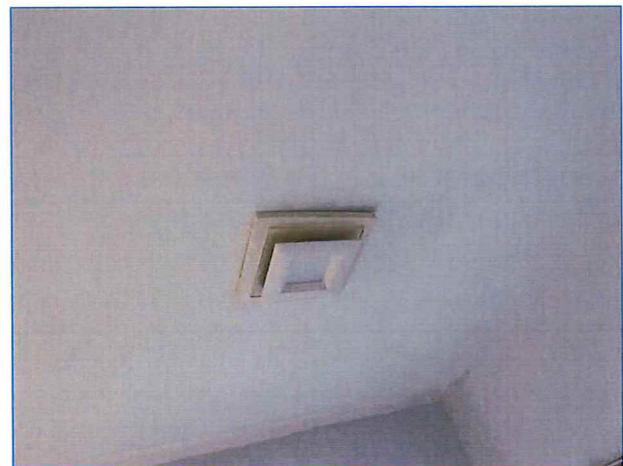
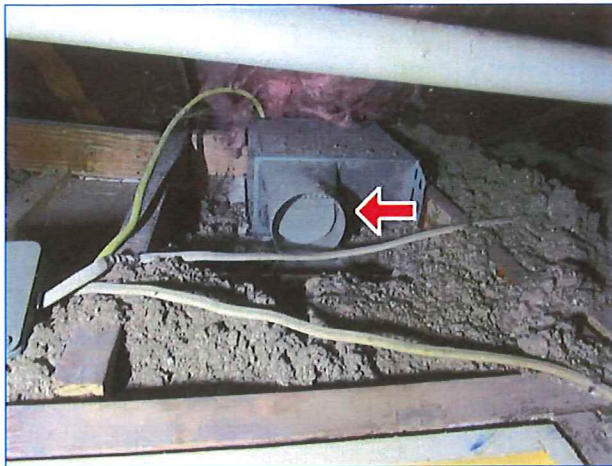
Bathroom vents terminate into the attic. All vents are required to vent out through the attic. Recommend repair as needed.

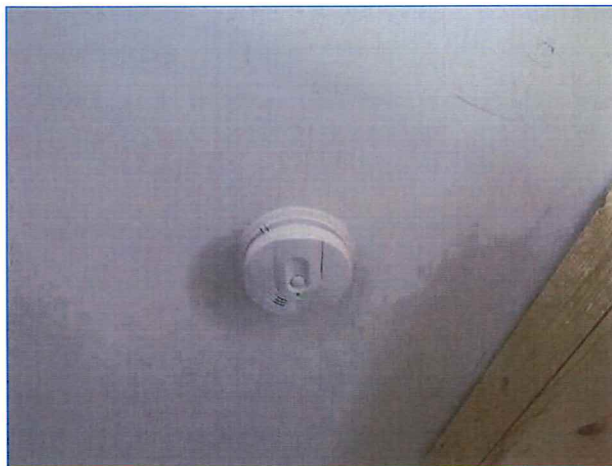
J. Item 1(Picture)

**Detectors not noted in bedrooms, hallways and kitchen area. Recommend new units installed as needed.**

Recommend service of all existing or new units in all bedrooms, hallways and kitchen areas.
