155 Chestnut Run Ct
Conroe, TX 77384

PROPERTY INSPECTION REPORT

By: Sean Salinas, Lic # 21192 06/28/2021
(Name and License Number of Inspector) (Date)

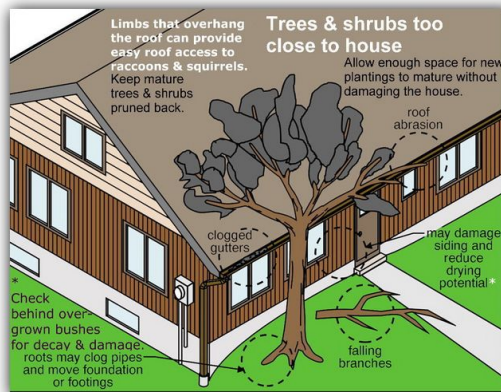
Recommend keeping vegetation cut back away from exterior of home to prevent damage.

Buyer's note; ensure flower bed soil does not rise above foundation to prevent water and wood destroying insect entry into house.

Recommend moving the drain tube in the front flower bed to terminate to the left side of the house closer to the yard drain.

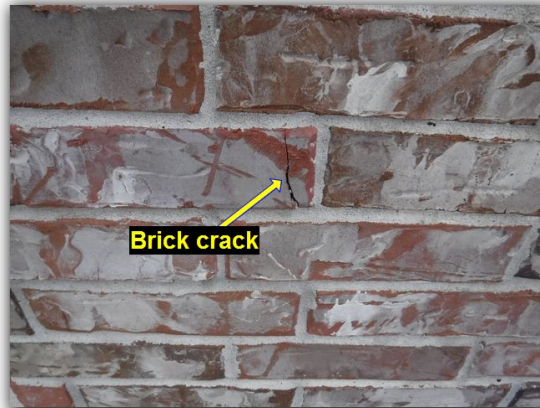
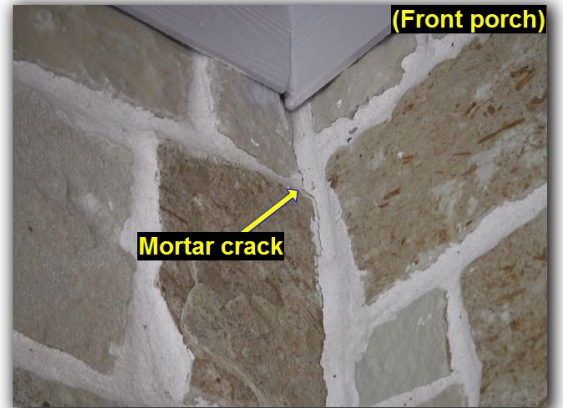
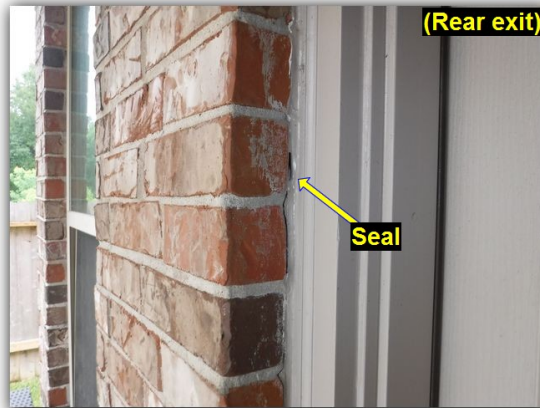
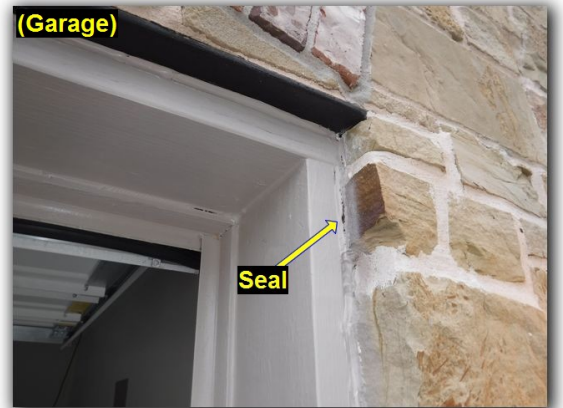
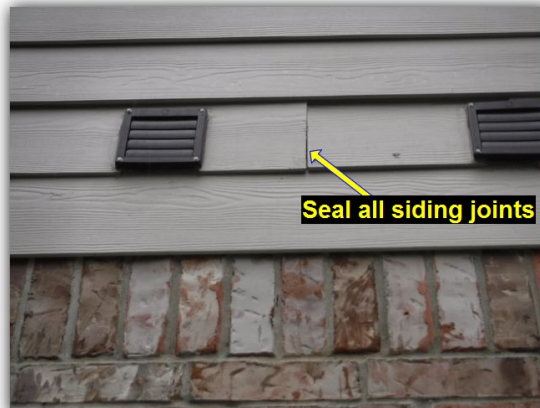
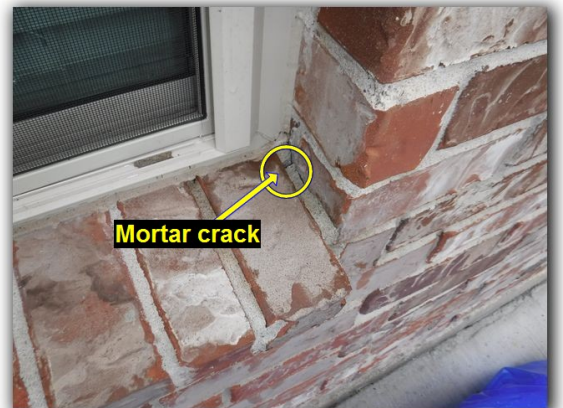
Observed cracks in the brick and mortar around the exterior in one or more areas (minor). Recommend sealing/caulking around all holes, gaps, cracks and exterior siding penetrations to prevent water & pest entry.

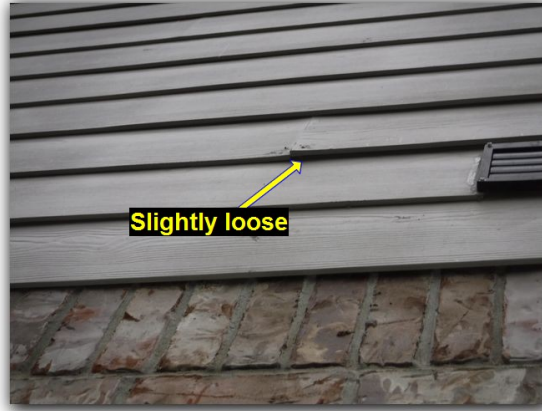
Observed loose siding that needs to be secured.

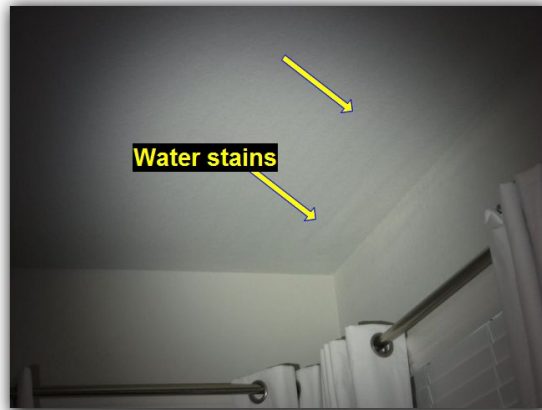
Observed some light water stains on the ceiling in the breakfast room. Moisture readings were low at time of inspection which usually indicates the stains are from a previous leak or condensation, but I could not be certain. Recommend asking the seller about a previous leak that may have been repaired or having further evaluation by a contractor.

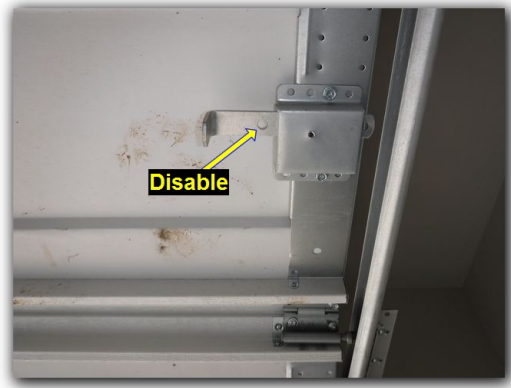
Recommend disabling the manual garage door lock(s) when a garage door opener is present to prevent damage to the door(s).

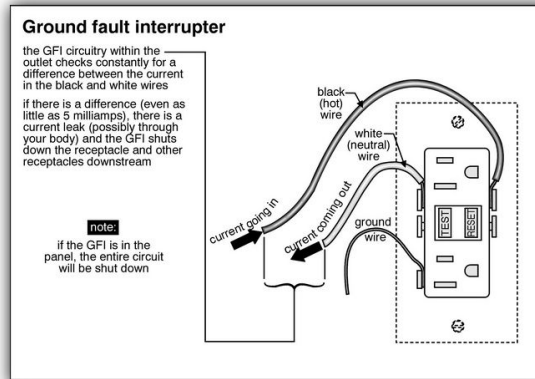
Did not observe GFCI protection for all outlets in the laundry room. Current standards now call for all laundry room outlets to have GFCI protection.

Observed a metal cover plate for the dryer outlet. Recommend replacing with a plastic cover to prevent a safety hazard.

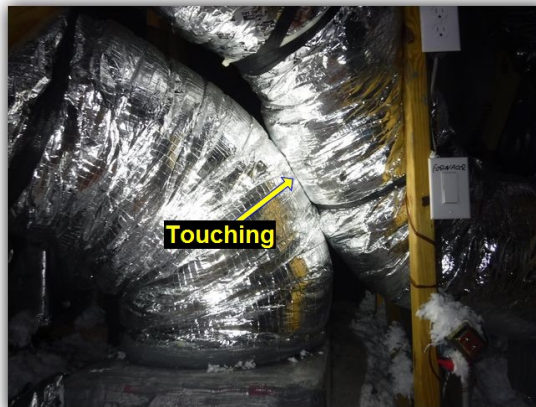
Observed ducts touching in one or more areas in the attic. This can allow condensation to form between the ducts which can drip onto the attic floor or ceilings below. Recommend separating the ducts or placing a piece of insulation between the ducts to prevent condensation from forming.

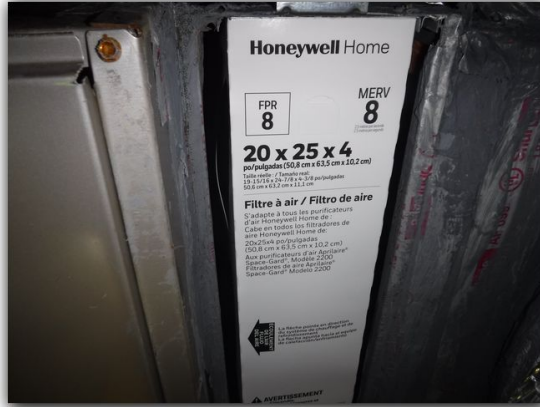
Whole house media filter(s) are present at the HVAC systems in the attic. Recommend changing the filter(s) every 3 months or per manufacturer recommendation.

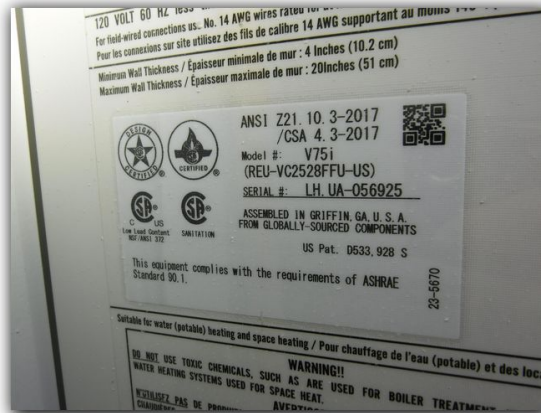
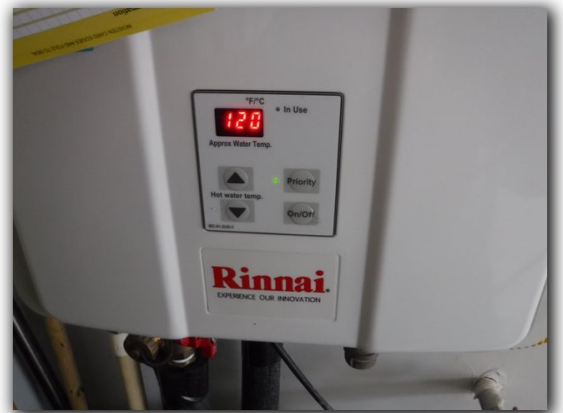
WATER HEATING UNIT(S): RINNAI

No significant deficiencies or anomalies observed.

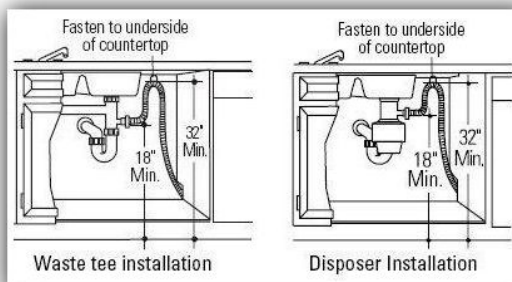
Did not observe a high loop or air gap installed for the dishwasher. The high loop or air gap prevents gray (dirty) water from backing into the dishwasher if the disposal or drain becomes clogged.

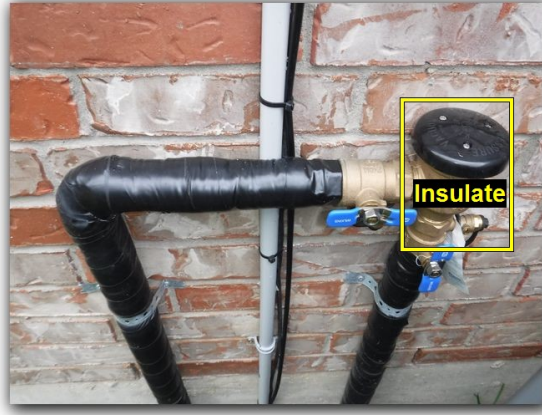
Recommend insulating the back flow preventer during the winter months to prevent damage during a freeze.
