PROPERTY INSPECTION REPORT

Concerning: 5007 Cedar Creek Drive, Dickinson, Texas 77539

By: Harold K. Randle License # 10237

April 17, 2020

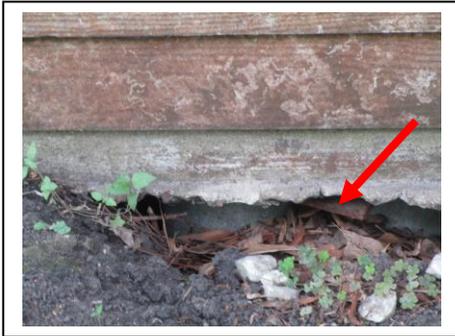
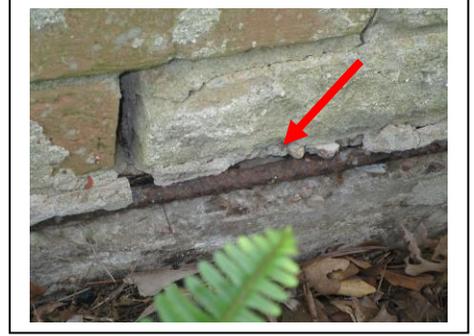
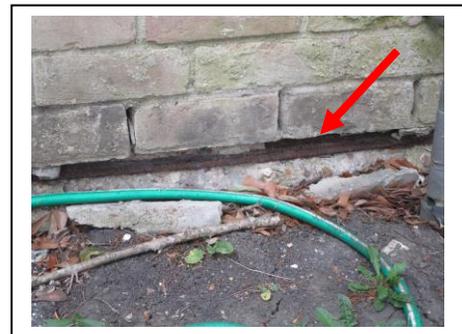
2. Foundation has cracks and damage at multiple locations.
 3. Exposed tension cable end/rebar at foundation wall should be properly concealed to prevent damage to foundation resulting from water intrusion and/or rust.

Exposed Foundation Wall Rebar

- Recommend having licensed foundation specialist further evaluate any item listed above and make appropriate repairs.**

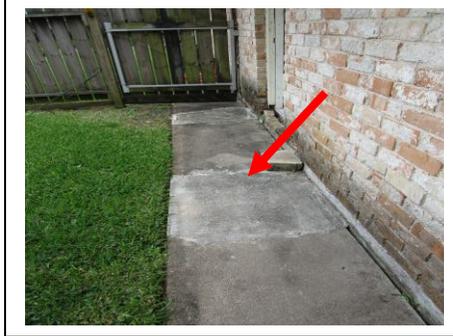
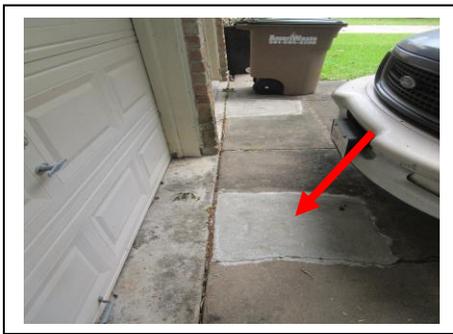
4. Apparent previous foundation repairs were observed at the time of inspection. Client should determine the extent of all previous foundation repairs and whether there is a warranty that can be transferred for those repairs.

Apparent Foundation Repair

5. Due to the apparent previous foundation repairs, it is recommended that the drain lines under the property be tested for leaks by a licensed plumber via a hydrostatic leak test.

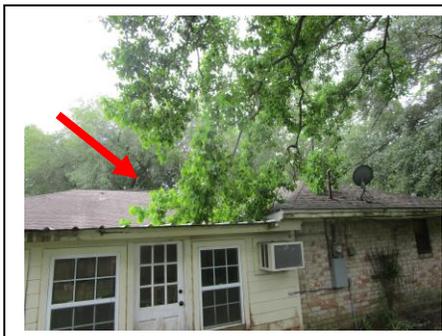
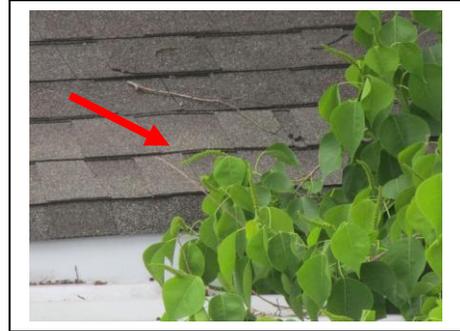
- 1. Tree limbs above roof should be cut back to prevent roof damage.**
- 2. Debris on roof should be removed to prevent damage to roof surface.**
- 3. Satellite TV stand has not been properly installed with satellite dish roof jack. The stand has been directly attached to wood decking which can allow water to leak through wood decking at screw penetrations. Screws should be properly sealed where they penetrate decking to prevent water from damaging decking via screw holes. This may be difficult to accomplish as silicone may not be compatible with asphalt shingles and roofing cement or tar can crack and/or deteriorate over time.**

Tree Limbs Above Roof

Recommend having licensed roofing professional further evaluate any item listed above and make appropriate repairs.

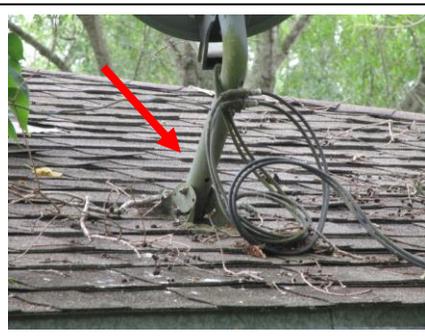
Satellite Dish Installed On Roof

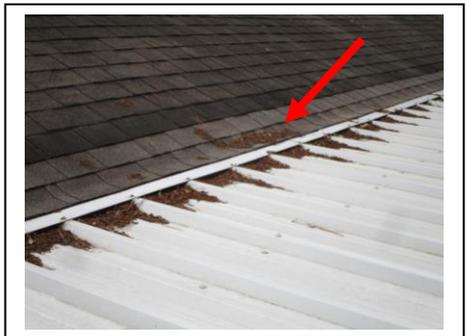
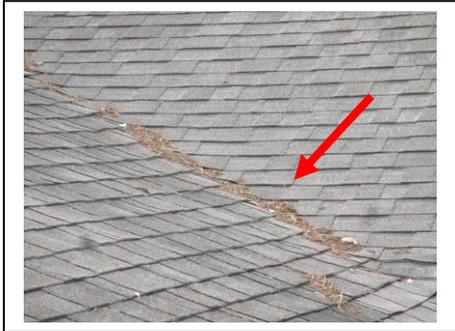
Debris On Roof Surface

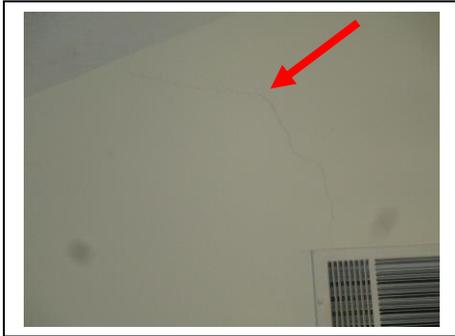
- 1. Family Room interior wall has apparent settlement cracks.**
- 2. Exterior cracks in masonry wall shows sign of previous**

Wall Crack

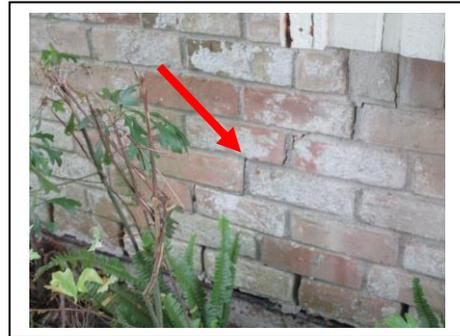
- movement and should continue to be monitored.
3. Exterior siding is installed too close to grade at multiple areas. Siding should be installed to allow soil height to be at least 6 inches below top of foundation wall and bottom of siding to prevent water penetration and damage to siding.
 4. Exterior siding is damaged at several locations. Recommend having licensed contractor evaluate any item listed above and make appropriate repairs.

Masonry Wall Damage

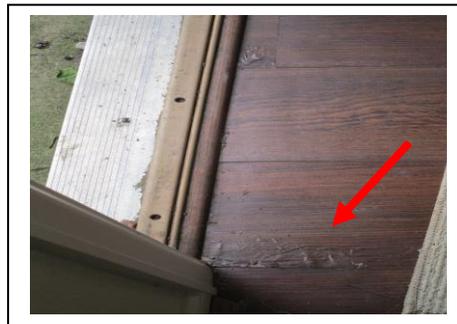
1. Wood floor shows sign of previous water damage at rear exterior door leading to back yard. Recommend having licensed contractor evaluate any item listed above and make appropriate repairs.

Damaged Wood Floor

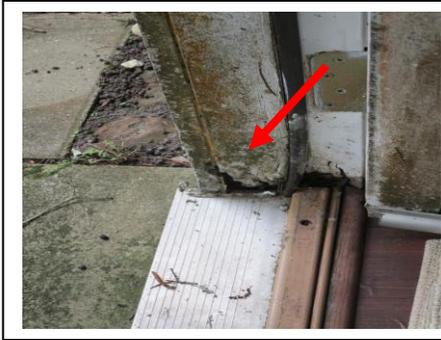
Damaged Door Frame

Recommend having licensed contractor evaluate any item listed above and make appropriate repairs.

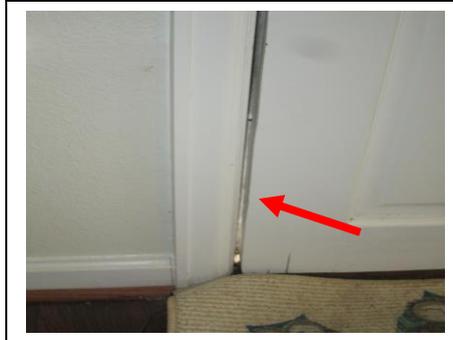
Inadequate Door Weather Stripping

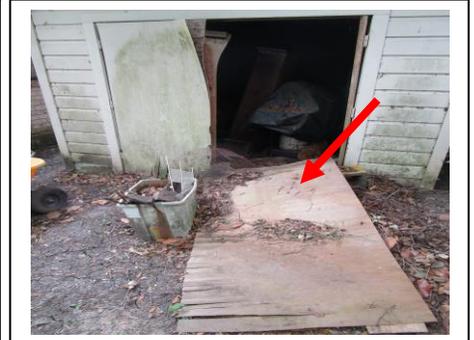
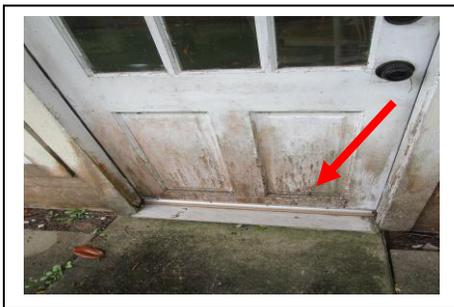
Damaged Door Panel

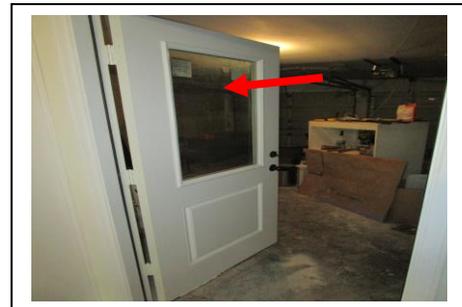
1. Garage door should either be 20-minute fire rated or a solid wood or honeycomb door not less than 1-3/8 inches thick with self closing hinges between the residence and attached garage. This is a **Life Safety** concern to prevent poisonous carbon monoxide gases and fire from spreading into the house.
2. Interior door leading to garage is installed backwards. Door should be installed so that hinges are not accessible from garage.
3. Exterior door and frame leading to rear yard is damaged.
4. Exterior door leading to rear yard does not have adequate weather stripping.
5. Missing door stops should be installed to prevent doors from damaging walls when opened.

Improper Garage Door

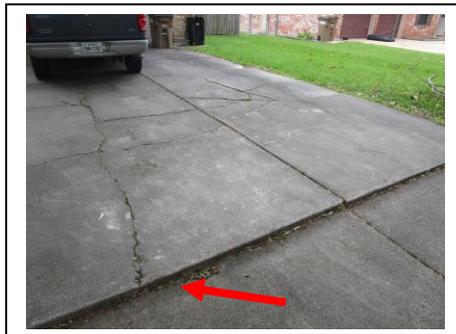
1. Sidewalks, driveway and garage slab had cracks.

Damaged Driveway Slab

Recommend having licensed contractor evaluate any item listed above and make appropriate repairs.

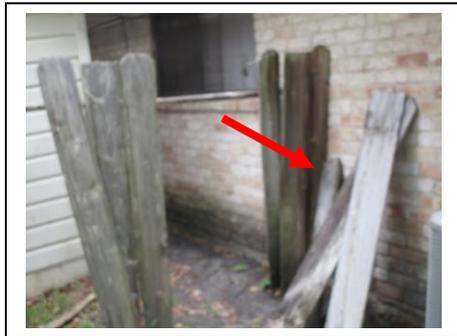
- 1. Wood fence is damaged at rear yard.**
 - 2. Wood fence gate lock did not latch properly.**
- Recommend having licensed contractor evaluate any item listed above and make appropriate repairs.**

Wood Fence Damage

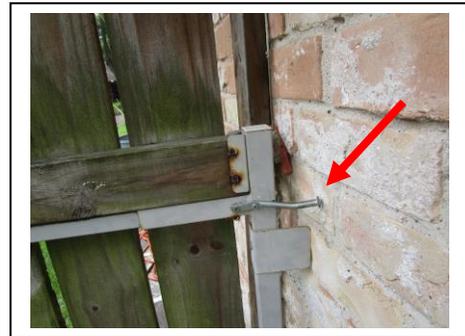
Inoperable Gate Lock

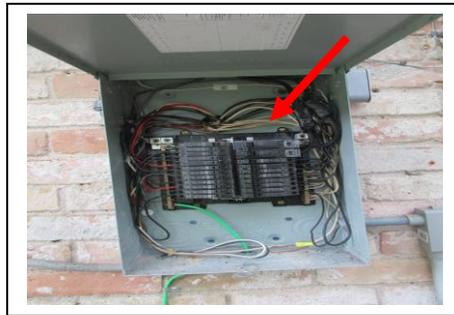
Electrical Service Panel

- 1. General Electric apparent 125 amp electrical service panel.**
- 2. Panel 30 amp breaker for exterior condensing unit should be replaced with the maximum 40 amp rated breaker for maximum operating efficiency.**
- 3. Arc-fault circuit interrupting (AFCI) breakers should be installed to protect circuits at family rooms, dining rooms, living rooms, parlors, libraries, dens, bedrooms, sunrooms, recreations rooms, closets, hallways, laundry rooms, or similar rooms or areas. AFCIs are breakers designed to protect against fires caused by arcing faults in the wiring of the property. Arcing**

4. Wires inside panel are connected with wire nuts. Wires entering panel should connect directly to breakers or bus bar when possible.

Recommend having licensed electrician further evaluate any item listed above and make appropriate repairs.

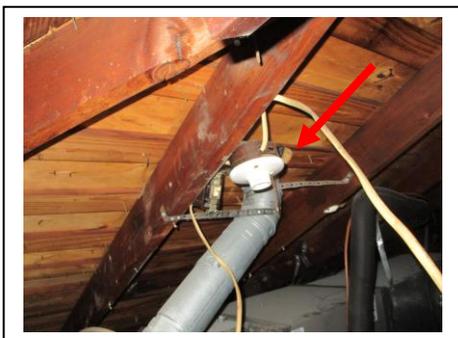
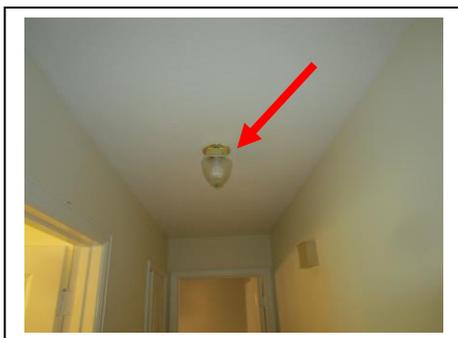
Inoperable Light Fixture

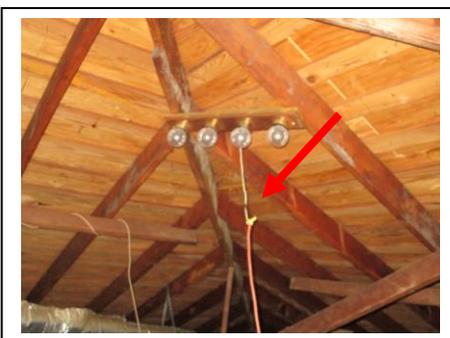
Improper Electrical Wiring

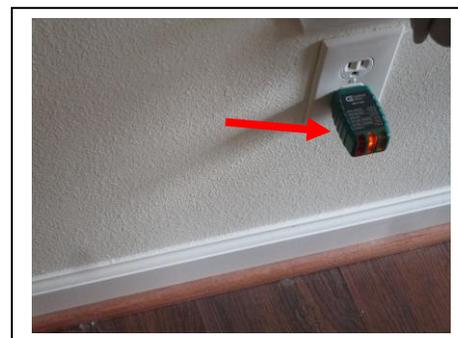
1. Multiple receptacles have open grounds or neutral wiring.
2. Garage receptacle wall box is not properly secured inside wall.
3. Light switch is required at entrance to attic equipment space.
4. Exposed attic wiring should be properly secured inside of electrical junction box.
5. Hallway and attic ceiling lights did not operate. This condition could be the result of a burned out light bulb, and/or damaged fixture or light switch.
6. Exposed exterior wiring at light fixtures should be enclosed in the

Improper Receptacle Wiring

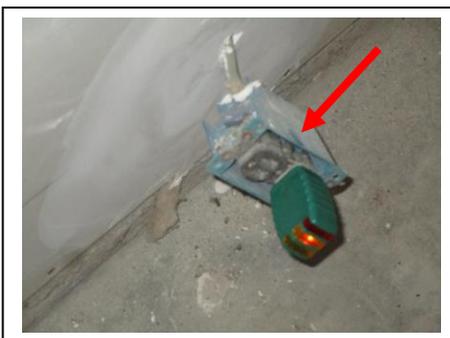
Improper Receptacle Location

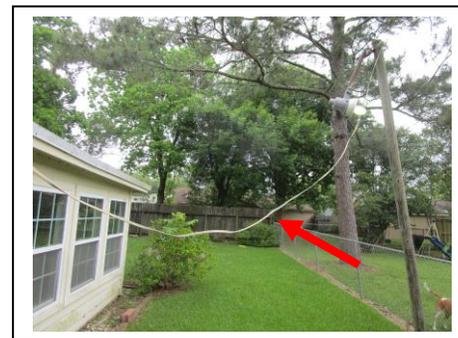
- proper pipe material.
7. Smoke alarms should be installed at each sleeping room, outside each separate sleeping area and in the immediate vicinity of the sleeping rooms and utility rooms.
 8. Carbon monoxide (CO) detectors should be installed in homes with fuel-fired appliances in areas where fuel-fired equipment is located and on each floor level.
 9. Some receptacles were inaccessible due to furniture and were not inspected.
- Recommend having licensed electrician further evaluate any item listed above and make appropriate repairs.**

Exposed Electrical Wiring

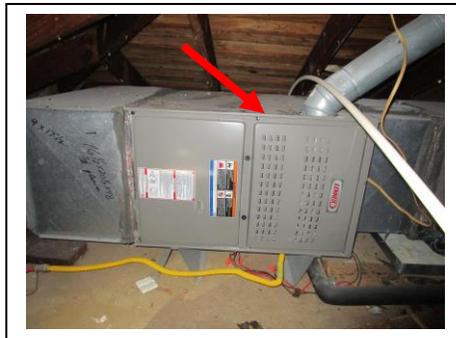
- 1. Furnace gas piping does not have sediment trap installed. A sediment trap should be installed as close to the inlet of the equipment as practical, downstream of the shut off valve and ahead of the control valve to catch any foreign material that may be in the gas before the gas enters the furnace.**

Recommend having licensed heating and air conditioning specialist further evaluate heating and air conditioning system.

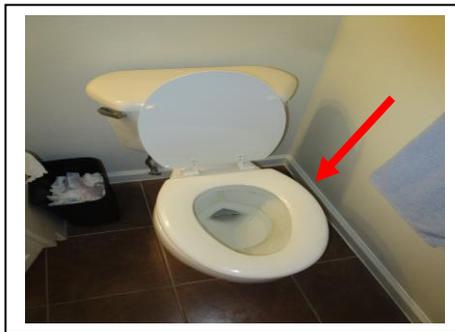
- 1. Master Bathroom toilet did not operate properly when flushed. Recommend having licensed plumber evaluate any item listed above and make appropriate repairs.**

Inoperable Toilet

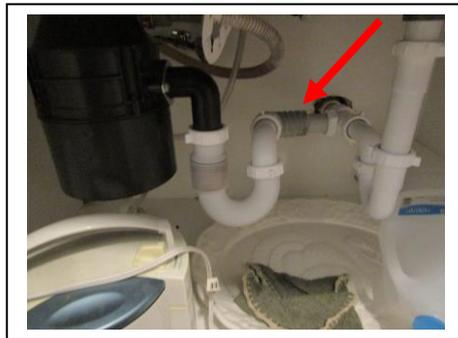
Improper Drain Pipe Installation

Recommend having licensed plumber evaluate any item listed above and make appropriate repairs.

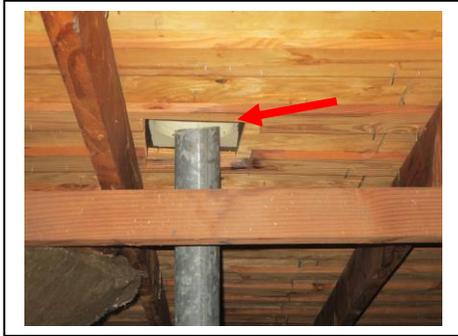
Improper Exhaust Duct Installation

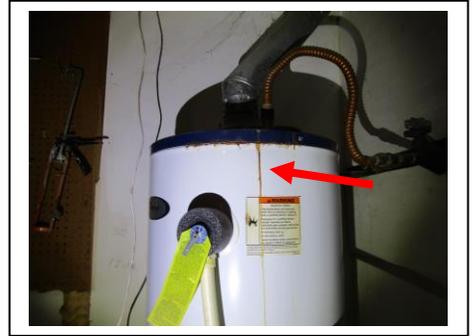
- enters the water heater.
 - 3. Water tank is rusted and shows signs of leaking.
 - 4. Water lines are not properly bonded near water heater as required by recent electrical code.
- Recommend having licensed plumber evaluate any item listed above and make appropriate repairs.**

Rust At Water Heater Tank

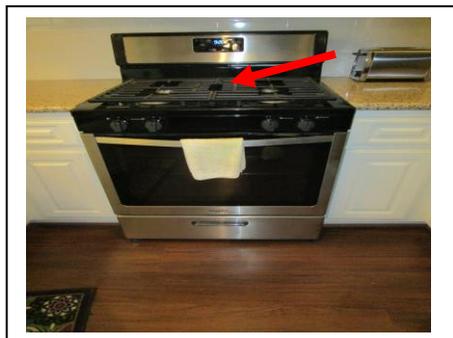
Range

1. Whirlpool gas range is missing recommended anti-tip bracket on back side of oven.

Recommend having licensed appliance specialist further evaluate this condition.

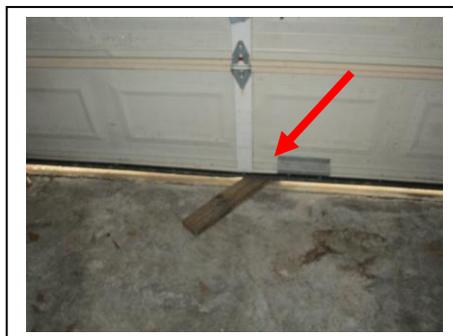
- 1. Garage door did not reverse when coming in contact with obstruction that prevented it from completely closing.**
- 2. Operator should not be connected to receptacle with extension cord.**

Inoperable Garage Door Operator

Recommend having licensed contractor further evaluate this condition.
