Baker Real Estate Inspections

Property Inspection Report
Exclusively Prepared For
Theresa Nguyen

2606 Silent Springs Creek Dr.
Katy, TX 77450

PROPERTY INSPECTION REPORT

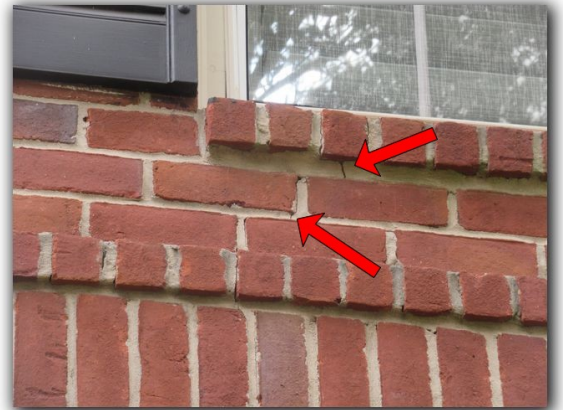
Movement: Brick Veneer Cracks

Brick veneer cracks were observed on the exterior walls of the house. This implies that structural movement of the building has occurred.

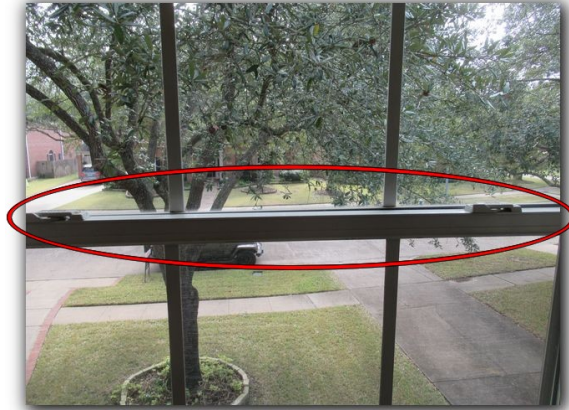
A window frame was found to be out-of square in the southwest bedroom . This implies that some structural movement of the building has occurred. As a result one of the window locks will not lock.

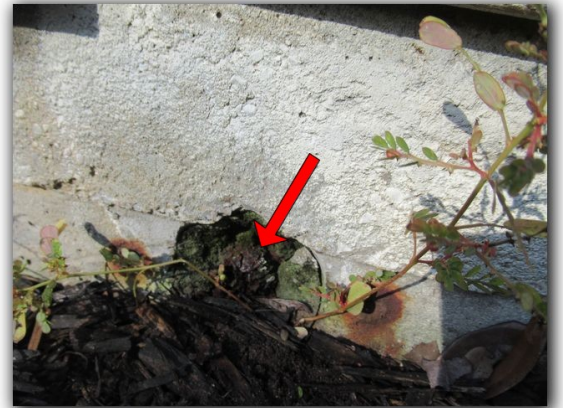
Cable Ends Visible

Post tension cable ends were observed on the exterior of the foundation. This should be repaired to prevent corrosion. All exposed steel cable ends should be properly covered to avoid corrosion of the exposed steel. Recommend repair before more extensive repairs become necessary.

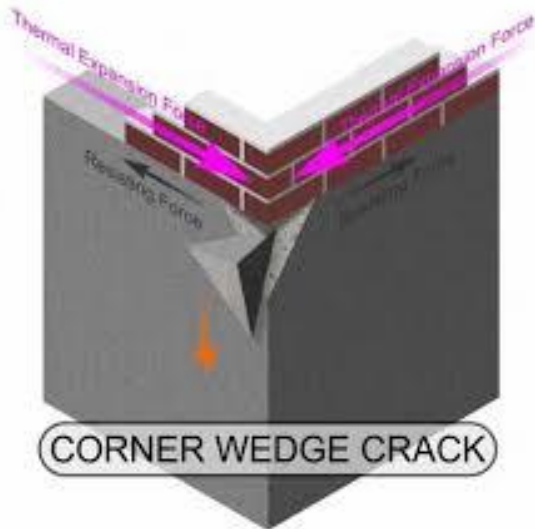
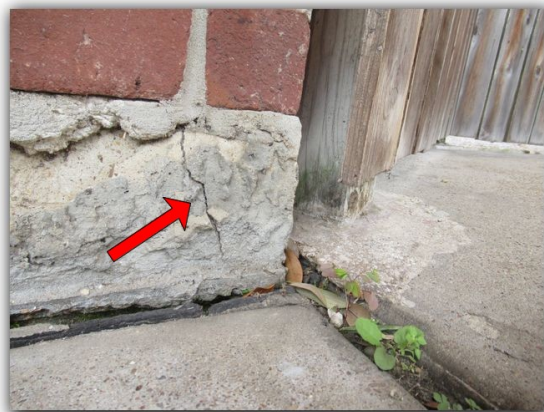
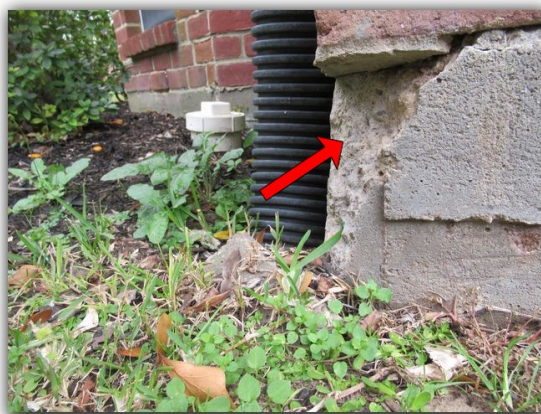
Corner Wedge Cracks

Corner wedge cracks were observed at the corner(s) of the foundation. It is the opinion of the inspector that the foundation beams are currently performing as intended. This appears to be cosmetic in nature and not structurally significant. The bricks on the brick ledge in this area appear to be unaffected.

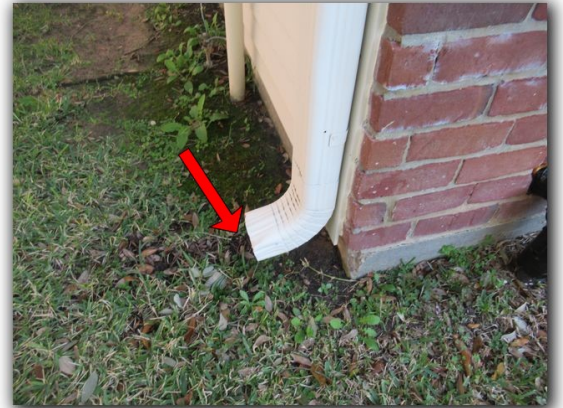
Downspout Discharge Near Foundation

The downspout(s) should discharge water at least five (5) feet from the foundation. Corrections to discharge the water away from the foundation should be made for proper foundation maintenance.

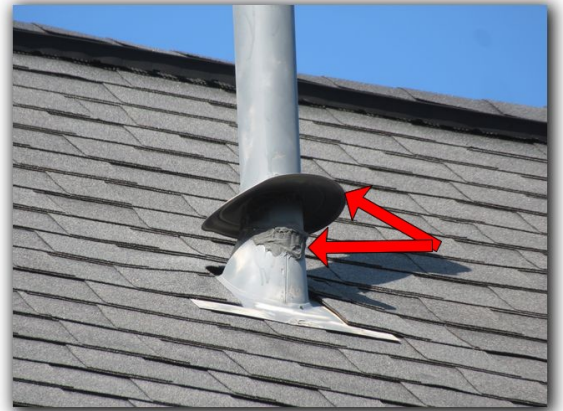
Two roof level flue storm collars are not properly installed and/or positioned over the roof jack. The storm collar needs to be properly positioned over the roof jack and sealed to prevent water intrusion into the structure.

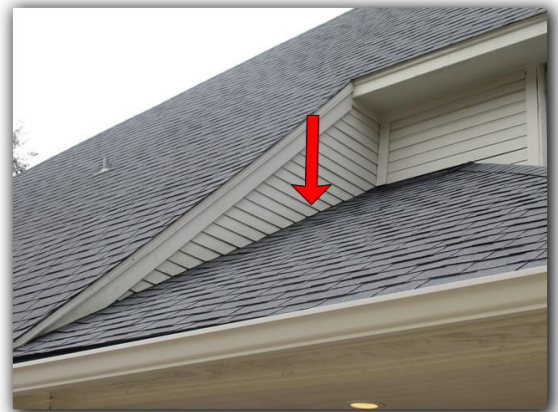
The clearance of the siding at the flashing is insufficient at least one to two inches of clearance should be provided. This condition leaves the siding vulnerable to rot as moisture and debris can become trapped between the flashing and the siding.

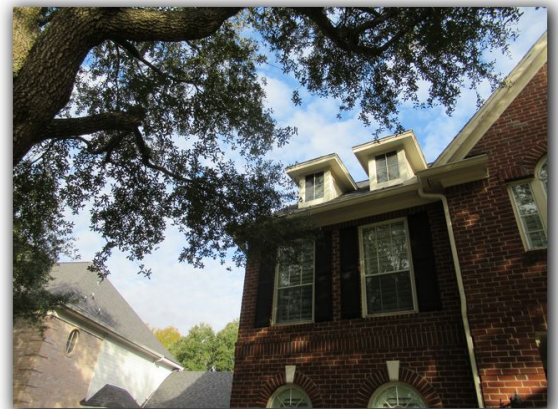
Trees in Contact

Trees in contact with roofing material should be trimmed back a minimum of six feet to avoid contact during winds. Tree limbs rubbing roofing material during winds can do extensive damage to the roofing material in a short period of time.

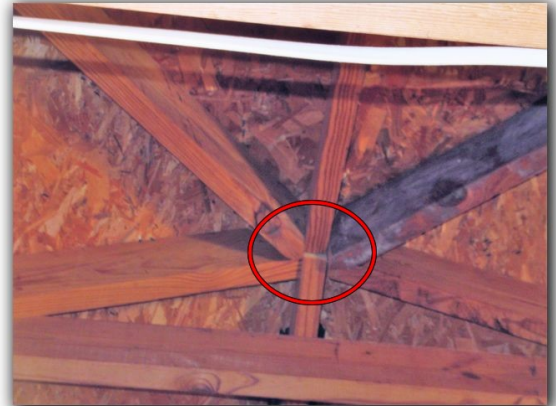
There is a lack of a palm brace to provide vertical support at the intersections of the hip rafters to the main ridge board in the garage and house. A palm brace in this location provides a load path to the foundation as required from the main ridge and attached hip rafters.

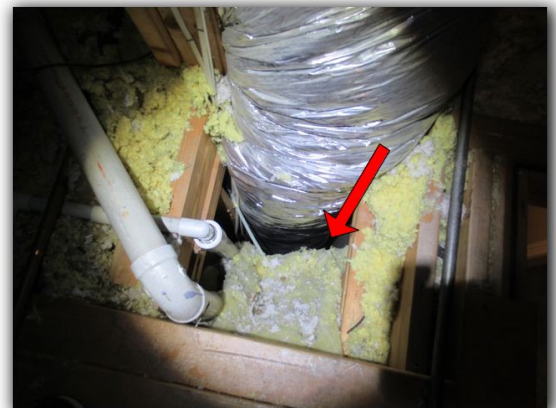
Lack of Fire Blocking

An open chase extends through the attic space with no fire blocking. Recommend sealing/fire stopping all open chases in attic down to the living area.

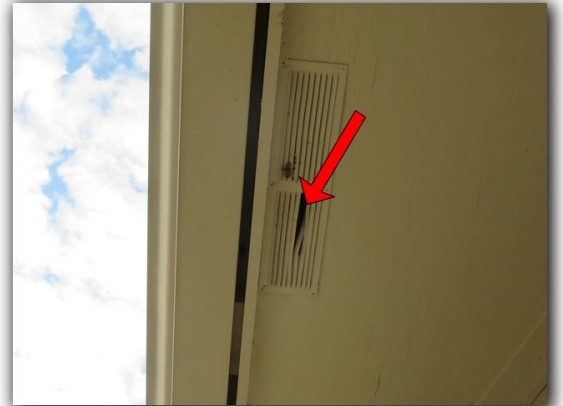
Damaged Louvers on Vents

Damaged louvers on vents should be repaired to prevent insect and vermin entry.

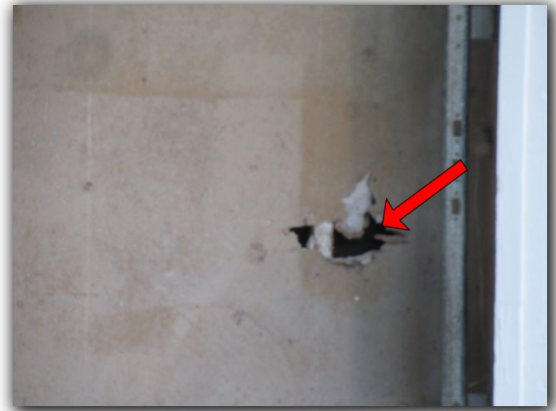
Damage Noted

Damage was noted to the interior finish was observed in the following listed locations.
garage
at master bedroom window

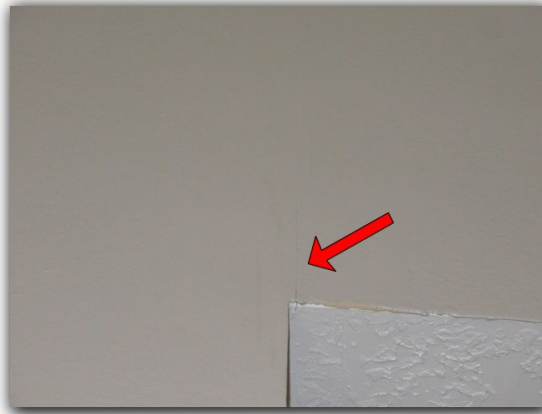
Movement: Interior Wall Cracks

A drywall crack was noted on the north wall of the southeast bedroom. This implies that some structural movement of the building has occurred.

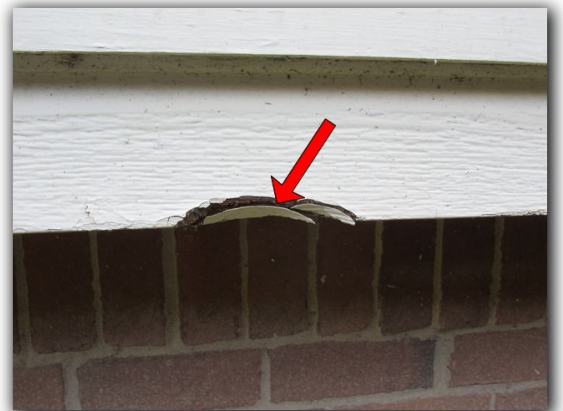
The siding on the house is hardbaord/composite type of material. The siding is known for premature failure. Decayed material was noted on the north and the east sides of te house. This material requires a great deal of maintenance to prolong it's life, it is necessary to maintain complete sealing of all penetrations and joints as well as solid paint coverage on the face and edging paying close attention to all bottom rows of material above the ground and roof surface. Replacement maybe necessary in te near future.

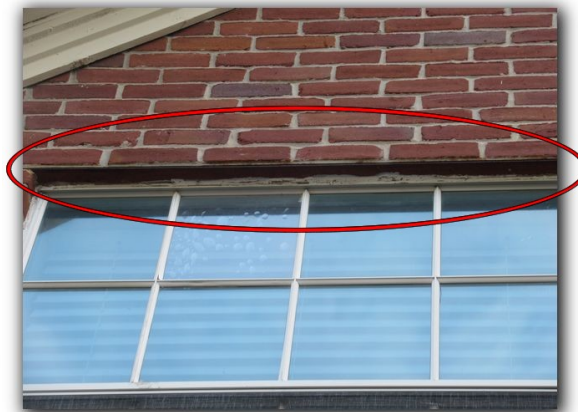
Lintels: Lack of Flashing

There does not appear to be any required flashing above the lintels as required for proper drainage. This can result in deterioration of the lintels as moisture comes in contact with the metal lintel.

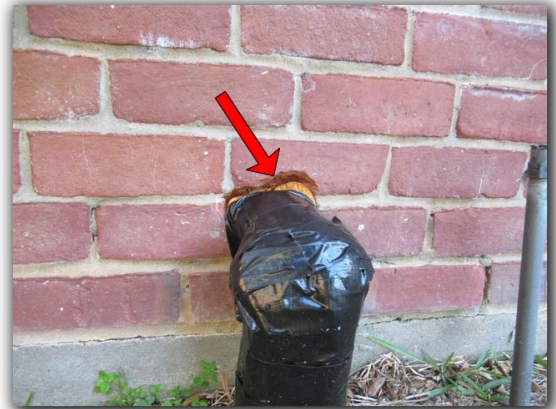
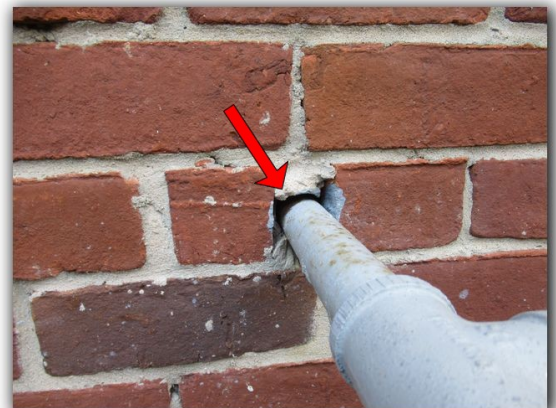
Deteriorated Sealant/Caulk: Various Locations

All deteriorated sealant/caulk should be replaced around windows, doors, vents, wall penetrations, exterior lights, ect.

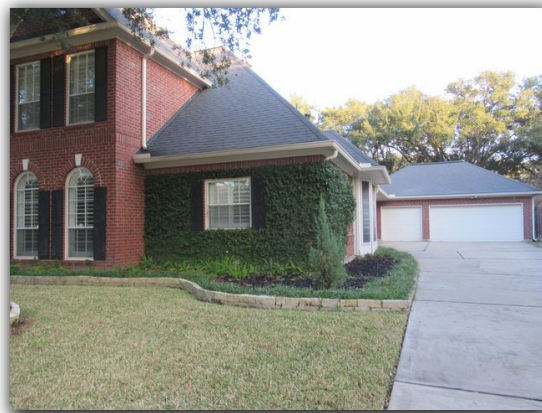
Vines on Exterior Walls

Vines growing on brick veneer should be removed as the vines attach themselves to the brick veneer and cause significant damage to brick mortar.

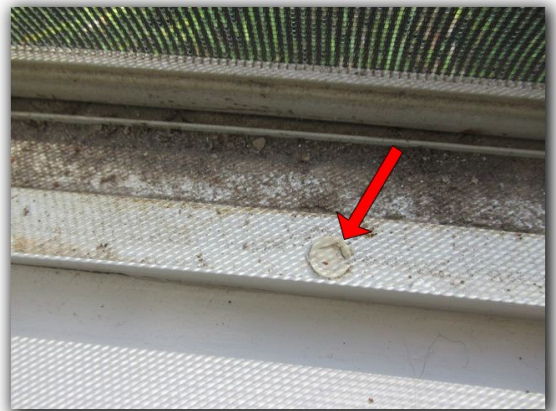
Penetration of Window Weeping System

The installation of the alarm contacts penetrates the windows weeping system. This can result in the entry of water into the wall cavity if the contacts are not sealed or the sealant fails. While most contacts are sealed some of the seals have failed and should be re-sealed. The drilling of the weeping system of the window system also voids most manufacture warranties.

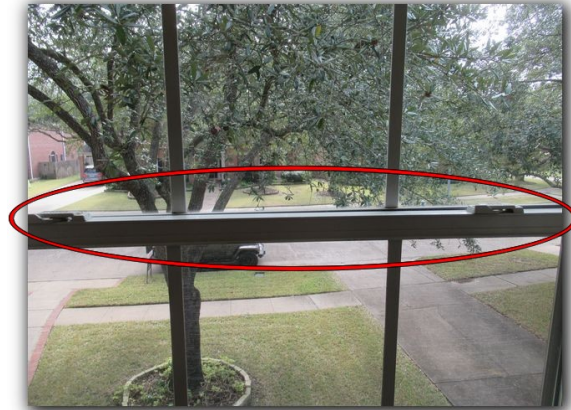
A window frame was found to be out-of square in the southwest bedroom . This implies that some structural movement of the building has occurred. As a result one of the window locks will not lock.

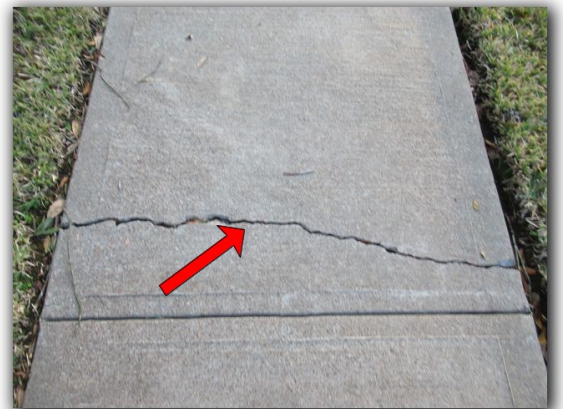
Larger than typical cracks and/or deficiencies were observed in the sidewalk.

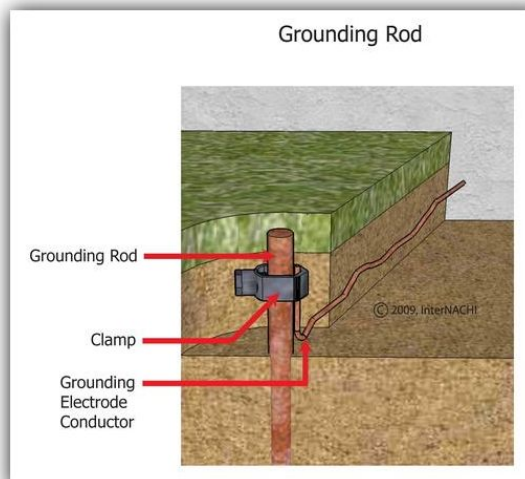
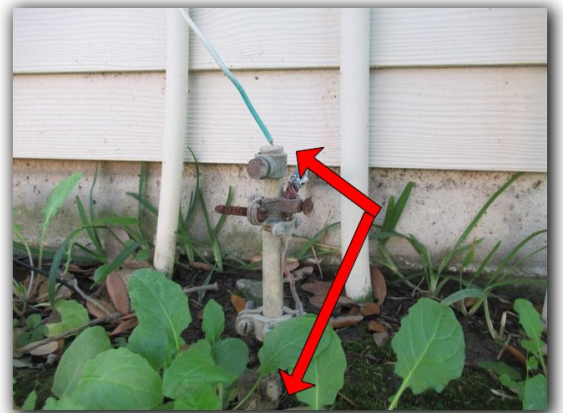
The ground rod is insufficiently driven in the ground. The rod length is 8 feet and must be driven fully in the ground to meet the requirement of 8 feet in full contact with earth. Improvements should be undertaken.

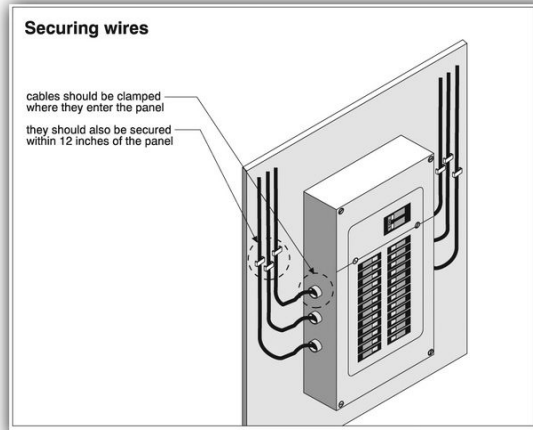
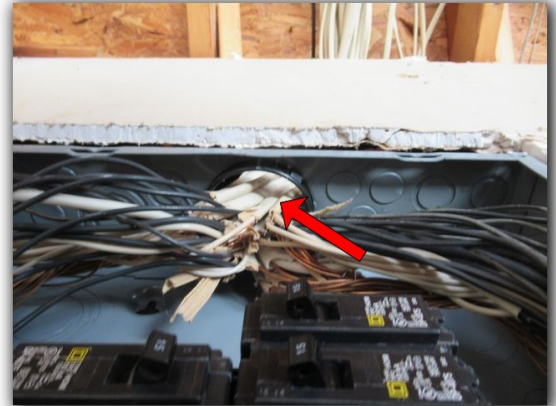
clamp or connector; unless the clamp or connector is identified for more than a single cable.

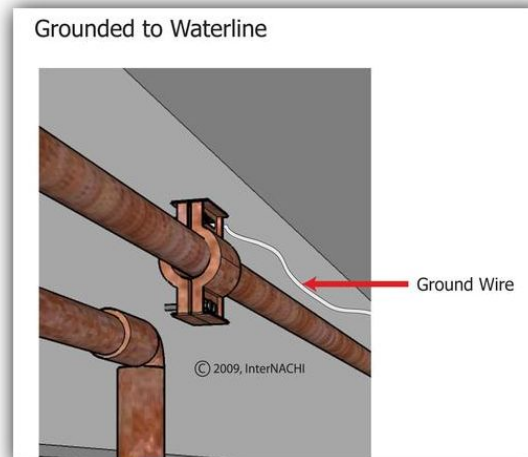
No Visible Bond To Metal Water Pipe

I was unable to locate the electrical bond connection for the metal water piping to the grounding electrode system. All bond connections should be accessible for inspection, repair, or replacement. This condition should be further investigated and corrected if necessary.

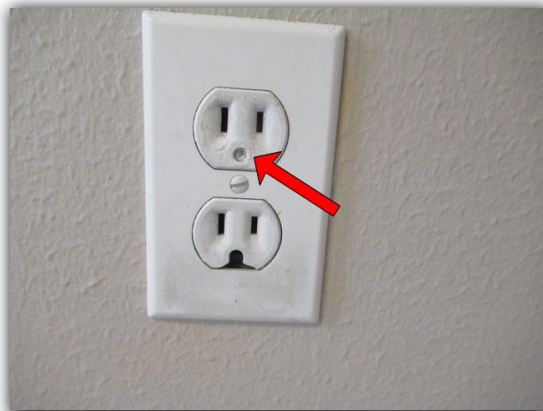
The following listed receptacle(s) were observed to be damaged. All damaged receptacles be replaced for personal and fire safety.
southwest bedroom (ground slot blocked)

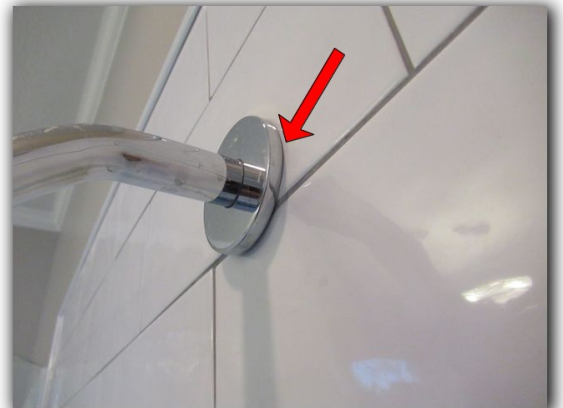
The master bath shower fixtures are not sealed to the shower surround tile. It is recommended these fixtures be sealed to the shower surround/tile to avoid water intrusion into the wall cavity.

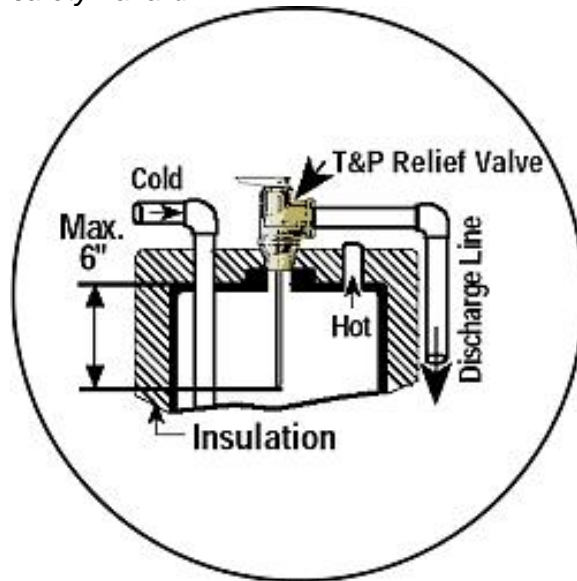
The Temperature and Pressure Relief (TPR) Valve serving the hot water heater is inoperative. *Corrections should be undertaken as soon as possible as this is a life safety hazard.*

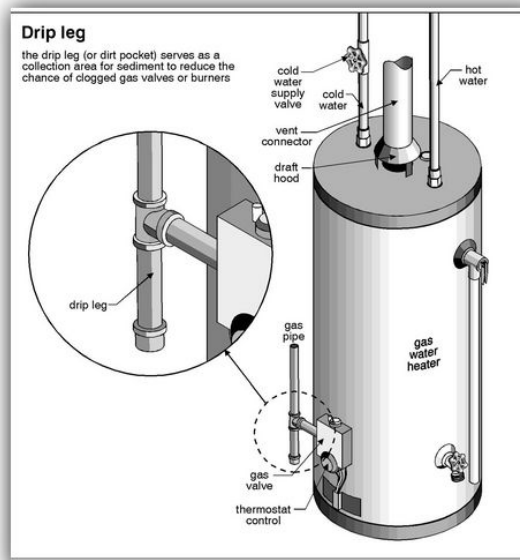
There was no sediment trap found on the gas line servicing the water heating equipment. The trap is intended to catch foreign material before it gets into gas valves, burners, etc. Implications include equipment malfunction because of foreign material entering the equipment. There is also a safety issue, as foreign material could block a valve, preventing it from closing completely.

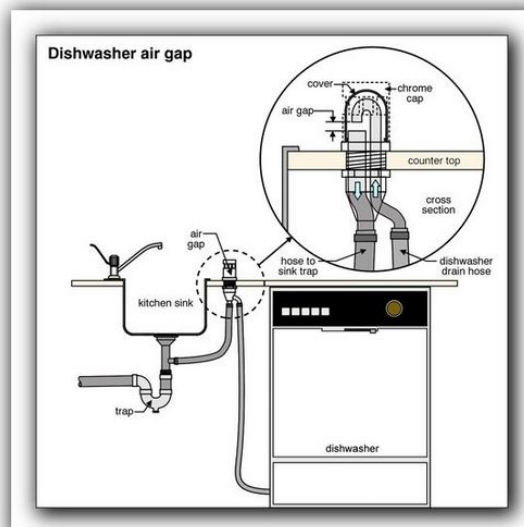
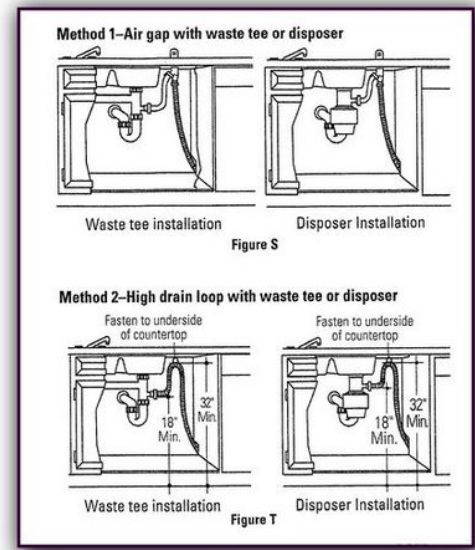
Improperly Installed Drain Line

The dishwasher drain hose is not properly installed to prevent back flow or anti-siphoning. It is recommended that an air gap device or high drain loop be installed in the drain line.

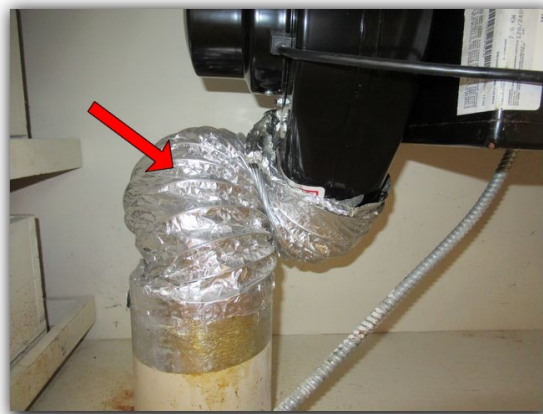
The material used for the range hood venting is improper. Corrections should be undertaken as this creates a *fire hazard* by trapping grease in the corrugations of the pipe.

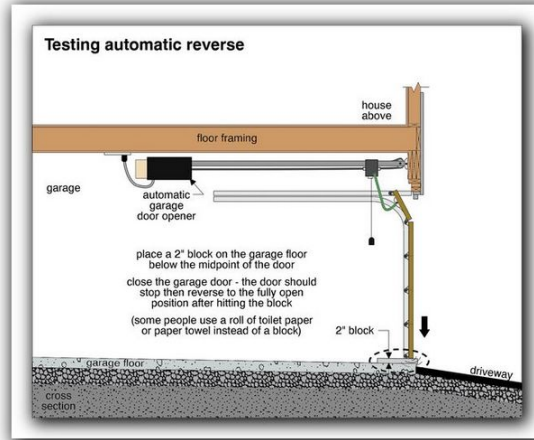
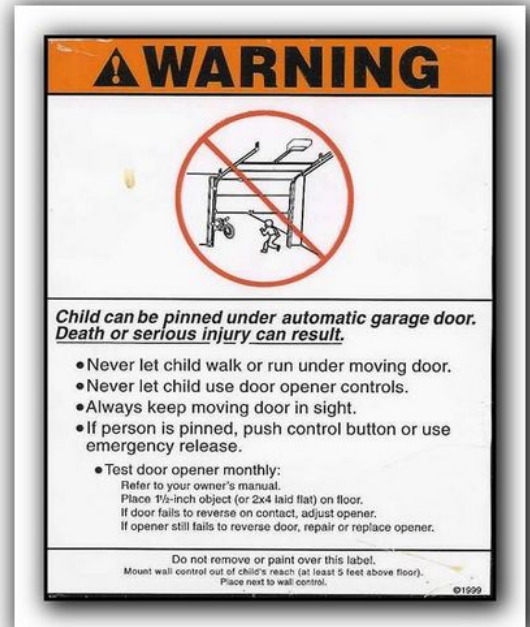
Improvement may be as simple as adjusting the sensitivity control on the opener. This should be repaired immediately for safety.
