RESIDENTIAL INSPECTION REPORT

5947 Mockingbird Ln Sealy, TX 77474

By: Gonzales Dowdell - TREC #23532 06/19/2020 3:00 pm

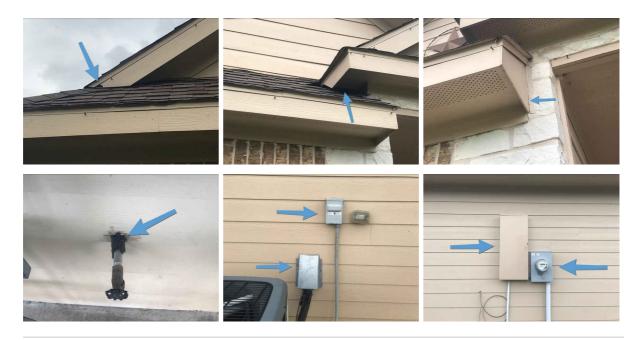
1: Exterior: Seal Wall Fixtures

All Exterior Wall Penetrations, A/C Disconnect Box(es), A/C return lines, Trim boards, Electrical Distribution Panel(s), Service Panel(s) -

Fixtures/Electrical boxes were not properly sealed. Remedy as needed.

Note: Modern building practices recommend sealing around components that are mounted on or pass through the exterior wall to limit moisture intrusion.

Recommendation: Recommended DIY Project
