PROPERTY INSPECTION REPORT FORM

| 3300 Pebblebrook Drive 23, Seabrook, TX 77586 <i>Address of Inspected Property</i> | |

Home Inspection Report

DATE OF INSPECTION: 07/20/2022
Inspection No. 521097-919

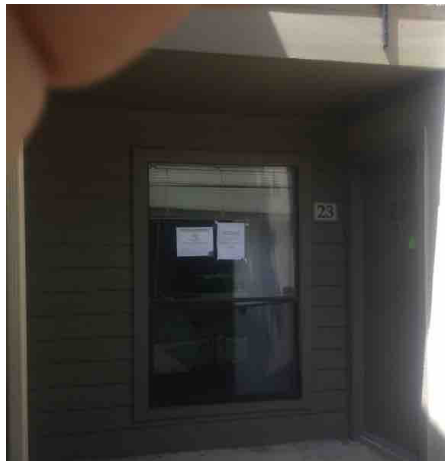
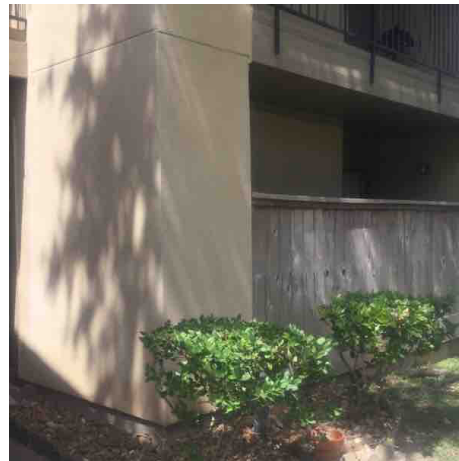
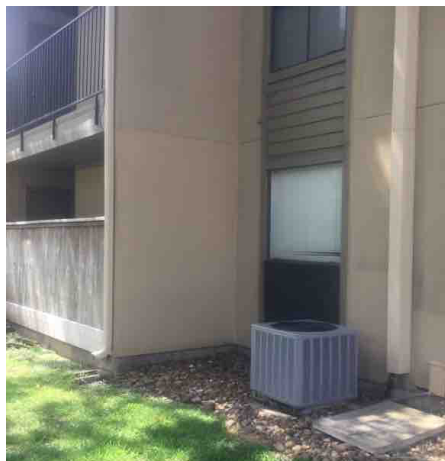
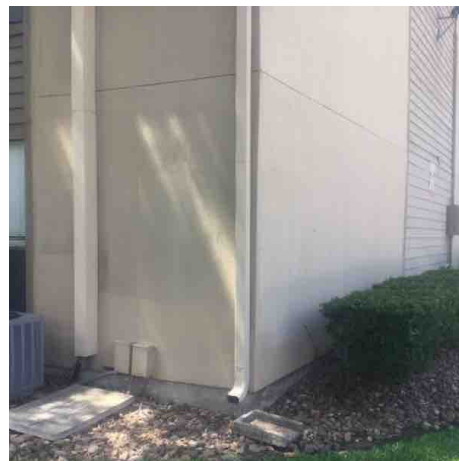
- EXTERIOR WALLS
- The exterior wall finish was stucco with wood board siding and trim.
The wall structure was conventional wood framing.
No structural deficiencies were observed.

The exterior wall structure was part of a larger building.

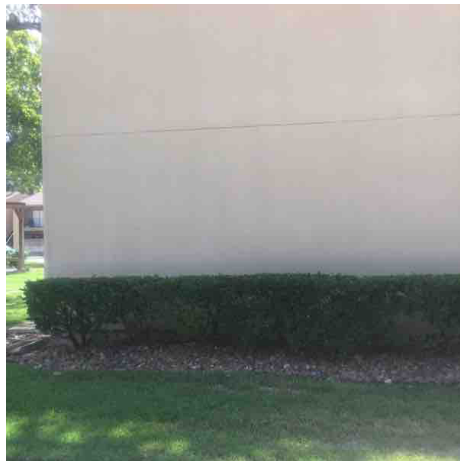
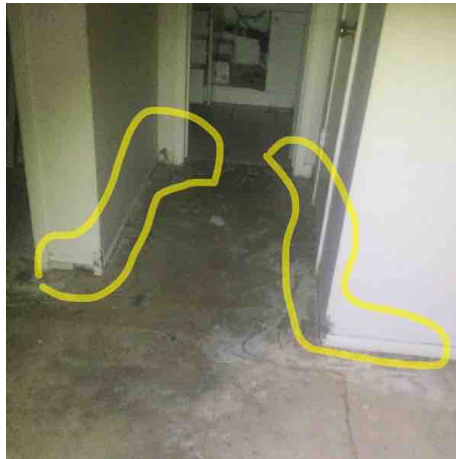
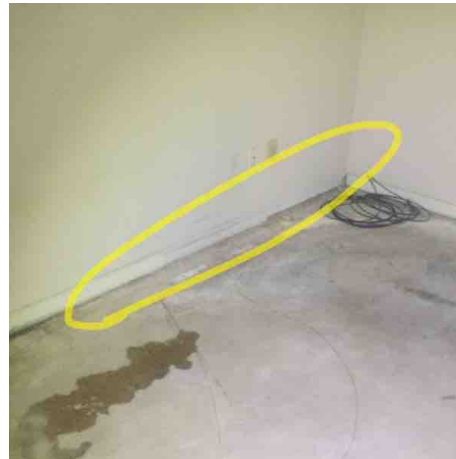
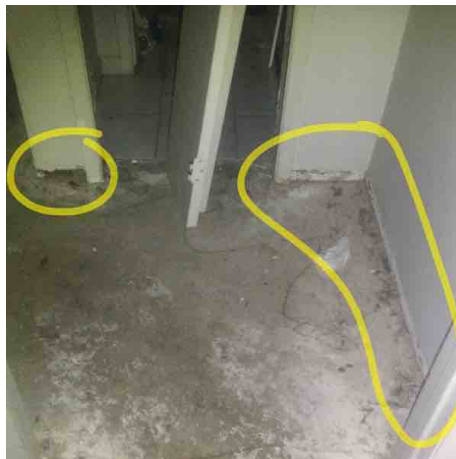
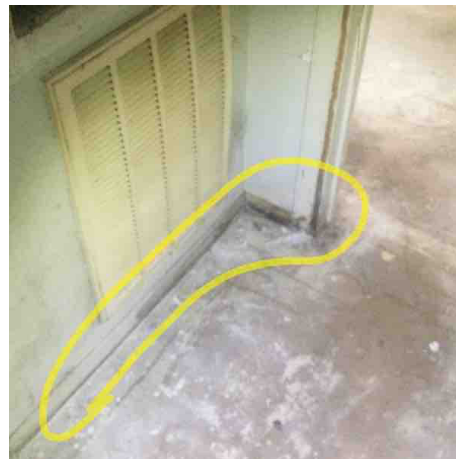
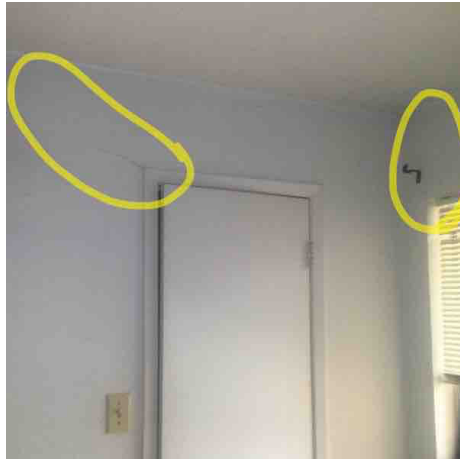
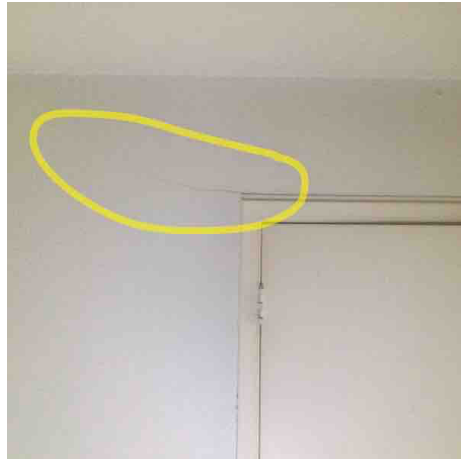
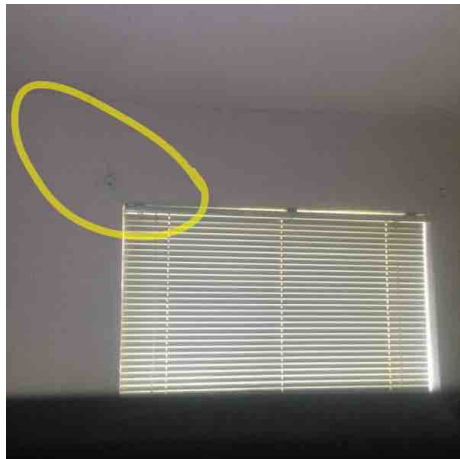
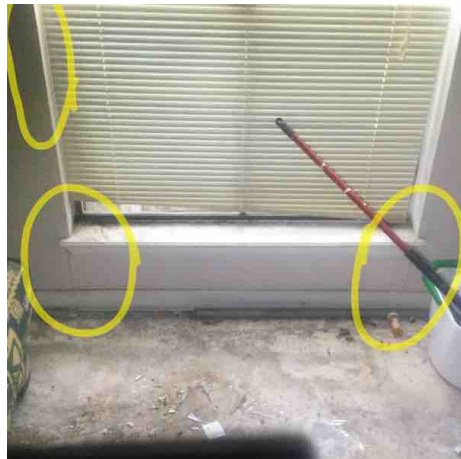
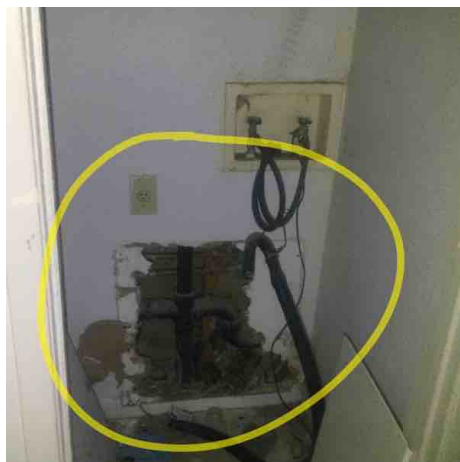
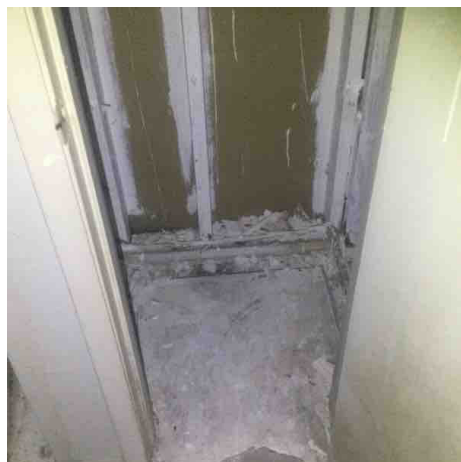
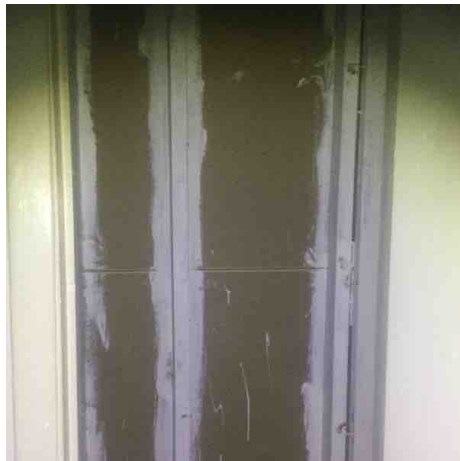
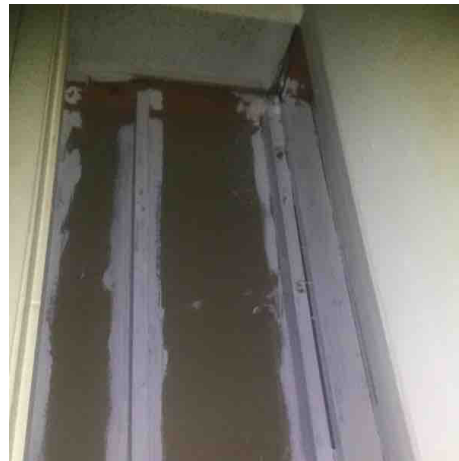
• INTERIOR WALLS

Observed missing and damaged base boards at various areas.

Observed hairline cracks at the left bedroom walls.

Observed missing and damaged gypsum wall board at the laundry room and hall closet.

Repairs and corrections are required and advised.

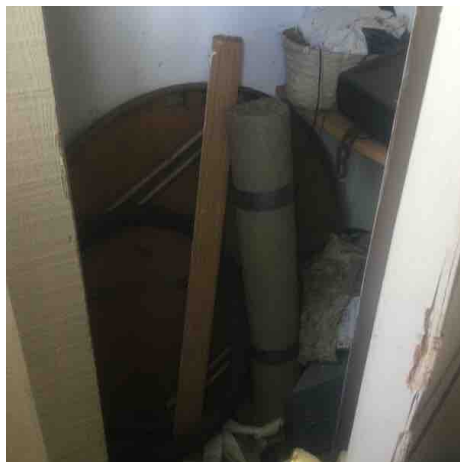
• **Observed outside closet full of debris.
In need of cleaning out.**

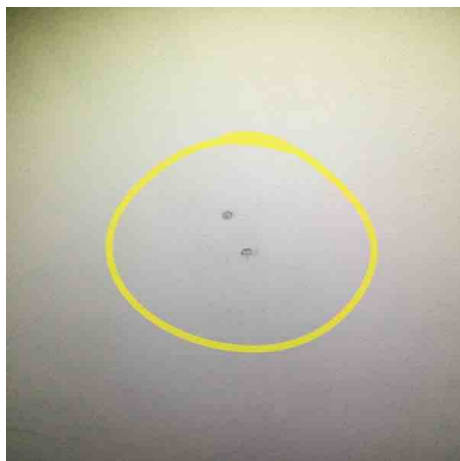
• **CEILINGS**

**Observed small hole at bedroom on right side.
Repairs and corrections are required and advised.**

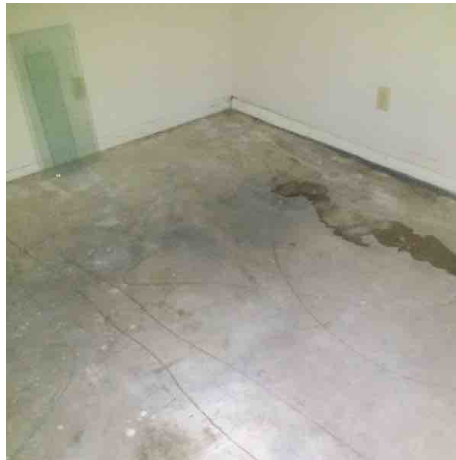
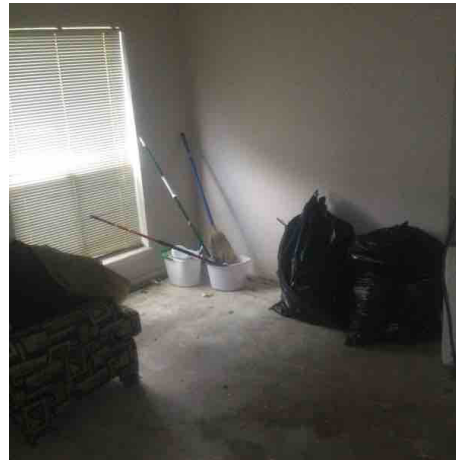
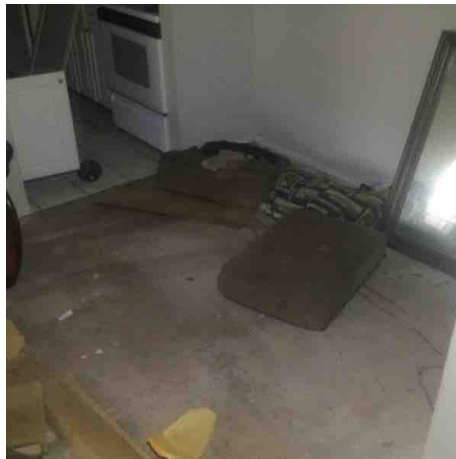
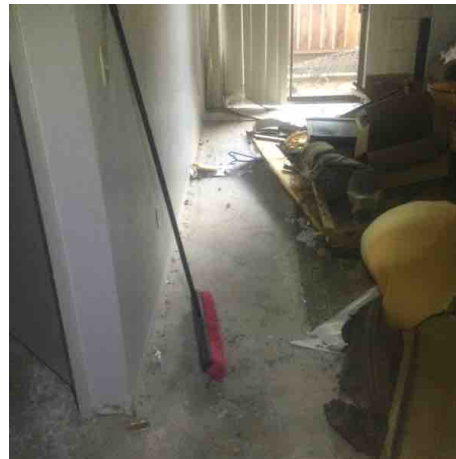
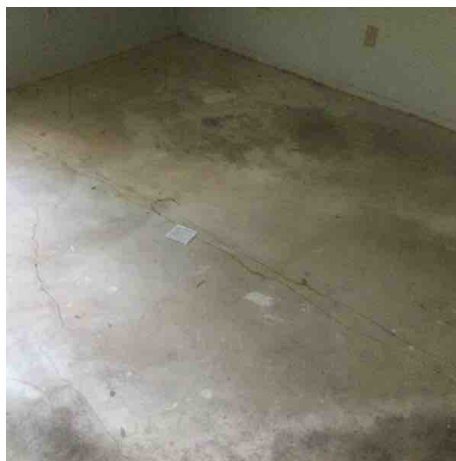
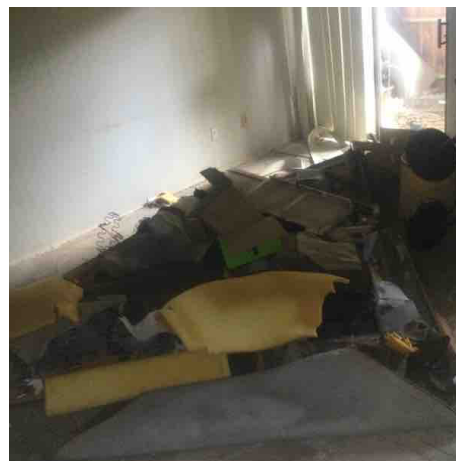
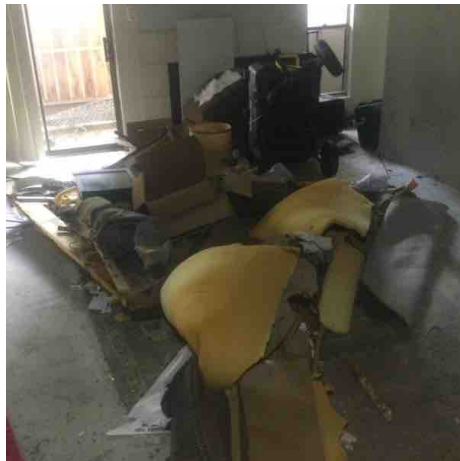
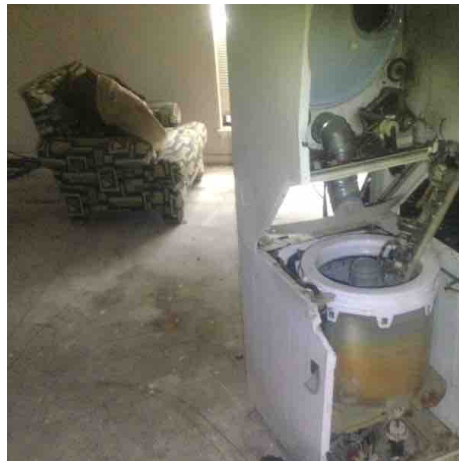
• FLOORS

Observed missing floor covering throughout home.

Observed debris, furniture and trash along floors at various areas.

Repairs, corrections and cleaning is required and advised.

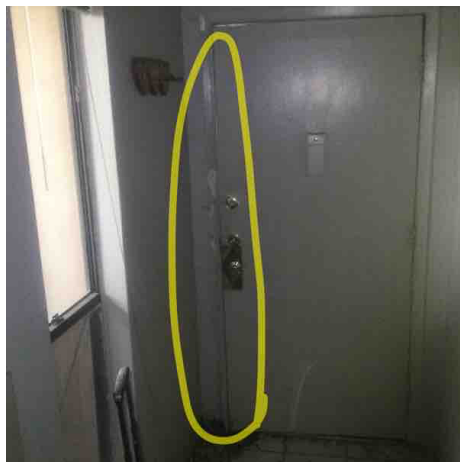
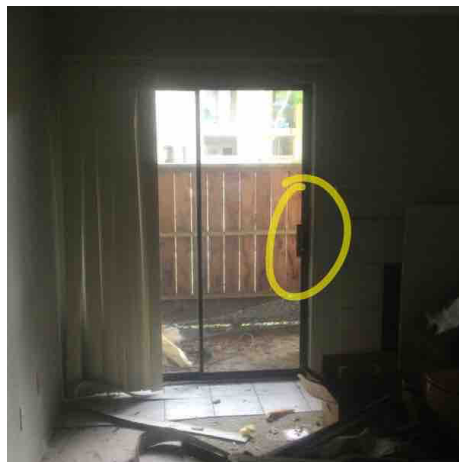
• **EXTERIOR DOORS**

Observed damaged door casing around front entry door.

The door was also sticking and hard to operate.

The glass patio door lock was inoperable.

The screen door was missing at patio door.

Repairs and corrections are required and advised.

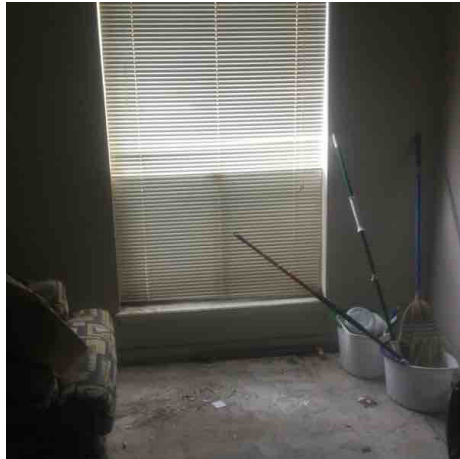
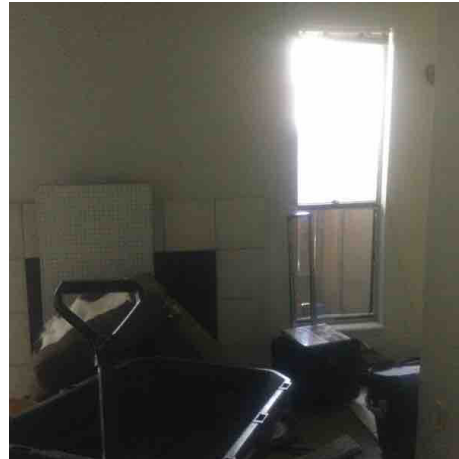
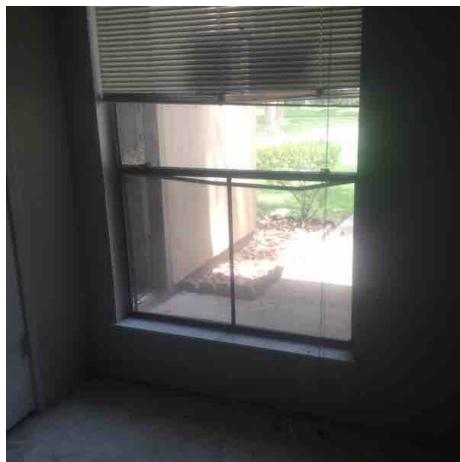
- The windows were single pane glass units.
 - Observed damaged window next to chimney
 - Observed missing screen at left bedroom.
 - Observed loose and weak spring supports at the right side bedroom window.
- Repairs and corrections are recommended and advised.

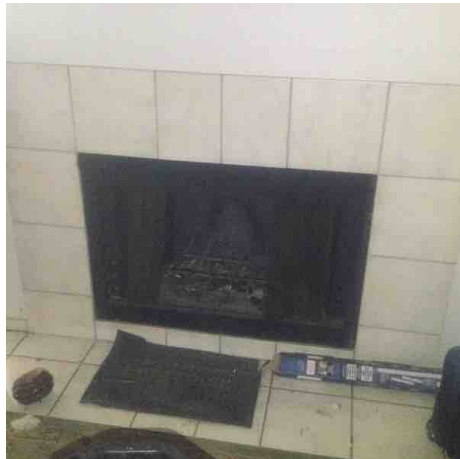
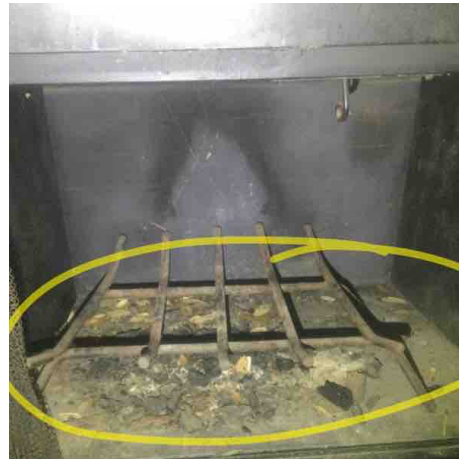
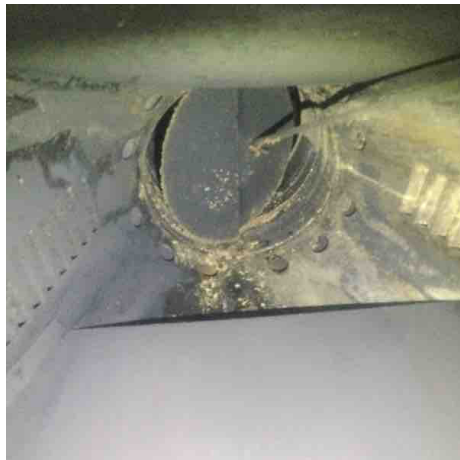
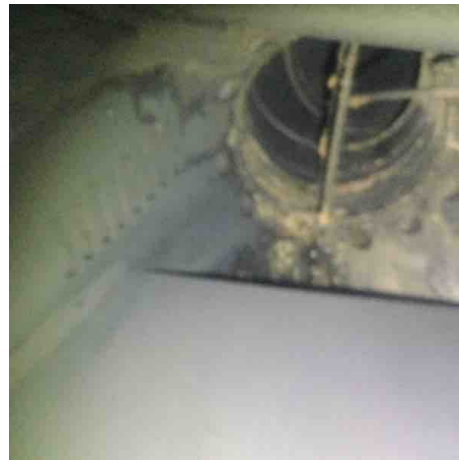
- The home was equipped with a wood burning fireplace. The spark screen was functioning as designed. The fire box appeared to be in satisfactory condition. Hearth extension was adequate.

In need of cleaning and service checkup by a qualified chimney sweep specialist.

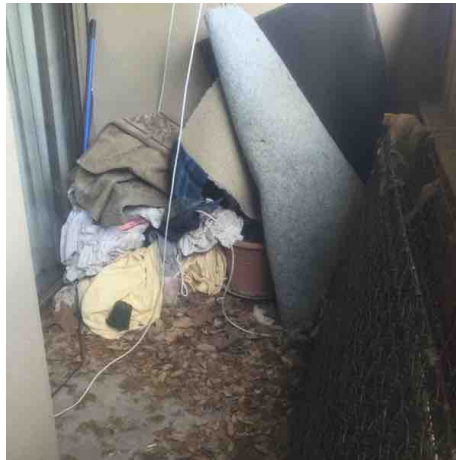
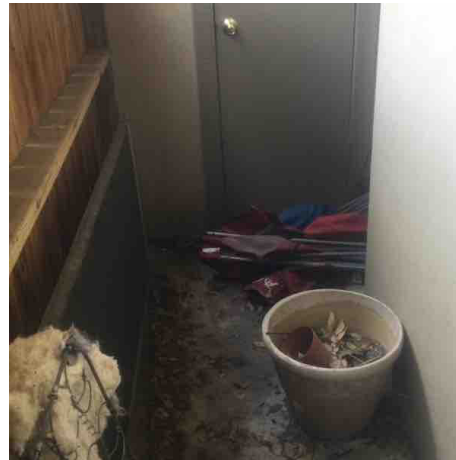
• PATIO

**Observed stored debris and trash along the patio area.
Corrections and cleaning are required and advised.**

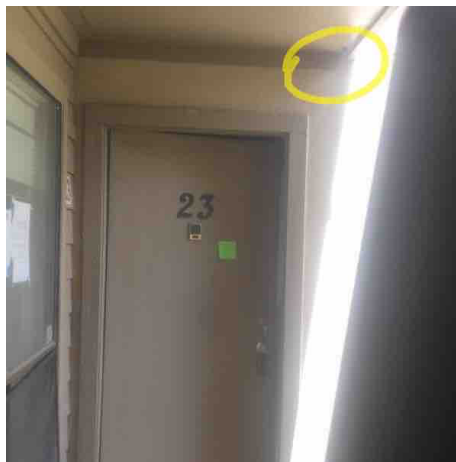
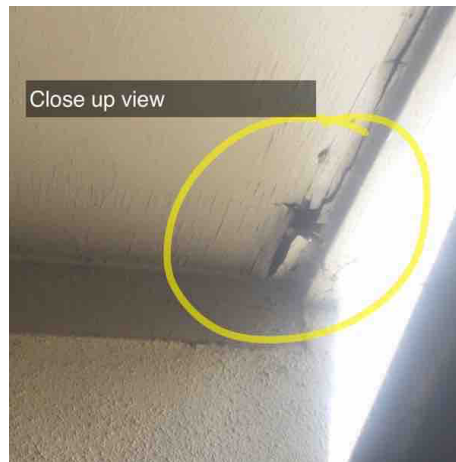
• FRONT ENTRY COVERING

**Observed damaged porch covering structure from upstairs unit at the entry door area.
Repairs and corrections are recommended and advised by a qualified contractor specialist.**

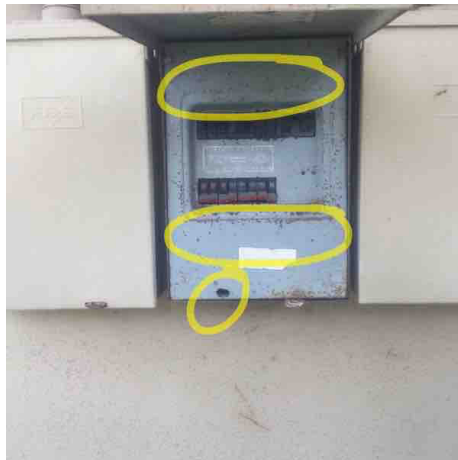
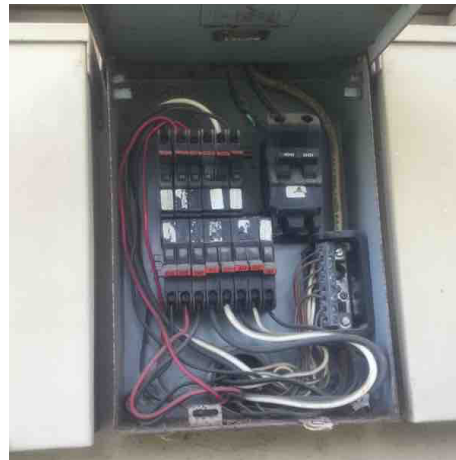
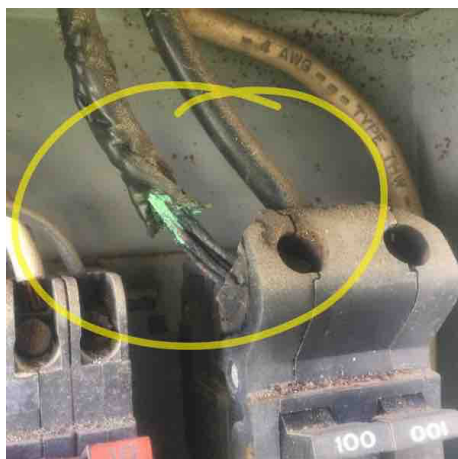
**• MAIN BREAKER PANEL
NAME: FEDERAL PACIFIC
LOCATION : EXTERIOR**

At the time of the inspection the breaker distribution box was located but deficiencies were observed including the following.

The panel was a FEDERAL PACIFIC panel which are no longer allowed due to fire hazards.

The 6 awg. copper grounding conductor to connected to the grounding rod could not be verified.

Panel board dead front cover was not labeled properly to identify each breaker slot as required.

Observed missing Anti-oxidant along the main lug terminals.

Observed over exposed conductor at the main electrical supply line.

Arc fault protection breakers were not observed at the required locations.

Observed missing screws at the dead front cover plate.

Repairs and corrections are required by a licensed electrician.

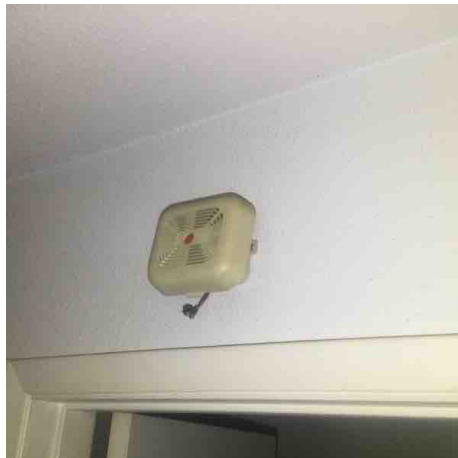
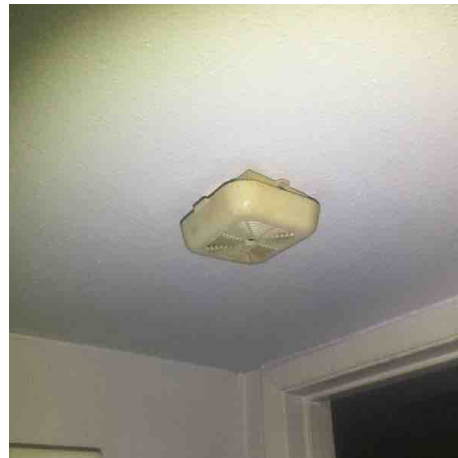
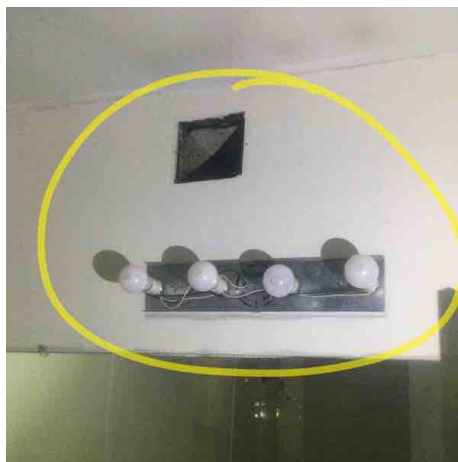
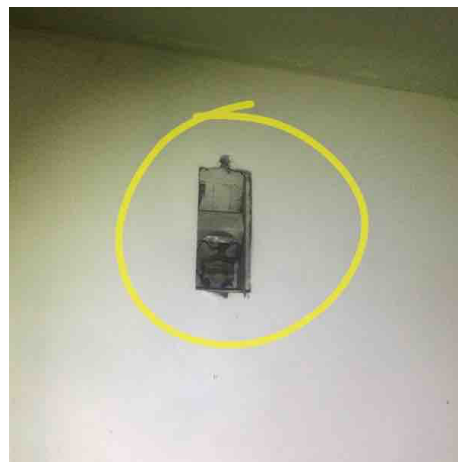
At the time if the inspection the electrical utility was not connected and so the branch circuits could not be properly inspected or tested.

Observed missing light fixture globe at the hall area.

Observed missing cover at lighting fixture in left bathroom .

Observed missing covers at the bathroom exhaust vents.

Observed missing and smoker detectors older than 10 years .

(As per manufacturer, Any detector ten years or older is required to be replaced heater they are functioning or not.)

Smoke detectors are required in every bedroom and hall areas.

Further evaluation, Repairs and corrections are required and advised by a licensed electrician.

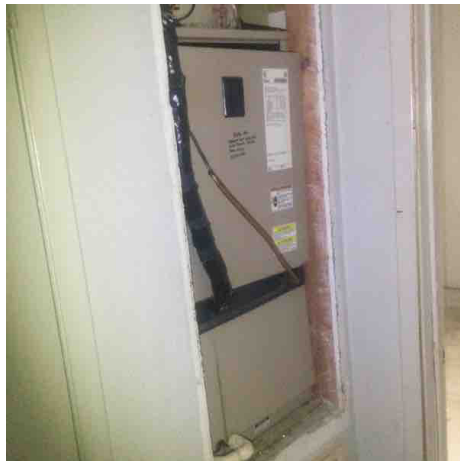
- At the time of the inspection the electrical utility was not connected and so the heating equipment could not be properly inspected or tested. Repairs and corrections are required by a licensed HVAC Company.

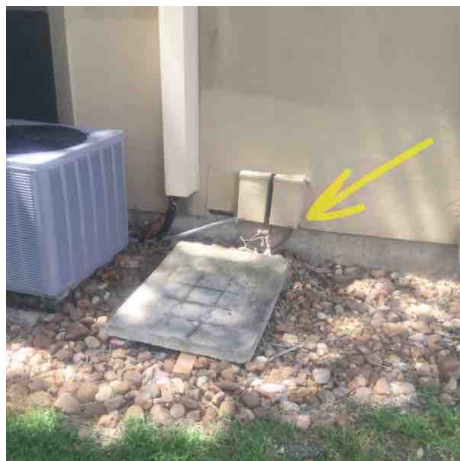
- It appears that the condensing unit had been removed and was missing. Not present. Not inspected.

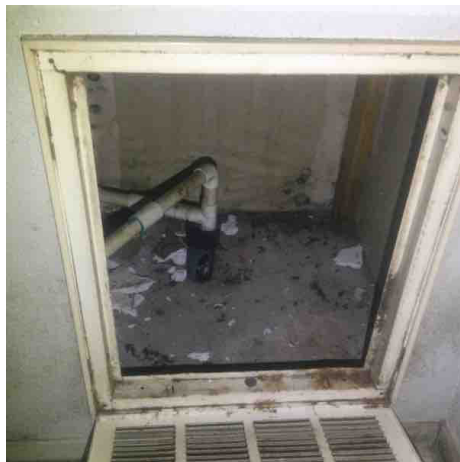
- All visible ductwork appears to be connected and functioning properly. Observed missing replaceable air return filters. 1-16x25x1 Replacement is required.

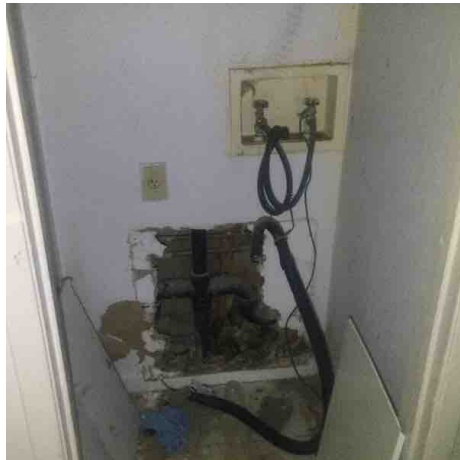
Not inspected or tested, but exposed plumbing was observed.

Further evaluation, repairs and corrections are required by a licensed plumber specialist.

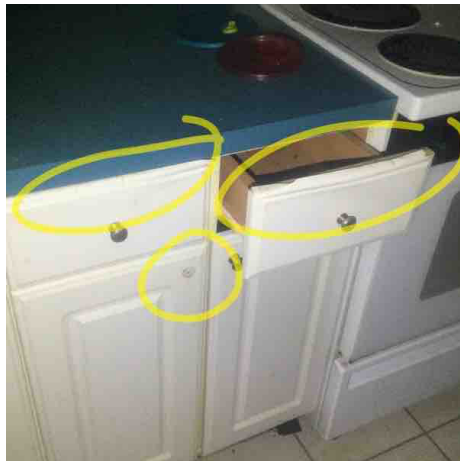
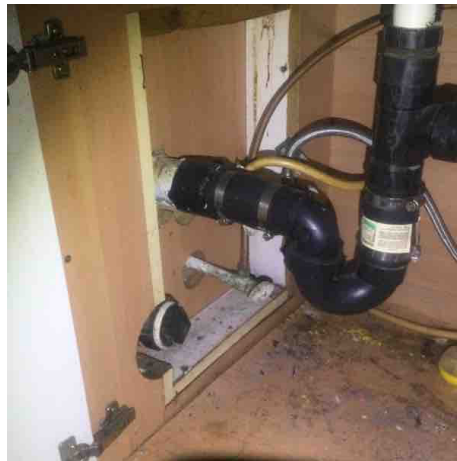
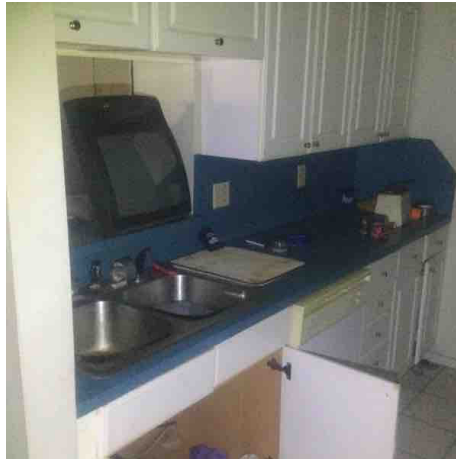
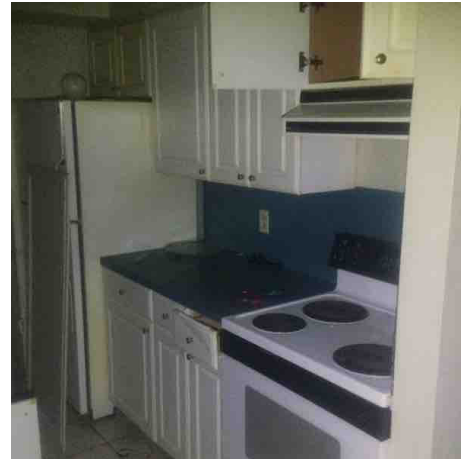
• KITCHEN

Observed missing knob and damaged cabinet covers.

Observed exposed plumbing under sink cabinet.

Repairs and corrections are recommended and advised.

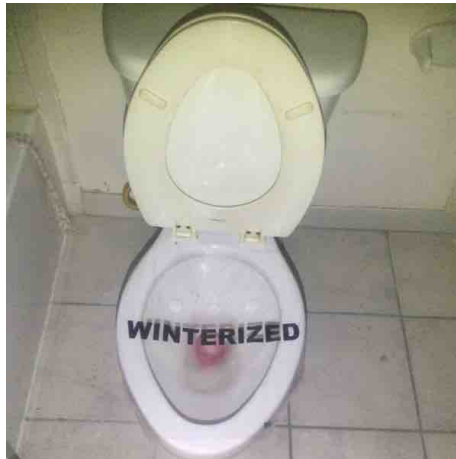
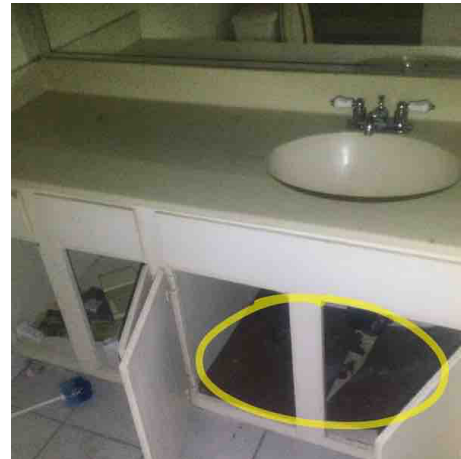
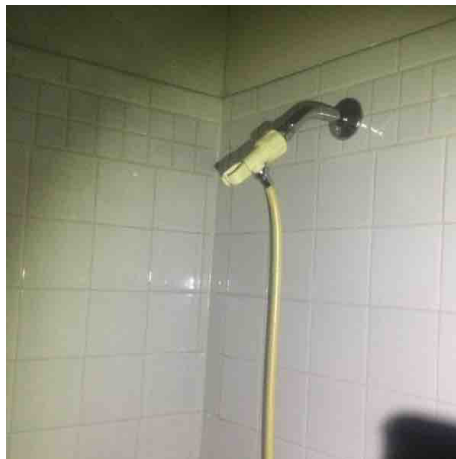
• LEFT SIDE BATHROOM
No water, Not inspected or tested.
Observed damaged flooring under sink cabinet .
Observed missing shower head.
Further evaluation, repairs and corrections are required by a qualified contractor specialist.

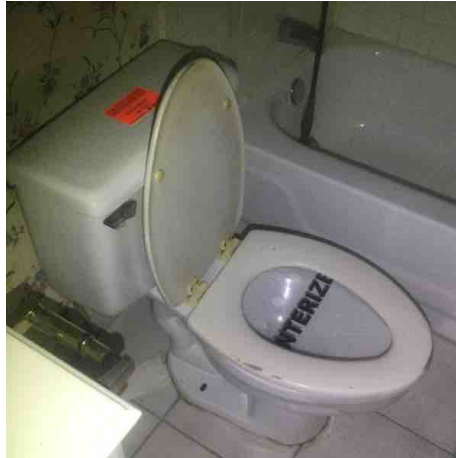
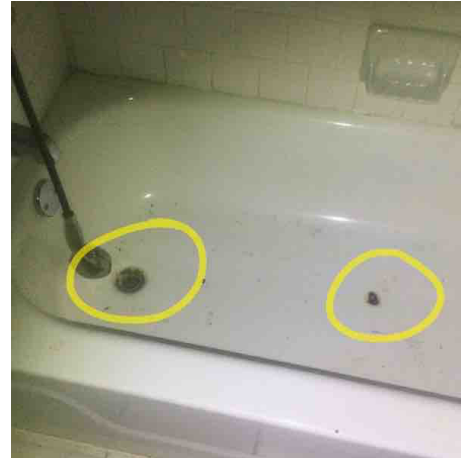
Observed missing tub stopper.

Observed chipped tub surface.

Repairs and corrections are required by a qualified contractor specialist.

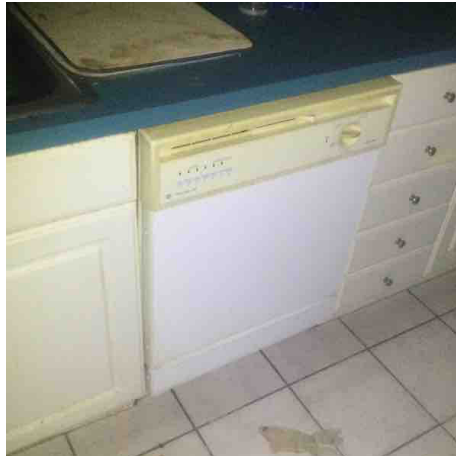
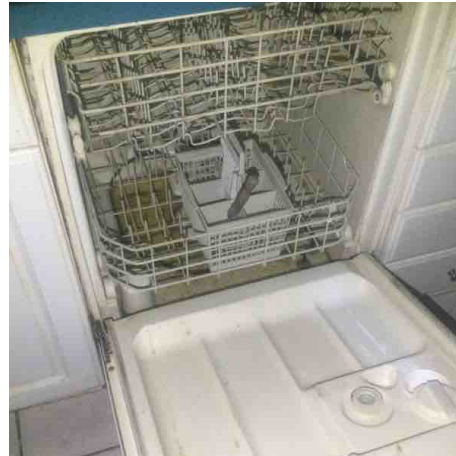
Observed standing water in the unit.

Further evaluation, repairs and corrections are required by a licensed specialist.

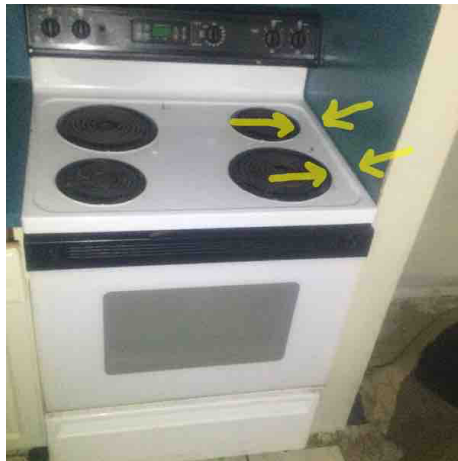
- There was no electrical utilities on, and so the unit could not be properly inspected or tested.
- Observed missing Handle at front panel.
- Observed missing anti tipping devise behind unit as required to avoid tip-over.
- Improper clearance was observed to the right side of the unit. (Minimum clearance from the edge of burners to combustibile materials is 6” inches.)
- (Overheating and damage, with a potential for fire to occur is present.)
- Further evaluation, repairs and corrections are required by a licensed specialist.

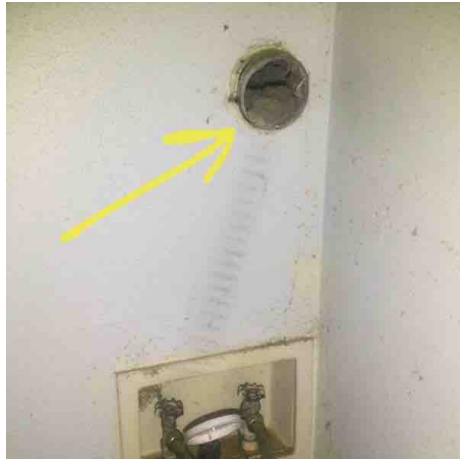
- Observed clogged and dirty exhaust dryer vent. In need of cleaning by a professional contractor.
