Inspection Report

Property Address:
3805 Shelby Circle
Houston Texas 77051

Shammah Inspection Group

Date: 8/10/2019	Time: 09:00 AM	Report ID: 156
Property: 3805 Shelby Circle Houston Texas 77051	Customer: Rahwa Baatai	Real Estate Professional: Saba Asfaha

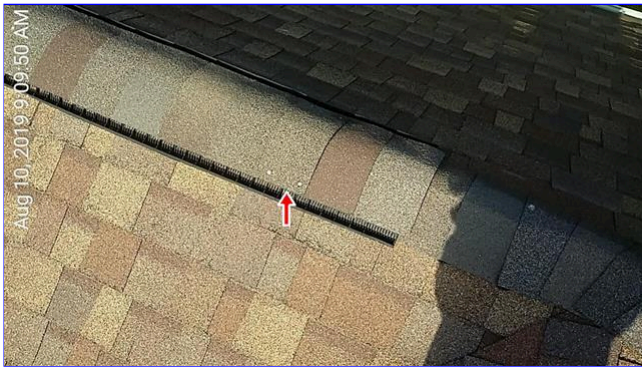
C. Item 11(Picture)

(2) Exterior Front Left Roof - Observed exposed nails on the ridge vent at the time of the inspection.

Recommend sealing the nail heads to prevent deterioration.

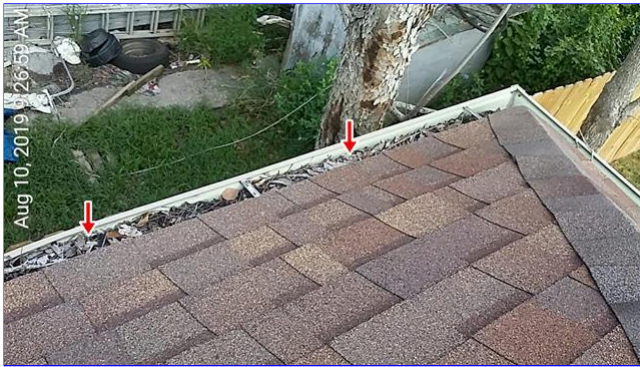
C. Item 24(Picture)

(9) Exterior Left Rear and Right - Recommend removing the debris from the gutters to allow proper water flow inside the gutters.

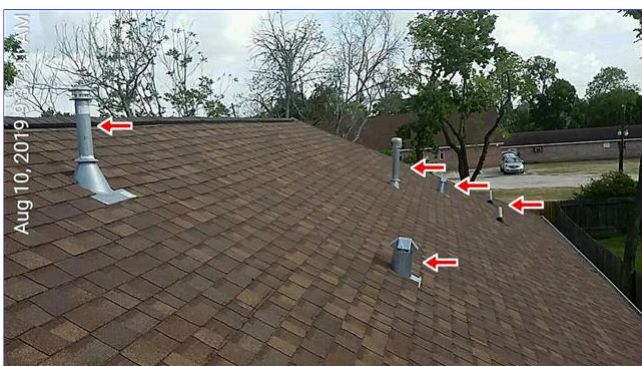
C. Item 37(Picture)

(13) Exterior Left Roof - The exhaust vents and plumbing vents were not painted at the time of the inspection. Recommend painting to prevent deterioration.

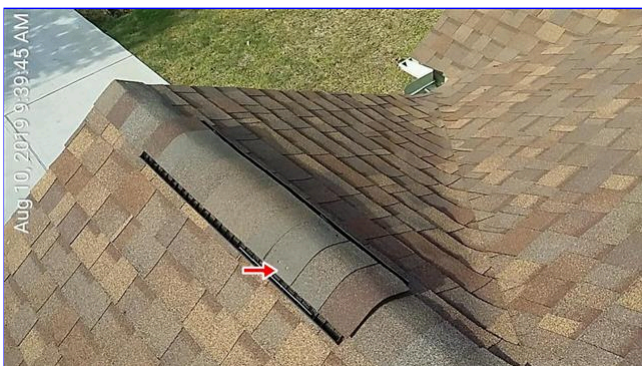
C. Item 38(Picture)

(14) Exterior Front Right Roof Ridge - Observed exposed nails on the ridge vent at the time of the inspection. Recommend sealing the nail heads to prevent deterioration.

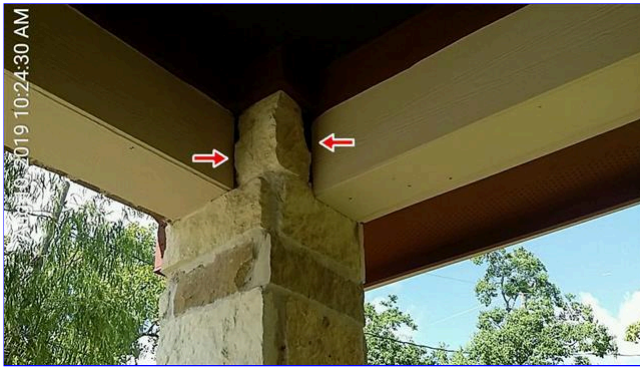
E. Item 7(Picture)

(3) Exterior Front Porch - Left Column - Observed a gap between the stone and cornice trim at the time of the inspection. Recommend pointing up to prevent pest intrusion.

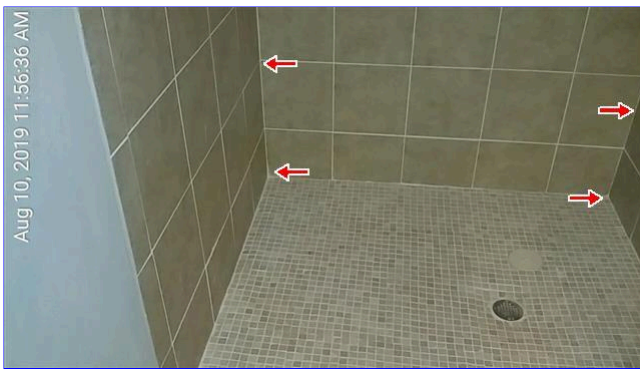
E. Item 10(Picture)

(5) Right Hallway Bathroom - Recommend sealing the shower tile joint to prevent water intrusion.

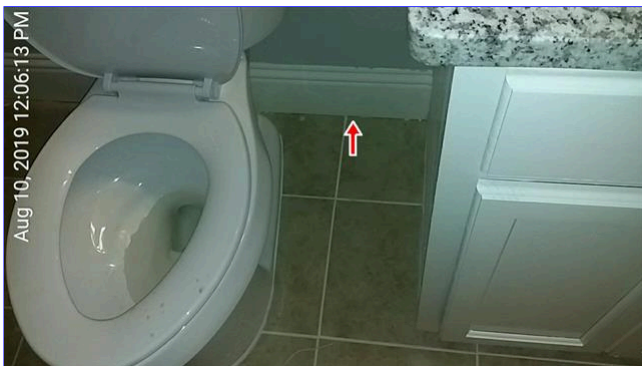
F. Item 3(Picture)

(2) Right Hallway Bathroom - The floor tile and floor base joints were not sealed at the time of the inspection.

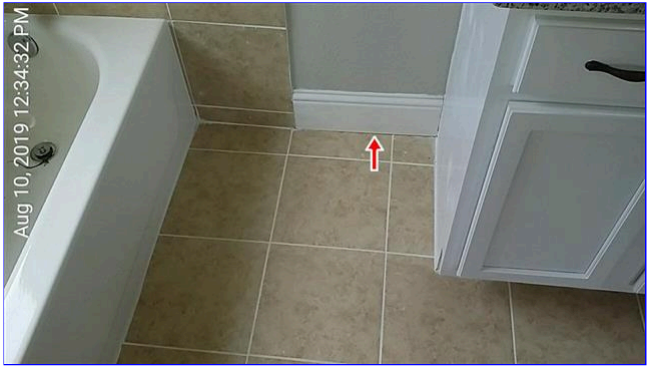
F. Item 6(Picture)

(3) Master Bathroom - The floor tile and floor base joints were not properly sealed at the time of the inspection.

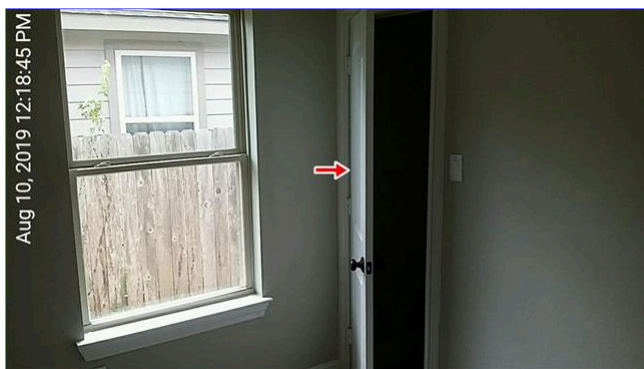
G. Item 9(Picture)

(5) Right Rear Bedroom Closet - The closet door did not latch properly at the time of the inspection.

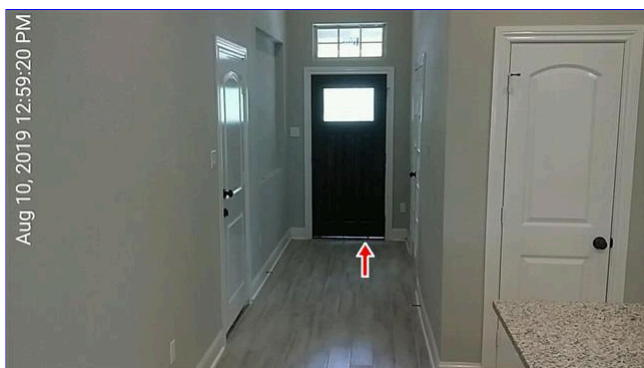
G. Item 10(Picture)

(6) Entry - Observed a gap under the exterior front door at the time of the inspection.

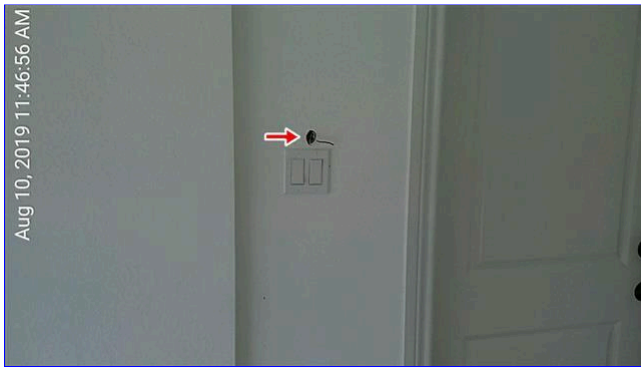
B. Item 4(Picture)

(4) Garage Left Rear - Observed exposed wiring at the time of the inspection.

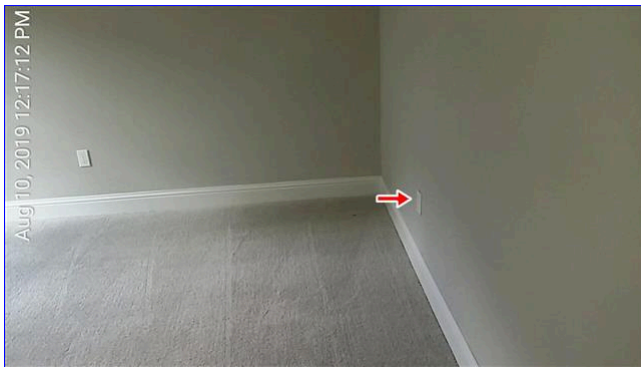
B. Item 5(Picture)

(5) Right Front Bedroom - The left front electrical receptacle was loose at the time of the inspection.

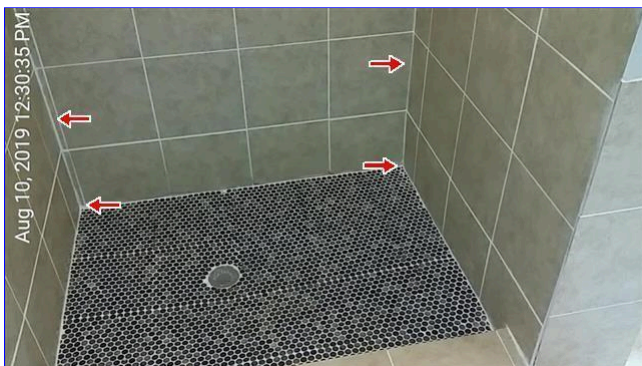
A. Item 5(Picture)

- (4) Kitchen Front Wall - The refrigerator water supply box was missing trim at the time of the inspection.
- (5) Master Bathroom - The shower was missing an enclosure at the time of the inspection.

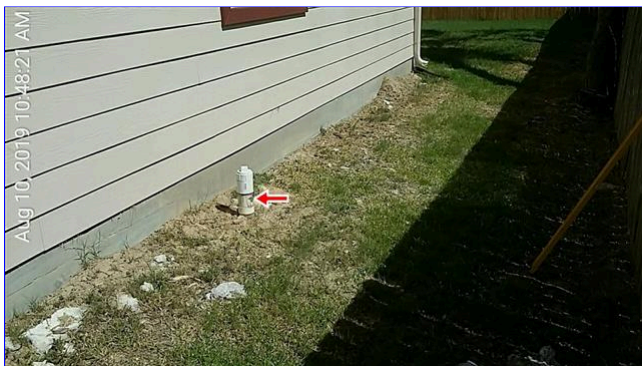
B. Item 1(Picture)

Exterior Right Middle - Recommend lowering the ground clean-cut to prevent possible damage.

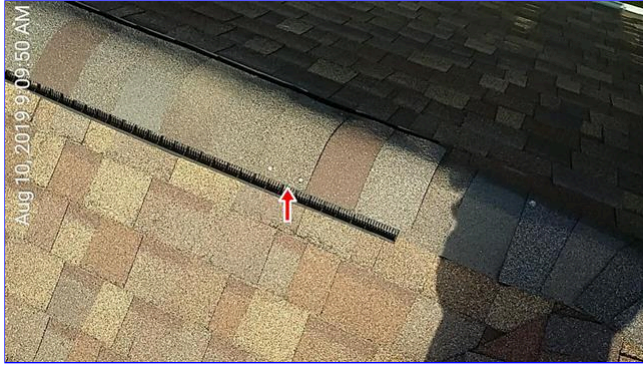
C. Item 11(Picture)

(2) Exterior Front Left Roof - Observed exposed nails on the ridge vent at the time of the inspection. Recommend sealing the nail heads to prevent deterioration.

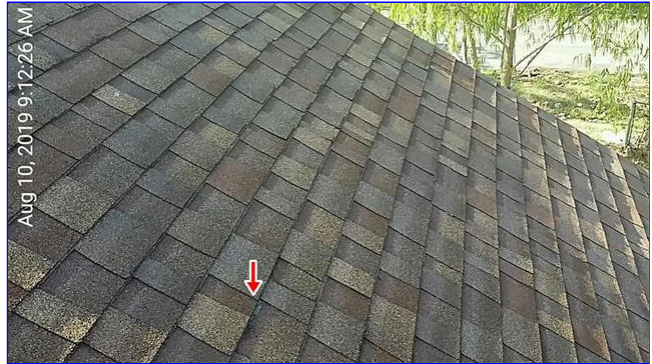
C. Item 15(Picture)

(3) Exterior Left Front Roof - Observed evidence of deteriorated shingles at the time of the inspection.

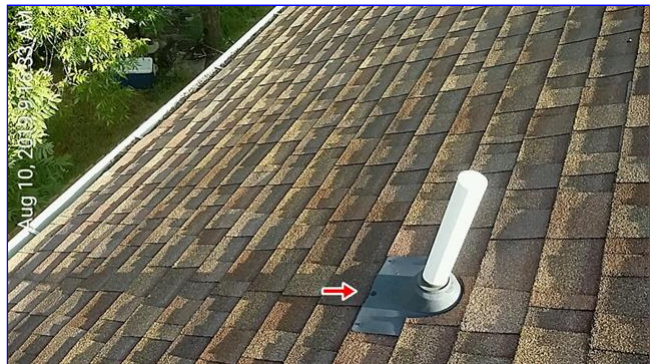
C. Item 17(Picture)

(4) Exterior Left Middle Roof - The plumbing vent flange fasteners were not sealed at the time of the inspection. Recommend sealing the nail heads to prevent deterioration.

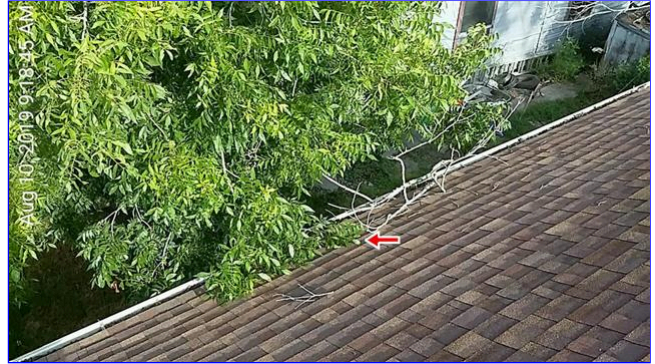
C. Item 19(Picture)

(5) Exterior Left Middle Roof - Observed tree branches rubbing the shingles at the time of the inspection. Recommend removing the tree branches to prevent shingle damage.

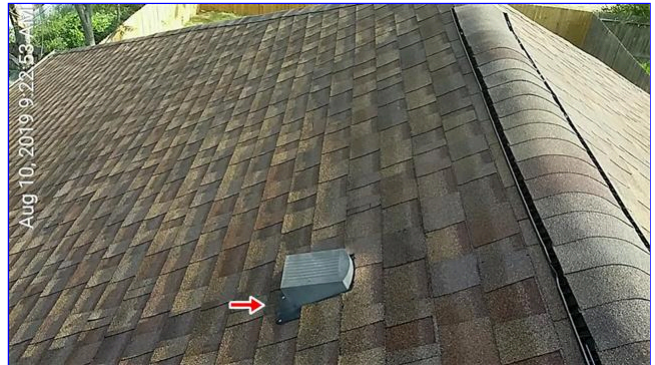
C. Item 22(Picture)

(7) Exterior Left Rear Roof - The exhaust vent flange nails were not sealed at the time of the inspection. Recommend sealing the nail heads to prevent deterioration.

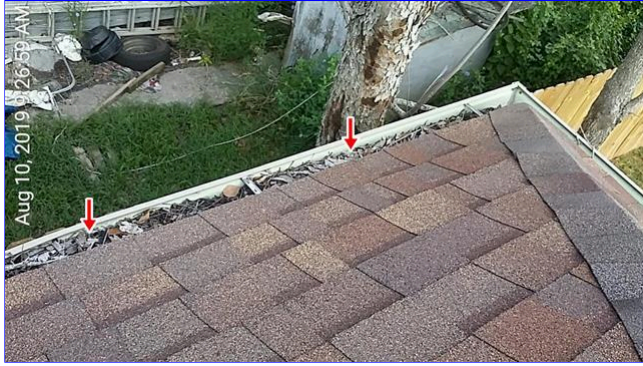
C. Item 24(Picture)

(9) Exterior Left Rear and Right - Recommend removing the debris from the gutters to allow proper water flow inside the gutters.

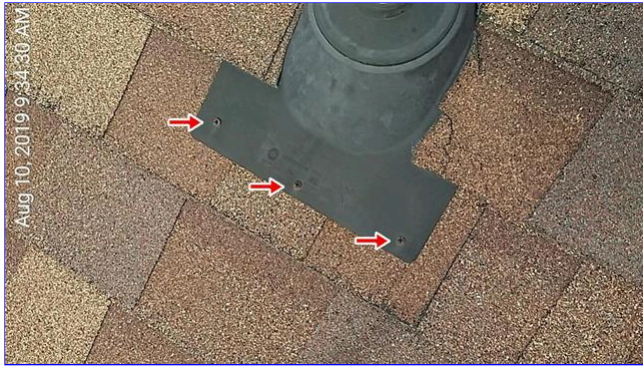
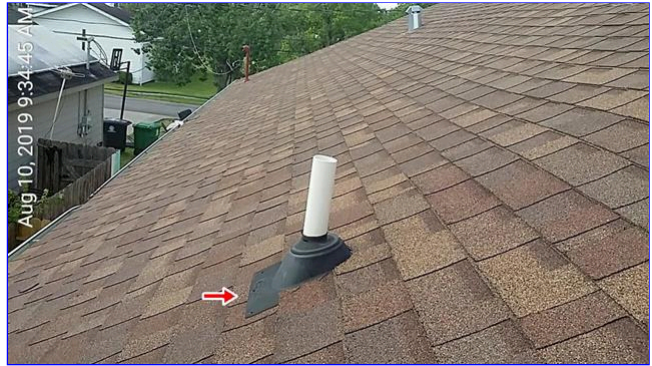
(11) Exterior Right Middle Roof - The plumbing vent flange nails were not sealed at the time of the inspection. Recommend sealing the nail heads to prevent deterioration.

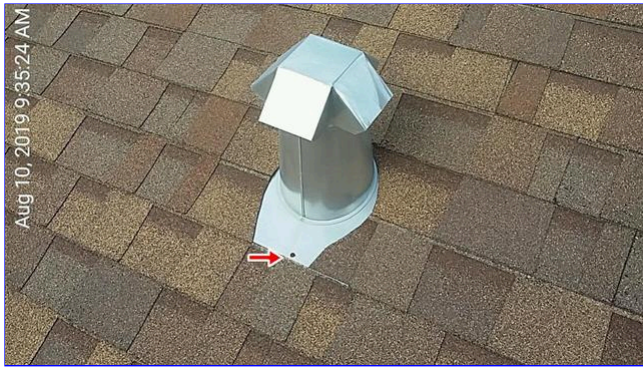
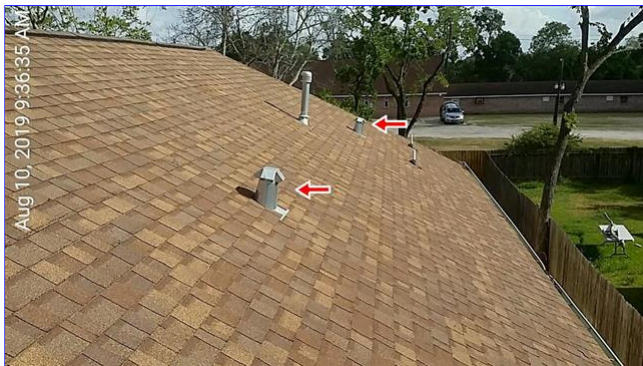
(12) Exterior Right Roof - The exhaust vent flange nails were not sealed at the time of the inspection. Recommend sealing the nail heads to prevent deterioration.

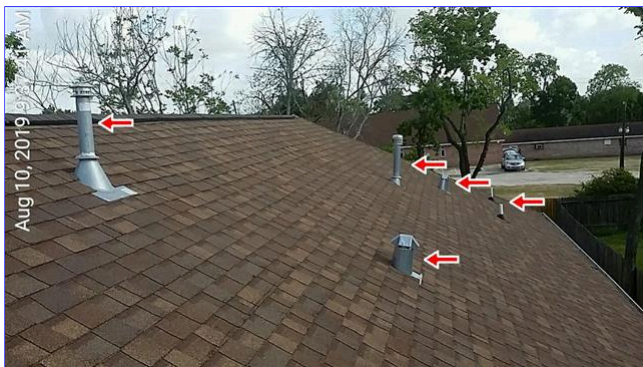
C. Item 37(Picture)

(13) Exterior Left Roof - The exhaust vents and plumbing vents were not painted at the time of the inspection. Recommend painting to prevent deterioration.

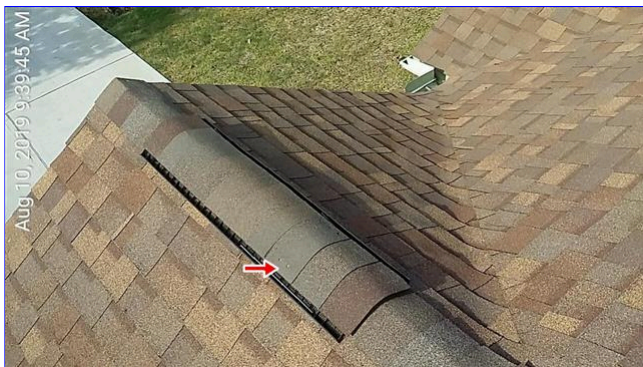
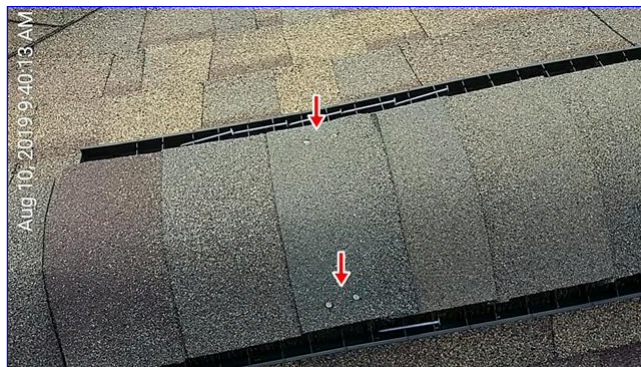
(14) Exterior Front Right Roof Ridge - Observed exposed nails on the ridge vent at the time of the inspection.

Recommend sealing the nail heads to prevent deterioration.

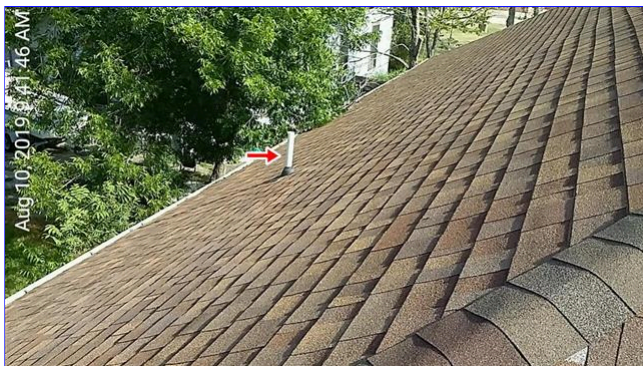
C. Item 40(Picture)

(15) Exterior Left Middle Roof - The plumbing vent was not painted at the time of the inspection. Recommend painting to prevent deterioration.

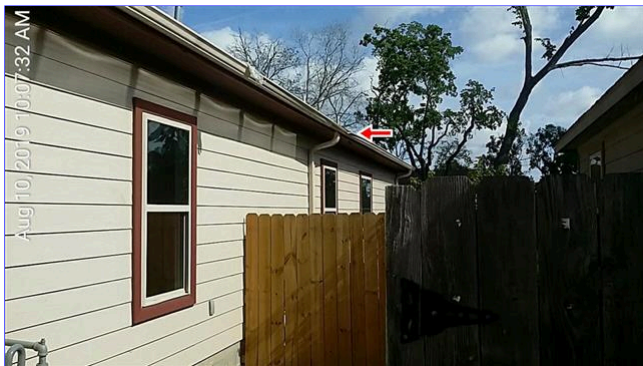
C. Item 41(Picture)

(16) Exterior Right Middle - Observed a damaged gutter at the time of the inspection.

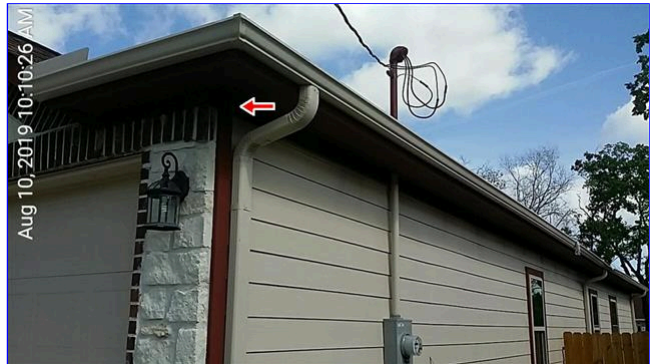
E. Item 6(Picture)

(2) Exterior Right Front - Observed a gap between the brick frieze trim joint at the time of the inspection. Recommend covering the area to prevent pest intrusion.

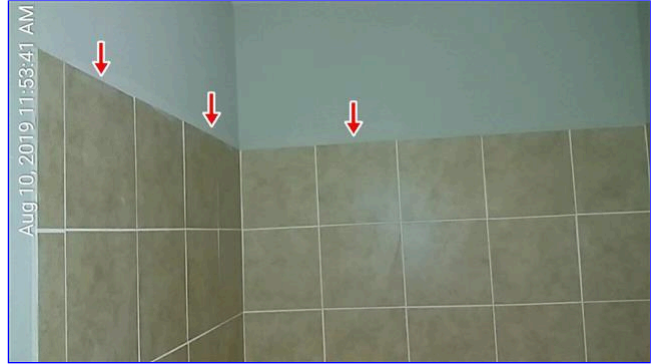
E. Item 9(Picture)

(5) Right Hallway Bathroom - Recommend sealing the shower tile joint to prevent water intrusion.

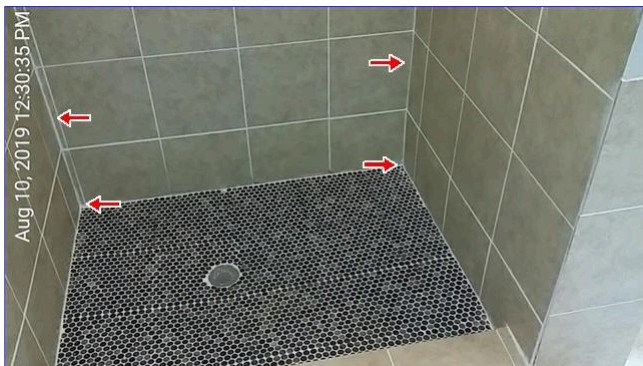
E. Item 11(Picture)

(6) Master Bathroom - The shower floor and wall tile joint were not properly sealed at the time of the inspection.

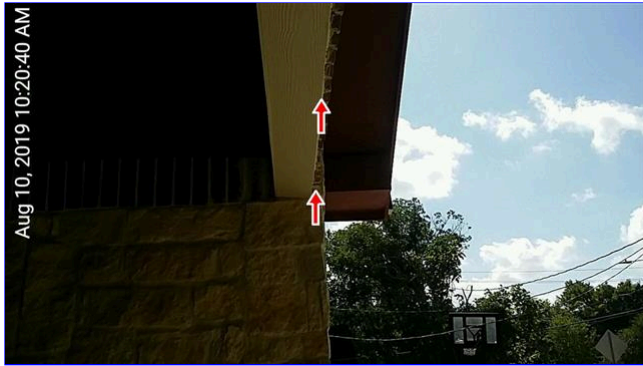
F. Item 1(Picture)

(1) Exterior Front Porch - The brick and cornice trim were not sealed at the time of the inspection.

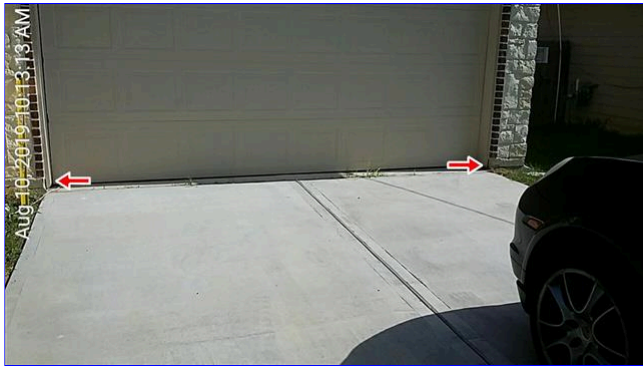
G. Item 1(Picture)

(1) Exterior Front Right - Observed gaps between the left and right garage door trimmers at the time of the inspection. Recommend sealing to prevent water and pest intrusion.

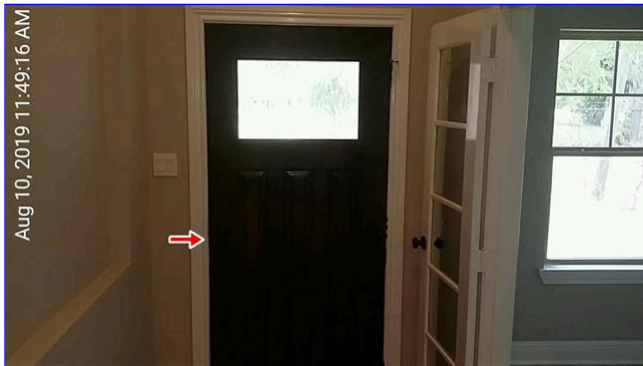
G. Item 5(Picture)

(3) Entry - The exterior front door did not latch properly at the time of the inspection.

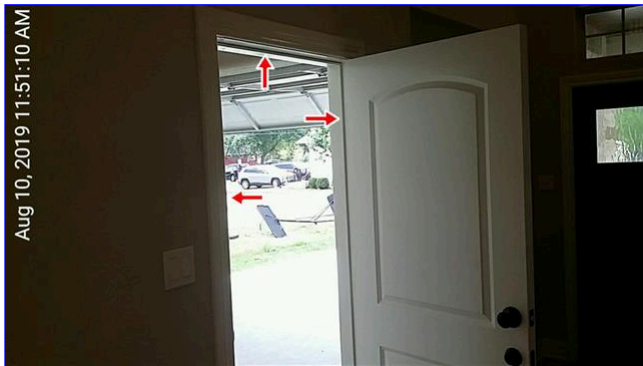
G. Item 6(Picture)

(4) Foyer Right - The garage pedestrian door was missing weather stripping at the time of the inspection.

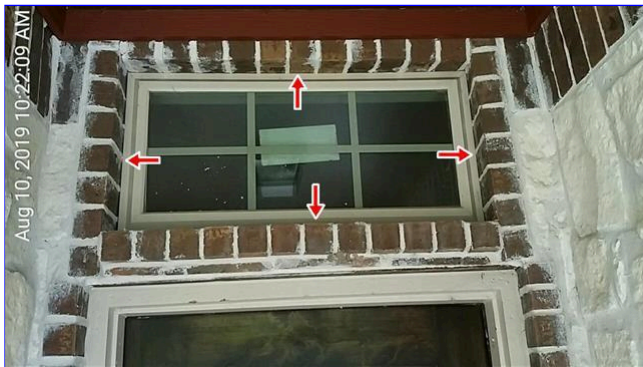
H. Item 1(Picture)

(1) Exterior Front Porch - The window frames were not sealed at the time of the inspection.

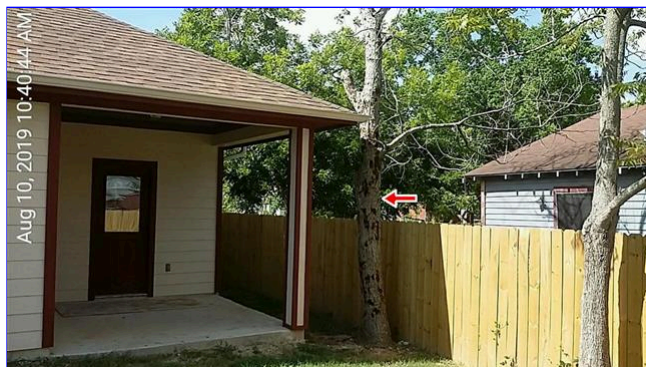
L. Item 1(Picture)

(1) Exterior Left Rear - Recommend removing the tree in the near future to prevent possible damage to the home during a strong storm event.

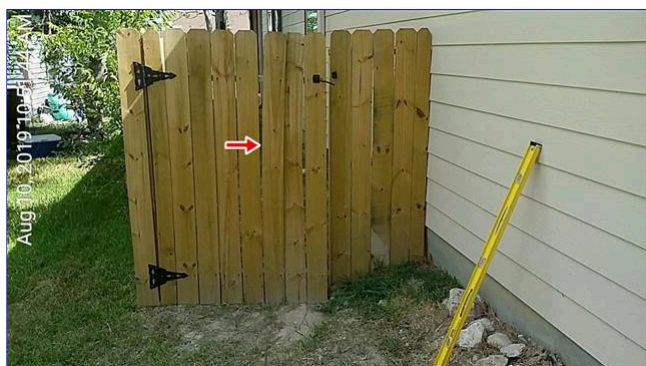
L. Item 2(Picture)

(2) Exterior Left Front - Observed loose pickets on the gate at the time of the inspection.

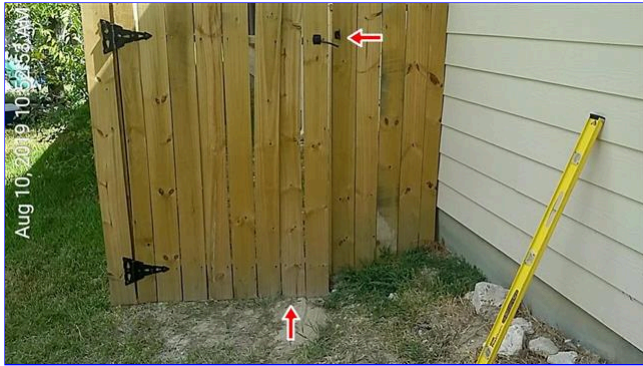
L. Item 3(Picture)

(3) Exterior Left Front - The gate was rubbing the ground and did not latch properly at the time of the inspection.

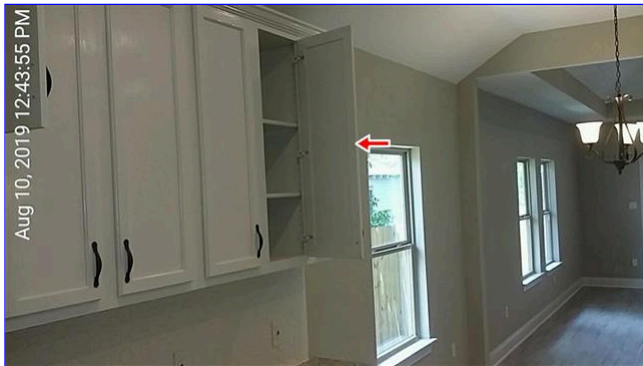
L. Item 4(Picture)

(4) Kitchen - The left rear upper cabinet door was loose at the hinges at the time of the inspection.

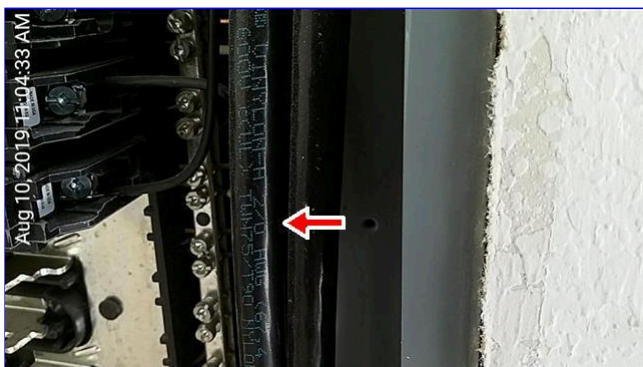
A. Item 8(Picture)

(2) Garage Right Wall - Electrical Panel - Observed a 2/0 AWG aluminum wire connected to a 200 AMP breaker at the time of inspection. A 200 AMP breaker requires a 4/0 AWG aluminum wire for proper service. Recommend hiring a licensed and experienced electrician to switch the breaker or the service wiring.

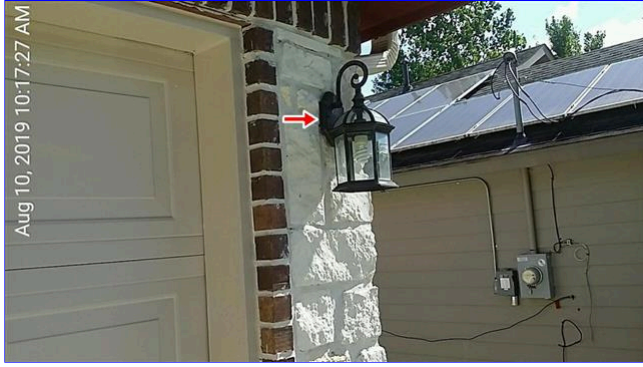
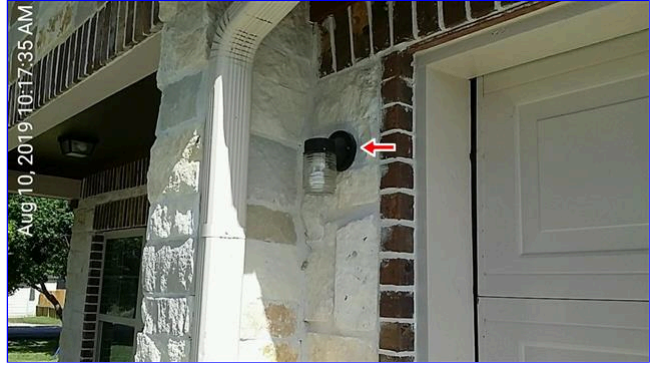
- (1) **Type of Wiring:** Observed type of branch wiring is copper.
- (2) Exterior Front Right - The coach lights were not sealed at the time of the inspection.

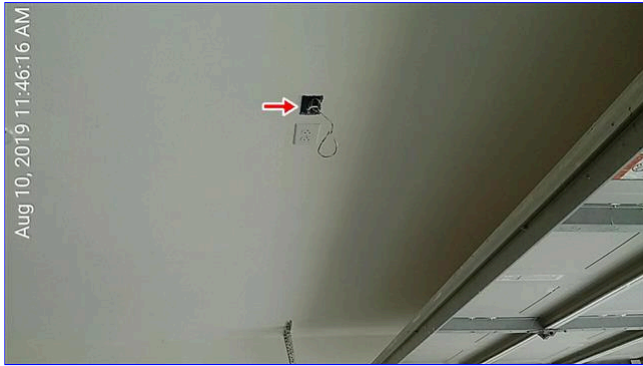
B. Item 3(Picture)

- (3) Garage - Observed a missing cover plate on the garage ceiling at the time of the inspection.

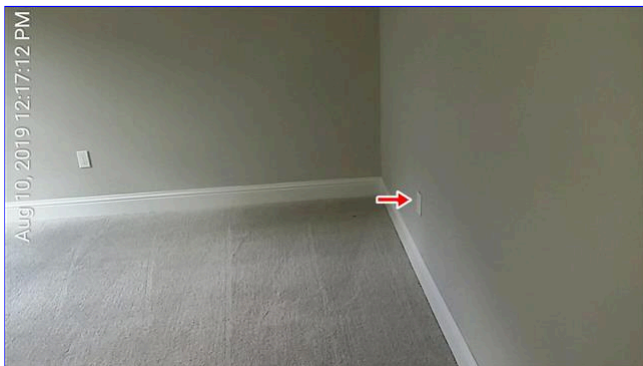
B. Item 5(Picture)

- (5) Right Front Bedroom - The left front electrical receptacle was loose at the time of the inspection.

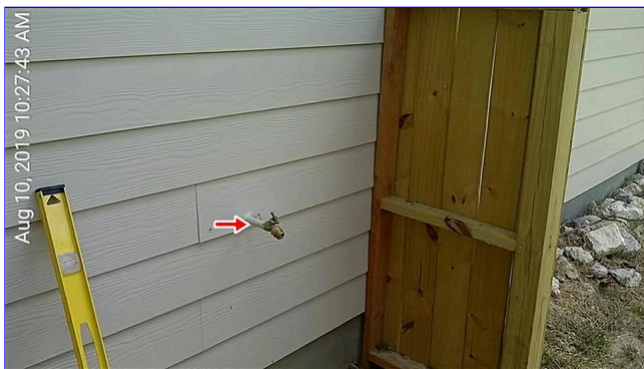
A. Item 3(Picture)

(2) Exterior Left Middle - Recommend adding insulation around the hose to prevent damage during a hard freeze.

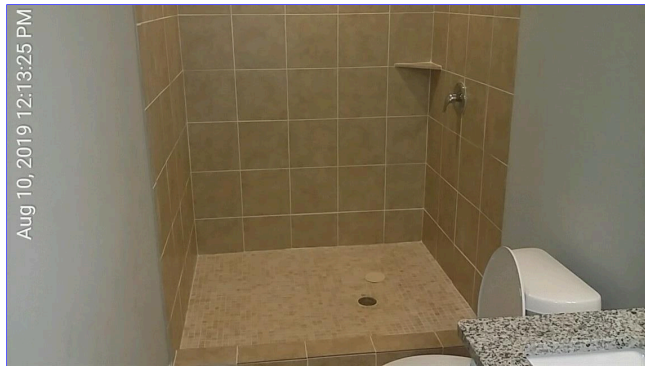
A. Item 4(Picture)

(3) Right Hallway Bathroom - The shower was missing an enclosure at the time of the inspection.

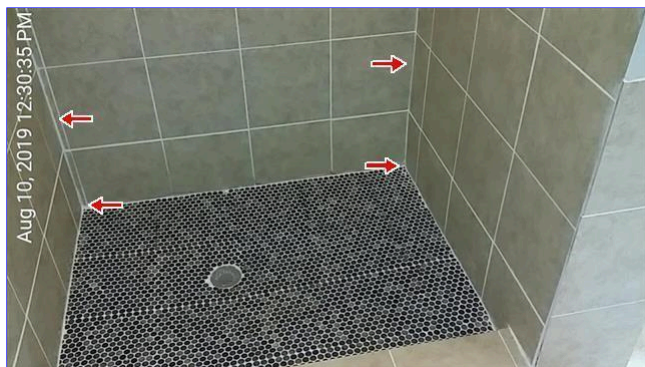
A. Item 5(Picture)

- (4) Kitchen Front Wall - The refrigerator water supply box was missing trim at the time of the inspection.
- (5) Master Bathroom - The shower was missing an enclosure at the time of the inspection.

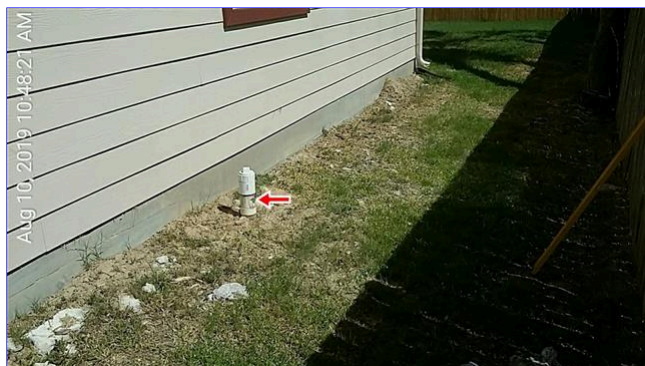
B. Item 1(Picture)

Exterior Right Middle - Recommend lowering the ground clean-cut to prevent possible damage.

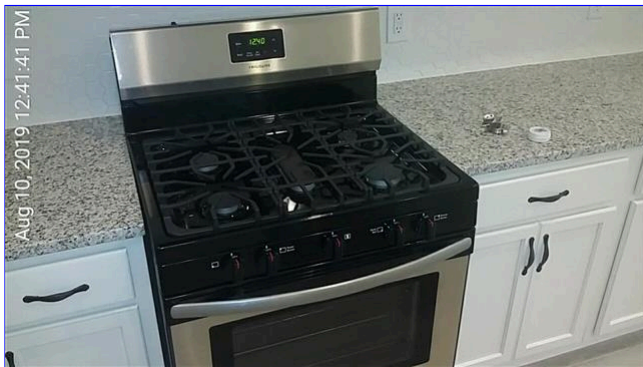
D. Item 1(Picture)

Kitchen - The stove was not connected to an anti-tipping device at the time of the inspection.
