Inspection Report

Property Address:
13604 Starwreath Dr.
Pearland TX 77584

American Dream Inspections TX, llc

PROPERTY INSPECTION REPORT FORM

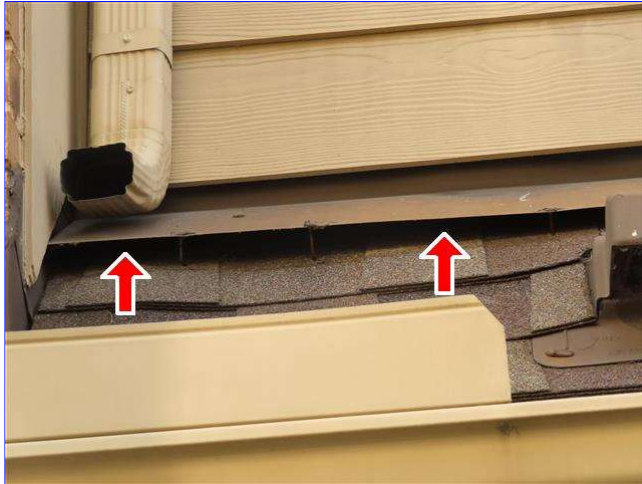
C. Item 1(Picture)

(1) All lifted roof shingles and flashing should be corrected and sealed properly by a professional roofer. Conducive to moisture intrusion and causing possible damage. Should have a professional roofer inspect and evaluate roofing.

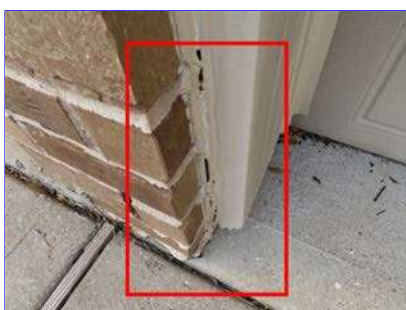
E. Item 2(Picture)

(2) All exterior and interior trim around garage doors should be sealed properly. Conducive to moisture and WDI (Wood Destroying Insect) intrusion.

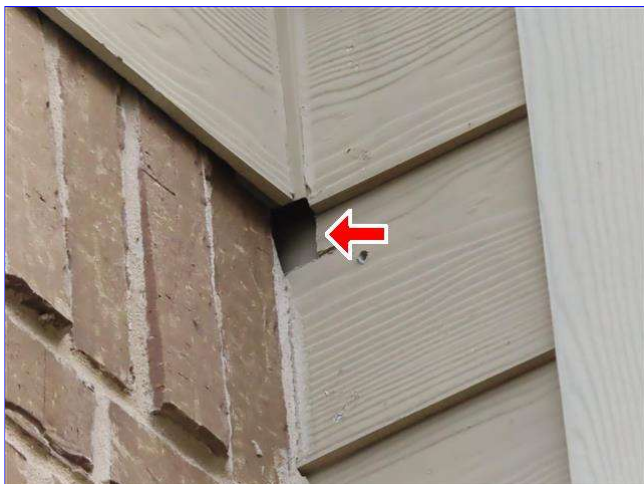
E. Item 4(Picture)

(4) Side exterior window box has large gaps and penetrations in several areas at time of inspection. Should have a professional correct and seal properly. Conducive to moisture and vermin intrusion.

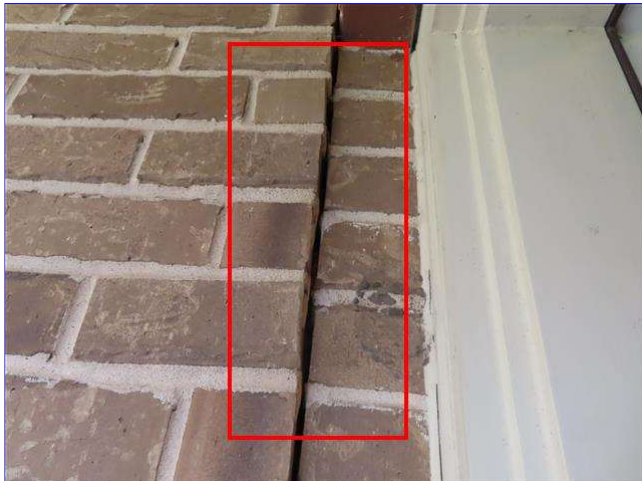
E. Item 7(Picture)

(5) All exterior wall expansion joints should be sealed properly. Conducive to moisture and WDI (Wood Destroying Insect) intrusion.

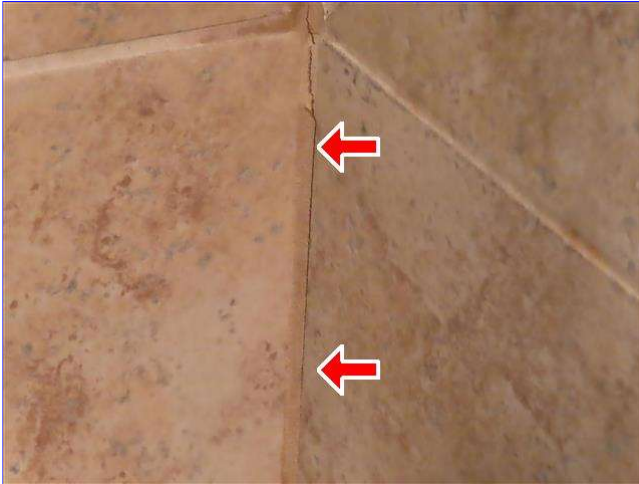
E. Item 9(Picture)

(7) All master shower tile wall penetrations and cracks should be sealed properly. Conducive to moisture intrusion and causing possible damage.

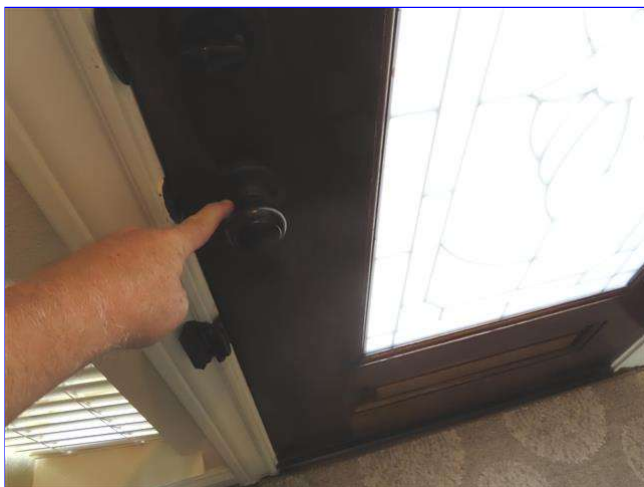
G. Item 2(Picture)

(2) Front exterior door handle was loose at time of inspection. Should correct properly.

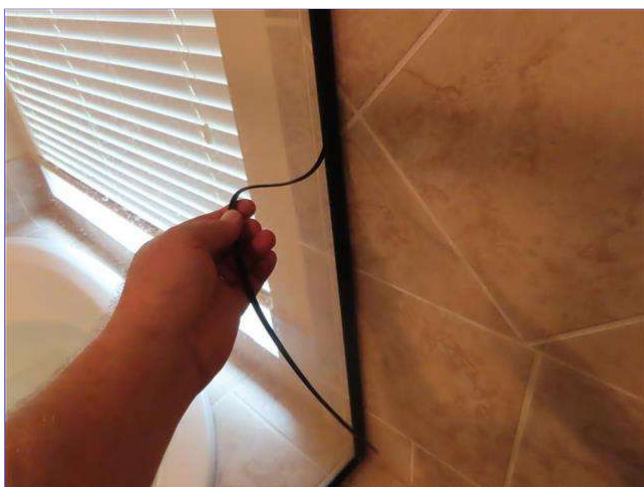
G. Item 3(Picture)

(3) Master shower glass surround gasket was loose at time of inspection. Should have a professional correct and seal properly. Conducive to moisture intrusion and causing possible damage.

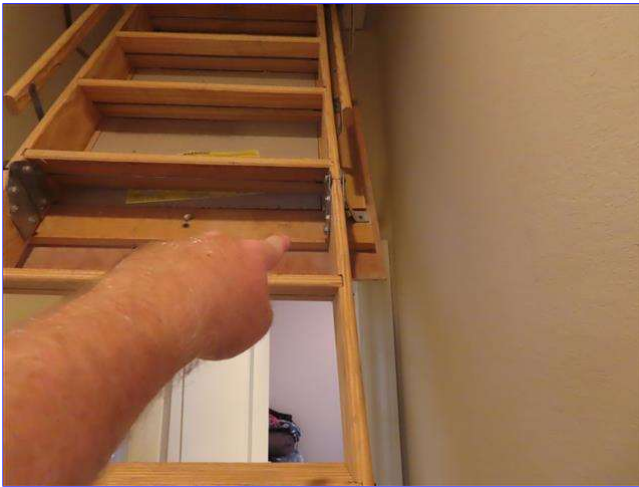
G. Item 5(Picture)

(5) Attic door was loose and not operating properly at time of inspection. Should have a professional correct properly.

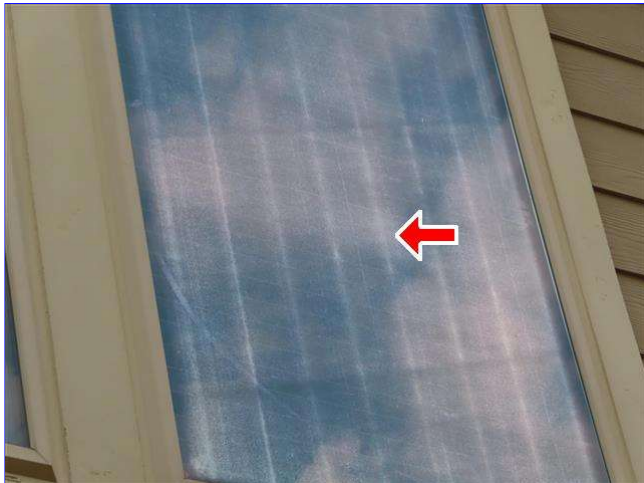
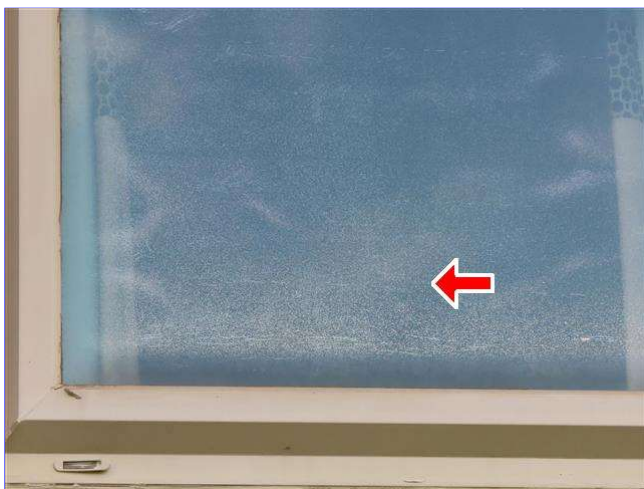
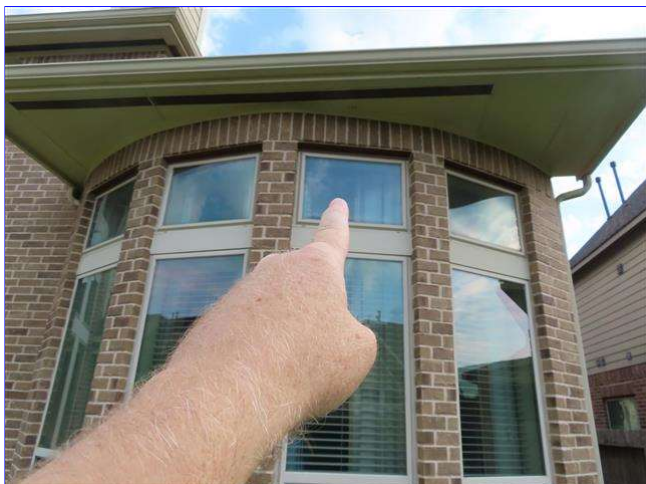
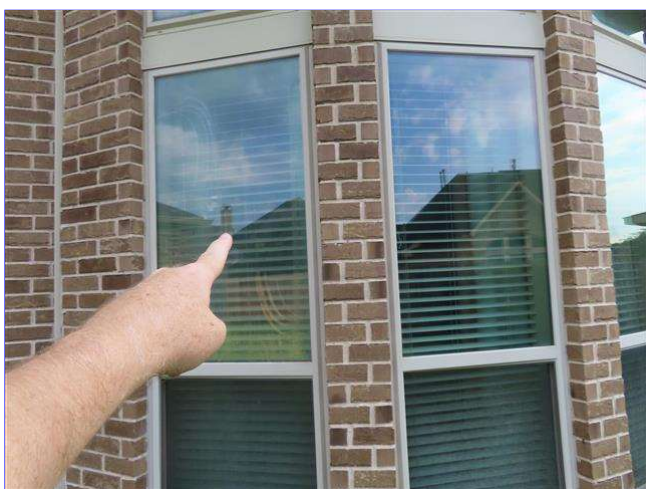
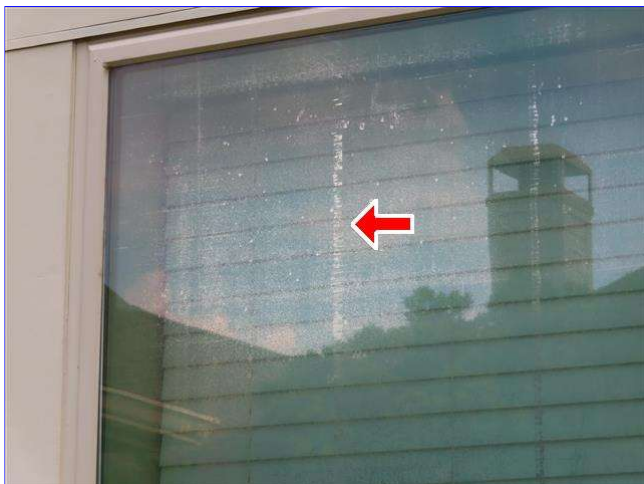
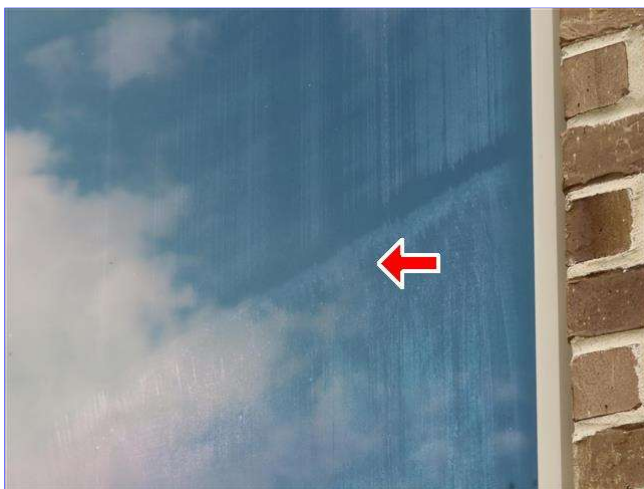
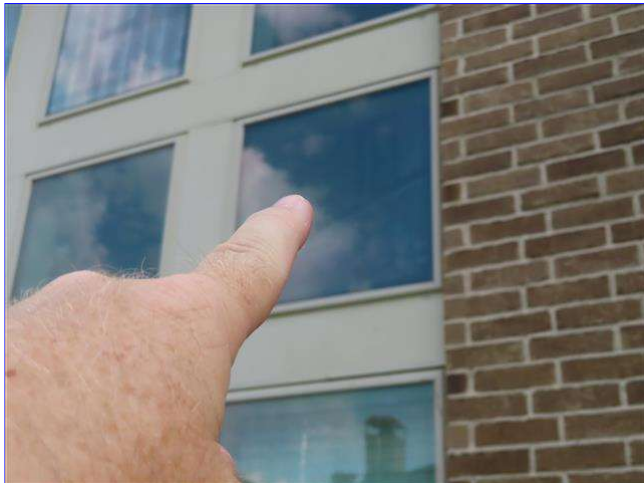
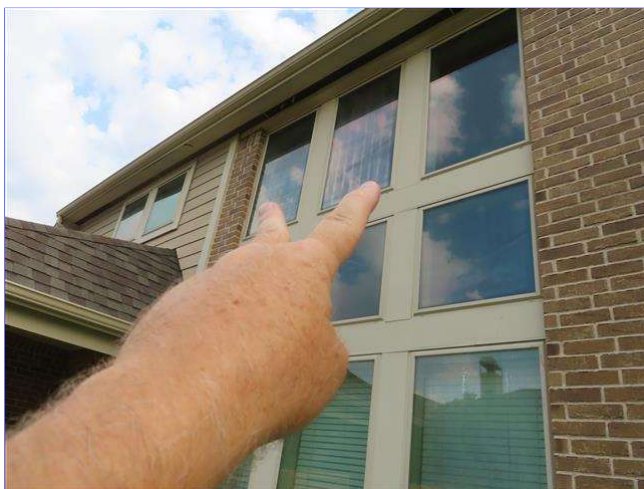
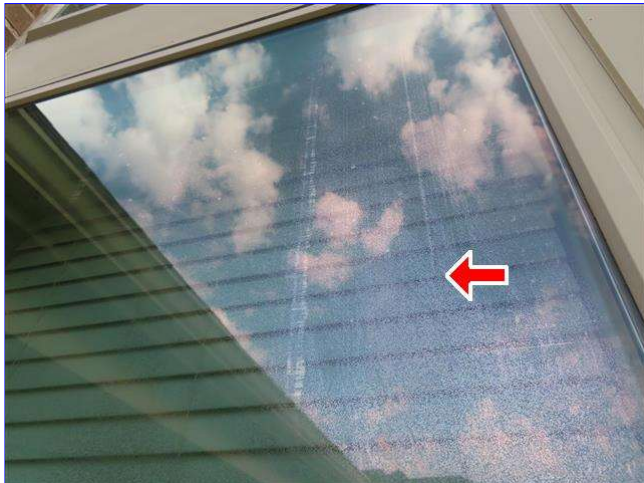
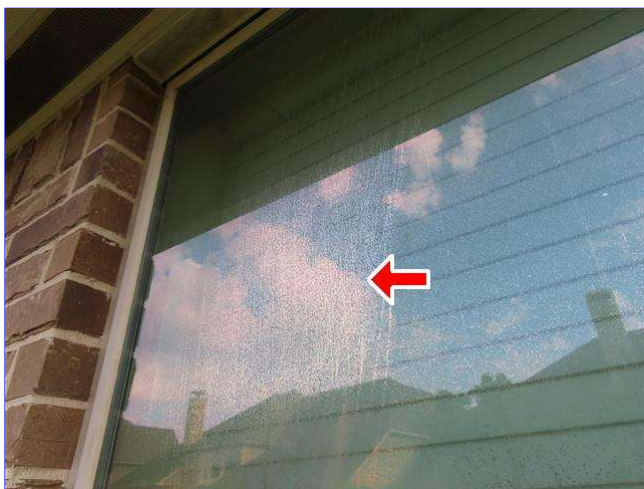
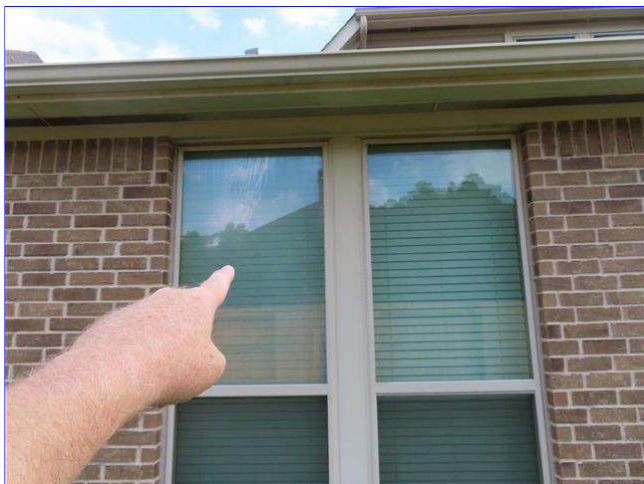
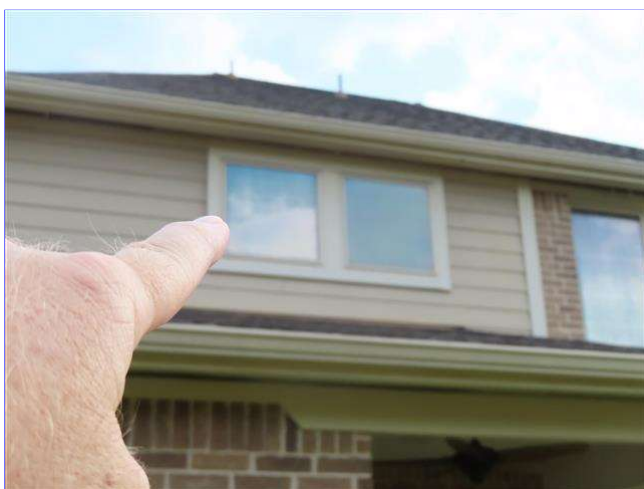
(1) 10 windows were discolored at time of inspection. This is signs of seal between panes cracked causing windows to not be energy efficient. Should have a professional replace windows properly.

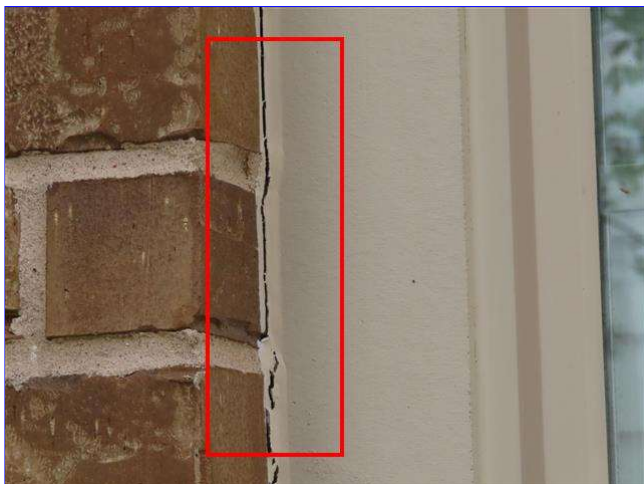
H. Item 19(Picture)

(2) All exterior and interior window penetrations should be sealed properly. Conducive to moisture and WDI (Wood Destroying Insects) intrusion.

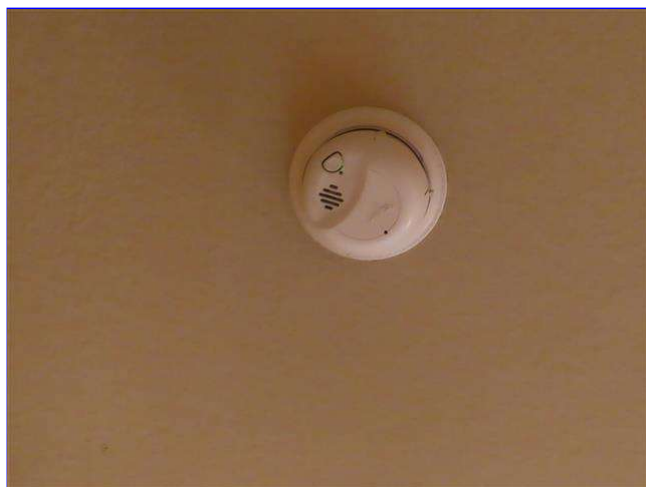
B. Item 1(Picture)

(1) The smoke detector should be tested at common hallway to bedrooms upon moving in to home. Smoke detectors should be replaced every 10 years and batteries at least every year. Smoke detectors were missing in bedrooms at time of inspection. Should have a professional electrician correct properly. This is a possible safety hazard.

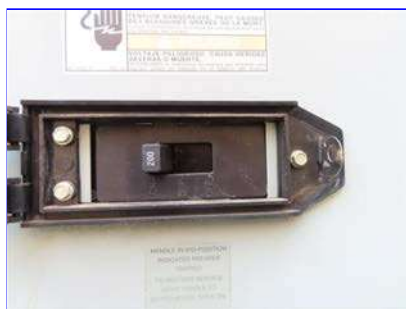
B. Item 3(Picture)

(2) 200 amp main disconnect. (This is for informational purposes only)

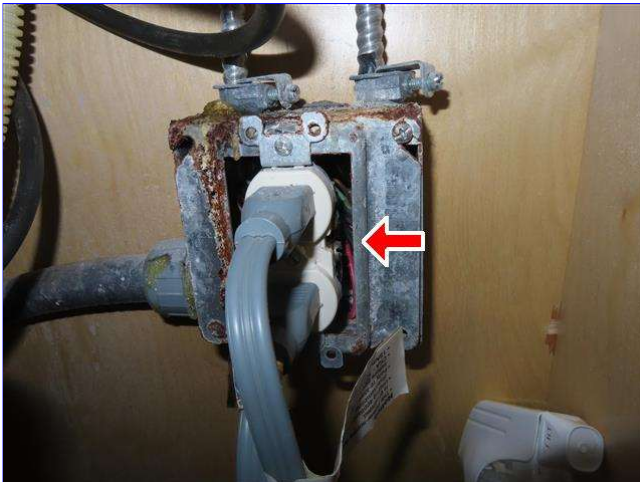
B. Item 7(Picture)

(6) Electrical outlet under kitchen sink should be GFCI protected outlet. Outlet was missing cover at time of inspection. Should have a professional electrician correct properly.

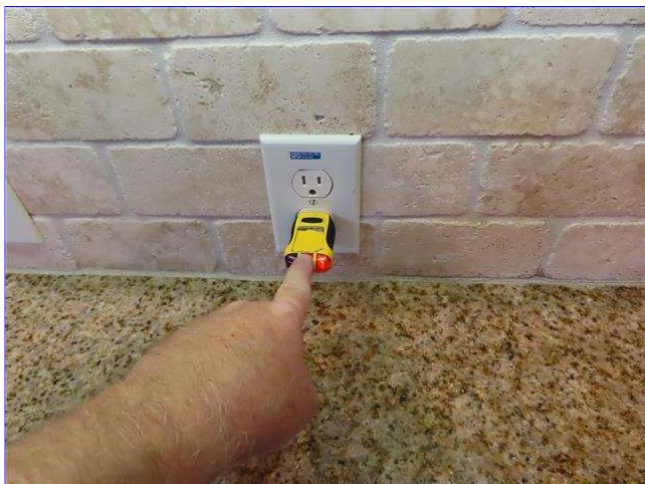
B. Item 8(Picture)

(7) Several interior electrical outlets were loose to the wall at time of inspection. Should a professional electrician secure properly.

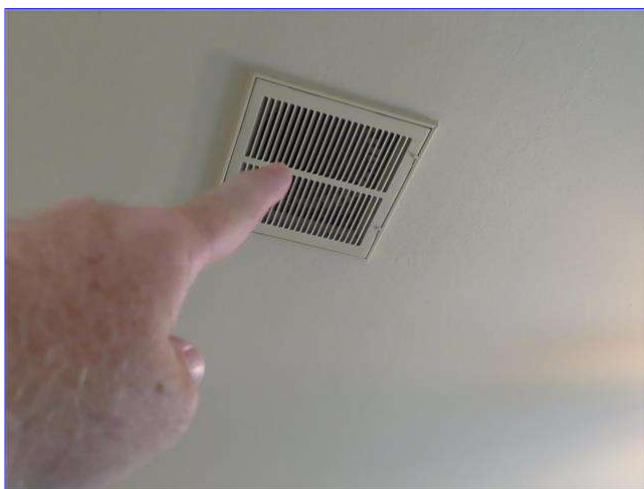
C. Item 1(Picture)

Second floor bedroom return was missing filter at time of inspection. Should correct properly.

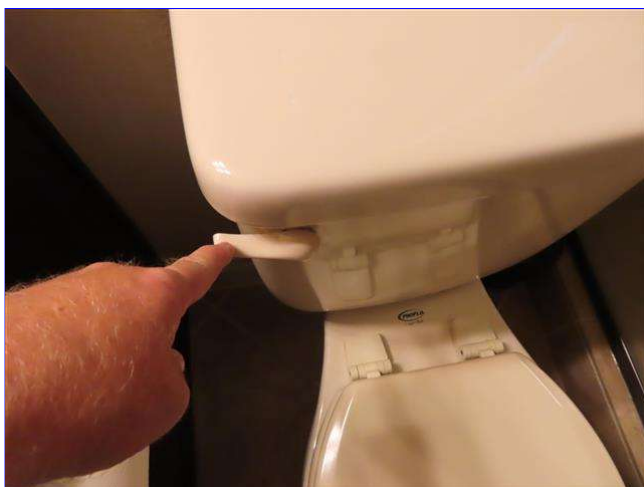
A. Item 4(Picture)

(4) Master toilet handle was loose from bowl at time of inspection. Should have a professional plumber inspect and correct properly.

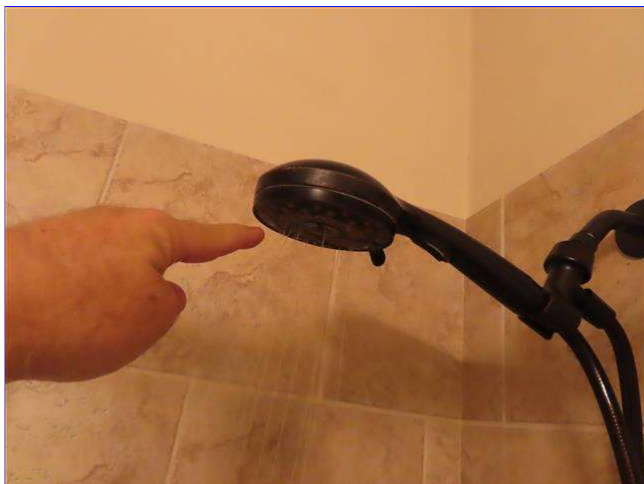
A. Item 5(Picture)

(5) Master showerhead was not flowing properly at time of inspection. Should have a professional plumber inspect and correct properly.

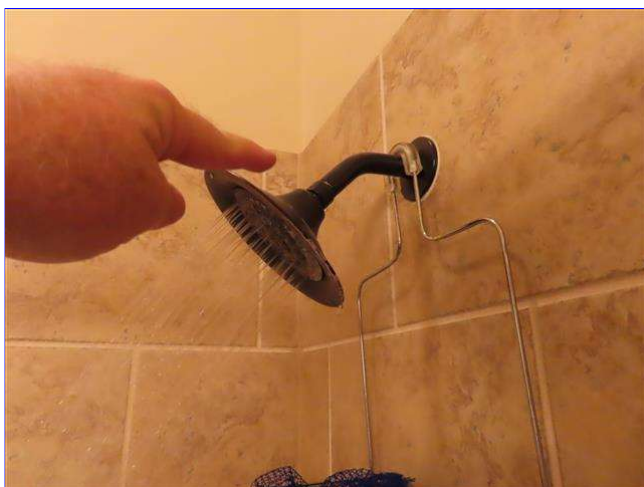
A. Item 6(Picture)

(6) Second floor bathroom showerhead was leaking at plumbing connection at time of inspection. Should have a professional plumber correct properly.

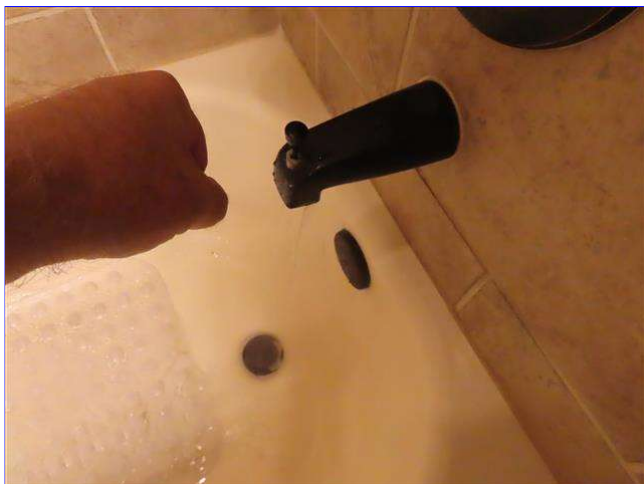
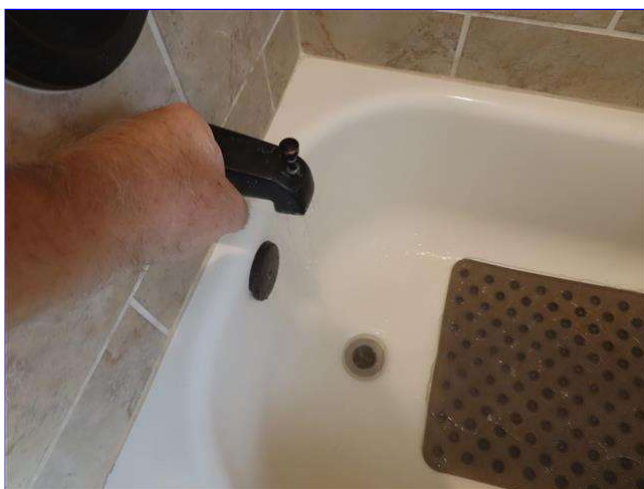
(7) Second floor bathroom shower diverters were not operating properly at time of inspection. Should have a professional plumber inspect and correct properly.

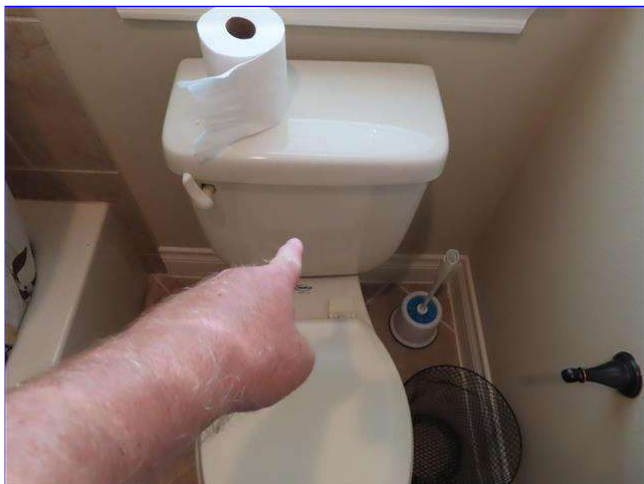
A. Item 9(Picture)

(8) Toilets bowls were loose at time of inspection. Should have a professional plumber correct properly. Conducive to leaking and causing possible damage.

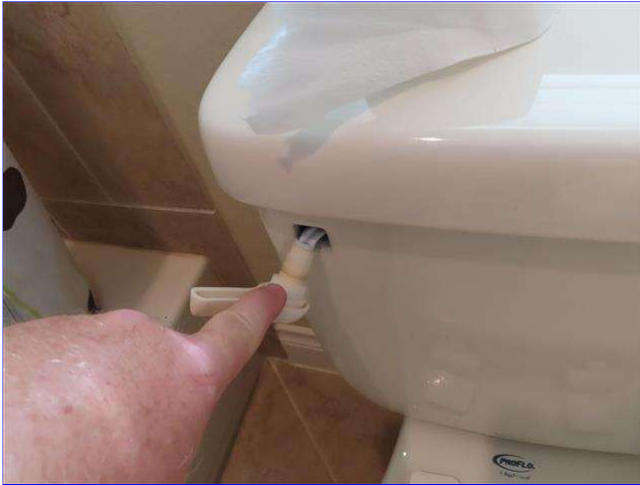
A. Item 10(Picture)

(9) Second floor bathroom toilet lever was loose from bowl at time of inspection. Should have a professional plumber correct properly.

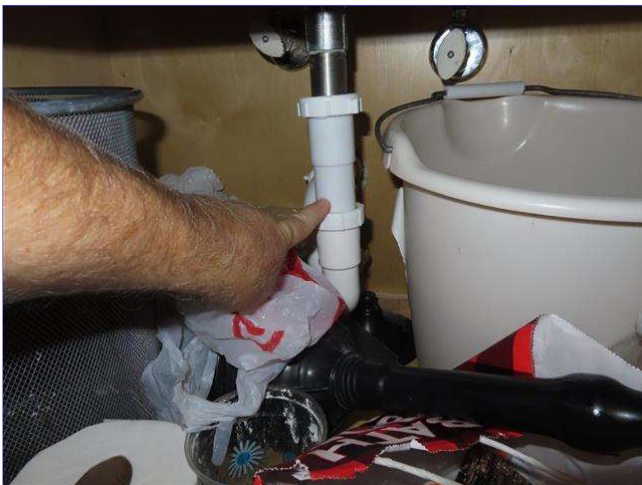
B. Item 3(Picture)

(3) Several bathrooms sink drain plumbing were loose at time of inspection. Conducive to leaking and causing possible damage. Should have a professional plumber correct.

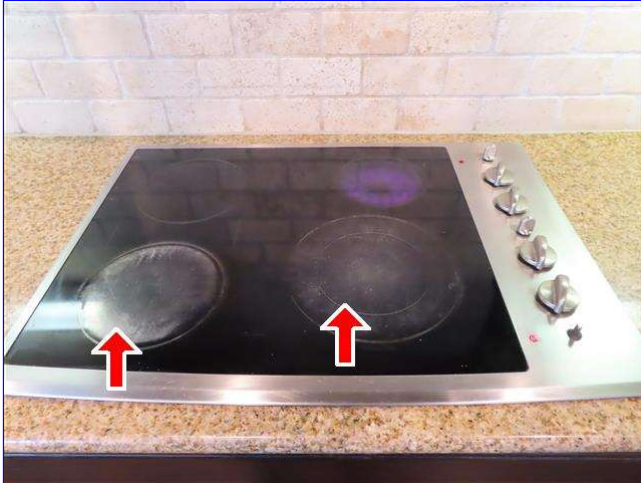
D. Item 1(Picture)

(1) GE electric cooktop was working properly at time of inspection. Cooktop has wear on several burners and control knob label was faded at time of inspection. Should have a professional correct properly.

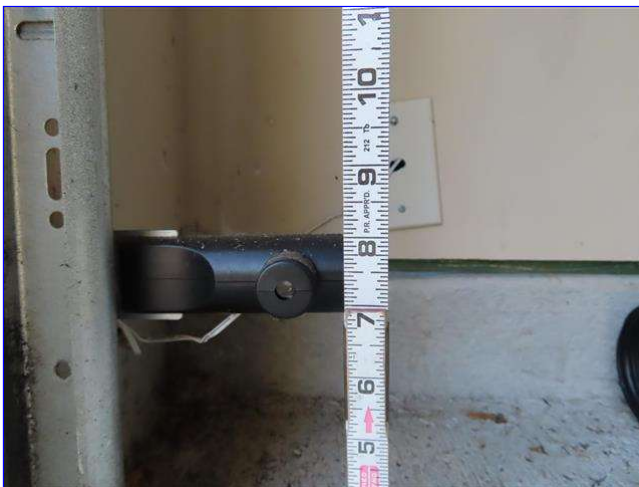
G. Item 2(Picture)

(2) Garage door electric eyes should be 6" from the ground. Should have a professional correct properly. This is a possible safety hazard.
