# PROPERTY INSPECTION REPORT

## BUYERS EYE HOME INSPECTION

**Concerning: 15314 State HWY 65 Winnie, Texas 77665**

**November 25, 2019**

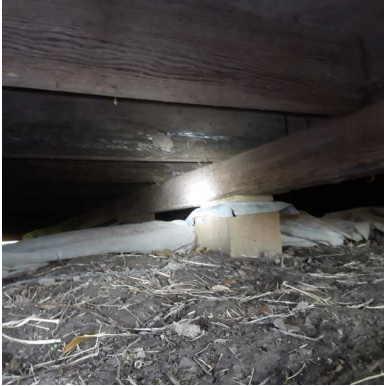
**Type of foundation: Block and Beam.** After inspection of the crawl space for cracks, leaning piers or the lack of, corresponding cracks in the vinyl siding, level or un-level floors, square and plumb doorjambes or the lack of, wall conditions, and structural condition. In this inspectors "opinion" the foundation may not be functioning as intended for the inspection period. There are several areas of the foundation that appears to have settled. **Deficient.** The crawl space could not be entered. A qualified foundation company should be consulted to inspect, study, and determine if the foundation has an acceptable deflection, and / or make necessary repairs, and re-level the home. This can be corrected simply by re-leveling. As a note the crawl space has dead grass stuck to the block termite shield, seals, and joist. It appears the flood waters from last big storm rose up under the foundation but appears not to have entered the home.

Grass debris under the home.

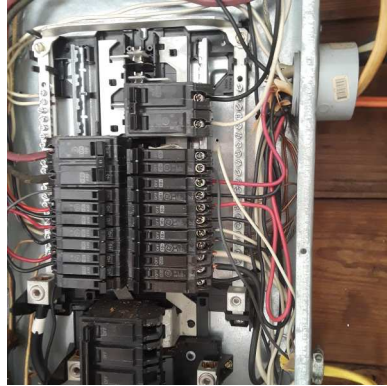
The electrical service panel is a General Electric 200-amp panel with the disconnect located in the panel. An old Square "D" 60-amp sub panel is located in the hallway (this may be the original service panel). Copper wiring, correct breaker and wire sizing are present. Appears to be functioning as intended for the inspection period. AFCI breakers are not installed. **Deficient.** This home was constructed well before this code was established. See note below. The small garage has a sub panel that may be powered by the service panel in the large barn which is in very poor condition. **Deficient.** As a note the large barn has its own electric meter.

Newer service panel.

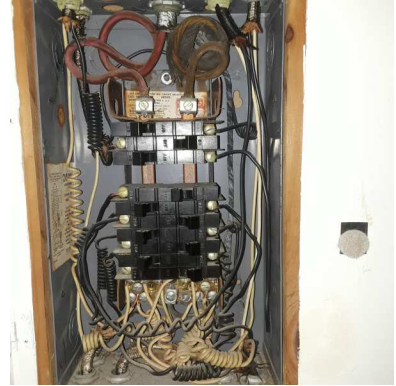
Sub panel in the hallway.

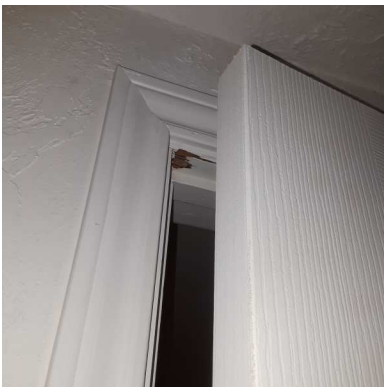
Appears to be functioning as intended for the inspection period. The front left bedroom entry door drags the casing at the top. **Deficient.**

Bedroom door dragging.

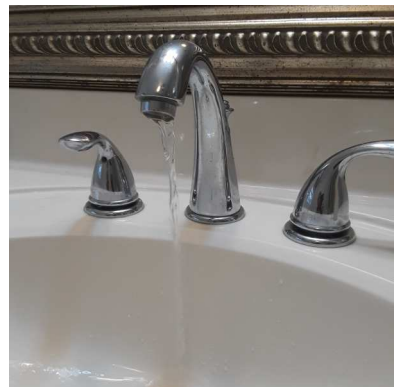
Appears to be functioning as intended for the inspection period. Water pressure appears normal. Not all fixtures operated correctly. The exterior faucets are not equipped with back flow devices. **Deficient**. The home is equipped with plastic CPVC and copper pipe. The location of the water meter is unknown. The location of the main water shut off is unknown. The static water pressure is 48 psig., on the day of inspection. There is low water flow to the hall bathroom sink and no flow to the end of the hall tub. **Deficient**.

Low water flow.

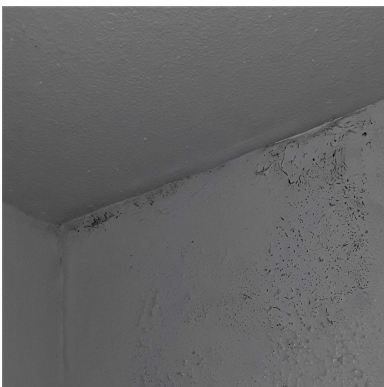
Appears to be functioning as intended for the inspection period. The interior drywall is in good condition. There is some sign of foundation settlement as well as some texture repairs. **Deficient**. There is what appears to be some mildew on the wall behind the hall toilet. **Deficient**. The exterior materials are vinyl siding, and trim. It appears several courses of vinyl has been replaced for unknown reasons.

Mildew in bathroom wall.

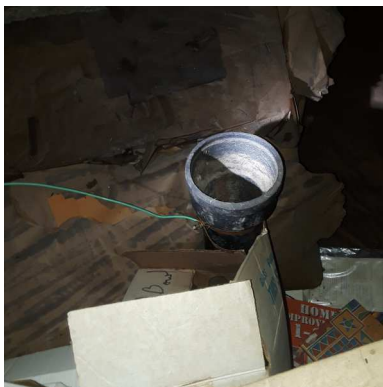
Appears to be functioning as intended for the inspection period. No assessment can be made of the condition of the drains from the home to the pump grinder system. The main four inch vent pipe is venting into the attic space. **Deficient**. It appears all plumbing vents are venting to the attic. **Deficient**.

Vent into attic.

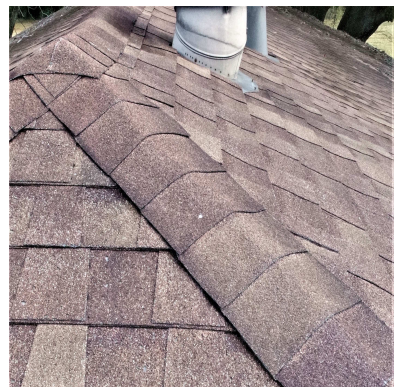
Appears to be functioning as intended for the inspection period. A TDI certificate of compliance WPI-8 was issued for the entire re-roof 11/29/2007. The composition shingle roof was inspected by drone. This appears to be a midlife covering. There is some gravel loss and no spider cracking at this time. An average composition shingle covering last approximately 15 to 23 years in the gulf coast area. It appears this covering is aging normally. The method of shingle attachment is unknown. It would require pulling up of a shingle and destroying the adhesive bond. The fascia and soffit material are wood based. As a note the corrugated steel roof of the small garage has been patched. And the large barn corrugated steel roof has several holes in it. **Deficient**. Tree limbs should be cut back at least four feet from any roof covering. **Deficient**.

Little gravel loss, no spider cracking.

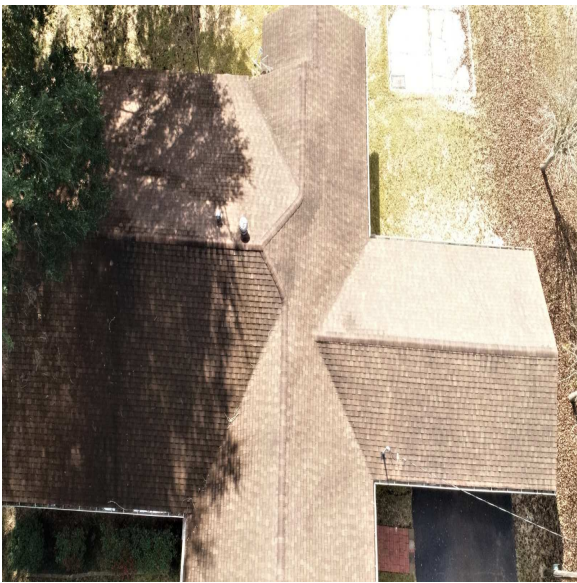
Roof typical.

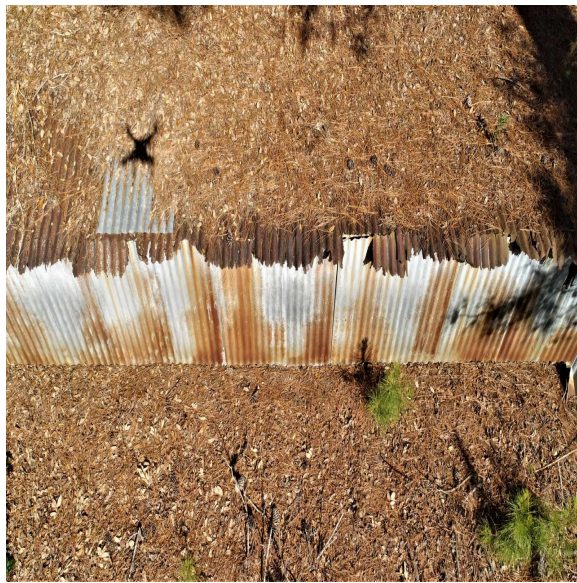
There are two outbuildings. The small garage is in poor condition but easily brought back to life. The large barn and side shelter have several issues. The roof structure in the large barn is water damaged. **Deficient**. The corrugated steel roof is rusted through in several areas. **Deficient**. The side shed roof is growing vegetation. **Deficient**.

Big barn, Side shed.

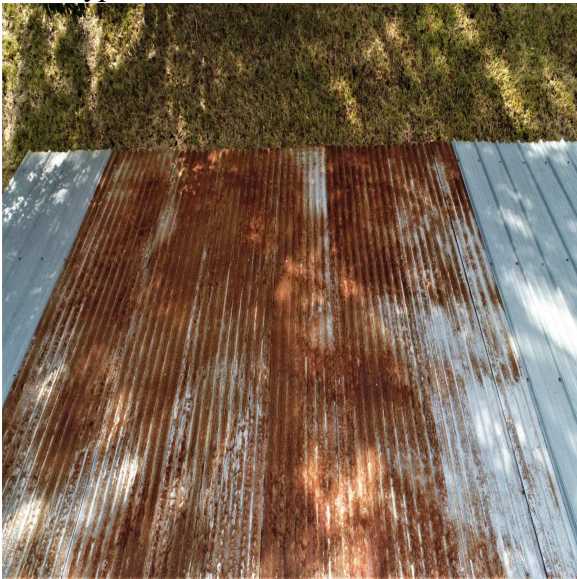
Small garage roof.

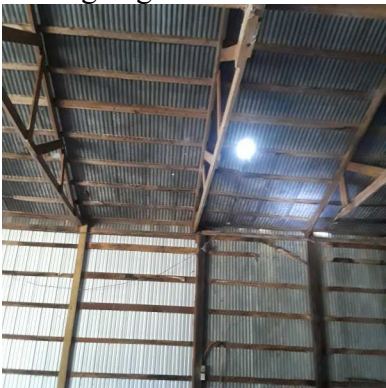
Holes in large barn roof.

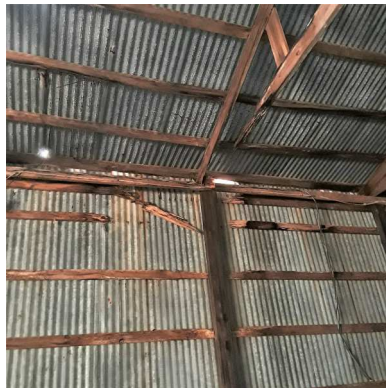
Water damage in large barn.

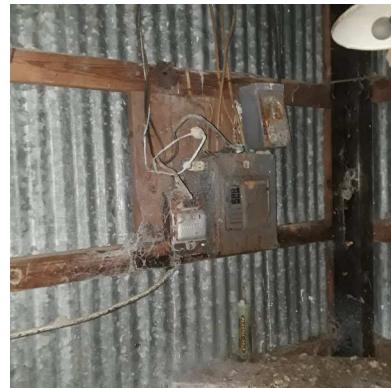
Large barn service panel.
